Appendix 2: Tree Survey Report

A Tree survey and Arboricultural Impact Assessment.

**For,
Majors wells road,
Longford,
Co. Longford.**

**Prepared for,
Longford County Council.**

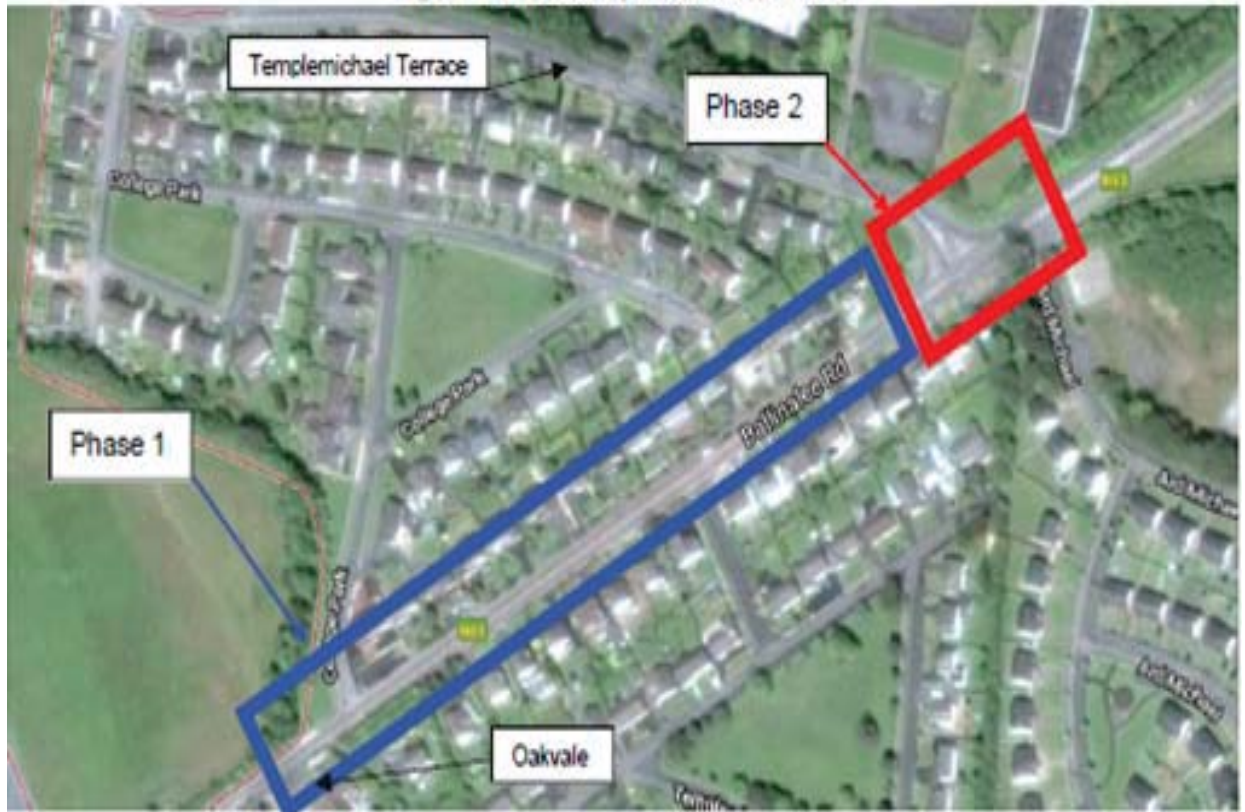
Figure 1.1: N63 Majors Wells Scheme

Figure 1. Displays the surveyed areas.

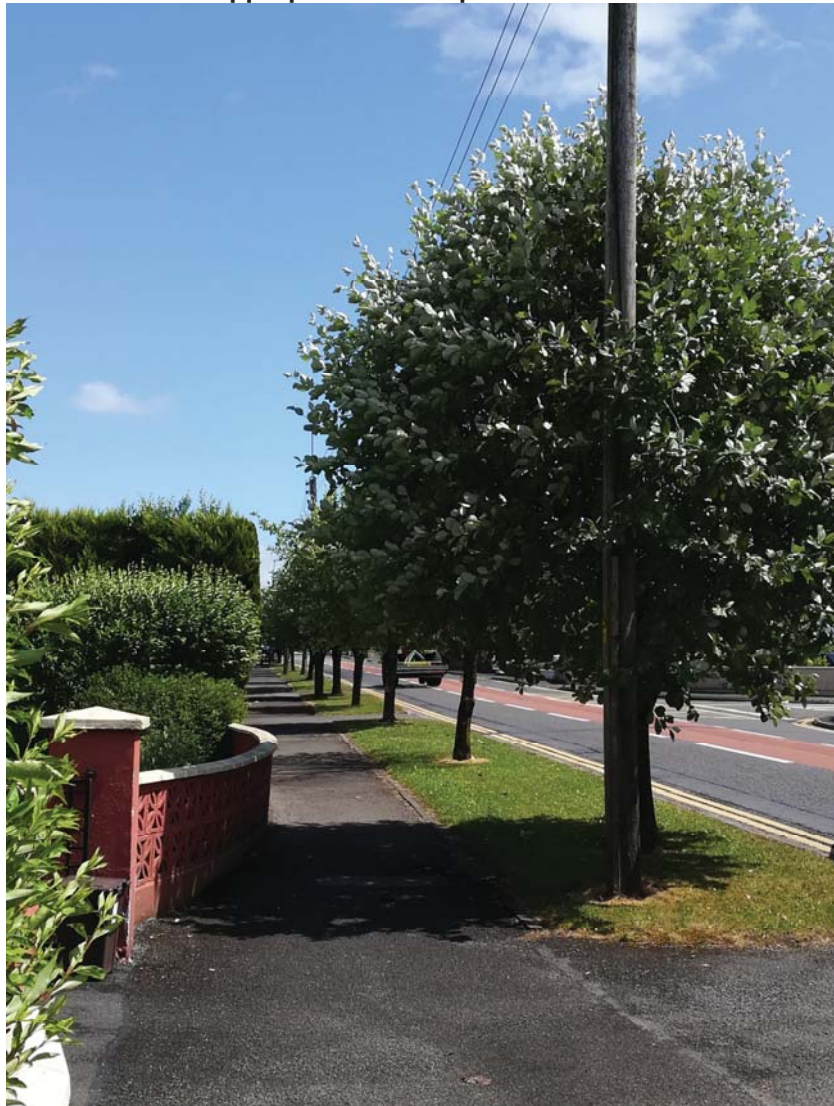
Figure 2. Displays an example of the surveyed trees. This is a Whitebeam that would be appropriate for a replacement trees.

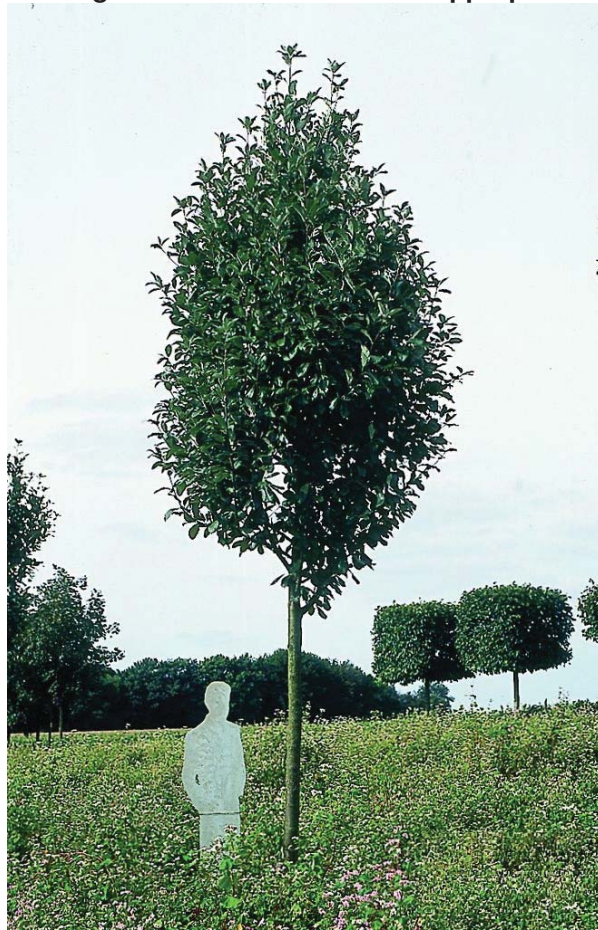
Figure 3. Mountain ash this is appropriate for a replacement tree, the image shows the 'Fastigata' form which would be appropriate.
