Stage 1/2 Road Safety Audit Interim Report
Proposed Residential Development, St. Rita's, Park Road, Longford
January 29, 2021

Client:	Cunningham Design and Planning
Document No:	211_011-ORS-XX-XX-RP-TR-7d-001

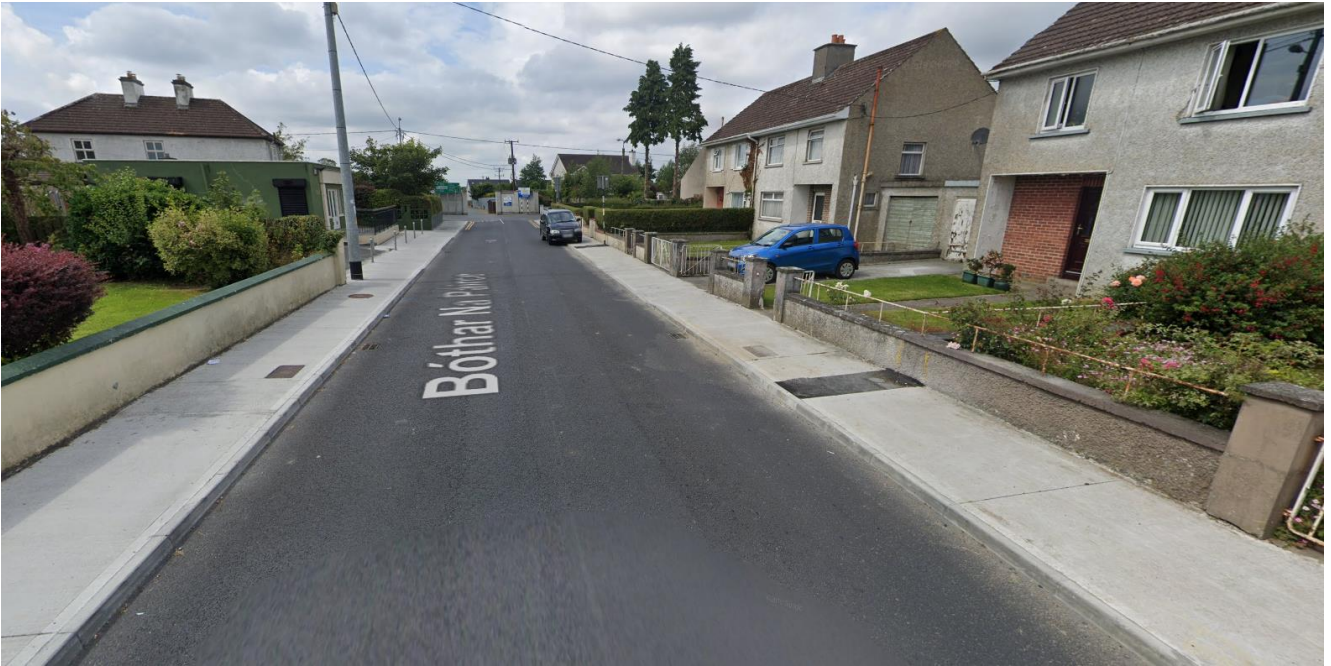
Problem No. 1: Vehicular Sightlines

Location: Along Park Road from site access junction

The audit team note from the drawings provided that sightline distances are not marked clearly on the drawings. Inadequate sightlines for vehicles exiting the development and/or for vehicles travelling along Park Road may lead to unsafe exit manoeuvres by vehicles departing the development which could cause vehicular collisions, leading to injury.

Figure B.1 – View west along Park Road from proposed new access location (Source: Google Maps)

The design team should ensure that the visibility and sightlines for vehicles exiting the development are appropriate to ensure that drivers can see vehicles approaching along Park Road from either direction.

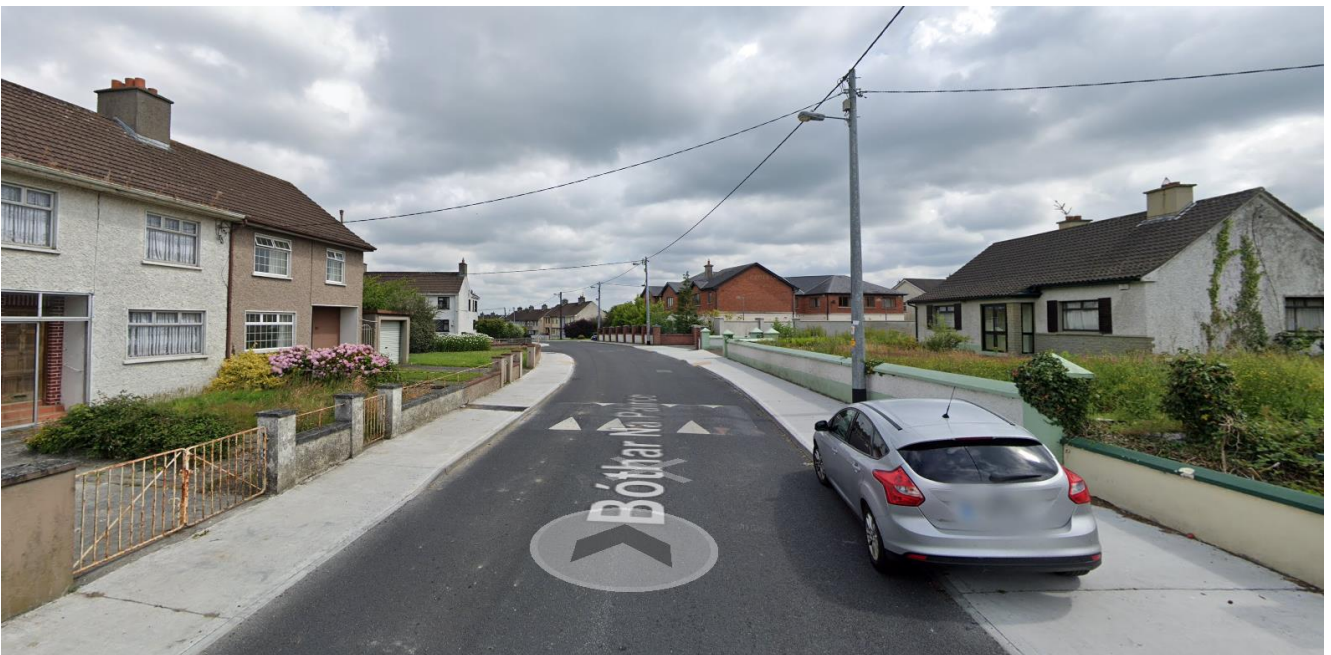
Figure B.2 – View east along Park Road from proposed new access location (Source: Google Maps)
