ASBESTOS SURVEY REPORT

(Refurbishment / Demolition Survey)

**Location: No. 24 Congress Terrace,
Longford Town, Co. Longford**

Report No. PE21-457

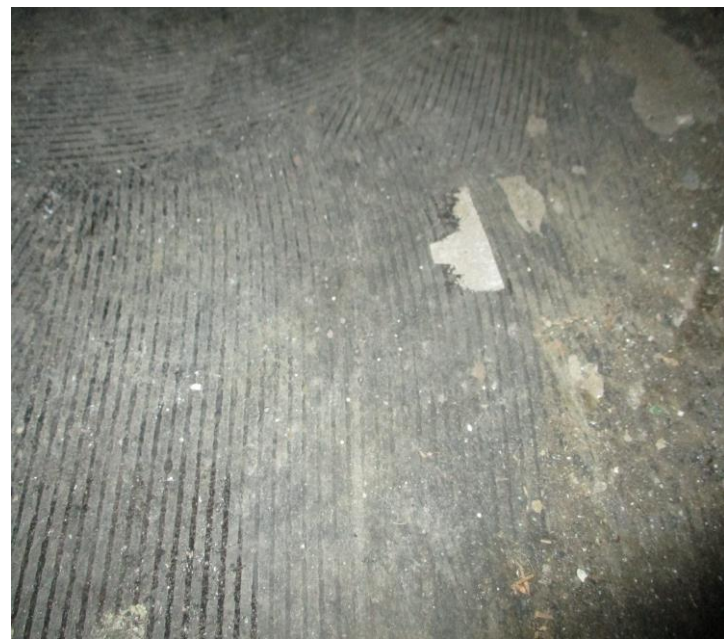
Created By	John Hickey
Date	25 th May 2021
Site Details	No. 24 Congress Terrace, Longford Town, Co. Longford
Client Name	Longford County Council
Survey Type	R/D Asbestos Survey
Site Ref	PE21-457
Building Ref.	No. 24 Congress Terrace
Location	Kitchen & front room
Extent/ Amount	35 m ² approx.

MATERIAL ASSESSMENT		PRIORITY ASSESSMENT
Product type	Bitumen adhesive	Normal occupant activity	N/A
Extent of damage	Low	Likelihood of disturbance	N/A
Surface treatment	Well bound material	Human exposure potential	N/A
Asbestos type	Chrysotile	Maintenance activity	N/A
	Material assessment score: N/A	TOTAL SCORE: N/A	Priority assessment score: N/A

The bitumen adhesive identified on the floor in the entrance, kitchen and front room contains Chrysotile (white) asbestos fibres. Bitumen adhesives contain a small quantity of asbestos fibres

As the floors are likely to be disturbed during the forthcoming refurbishment works, the asbestos containing bitumen adhesive should be removed by an asbestos removal contractor and disposed of as asbestos waste before the refurbishment works commence

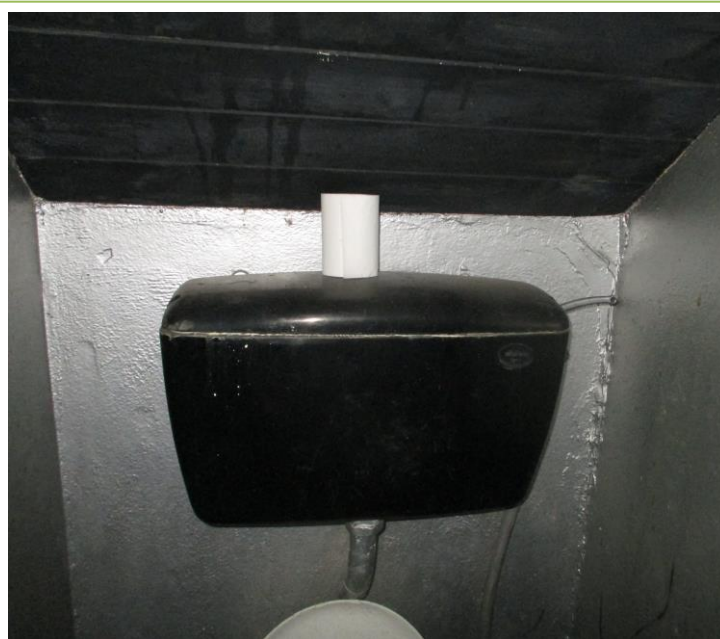
Created By	John Hickey
Date	25 th May 2021
Site Details	No. 24 Congress Terrace, Longford Town, Co. Longford
Client Name	Longford County Council
Survey Type	R/D Asbestos Survey
Site Ref	PE21-457
Building Ref.	No. 24 Congress Terrace
Location	Ground floor W/C
Extent/ Amount	1 cistern

MATERIAL ASSESSMENT		PRIORITY ASSESSMENT
Product type	Resin toilet cistern	Normal occupant activity	N/A
Extent of damage	Low	Likelihood of disturbance	N/A
Surface treatment	Composite material	Human exposure potential	N/A
Asbestos type	Amosite	Maintenance activity	N/A
	Material assessment score: N/A	TOTAL SCORE: N/A	Priority assessment score: N/A

The resin toilet cistern identified in the W/C on the ground floor contains Amosite (brown) asbestos fibres. Resin products may contain between 20 and 50% asbestos fibres

As the toilet is likely to be disturbed during the forthcoming refurbishment works, the asbestos containing resin toilet cistern should be removed by an asbestos removal contractor and disposed of as asbestos waste before the refurbishment works commence

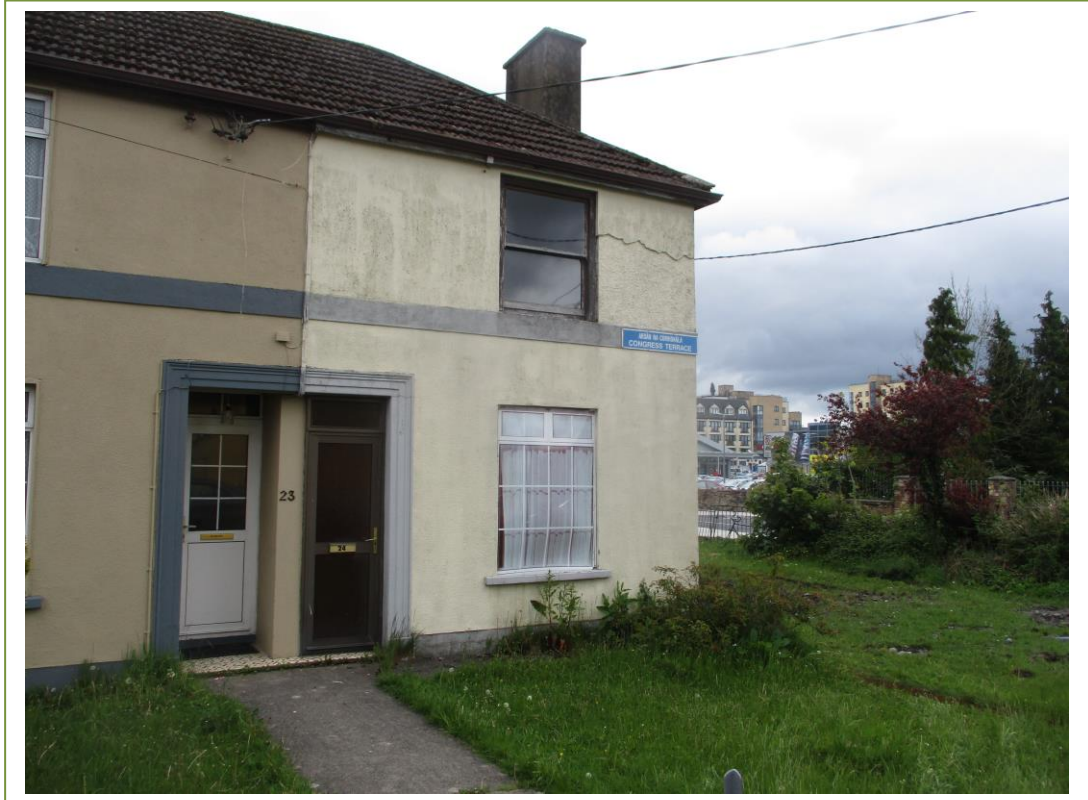
Concrete tiles on the roof of the house

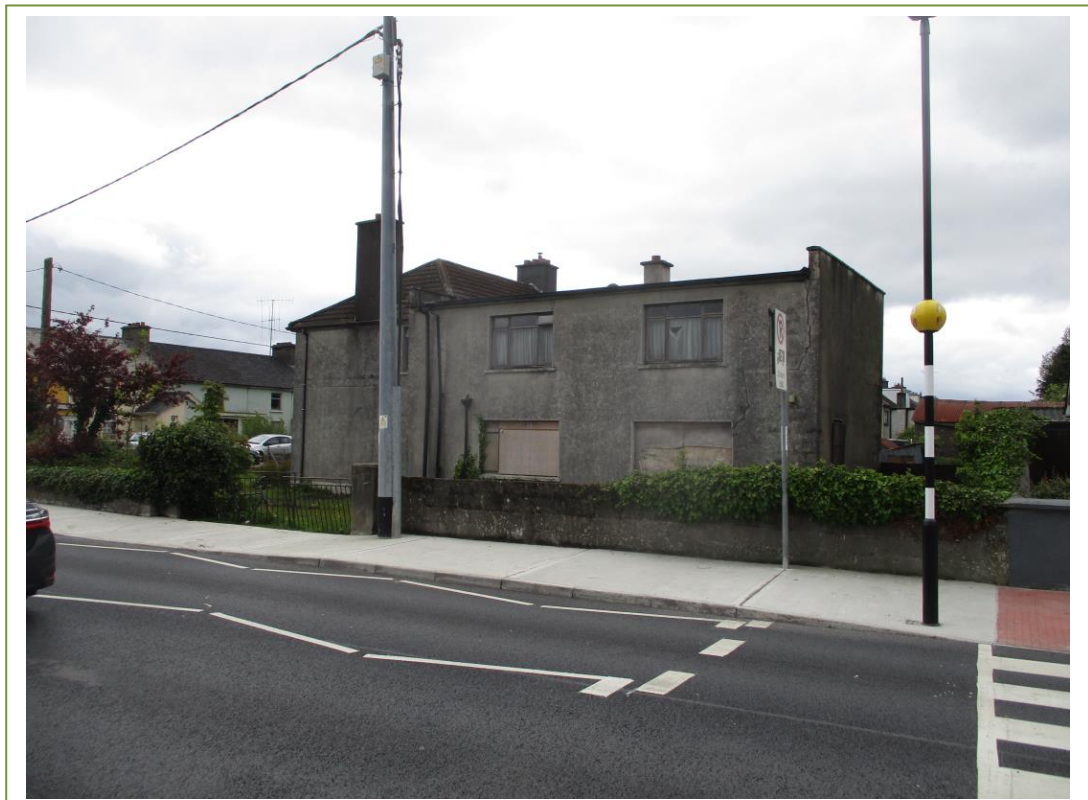
Felt on the flat roof on the rear extension

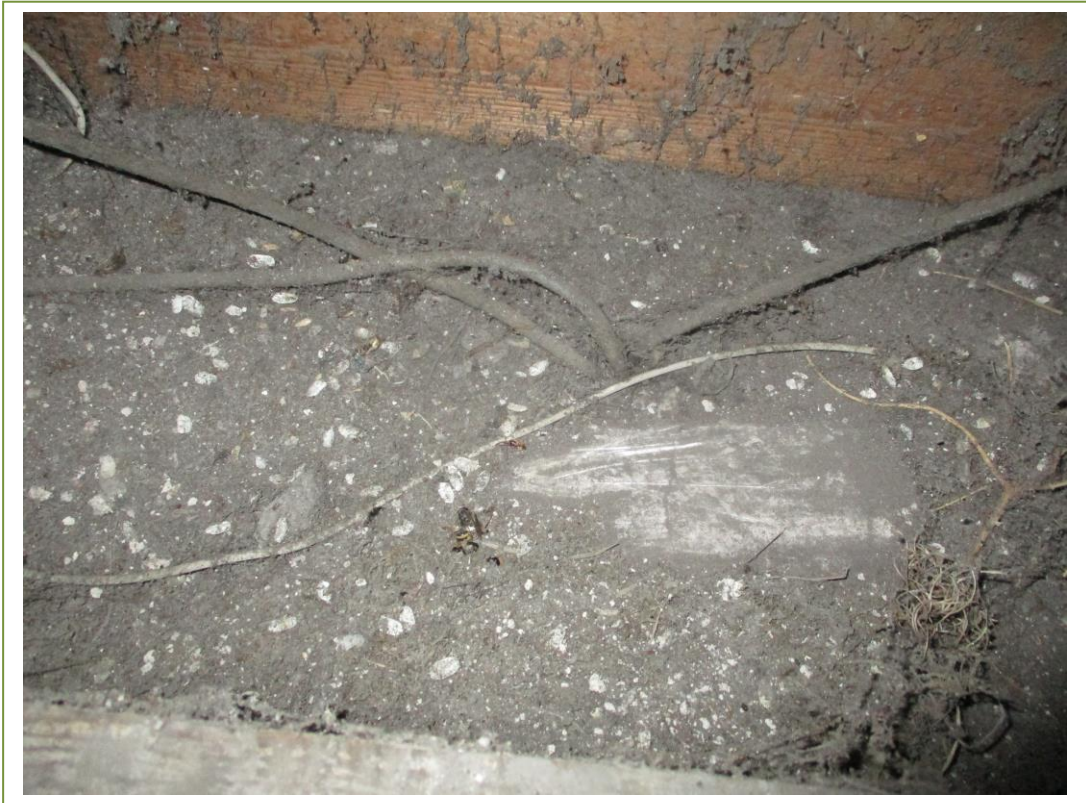
Plasterboard on the ceilings

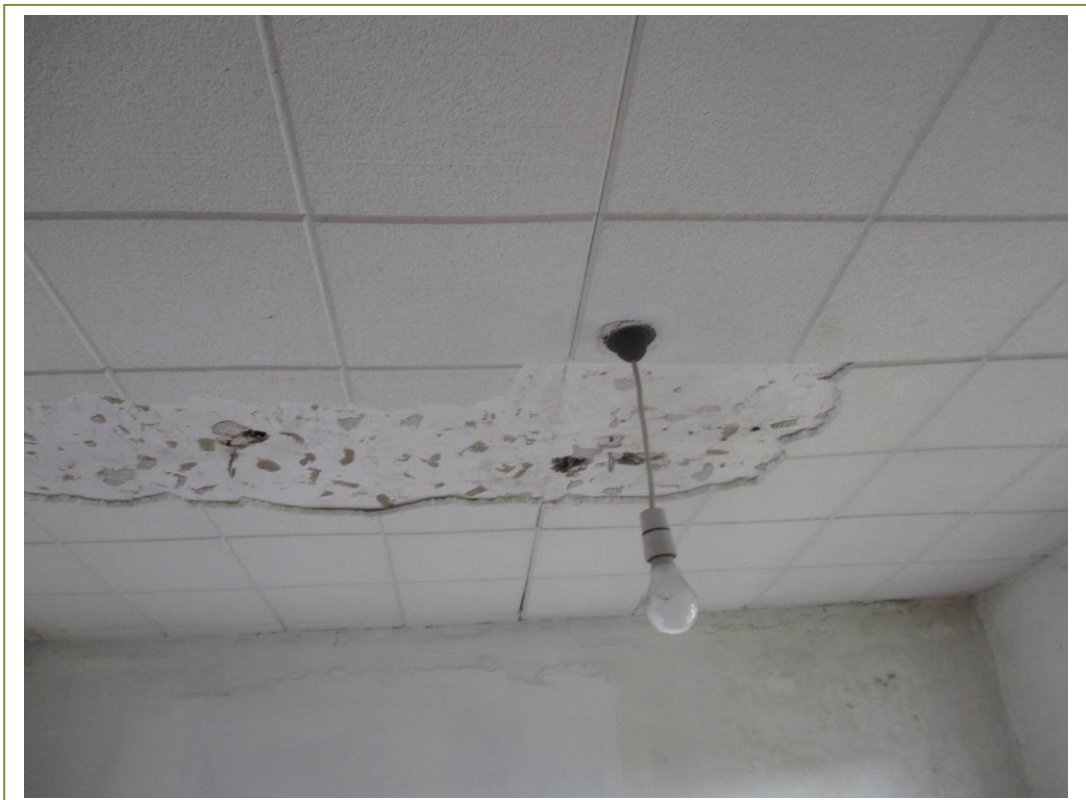
Polystyrene ceiling tiles

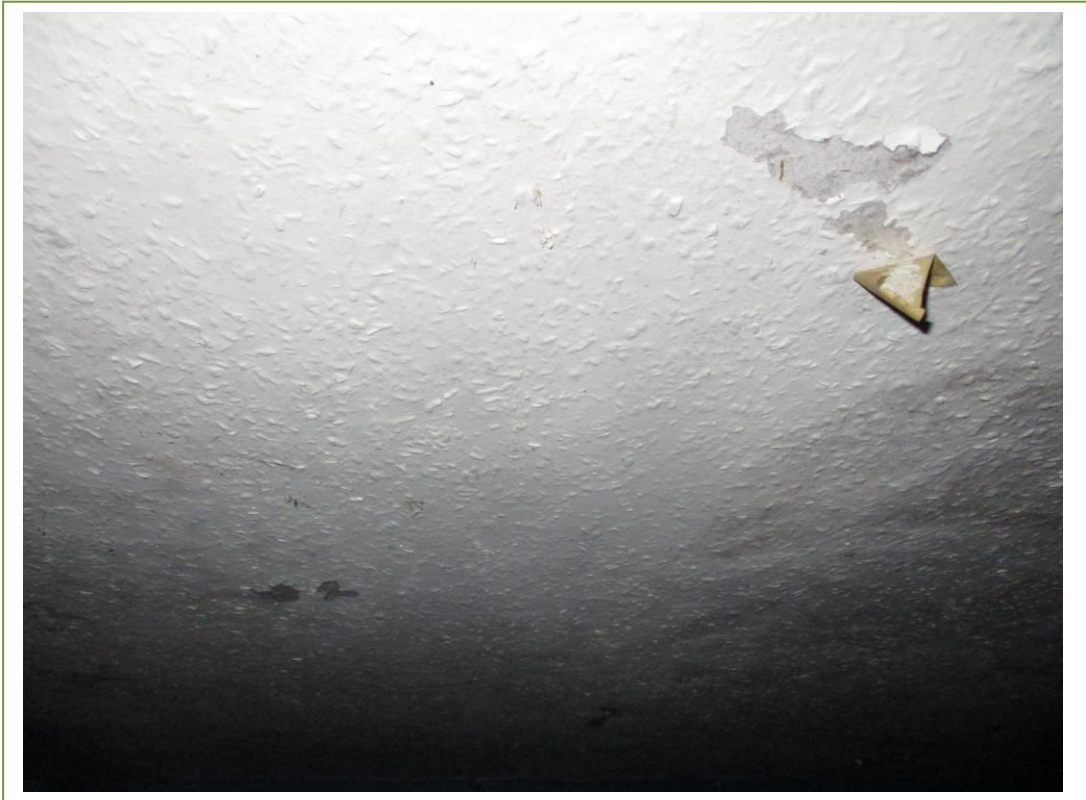
Woodchip paper on the kitchen ceiling

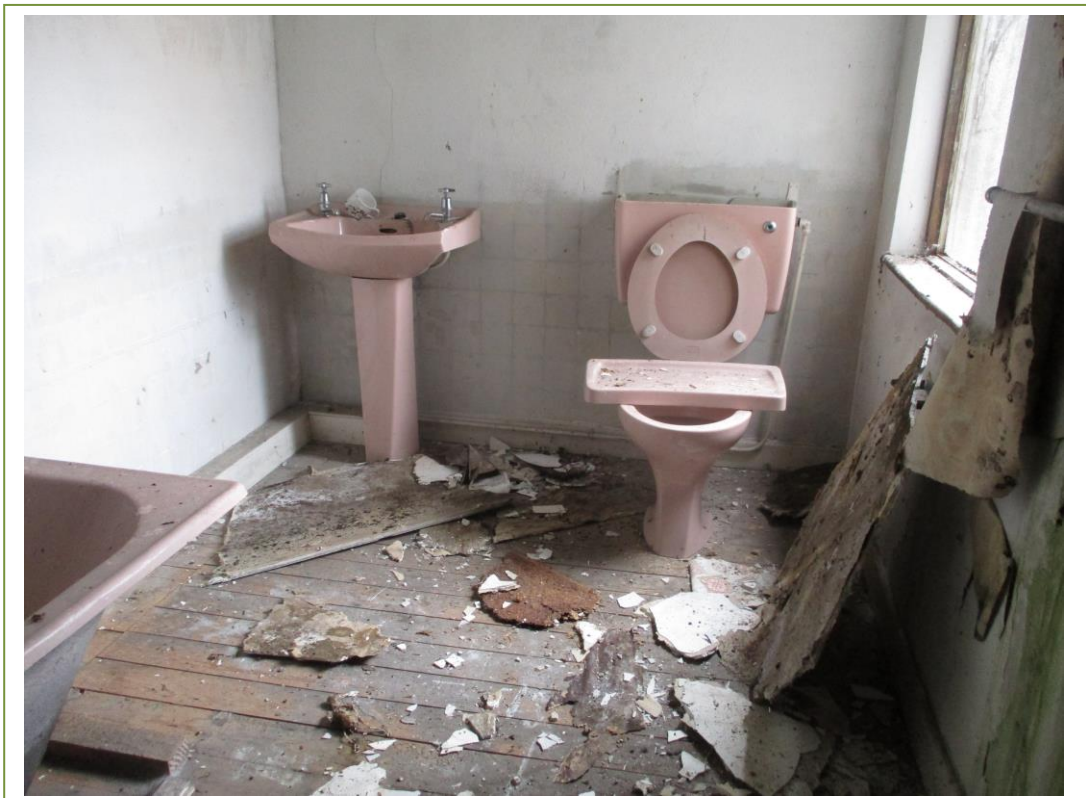
First floor sanitaryware

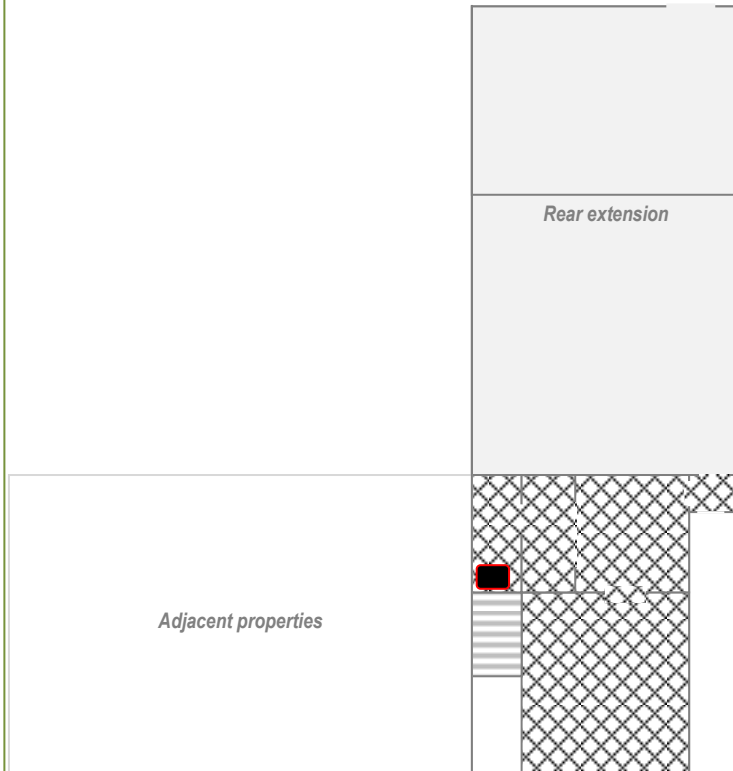
GROUND FLOOR PLAN

Areas where asbestos containing bitumen adhesive was identified

Area where an asbestos containing toilet cistern was identified
