### Pre-Condition Survey

23 Congress Terrace  
Townspark  
Longford  
Co Longford

Prepared by – Darragh Rowan  
File Ref: 21.107  
Dated 16<sup>th</sup> August 2021

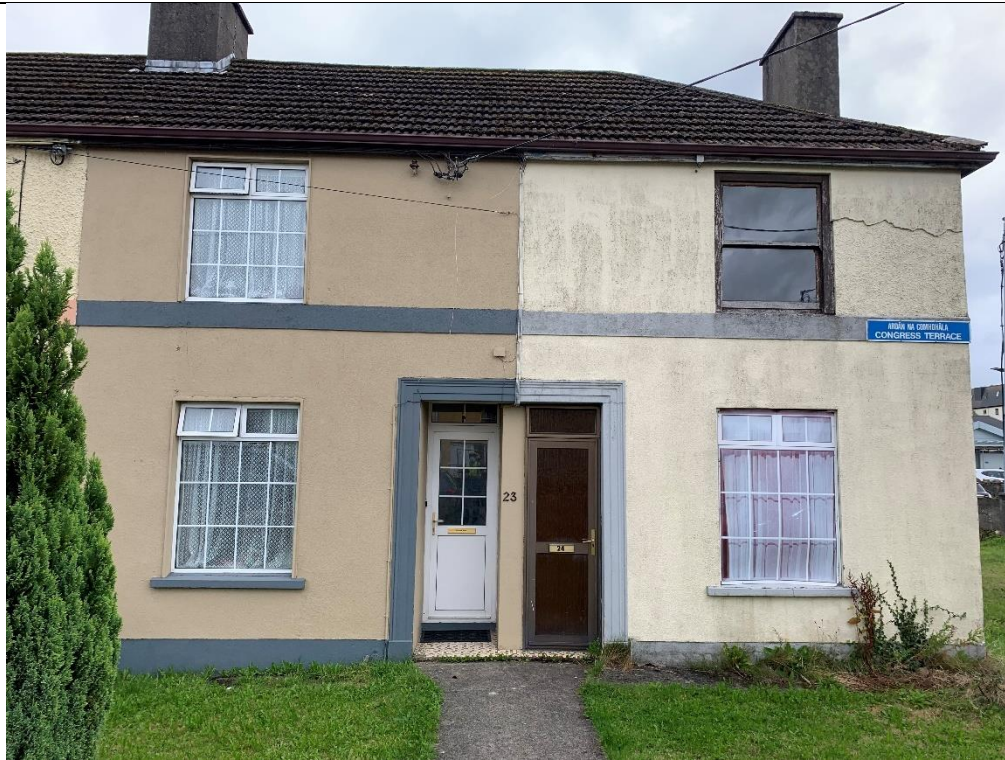
1.

No 23 and no  
24 Congress  
Terrace

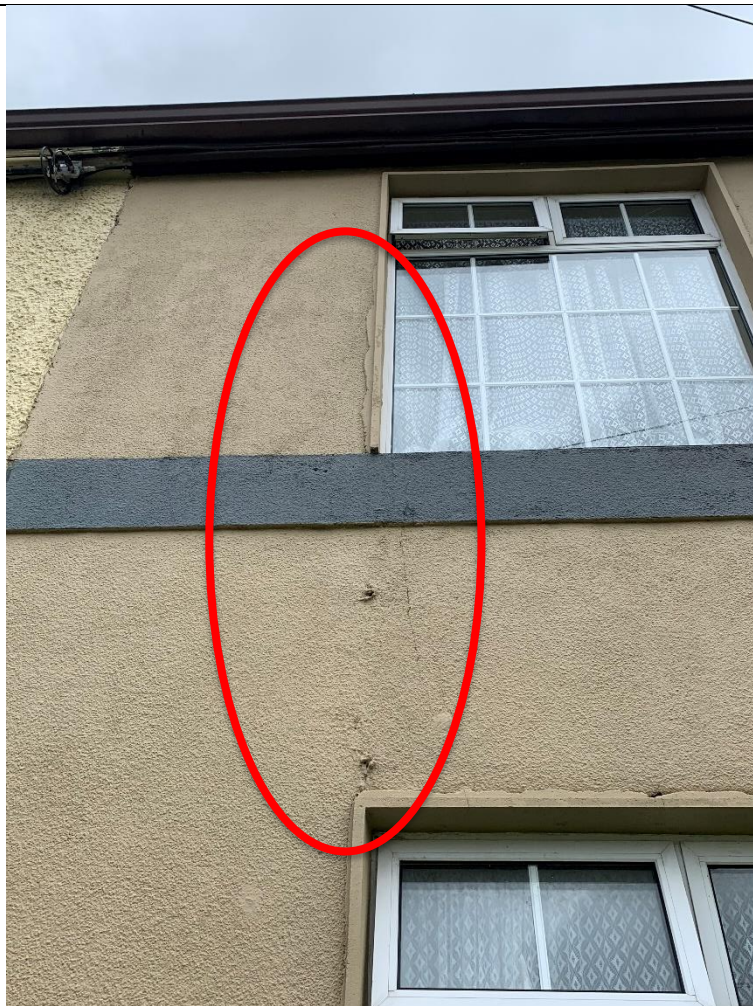
2.

Vertical cracking  
in the plastered  
render between  
the ground floor  
and first floor  
windows.

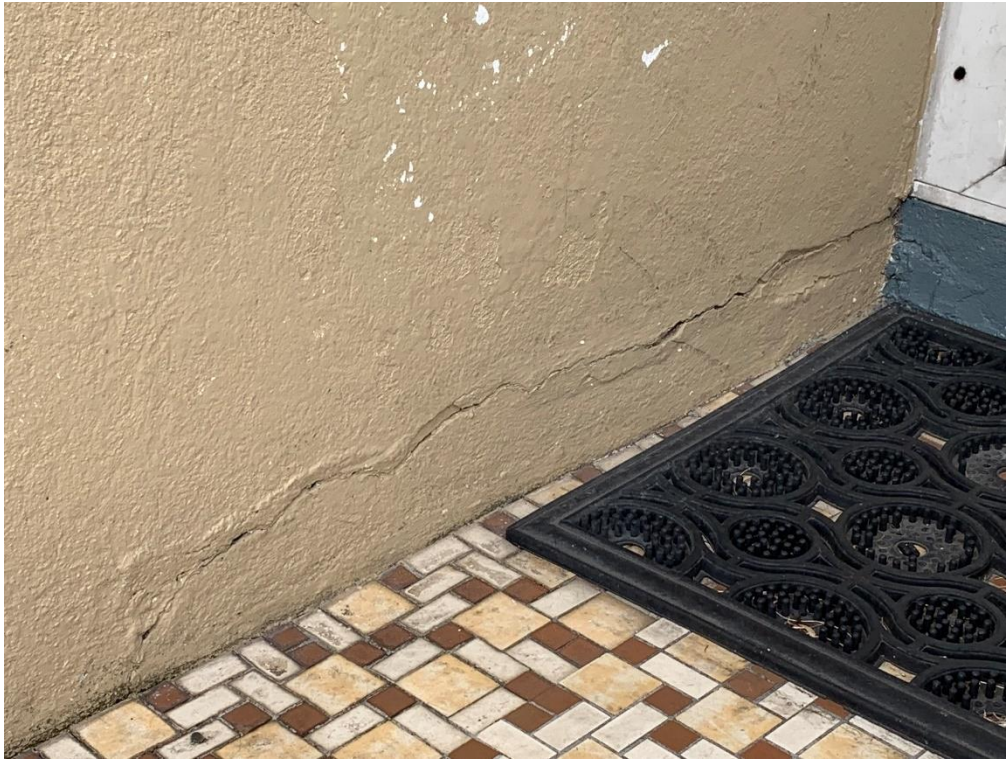
3.

Horizontal cracking at threshold in entrance porch.

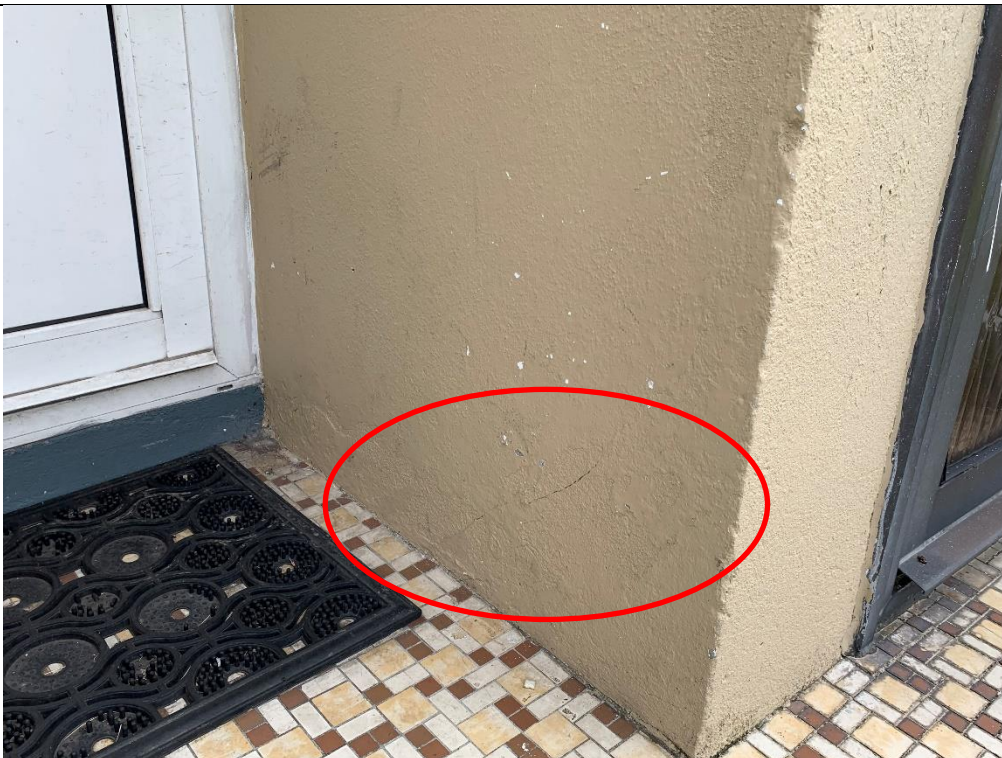
4.

Vertical cracking at low level in entrance porch along party wall of the property.

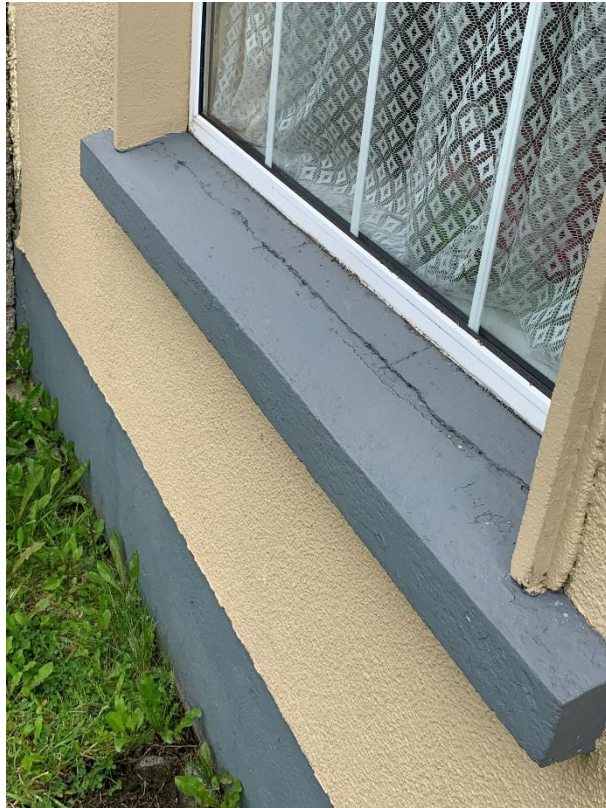
5.

Ground floor window cill cracked and boast.

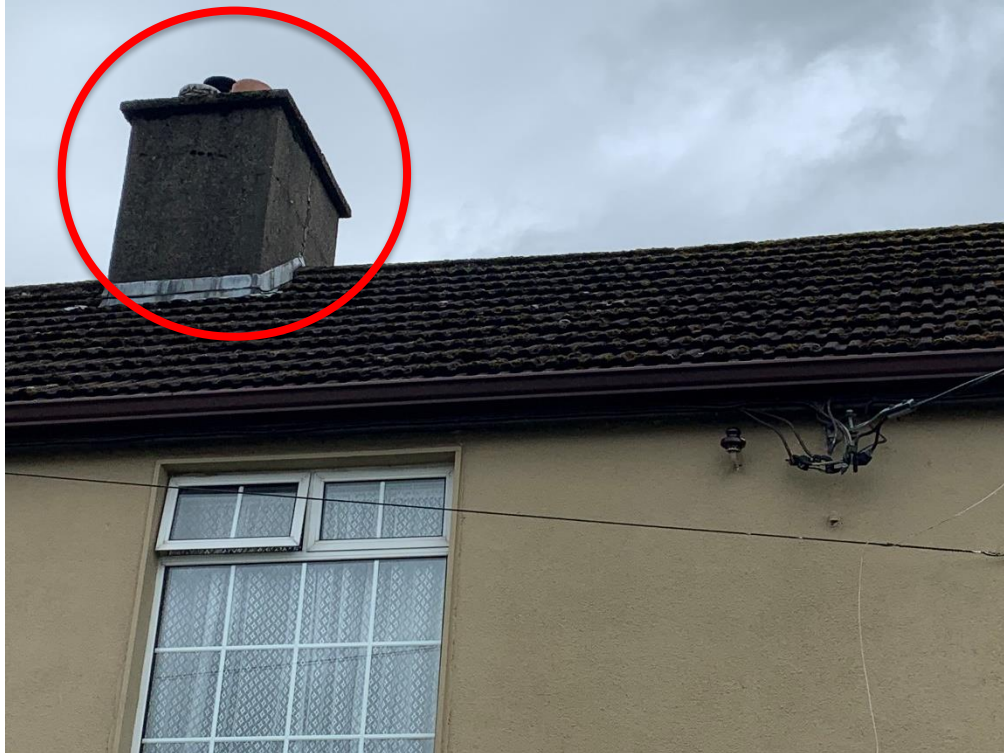
6.

Vertical and horizontal cracking visible in chimney stack.

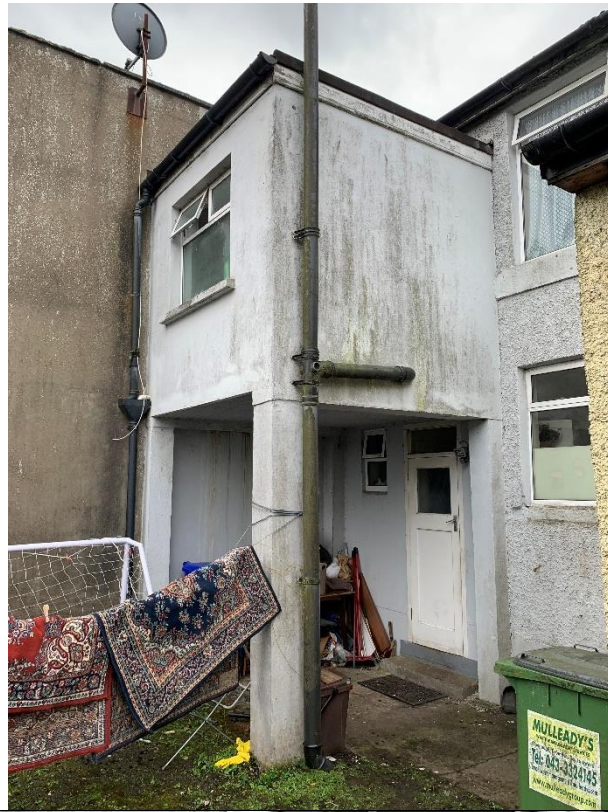
7.

Rear extension to property.

- 5.1 Due to the poor condition of the rear extension extreme care will be required when carrying out excavation in the proximity of the supporting concrete columns. This extension does not appear to be adequately tied to the rear wall of the property.

- 1. Construct a Temporary Stud partition inside the existing first floor bathroom and demolish the extension to the adjoining property. The new cavity wall to adjoining property will form anew external wall for first floor extension. New roof flashings and movement joists to be provided to extension with wall tiled and bathroom decorated and made good.

- 2. Retain wall of rear extension which will require temporary shoring/propping and tie into new extension to adjoining property.

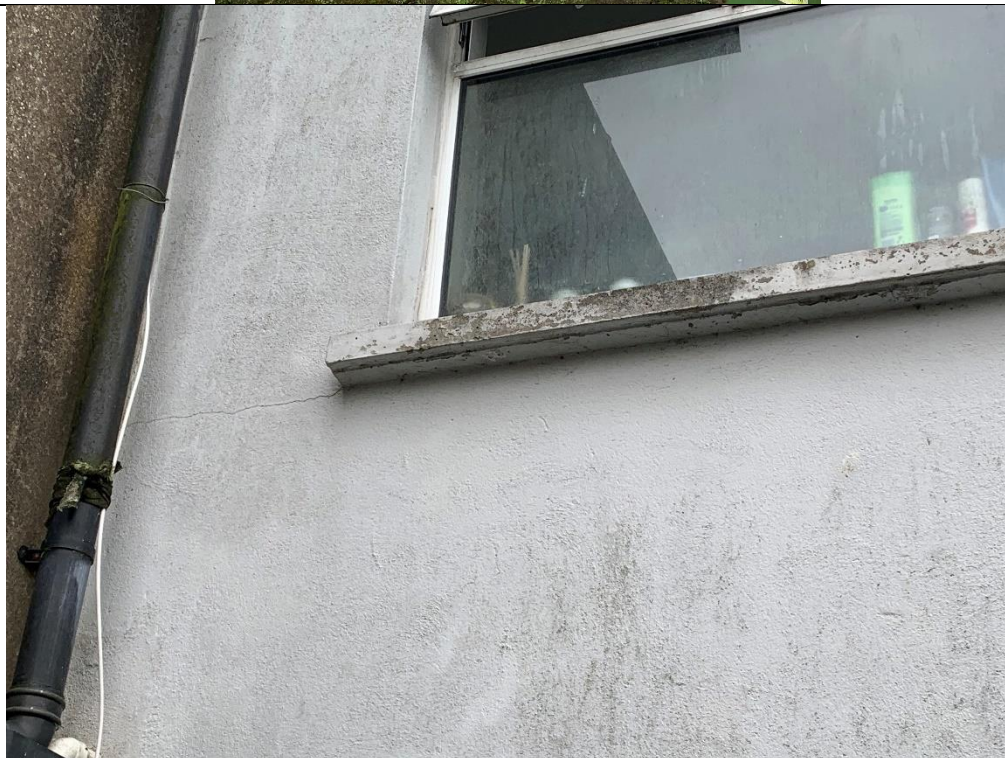
8.

Horizontal cracking at cill level of first floor bathroom window.

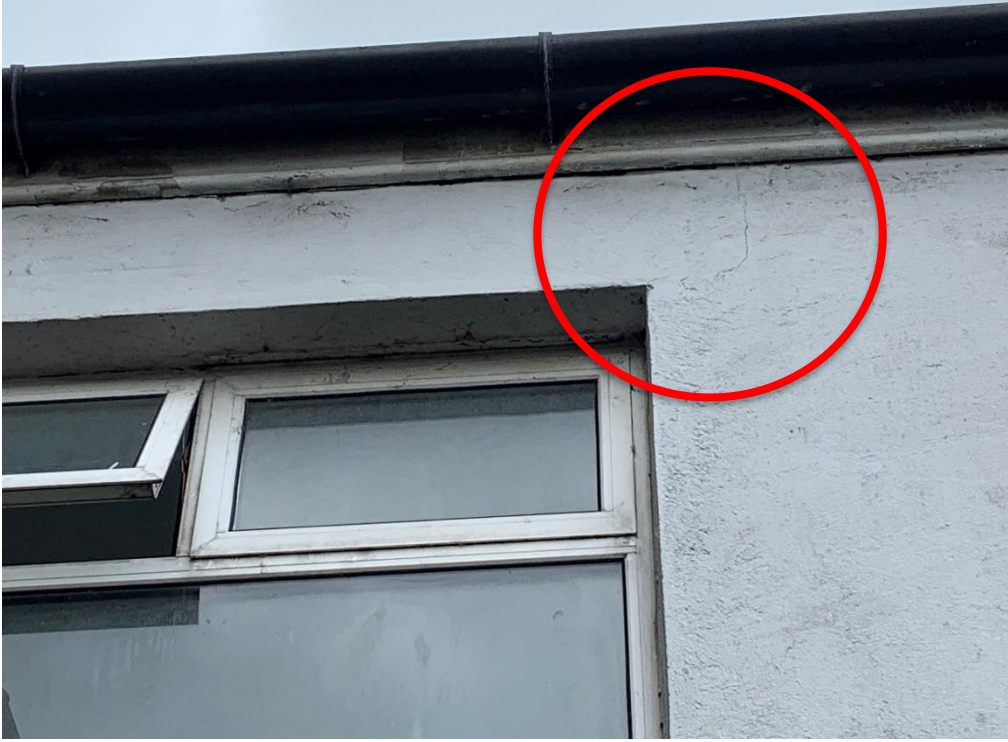
Diagonal crack to RHS of first floor window head.

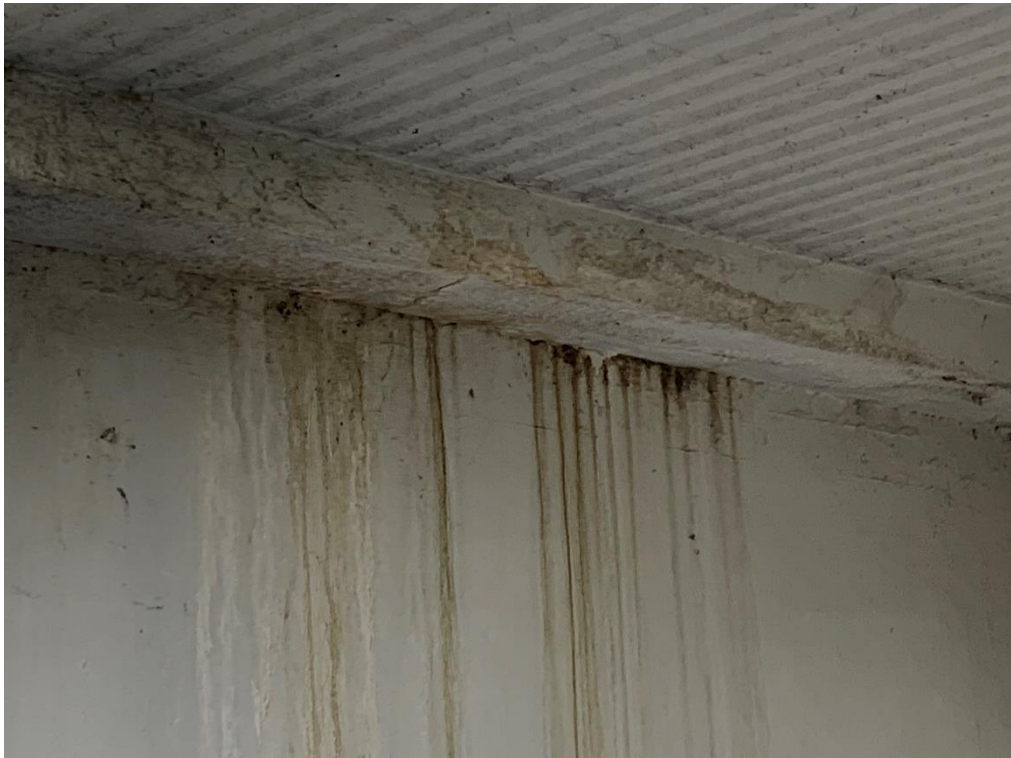
11.

Efflorescent staining to R.C Beam below first floor extension. Staining also evident on Boundary Wall which may be due to leak in bathroom
12.

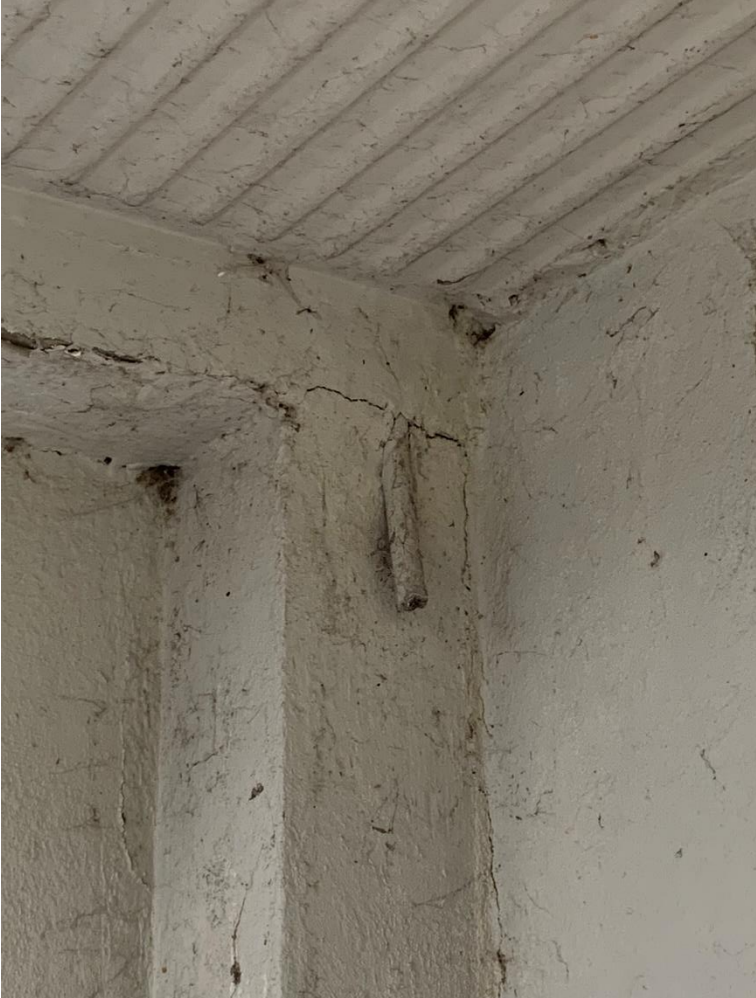
Horizontal crack between concrete beam and concrete column.

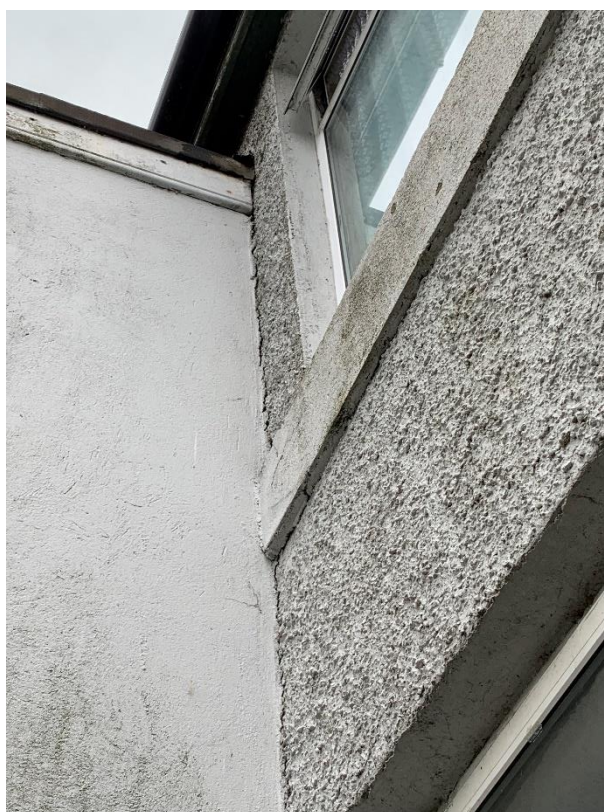
13.

Rear extension is abutted to original property, Note the slight joint between the plastered wall and the dashed wall. This may be due to no wall ties installed during construction.

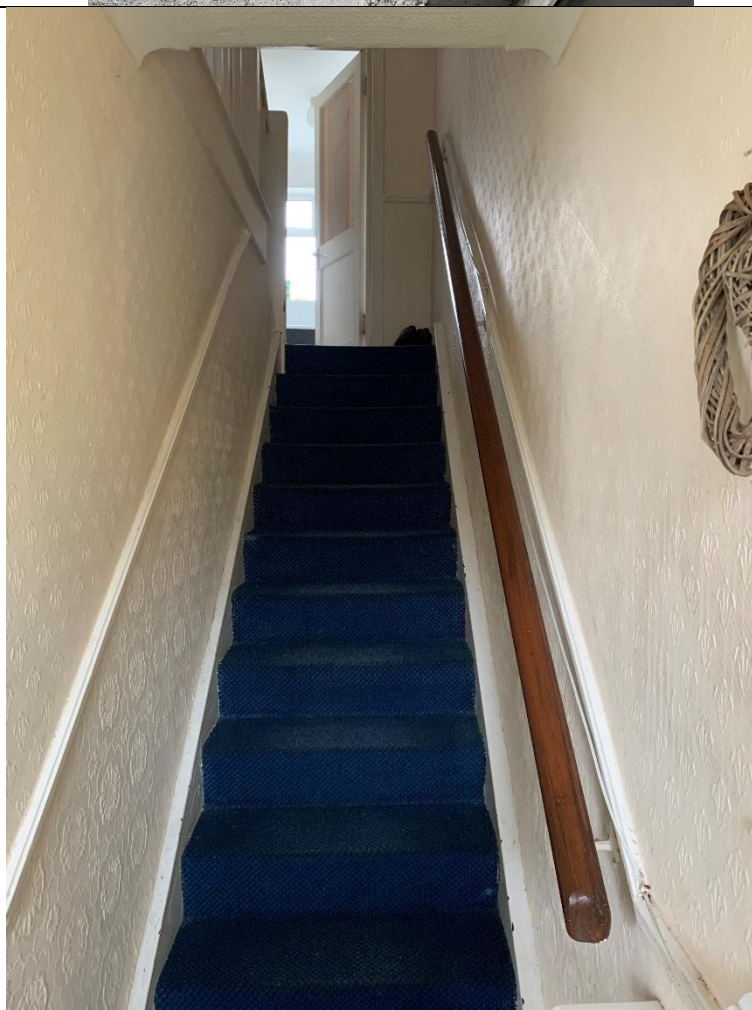
14.

Entrance hall and landing. Party Wall covered with wallpaper.

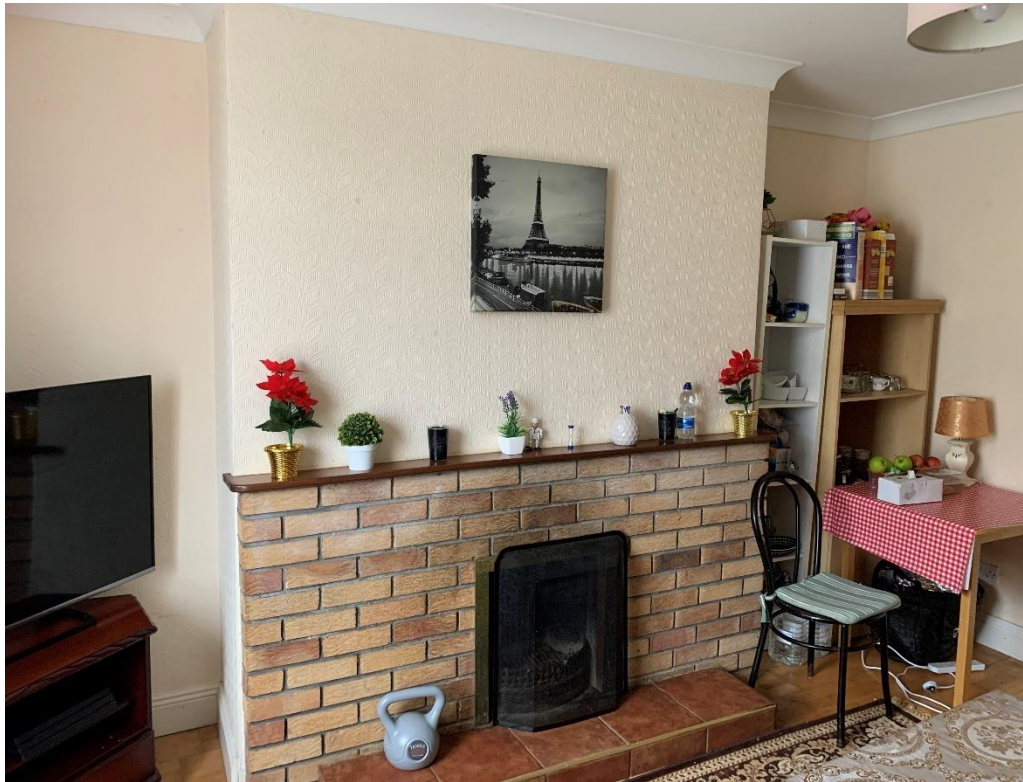
15.

Ground floor living room wall covered with wall paper.

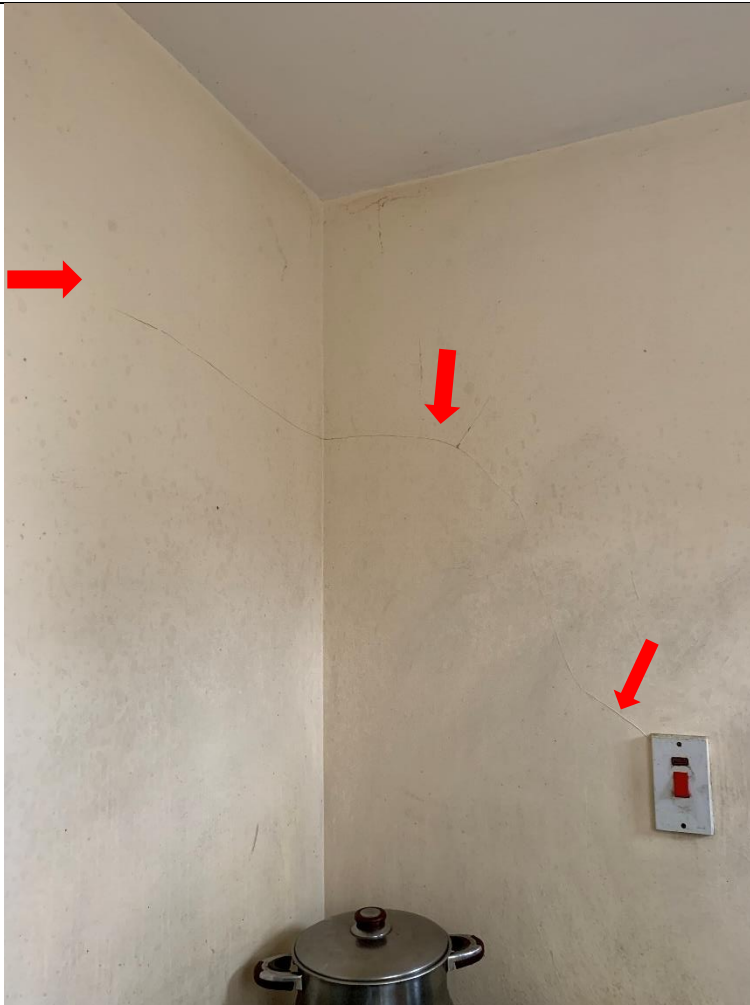
16.

Kitchen located to rear of property. Diagonal crack staggering between two walls

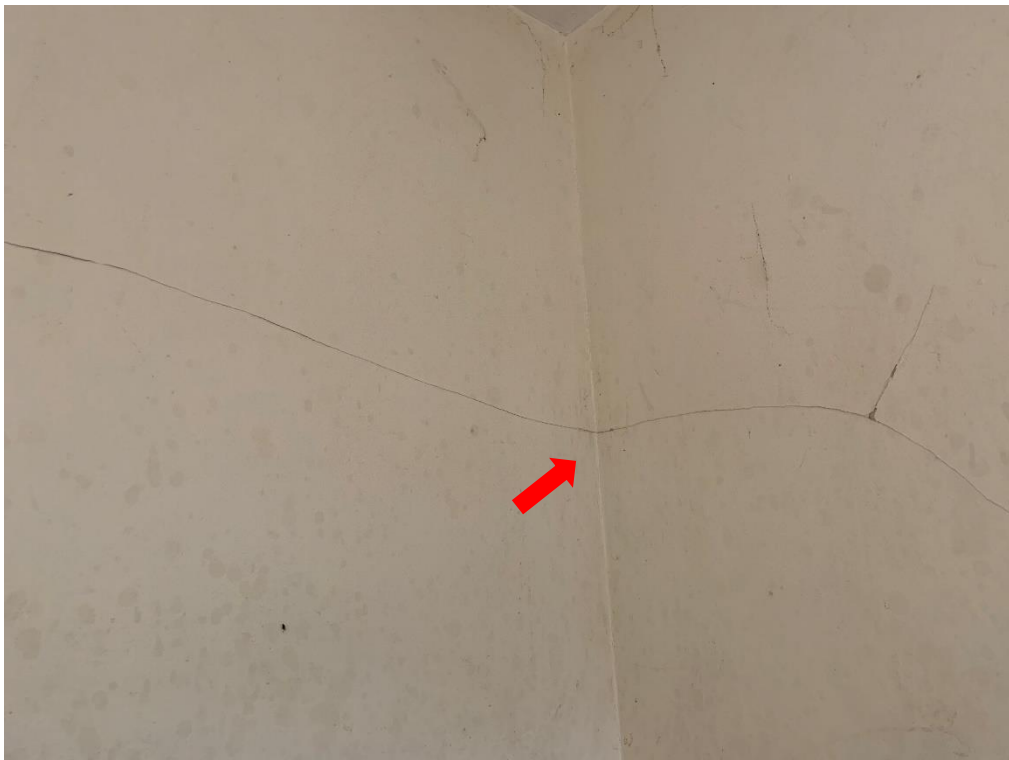
17.

Close up of cracking in kitchen. Thickness/Classification BRR digest?
18.

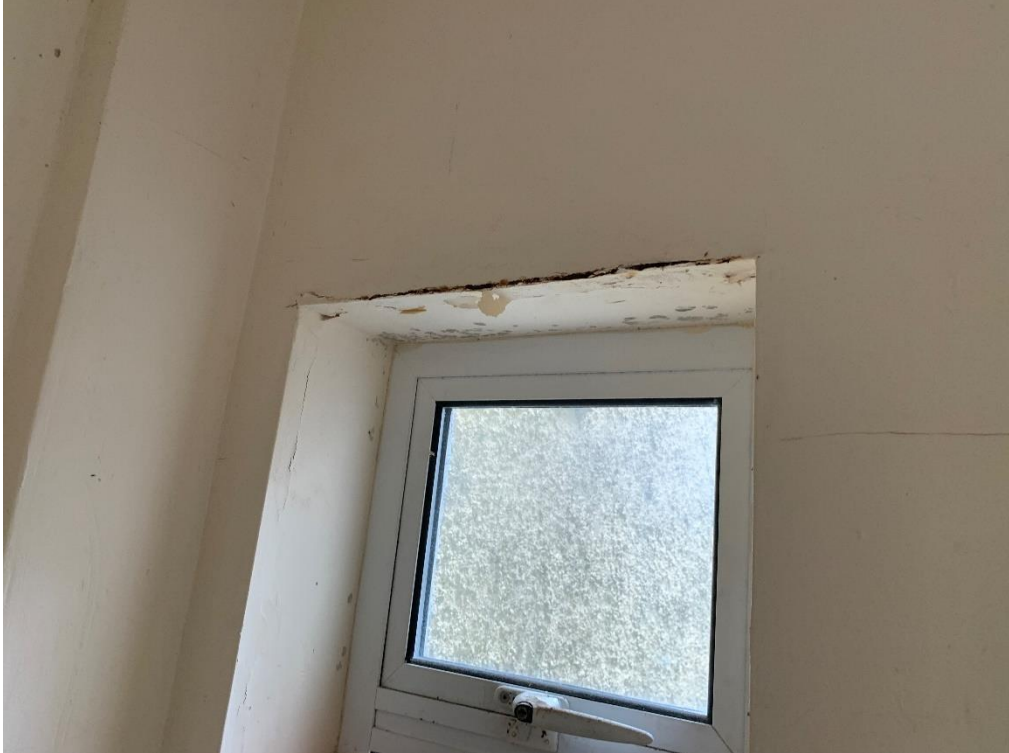
Water ingress above window head in kitchen and corruptions of plaster bead.

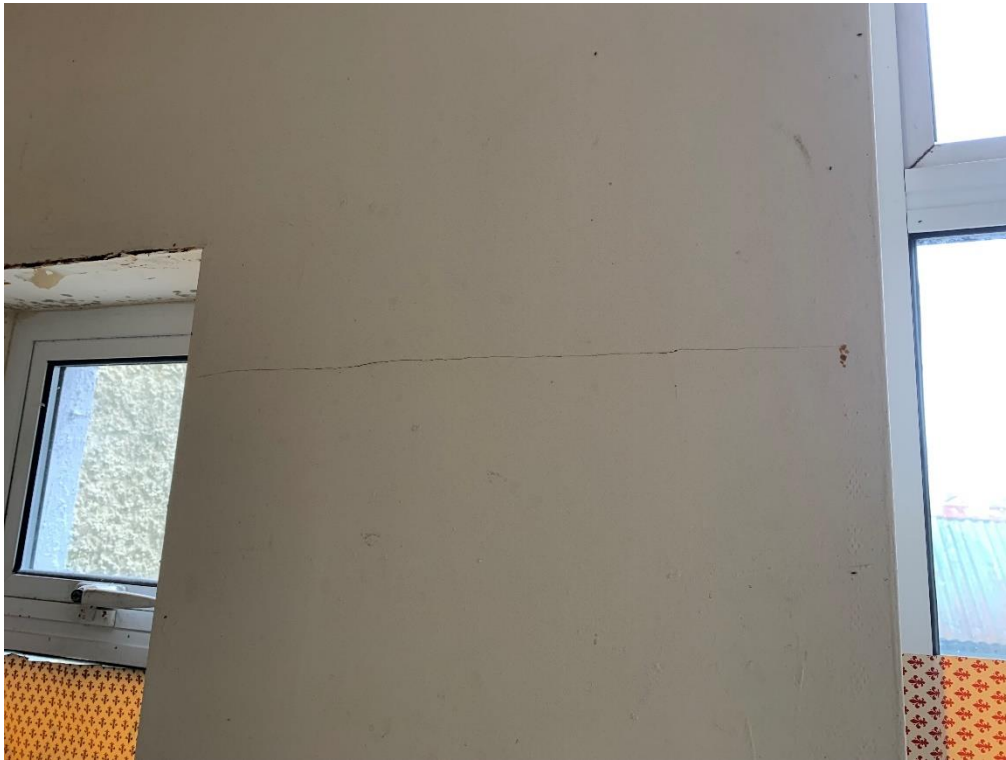
19.

Horizontal crack between windows in kitchen area.

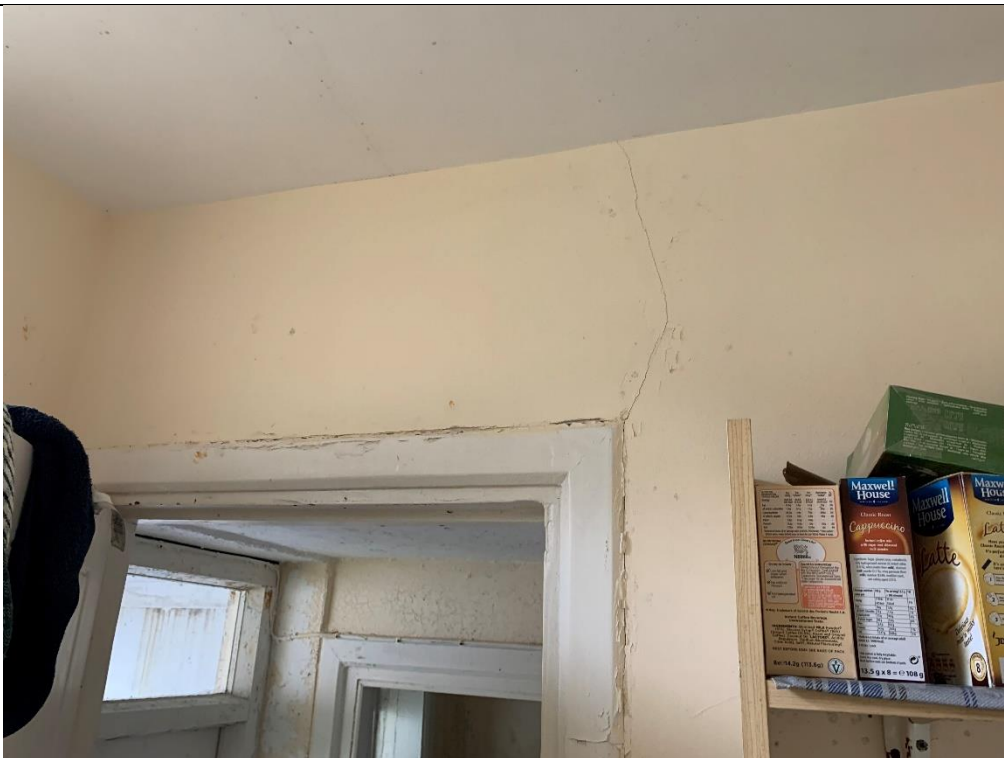
20.

Vertical crack above door head between kitchen and rear entrance porch.

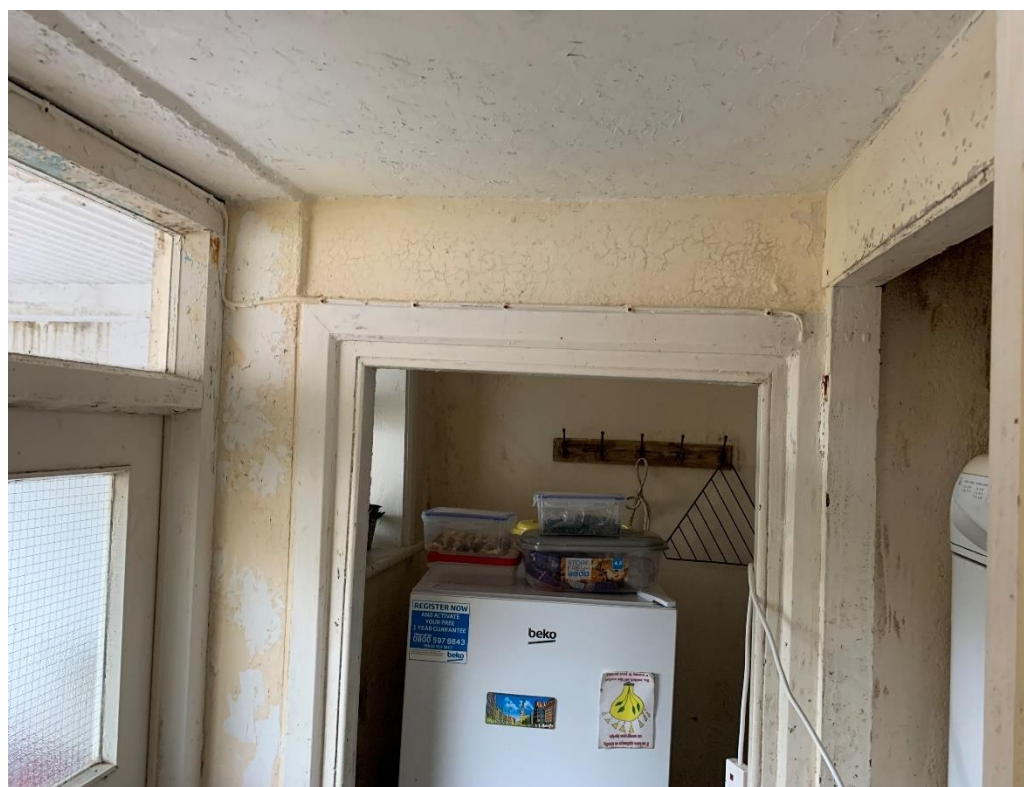
21.

Flaking paint in the rear entrance porch indicated damp present.

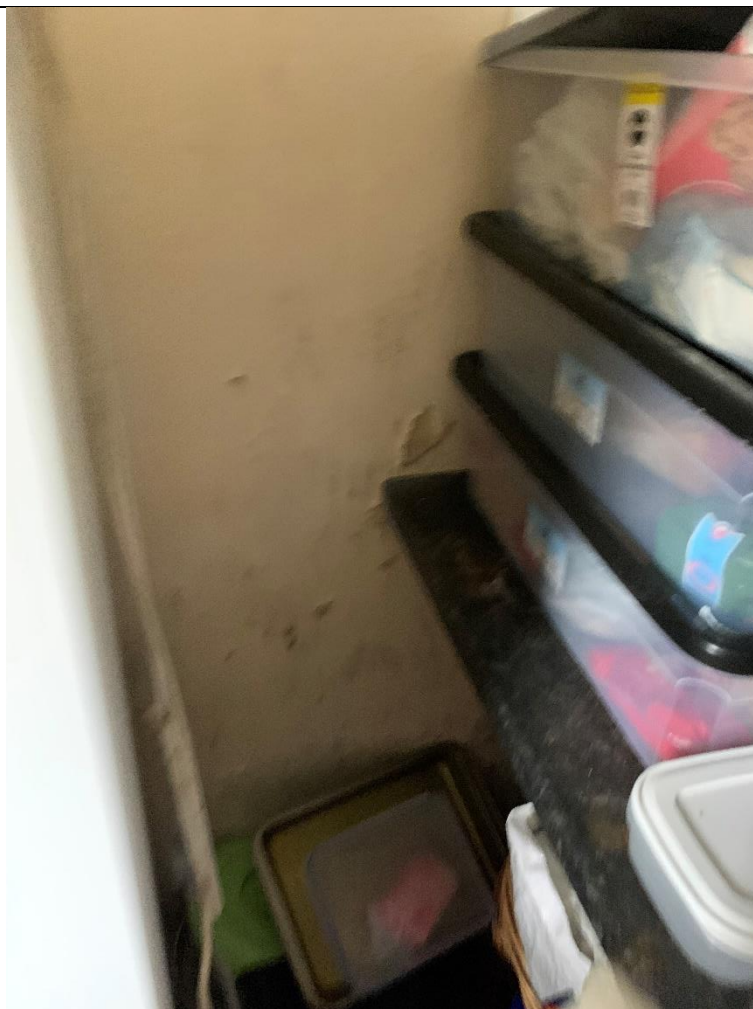
22.

Low level damp and flaking paint indicates rising damp present along the party wall of no 23 and no 24.

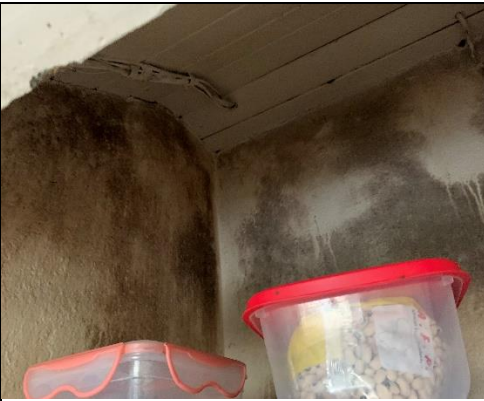
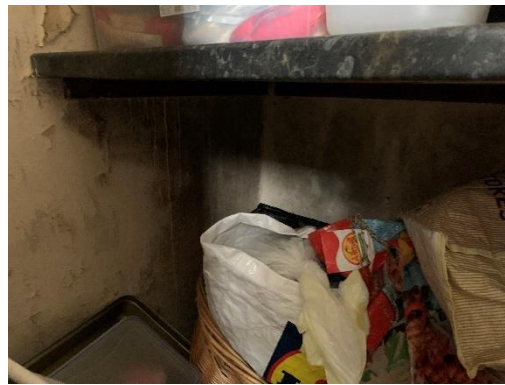
23.

Further indication of damp present in the property, the use of a washing machine and tumble dries in this area would also be a contributing factor due to lack of ventilation.

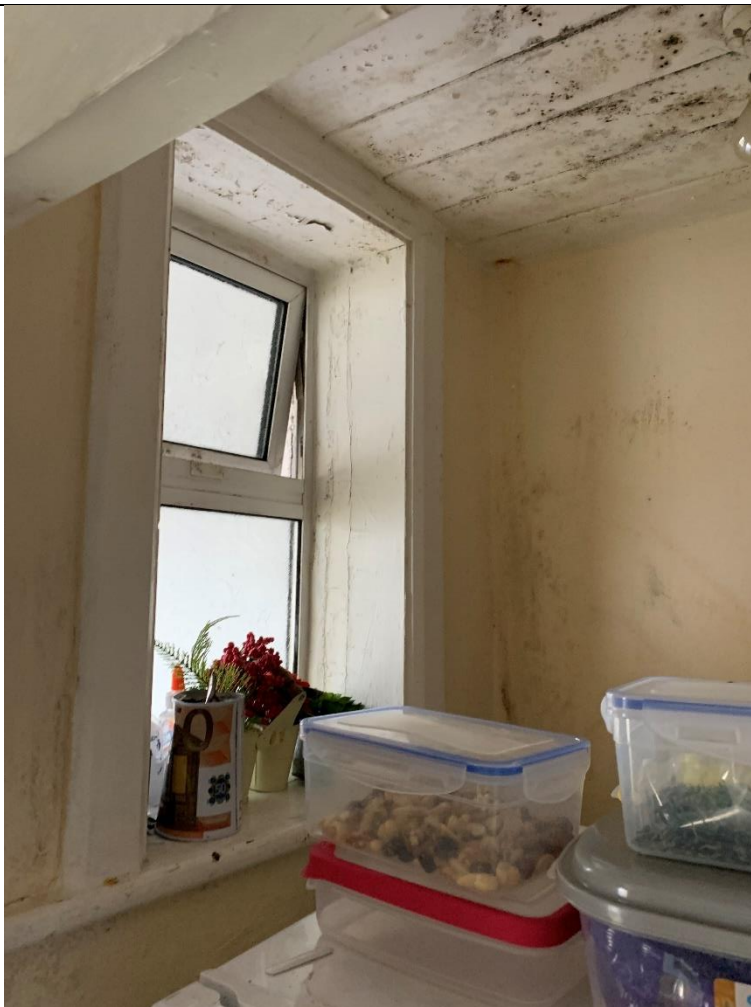
Further damp present between party walls of no 23 and no 24.

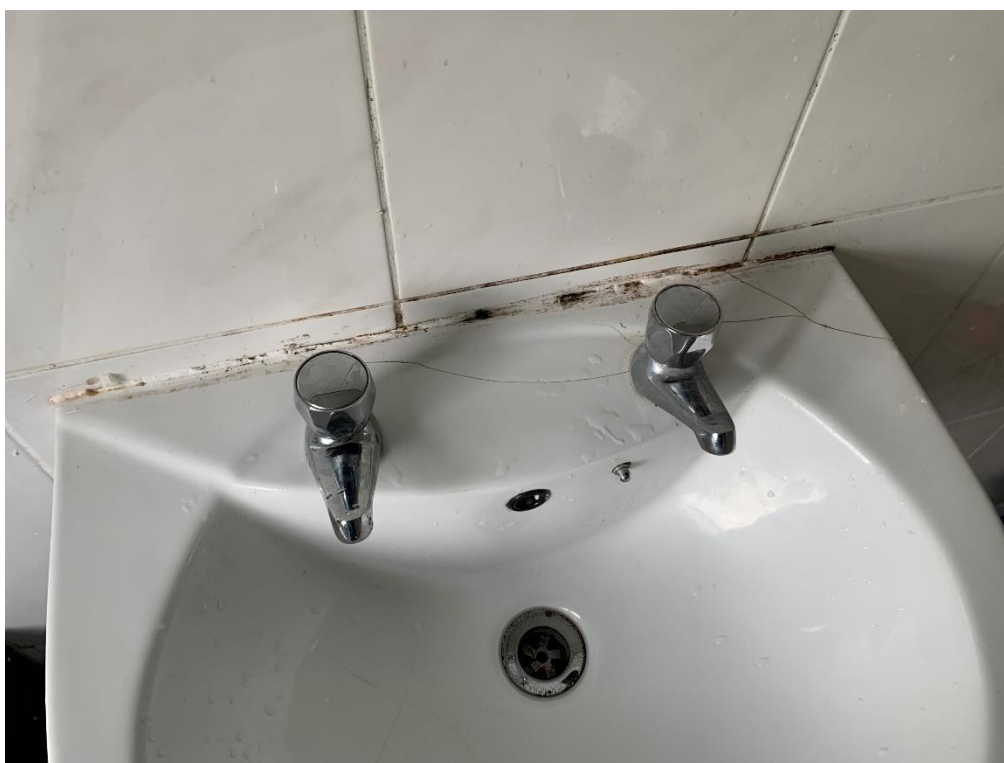
27.

Sanitary ware cracked along party wall of the property.

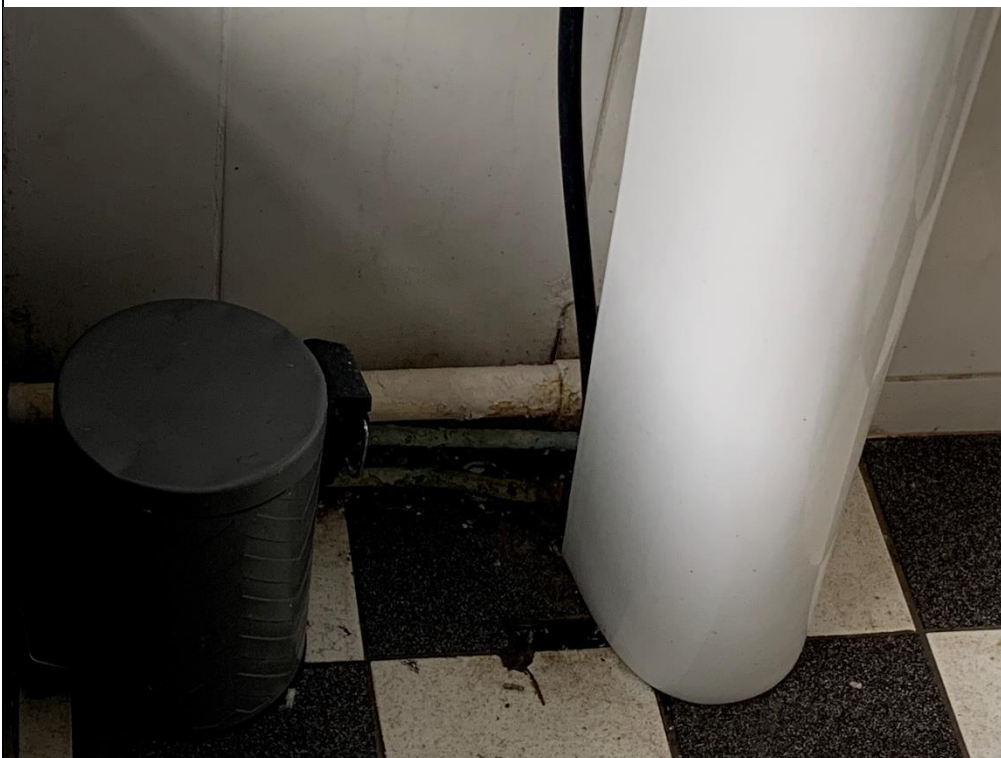
28.

Leaky pipe work present in the first floor bathroom, which may contribute to the staining to party wall at ground floor level.

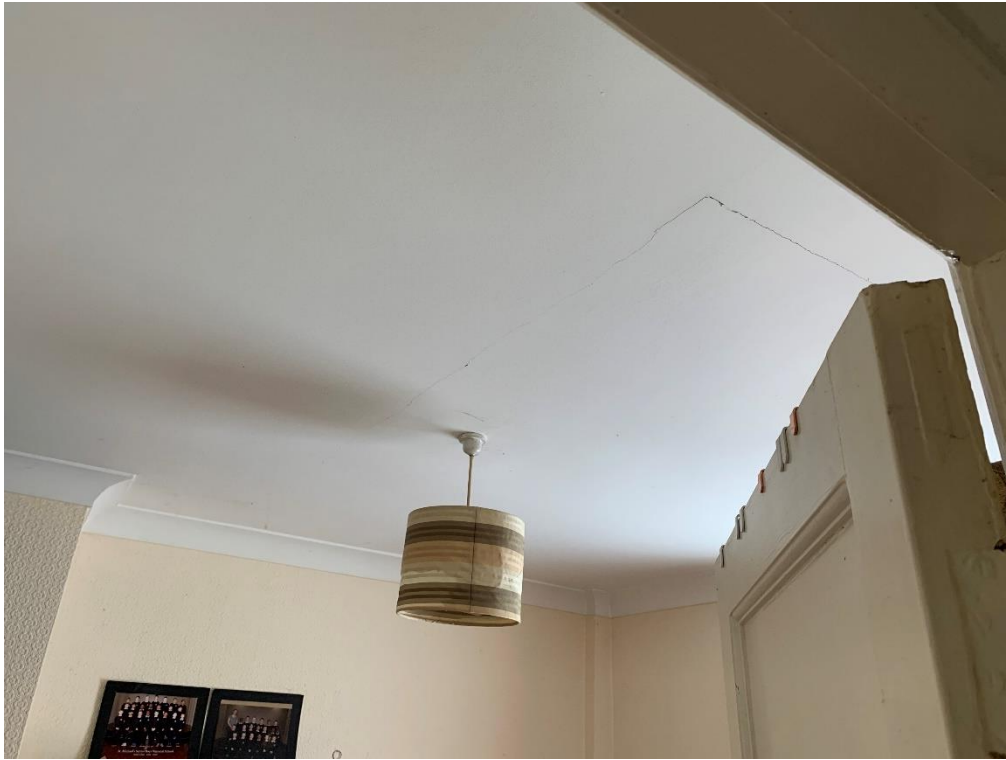
29.

Cracking in the ceiling of the first floor bedroom to the front of the property.

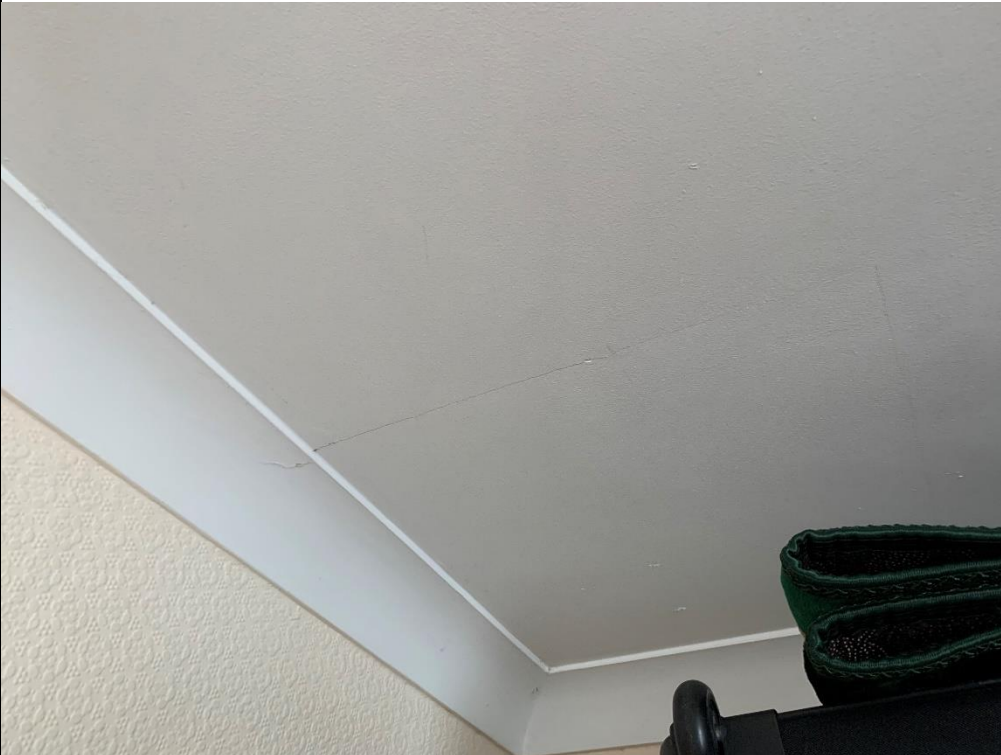
30.

Cracking in the ceiling of the first floor bedroom to the rear of the property.

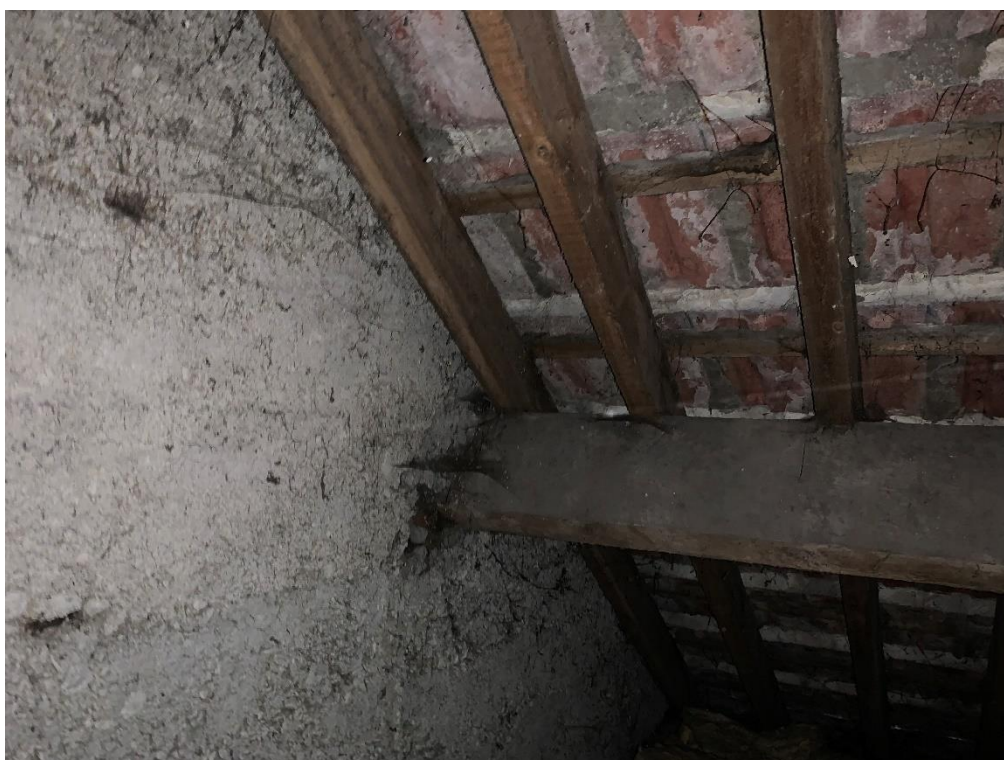
31.

View of the party wall in the attic space

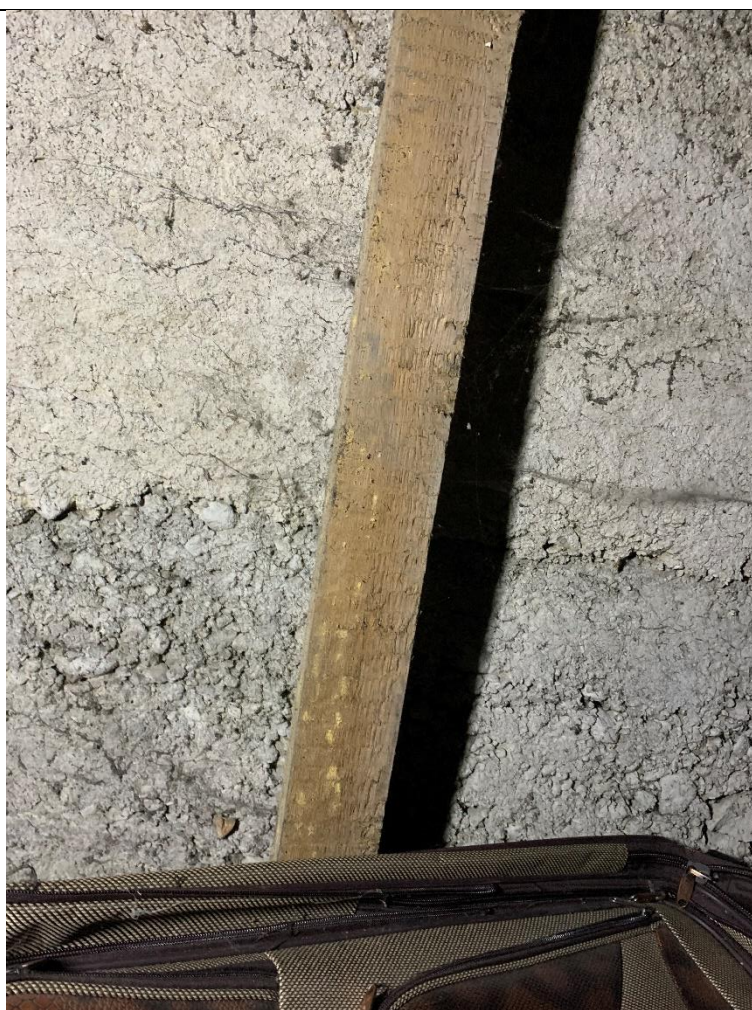
32.

- 4.3** The roof structure is a typical cut roof construction with concrete tiles over. The rear extension consists of a flat roof with a torch on felt finish. The timber purlins and timber Ridge board extend through the party wall to the neighbouring property. Evidence of wood worm is present in the

Evidence of wood worm in timber rafters.

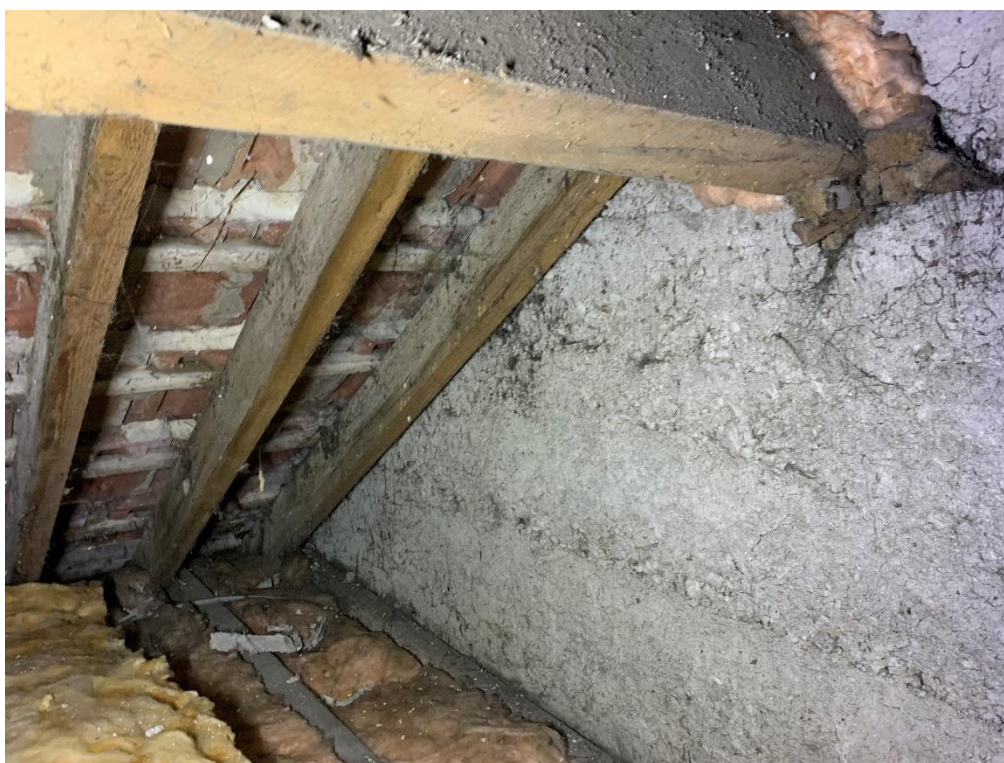
33.

No evidence of fire stopping between properties.
