### Pre-Condition Survey

23 Congress Terrace  
Townspark  
Longford  
Co Longford

Prepared by – Darragh Rowan  
File Ref: 21.107  
Dated 16<sup>th</sup> August 2021

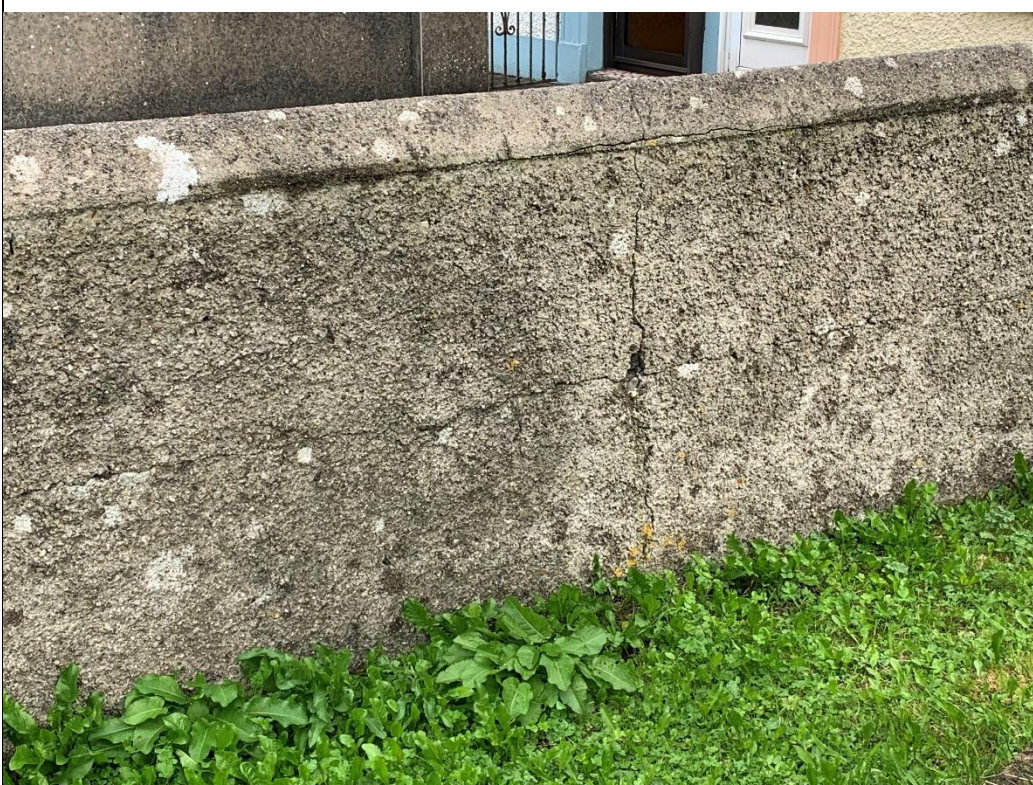
34.

Multiple cracking in the boundary wall to the front and side of the property.
