Structural Survey Report

Two Storey Dwelling

24 Congress Tce,
St Michaels Road,
Longford,
Co Longford.

Prepared by – Pauric Loughlin
File Ref: 21/107
Dated 17th May 2021

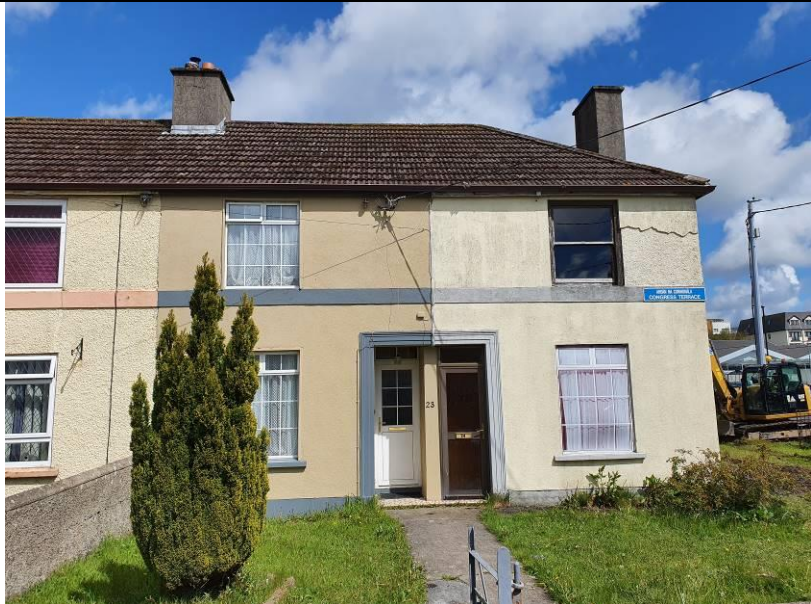
1

A photograph showing the front elevation of a two-story house. The house has a light-colored, textured facade with a central entrance door and two chimneys on the roof. There are several windows, some with white frames. A small blue sign is visible on the right side of the house. The house is surrounded by green grass and a small tree.	Front Elevation of 23 & 24 Congress Tce.
2

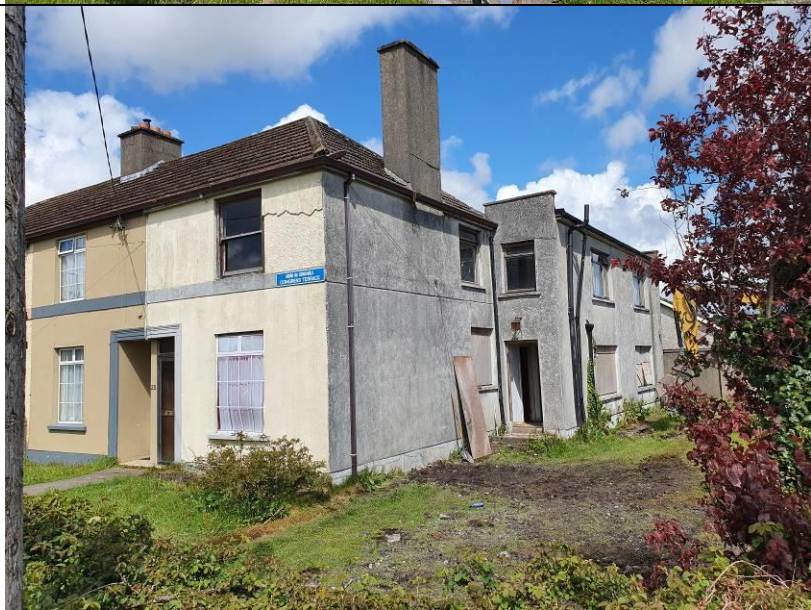
A photograph showing the side elevation of the same house. The side wall is a different color, possibly grey or a darker shade of the main facade. There is a chimney on the roof. The house is surrounded by green grass and some trees.	Front/side elevation of 24 Congress Tce.

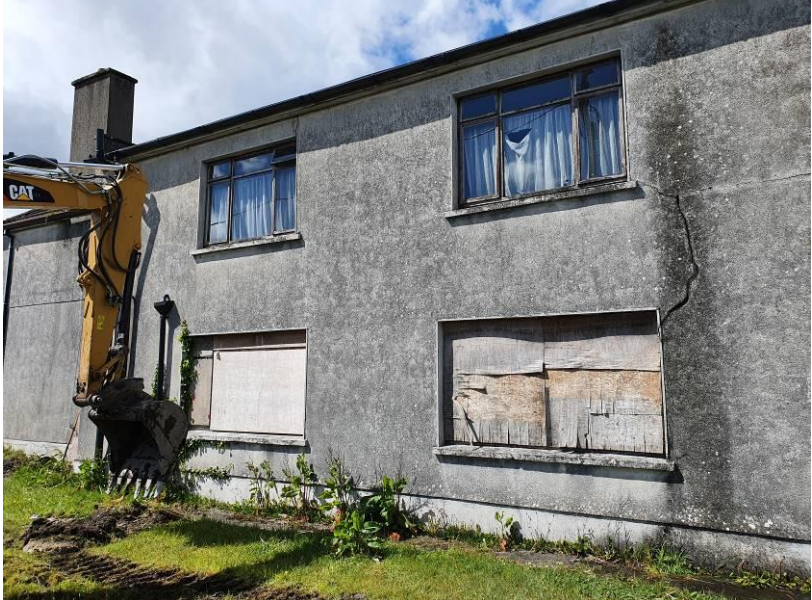
<p>3.</p>

<p>A photograph showing the side elevation of a rear flat roof extension. The building has a grey, textured facade. There are three windows: two on the upper floor with blue curtains and one on the lower floor that is boarded up with wooden planks. A yellow excavator is visible on the left side of the building, and a chimney is visible in the background.</p>	<p>Side elevation of rear flat roof extension.</p>
<p>4.</p>

- 8.2 We would recommend demolition of the existing two storey flat roof extension and construction of a specialist raft foundation for the new extension and additional proposed housing unit.

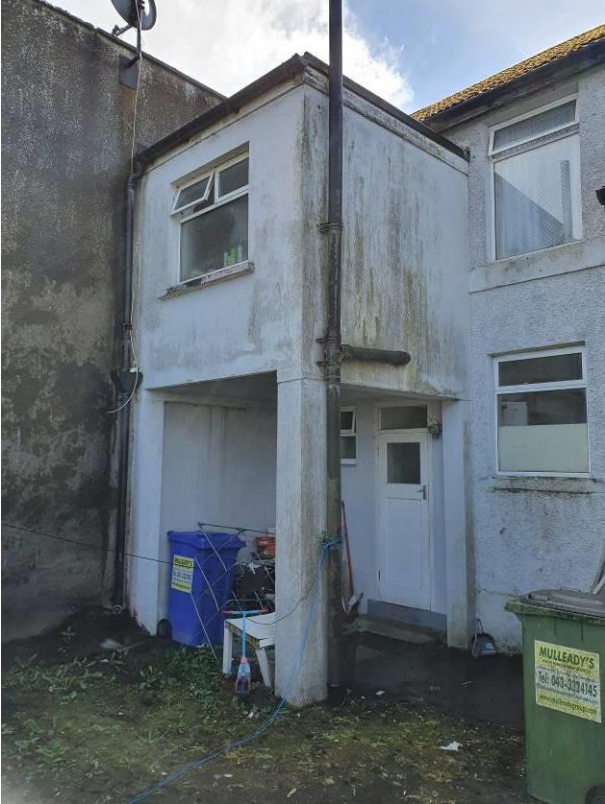
<p>A photograph showing the rear extension of a building. The extension is a two-story structure with a white facade. It has a white door on the ground floor and a window on the upper floor. A blue recycling bin and a green trash bin are visible in the foreground. The building is situated on a narrow street.</p>	<p>Rear extension to 23 Congress Tce.</p>

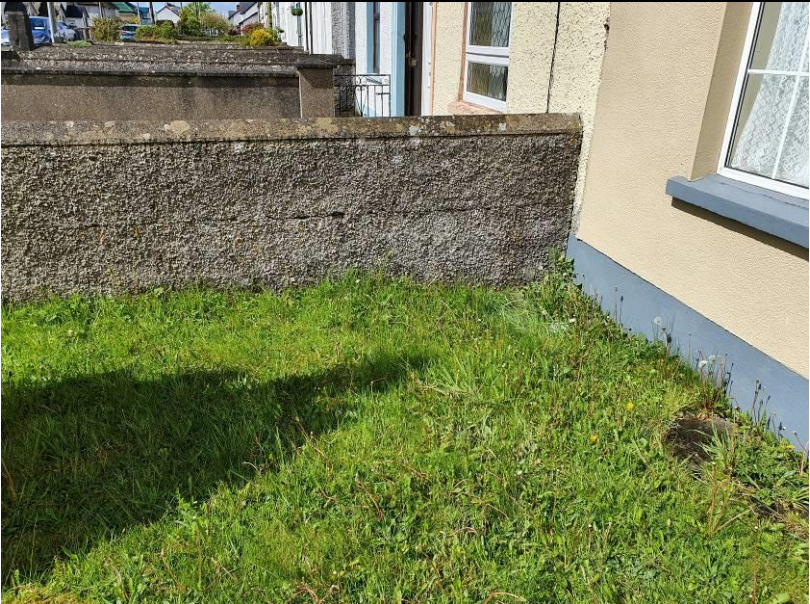
Cracking to boundary wall between properties 22&23.

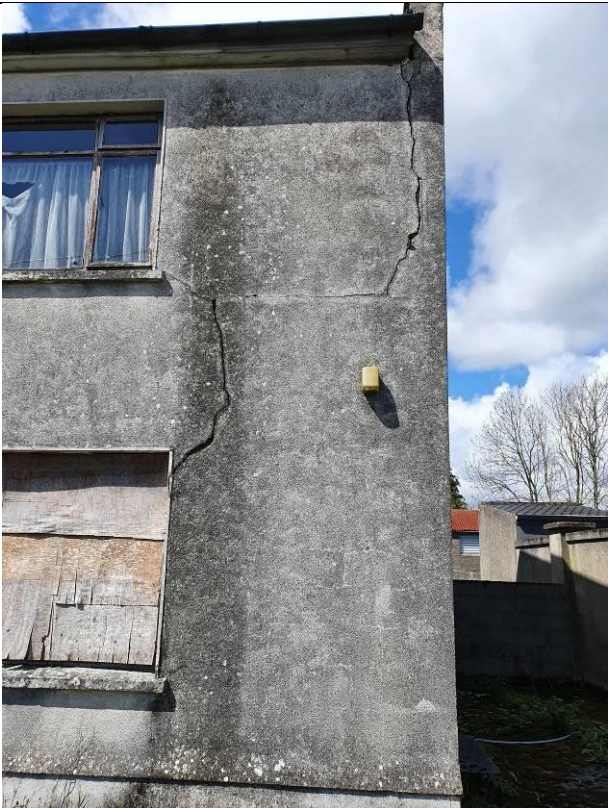
9.

- 8.1 The property is noted to be in generally poor structural and decorative condition and is in a very dilapidated state of repair. There is significant structural cracking evident to the rear extension and from the trial hole site investigation it would appear that ground conditions to the north-east of the site are very soft. The foundations to this extension are wide but are very shallow with soft strata under. It would appear that roof water to this extension is overspilling onto the ground and this may have causing the clay material to become soft.

A photograph of a building's exterior wall. The wall is made of grey concrete or masonry. A prominent vertical crack runs down the right side of the wall. To the left of the crack, there is a window with blue curtains and a smaller, boarded-up window below it. A yellow object is attached to the wall. The sky is blue with some clouds.	Cracking to south-east elevation of rear extension.
10.

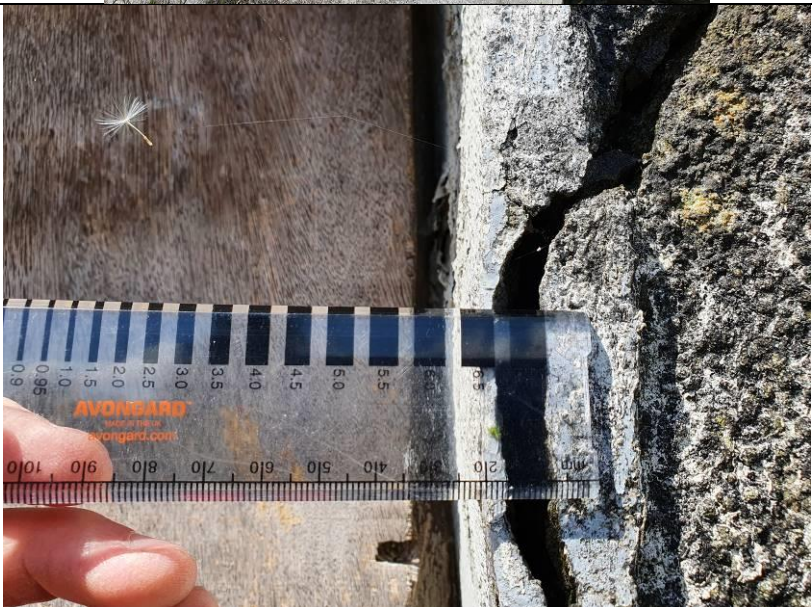
A close-up photograph of a large, deep crack in a concrete wall. A ruler is placed horizontally across the crack to provide scale. The ruler has markings in centimeters and millimeters. The crack is dark and appears to be quite deep. The concrete surface is rough and textured.	Close-up of large crack to side elevation.

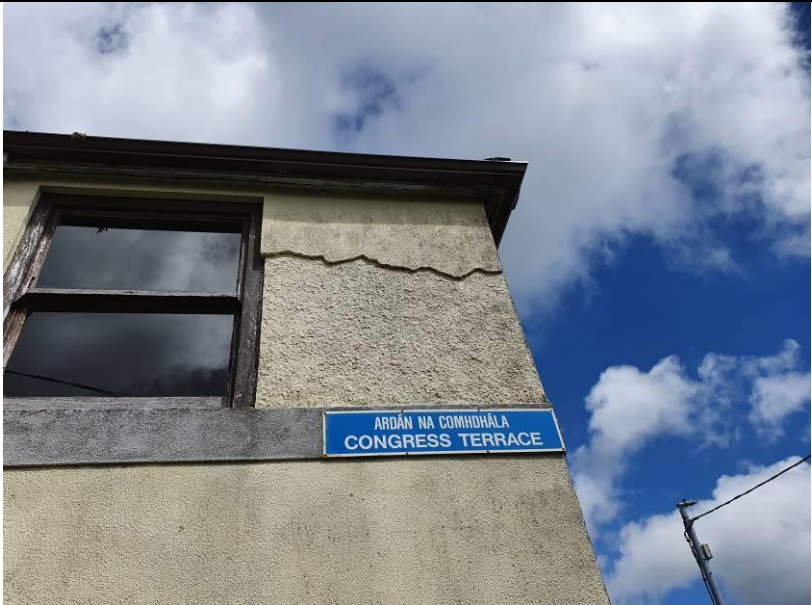
11.

- require the installation of an electric osmosis damp proof course. There was no significant cracking evident however there was some detached render to the front elevation at first floor level.
- 4.2.2 The walls of the rear two storey extension are of cavity block construction. There is significant cracking to the north-east corner of this extension. This crack can be categorised as Category 3 (BRE Digest 251 assessment of damage in low-rise buildings) which are cracks with a width of 5 to 15mm which is significant structural cracking.
 - 4.2.3 There was some evidence of fine hairline cracks internally however these can be easily repaired during normal decoration works.
 - 4.2.4 There are no wall vents provided to allow for natural ventilation and wall vents or trickle vents incorporated into windows should be provided when carrying out renovation works.

Detached render to front elevation at first floor level.
12.

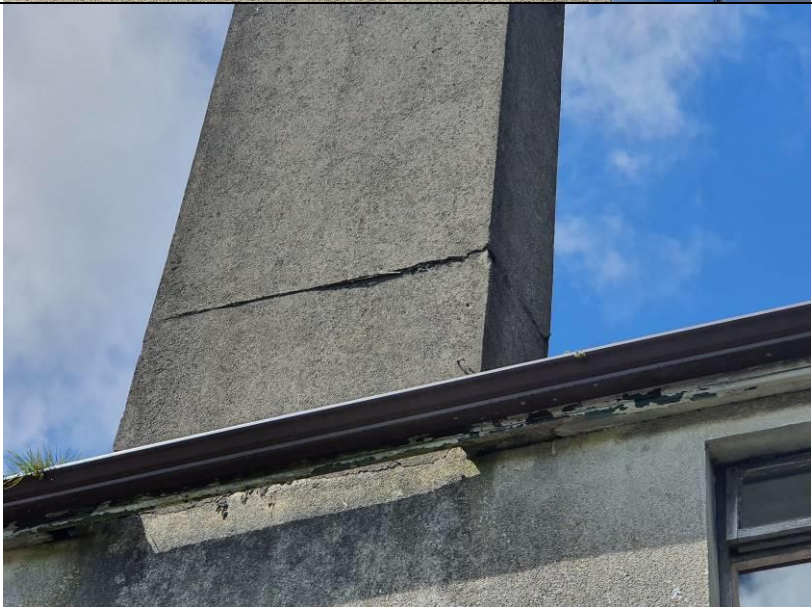
- 4.1.8 There is a single chimney to the front of the property which serves an open fire to the living room and bedroom at first floor level. There is some cracking to the render finish on the chimney to the side and evidence of damp staining to the blockwork in the attic. There are flue liners provided to this chimney.

Cracking to existing chimney.

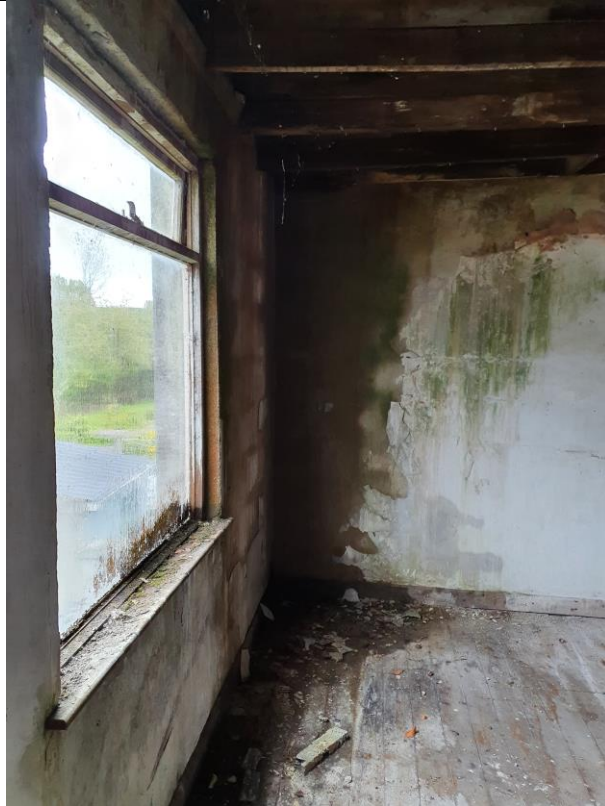
15.

- 5.3.1 There is extensive damp penetration to the rear two storey extension due to a defective flat roof covering and/or parapet flashings. This damp penetration has caused significant damage to the fabric and structure of the extension.
- 5.3.2 There were signs of damp staining to the blockwork of the chimney in the attic which may be due to damp penetration due to cracked render.
- 5.3.3 There was woodworm infestation evident to roof timber, it would be recommended to spray treat the entire roof timbers.
- 5.3.4 There was some dampness evident to walls to w/c under stairs and as walls are of solid construction there may be no dpc present. Due to the age of the property there may not be a damp proof membrane provided to floors.

Damp penetration to rear flat roof extension to north-east elevation.

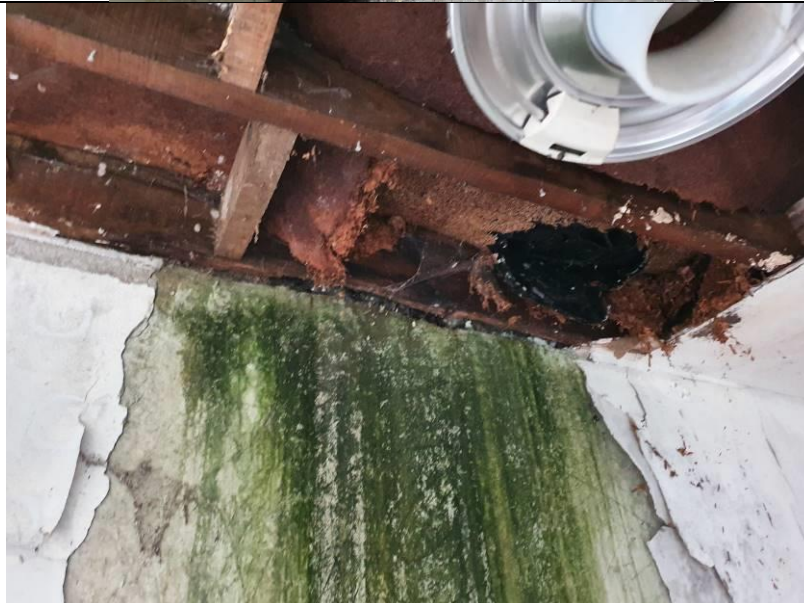
16.

- 4.1.2 The flat roof to the two-storey rear extension has a parapet on three sides and discharges to an external gutter to the south-east elevation. The roof covering and parapet flashings could not be inspected however from inspection of the property internally it is clear that the roof covering, and flashings have failed as there is significant damp penetration. Due to the damp penetration the flat roof joists have significant wetrot and have dropped where bearing on external walls.

Wetrot of flat roof joists due to failed flashings at parapet wall.

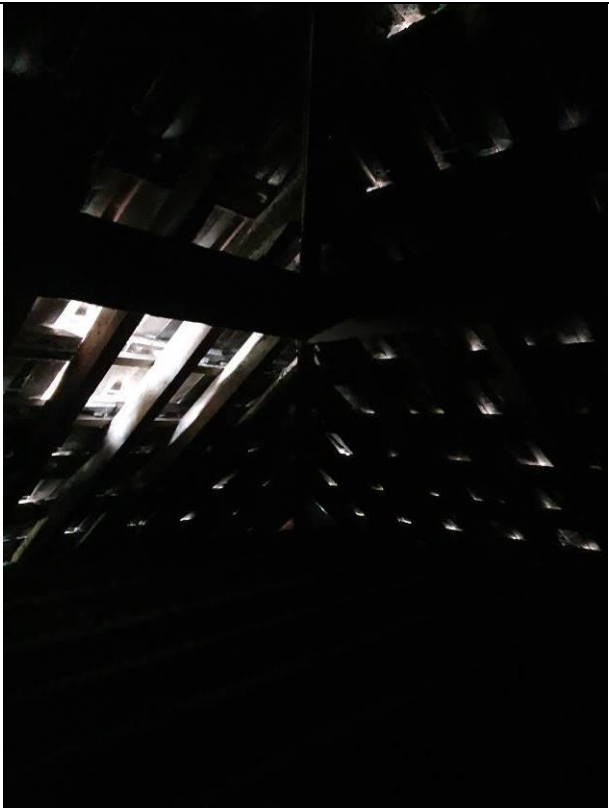
17.

- 4.1.4 There is no roofing felt provided under the roof tiles and there is evidence of daylight in the roof covering. There is some damp staining to the blockwork in the vicinity of the chimney which may be due to damp penetration from cracking to render or damaged lead flashings. There is also some evidence of dampness to timbers at the junction of the rear flat roof extension.

No roofing felt present under roof tiles to front pitched roof and daylight present in joints.
18.

- 8.4 The timber purlin to the roof structure will require additional support especially at corner hips. The entire roof timbers will require spray treatment due to the presence of woodworm. As there is no roofing felt under roof tiles it would be advisable to remove roof covering and install a breathable felt with new roofing battons and new roof covering. The party wall will also require fire stopping to comply with Part B (Fire) of the building regulations.

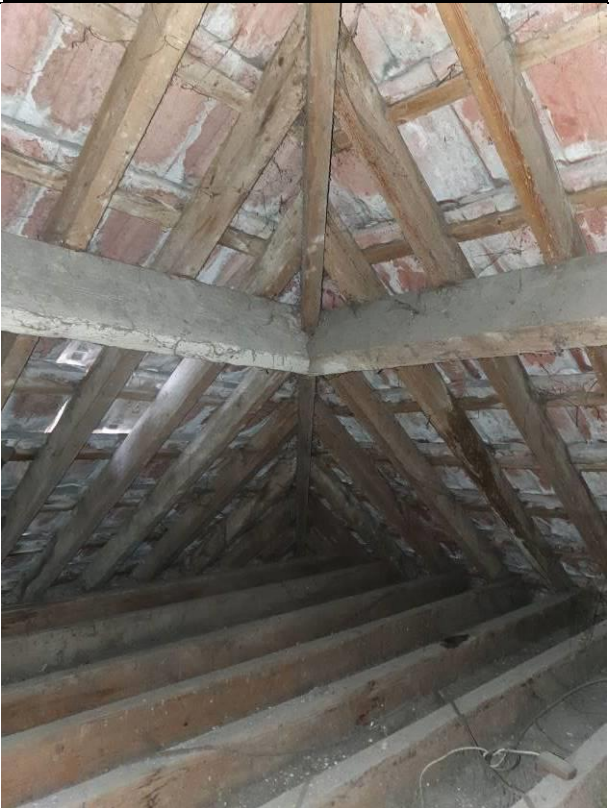
- 4.1.3 There was access to the pitched roof structure from an access hatch on the landing. The roof structure is of traditional cut roof construction and there is an intermediate timber purlin support which is supported of the party wall but has no additional supports provided and therefore is providing no support to the roof structure.

- 4.1.5 There was some evidence of woodworm to roof timbers around the access hatch therefore all the timber will require inspection and spray treatment carried out.

Existing timber purlin not adequately supported and woodworm present to roof timbers.
