Noel Lane
Caherpeak
Kilcolgan
Co Galway

Date: 14/04/2022

Re: An Arboricultural Assessment of the Site Area at Ballinalee Road, Longford

A Condition Assessment of the Tree and Hedge Vegetation within the site area at Ballinalee Road, Longford

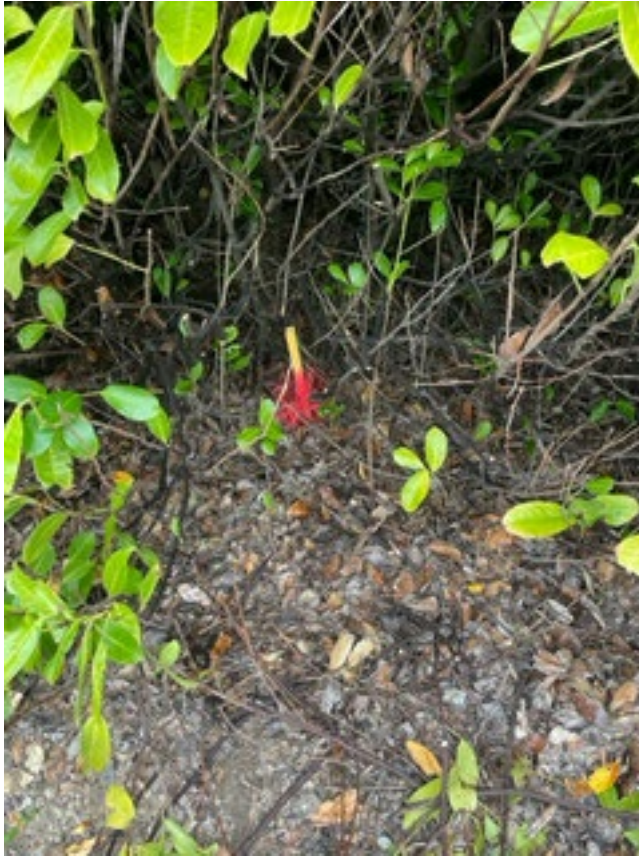
Laurel hedges to be pruned back to provide clearance for development

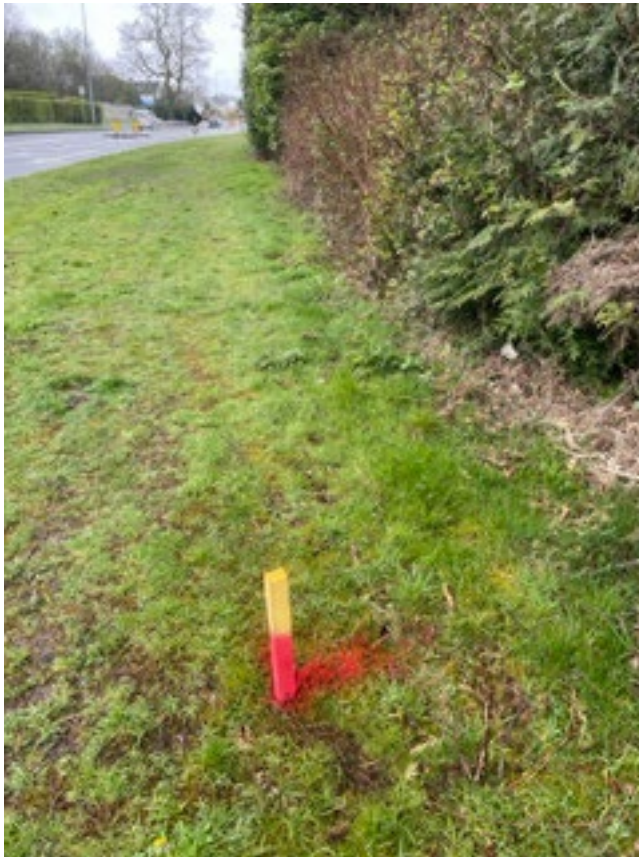
Cypress trees to be lowered back to c4m to mitigate some root lost

Most of those trees can be retained with only **7 young alder trees to be removed**. Lower the crowns of the cypress trees to c4m.

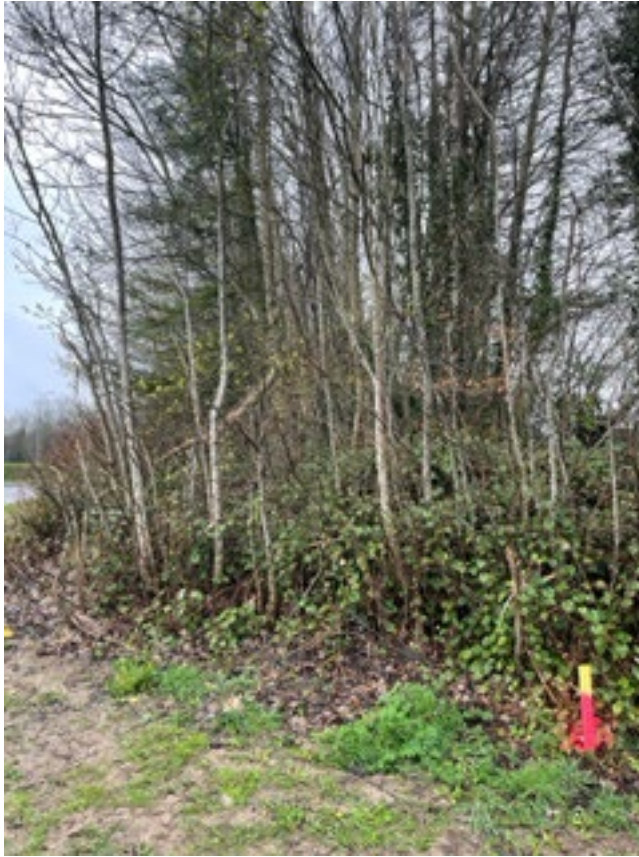
Some alder trees to be removed at this corner

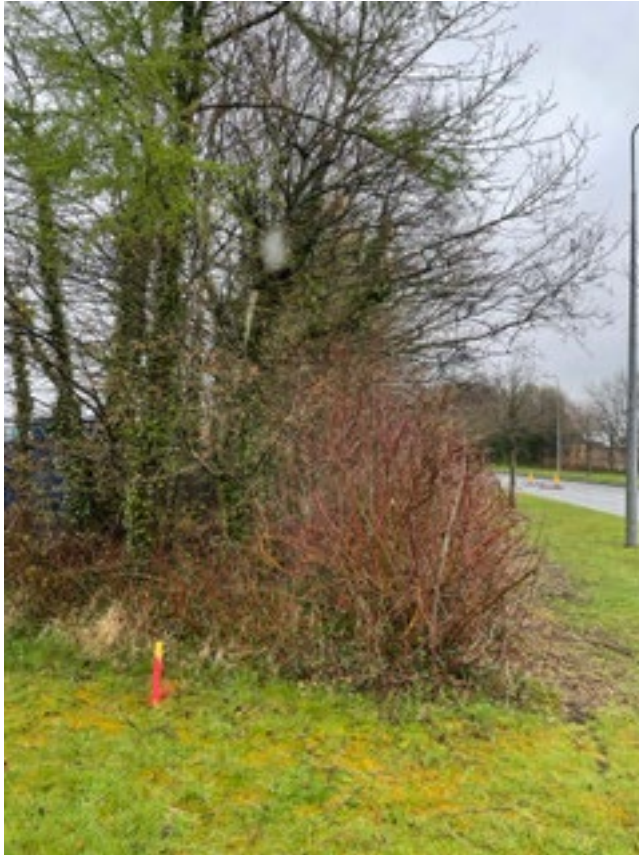
Marker shows the proximity of trees to excavation area

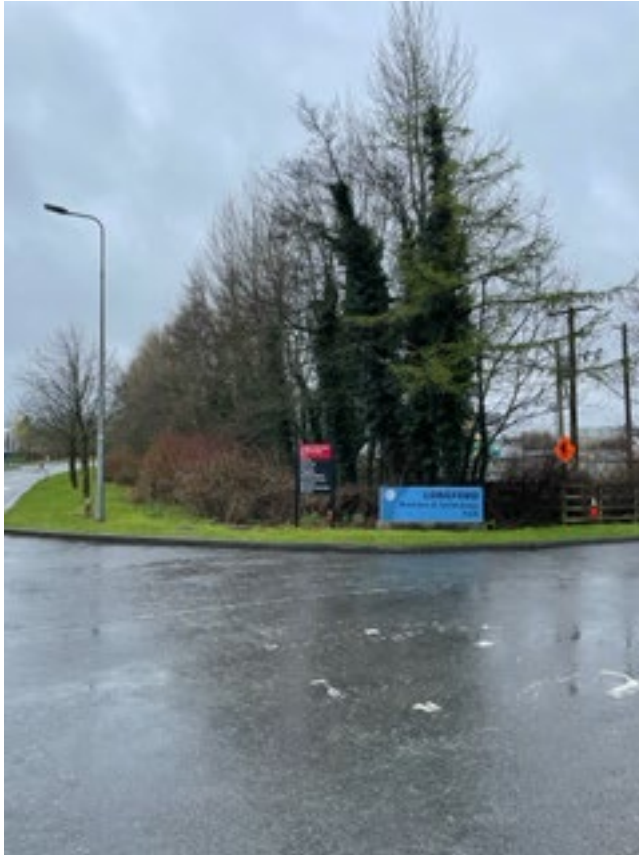
Poplar trees to be lowered to c5m to mitigate root loss

The poplar trees should be lowered to c5 meters to mitigate some potential root loss that may occur during construction stage.

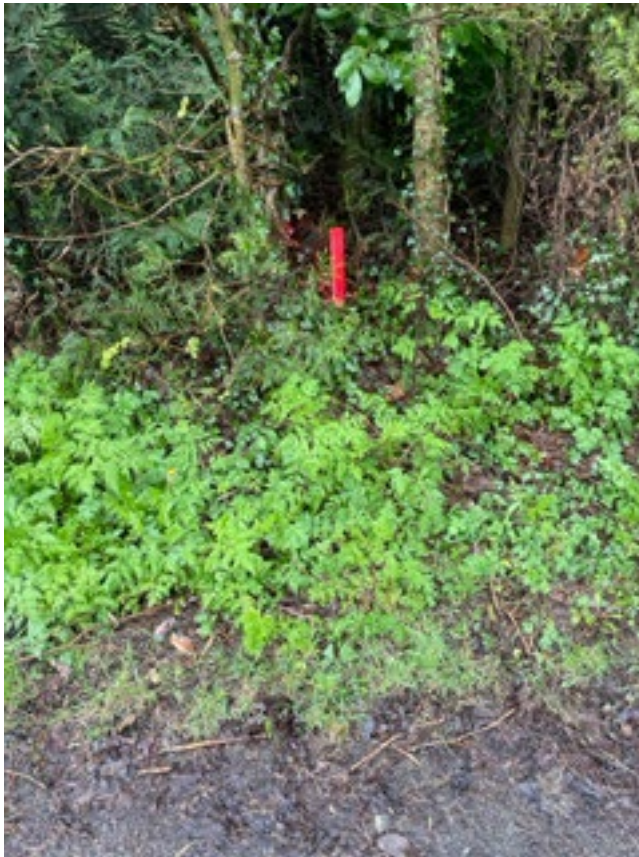
Proximity of excavation area to young trees

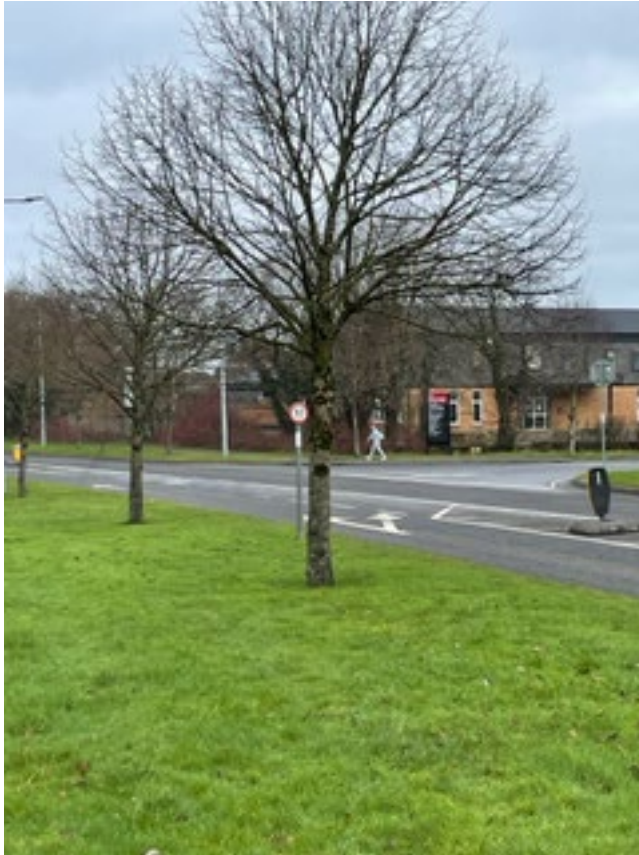
Typical lime tree in good condition and high amenity value

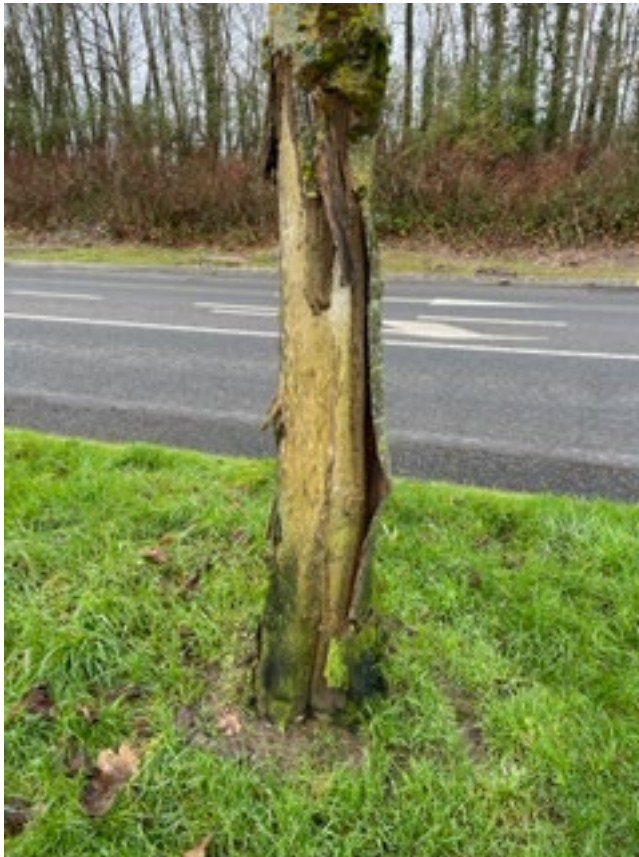
Label number 678 – A lime tree with major wounds and decay

Tree No	Species Botanical Name	Common Name	Age Y SM EM M OM V	DBH (cms)	Height (m) ----- Height of clear stem	Crown Span (m)	Physiological Condition -Good -Fair -Poor -Dead	Comments Structural Observations	Retention Category A-High B-Moderat C-Low D-Fell -Lifespan	Preliminary Management Recommendations Priority A, B, C or U
676	<i>Tilia</i>	Lime	EM	29	7	N – 3 S – 2 E – 3 W - 2	Good	Good vigour and good form.	A >50 years	No work required (NWR)
677	<i>Tilia</i>	Lime	EM	24	7	N – 3 S – 2 E – 3 W - 2	Fair	Good vigour and good form. Slight lean	B >20 years	NWR
678	<i>Tilia</i>	Lime	EM	24	7	N – 3 S – 2 E – 3 W - 3	Poor	Poor vigour and fair form. Major wound and decay at base of main stem	U	Remove

Trees to be removed due to their condition consist of 1 lime tree – label number 678.

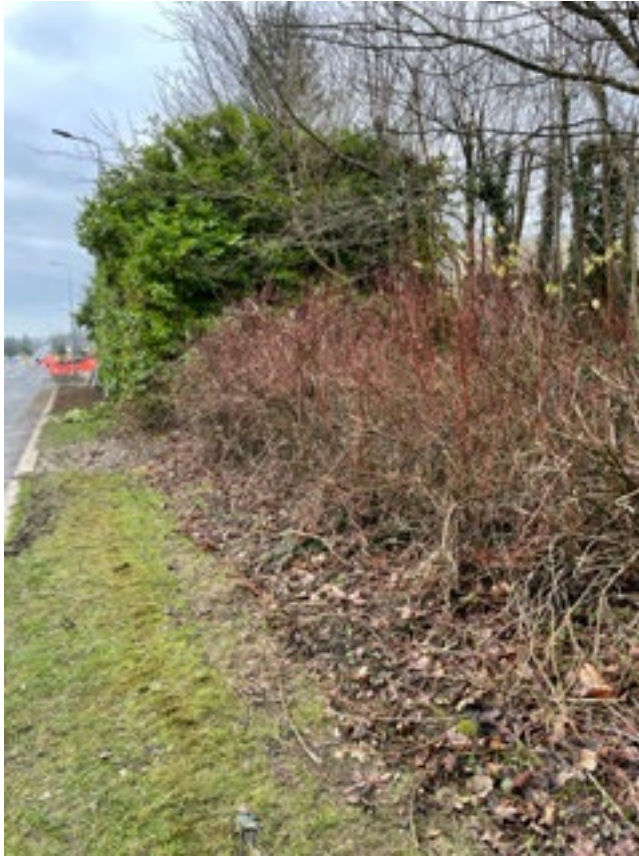
21TS001- Berberis and laurel border shrubs with groups of trees in background

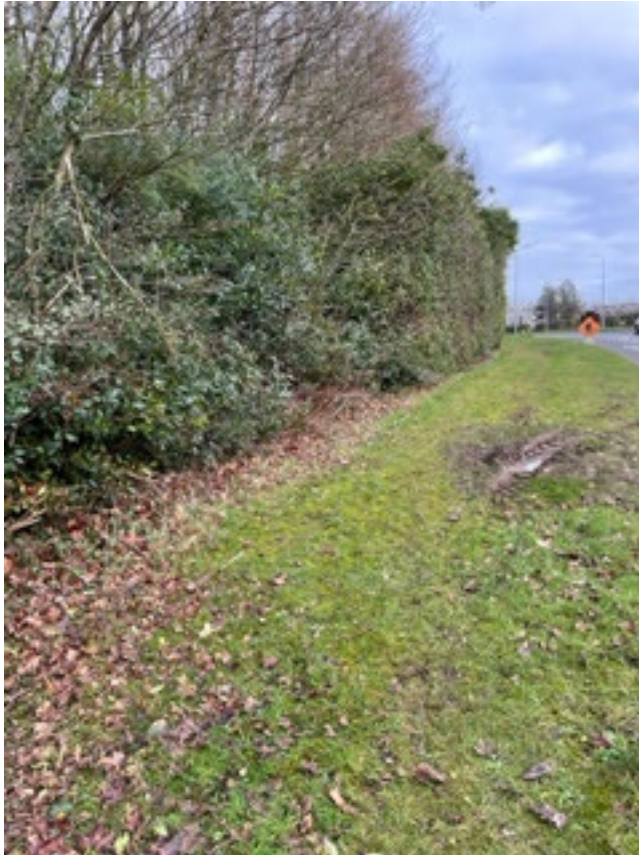
21TS001 – Border shrubs with mainly maple trees planted in the background

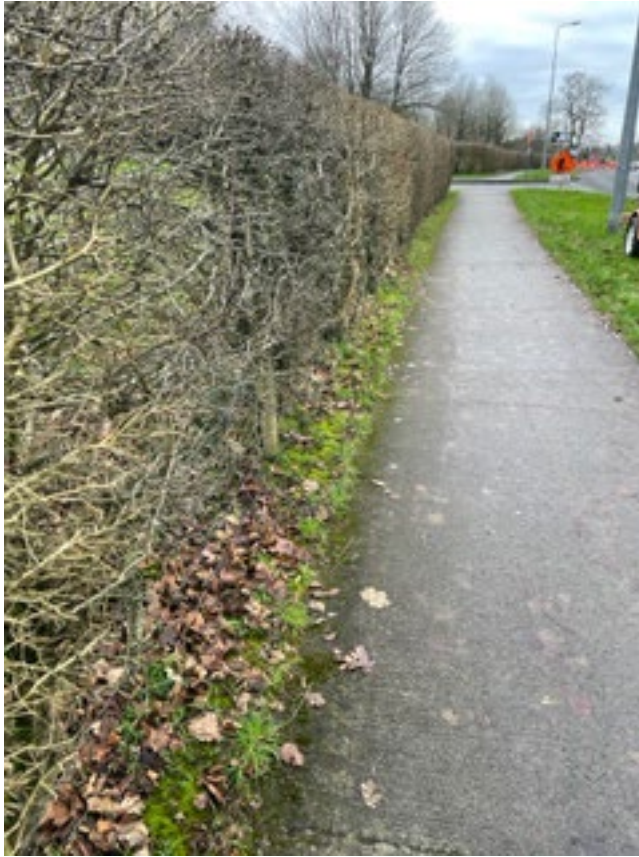
21TS001- Hawthorn and maple hedge

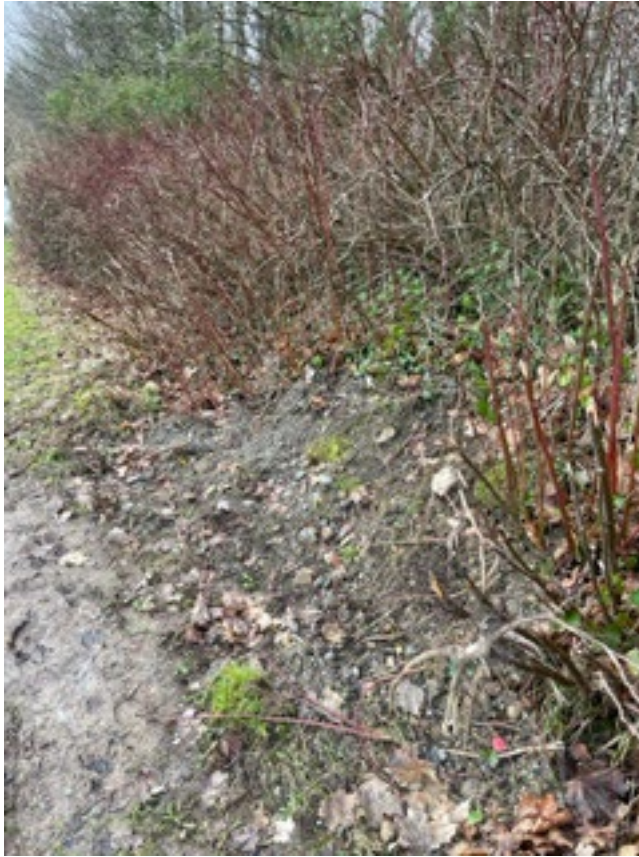
21TS001- Berberis border to be reduced back

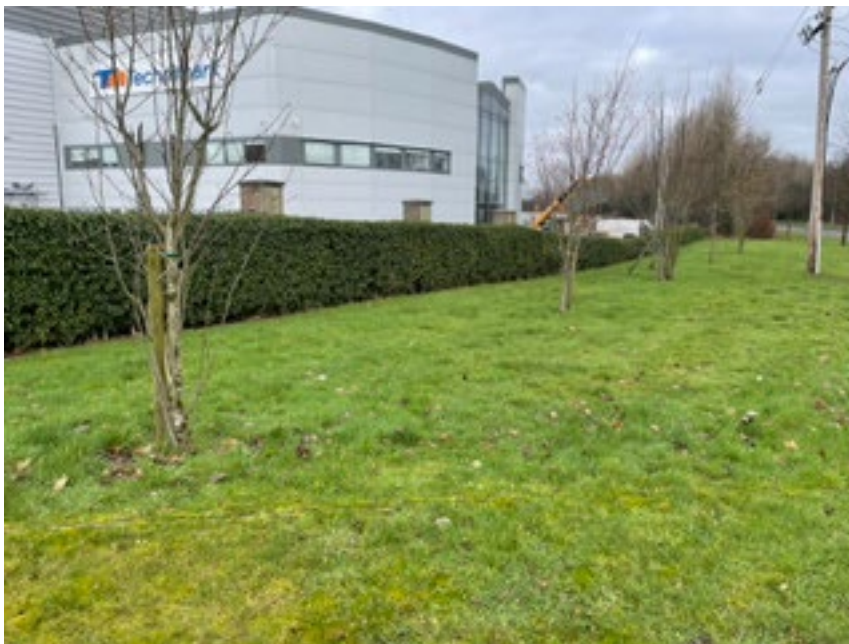
21TS001 - A line of 6 young Mt ash and cherry trees planted and to be retained

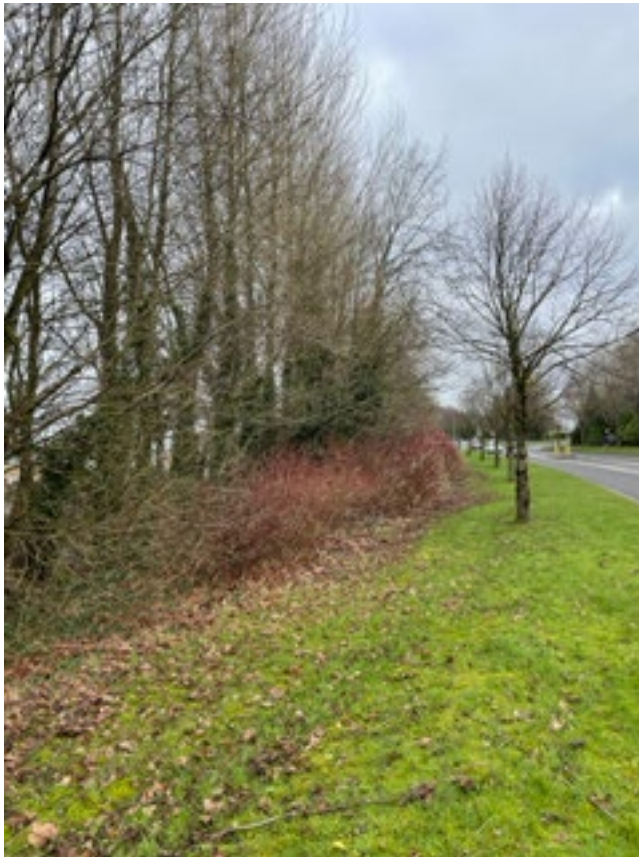
21TS002 View 3 Section – Berberis border with some ash to the front and Poplar trees laden with ivy (to be lowered to c5m)

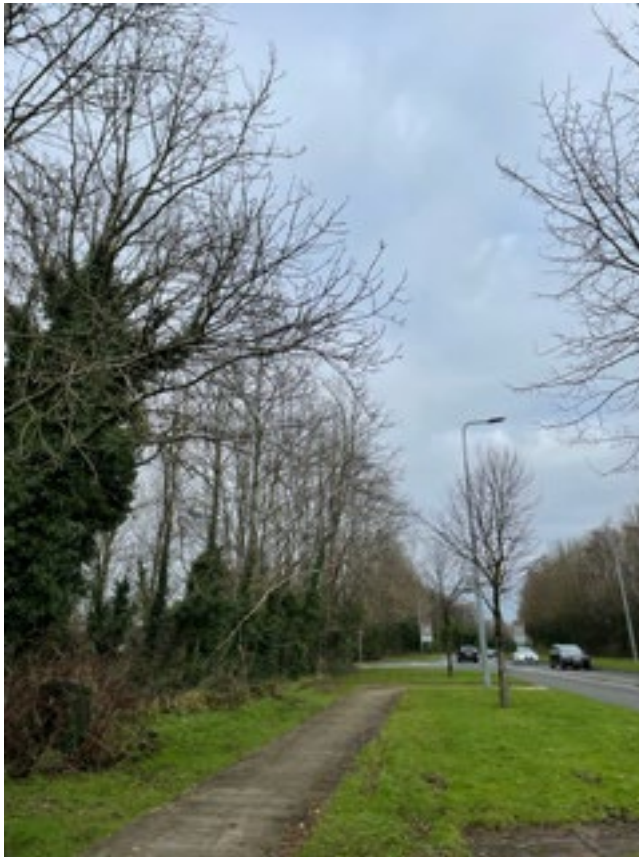
- Ash – ash dieback is present practically on all the young trees along this stretch of Ballinalee road. They are in various stages of decline with the possibility of removing all imminent in the medium term.

21TS002 - Ash trees laden with ivy - ash dieback disease present

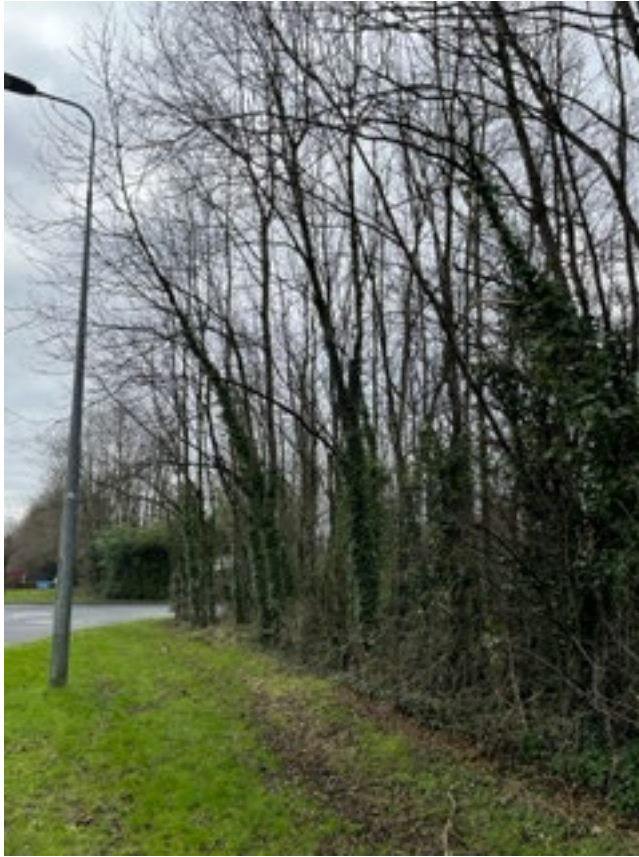
21TS002 - Mainly maple trees

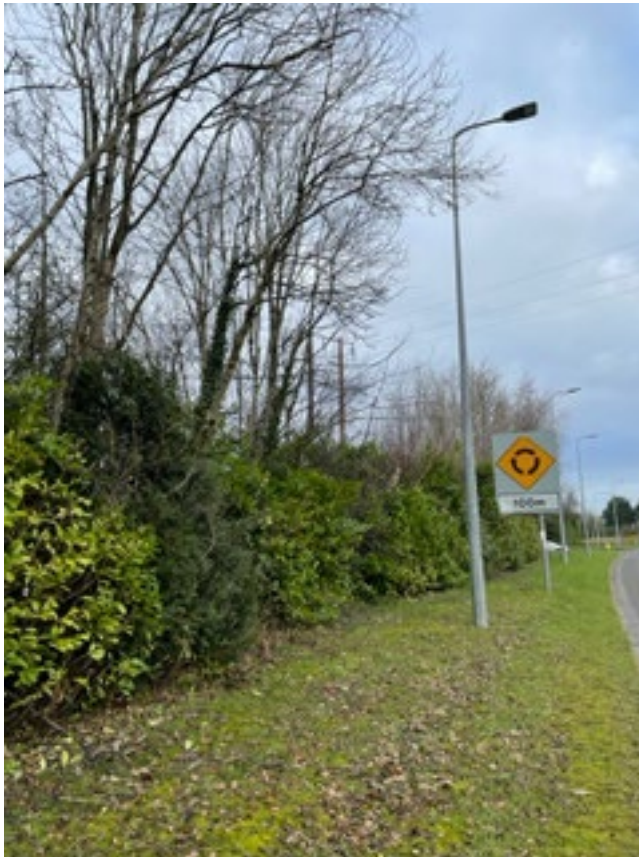
21TS003 - Laurel with maple and ash trees in background

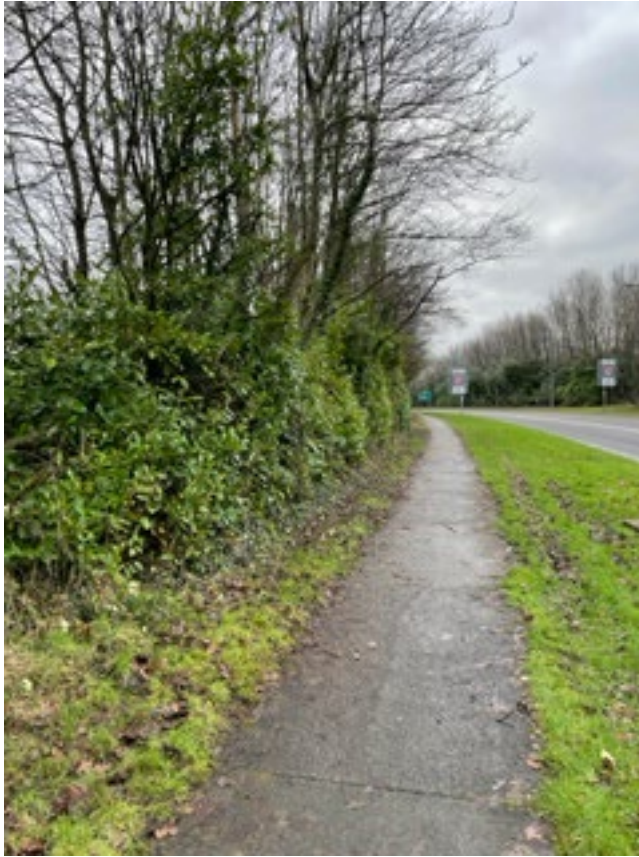
21TS003 - Laurel with maple trees in background to be retained
