**An Arboricultural Assessment of the Site Area at Ennybegs, Co Longford**

**Prepared for: Longford County Council**

**Prepared by: Noel Lane, Certified Arborist, MSIF National Dip in Science (Forestry)**

**Date: 23/03/2022**

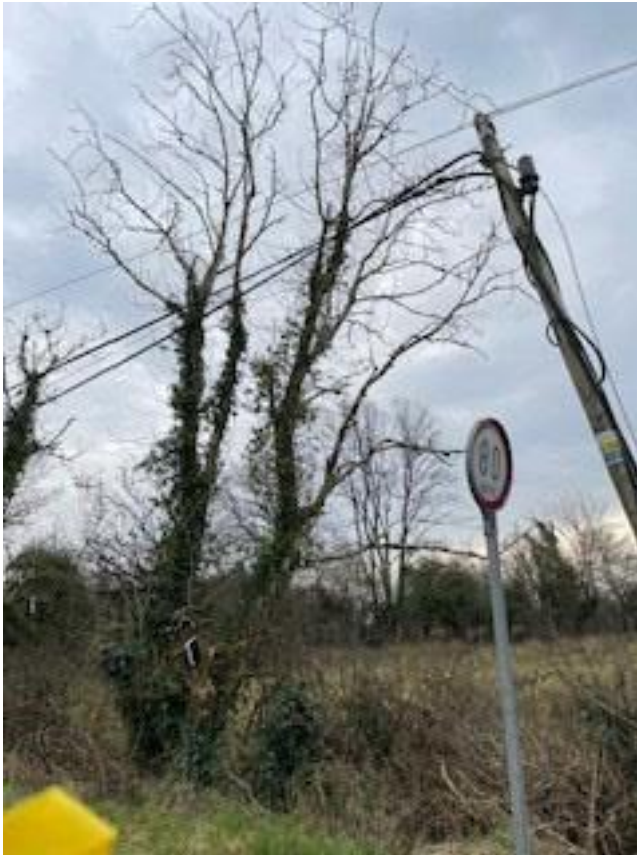
Drawing No 2 - Impact and Tree Protection Plan
- 4.4 It is noted that all the ash trees are diseased with ash dieback present and vary from early stages of decline to some dead trees.

Label 2419 – Ash tree with ash dieback and dying

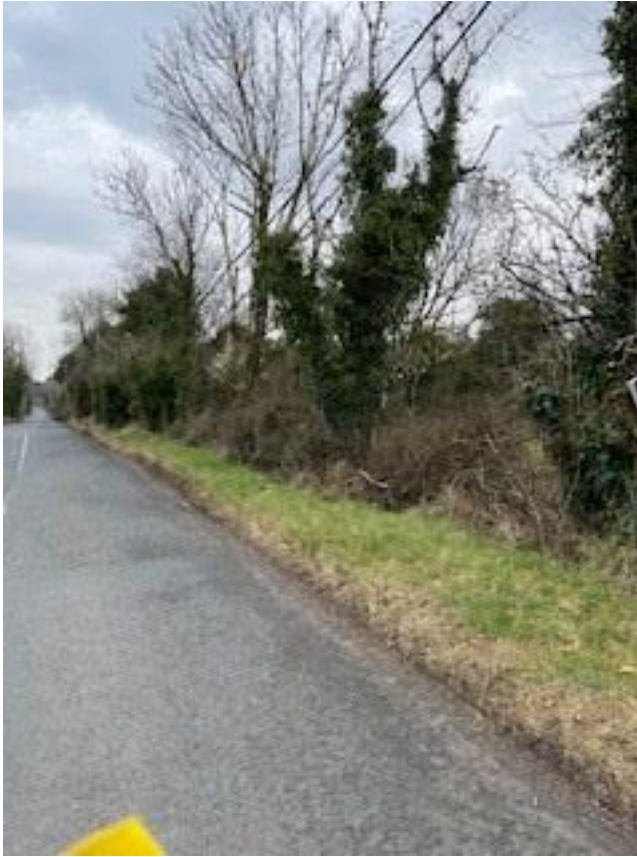
View of roadside hedgerow impacted on by the proposed development

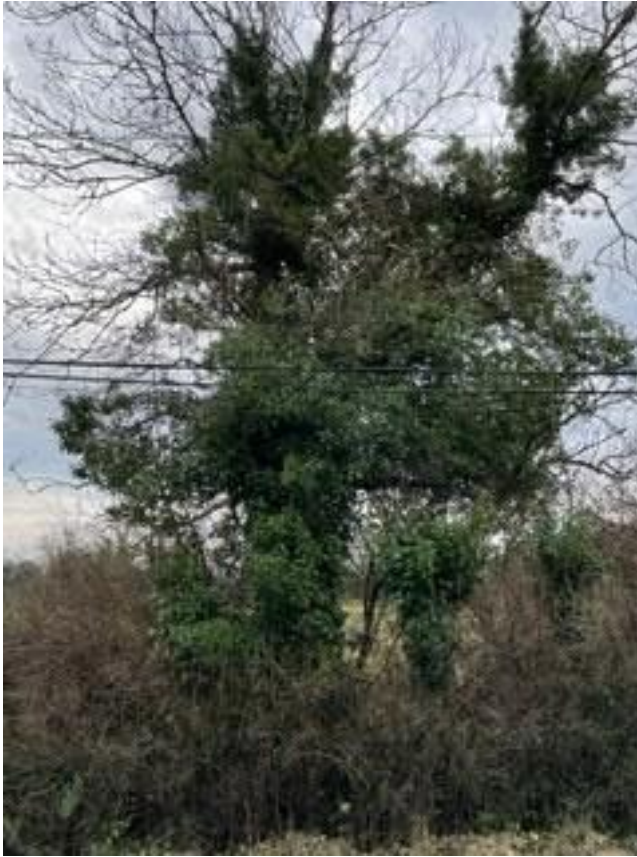
Label 2430 - Ash tree laden with ivy

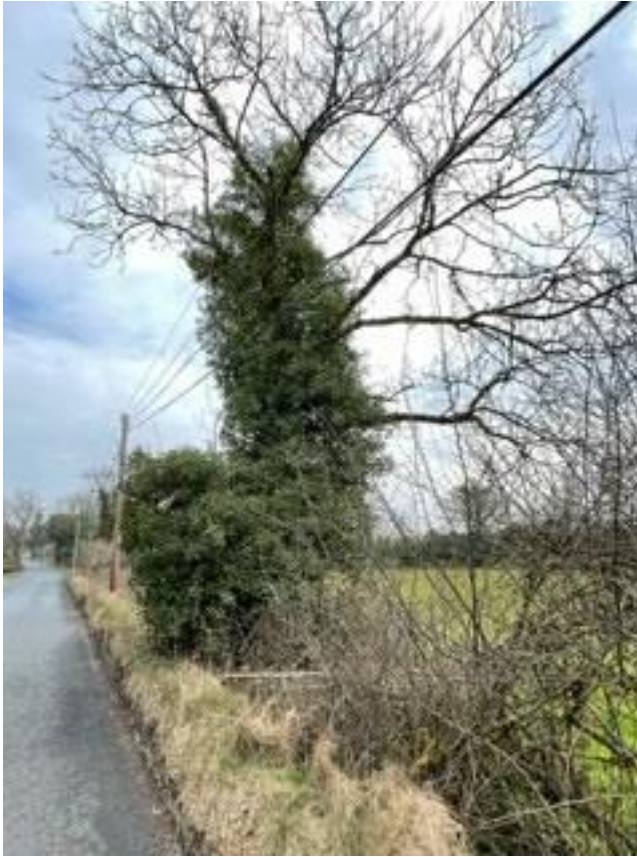
Label 2337 - Outer limbs of trees lowered to c2m to facilitate overhead powerlines

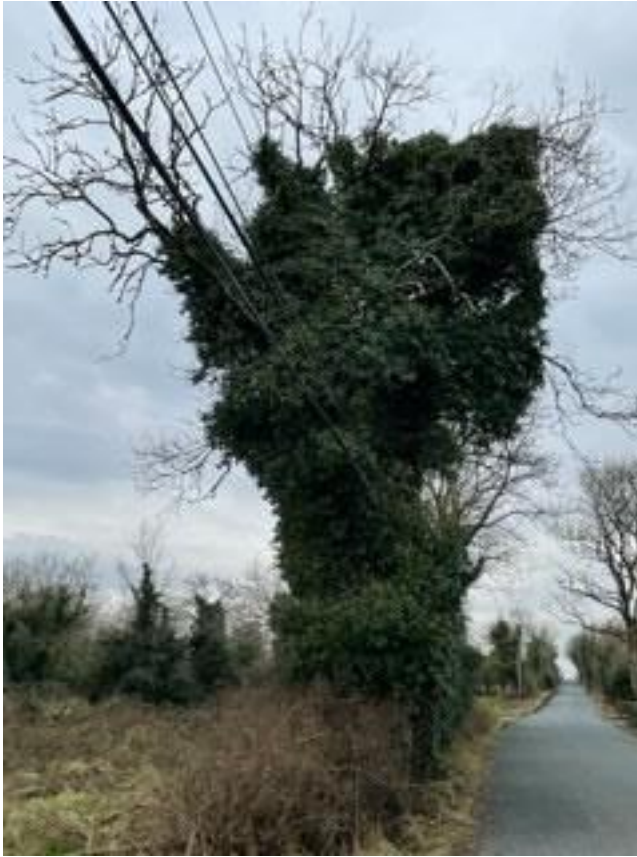
Label 2445 - Ash tree heavily laden with ivy and dying with ash dieback disease

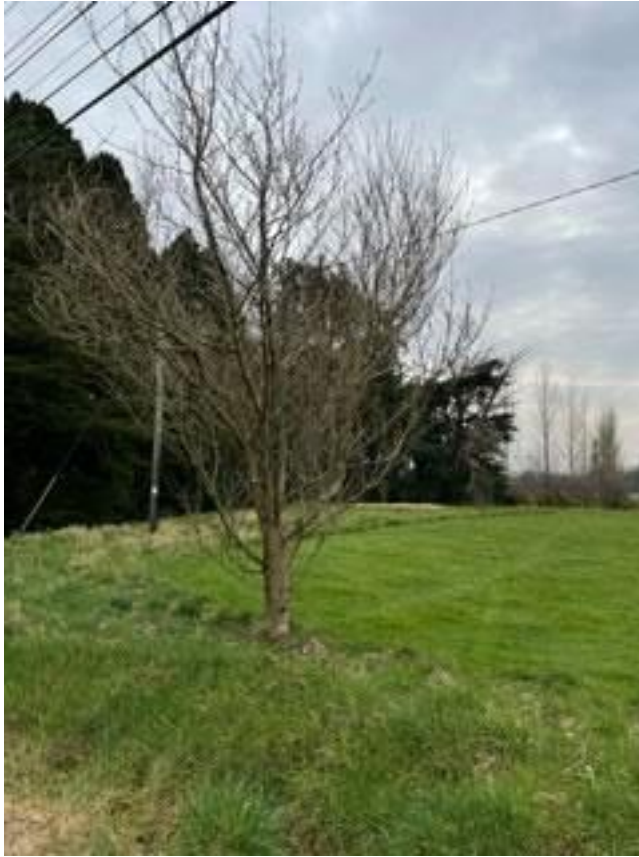
Label 2447 - Cherry tree in private field adjoining the development

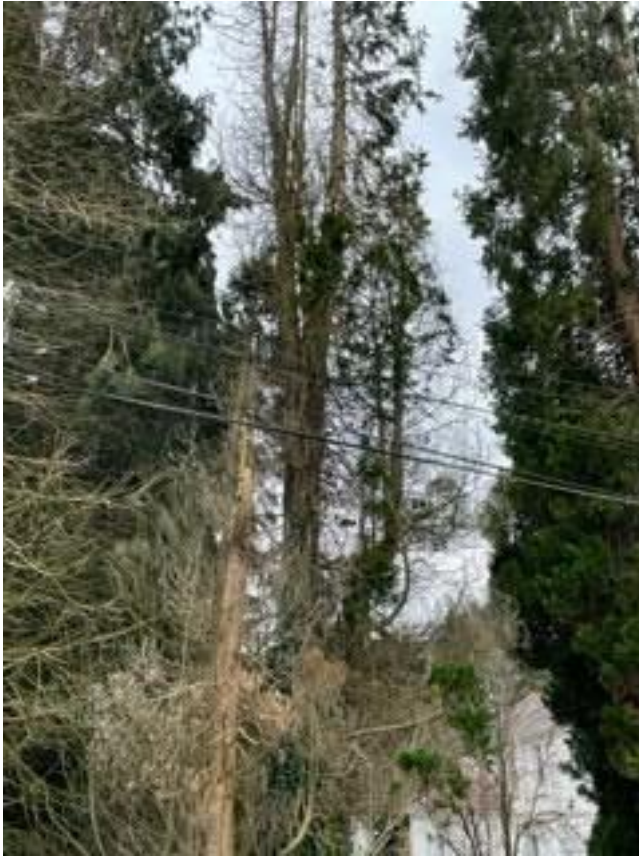
Cypress trees on private property

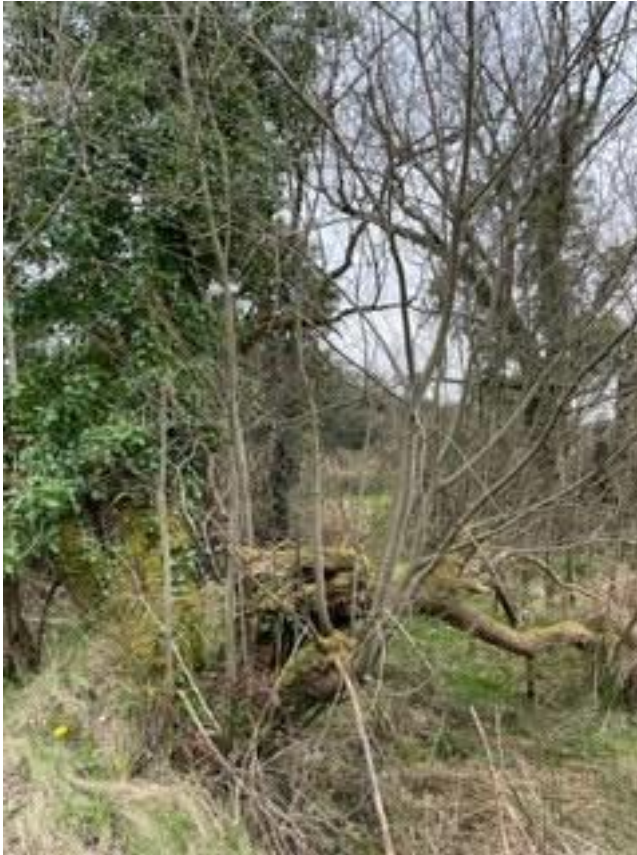
Label 2424 – Willow tree with major limb failure

2424	<i>Salix</i>	Willow	EM	50	11	N – 1 S – 4 E – 5 W - 2	Fair	Fair vigour and fair form. Major limb failure in the past. Ivy and sucker growth at base of tree. Some limbs lowered in the past to facilitate the over.	B >25 years	Clean and reshape the crown. Sever ivy and remove sucker growth

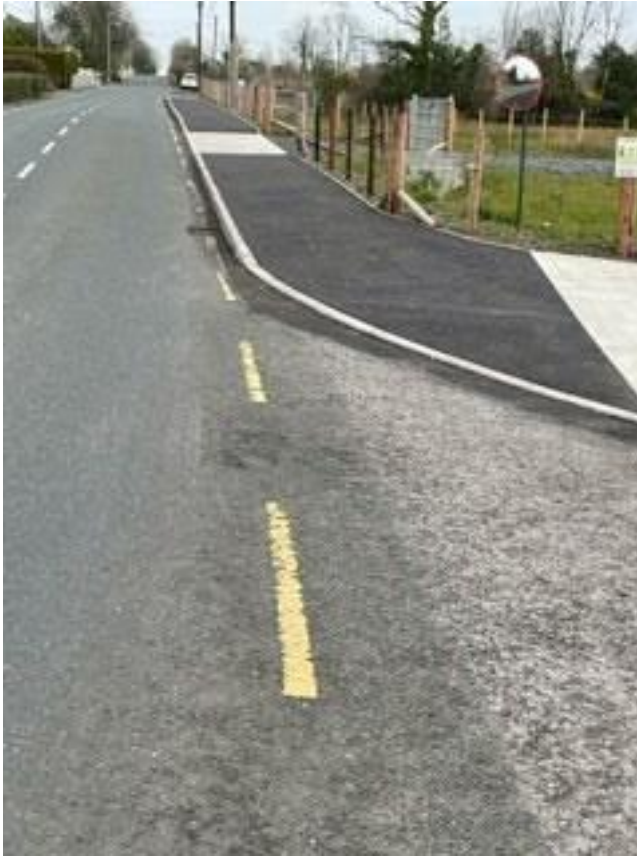
Existing pedestrian/cycle track close to village
