## TAG-21-002-BCC-SITE INSPECTION REPORT

<b>Site Name:</b>	Corneddan, Ballinalee
<b>Location / GPS:</b>

<b>Project Number:</b>	TCCE-2022-097 – OGP - LD
<b>Date of Visit:</b>	16/03/2023
<b>Inspector Name:</b>	Thomas Campbell
<b>Developer Name:</b>	Longford County Council
<b>In Attendance:</b>	
<b>Weather:</b>	Showers
<b>Time of Visit (Start):</b>	08:01 (0 GMT)
<b>Time of Visit (Finish):</b>	11:24 (0 GMT)

<b>Inspection Type(s):</b>	Foundation
<b>Unit Number(s) Inspected:</b>	1
<b>Additional Information:</b>	Site investigation- trial holes

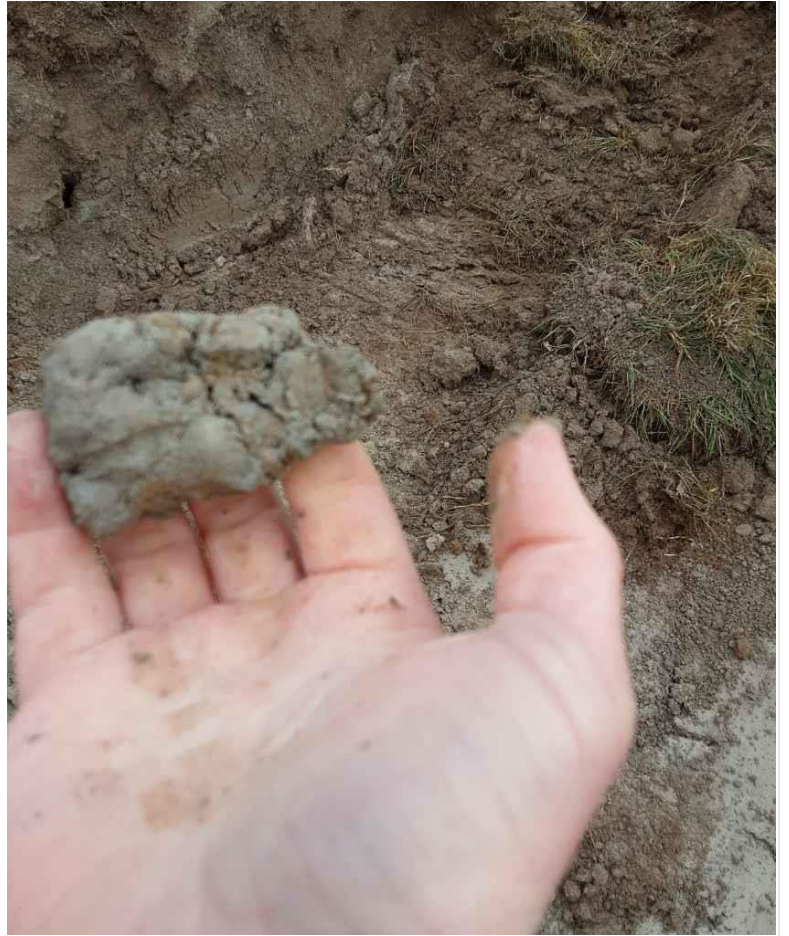
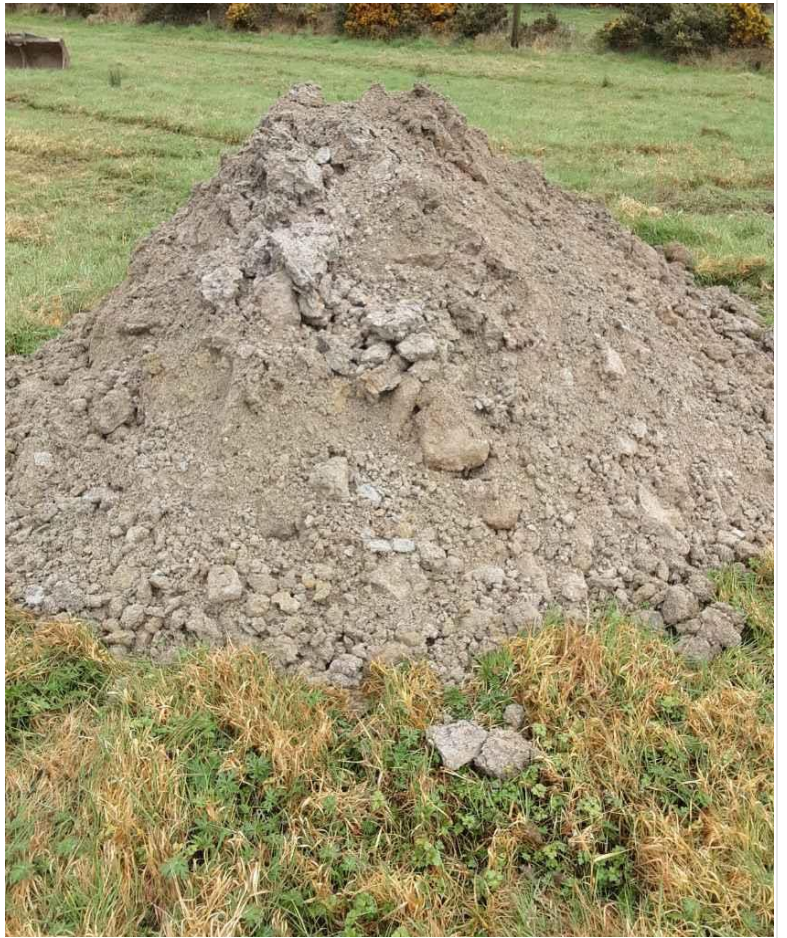
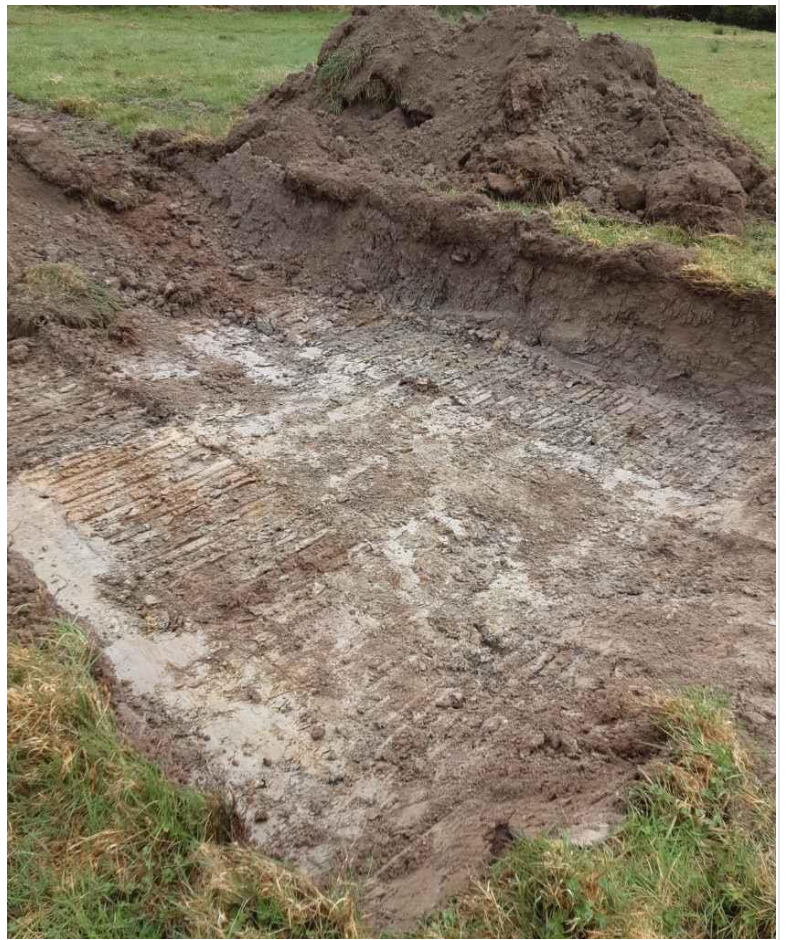
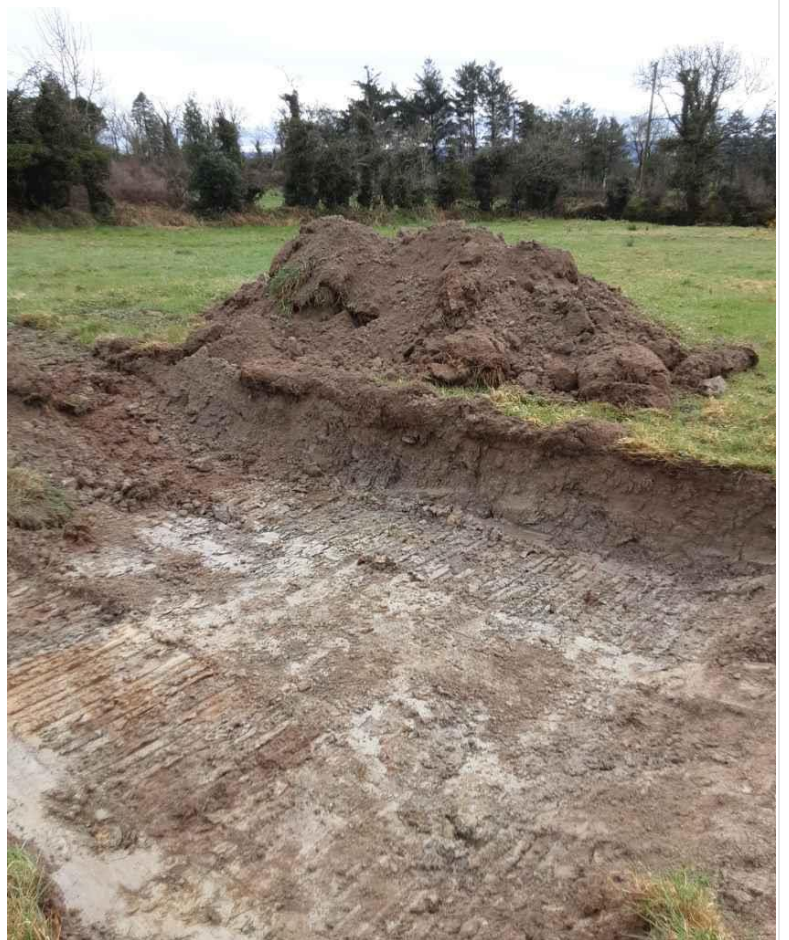
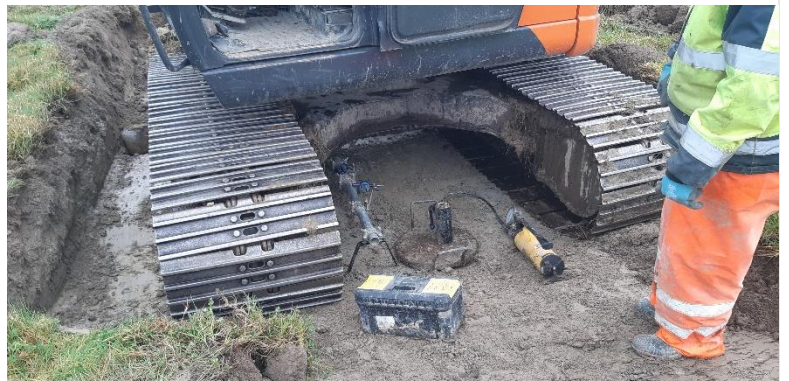
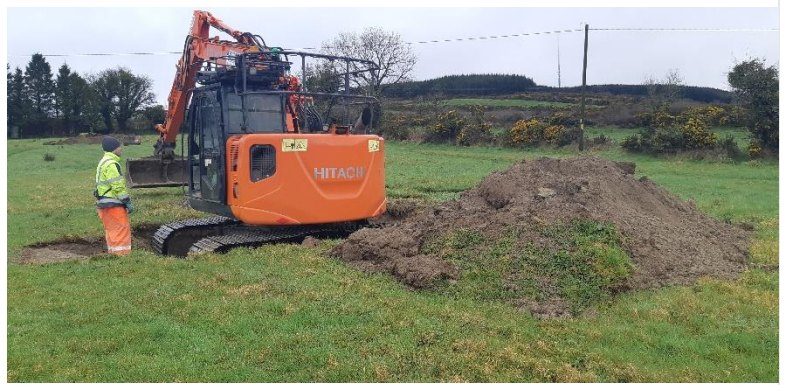
Photo Guidance:	Minimum photos per visit - Front, Back and Side of the Building, Identify Unit/House Number, Photo Unit(s)/House(s) in sequence.
<b>TGD Part A</b>	<b>STRUCTURE 2012</b>
Unit(s) Number(s) Inspected:	1 unit
Description of Observation(s):	<p>Trial hole no 1 / plate bearing test 50mm top soil 400mm of silty boulder clay light brown and grey 3% CBR achieved</p> <p>Trial hole 2 50mm topsoil 550mm of silty boulder clay Moisture in clay at 400mm bgl 15% CBR achieved</p> <p>Trial hole 3 50mm topsoil 650mm of silty boulder clay Trial Hole completed at 2.0mBGL Boulders encountered at 1.5m BGL</p>

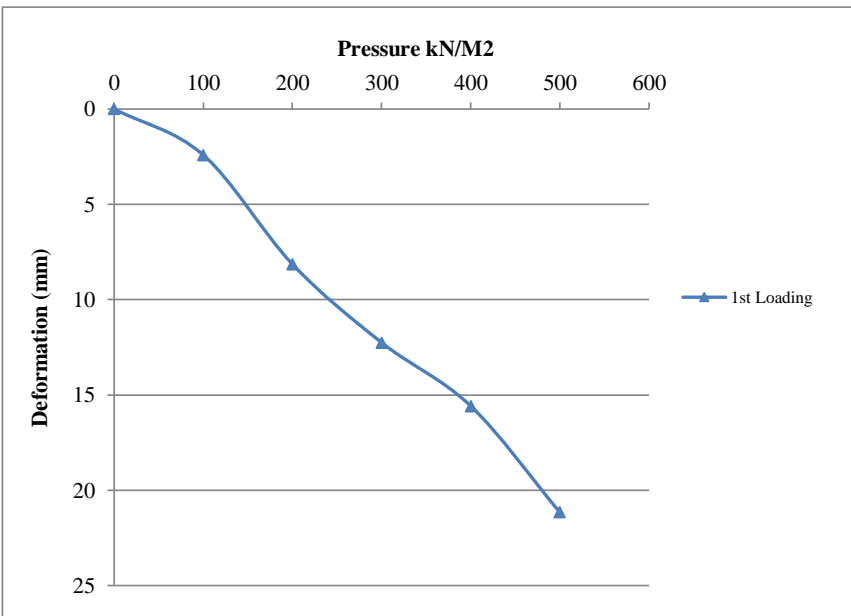
**Location Reference:** Site CBR Test Location - Test 1

Bearing Pressure kN/m <sup>2</sup>	Plate Settlement (mm)
0	0
100	2.41
200	8.14
300	12.25
400	15.58
500	21.16

Maximum Applied Pressure ( kN/m <sup>2</sup> )	500
Maximum Deformation (mm)	21.16
Estimated CBR % @ 1.25mm deformation	3
K= ( KN/m <sup>2</sup> /m) @ 1.25mm deformation	25792
K= ( MN/m <sup>2</sup> /m) @ 1.25mm deformation	26

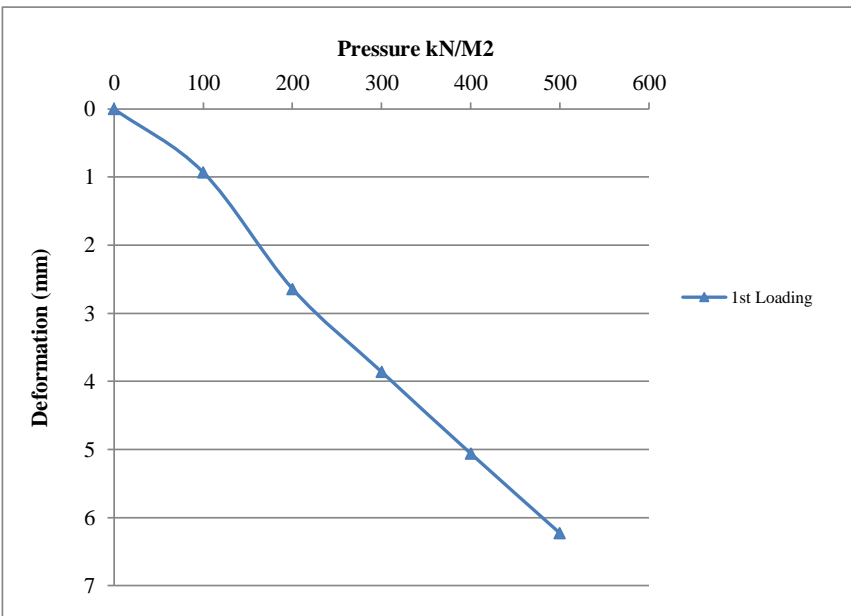
**Location Reference:** Site CBR Test Location - Test 2

Bearing Pressure kN/m <sup>2</sup>	Plate Settlement (mm)
0	0
100	0.93
200	2.64
300	3.86
400	5.06
500	6.23

Maximum Applied Pressure ( kN/m <sup>2</sup> )	500
Maximum Deformation (mm)	6.23
Estimated CBR % @ 1.25mm deformation	11
K= ( KN/m <sup>2</sup> /m) @ 1.25mm deformation	59024
K= ( MN/m <sup>2</sup> /m) @ 1.25mm deformation	59
