Stage 1 Road Safety Audit

R194 Longford Road Pedestrian Improvements Scheme, Granard, Co. Longford.

On behalf of Longford County Council

December 2023

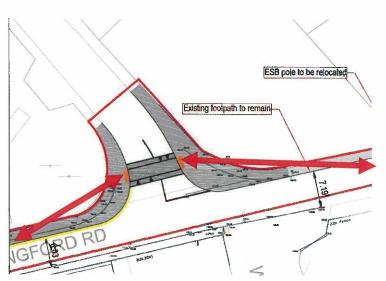
3.3.1 Pedestrian Crossing of Redmond's Terrace Road (L1069)

Problem: There is a ramped uncontrolled pedestrian crossing located inset on Redmond's Terrace road. Pedestrian visibility to / from vehicles turning off Longford Road is restricted by boundary walls/fences.

Hazard: Pedestrians may commence their crossing and be subject to impact from vehicles turning off Longford Road.

Recommendation: Relocate the ramped crossing closer to Longford Road, where improved visibility can be achieved.

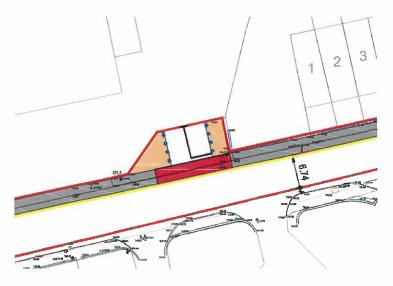
3.3.3 Pat the Baker - Distribution Yard

Problem: Roadside bollards are indicated on the entrance to Pat the baker distribution yard. The bollards appear to be directly adjacent to the traffic lanes. Motorists are likely to drive with reasonable clearance to the bollards. This may result in vehicle straddling the access centreline. Exiting vehicles may prevent entering vehicles from clearing the mainline.

Hazard: Rear end shunts from following vehicles may result.

Recommendation: Set the bollards back sufficient to allow for two way traffic at the development entrance.

3.3.2	Yes	Yes	Provision of bollards may impede exiting left turning HGVs. Hatching will be provided instead of bollards.	
3.3.3	No	No	There is 7.0m clearance between the proposed bollards, this is considered easy passage for two-way traffic.

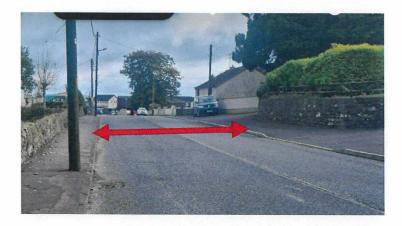
3.3.5 Zebra Crossing – Street Lighting.

Problem: The proposed zebra crossing is located approximately midway between the existing street lights. There is concern that the zebra crossing will not have the same level of illumination as the adjacent roadway.

Hazard: Pedestrians on the crossing may be inconspicuous and susceptible to vehicle strikes.

Recommendation: Provide additional street lighting at the crossing location.

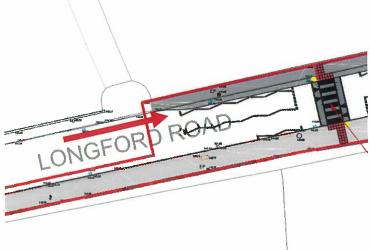
3.3.6 Widened Footpath to North-west of Zebra Crossing

Problem: The existing footpath is being widened via a short taper to the north-west of the zebra crossing. The widened footpath may not be obvious to eastbound motorists.

Hazard: Motorists may impact with the kerb.

Recommendation: Provide vertical reflective features on the footpath taper.

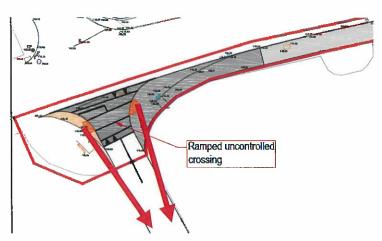
3.3.7 Road to the East of Ardscoil Phadraig

Problem: There is a proposed raised uncontrolled pedestrian crossing of the road to the east of Ardscoil Phadraig. Pedestrian visibility to the south from the crossing is restricted by boundary walls and vegetation, the crossing is also angled towards the barrier at the school entrance.

Hazard: Pedestrians may commence their crossing and be subject to vehicle strikes. Sight impaired pedestrians crossing may be guided into the barrier at the school entrance.

Recommendation: Relocate the crossing closer to Longford road, where improved visibility can be achieved and also sight impaired pedestrians will be guided onto the footpath continuing past the school barrier.

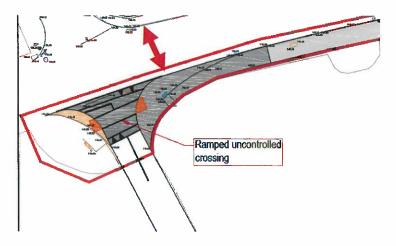
3.3.8 Dropped Kerb at Junction of Longford Road with L5128

Problem: There is an existing dropped kerb to the northern side of Longford Road near the junction with the L5128. Presently pedestrian can cross north-south from this dropped kerb to the far side of the road with no trip hazards. Upon completion of the proposed works and new full face kerb will need to be negotiated.

Hazard: Mobility impaired pedestrians may trip/fall due to the high kerb.

Recommendation: Provide dropped kerbs, complete with blister tactile paving to both sides of the Longford Road.

3.3.4	Yes	Yes		
3.3.5	Yes	Yes		
3.3.6	Yes	Yes		
3.3.7	Yes	Yes		
3.3.8	Yes	No	Dropped kerb will be provided. As no works are proposed on the northern footpath at this location and there is no existing blister in the path, no blister tactile paving will be installed with the dropped kerb on the southern footpath
