# Stage 1 Road Safety Audit

Market Street to Barrack Lane Pedestrian Improvements Scheme, Granard, Co. Longford

On behalf of Longford County Council

December 2023

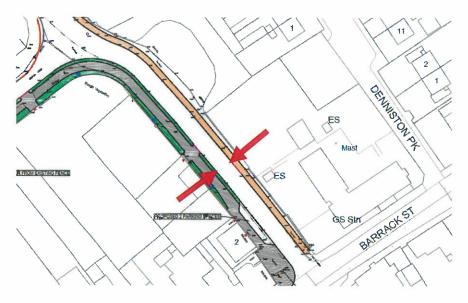
#### 3.2.4 Barrack Lane - Width

**Problem:** The proposals drawings appear to show Barrack Lane as quite narrow. There is a current planning application for an Aldi store on lands to the north. Delivery vehicles for this store are likely to use Barrack Lane. It is not clear if the carriageway is sufficiently wide for opposing vehicles to pass.

**Hazard:** Motorists may mount the footpath in order to pass opposing vehicles. Impact with pedestrians may result.

Recommendation: Undertake swept path analysis and widen the carriageway if necessary.

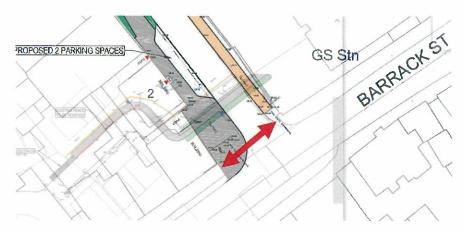
### 3.3.1 Footpath at Junction of Barrack Street / Barrack Lane

**Problem:** The proposed macadam finish footpath extends to Barrack Street. The existing Barrack Street footpath is concrete finish and appears in good condition. Sight-impaired users may believe the interface of the existing concrete footpath with the new macadam footpath is the carriageway edge, resulting in confusion for these users.

**Hazard:** The sight-impaired user may, once entering the macadam footpath, attempt to walk the full distance across to the far side of Barrack Lane. Motorists may arrive in the time the pedestrian walks the long distance. Impact between the users may result.

Recommendation: Retain the existing concrete footpath on Barrack Street

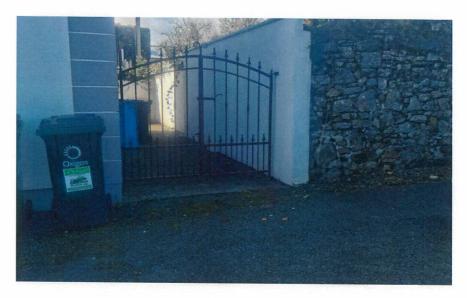
### 3.3.3 Driveway at Number 2 Barrack Lane

**Problem:** There is a narrow driveway to the side of Number 2 Barrack Lane. The proposals drawings indicate a roadside parking bay in front of the driveway. There is concern that motorists or powered two-wheeled vehicles will drive along the footpath to the rear of the parking bay in order to access/egress the driveway.

Hazard: Pedestrian impacts may result.

Recommendation: Relocate the parking bay and make allowance for vehicular access to the driveway.

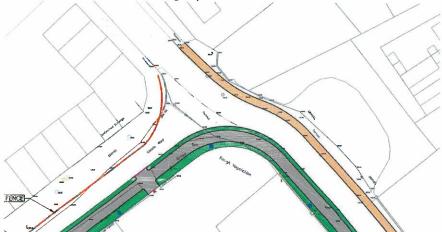
## 3.3.4 Barrack Lane / Link Road Junction

**Problem:** The proposed kerb line at the interface of Barrack Lane with the link road is very large. This does not indicate a junction but may be read as a bend in the road. Motorists may drive from Barrack Street into the Link Road at high speeds.

Hazard: Impact with pedestrians crossing south-north, possibly to the future Aldi store, may result.

Recommendation: Redesign the junction in order to slow the speed of turning vehicles.

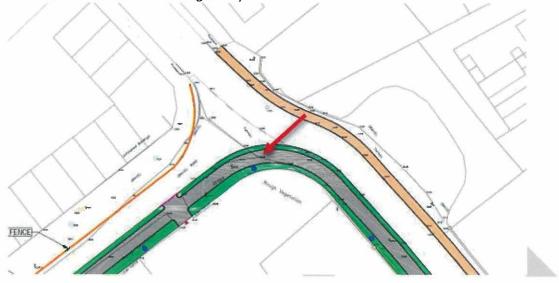
#### 3.3.5 Barrack Lane / Required Crossing Facility

**Problem:** Pedestrians walking south on the east footpath on Barrack Lane intending to enter the Link Road to Market St have no crossing facility.

Hazard: Impact with pedestrians crossing onto the link road may occur.

**Recommendation:** Provide a crossing facility on Barrack Lane leading to the footpath on the Link Road to Market St.
