Archaeological Impact Assessment & Building Appraisal Former Convent of Mercy Ballymahon, Co. Longford

Applicant: Longford County Council
Issue Date: April 2025
Prepared by: Marion Sutton & Philip Kenny, Shanarc Archaeology Ltd.

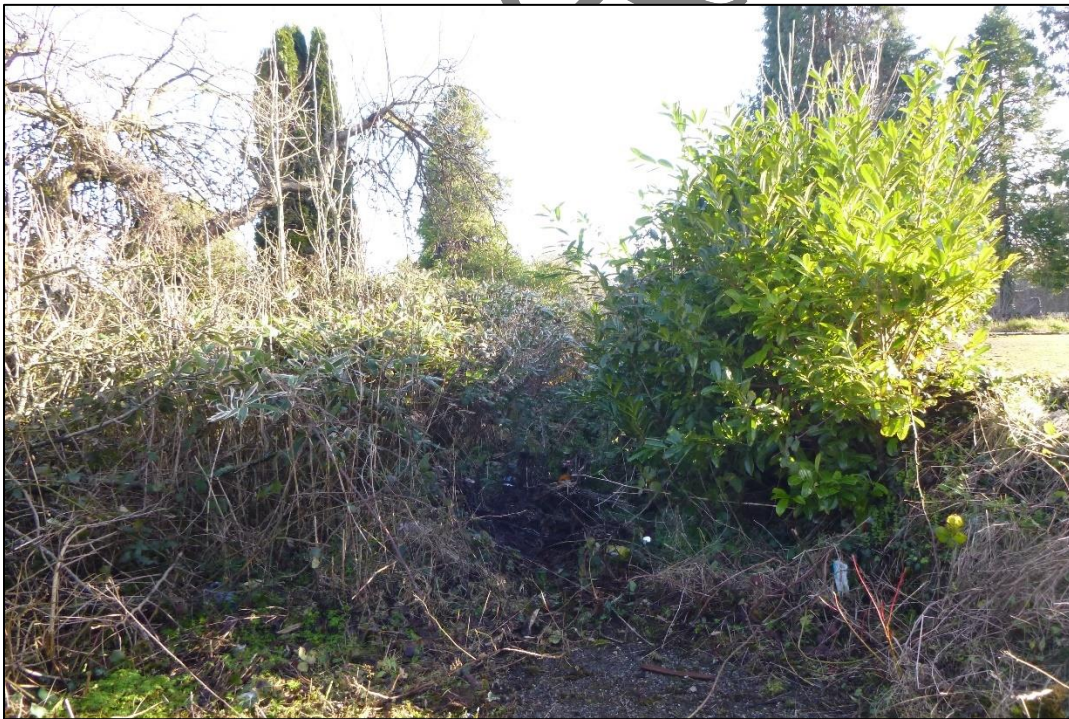
Plate 11 Overgrown garden plants obscuring concrete capped stone retaining wall at NE end of front forecourt (05.02.2025).

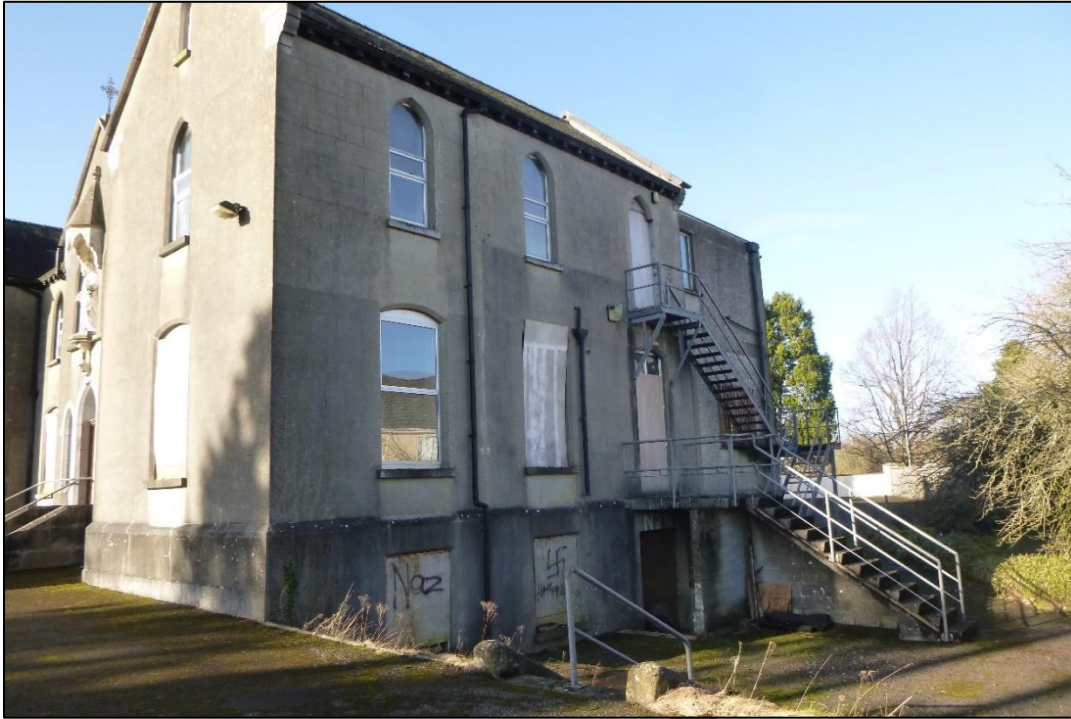
The NE side elevation (Plate 14) is a three-bay, two storey façade over an exposed basement, with two later fire escape stairs added. Ground floor and first floor window opes are identical to the front façade, having replacement aluminium frames. The north window ope to both floors have been modified, to provide door opes, having later doors, to the fire escape stairs (Plate 15). The ground floor fire escape is a mass concrete and concrete block structure providing cover to a slightly lower basement level square headed door ope that is likely a modified square headed window ope. The basement level windows are square headed and boarded. A concrete lined, rectangular sunken feature at ground level outside the south basement window is filled with rubbish; its function is unknown. A 20th century two-storey over basement pebble-dashed addition infills the convent's NE corner, having square headed timber framed windows to basement and ground floor and square headed aluminium framed window at first floor. Basement level windows and one ground floor window are barred.

Plate 14 NE elevation of convent with fire escape stairs (05.02.2025).

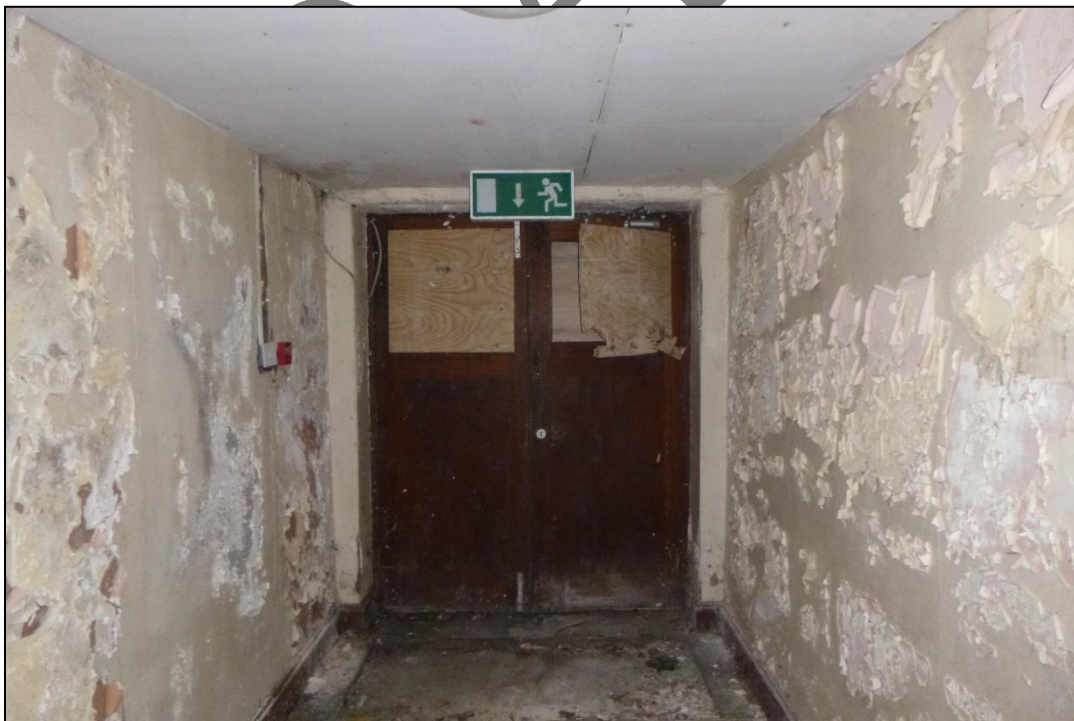
Plate 23 Blocked timber fire escape door at NE end of central corridor at basement level (18.02.2025).

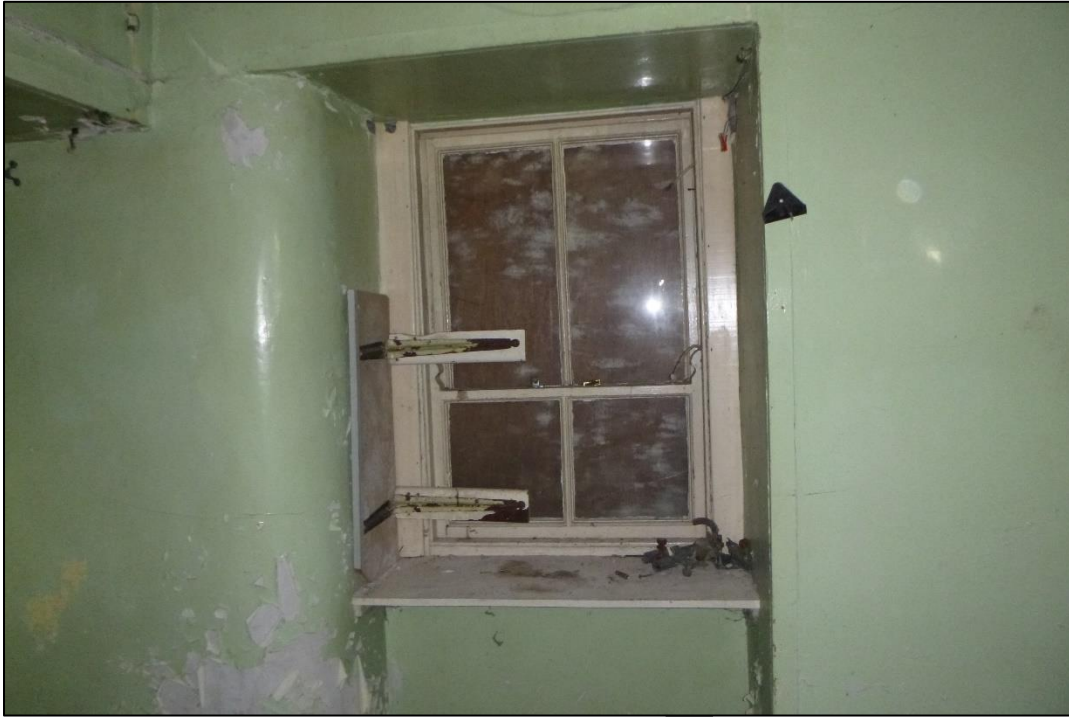
Plate 24 Blocked basement level window type with original timber sash window frame (18.02.2025).

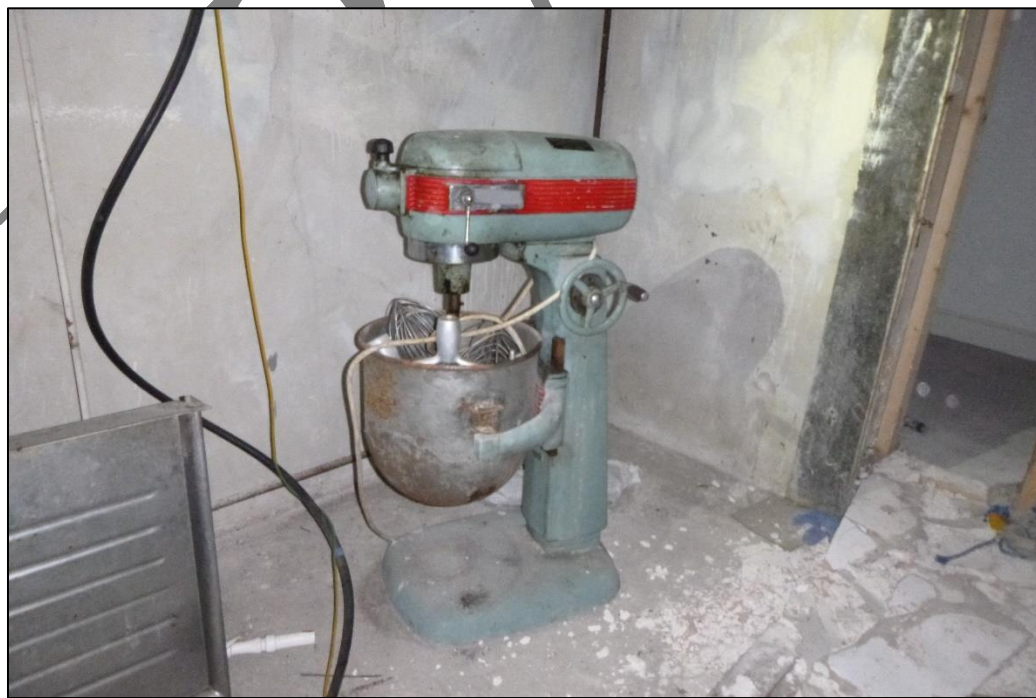
Plate 33 Non-fixed chattel (food mixer) in generator room positioned centrally in front range (18.02.2025).

The visual link between the convent and former graveyard should be maintained in respect of development at this site. The link has been acknowledged in the project design, aligning the proposed community hall to reduce the effects and to frame the site with the former graveyard. It has been confirmed that the present catholic statue in the surviving garden will be retained on site; a green or planted area of the site for relocation is recommended. The steps and access gate in the rear boundary wall at Saint Matthew's Catholic Church should remain unaltered, in acknowledgement of the former relationship between the convent and the church. A remaining chattel at basement level, a food mixer associated with the convent, should also be retained internally.

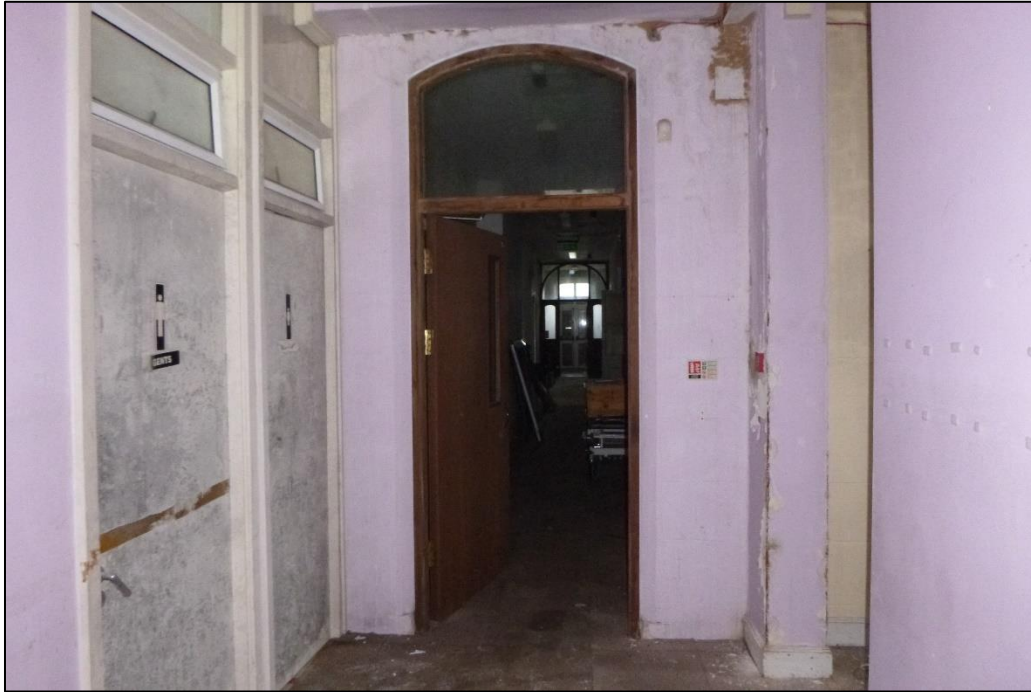
The original side entrance door at the SW end of the main NE-SW corridor, providing access between the 1970s annex and 19th century convent has a replacement timber door (Plate 40). Toward the NE end of the corridor, a square headed glazed and panelled timber door with flanking panels and an arched framed overlight with spandrels is original, and delineates a former temporary office at the NE end of the corridor (Figure 4; Plate 41). A replacement PVC fire escape door at the NE end of the corridor retains original timber embrasure lining, shutters and architrave (Plate 42). Access to the stairwell from the corridor is blocked with a rendered partition (Plate 43); elsewhere along the hall the walls are hung with white wallpaper. Central along the corridor, an original round headed statue niche with timber architrave and pilasters on the NW wall faces the main front entrance hall (Plate 44).

Plate 40 Original door open at side entrance to convent on SW elevation, looking NE from annex (18.02.2025).

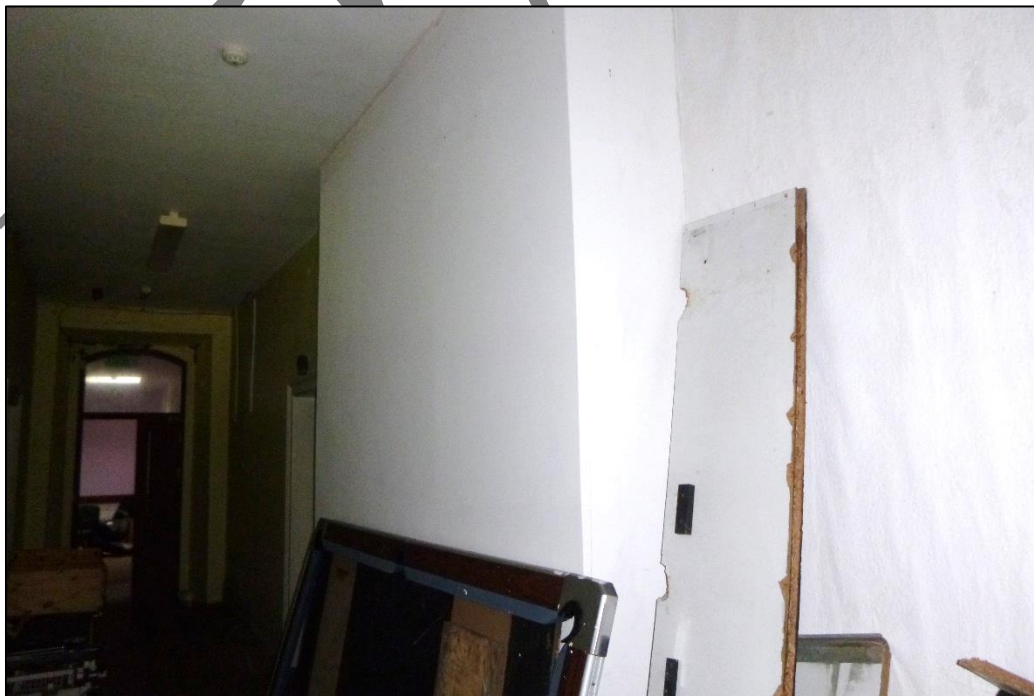
Plate 43 Blocked access to stairwell from main ground floor corridor (18.02.2025).

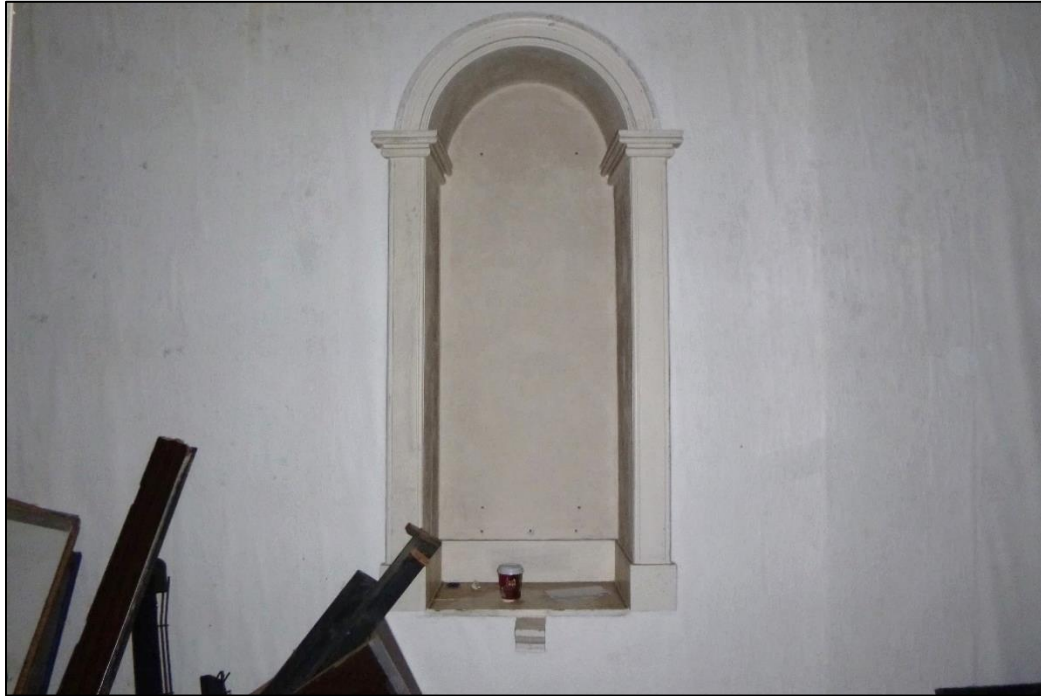
Plate 44 Statue niche in main corridor facing front entrance hall (18.02.2025).

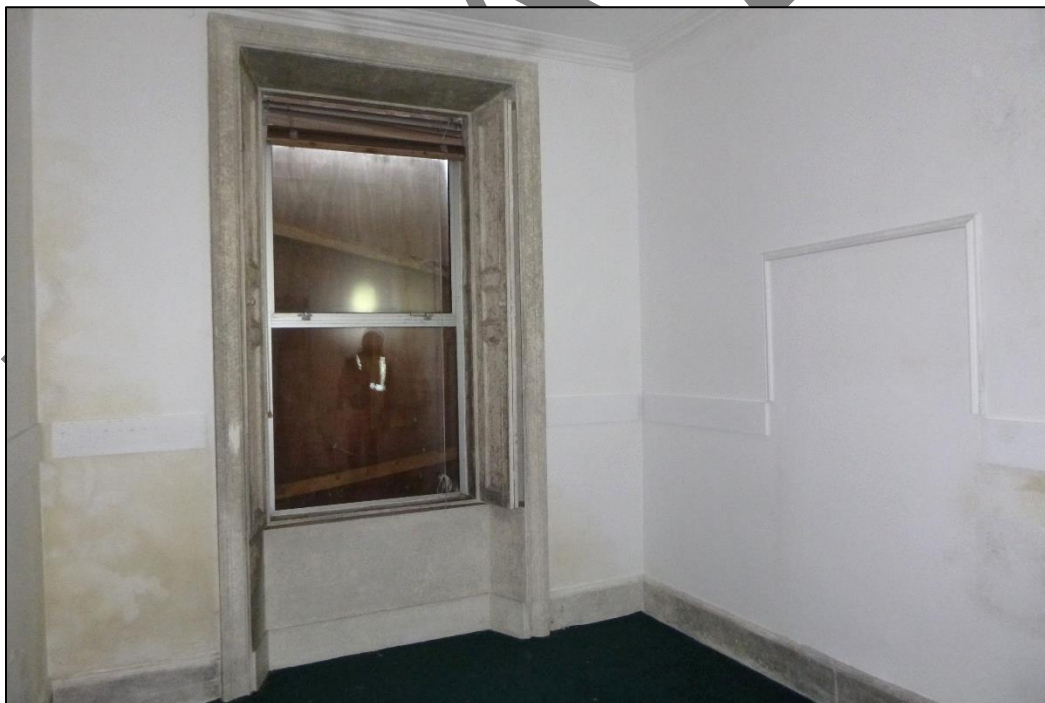
panelled door, one original window embrasure with timber shutters and replacement aluminium frame on the SE elevation, cornice moulding and dado rail height wall mounding incorporating a square headed moulded surround (Plate 49). A former community room (Figure 4) at the NE end of the range has a timber floor, square headed door ope with timber 4-panelled door, three original window embrasures with timber shutters and replacement aluminium frames on the NE and SE external elevations and cornice moulding and panel to walls (Plate 50); a cast iron fireplace mantle with fireplace hood, decorated cheek tiles and tiled hearth is positioned on the internal SW wall (related grate currently sitting centrally in the room) (Plate 51); a blocked door ope into the room on the NW wall is evident on the wall face in the main corridor.

Plate 49 Small front library to NE side of front hall with original shuttered window embrasure and wall moulding (18.02.2025).

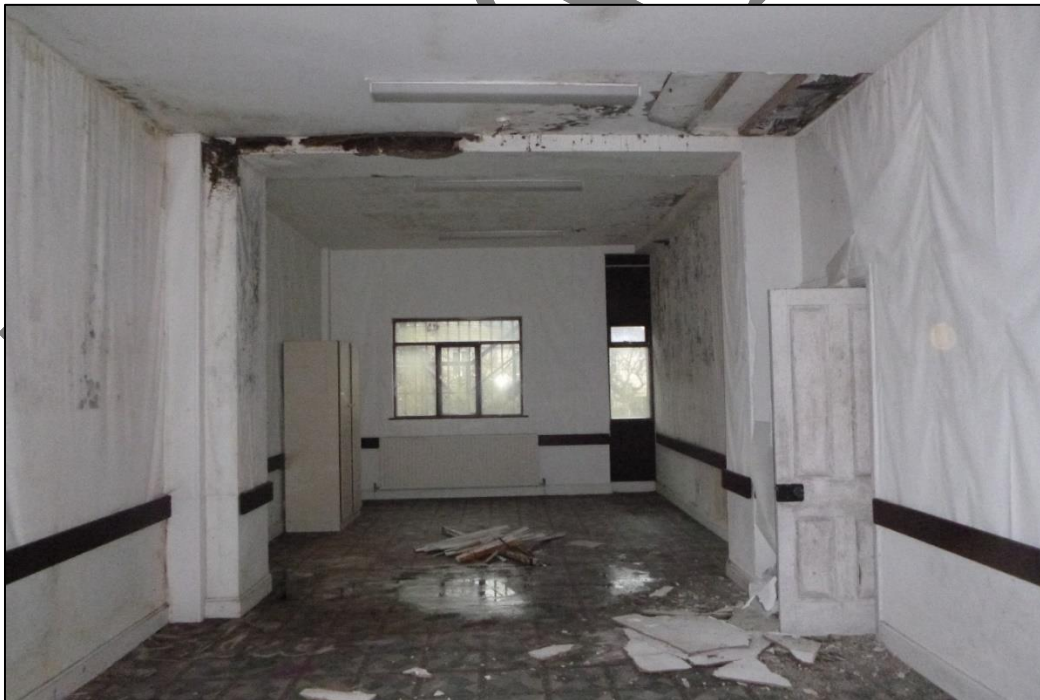
The ground floor in the rear range is a single large space consisting of a former refectory room (Figure 4) opened out through the 19th century NE gable into the 20th century infill extension at the NE corner of the convent. It has three square headed door opes, two with timber 4-panelled doors, one smaller sized with a flat panel door. Two door opes in the SW wall access the stairwell, to either side of a blocked chimney breast (Plate 52). The room contains two original window embrasures with timber shutters and replacement aluminium frames on the NW external elevation, and a small window, visible from the exterior is hidden behind the room's wallpaper lining. The room is wallpapered white throughout, with a timber dado rail. Two projecting wall stumps, represent original gable wall fabric, marking the divide between the 19th century convent and 20th century infill (Plate 53).

Plate 53 View NE from former refectory room to 20th century infill at NE corner of convent; original gable wall knocked through into extension (18.02.2025).

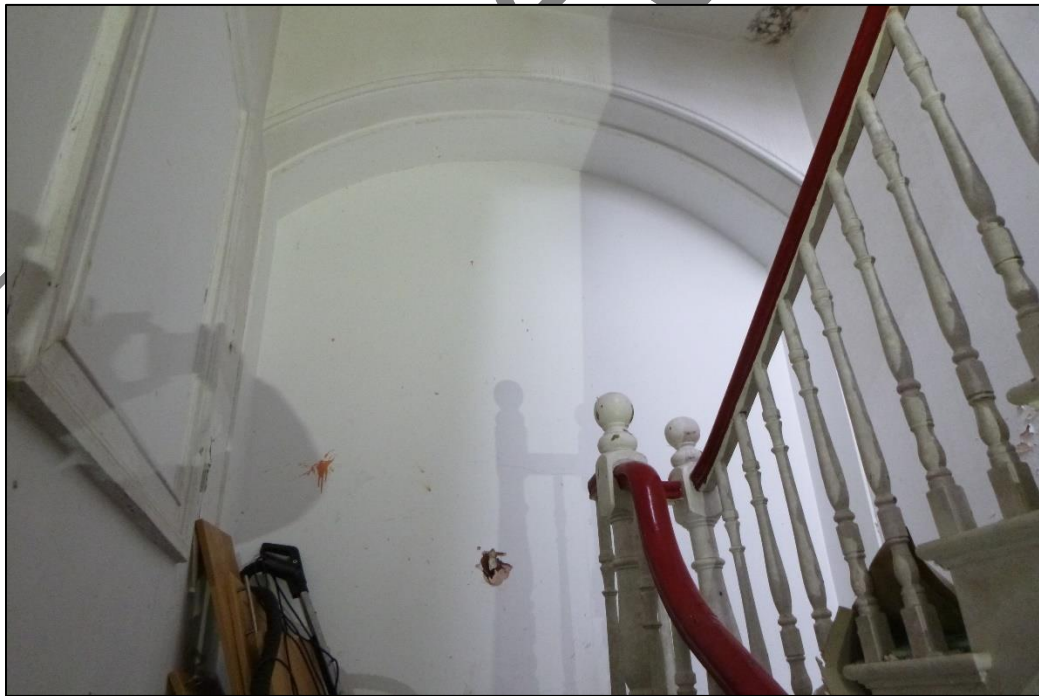
Plate 55 Stairwell landing at ground floor level showing blocked wide segmental arched ope (18.02.2025).

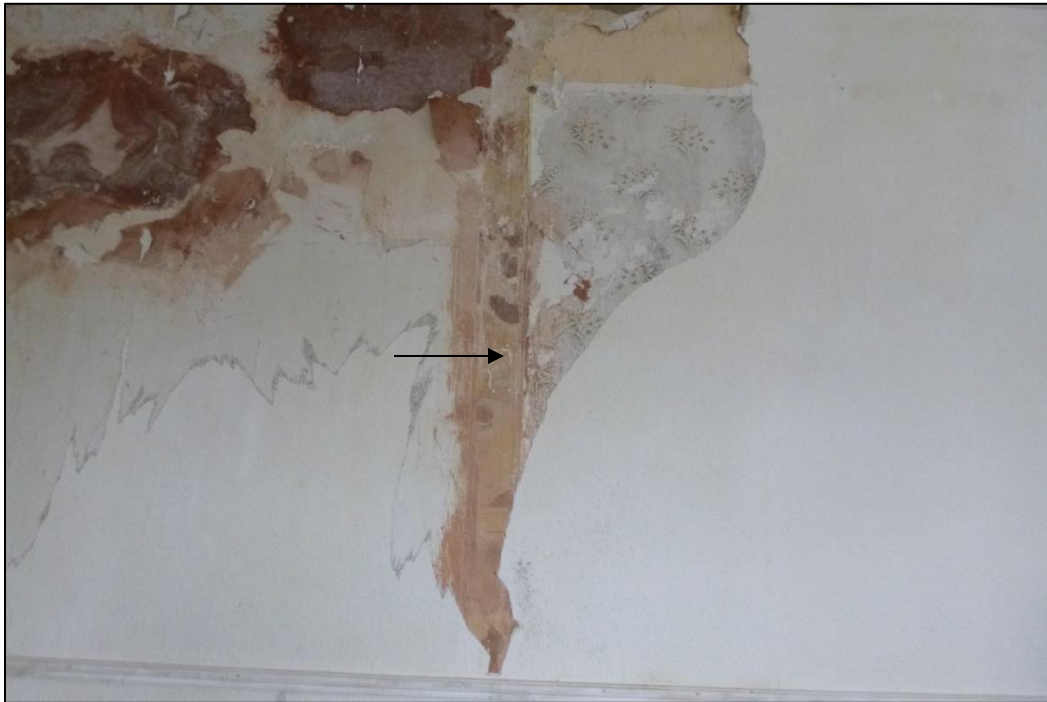
Plate 68 SW corner room to front range with early wallpaper and former partition scar (arrowed) on internal NE wall (18.02.2025).

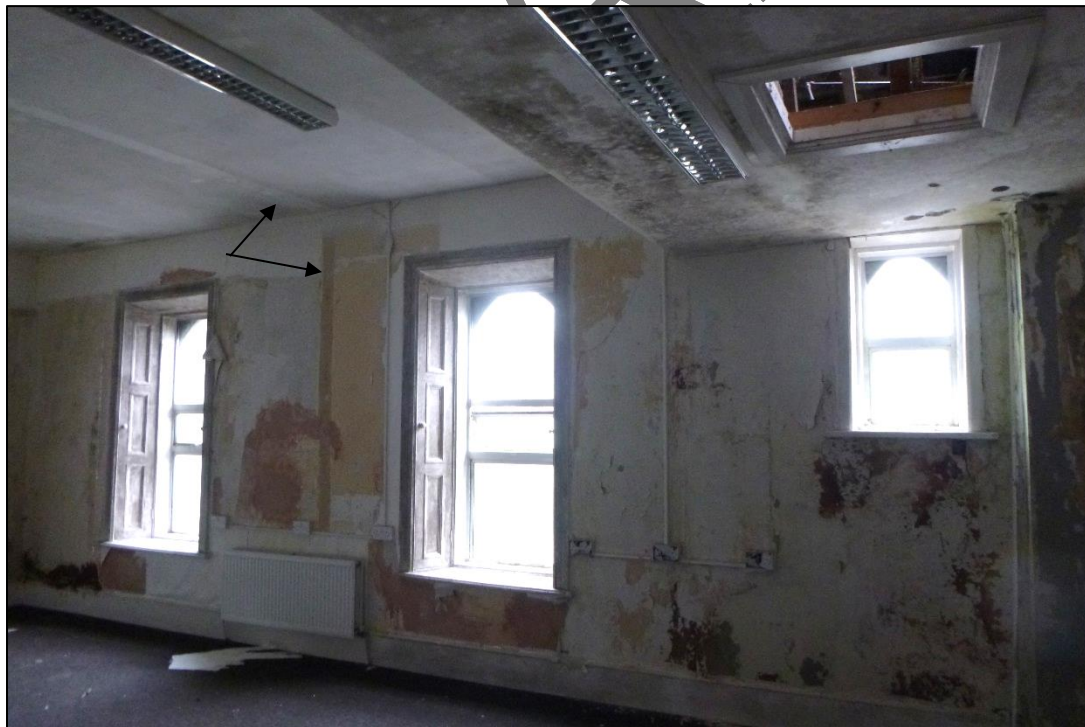
Plate 73 NW elevation of room to rear range, with lower ceiling and attic hatch above small window and partition scar (arrowed) (18.02.2025).

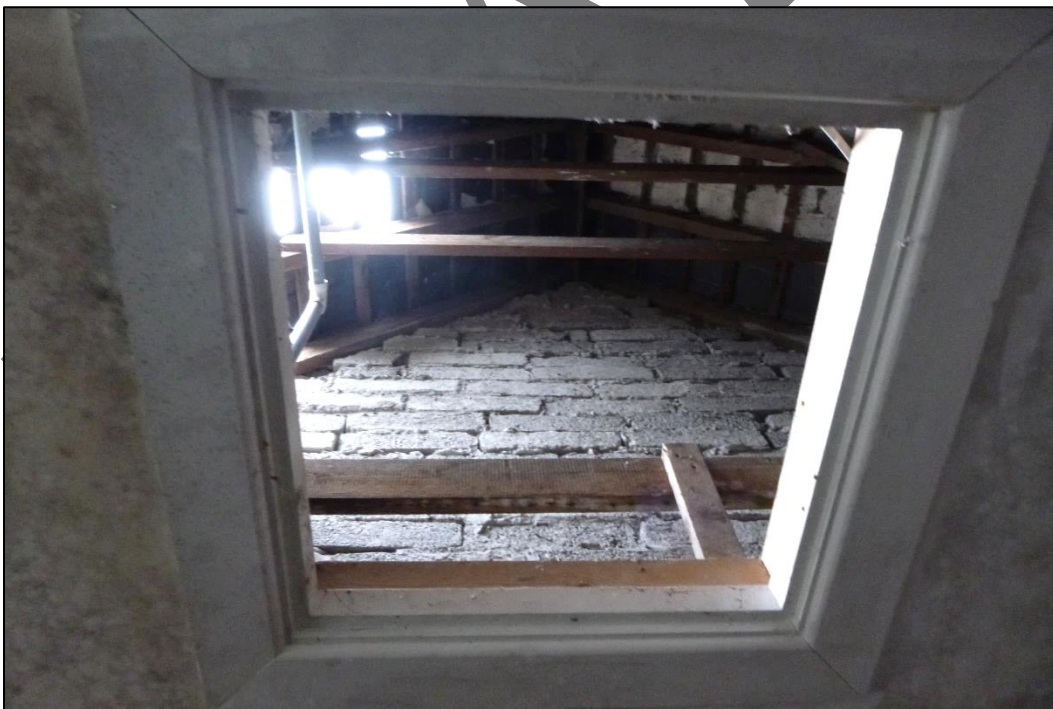
Plate 75 View through attic hatch to NE concrete block gable, original roof timbers and lime mortar torching (18.02.2025).
