Architectural Conservation Assessment

Convent of Mercy

Main Street, Ballymahon, Co. Longford

Date of Assessment: March 2025

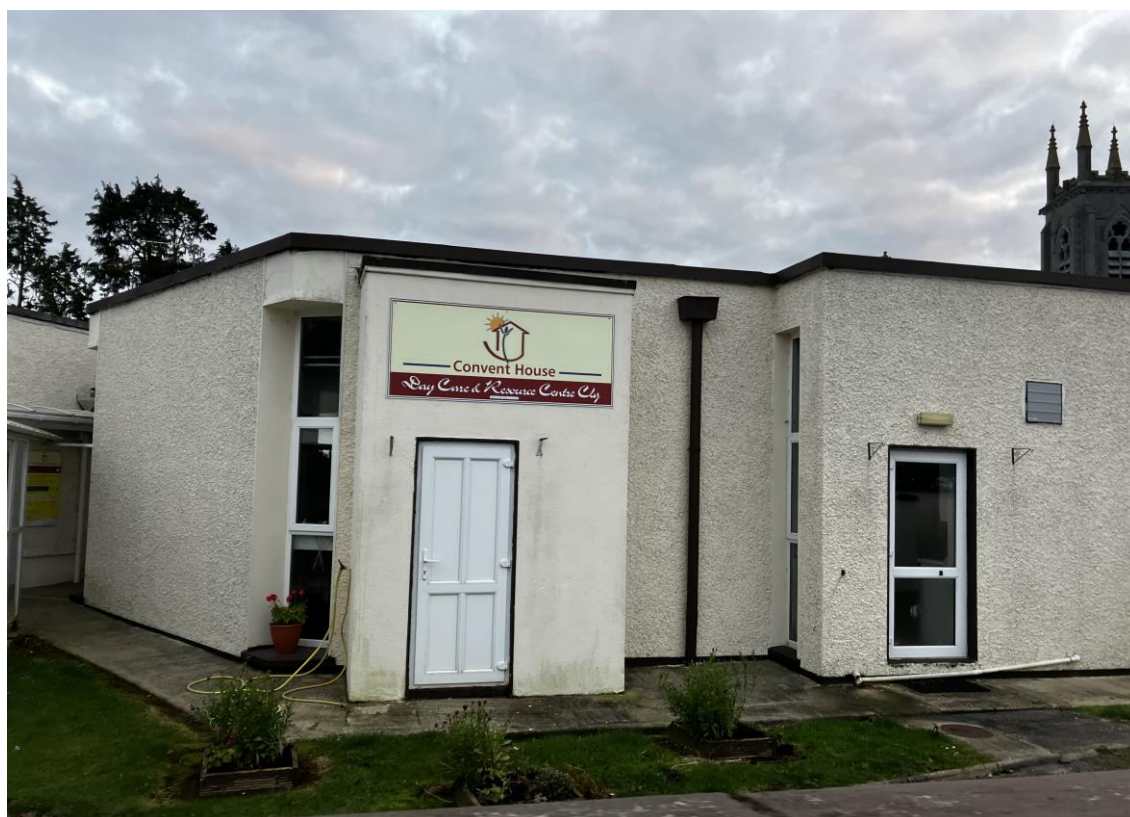
KLA – Image of hexagonal extension to be demolished viewed from northwest boundary

- Demolition works which consist of the demolition of the poor quality flat roofed hexagonal extension to southwest and the demolition of extension to northwest at ground floor level. It is important to note that such renovations will be carried out in accordance with building regulations and with the guidance of qualified structural engineers.

Feature Ref	Description	Proposed Alteration	Impact Of Proposed Alteration	Evaluation of proposed works/ mitigating measures/ justification
Existing Extension	Existing 20 th Century hexagonal single-storey flat-roofed extension (former chapel) to the west of Convent & existing flat-roofed extension to the north of the Convent.	Existing 20 th Century extensions to be demolished as indicated as they are in poor condition and not part of the original Convent of Mercy	This will be positive as the existing extensions take away from the original Convent of Mercy and are in poor condition.	This step is necessary as the extensions do not compliment the architecture of the existing Convent and occupy a crucial area on this site where a new extension, sensitive to existing form, could be built.
Internal Works	Dry lining of rooms, minor internal demolition works, addition of new lift and addition of a new stair core to north of building.	The dry lining of internal rooms, where possible. The demolition of internal walls to repurpose rooms. The addition of a lift serving all three levels in the centre of the building. The addition of a new stair core to the north of the building to access all three levels.	Positive as dry lining of rooms will improve thermal performance of the building. The demolition of some internal walls will create the space needed to meet the room requirements for a day care centre. The addition of an internal lift will make the building accessible to all users. The addition of a new stair core will improve circulation within the building.	These works are justified as the Convent is an old building with poor thermal performance, therefore dry lining is needed. The day care centre has specific room requirements, many of which cant be met with existing size/ types of rooms. The new lift is an essential addition to make the entire building accessible. The stair core is a positive addition, vital to the fire safety and good circulation of the building.

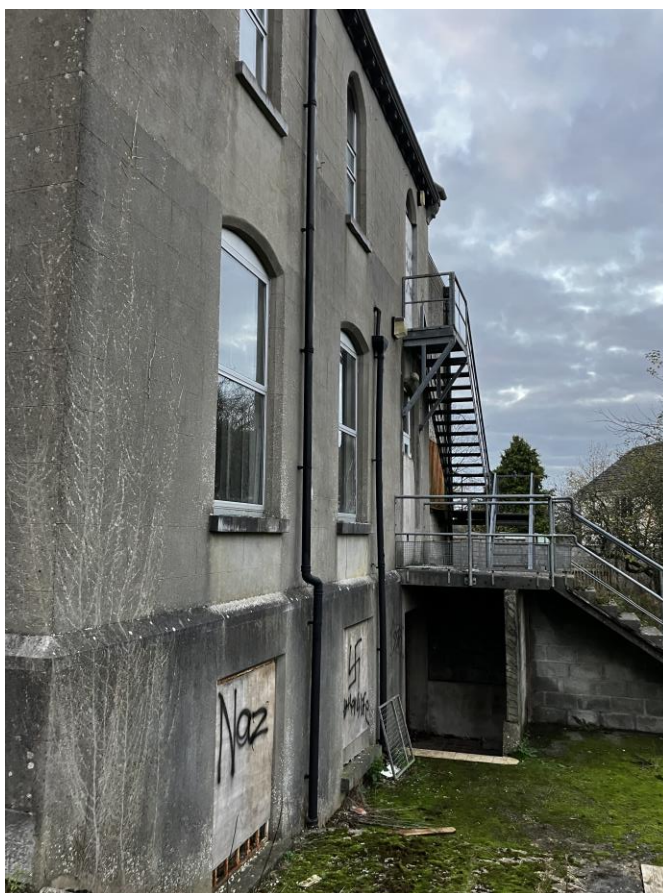
KLA – Image of external stairs to be demolished on east side of building

Other Demolition Works	Additional minor demolition works such as external ramps and stairs.	Poor condition ramps and stairs currently surrounding the Convent and accessing the extensions, to be demolished.	Positive as the external facades of the Convent will be uninterrupted by poor condition ramps and stairs and will be allowed to be appreciated fully by the public.	These works are justified as the current external ramps and stairs interrupt the architectural beauty of the Convents facades and are currently falling into disrepair.

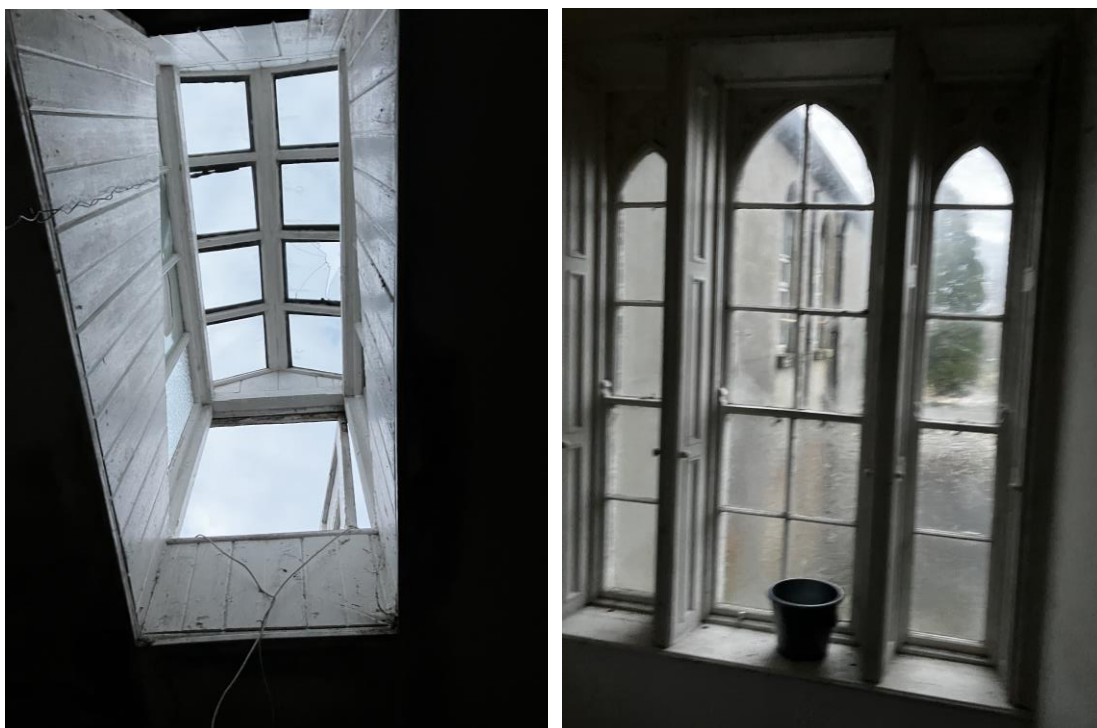
KLA – Image of original timber rooflights which are in severe disrepair & first floor feature window in the Convent of Mercy

- The refurbishment of the existing structure, the Convent of Mercy. This renovation would include the repair and replacement of all existing external windows and doors, including the feature window in the South West gable and the timber dormer in the North West-facing plane of the main roof. It would also include the repair and replacement of the existing roof and damp proofing the basement. It is important to note that such renovations will be carried out in accordance with conservation best practice, current building regulations and incorporating the input of qualified structural engineers where required.

Pitched Slate Roof	Pitched slate roofs with ridge tiles, overhanging eaves, timber dormer feature, brick chimneystacks, wrought-iron finial to central breakfront gable and cast-iron rainwater goods	Repair and replacement of existing roof, chimneystacks, timber dormer and all other roofing elements.	This will have a positive impact on the building as it preserves the original roof structure and the buildings character.	This is a justified step to retain the original roof of the protected structure.

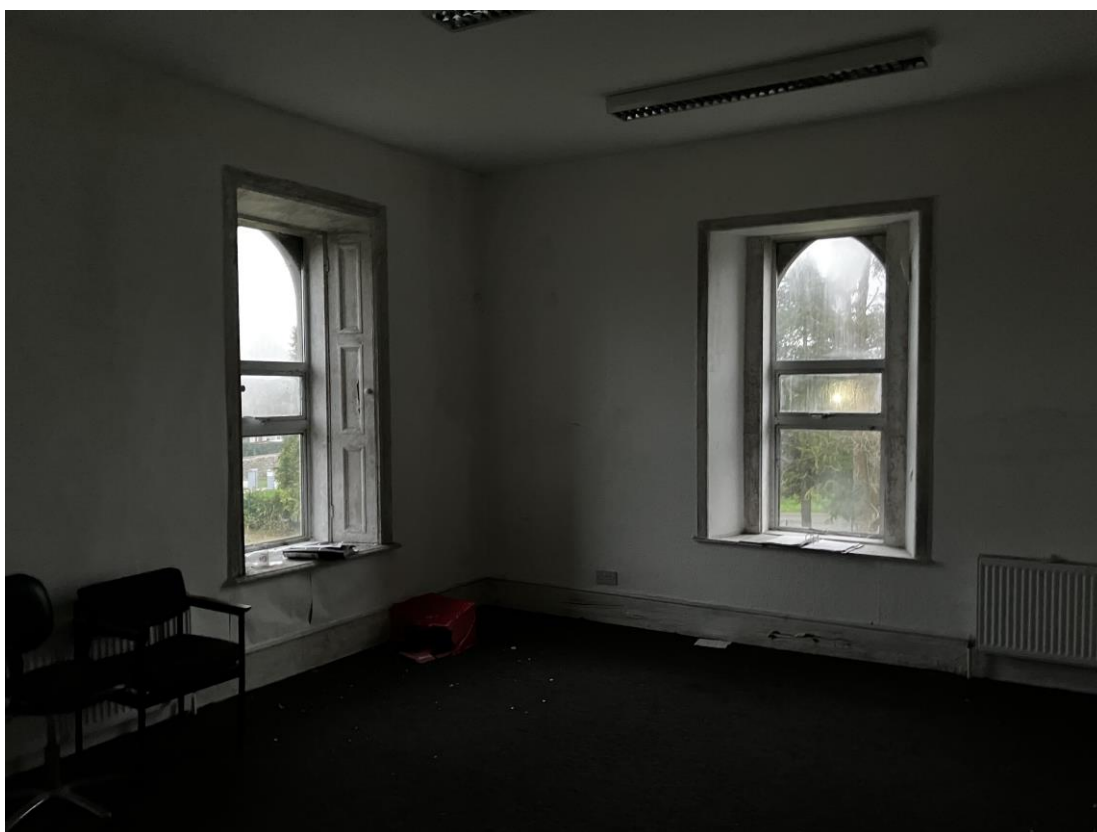
KLA – Image of the original timber sash windows of the Convent of Mercy

Feature Ref	Description	Proposed Alteration	Impact Of Proposed Alteration	Evaluation of proposed works/ mitigating measures/ justification
Windows	Pointed arch window openings to first floor having tooled limestone sills and replacement windows. Segmental-headed windows to ground floor, feature First Floor window to South West gable with tooled cut limestone sills and replacement windows.	Repair existing windows and where necessary, replace windows.	Positive impact restoring the original character and fabric visuals of the building.	Best conservation practice will be implemented. Specialist window supplier.
Timber Panelled Door	Pointed arch door opening to central breakfront having square-headed doorway with timber panelled door, cut stone surround, plain overlight and flanking pointed arch sidelights with cut stone surrounds.	Repair existing door, sidelights and overlight, and if necessary, replace.	Positive impact, the repaired panelled timber door will improve function and visual aesthetic.	Best conservation practice will be implemented. Specialist timber supplier.

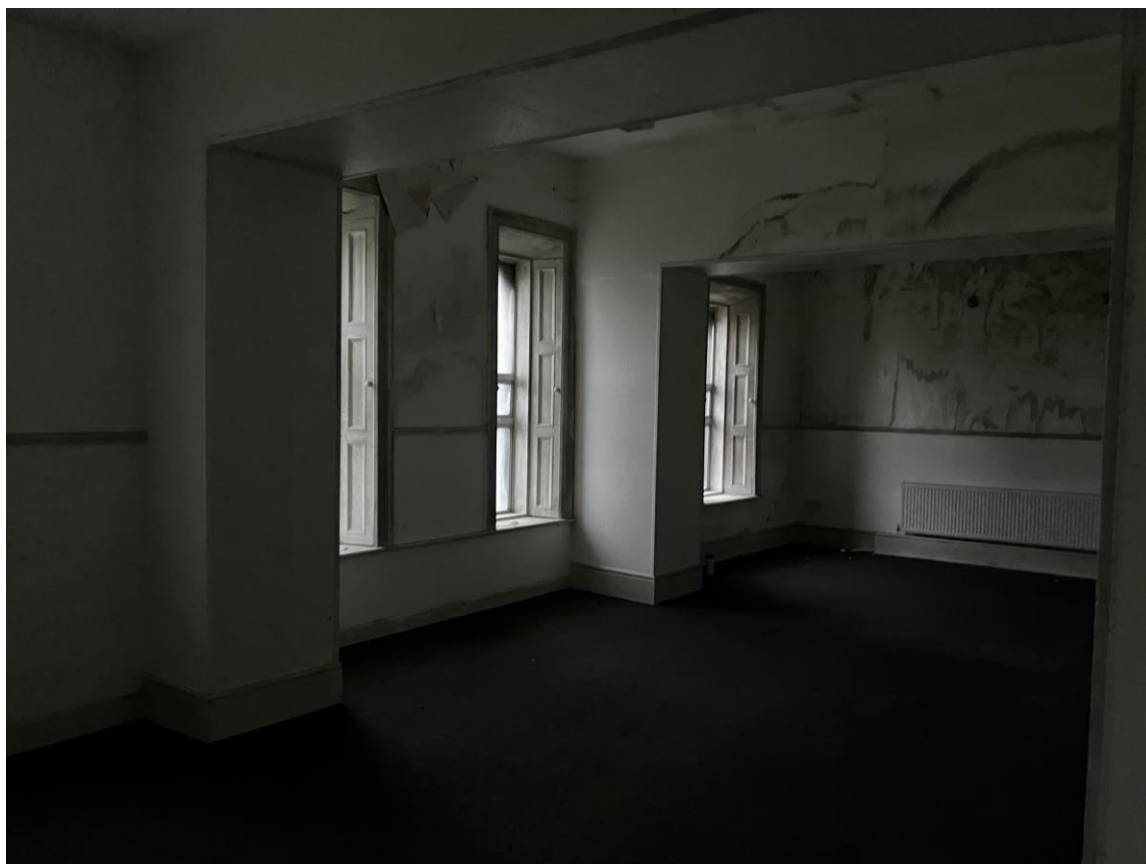
KLA– Image of the extensive water damage and damp on the upper floors
