REF: AHIA REPORT, OLD POST OFFICE LONGFORD

Architectural Heritage Impact Assessment (Conservation Report, Repair and Methodology)

Project Title: Renovation, Alterations at the Old Post Office, Longford to house a **new tourist office**.

Site Address: 43 Main Street, Longford, Co. Longford. Eircode: N39 FD45

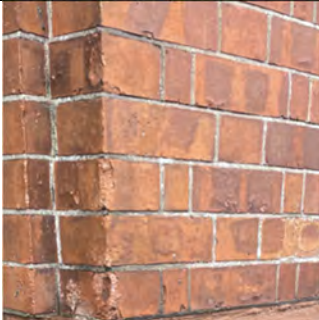
Element 01	Photo	Condition Description
Historic brickwork exposed to front facade

Natural fair faced red brickwork walls with traditional Flemish bond. The bricks appear to be machine made facing red bricks which would have been common in the late 19 th century. The bricks have become worn/eroded in places. The traditional lime mortar has been in places repointed with cementitious mortars.
Proposed Conservation works & methodology	<p>Repairs to brickwork should be to the minimum to prevent further decay. Where bricks have spalled and where it is considered that retaining damaged brickwork will cause further fabric decay such damaged bricks will require replacement. Where bricks are fractured the source of structural movement to be determined and resolved with structural engineer. Fractured bricks should be replaced. Where brick replacement is unavoidable damaged bricks should be carefully cut out by hand. Replacement bricks should be sourced to match the original in size, colour & texture. Any cementitious repair pointing should be removed and replaced with appropriate lime mortar pointing- a small test area should be raked out to ascertain potential level of damage by removal. If cement mortar would cause damage to the historic fabric it should be left to decay over time – to be replaced at a later date with lime mortar. Existing lime mortars should be retained and only repointed where the pointing has failed and is causing water ingress. In such instances the decayed mortar should be carefully raked out to the full width of the joint- depth min twice joint width or 15-20mm- only using hand tools. New mortars should be lime based to match as far as possible existing historic mortar. Lime to sand ratios generally 1:3, however often historic mortars are more lime-rich, ratios between 1:1 1/2 and 1:2 1/2. Pointing style should match the original- note that flush pointing will weather better than recessed pointing. Arrange for a small sample of pointing to agree mortar colour and pointing style. Arrange for a sample of any replacement brickwork to agree size, colour & texture. Refer to Advice Series “BRICKS A GUIDE TO THE REPAIR OF HISTORIC BRICKWORK” from the Environment, Heritage & Local Government (2009) for further details. Note that given the driving rain/ wet climate it may be prudent to add a protective colourless fully breathable coating to the brickwork. The hygrothermal risk assessment will establish if this is advised. If so details will need to be agreed with LCC Conservation officer to ensure full compatibility with historic brickwork and it ensure that there would be no visual impact- we know of products that are suitable and fully invisible to the naked eye.</p>

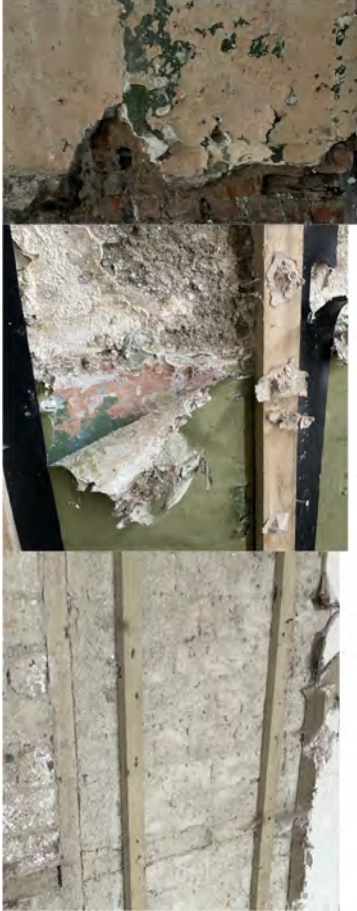
Element 02	Photo	Condition Description
<i>Historic internal solid masonry walls/ internal lime finishes</i>

<p>Existing lime mortars are generally in very poor condition, crumbling, with only a few locations where sound internal historic lime plaster is still sound. Inappropriate dry lining materials (gypsum based) have been added to the party walls (where plasterboard generally has been removed) and to the external walls. Modern dry lining materials should be removed fully- gypsum based materials are not recommended as prone to mould growth. In places the existing historic plaster has been removed revealing solid masonry brickwork walls. Note that in the case of the internal partitions timber framed walls were infilled with brickwork- this is known as nogging. Brickwork to internal walls is generally of poorer quality than external facing bricks. It is only when damaged finishes are removed that the full extent of damaged brickwork can be ascertained.</p>

Proposed Conservation works & methodology	<p>Remove modern dry lining materials as stated. Remove unsound historic plasters. Where existing brickwork is fully revealed check condition carefully. Where repairs are required follow recommendations for repairs to existing brickwork and lime mortar as described in Element 01 above.</p> <p>Only remove unsound historic lime plasters, retaining sound plaster. New lime plasters to be provided to reinstate finish. For external walls (to front & rear) provision of lime based thermal plaster solutions can be considered to improve the thermal performance/ comfort and provide a route for new services. Any new system must be fully breathable and appropriate for application to historic brickwork walls. A Hygrothermal Risk Assessment should be carried out by a specialist to review and proposals for the external walls.</p>

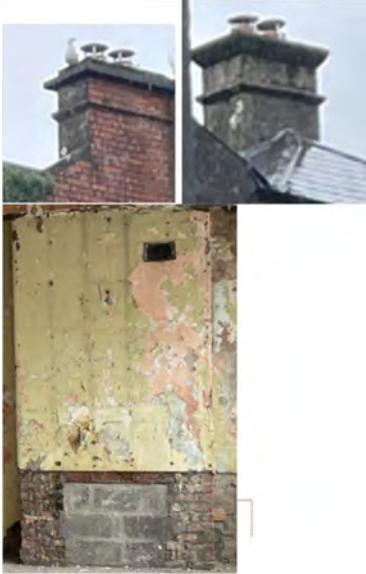
Element 03	Photo	Condition Description
Historic chimneys

<p>There is evidence of historic water ingress near the chimneys- especially along the northern gable. We have been advised that the sources have water ingress have been repaired. We advise that access is arranged to inspect all chimneys and check condition of the existing chimney stacks (fair faced brickwork / lime mortar to front and rendered moulded chimney stack to the rear). Haunchings to be checked and repaired as necessary. Flashings to be checked.</p> <p>Existing cracked sand cement render is to be replaced with new lime render.</p>
Proposed Conservation works & methodology	<p>Where repairs are required to existing brickwork follow recommendations for repairs to existing brickwork and lime mortar as described in Element 01 above. If rendered chimney has lime rendered finish we recommend repairs to any cracks. If the render is cementitious and cracked we recommend removal and replacement with lime render (refer to details in element 06 below). We recommend that existing flues are fully vented with installation of terraco8a vented caps onto existing terraco8a chimney pots ventilated (at top & bo8om of flue) even though no longer active- to avoid condensation within the chimney stack. We recommend new flexible flue liners- gaps around flues may be filled (subject to detailed design preference) with a vermiculate insulation or similar. We recommend un-blocking the flue recess visible at 1st floor level on the southern gable reinstating fire recess as a feature. We recommend providing a ventilation grilles to the flue over the fire recess to act as additional background ventilation to the room and to reduce heat loss. Similar measures can be considered to other existing flues to improve background ventilation and ensure flues are fully vented to reduce condensation risk. Lead flashings/ lead work to be repaired in accordance with Lead Sheet Association advice. Full details of measures will be subject to detailed design.</p>

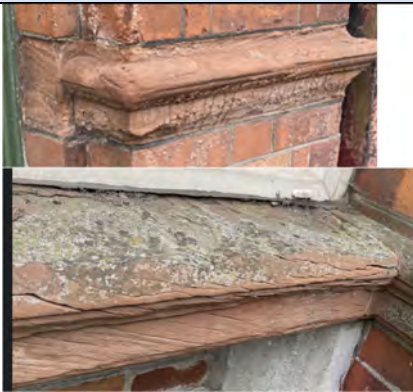
Element 04	Photo	Condition Description
Historic moulded sandstone/ terracotta elements

There are beautiful carved sandstone features on the main street façade-cill course to ground floor windows, projecting string courses etc. In places the sandstone has become quite eroded and in places cracked.
Proposed Conservation works & methodology	<i>Existing stonework to be retained. Only in the instance of very severely damaged stone, there the degradation is causing water ingress, should any sections of new replacement stone be considered. If in very limited circumstances sections of stone need replacement be careful to select either matching salvaged stone or matching high quality new sandstone with similar colour and texture to the original stone. Carved elements should be reproduced with profiles to match existing sections being replaced. Cracked stone to be secured with non ferrous pins, filling in cracks with lime mortar. It is important to ensure that mortar repairs do not damage surrounding stonework paying attention to the appearance of the mortar. Do not use cementitious mortars or modern resins for repairs. Carry out a trial sample with the stone specialist to review and approve material matches/ techniques.</i>

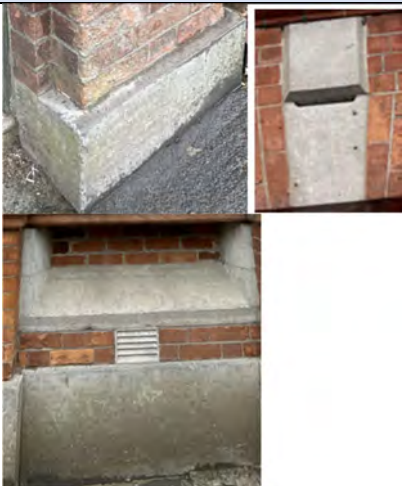
Element 05	Photo	Condition Description
Historic Limestone features

The Limestone elements are generally in good condition.
Proposed Conservation works & methodology	If repairs are required methodology as per element 04 above should be followed using Limestone to match the existing stonework. Limestone thresholds that survive (eg to rear door) should be removed & reinstated- refer to works to ground floor slabs (element 12) below.

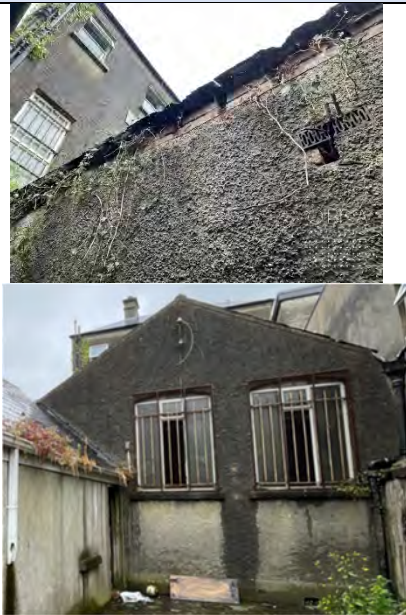
Element 06	Photo	Condition Description
Historic external rear masonry walls

<p>Modern pebbledash cementitious renders have been applied to the rear facades of the historic structures. This render is in poor condition. The cement render unfortunately is an impermeable material and is not compatible with historic solid brickwork walls as it prevents breathability/ release of moisture in the walls to the external air.</p> <p>We therefore recommend as a priority removal of all cement renders and replacement with breathable lime renders to rear facades and to rendered chimneys only.</p>
Proposed Conservation works & methodology	<p>Remove existing cementitious render in small bands, using hand tools only, beginning at the top of the wall and working downwards. Specialist to repair exposed masonry before removal of further render to ensure that structural integrity is protected. A record to be taken of the condition and appearance of each masonry wall section prior to any repairs. For each wall section specialist to carefully inspect all pointing. Sound pointing should be left undisturbed. Where mortar is loose or damaged- to be carefully raked out using extreme care, carrying out with hand tools only.</p> <p>Walls to be thoroughly dampened prior to any repointing, allowed to dry just enough to give some initial suction. Mortar to be repaired with matching lime-based mortar (based on a section of sound original mortar). The new lime based mortar to have a strength grade less than that of the walling with flush or nearly flush finished joints. A sample repair panel is to be carried out so that mortar details, workmanship and finish can be agreed, acting as an exemplar panel for the remaining works.</p> <p>Where there are gaps in stonework repair with new mortar where possible or new stone indents (for larger gaps) formed in stonework to match existing.</p> <p>No lime-work or stonework is to be carried out when temperatures are forecast to be lower than 5 degrees. The works are to be protected from exposure to extreme sunshine/ frost & rain for min 7 days. Lime work needs to dry out slowly- protect with damp hessian material kept min 100mm from works.</p> <p>Where walls are severely cracked structural repairs to be carried out and secured to details to be agreed with structural engineers.</p> <p>We assume for ease of maintenance that the walls will not be painted.</p> <p>Note that given the driving rain/ wet climate it may be prudent to add a protective colourless fully breathable coating to the lime render. We recommend a hygrothermal risk assessment to establish risk and advise if this is required. If so details will need to be agreed with LCC Conservation officer to ensure full compatibility with breathable lime render ensuring no visual impact (there are suitable breathable products fully invisible to the naked eye available).</p>

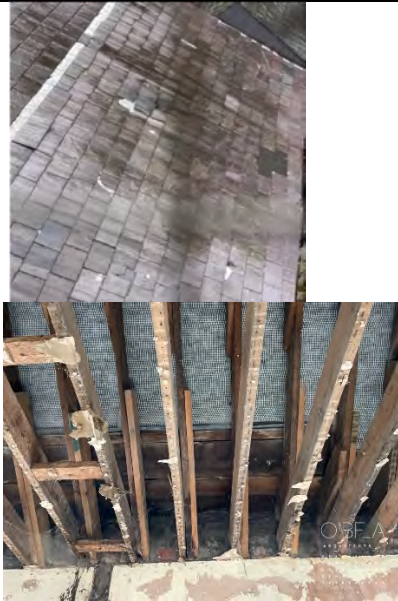
Element 07	Photo	Condition Description
Pitched roof/ exposed ceiling

<p>The pitched roof structures are cut timber roof with replacement slate finishes. The roof finishes appear to have been replaced with modern slates with modern roofing felts visible from underneath. The lower levels roofs have serious water ingress issues therefore the modern slate/ felt finishes together with associated battens must be fully removed. The exposed timber roof structures to be retained where timber is still sound- new replacement timbers are likely to a considerable extent to the roofs over the single storey areas. It is important to retain the cast iron truss/ framing structure of the main rear hall at ground floor level. We understand that the slate finish to the main upper level roof has been recently replaced and flashings repaired. We recommend access is gained to ascertain this, if damaged this finish may need replacement also.</p>

Proposed Conservation works & methodology	<p>Repairs to be carried out to timber roof structure in accordance with structural engineer's recommendations retaining existing timber and replacing defective timbers ensuring that replacement is on a like for like basis.</p> <p>We can see rotten sections of timber and fruiting bodies Damp Assessment report is recommended to assess the extent of rot as well as presence of woodworm.</p> <p>Sources of moisture ingress to be repaired encouraging ventilation speed natural drying out. Cut out & carefully dispose of fruiting bodies. Cut out only severely damaged decayed/ weakened timber. Use of chemicals should be limited, where necessary treat the timber with a fungicide. Monitor levels of dampness for signs of renewed attack. Where insect infestation has occurred ascertain where infestation is active by covering over emergent holes in early summer (emerging beetles will eat their way through this paper resulting in fresh bore dust & new holes). Active infestations to be treated by a specialist.</p> <p>Recommend high quality natural slate finish where modern slate finishes are being replaced-with min 60 year durability.</p> <p>Natural breathable insulations to be fitted between and above ceiling joists to main under eaves - ensure min 50mm vented air space to eaves. To lower roofs where full replacement of finish is recommended an insulated breathable sarking (wood fibre)- min depth above rafters prior to fitting breathable roofing felt, counter battens, slate battens and new natural slate finish. This creates a warm roof and will protect the timber structure from condensation risk as well as providing for improved insulation. Fully breathable airtight vapour control barriers to be fitted to the underside of roof structures (ceiling joists/ collar/ rafters over sloped part) prior to ceiling finishes. Design team to determine details of build up to suit desired u-values at design stage- the important issue is ensuring breathability and ventilation to cold roofs.</p> <p>New lead flashings/ lead work to be fitted in accordance with Lead Sheet Association advice. Full details of measures will be subject to detailed design.</p>

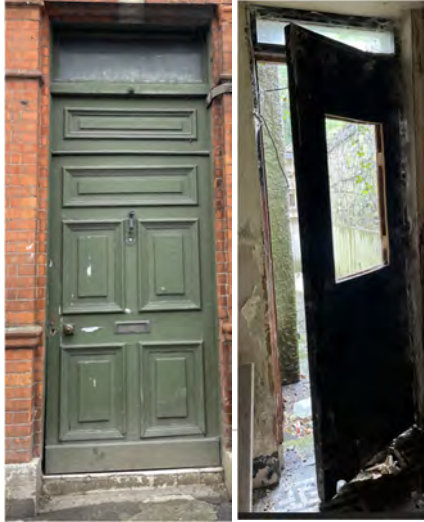
Element 08	Photo	Condition Description
<p><i>Historic Openings (Doors)</i></p>

<p><i>Front door</i> <i>rear door</i></p>	<p>Main entrance door is generally in good condition however some sections of frames are missing near ground level where new infill sections will be required to make good. The external door to the rear is in very poor condition and is most likely beyond repair and should be replaced. Any new timber external door should be formed in high quality timber joinery with partial glazing well proportioned to match in with historic context.</p>
<p>Proposed Conservation works & methodology</p>		<p>Follow steps outlined above (element 07) for dealing with rot/ fungal and insect infestation. For small localised areas of decay -scrape out decayed timber and treat surrounding area with a preservative. Once this has dried fill void with filler, keeping filler to a minimum or matching timber profiles splices to larger areas. Where joinery is damaged carry out any necessary repair/ filling/ splicing of elements as necessary. Where small replacement sections are required care to be taken to ensure that new profiles will match existing element being repaired. Loose joints can be repaired by re-gluing and insertion of new wedges. Replacement timber should be high quality Accoya wood or well-seasoned so- wood (heartwood only).</p>

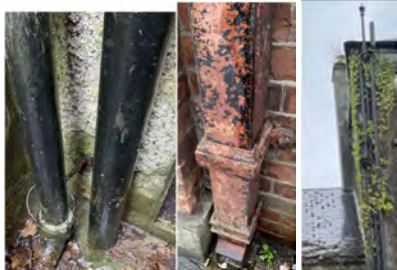
Element 09	Photo	Condition Description
<p><i>Historic rainwater goods</i></p>

<p>Existing rainwater downpipes and vent pipe are formed in high quality cast iron. They have not been maintained and have rusted and should be reconditioned. A detailed condition assessment should be carried out by a metal specialist to advise on details and extent to repair.</p>
<p>Proposed Conservation works & methodology</p>		<p>Where rusted, specialist to advise on method of cleaning. Rust needs to be cleaned off before repainting. Repairs to be carried out and all rainwater goods to be repainted. Propose new colours match existing. Any new rainwater goods required (eg gutters where missing) to be formed in high quality cast iron or cast aluminium with details to match existing. Ensure that backs of all downpipes are fully painted to ensure complete protection.</p>

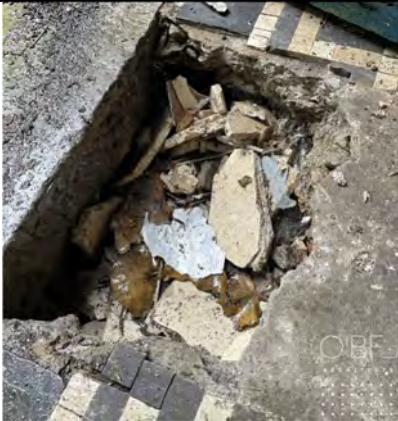
Element 12	Photo	Condition Description
Exposed Ground floor slabs

<p>The existing ground floor is formed in solid slabs- there have been some opening up as we can see in this photo. There are some decorative tiles still in place. We accept that a new replacement solid floor slab is required to accommodate services/ improve thermal performance/ deal with rising damp. Ideally this would be limecrete, however given the concerns about radon we accept that the new slab can be formed in concrete incorporating a radon barrier.</p> <p>We note that there is an issue with provision of level universal access to the main entrance as there is a step at the door. The replacement of the existing slab may present an opportunity to allow lowering of the new ground floor slab level- this would need to be considered in carefully at detailed design stage as it may be too tricky because of getting stairs levels to work. We mention this to ensure it is reviewed. It would be acceptable to increase the heights of the existing entrance doors by adding new timber sections to the bases of the doors.</p>

Proposed Conservation works & methodology	<p>Record details (patterns) of existing tile finishes before removal of the existing slab. We recommend taking up the tile floor finishes very carefully by an expert - reinstating as much of the original tile finish as possible. Ensure also the existing limestone thresholds (eg to rear door) are removed carefully for reinstatement. The concern in using a modern concrete slab is ground water being sucked up by existing masonry walls in contact with the earth resulting in rising damp. The mitigation to alleviate this is to provide an insulated cellular glass base which is inert and does not absorb any moisture, but has air pockets allowing moisture to move without pushing all the moisture into the solid walls. The deeper depth the cellular glass the better- recommend min 300mm after compaction. Recommend the build up as follows: screed (min 50mm-possibly increasing to 80/85mm to suit services) on rc slab to structural detail on radon/ dpm barrier on geo textile on min 300mm cellular glass (in lieu of hardcore) on geotextile. There is no requirement for capping/ blinding. The cellular glass is also an insulant material. If underfloor heating is considered there is an option to introduce additional rigid insulation under the screed. Reinststate limestone thresholds on DPC. Final details by the design team.</p>

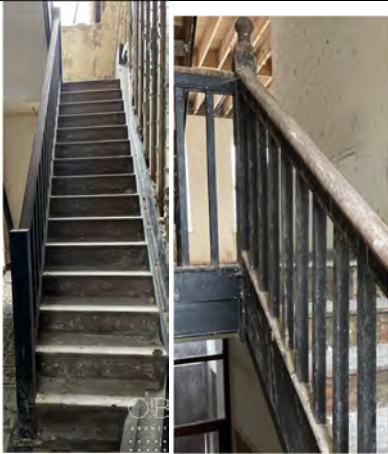
Element 13	Photo	Condition Description
<i>Historic staircases</i>

The original solid timber stairways are still in place with beautifully crafted turned newel post caps and curved solid timber handrails with slender balusters. The style is typical of the style of the late 19th century. The solid cut timber supports to the underside of the lower flight, visible from the hallway, are suffering from exposure to high levels of humidity. Some newel post caps are missing, the adjacent skirtings are damaged. Timber sheeted panelling which would have most likely concealed the underside of the ground floor flight below the timber string, is no longer in place
Proposed Conservation works & methodology	<p>Existing stairways to be fully reconditioned and retained. Internal timber elements to be repaired as required by specialist joiner. Follow steps outlined above (element 07) for dealing with rot/ fungal and insect infestation.</p> <p>Existing paint (where applicable) to be removed with a carefully selected cleaning method -tested on small discreet sample area-to ensure that it does not cause any damage. Where possible joinery to be retained in-situ. Where dismantling is unavoidable to allow repair-detailed record/ drawings to be carried out prior to works to ensure accurate reinstatement. Where elements are damaged new timber splices to be inserted taking care to match original elements. Samples of any replacement profiles to be provided for agreement.</p> <p>Sources of moisture ingress to be repaired encouraging ventilation speed natural drying out. Cut out & carefully dispose of fruiting bodies. Cut out only severely damaged decayed/ weakened timber. Use of chemicals should be limited, where necessary treat the timber with a fungicide. Monitor levels of dampness for signs of renewed attack. Where insect infestation has occurred ascertain where infestation is active by covering over emergent holes in early summer (emerging beetles will eat their way through this paper resulting in fresh bore dust & new holes). Active infestations to be treated by a specialist.</p>

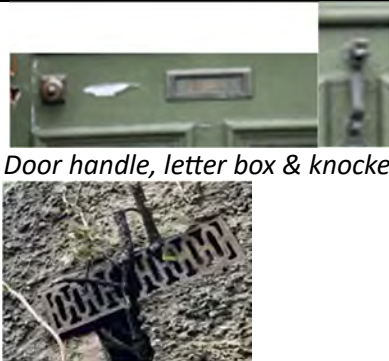
Element 14	Photo	Condition Description
Historic Ironmongery

<p>Door handle, letter box & knocker</p> <p>Cast iron wall grilles</p>	<p>A8 ractive le8 erboxes, door knobs and knockers to front door and in good repair and should be retained- reconditioned as necessary.</p> <p>There are a8 ractive cast iron ventilation grilles in the external walls of the single storey buildings to the rear. They are in poor condition and have cracked. These elements should be repaired by a metal specialist and reinstated to provide background ventilation to the wcs.</p>
Proposed Conservation works & methodology	Repairs to damaged cast iron grilles should be carried out by a skilled metal cra- sperson. New sections where required should match the original.

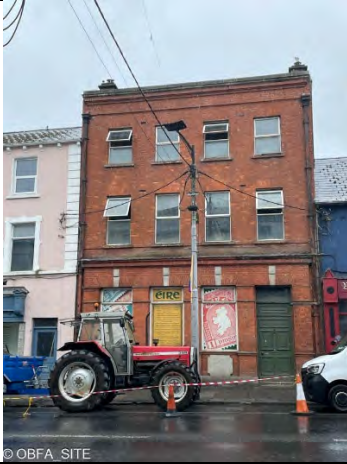
01	Front Street Facade	Description	Comments

Existing front brickwork façade together with associated chimney stacks- decorative historic features intact. Refer to NIAH description above- has “Architectural” significance.	Repairs require to all historical elements- brickwork, decorative stone, historic timber panelled doorway. All windows are modern upvc replacement windows of poor quality. The upvc windows should be replaced with high quality timber sash windows.
02	Historic Main Entrance	Description	Comments

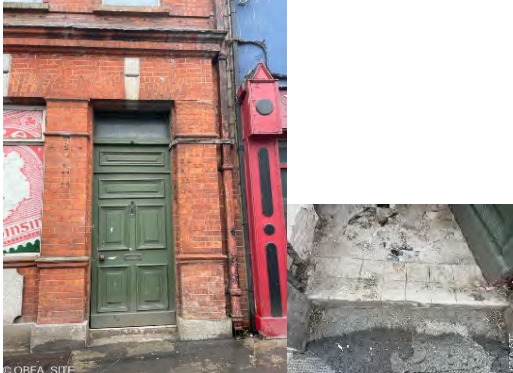
Existing historic panelled doorway with fanlight. Threshold is more recent tiled upstand. If new slab provide recommend new dressed limestone threshold.	Detail for DAC access Temporary removable element recommended.
03	Commemorative Stone plaque	Description	Comments

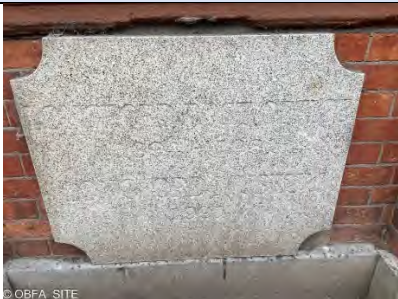
Commemorative plaque over the limestone plinth to the left hand side of the entrance door. This feature has “social” significance	The text is very worn Preserve... restore to keep legible

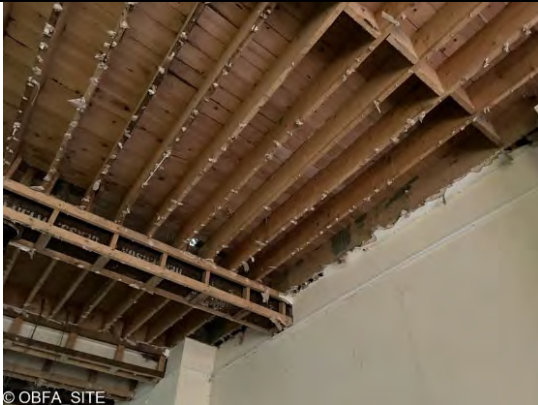
Timber boarded upper floors and joists- Propose retained where sound. Accept that sections will require replacement to be determined by structural engineer. To be replaced with matching timber elements.	New ceilings, services zones to be carefully considered so that the existing spaces do not lose too much height.
07	Internal Wall decorative features	Description	Comments

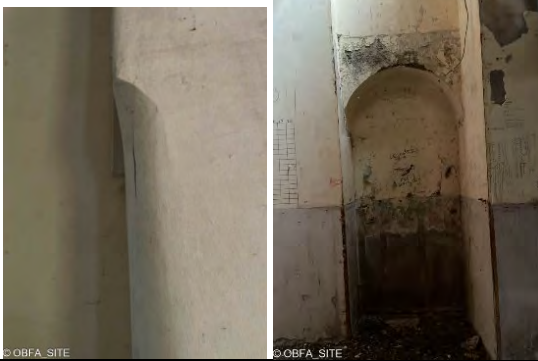
Decorative features such as rounded edges and arched alcove recess features to be protected as they add character.	Protect and reinstate when carrying out repairs/ new finishes.

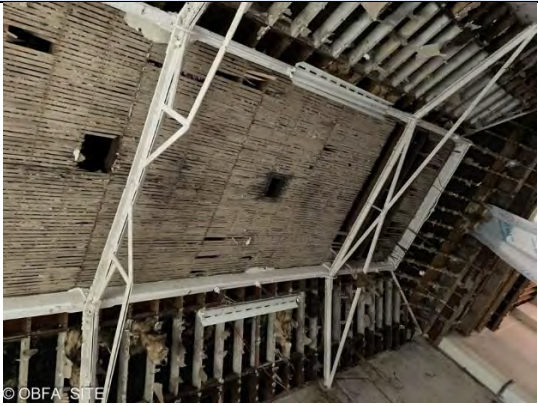
Cast Iron trusses, collar frames together with timber rafters, collar ties & timber laths. Accept that sections will require replacement to be determined by structural engineer. To be replaced with matching timber elements.	Fire protection (if applicable) with proprietary system (intumescent paint) so that cast iron features can be left fully exposed.

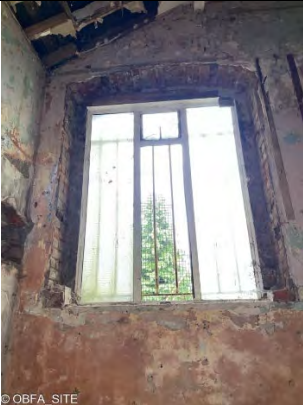
High level windows to the rear of the open plan room are not original and do not follow the arched profile of the brickwork opening. Propose new high-quality windows in timber frames to detail.	New window to follow arched profile of structural opening.
10	Old Kitchen-Museum exhibit	Description	Comments

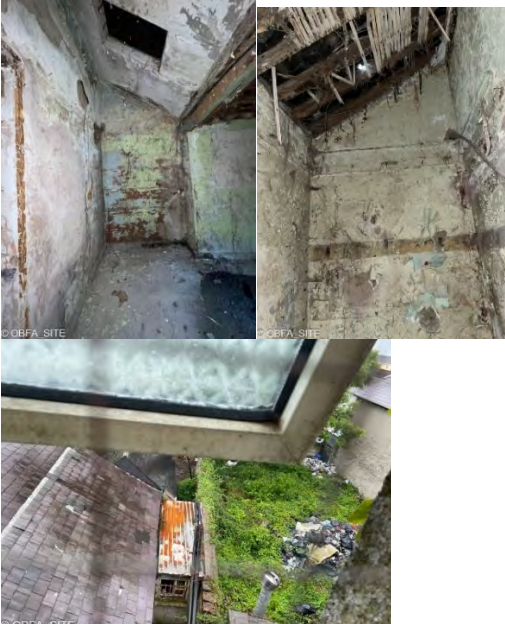
Lean to single storey structures are original and should be retained. Recommend removal of 20 th century flat roof extension as poorly constructed and detracts from the architectural character. Recommend new external wall within existing opening between original lean-to structure and flat roof extension. Conservation style rooflights can be fitted in locations of old rooflights if desired.	The depth of the store towards the rear calculated from KGSS survey plans is just over 1500mm depth therefore this is wide enough to fit a universally accessible wc in compliance with diagram 15b of TGD M 2022. LCC may prefer to have new windows on the external walls in lieu of rooflights.

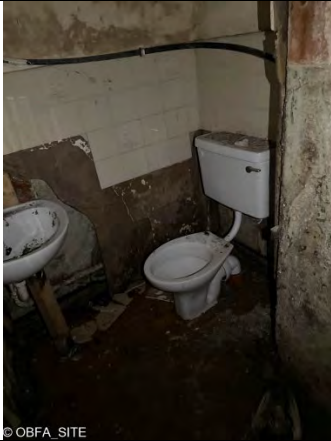
There are existing sanitary ware elements that are not original and should be fully replaced.	New toilets including and accessible wc will be provided with new sanitary ware. All old poor quality sanitary ware to be fully removed.
13	Modern dry lining to be removed	Description	Comments

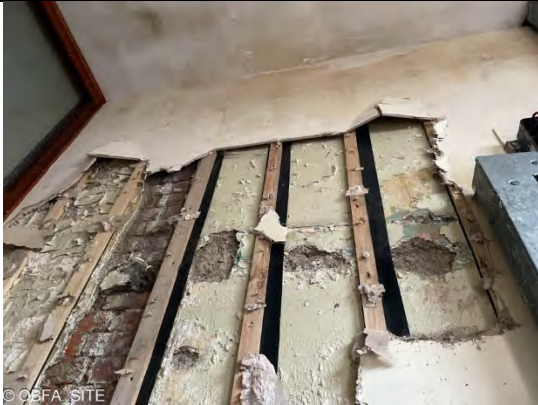
Image shows typical modern dry lining on party walls – plasterboard is susceptible to mould growth. Recommend that all modern dry lining is fully removed returning to original lime plaster finish. Lime plaster generally in poor condition.	Existing walls to be stripped back revealing original lime plaster finishes. Where unsound to be fully removed and replaced with new lime plaster-matching depths. To external walls (including exposed walls over party walls) recommend thermal lime plaster system to improve thermal performance.
14	Historic Timber Stairs-GFL	Description	Comments

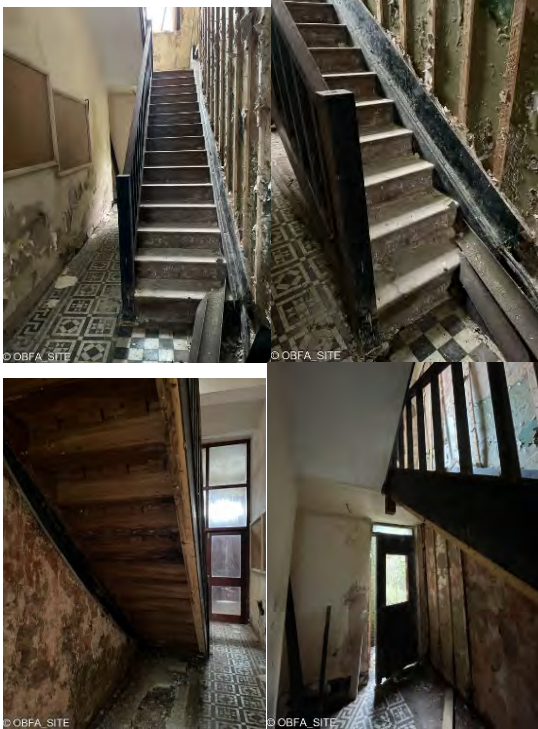
Historic timber stairs must be fully retained and repaired. New tops to newel posts to be fitted- rounded profile tops as per newel posts on GFL half landing. Understand that LCC preference is to not to close of space under the stairs at ground level to give sense of spaciousness.	Argument to be made in fire safety certificate to keep existing stairs. Width between wall and guarding is more than 800mm according to KGSS survey. Fire rated boards (propose magnesium type without gypsum to mitigate against mould growth in potentially damp conditions) to be fitted to soffits for fire protection.

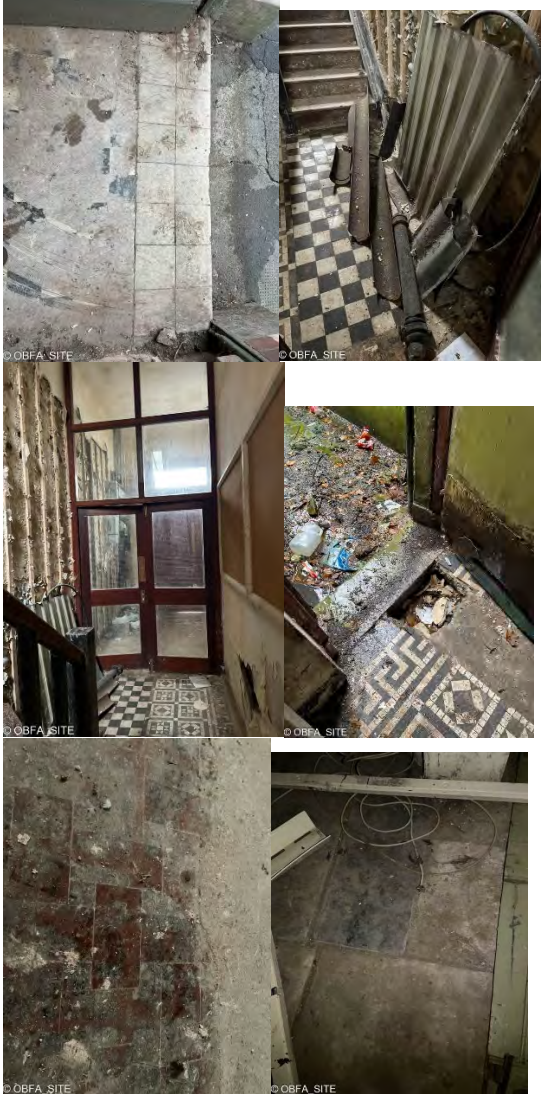
<p>Existing ceramic tile floor finishes still existing at ground floor level- generally covered in grime so difficult to see.</p> <p>Existing stone flag finishes in old kitchen in good condition.</p>	<p>Accept that it is likely that a new floor slab will be required which will allow for improved thermal performance. Floor finishes to be carefully removed so that if practicable they can be reinstated.</p> <p>Opportunity of providing a new slab allows for improved moisture mitigation. New slab will allow heating pipework at ground floor level to be concealed, with potential for underfloor heating subject to detail at later design stage.</p>
16	Historic Stairway GFL half landing	Description	Comments

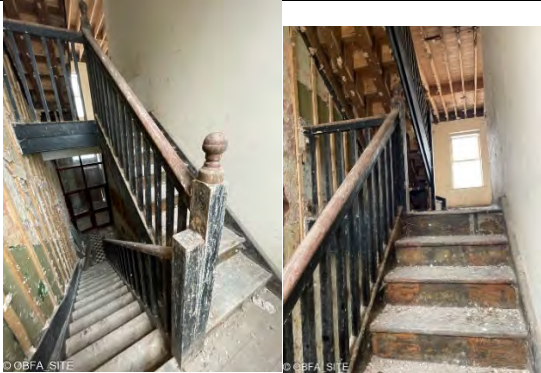
<p>Historic timber stairs must be fully retained and repaired.</p>	<p>Fire rated boards (propose magnesium type without gypsum to mitigate against mould growth in potentially damp conditions) to be fitted to soffits for fire protection.</p>

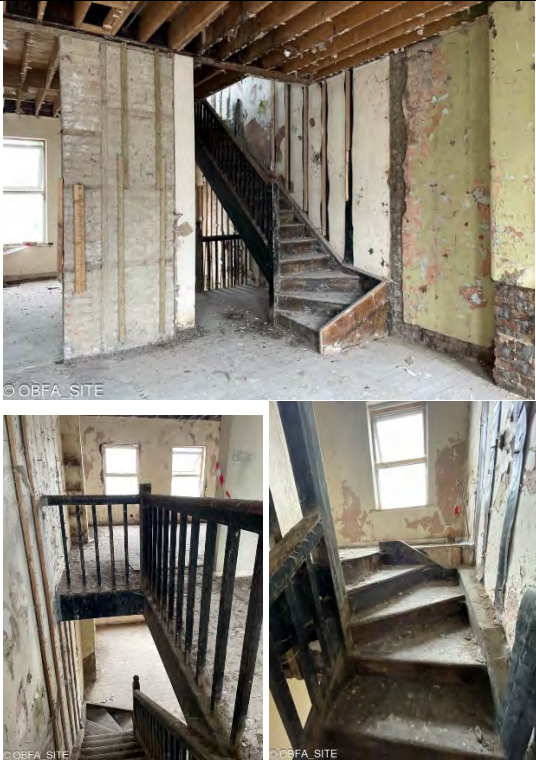
<p>Historic timber stairs must be fully retained and repaired.</p>	<p>Fire rated boards (propose magnesium type without gypsum to mitigate against mould growth in potentially damp conditions) to be fitted to soffits for fire protection.</p> <p>Detail of fire enclosure around stairwell at 1st floor level to be carefully considered by LCC.</p>
18	Room 02-First floor level	Description	Comments

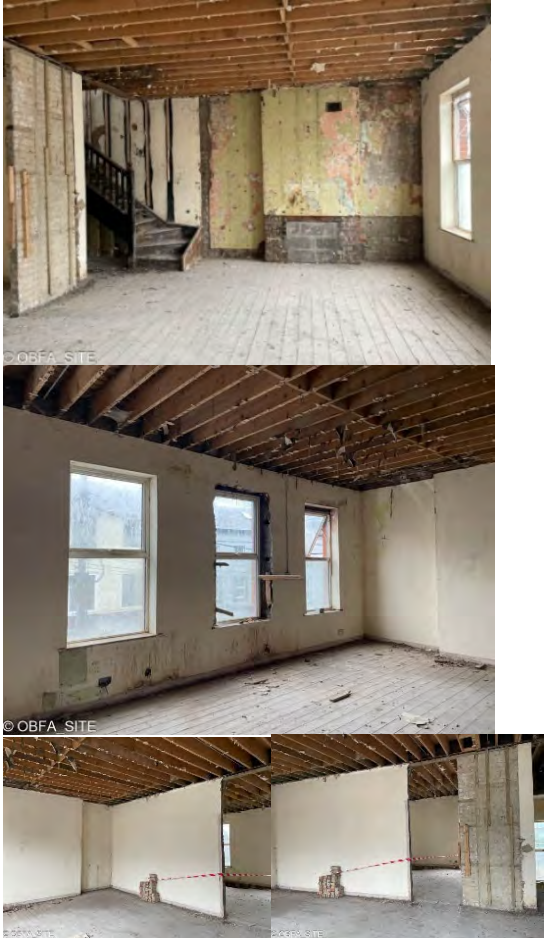
<p>Front room @ 1st floor level. Propose that existing fireplace is unblocked so that ventilation can be provided to flue to avoid condensation risk.</p>	<p>Detail of fire enclosure around stairwell at 1st floor level, subdivision of rooms to be carefully considered by LCC.</p>

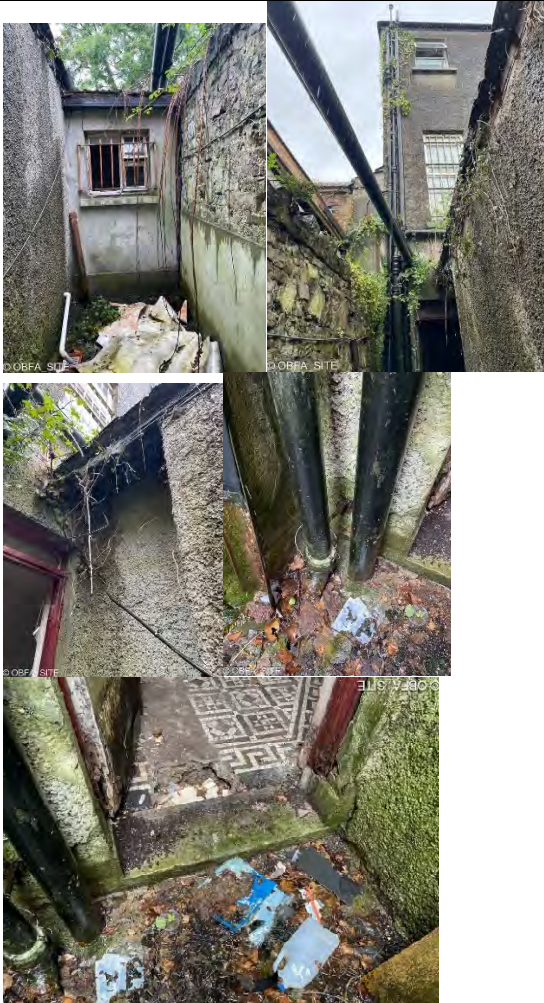
<p>Recommend that modern flat roof extension to be removed. Dressed limestone threshold to rear hallway door should be retained.</p>	<p>Opening up the central courtyard will provide opportunity for rear door of stairway area to act as a real fire escape.</p>
25	Rear Yard	Description	Comments

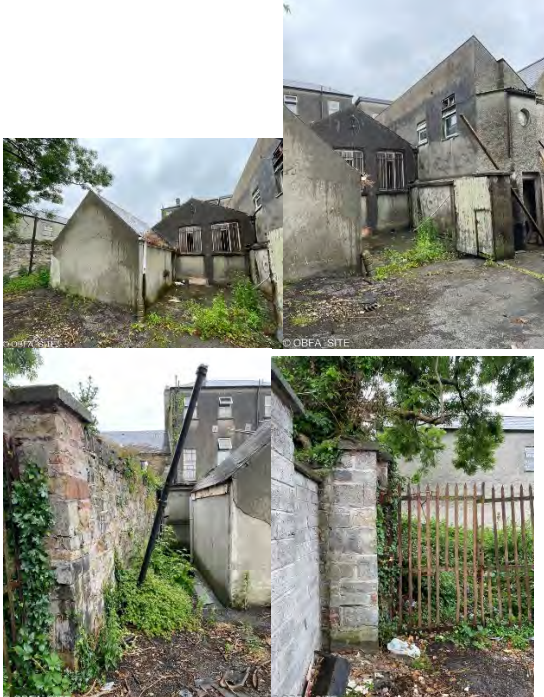
<p>All upvc / modern windows to be replaced.</p>	<p>New replacement windows should be formed in high quality timber joinery with slim profile high thermal performance glazing.</p>

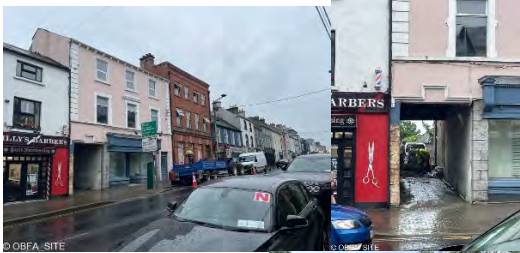
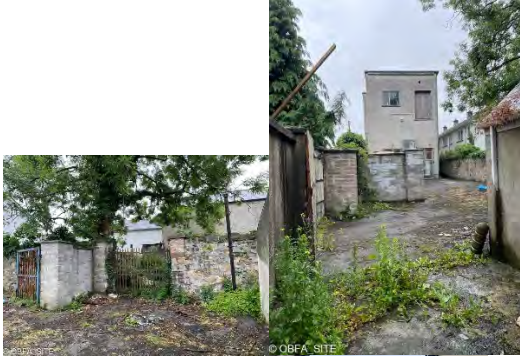
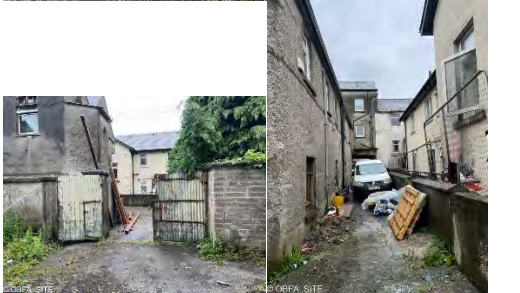
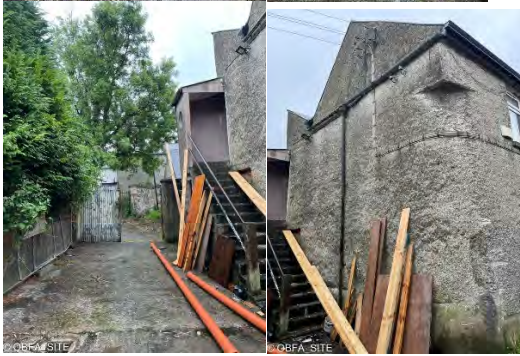
<p>Existing surfaces in poor condition. Ideally the surfaces should be repaired/ replaced. Recommend agreements with all stakeholders to avoid rubbish being left in the right of way and blocking access.</p>	<p>Details of repair to external surfaces to allow improved accessibility to rear. At detailed design stage consideration should be given to the provision of French drains to the perimeter of the existing buildings to be rear to improve drainage and mitigate against rising damp.</p>

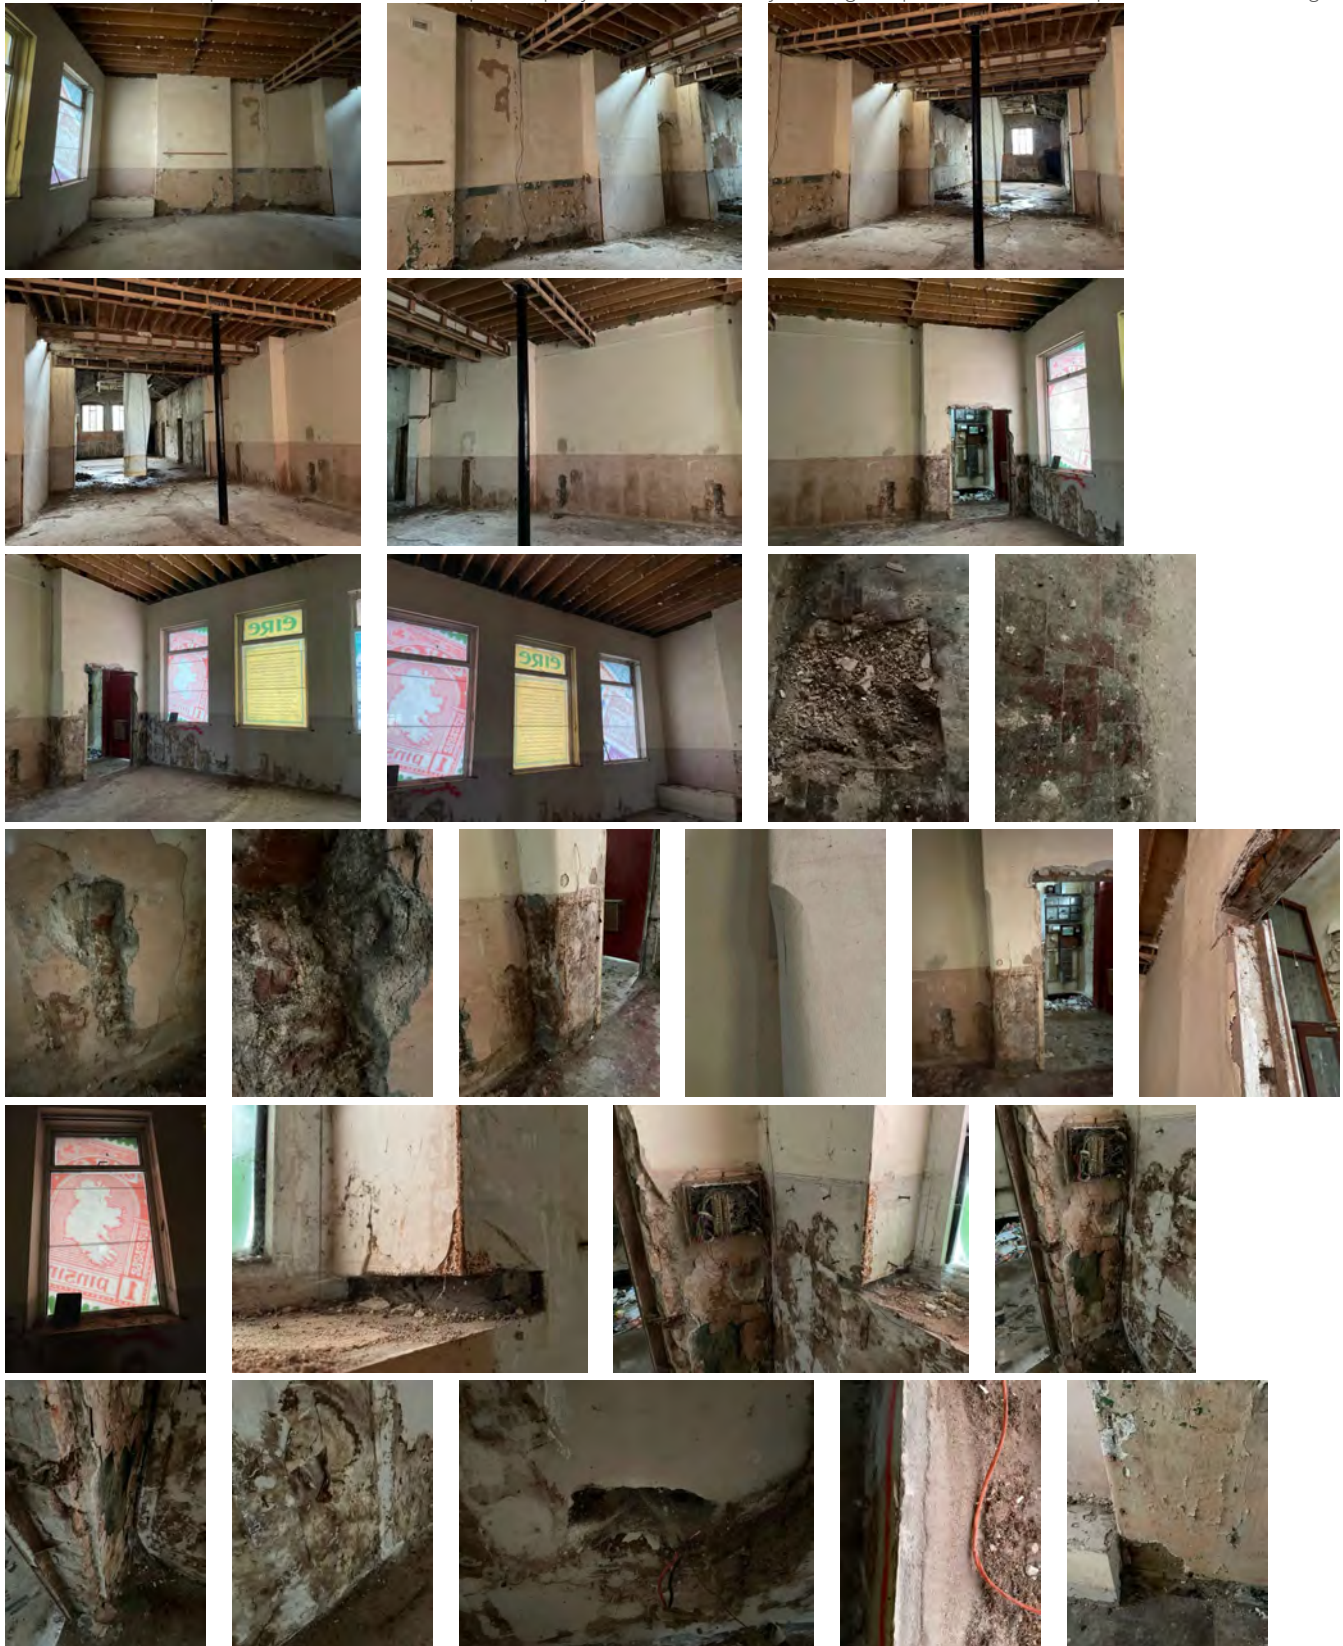
Evidence of serious dampness - especially near floor level and on plasterboard wall finishes (painted skimmed) which have become seriously degraded. No internal doors present. Modern steel beams visible with modern battens- cast iron column in place under one beam. Existing timber boarding on timber floor timber joists visible overhead seriously degraded at junction with beam supporting upper level rear wall and party wall where section is missing. Openings reveal dry lining to front wall on brickwork, lime plaster on brickwork to party wall, thin floor tiles on thin base (appears to be concrete)-slab depth not clear.

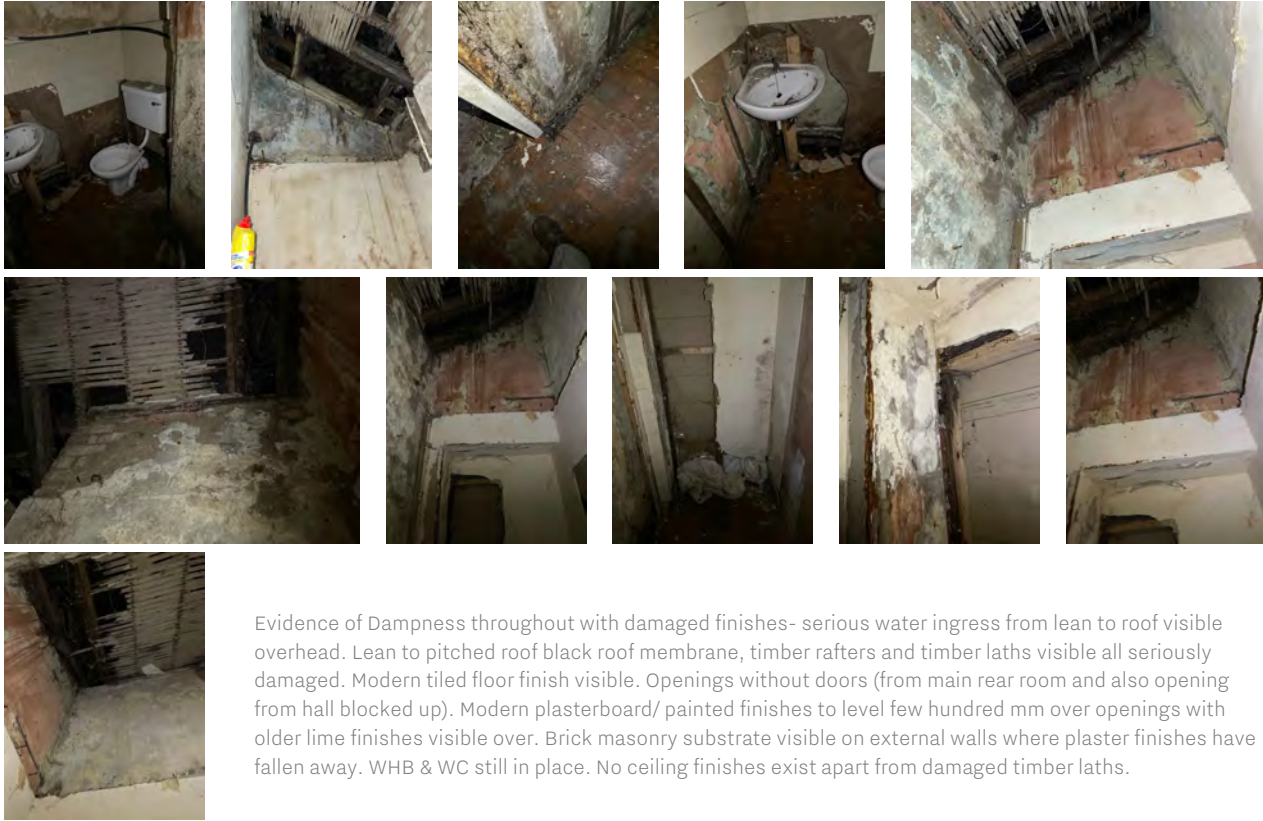
Evidence of Dampness throughout with damaged finishes- serious water ingress from lean to roof visible overhead. Lean to pitched roof black roof membrane, timber rafters and timber laths visible all seriously damaged. Modern tiled floor finish visible. Openings without doors (from main rear room and also opening from hall blocked up). Modern plasterboard/ painted finishes to level few hundred mm over openings with older lime finishes visible over. Brick masonry substrate visible on external walls where plaster finishes have fallen away. WHB & WC still in place. No ceiling finishes exist apart from damaged timber laths.

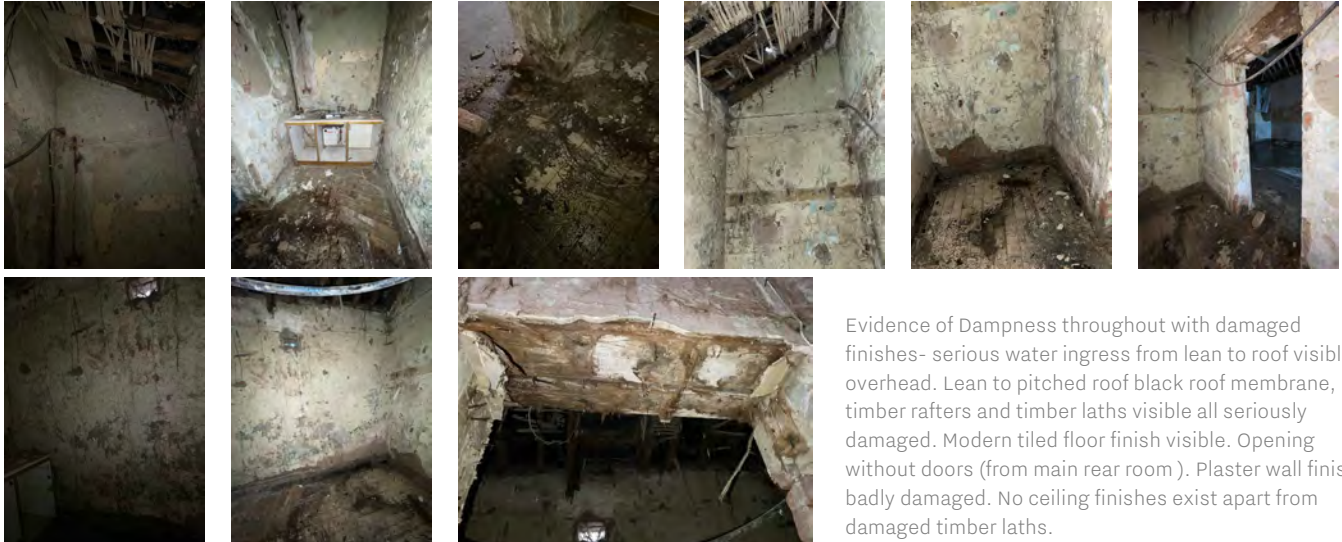
Evidence of Dampness throughout with damaged finishes- serious water ingress from lean to roof visible overhead. Lean to pitched roof black roof membrane, timber rafters and timber laths visible all seriously damaged. Modern tiled floor finish visible. Opening without doors (from main rear room). Plaster wall finishes badly damaged. No ceiling finishes exist apart from damaged timber laths.

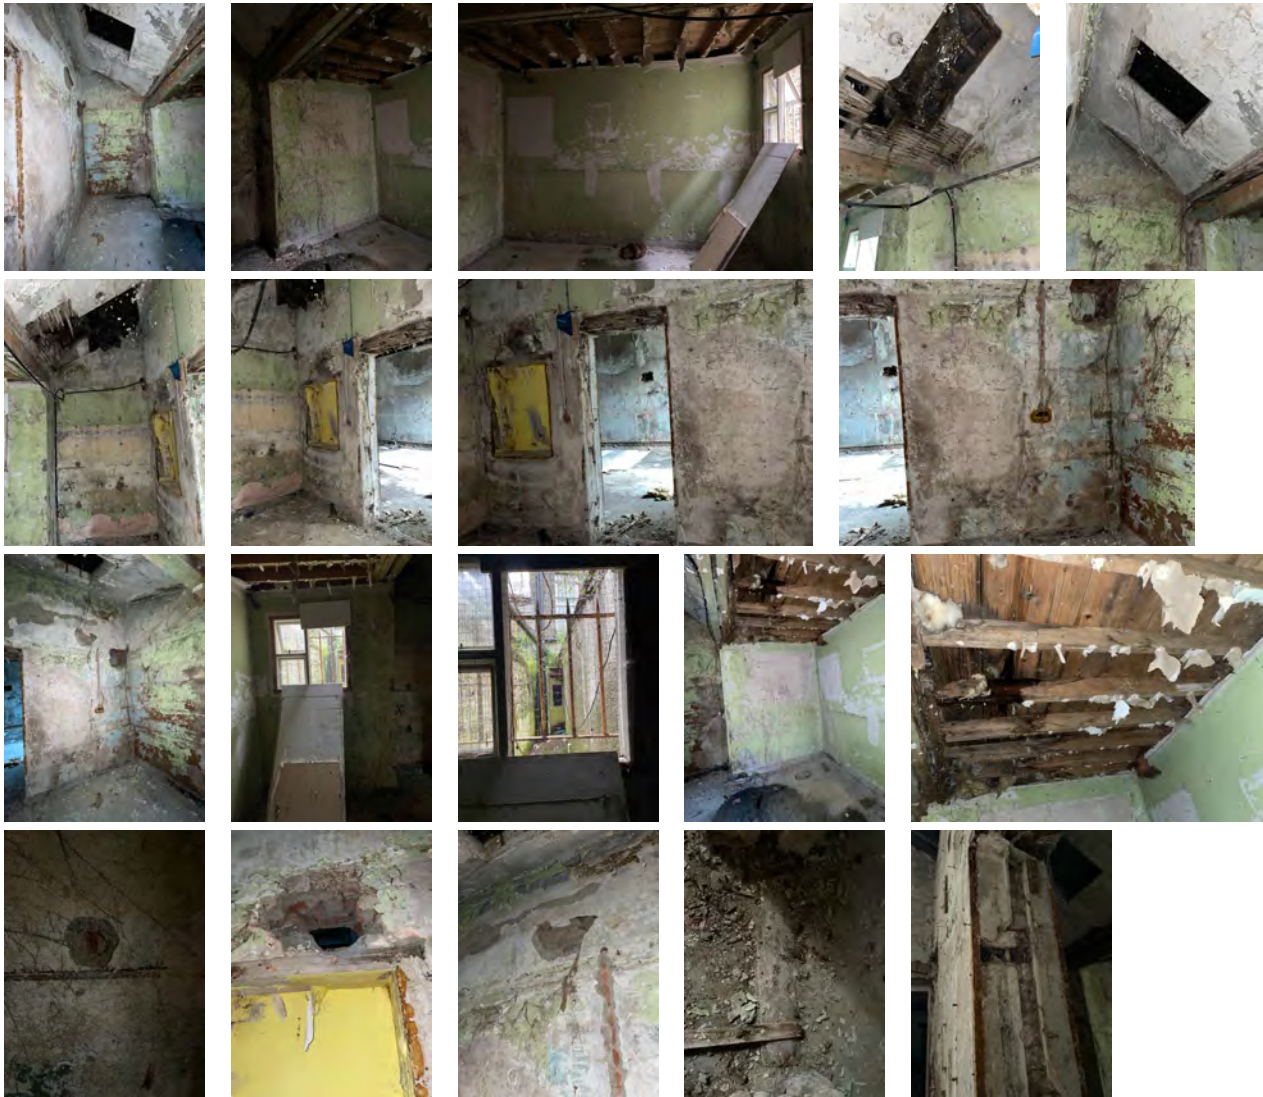
Evidence of Dampness throughout with damaged finishes- serious water ingress from roofs visible overhead. Room includes modern flat roof extension supported from large beam over large opening in old masonry wall. Lean to pitched roof over old part with badly damaged sloped ceilings, openings of old rooflights no longer in place, black roof membrane, timber rafters and timber laths visible all seriously damaged- where section of ceiling has fallen away. Timber sarking board on timber joists visible under flat roof. No ceiling remains under flat roof. Modern tiled floor finish visible. Opening without doors (from main rear room). Old window opening also visible in wall beside internal door opening. Modern timber casement window with rotten frames in extension external wall. Plaster wall finishes badly damaged. Floor appears to be concrete without any finish- covered in grime.
