REF: AHIA REPORT, OLD POST OFFICE LONGFORD

Architectural Heritage Impact Assessment (Conservation Report, Repair and Methodology)

Project Title: Renovation, Alterations at the Old Post Office, Longford to house a **new tourist office**.

Site Address: 43 Main Street, Longford, Co. Longford. Eircode: N39 FD45

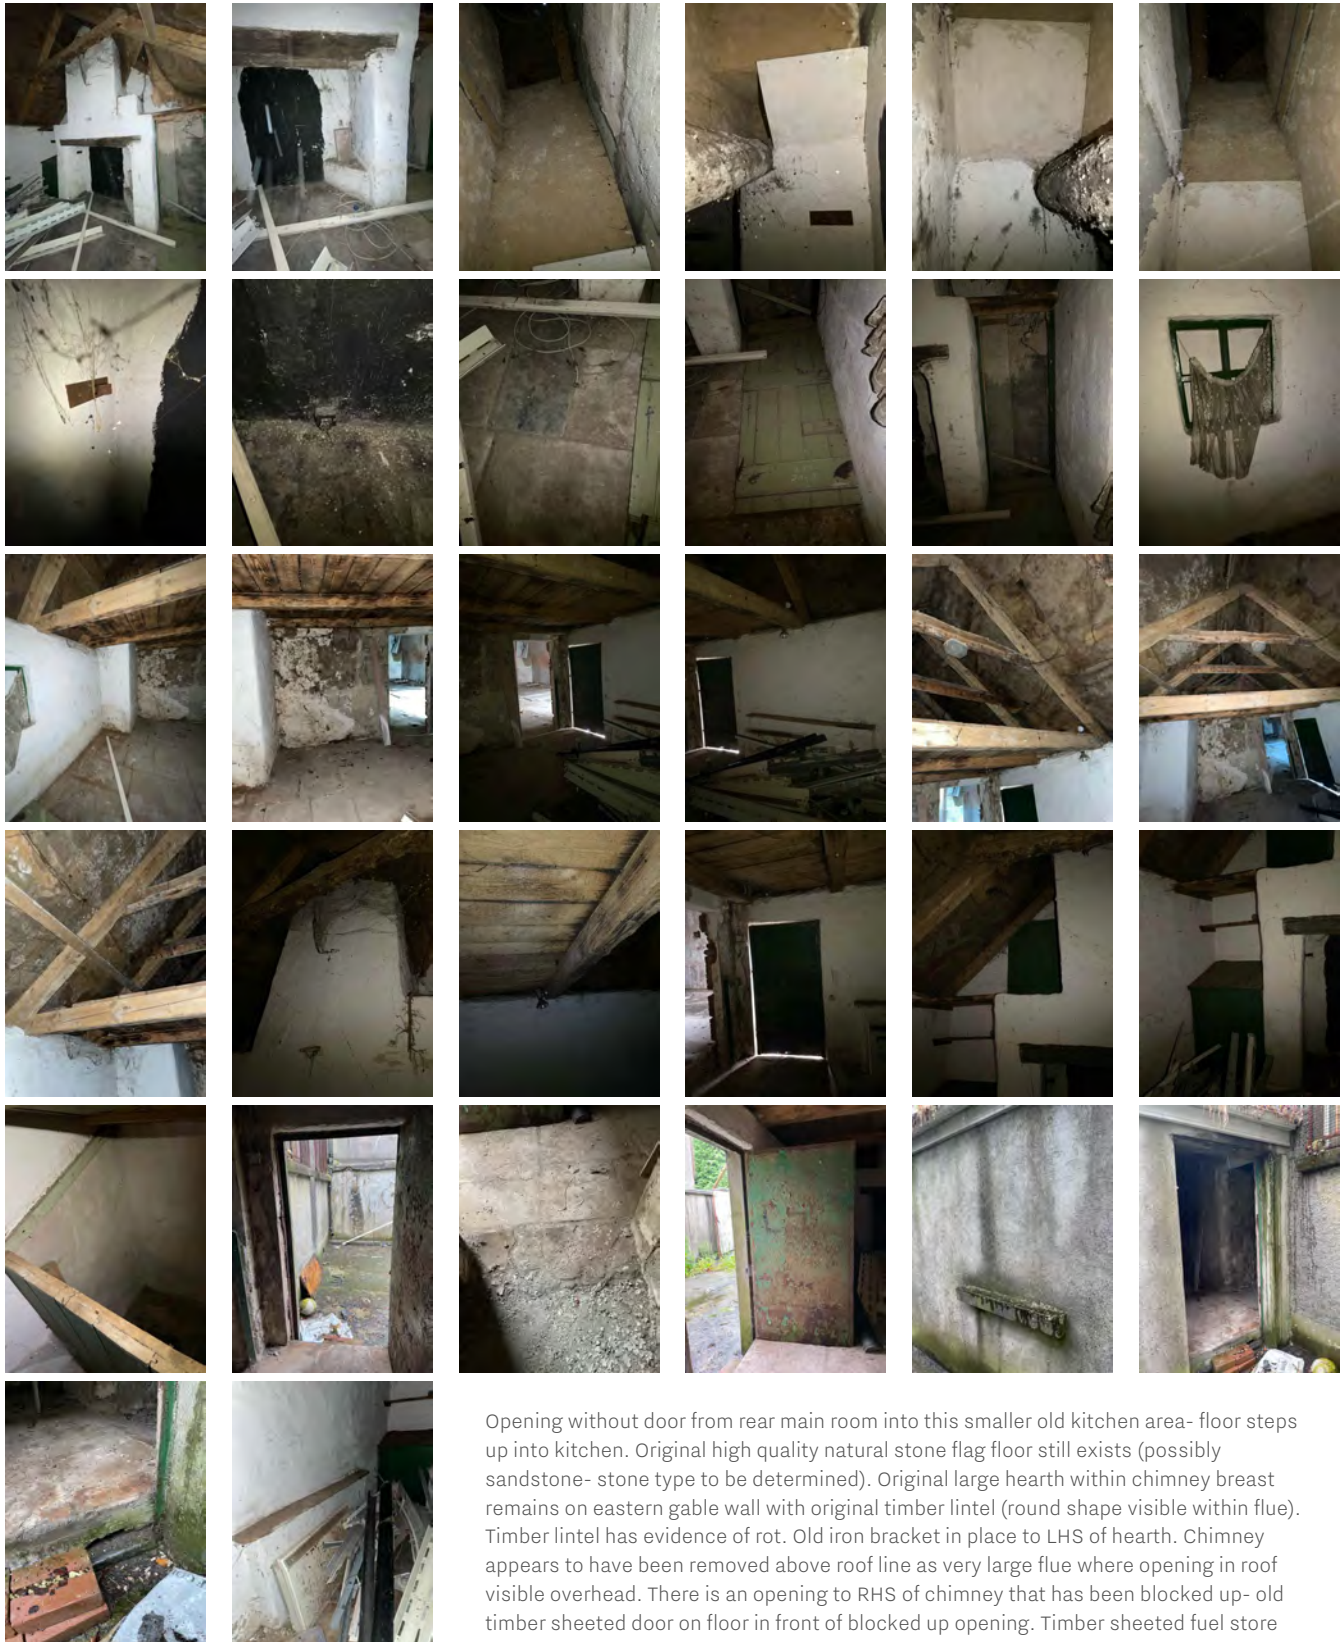
Opening without door from rear main room into this smaller old kitchen area- floor steps up into kitchen. Original high quality natural stone flag floor still exists (possibly sandstone- stone type to be determined). Original large hearth within chimney breast remains on eastern gable wall with original timber lintel (round shape visible within flue). Timber lintel has evidence of rot. Old iron bracket in place to LHS of hearth. Chimney appears to have been removed above roof line as very large flue where opening in roof visible overhead. There is an opening to RHS of chimney that has been blocked up- old timber sheeted door on floor in front of blocked up opening. Timber sheeted fuel store with hinged timber lid exists to the LHS of chimney breast. Old timber truss ceiling under pitched roof -rotten plywood conceals rafters. Timber ceiling ties of trusses supporting timber boarded loft floor across part of space. External window in timber frames with ply panes instead of glass visible on southern external wall. External flat steel door badly rusted in timber frames to northern external wall with single step down to rear yard. Window to side of external door in north wall has been fully blocked up and is not visible internally (cill still in place externally). Wall boxed out under old window location with old storage heater. Plastered internal wall finishes on internal wall (beside internal opening) in very poor condition. External walls have internal cementitious plastered finishes painted white.

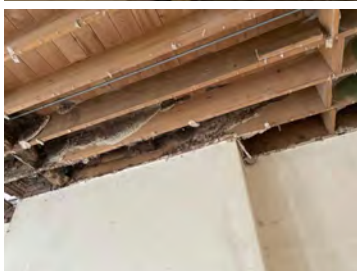
The timber floor overhead is severely damaged beside the northern party wall- worst part near the front facade where rot infestation is visible- and a section of the upper floor boards has disintegrated.

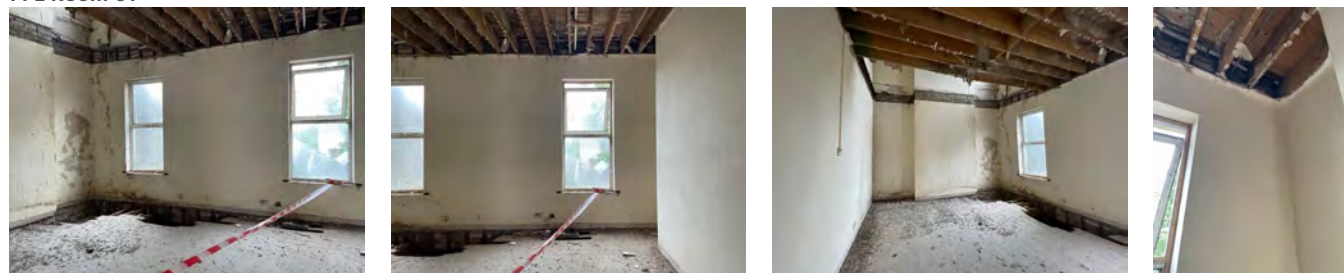
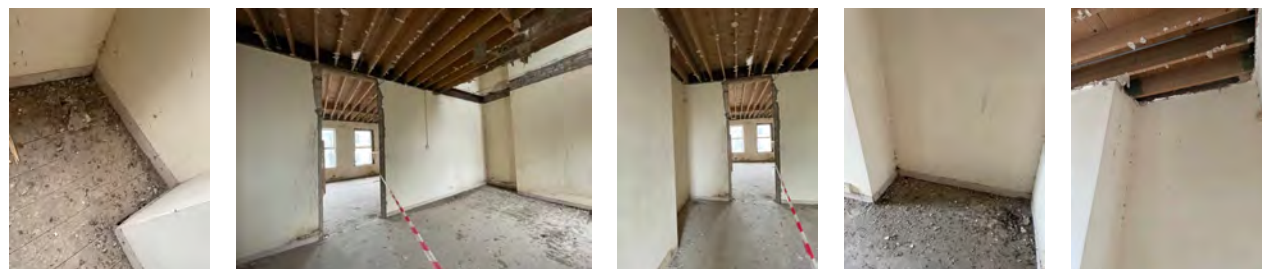
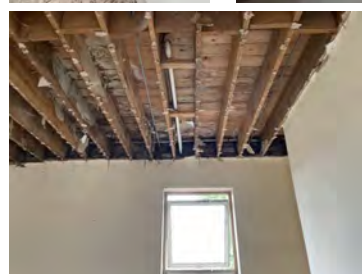
It was only possible to walk in part of this room as there is a large hole in the floor and it is unsafe- the unsafe section has been cordoned off. As above a modern steel beam is visible above top of internal partition with full height internal opening under steel beam- this partition has painted plaster finishes. Northern party wall has chimney breast - wall finishes painted plaster. External wall to rear façade appears to have modern dry lining with painted plasterboard finishes and uPCV windows. Solid internal masonry wall with deep reveal indicates possible chimney breast with adjacent thinner partitions between this room and adjacent stairs landing. Internal wall as painted finishes. Timber joisted upper boarded floor on timber joists visible overhead. No ceiling finishes remain. A number of steel rods have been inserted between the joists to tie the front façade back to the rear facade- threaded through modern steel beam. The timber boarded floor at this level and overhead is severely damaged. At this level there is a missing timber floor section along the rear external wall. There is a large section missing of the floor overhead along the northern party wall.

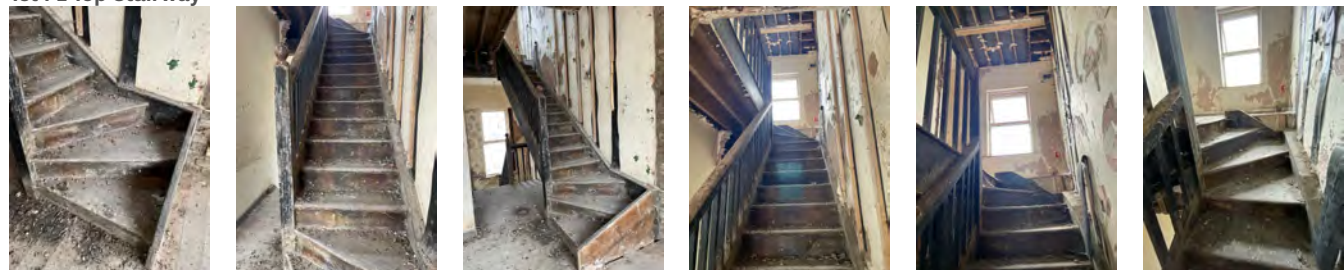
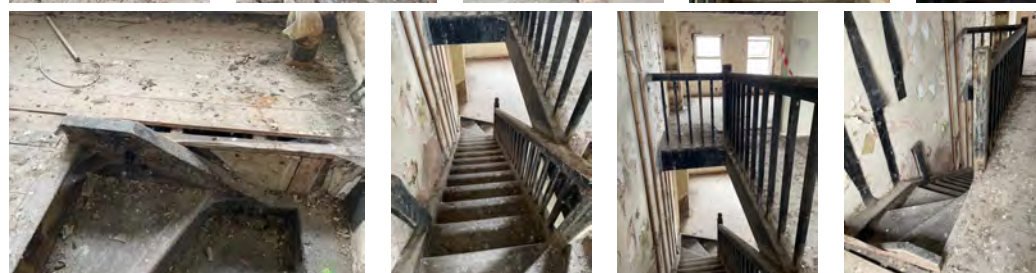
Existing historic timber staircase with timber stringer, handrail and balustrade remains. Evidence of dampness evident everywhere. Modern party wall dry lining battens on DPC added to original lime finish- plasterboard no longer there- lime finishes in poor condition.

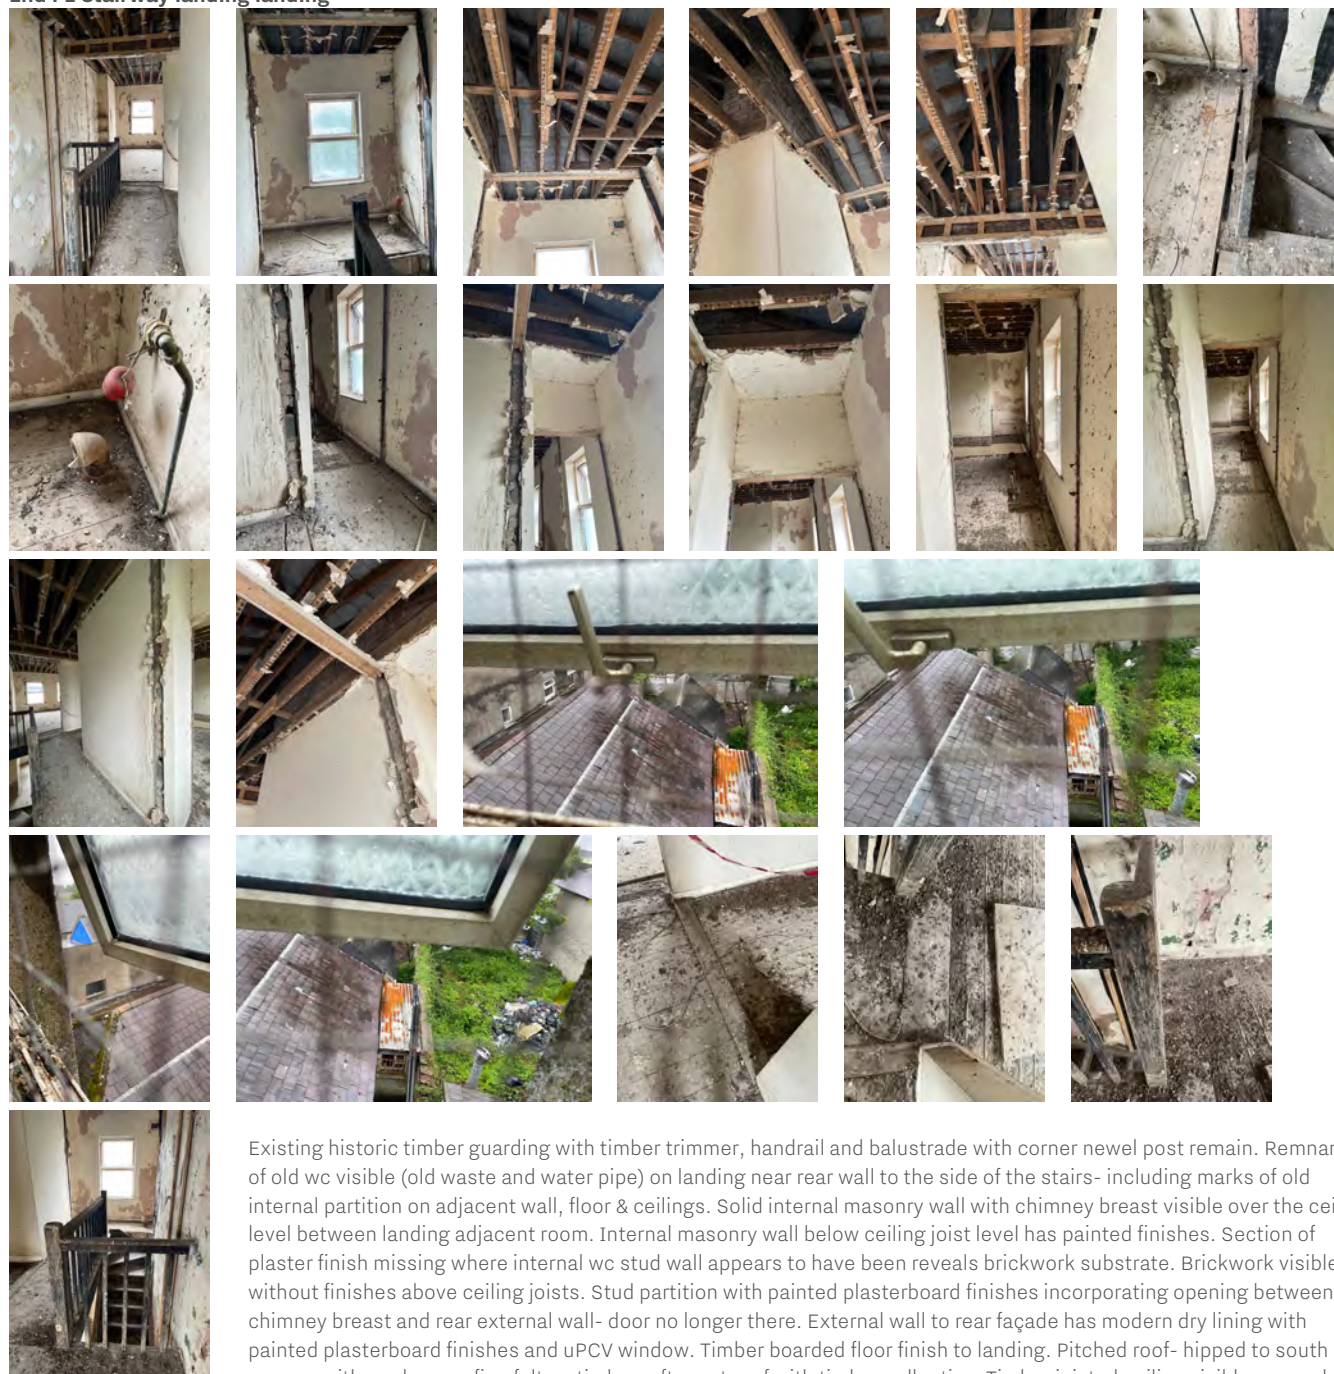
Existing historic timber guarding with timber trimmer, handrail and balustrade with corner newel post remain. Remnants of old wc visible (old waste and water pipe) on landing near rear wall to the side of the stairs- including marks of old internal partition on adjacent wall, floor & ceilings. Solid internal masonry wall with chimney breast visible over the ceiling level between landing adjacent room. Internal masonry wall below ceiling joist level has painted finishes. Section of plaster finish missing where internal wc stud wall appears to have been reveals brickwork substrate. Brickwork visible without finishes above ceiling joists. Stud partition with painted plasterboard finishes incorporating opening between chimney breast and rear external wall- door no longer there. External wall to rear façade has modern dry lining with painted plasterboard finishes and uPCV window. Timber boarded floor finish to landing. Pitched roof- hipped to south east corner- with modern roofing felt on timber rafter cut roof with timber collar ties. Timber joisted ceiling visible as nearly all ceiling finishes no longer present. It is possible get limits view through the window (has limited opening) of the roofs below of rear ground floor single storey parts- generally with slate roof finishes (likely to be fibre cement) with the exception of the modern flat roof extension which has a rusted corrugated roof finish. The ridge tiles appear to be clay or concrete.

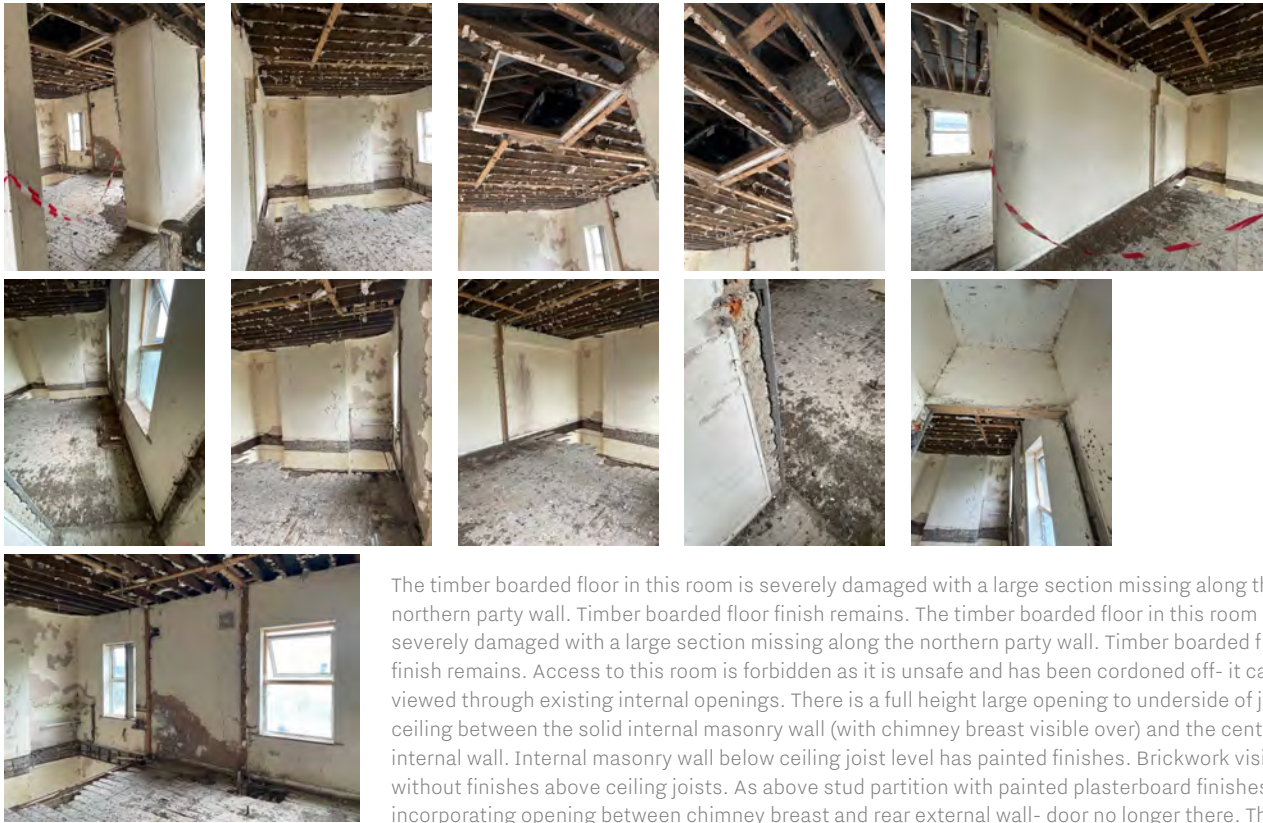
The timber boarded floor in this room is severely damaged with a large section missing along the northern party wall. Timber boarded floor finish remains. The timber boarded floor in this room is severely damaged with a large section missing along the northern party wall. Timber boarded floor finish remains. Access to this room is forbidden as it is unsafe and has been cordoned off- it can be viewed through existing internal openings. There is a full height large opening to underside of joisted ceiling between the solid internal masonry wall (with chimney breast visible over) and the central internal wall. Internal masonry wall below ceiling joist level has painted finishes. Brickwork visible without finishes above ceiling joists. As above stud partition with painted plasterboard finishes incorporating opening between chimney breast and rear external wall- door no longer there. There are remnants of 2 no timber stud partitions visible to the inside of the dry lining suggesting that they were modern stud partitions. Northern party wall has chimney breast - wall finishes appear to be painted plaster- with exposed brickwork to section of wall at intersection of floor now missing.

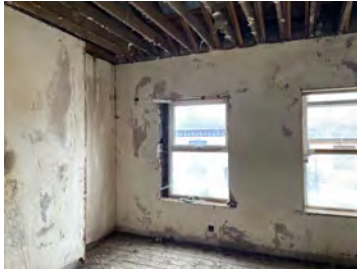
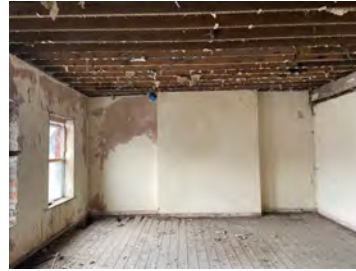
Existing chimney breast on southern party wall with painted plaster finishes to ceiling level - finishes appear modern and in poor condition. External wall to front façade has modern dry lining with painted plasterboard finishes-to ceiling level. Upvc windows to front façade.

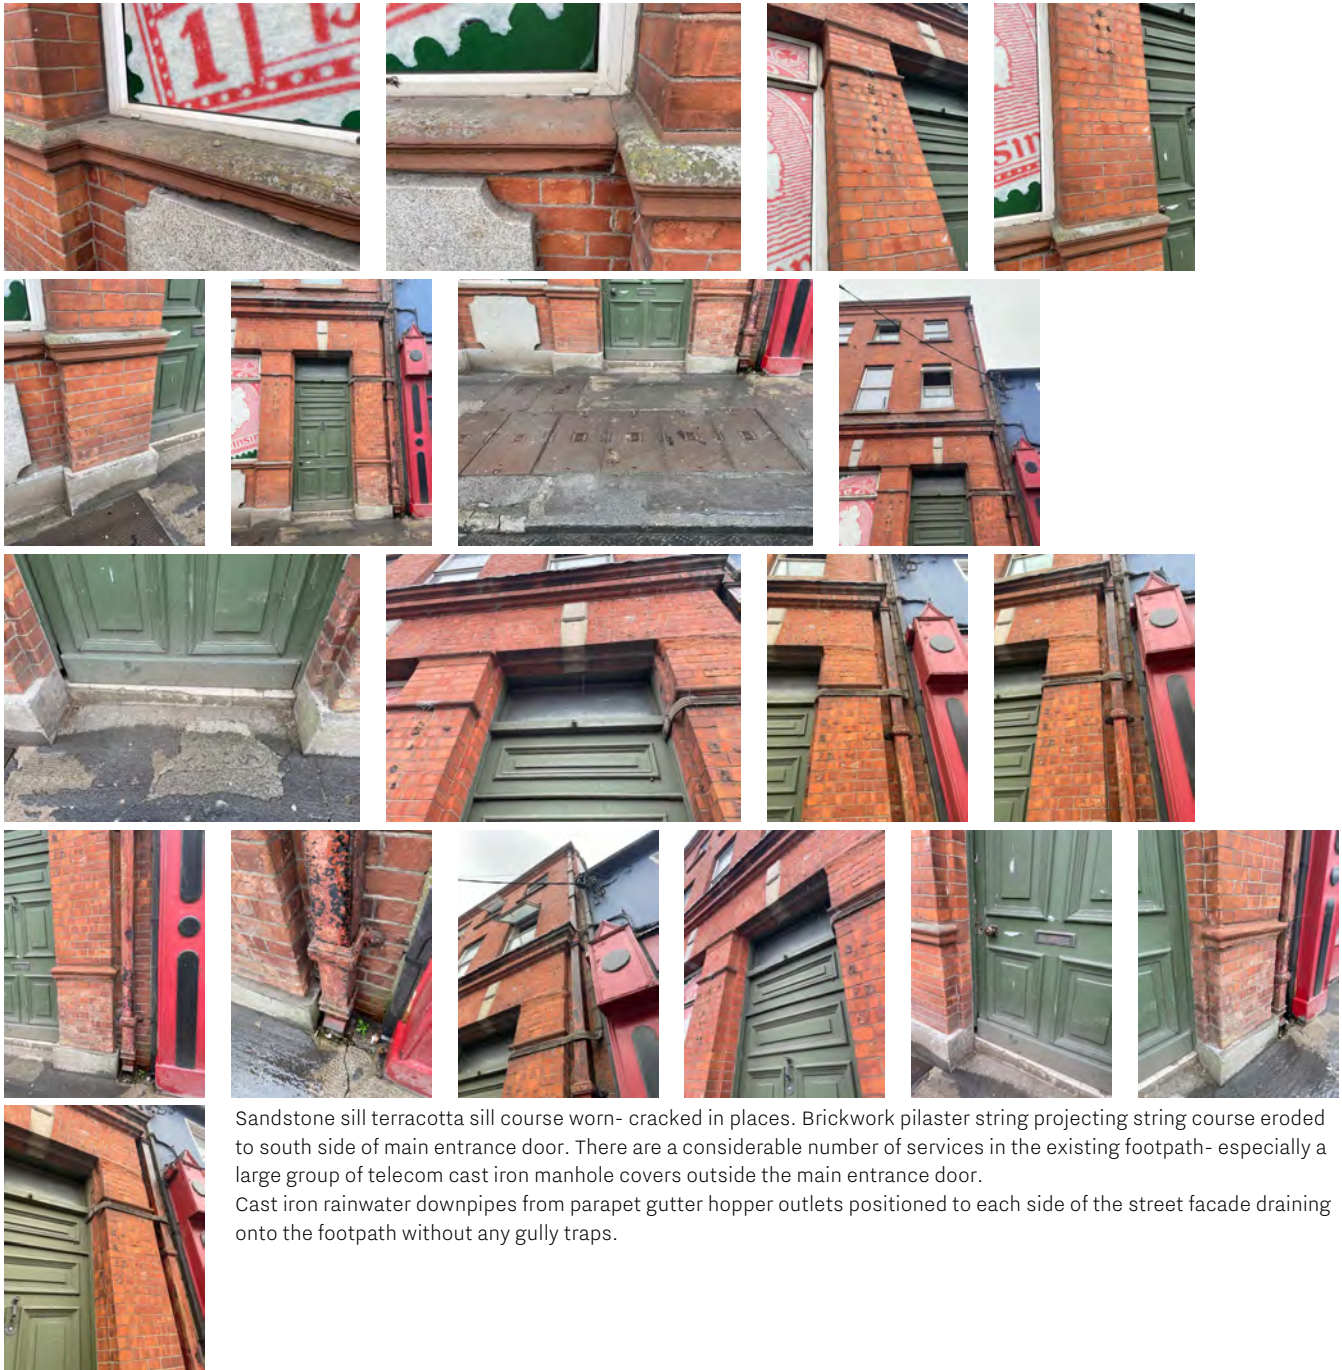
Sandstone sill terracotta sill course worn- cracked in places. Brickwork pilaster string projecting string course eroded to south side of main entrance door. There are a considerable number of services in the existing footpath- especially a large group of telecom cast iron manhole covers outside the main entrance door.

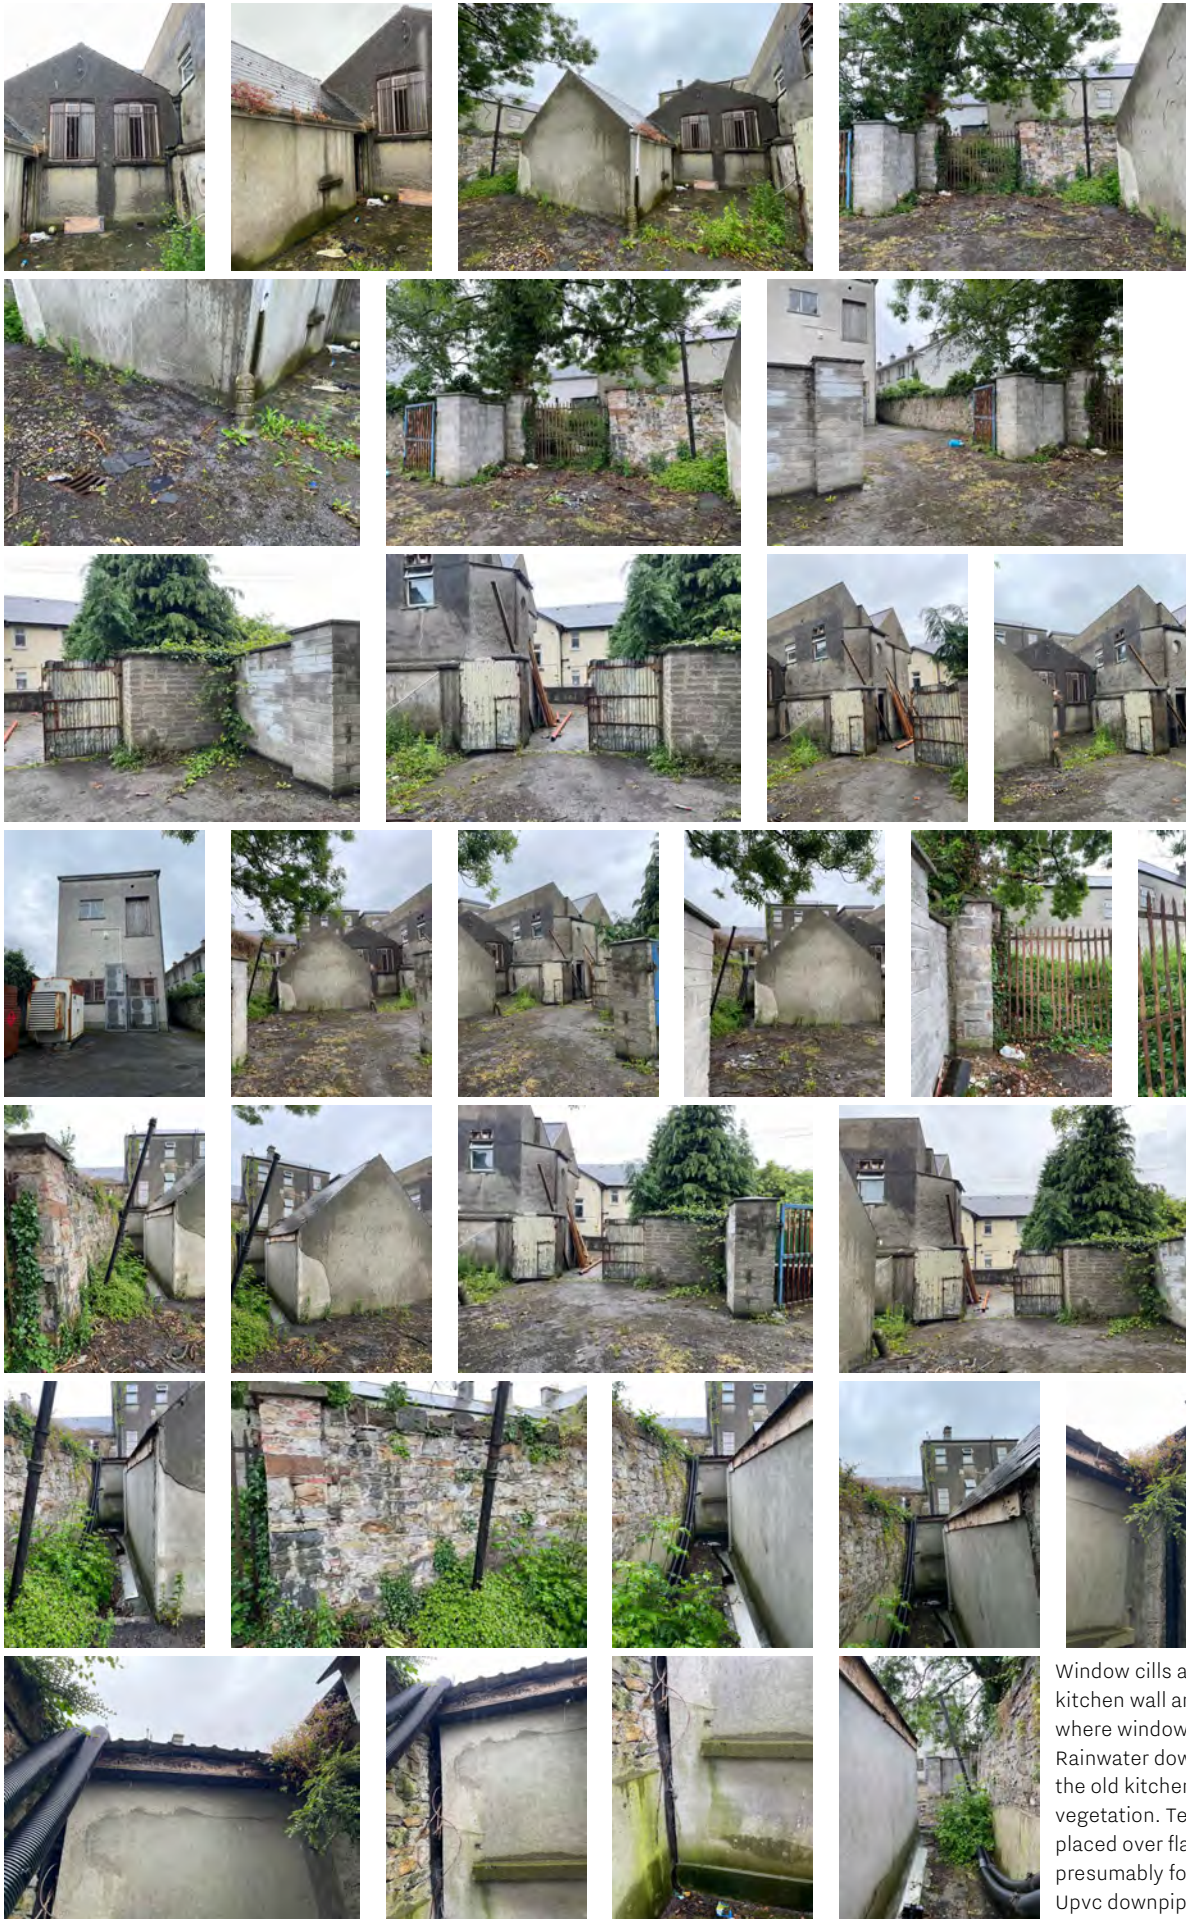
Rear gable wall of large open plan room has unpainted dashed cement render finish. The high level external windows have metal security grilles. The old kitchen rear single storey building has unpainted smooth cement render finish. The window cill is visible on north kitchen wall where window blocked up. The pitched roof finishes appear to be modern fibre cement slate. There are upvc rainwater goods to the old kitchen building- the northern gutter is full of vegetation- southern gutter is mostly missing- the downpipe is broken. There is no chimney visible externally over the old kitchen.
