SOIL CHARACTERISATION AND
SITE SUITABILITY ASSESSMENT REPORT
TE REF: 23/032TE

**LONGFORD COUNTY COUNCIL
CORNEEDAN
BALLINALEE
CO. LONGFORD**

**IN ACCORDANCE WITH
EPA CODE OF PRACTICE
WASTEWATER TREATMENT AND DISPOSAL
SYSTEMS SERVING SINGLE HOUSES 2021**

SITE CHARACTERISATION FORM FOR AN ON-SITE WASTEWATER TREATMENT SYSTEM

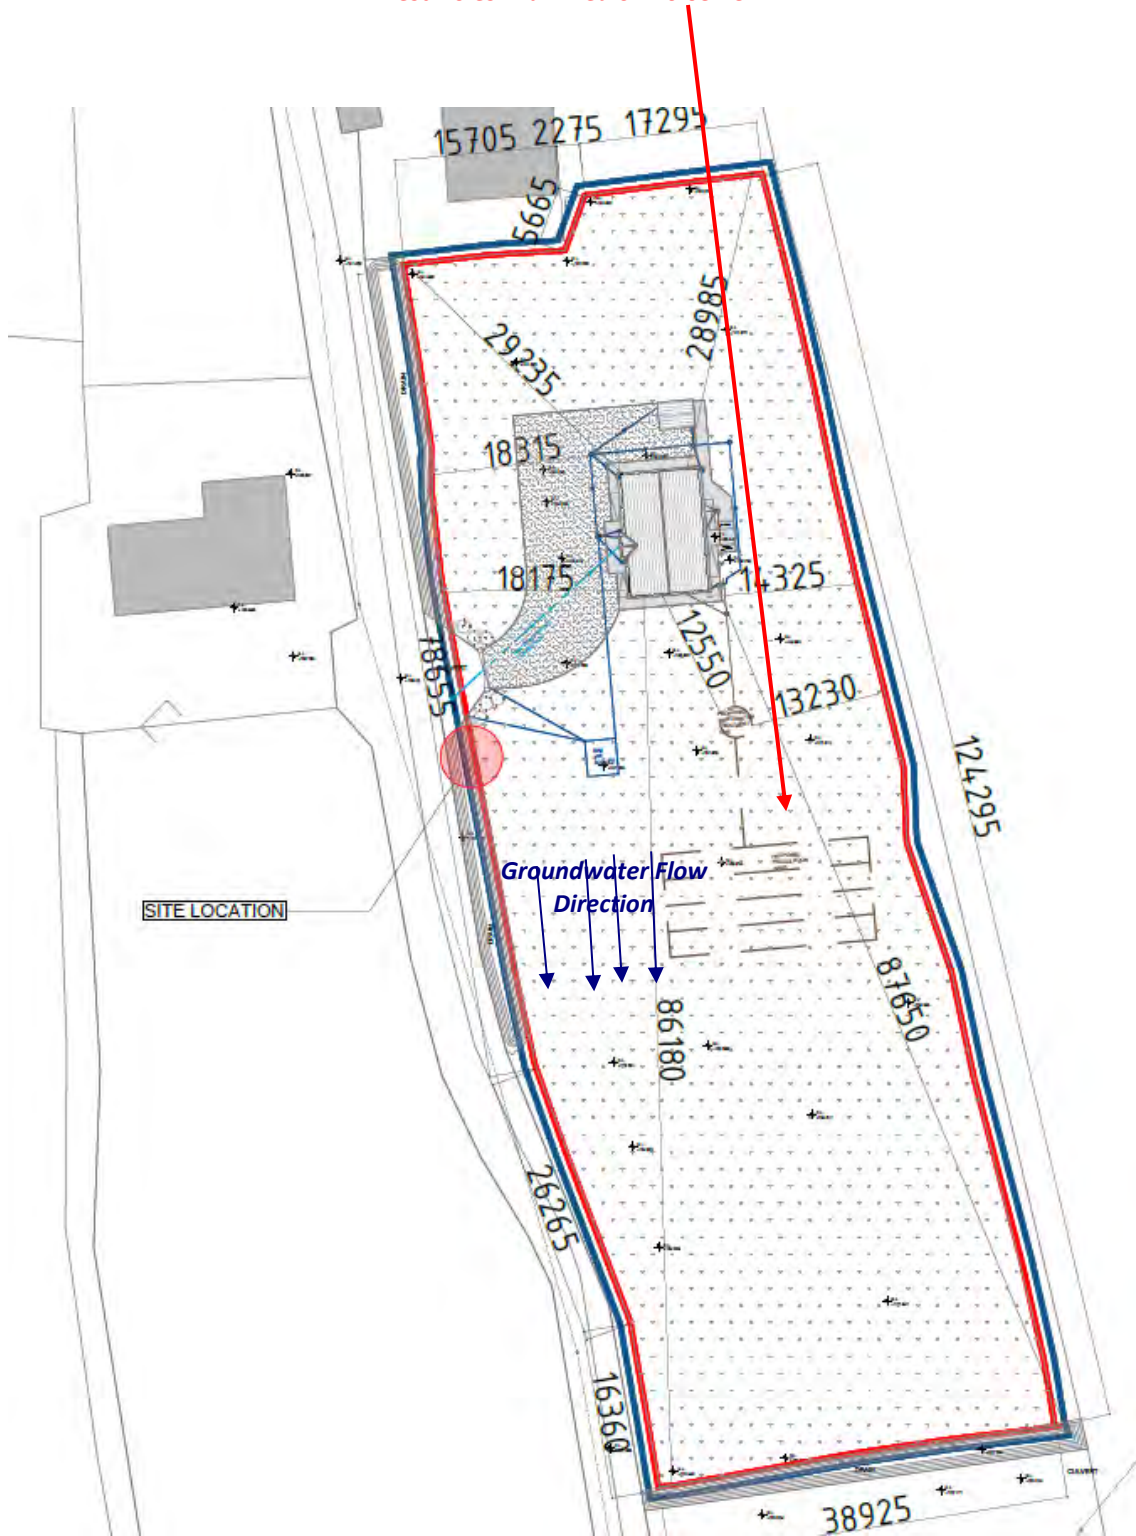
SITE LAYOUT DRAWING SHOWING TEST HOLE LOCATIONS

*Approximate Location of Trial Hole & Percolation
Test Holes Examined on 16.03.23*

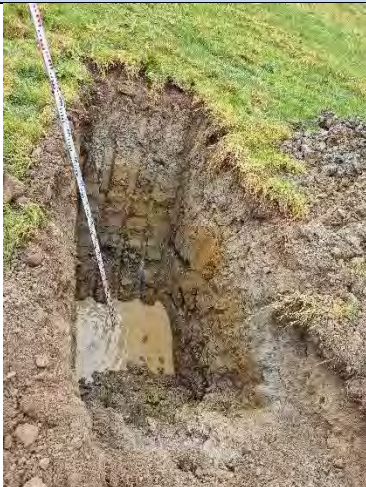
Trial Hole – Front View

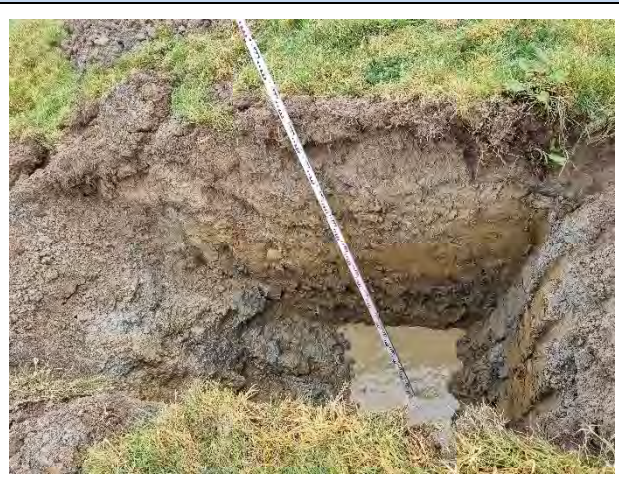
Trial Hole – Side View

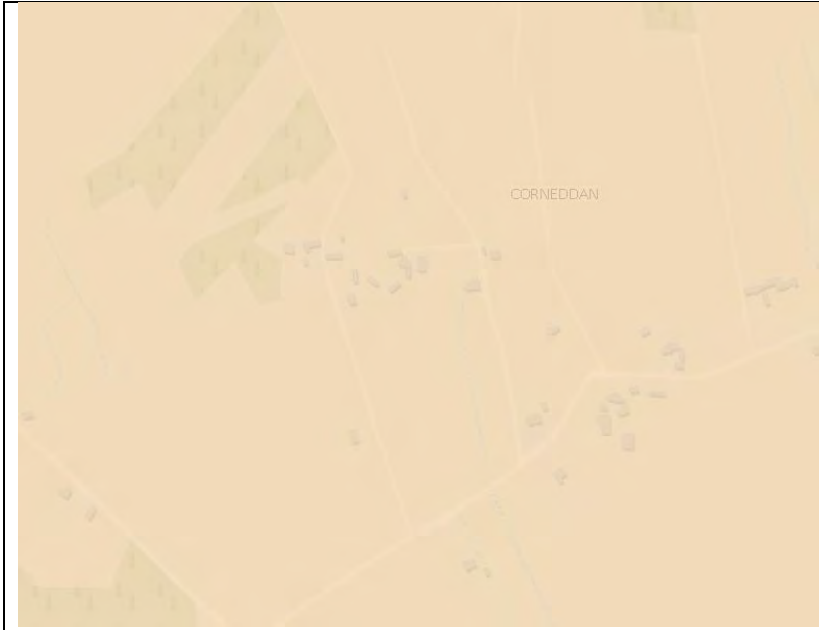
Groundwater/Aquifer Map

*From the GSI Groundwater
Aquifer Map Site is
classified as Poor Aquifer -
Bedrock which is Generally
Unproductive except for
Local Zones*

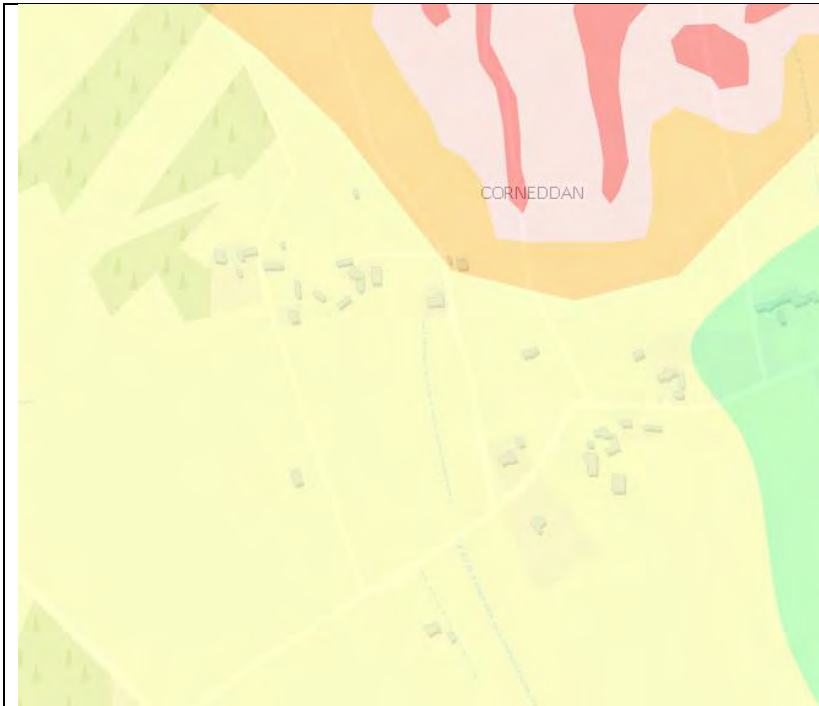
*From the GSI Vulnerability
Map Site is classified as
Moderate*

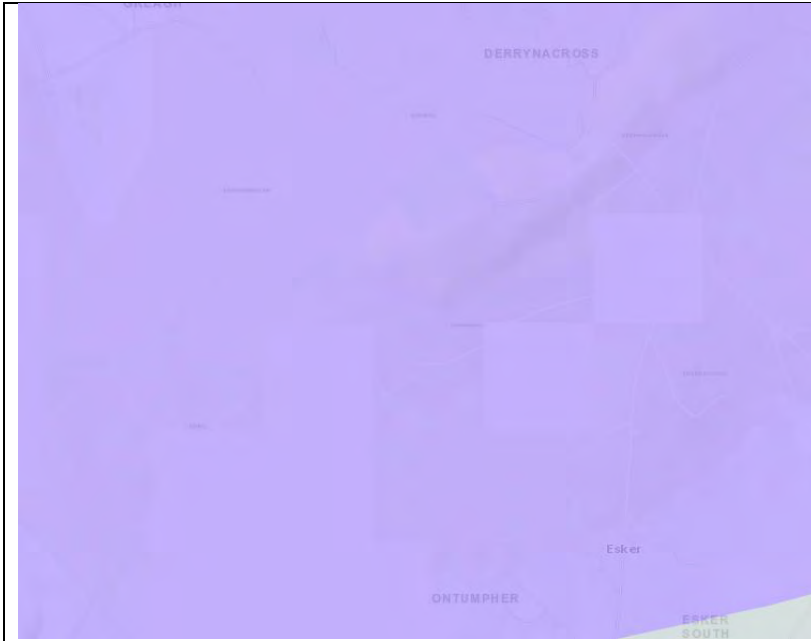
*From the GSI Bedrock Map
Site is classified as OM-
Ordovician
Metasediments*

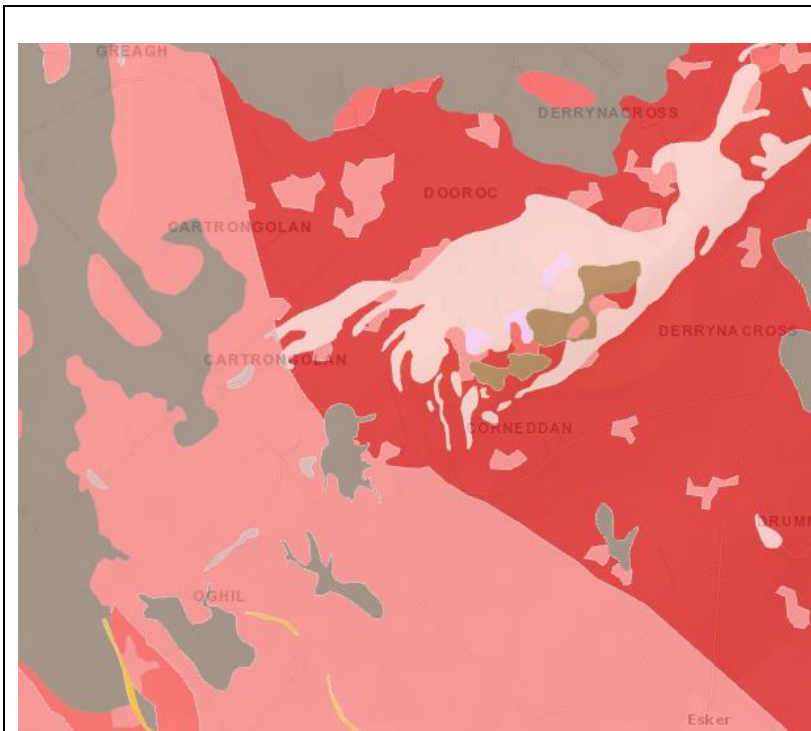
*From the Teagasc Subsoil
Map Site is classified as Till
derived chiefly from Lower
Palaeozoic rocks*
