OFFICERS BUILDING
LONGFORD | COUNTY LONGFORD
ARCHITECTURAL HERITAGE IMPACT ASSESSMENT REPORT

ROBIN LEE ARCHITECTURE
JANUARY 2025

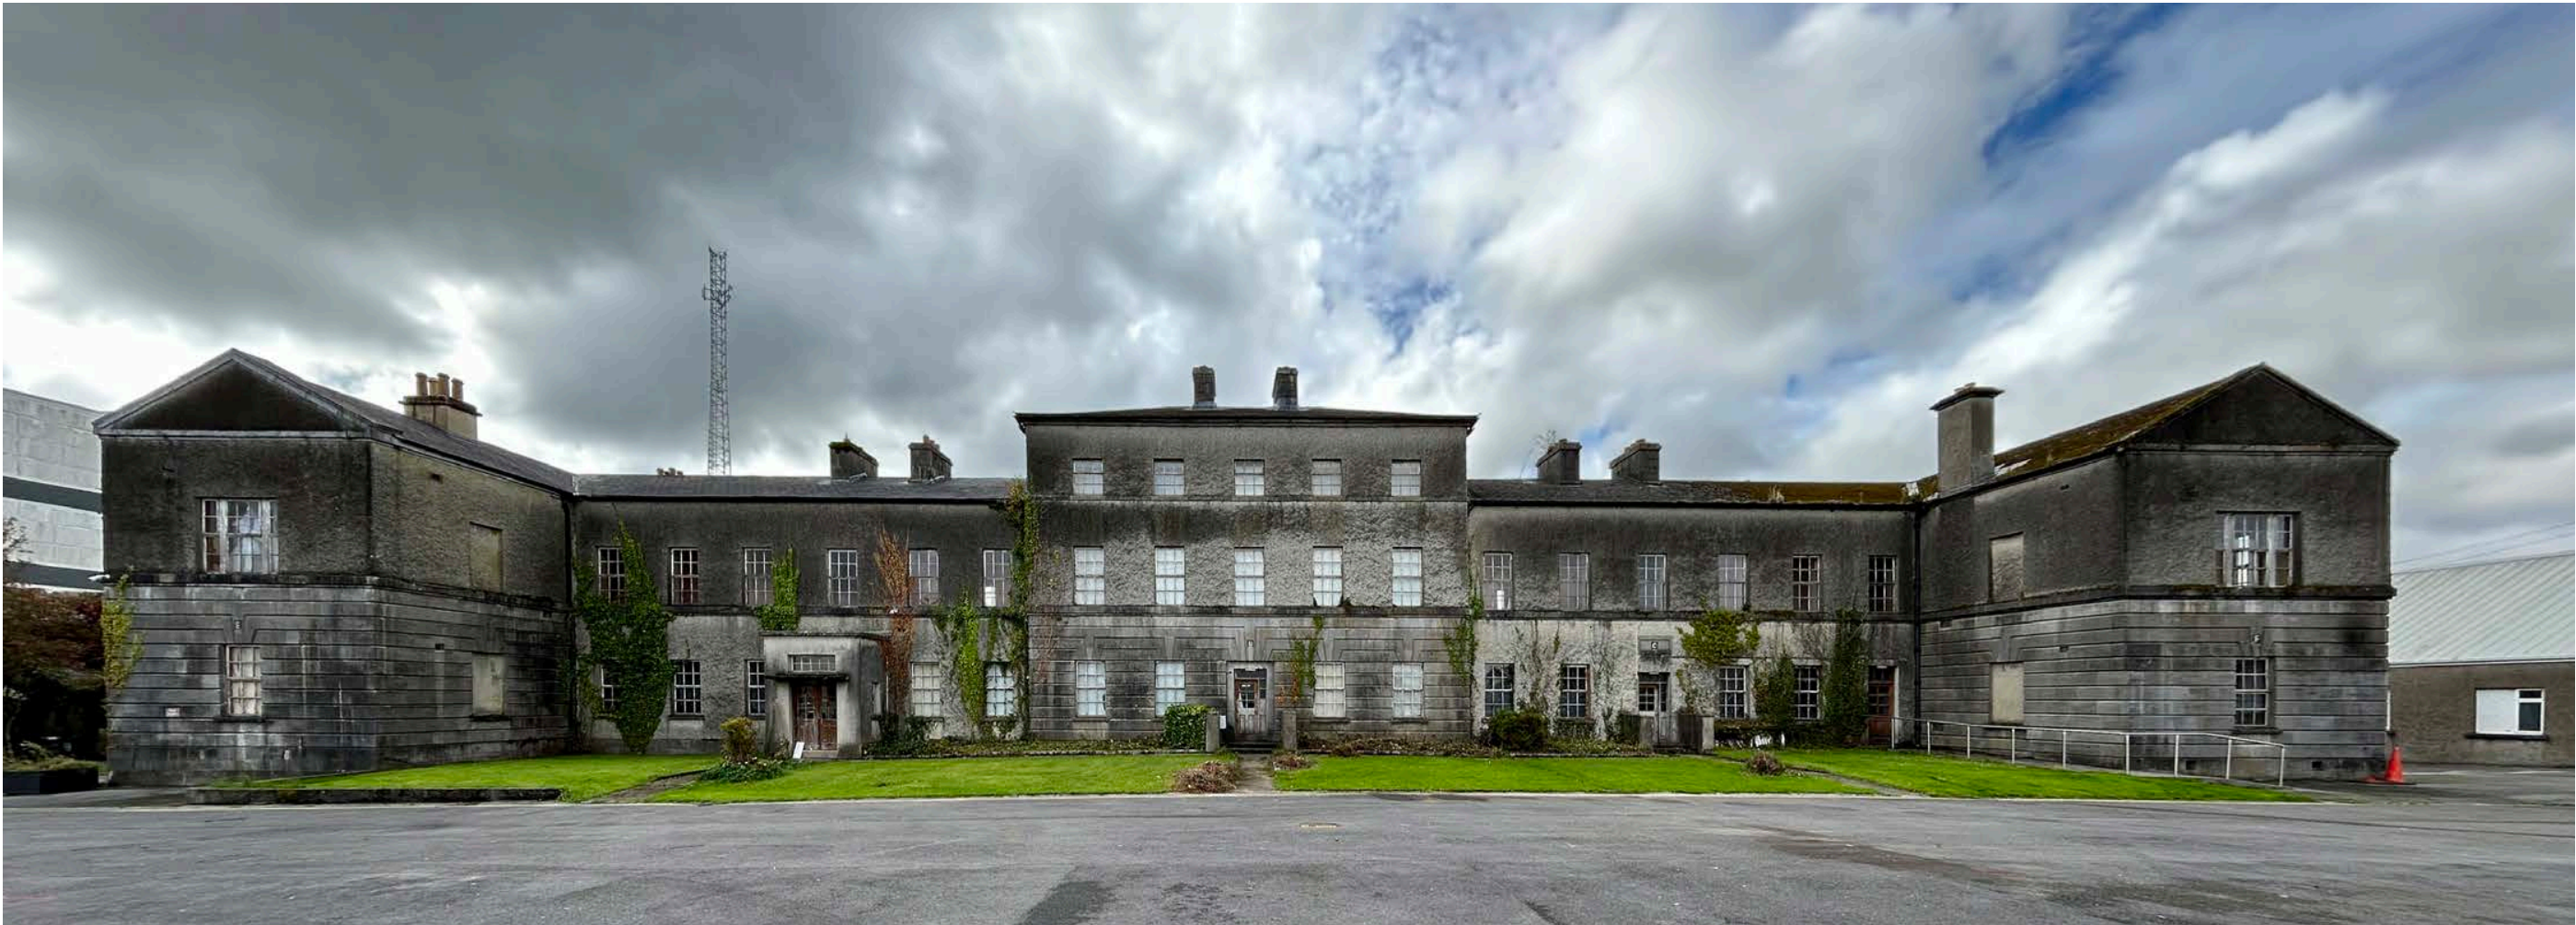
Officers Building _ East Elevation

View of the Officers Building east elevation from the former parade yard.
Note alterations to existing frontage including infilled window openings, projecting porch to the front southernmost entrance, replacement of ground floor window with door opening adjacent to northern wing.

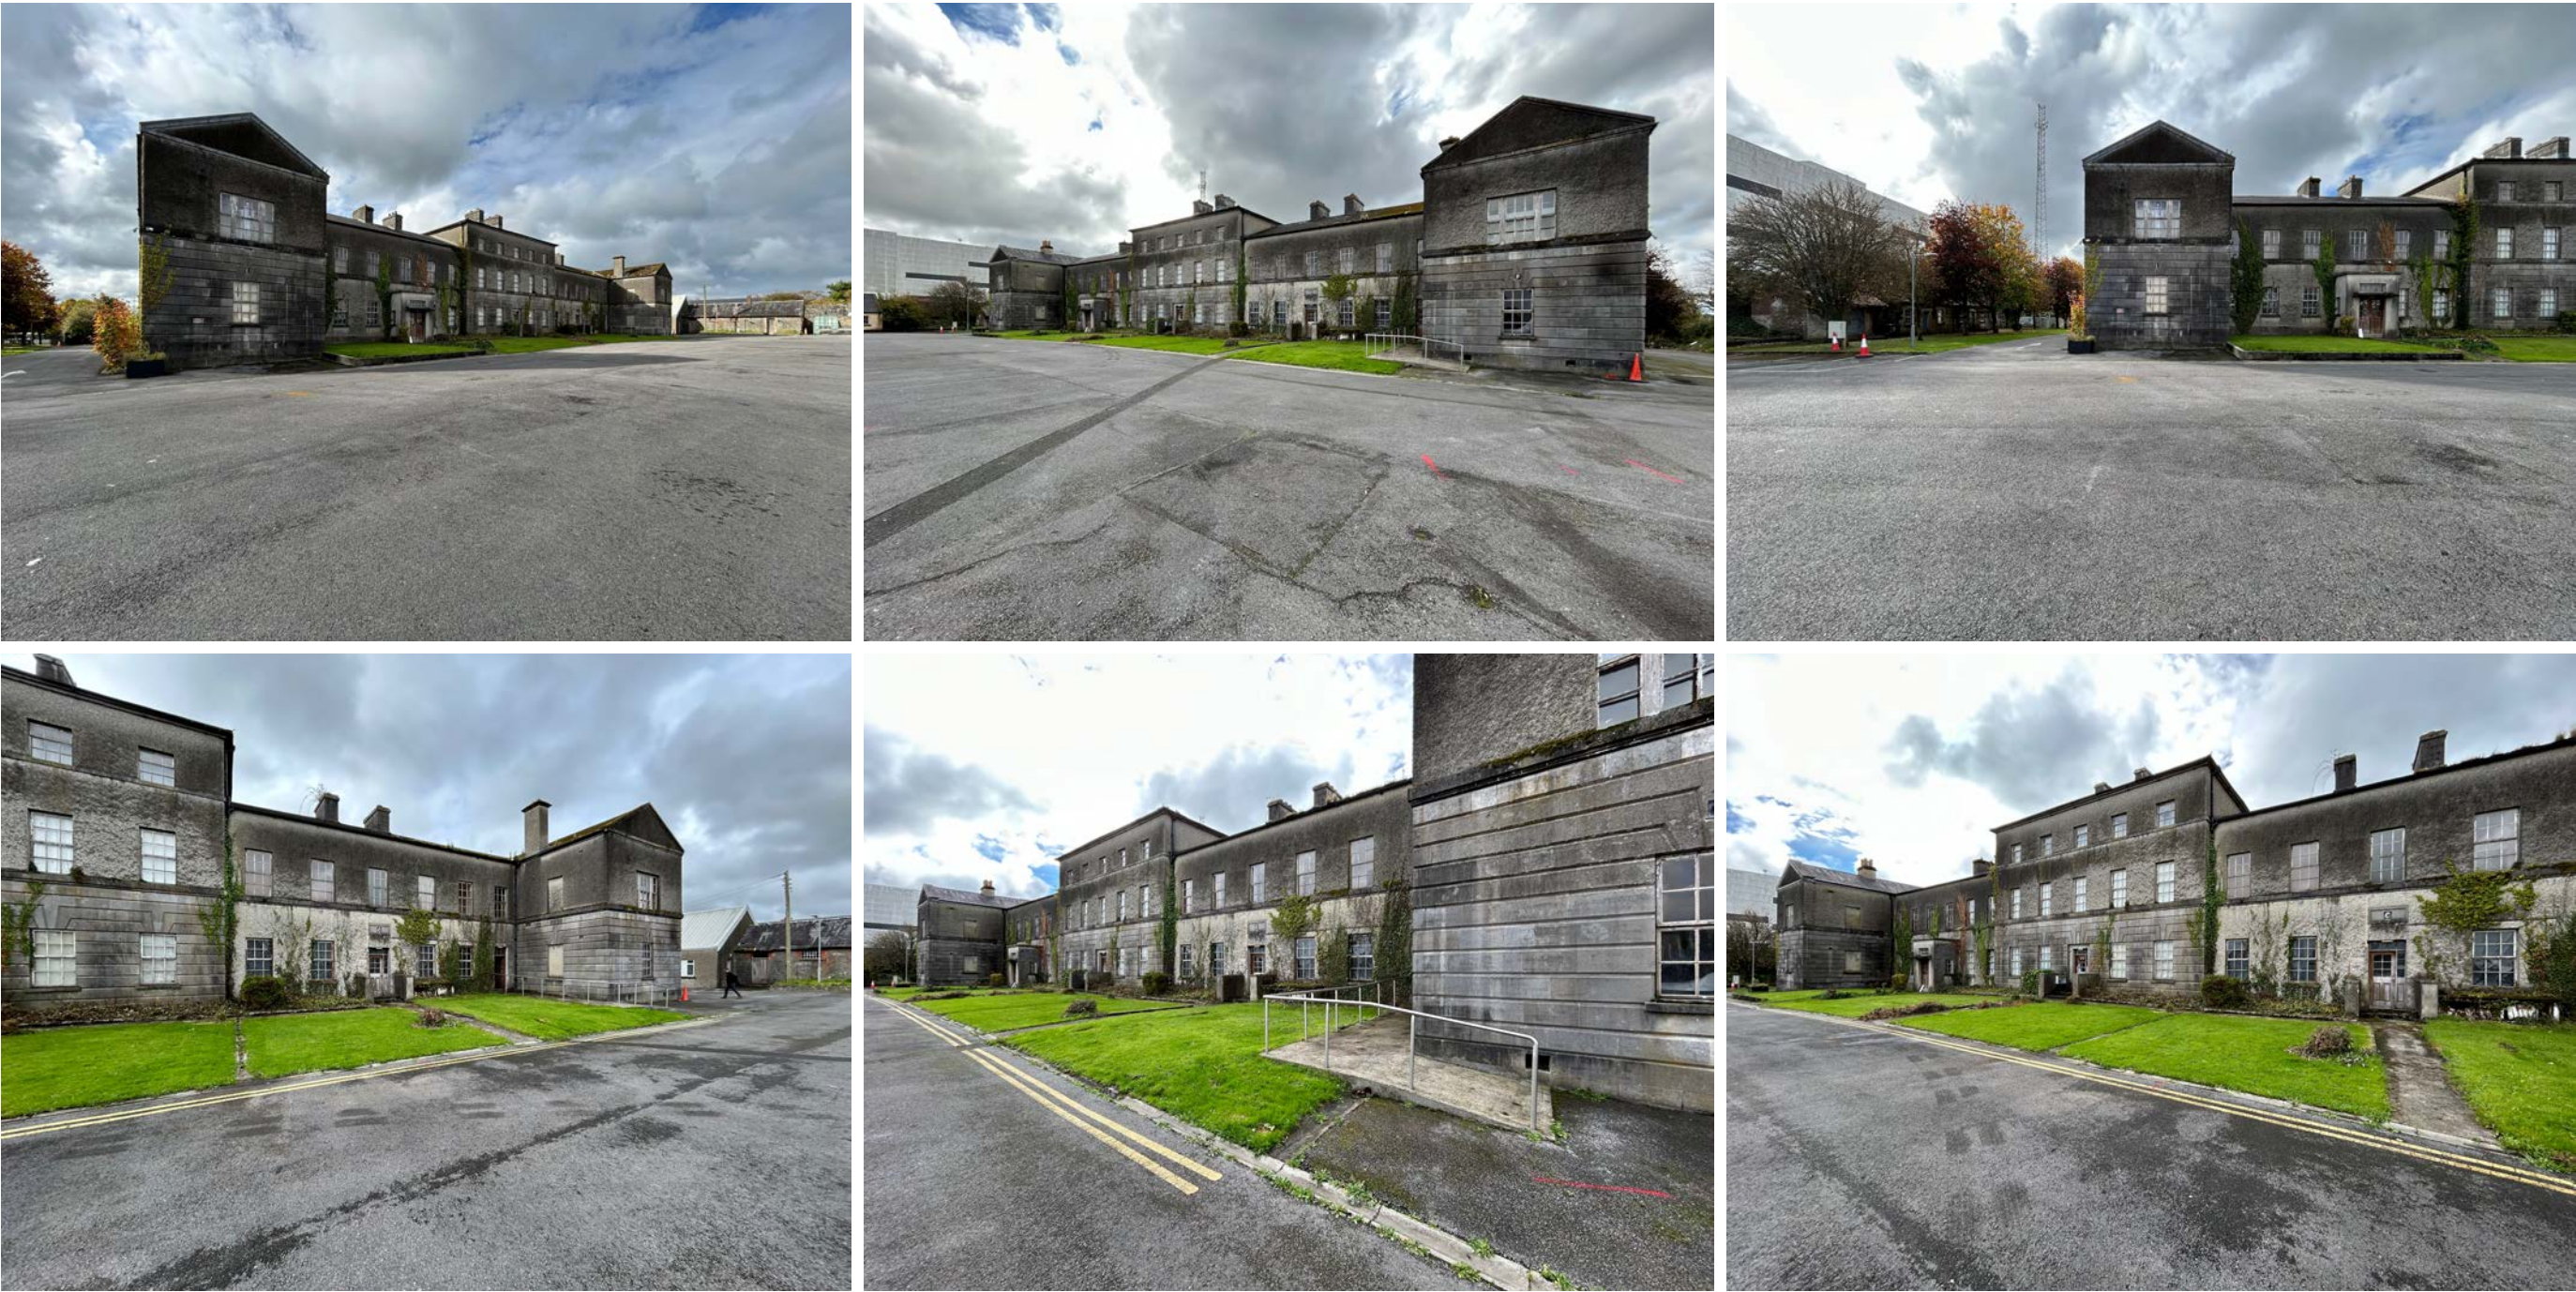
Officers Building _ East Elevation

Oblique views of the Officers Building east elevation from the former parade yard.
Note alterations to existing frontage including ramped entrance route adjacent to and extending across the front elevation of the northern wing.

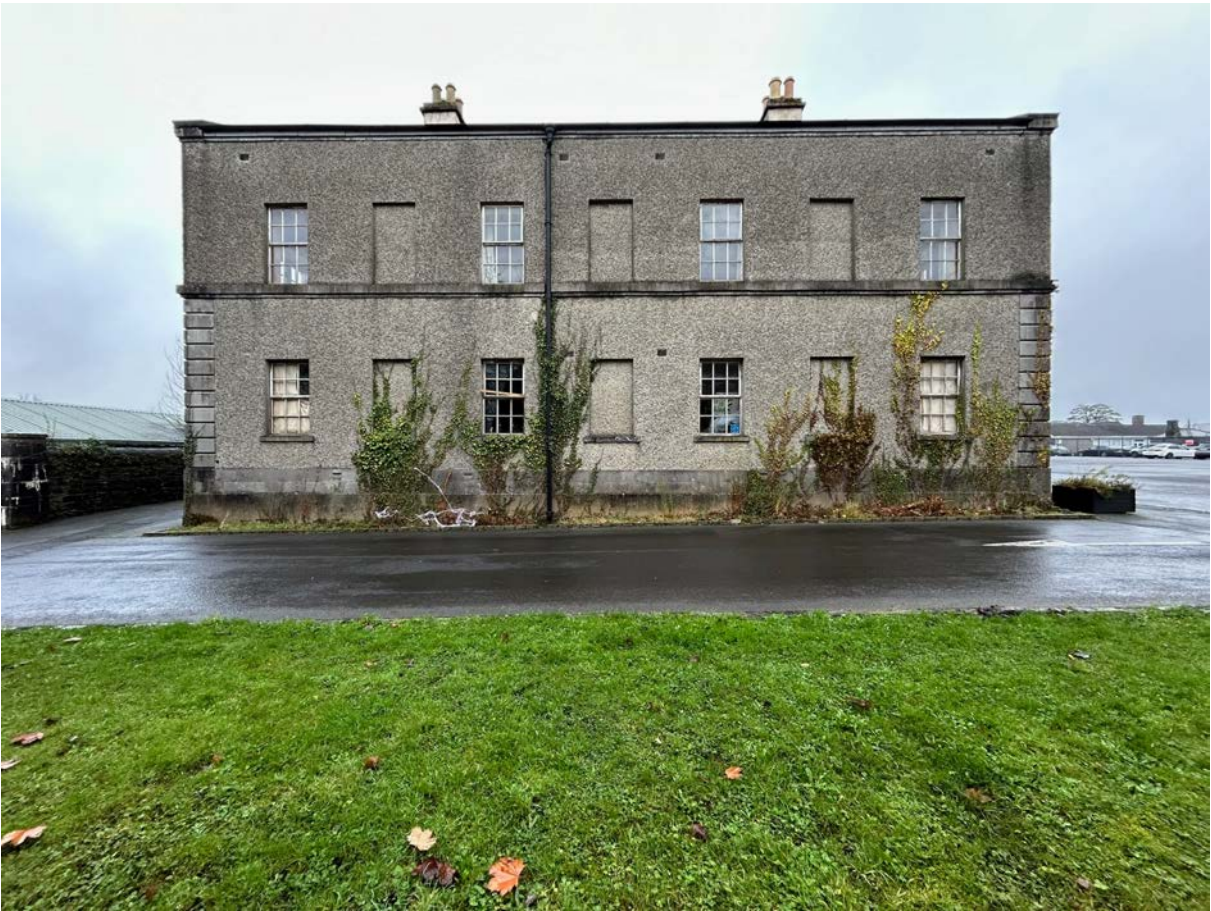
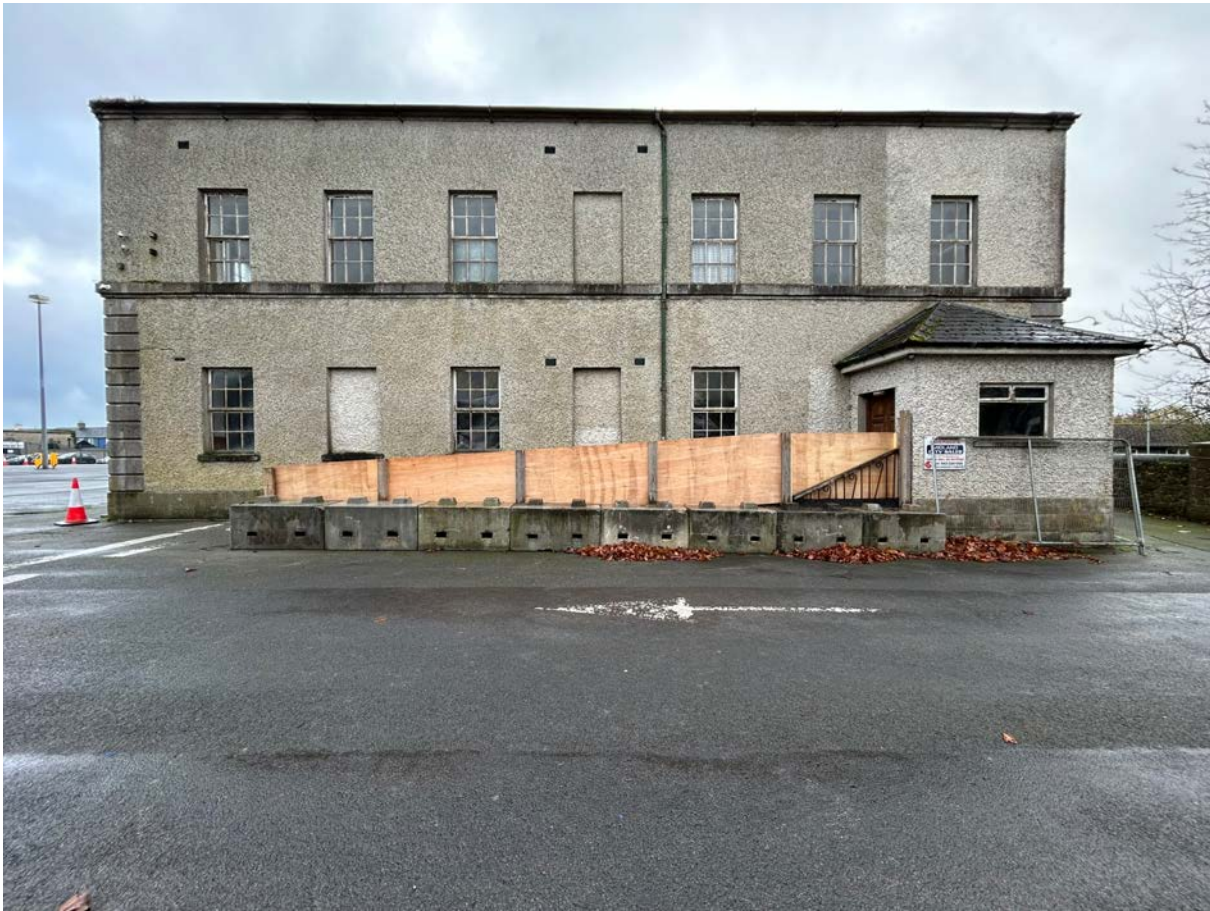
Officer's Building _ South and North Elevation

Elevation views of the south and north gables to Officers Building.
Note alterations to existing frontages including infilled window openings and consequent loss of sash windows, ramped entrance route and projecting single storey porch to north elevation.

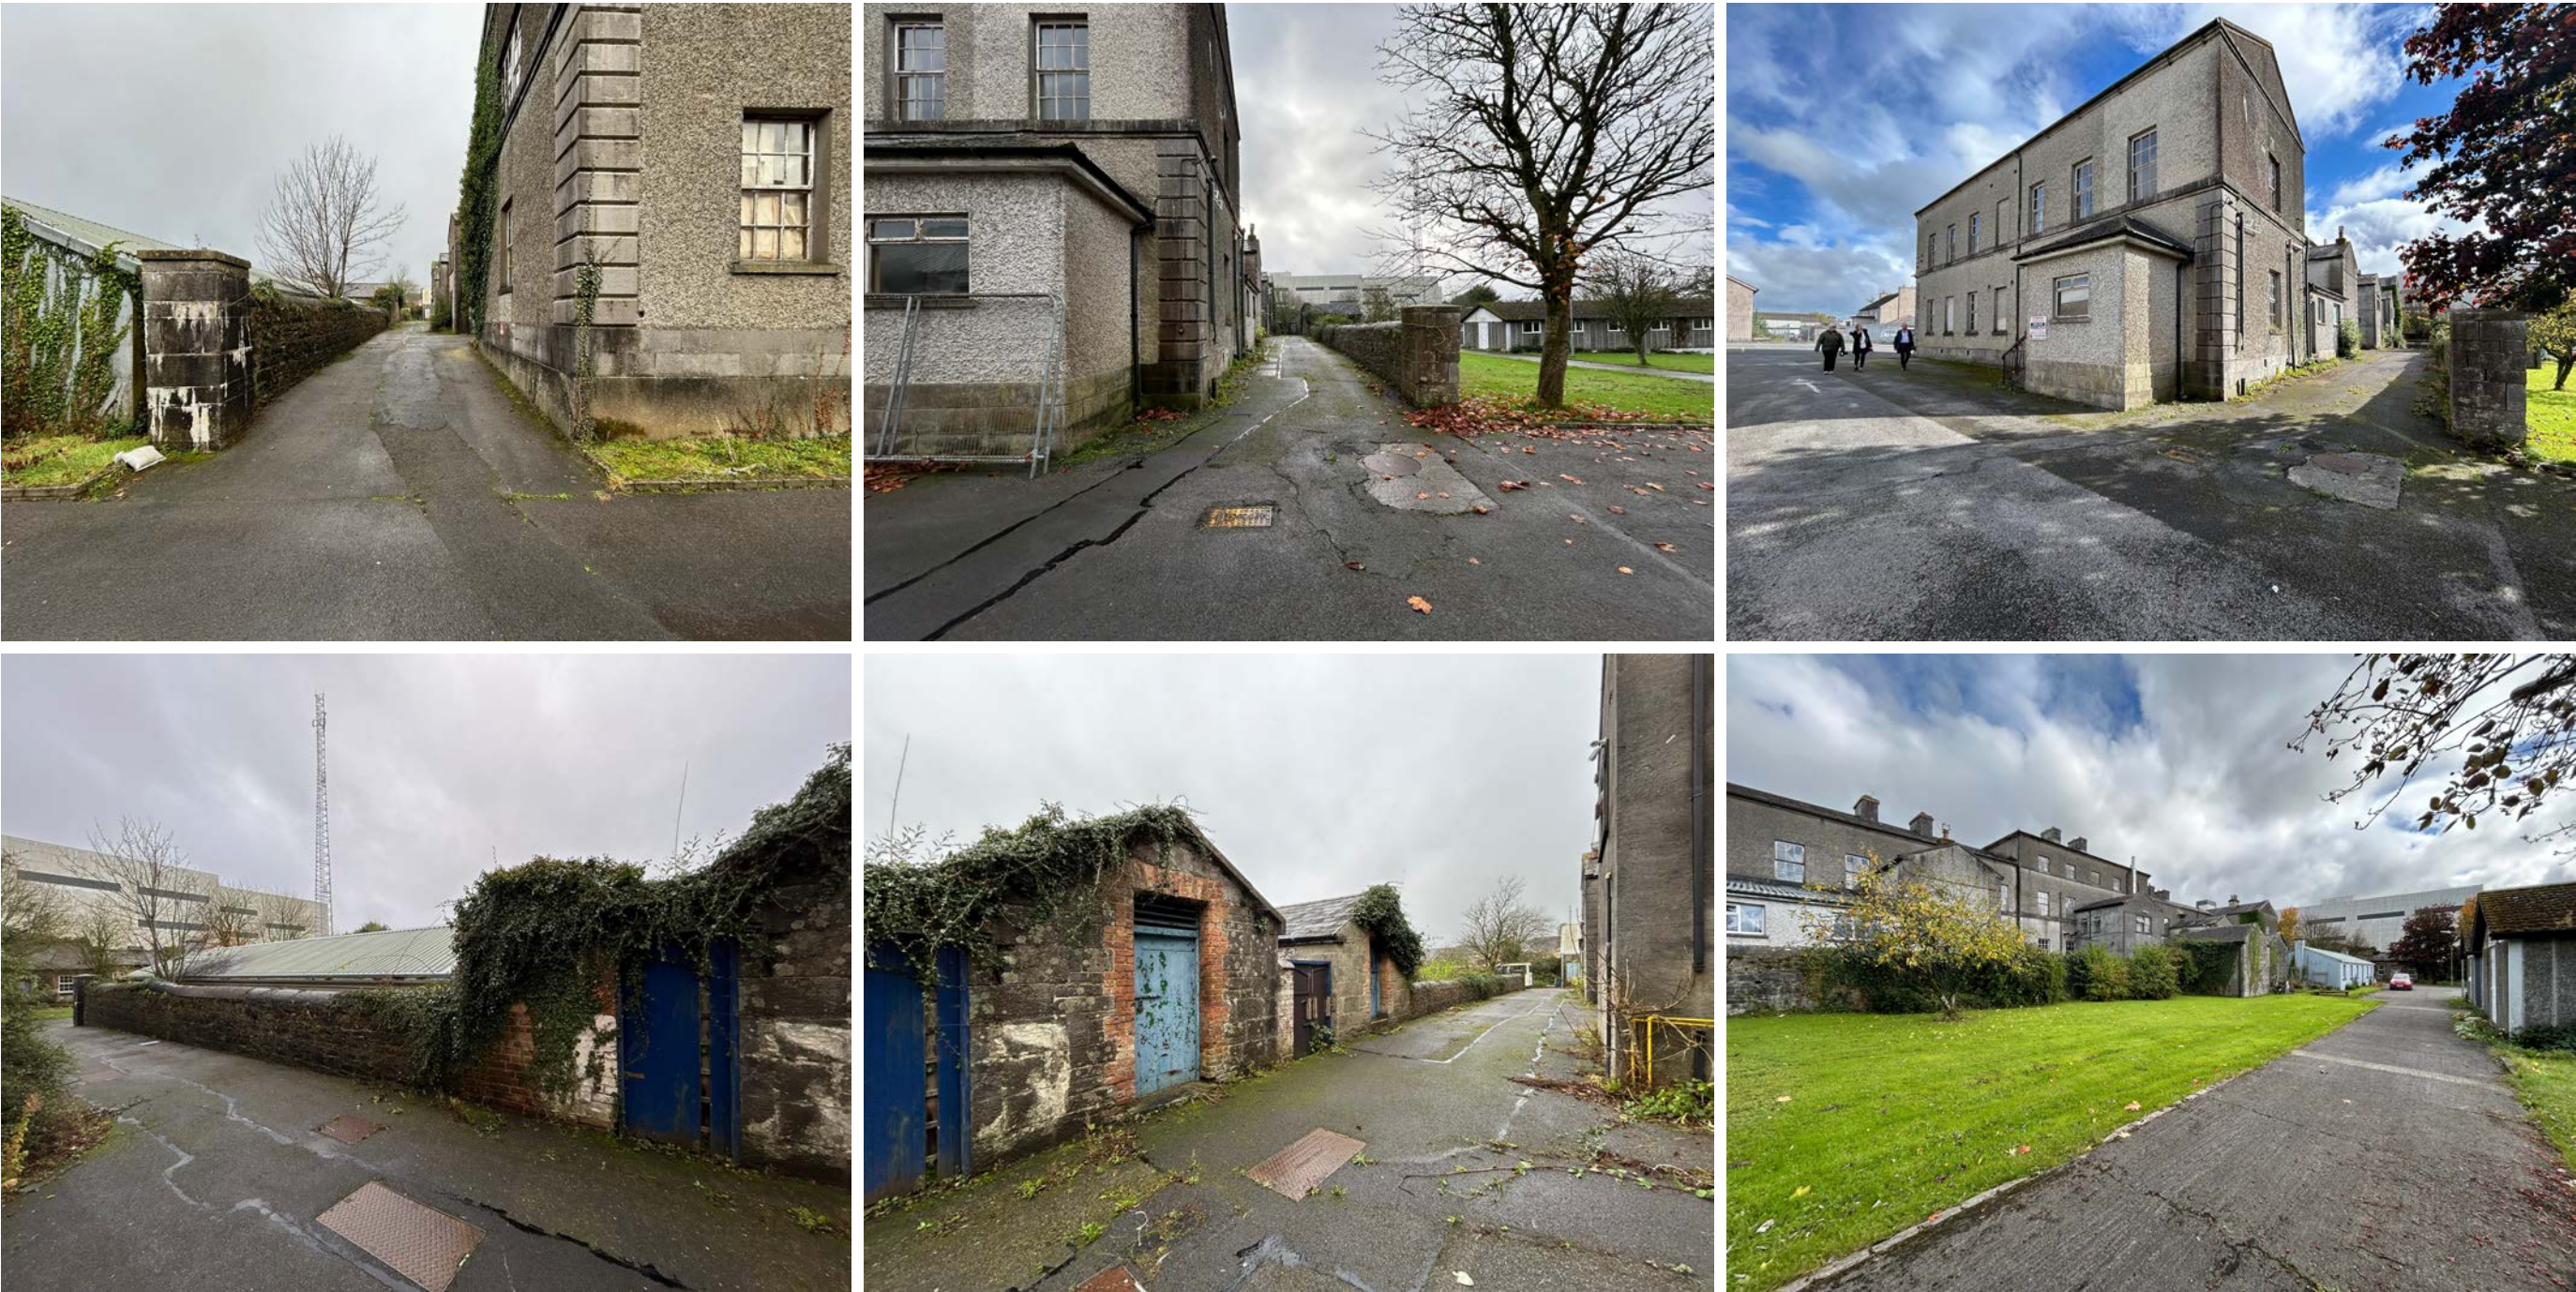
Officers Building _ Western Frontage and Adjacent Lands

Views of the laneway that extends across the length of the west elevation to Officers Building showing stone boundary wall and small stone outbuildings.
To the west of the boundary wall an open area is situated with single storey accommodation buildings of 20th century construction, one of which sits within the application site.

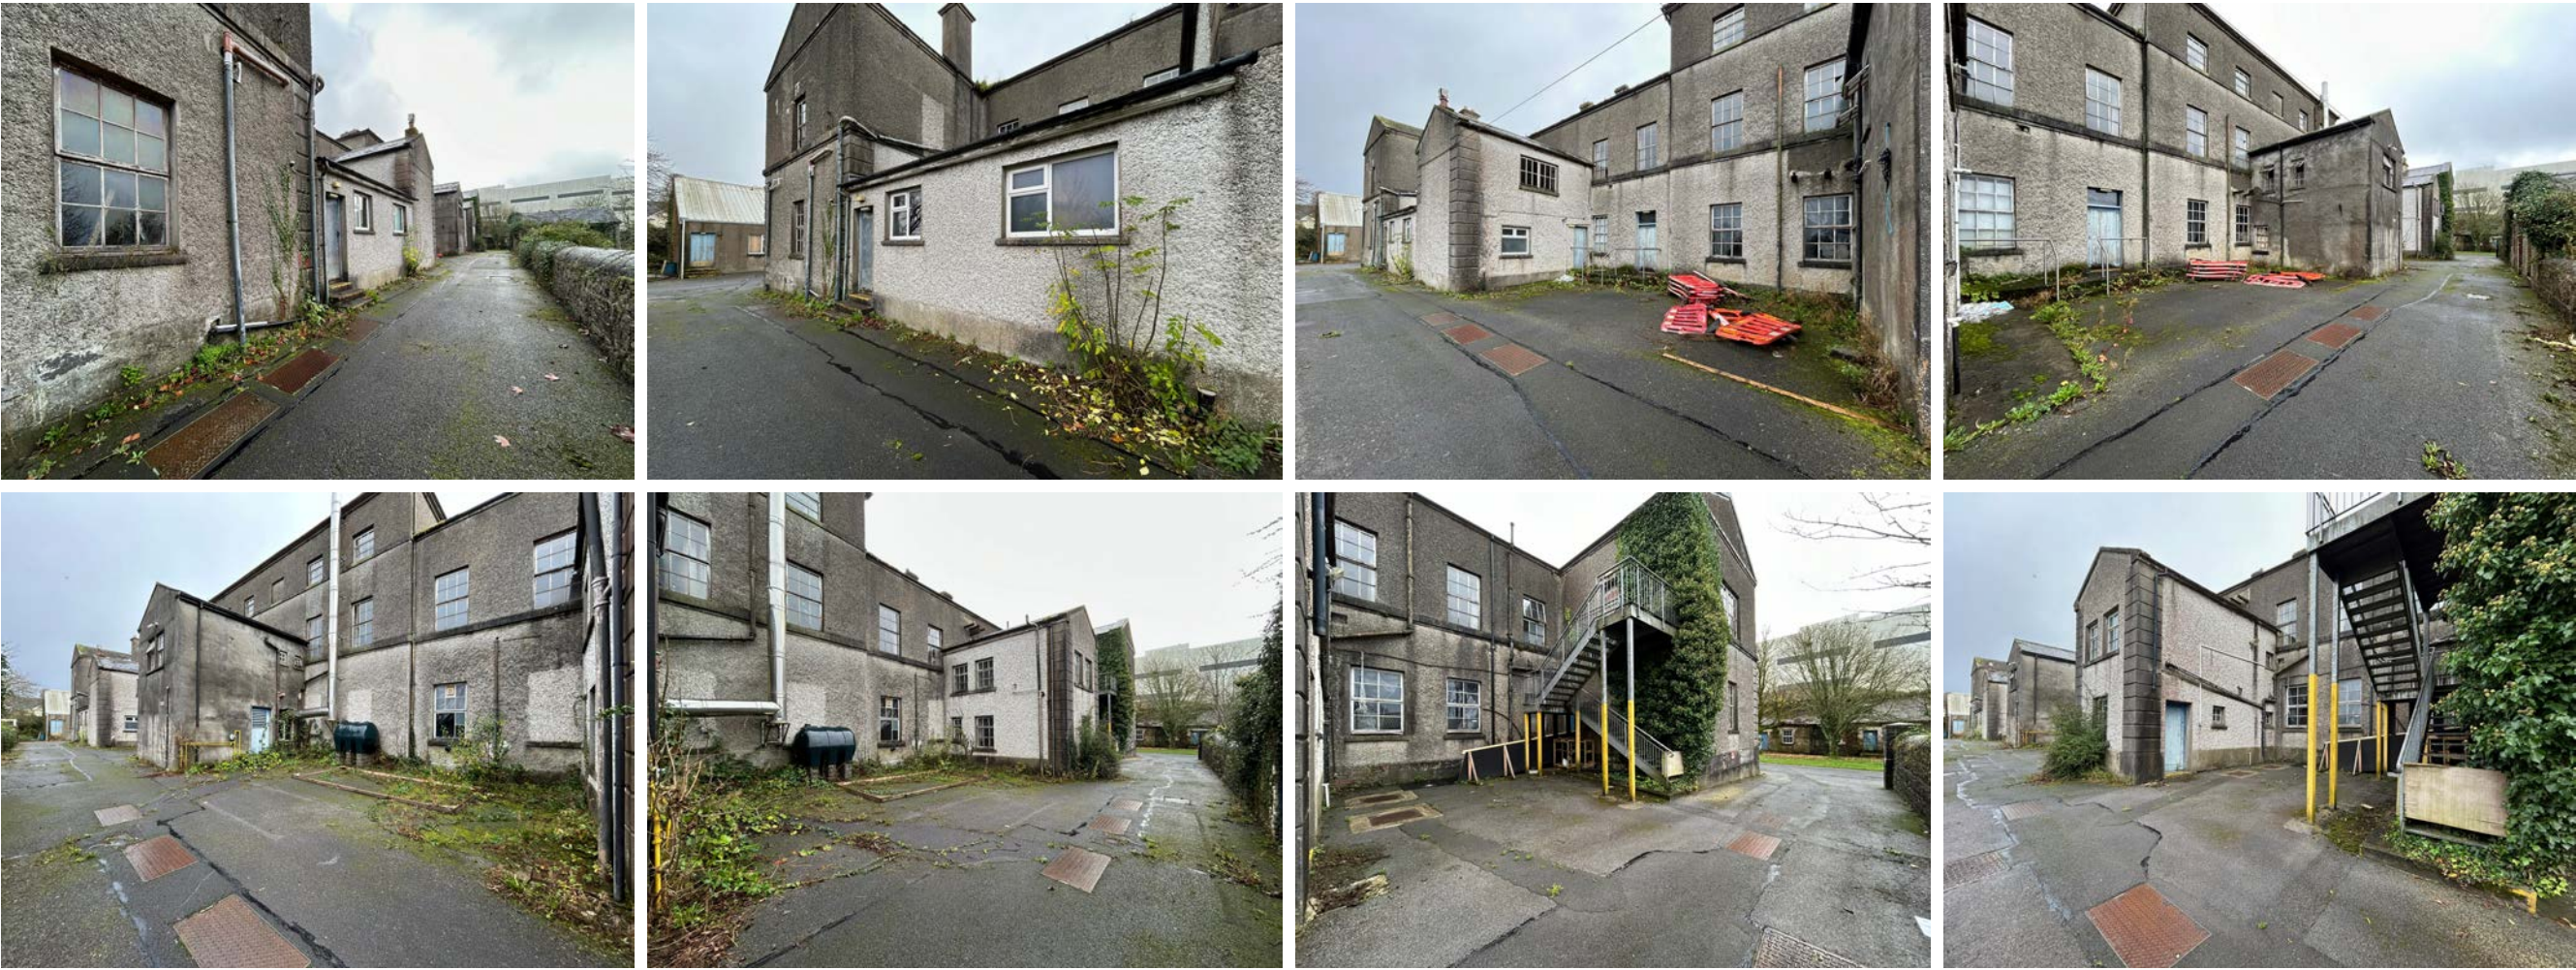
Officers Building _ West Elevation

Oblique views of the Officers Building west elevation from the rear laneway showing projecting two-storey annexe structures. To the northern end the northern wing and northern annexe have been conjoined by the construction of a single storey flat-roofed infill with rear access door and two small windows. A fire escape stair is located adjacent to the southern wing.

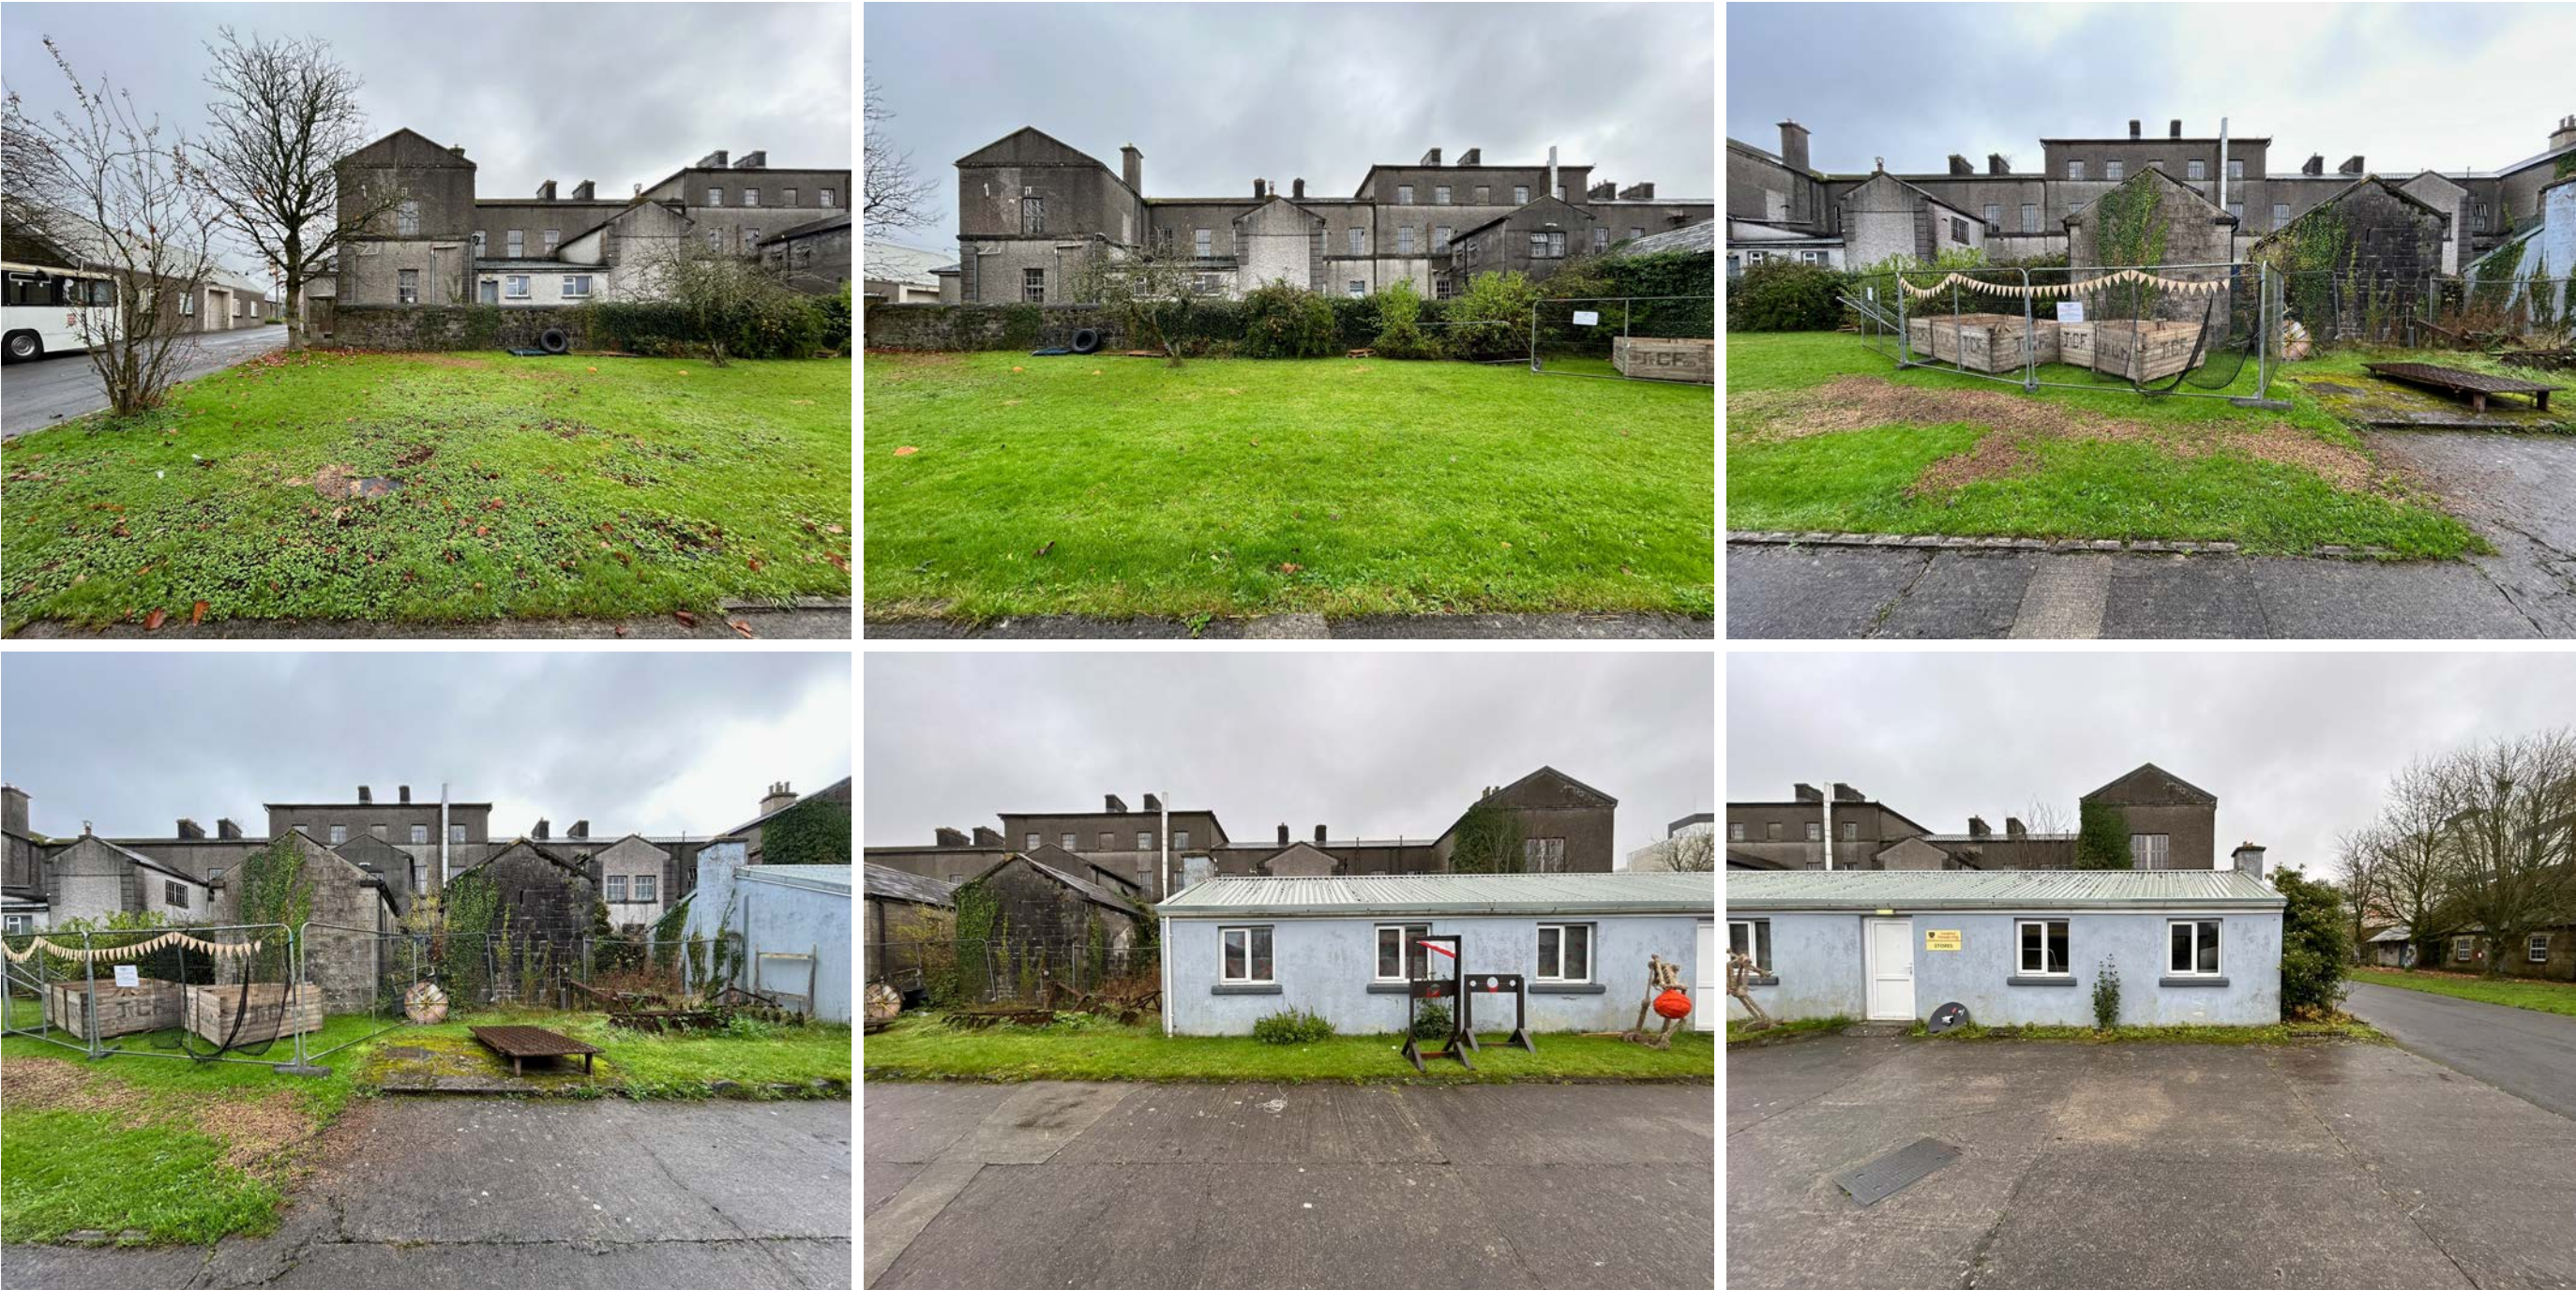
Officers Building _ Western Context

To the west of the Officers Building are extents of open land with two small stone outbuildings and a single storey building. The Officers Building west elevation is partially visible over the roofs of and between these structures.

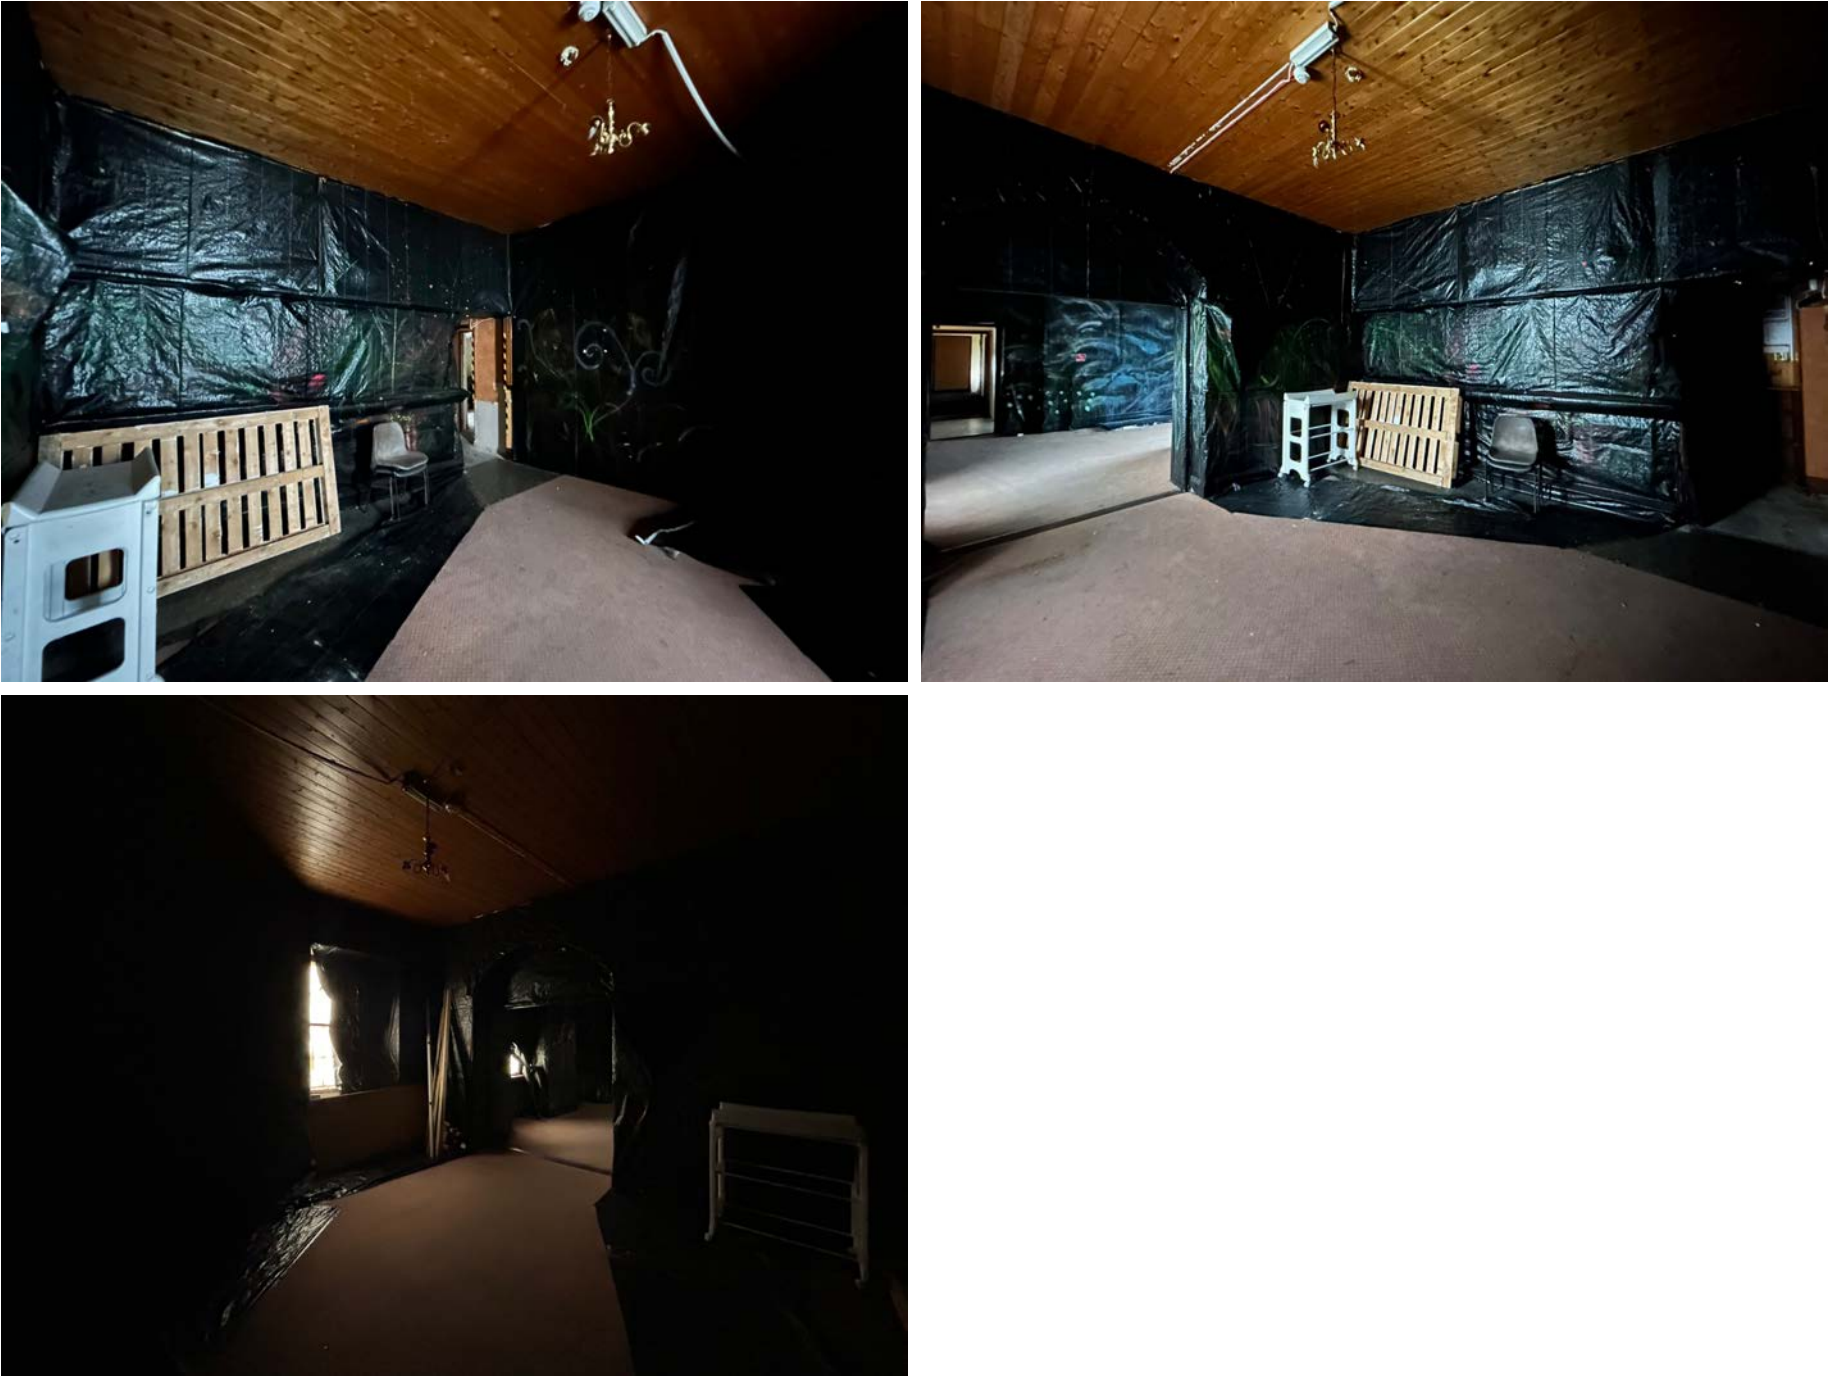
ROOM 00.M.04

Access to Room 00.M.04 is currently restricted as illustrated above. It can be assumed that the condition of the room is similar to other rooms within the building. The room is plain and unadorned in character with no ornamental historic plasterwork or timber features evident, such as cornice-work, dado rails, architraves or roses. The ceiling is lined with timber boards.

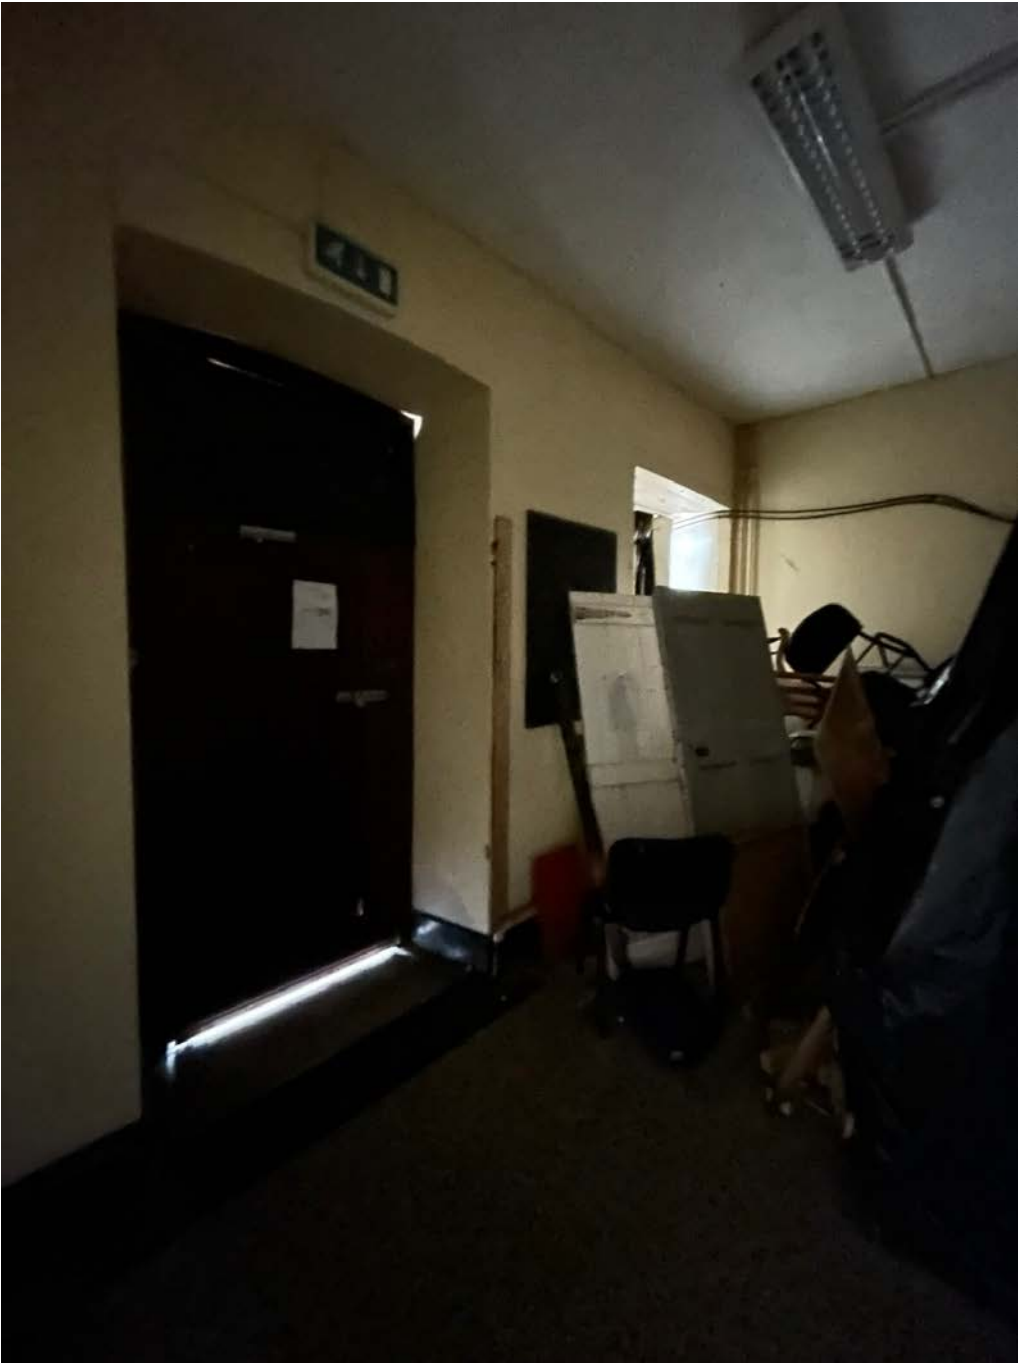
ROOM 00.M.06

Access to Room 00.M.06 is currently restricted as illustrated above. It can be assumed that the condition of the room is similar to other rooms within the building.

The room is plain and unadorned in character with no ornamental historic plasterwork or timber features evident, such as cornice-work, dado rails, architraves or roses. A door opening is noted as located of an original window opening.
