OFFICERS BUILDING
LONGFORD | COUNTY LONGFORD
ARCHITECTURAL HERITAGE IMPACT ASSESSMENT REPORT

ROBIN LEE ARCHITECTURE
JANUARY 2025

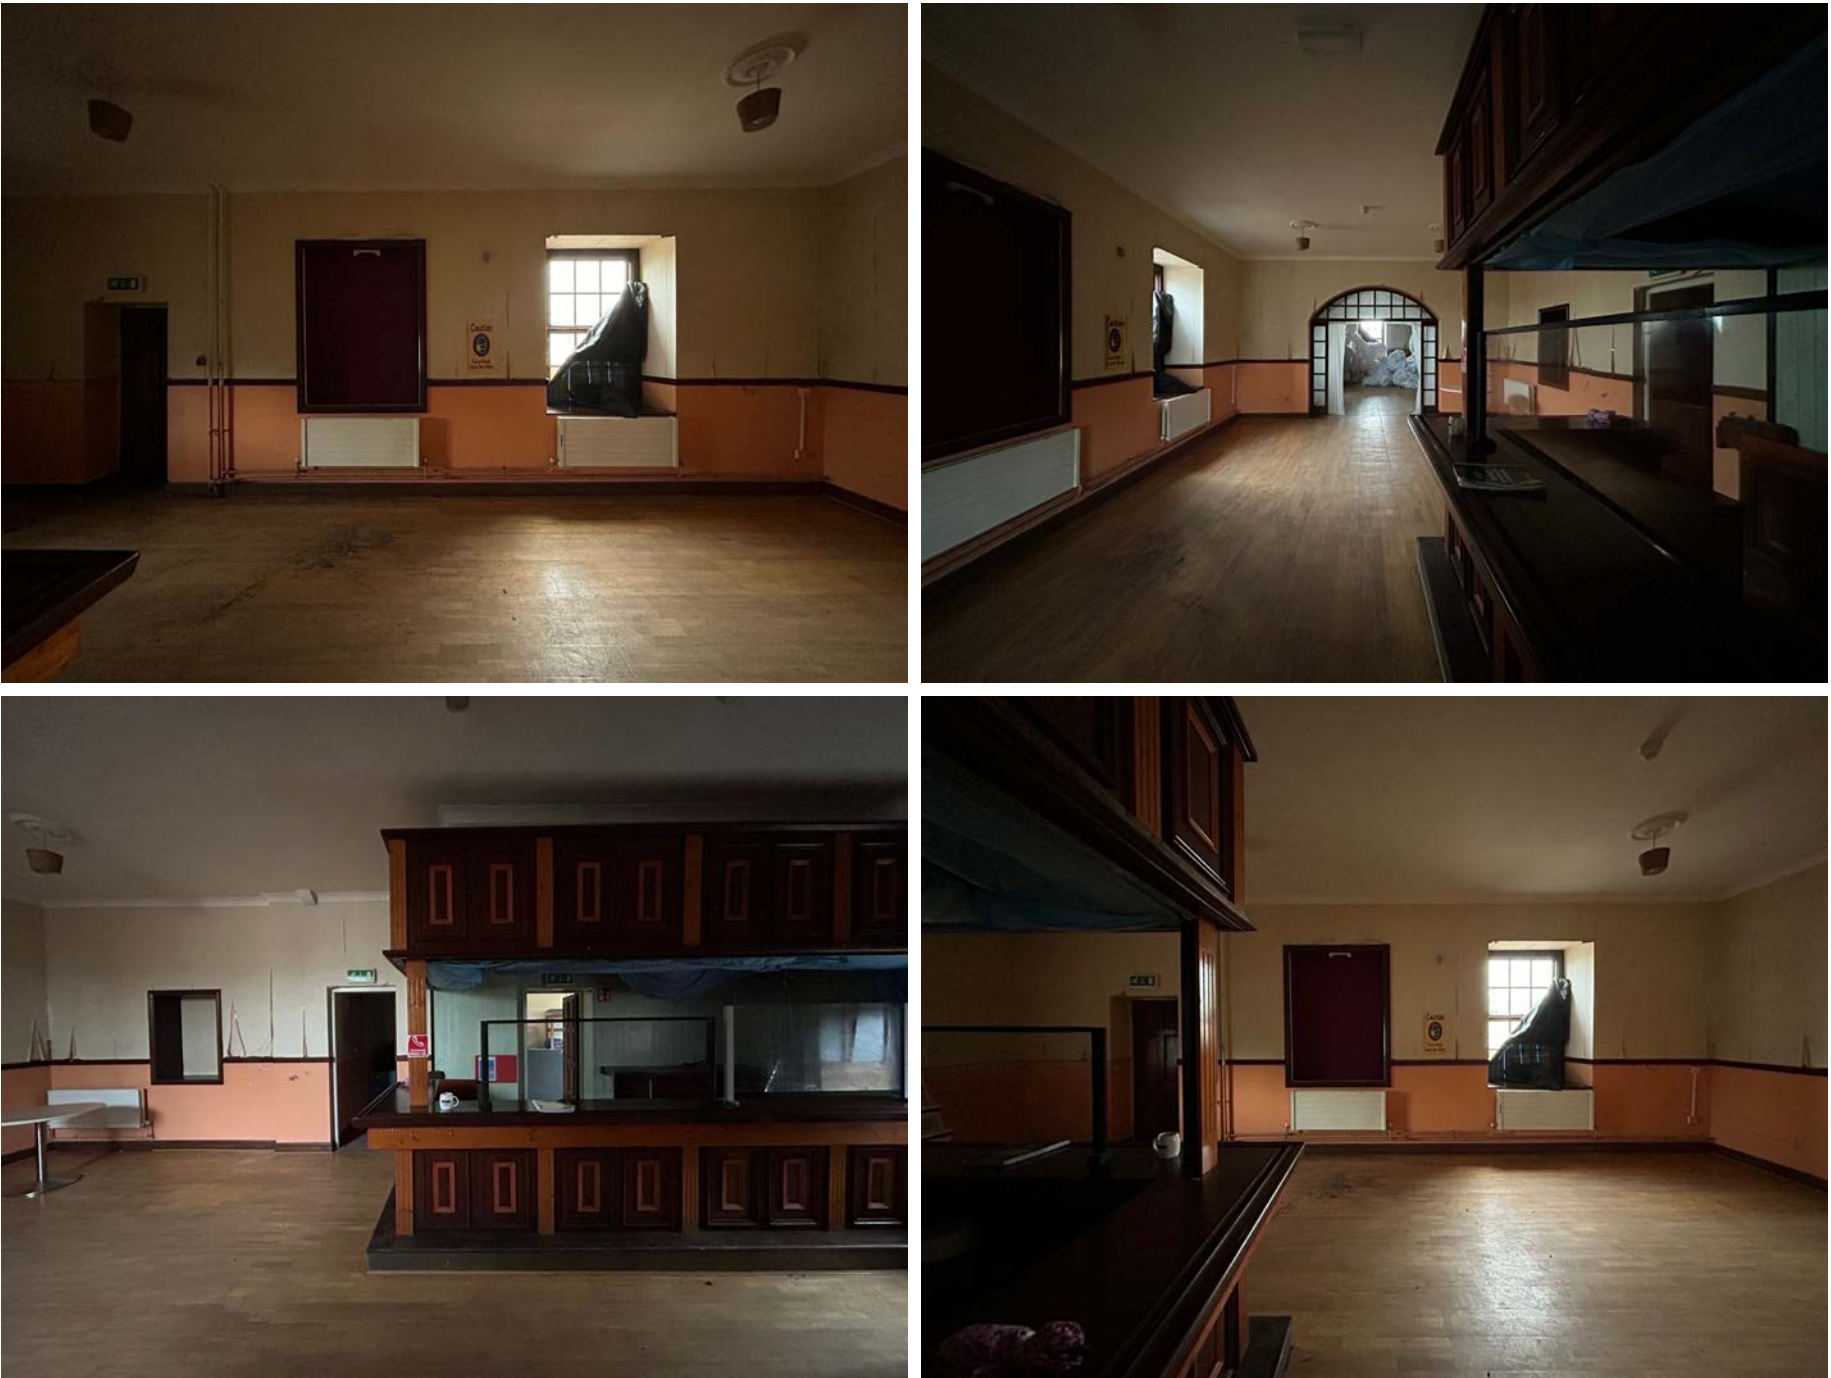
ROOM 00.N.02

Access to Room 00.N.02 is currently restricted as illustrated above. It can be assumed that the condition of the room is similar to other rooms within the building. The room is plain and unadorned in character. Some timber fitted furniture and lining features and plain cornice-work and roses are evident and further research into their origins and date will be carried out.

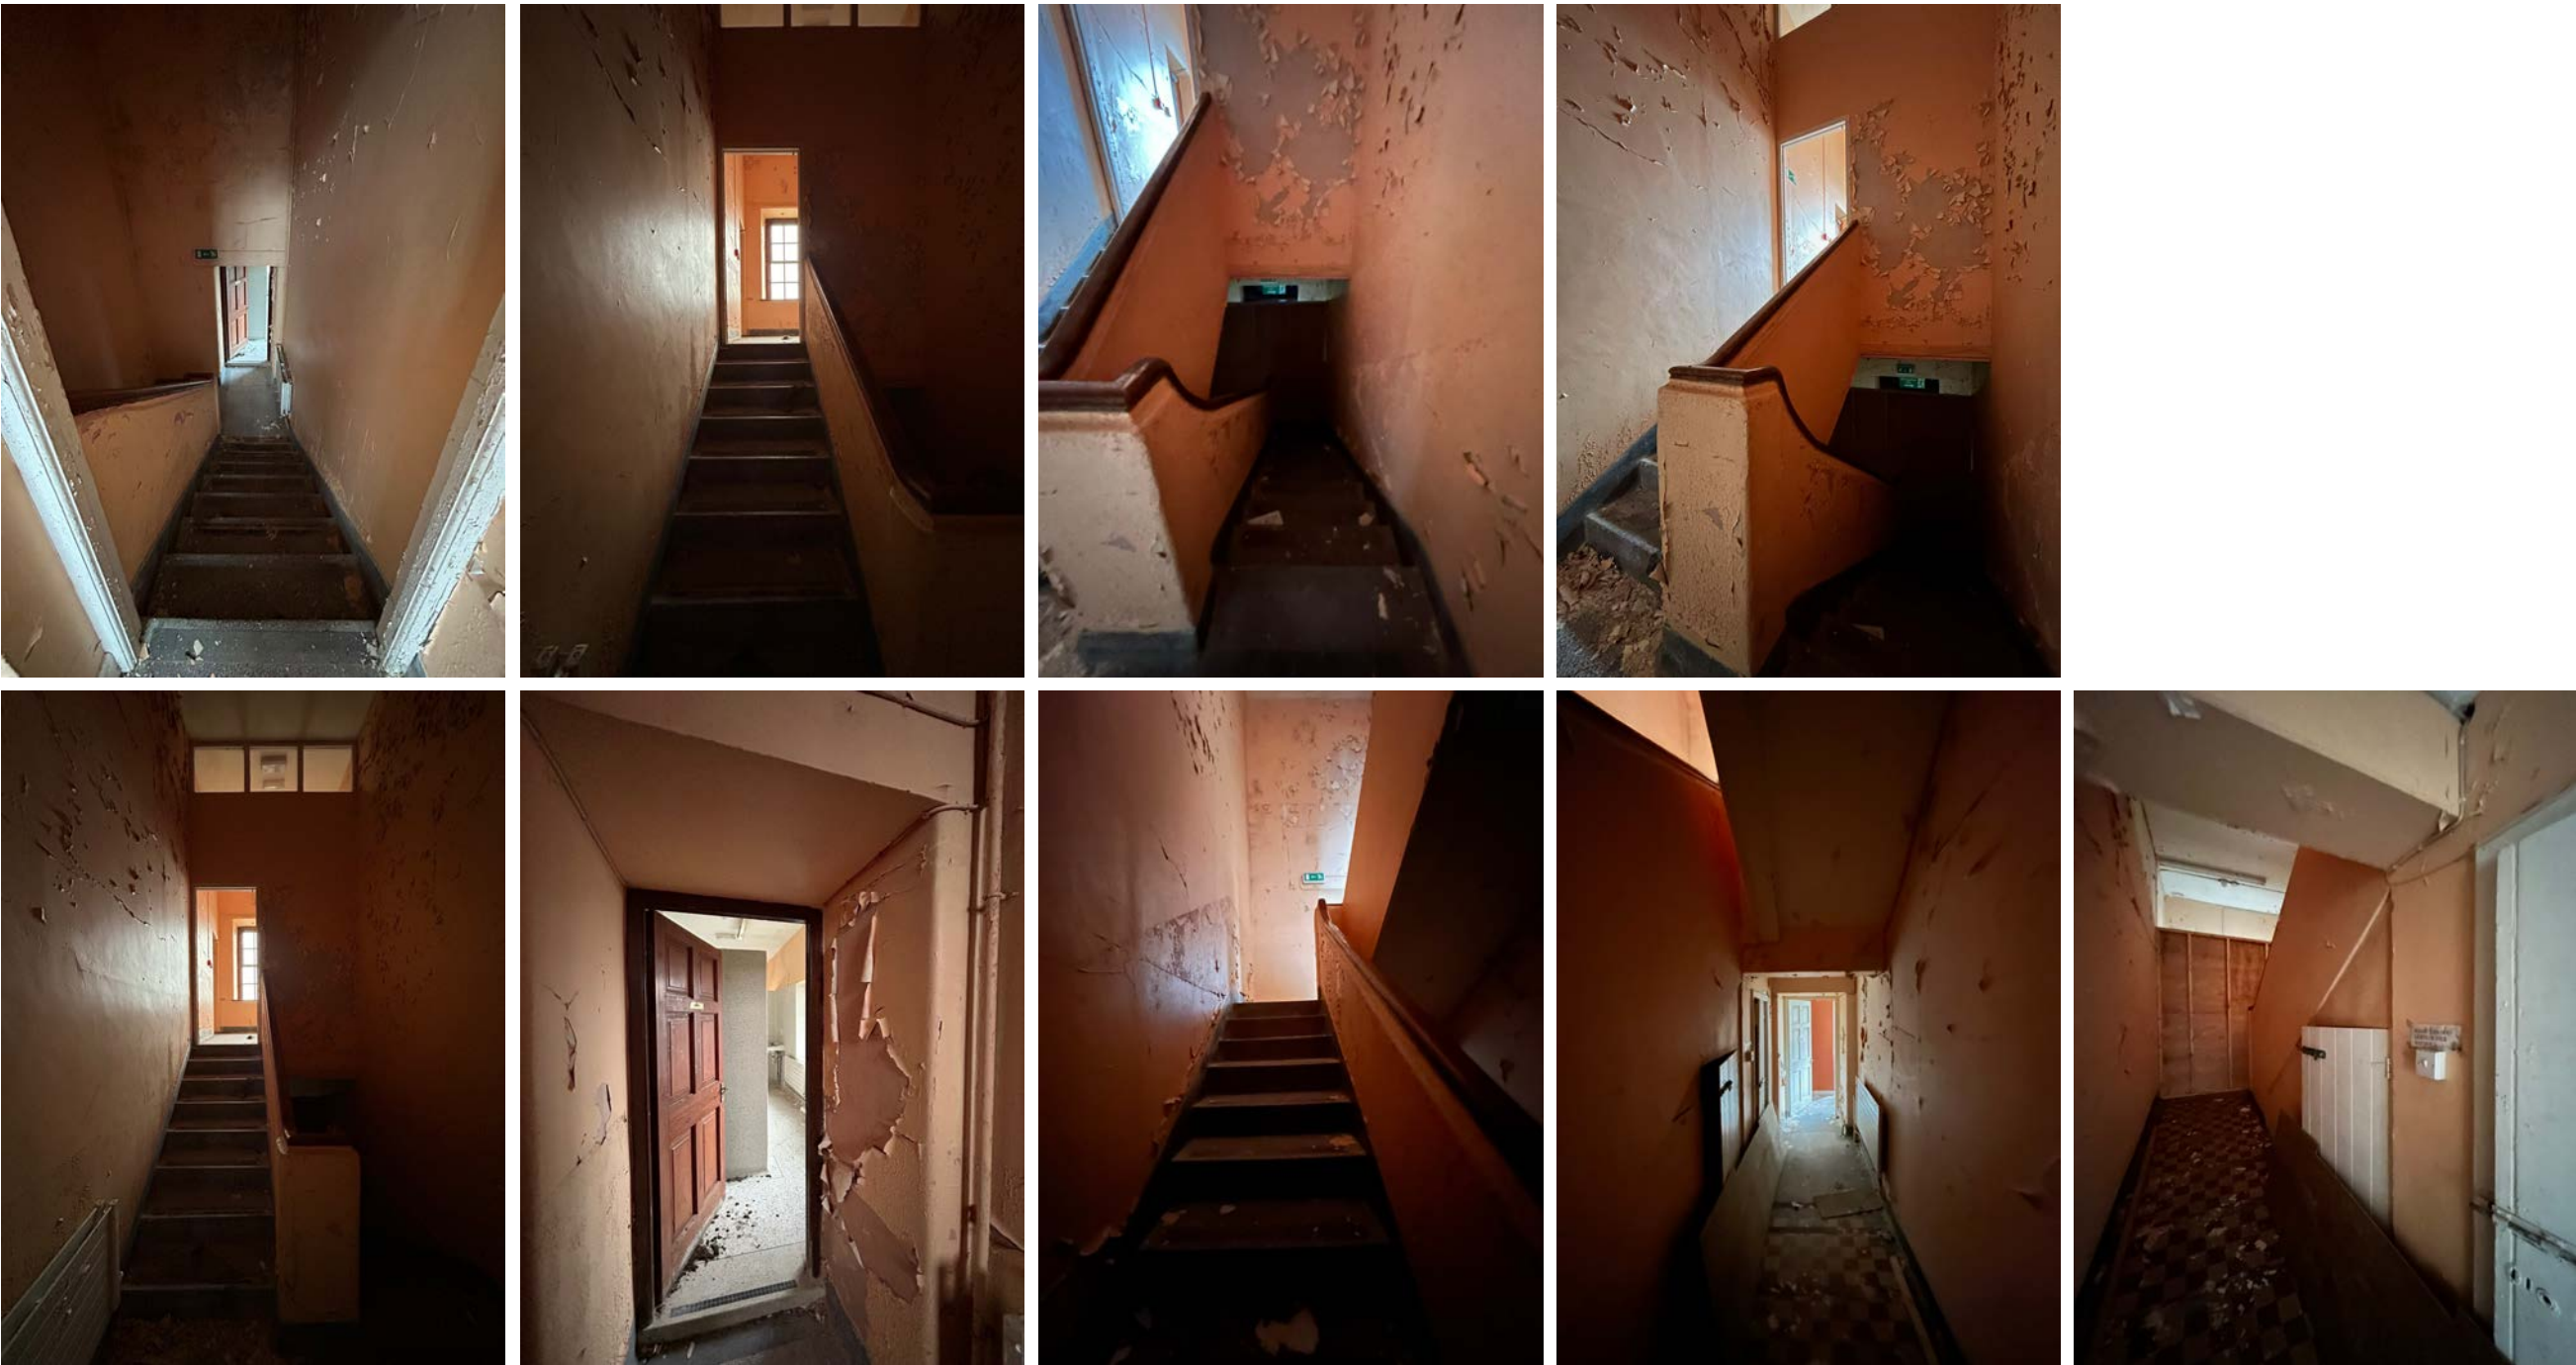
ROOM 01.ST.01

The stairwell is plain and unadorned in character with no ornamental historic plasterwork or timber features evident, such as cornice-work, dado rails, architraves or roses. The stair formed in concrete and terrazzo although of a date later than the original constructed has secondary significance.

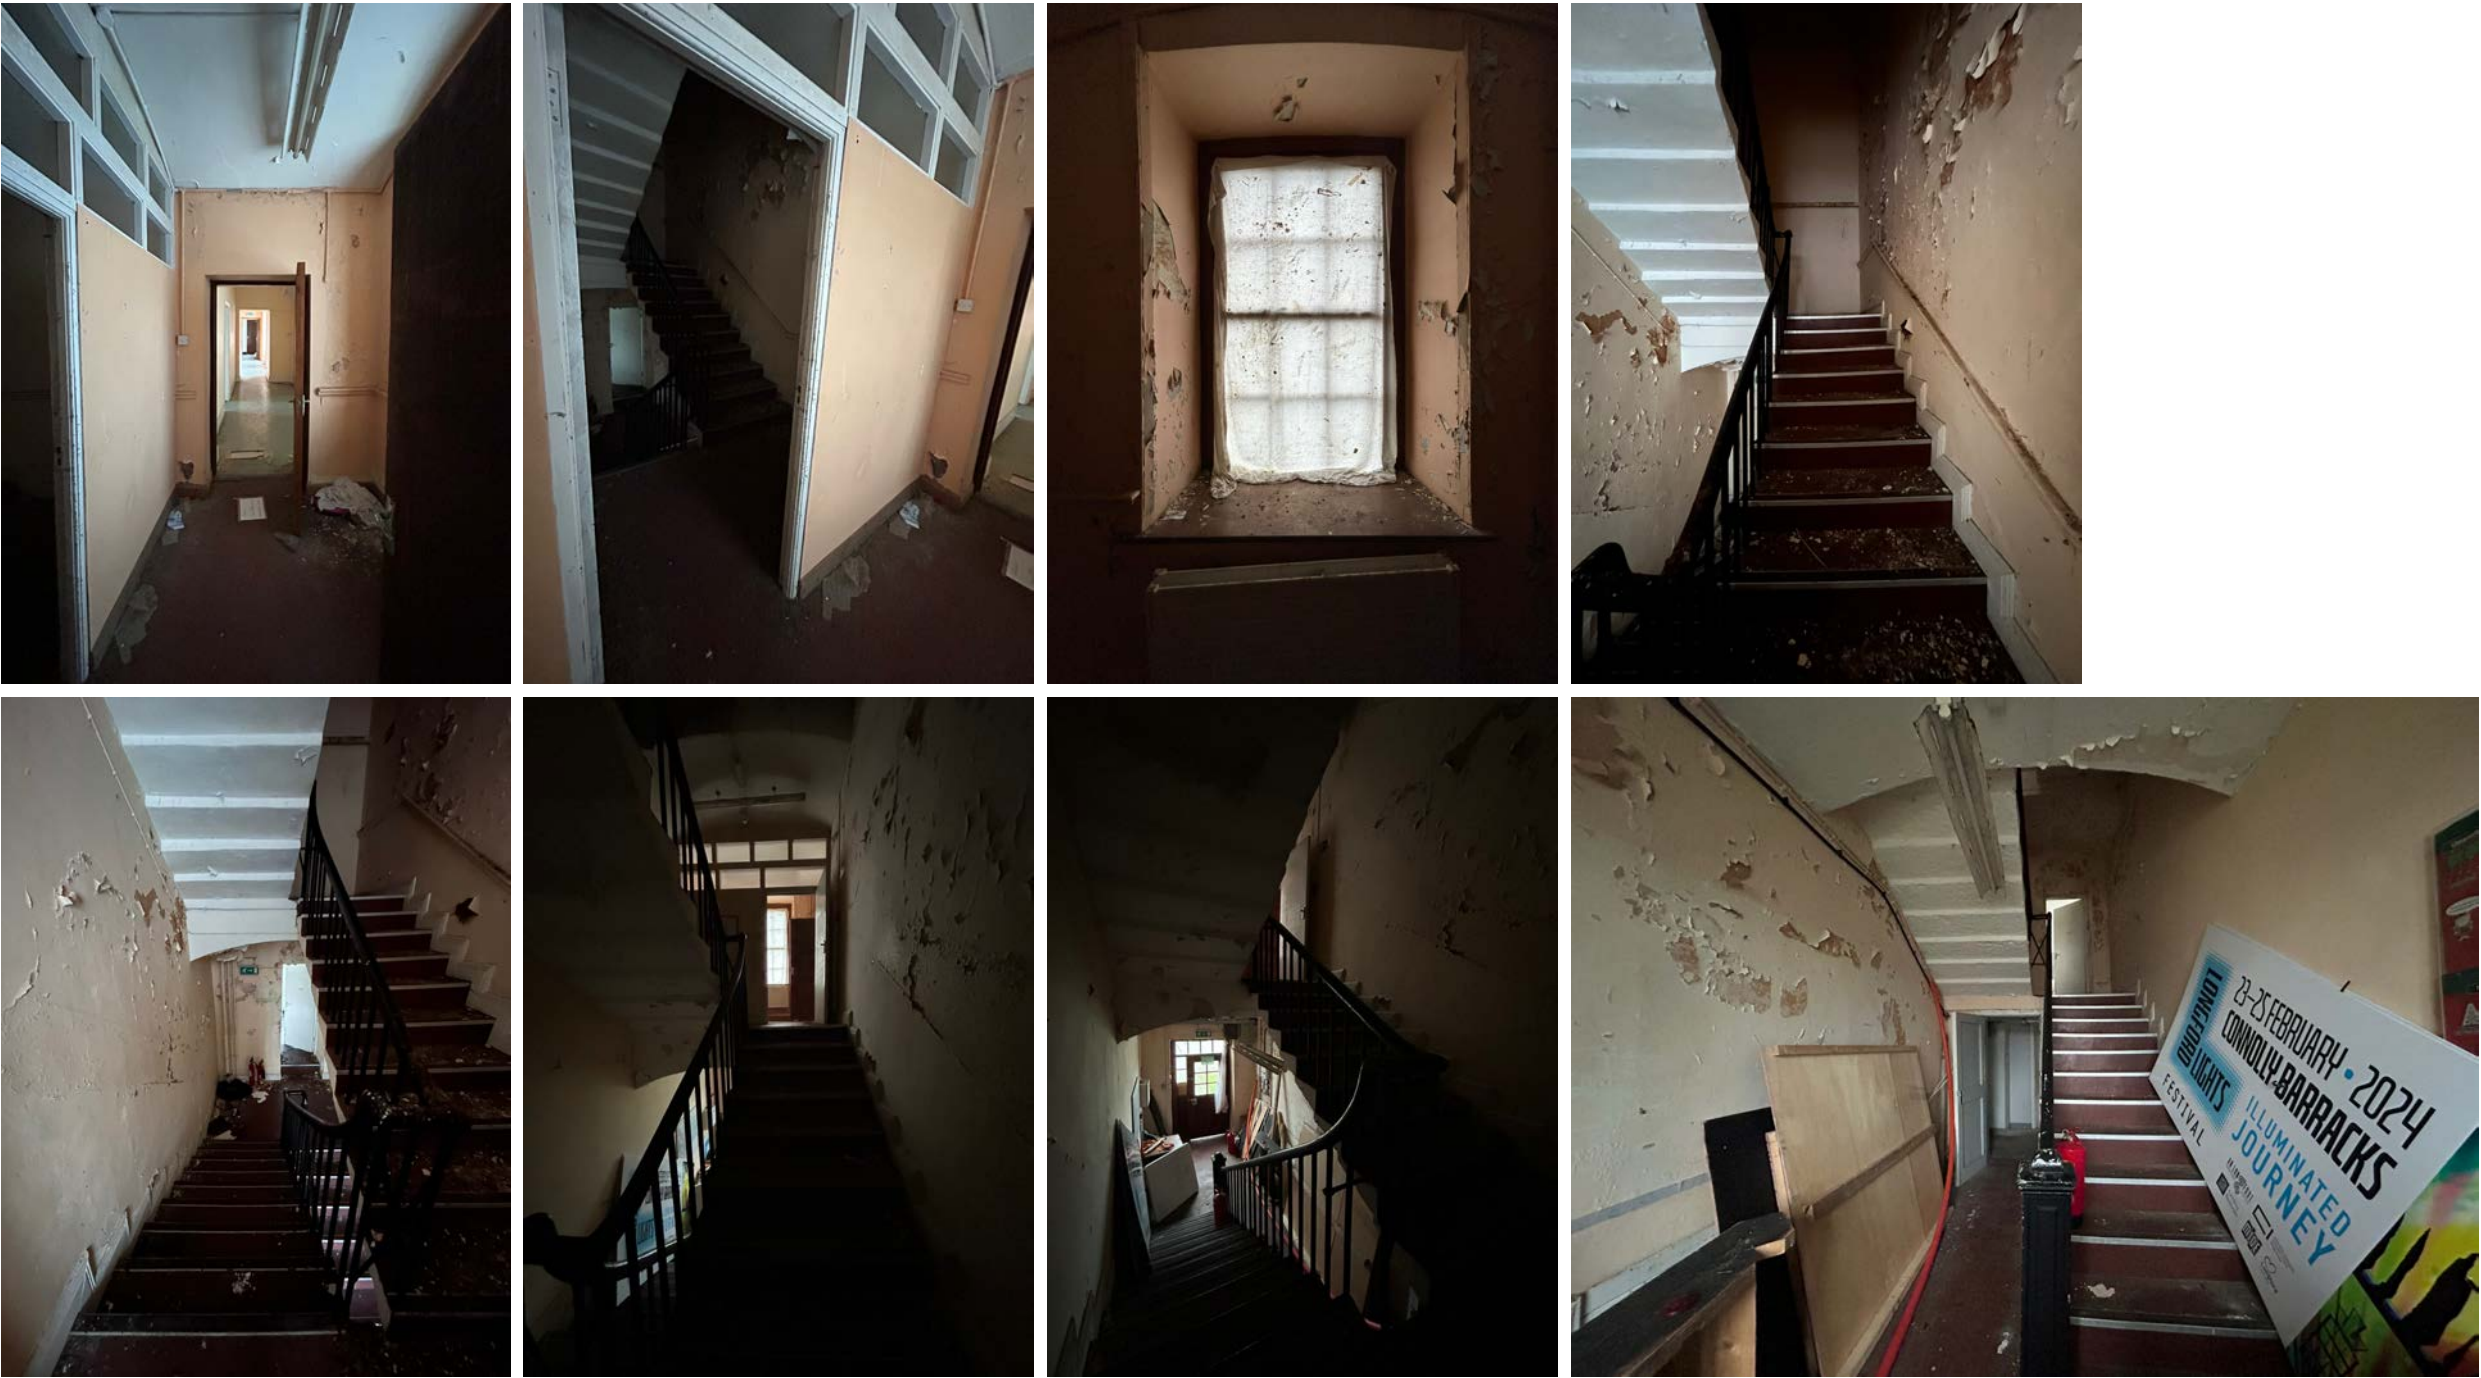
ROOM 01.ST.02

Glazed timber door and fixed surround screen, timber newel post, cast ironwork to stair, cantilevered stone stair and vaulted ceiling are features of significance. Potential historic floor finishes to be uncovered.

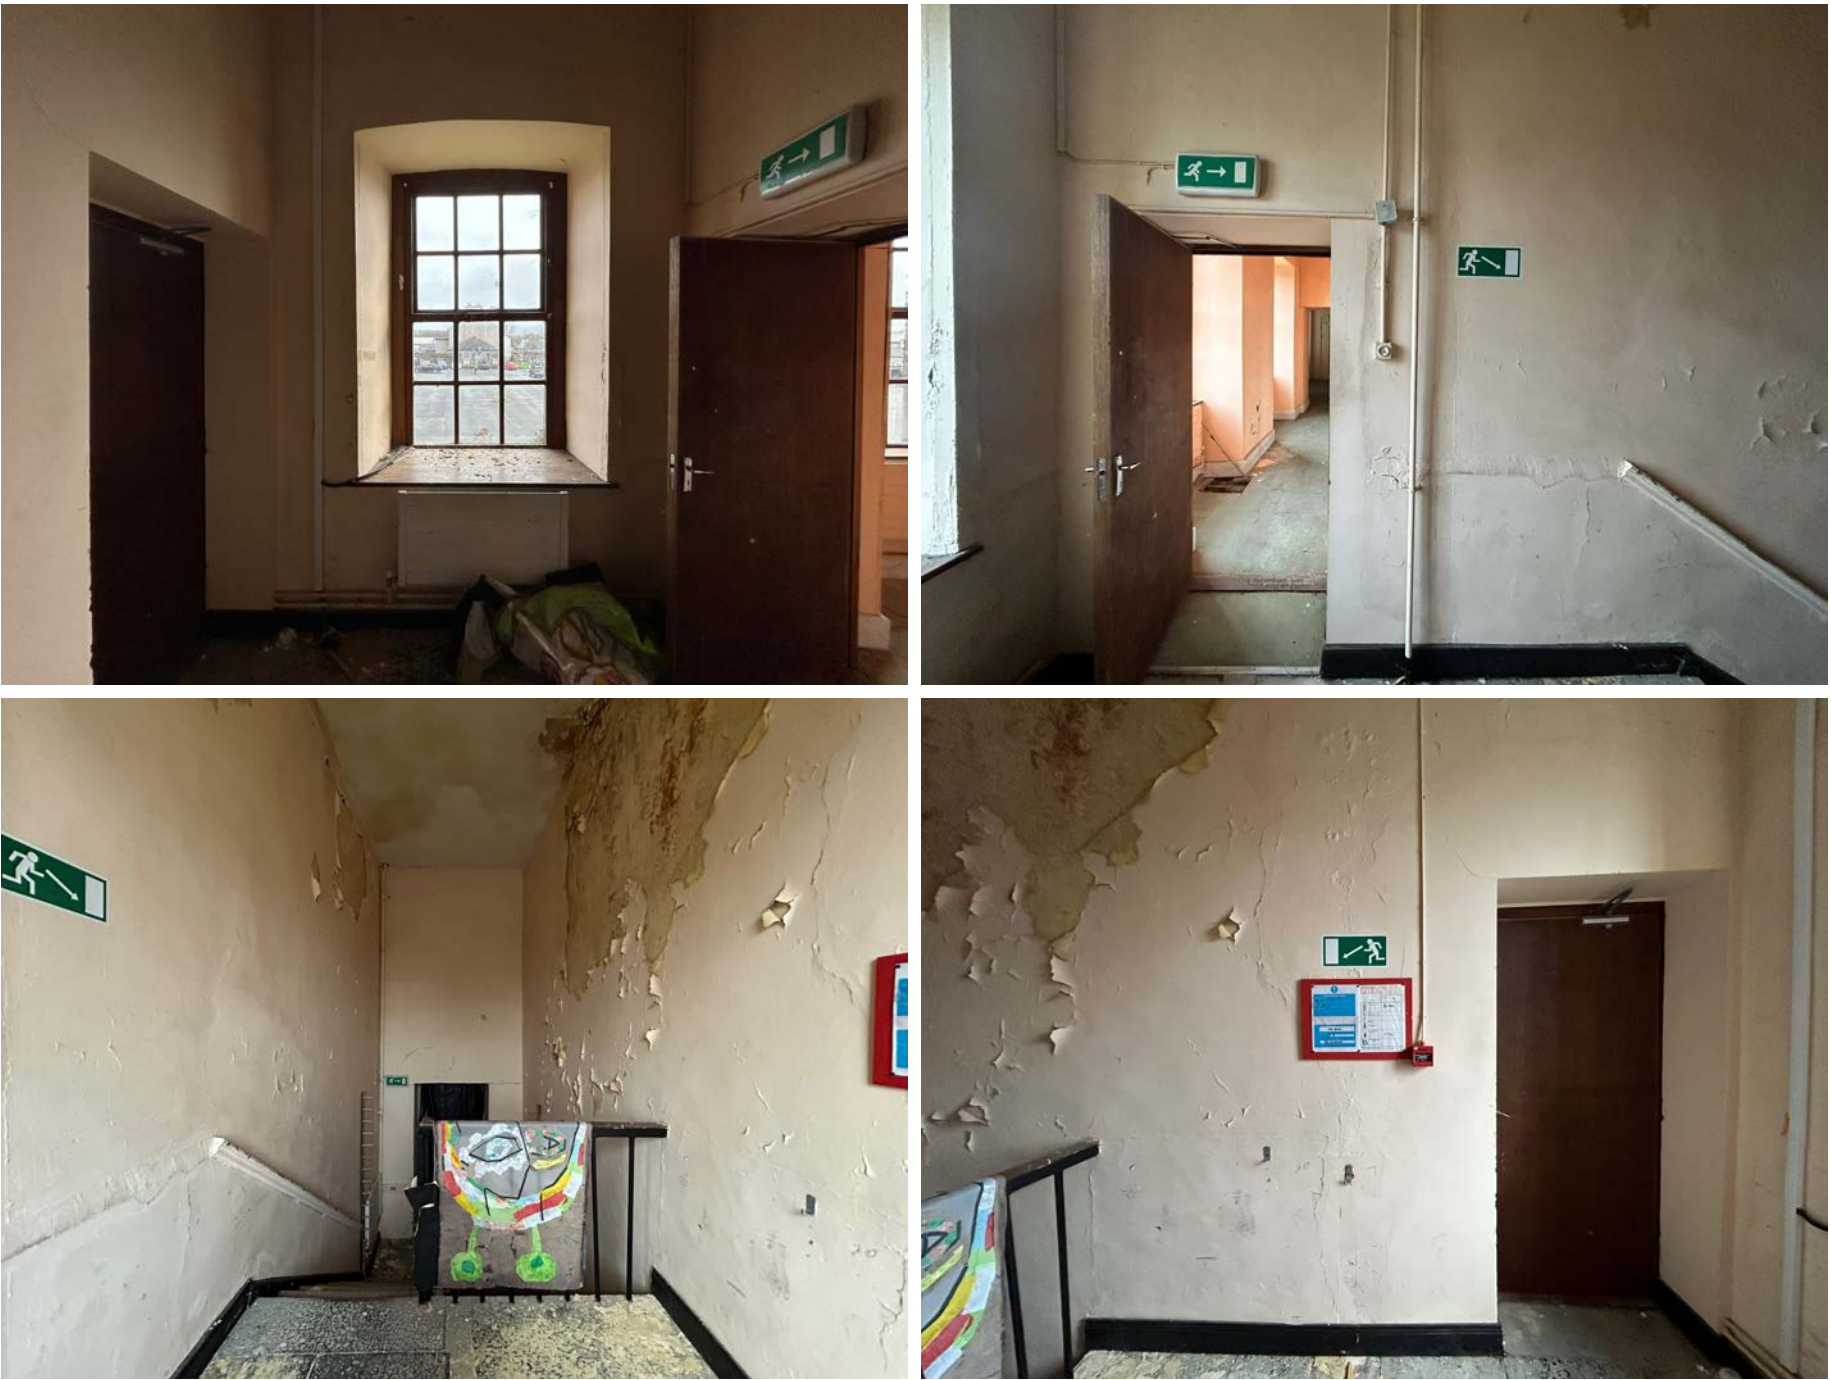
ROOM 01.ST.03

The stairwell landing is plain and unadorned in character with no ornamental historic plasterwork or timber features evident, such as cornice-work, dado rails, architraves or roses. Cast ironwork to stair, timber handrail and cantilevered stone stair are features of significance. Potential historic floor finishes to be uncovered.

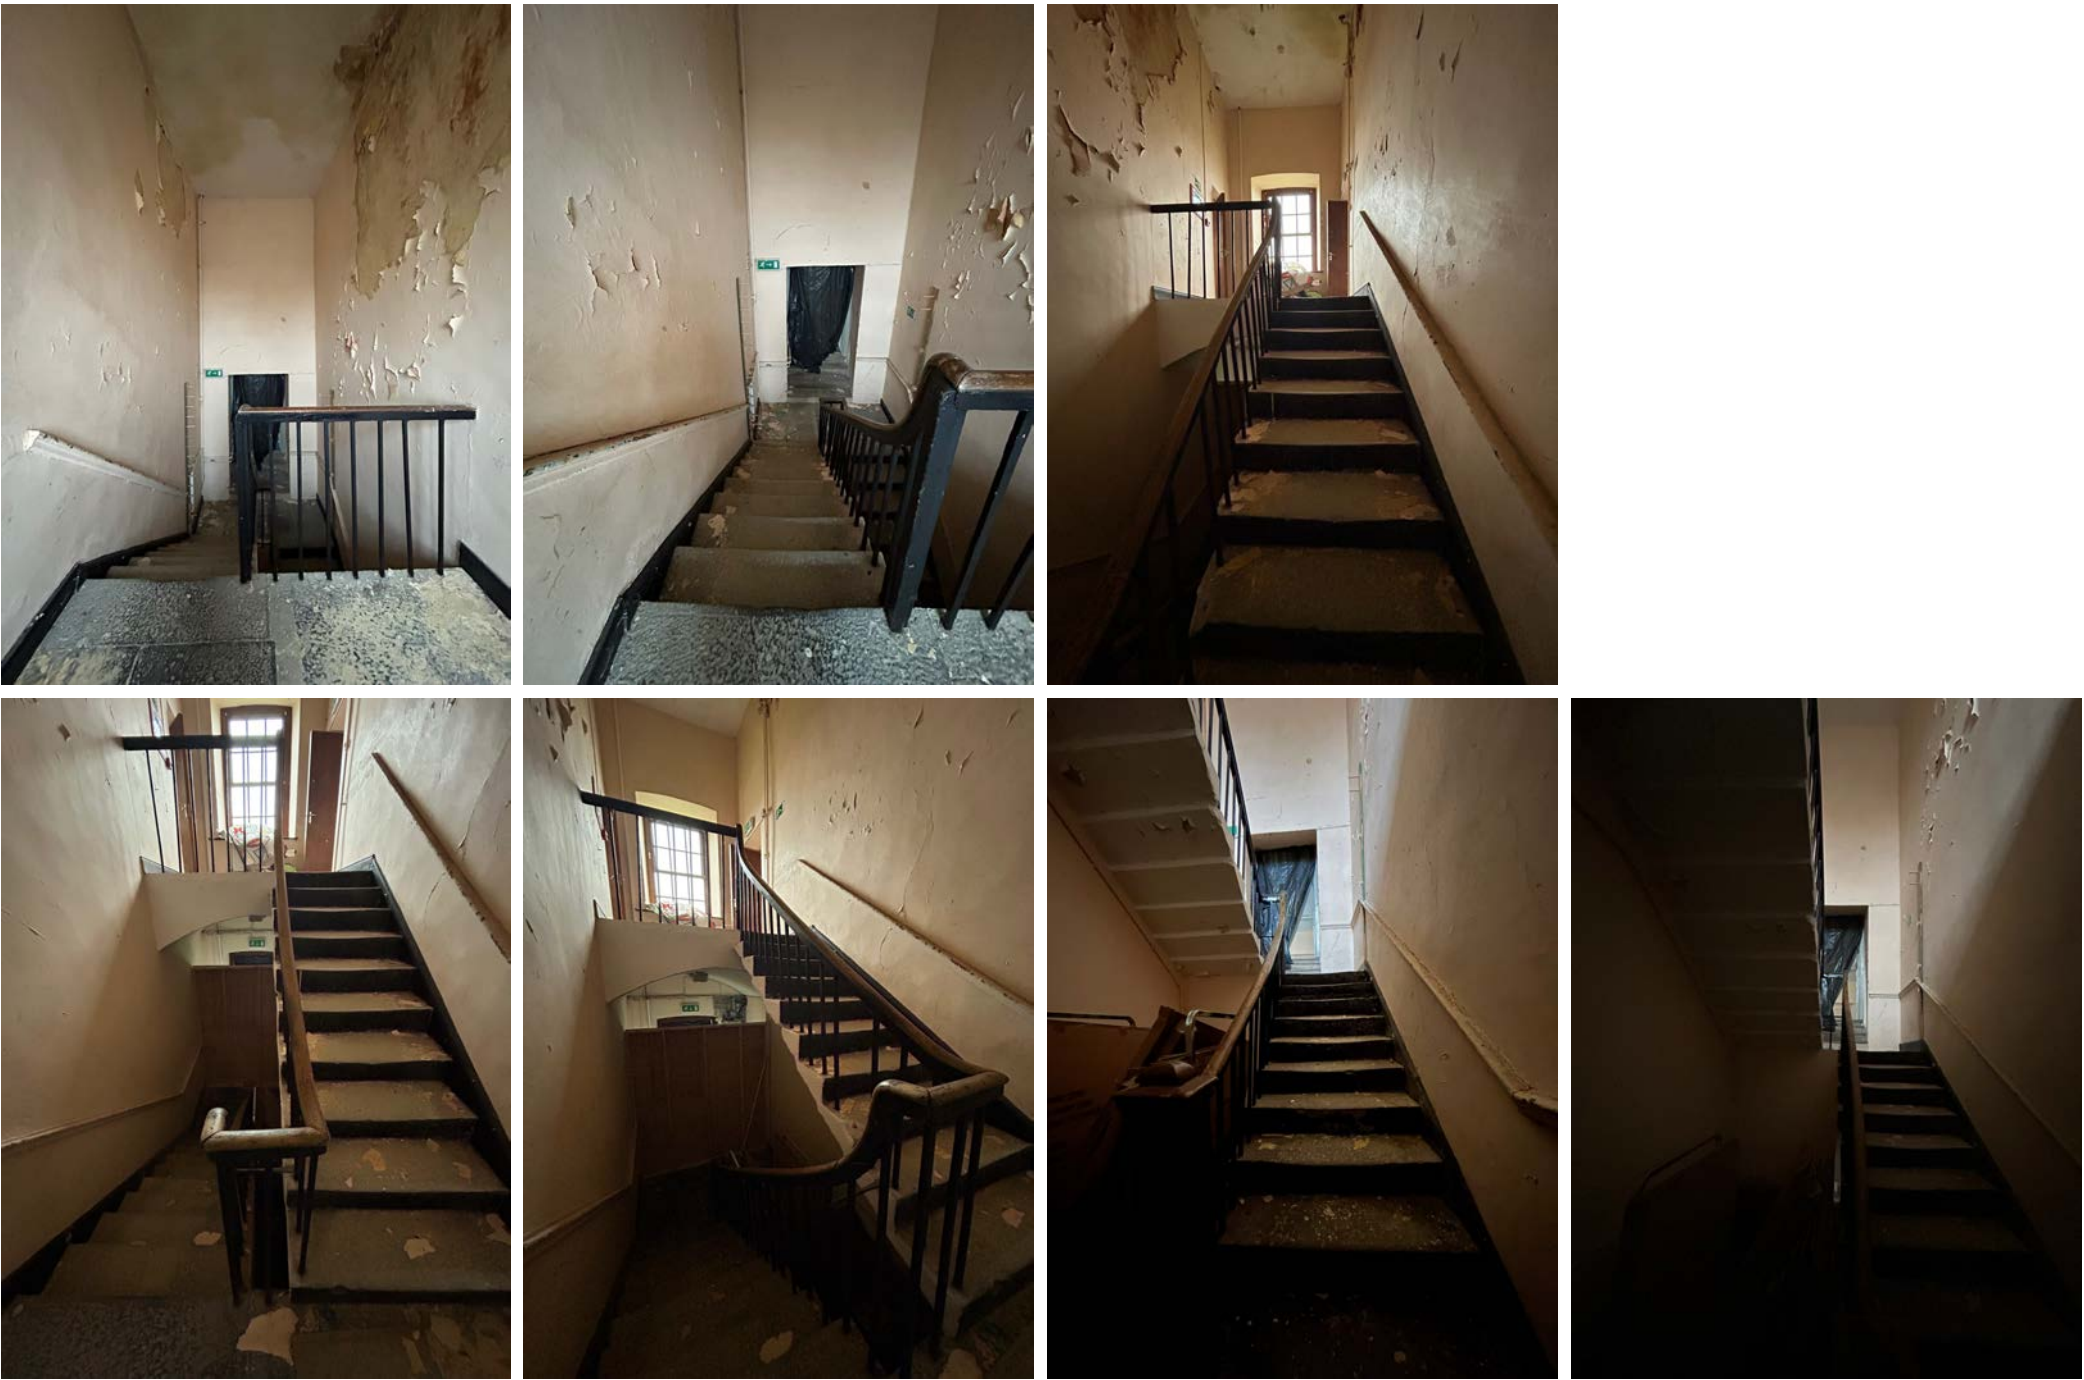
ROOM 01.ST.03

The stairwell is plain and unadorned in character with no ornamental historic plasterwork or timber features evident, such as cornice-work, dado rails, architraves or roses. Cast ironwork to stair, timber handrail, and cantilevered stone stair are features of significance. Potential historic floor finishes to be uncovered.
