# N4 Mullingar to Longford (Roosky) Route Corridor Selection Report Volume II

### Route Corridor Selection Report Volume II

**Report no:** 5049-GD01038-DBR-08-  
RCSR Volume 2 Finalv

**Date:** June 2010

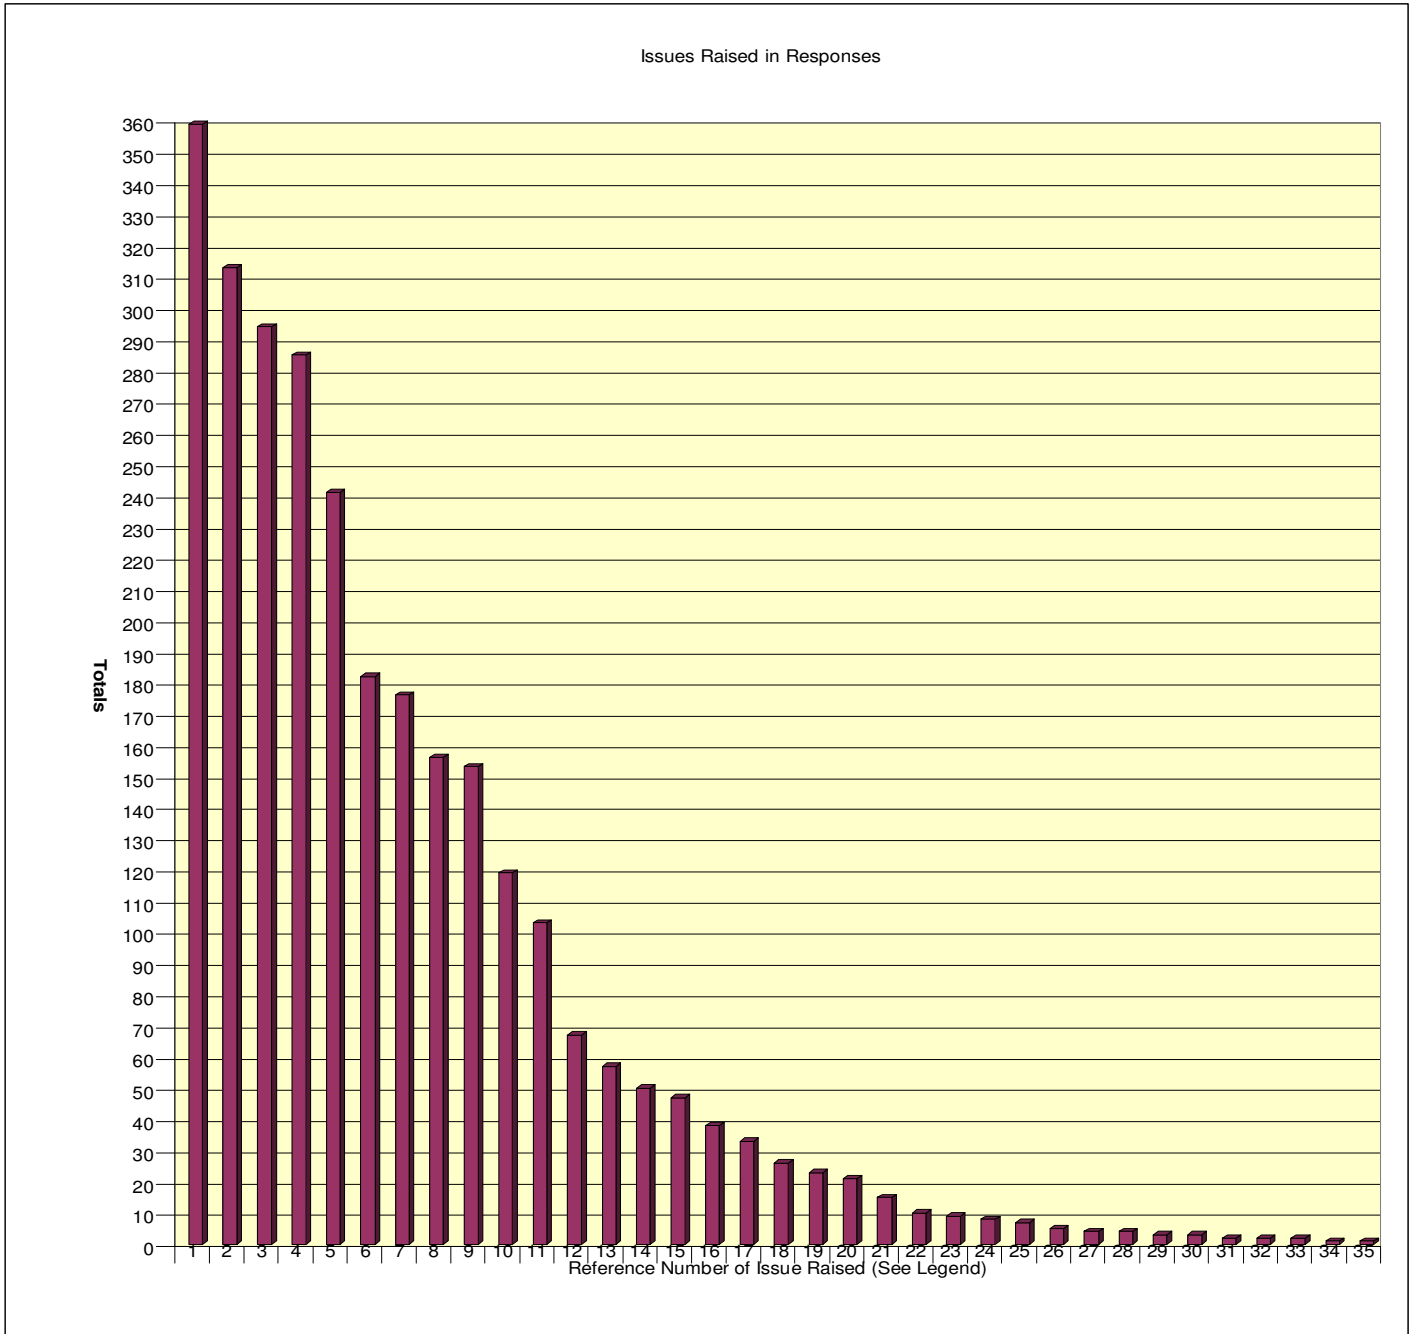
Chart 8.1-5: General Issues Raised

**Legend to Chart 8.1-5:**

1	Noise/Vibration
2	General Environmental Impacts
3	Landscape or Visual Impact
4	Impact on Lough Owel Amenity Area
5	Direct impact or in close proximity to home/property
6	Impact on Ecology (Flora & Fauna)
7	Air Pollution & Dust
8	Risk of Pollution of Watercourses
9	Impacts on Heritage Garden 'Narrow Meadow', Portnashangan, near Lough
10	Effects on Designated Sites e.g. SPA/NHA/SAC
11	Severance Impacts on Property/Farming Activities
12	Public exhibitions: information provided and time allowed for response
13	Impacts on Quality of Life
14	Access to/from Property/Business
15	Safety of nearby residents
16	High Density of traffic
17	Light Pollution
18	No need for scheme
19	Impact on Value of Property
20	Drainage/Flooding
21	Impact on Wildlife
22	Request for more information
23	Archaeological/Heritage features affected
24	No Objection
25	Impact on animal breeding facilities
26	Effects on Fishing Spots
27	Time frame to confirm land required

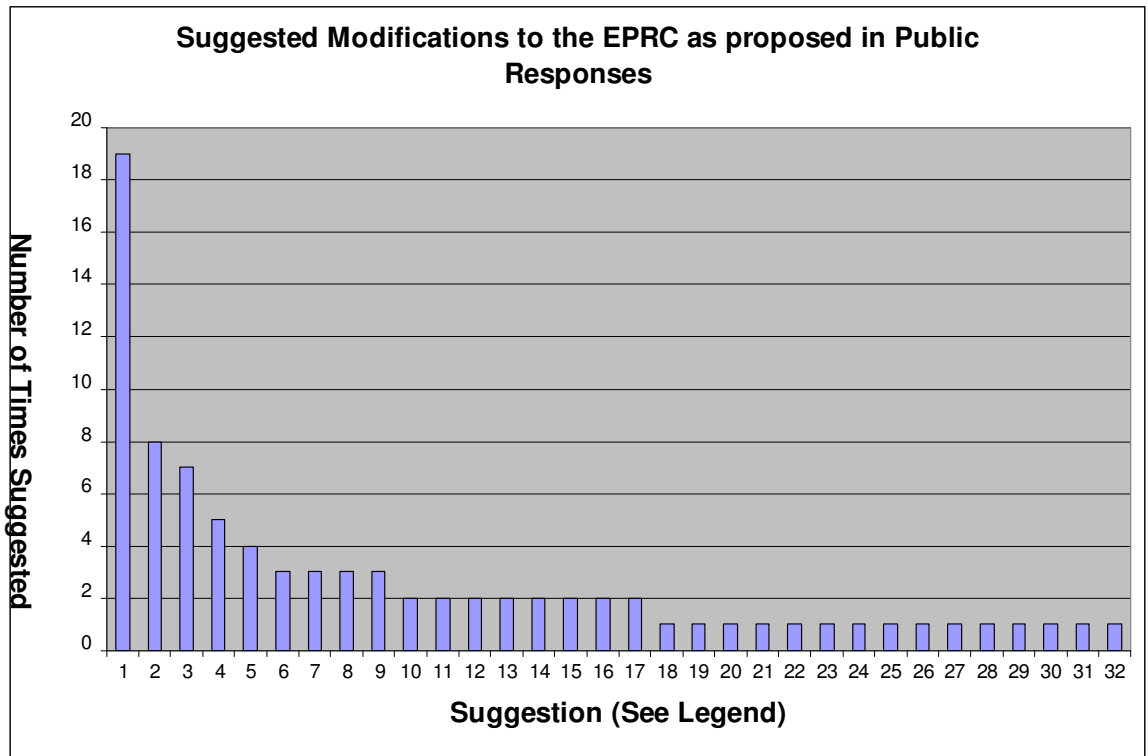
Chart 8.1-6: Suggested Modifications to the EPRC as proposed in Public Responses

**Legend to Chart 8.1-6:**

<b>Ref. No.</b>	<b>Brief Description of Suggestion</b>
1	Widen existing N4
2	Move R194 junction
3	Route South of Kilsallagh Bog/through Derrydoon
4	Route South of Longford Town
5	Go further north at Shantum
6	Move south towards Black River, east of Rathowen
7	North of existing N4 between Bunbrosna and Ballynafid (Kilpatrick)
8	Parallel to railway line at Portnashangan
9	Relocate side road bridge nearer where old N4 meets new N4 at Ballinagall
10	Extend side road on south side at Portnashangan, to link up with old road into Mullingar
11	Green Route (Option 3)
12	Move further north at Joanstown, east of Rathowen
13	Move R194 junction to other side
14	North of Edgeworthstown
15	Provide junction/link to Ballinalack & Rathowen
16	Route south of Carrickmoyragh/Kilmacannon into Deerpark
17	Move north away from Lough Owel (i.e. Green route/Option 3)
18	Further south at Ballinalack
19	Go north of Edgeworthstown
20	Go south of existing N4 at Edercloon
