OFFICERS BUILDING
LONGFORD | COUNTY LONGFORD
ARCHITECTURAL HERITAGE IMPACT ASSESSMENT REPORT

ROBIN LEE ARCHITECTURE
JANUARY 2025

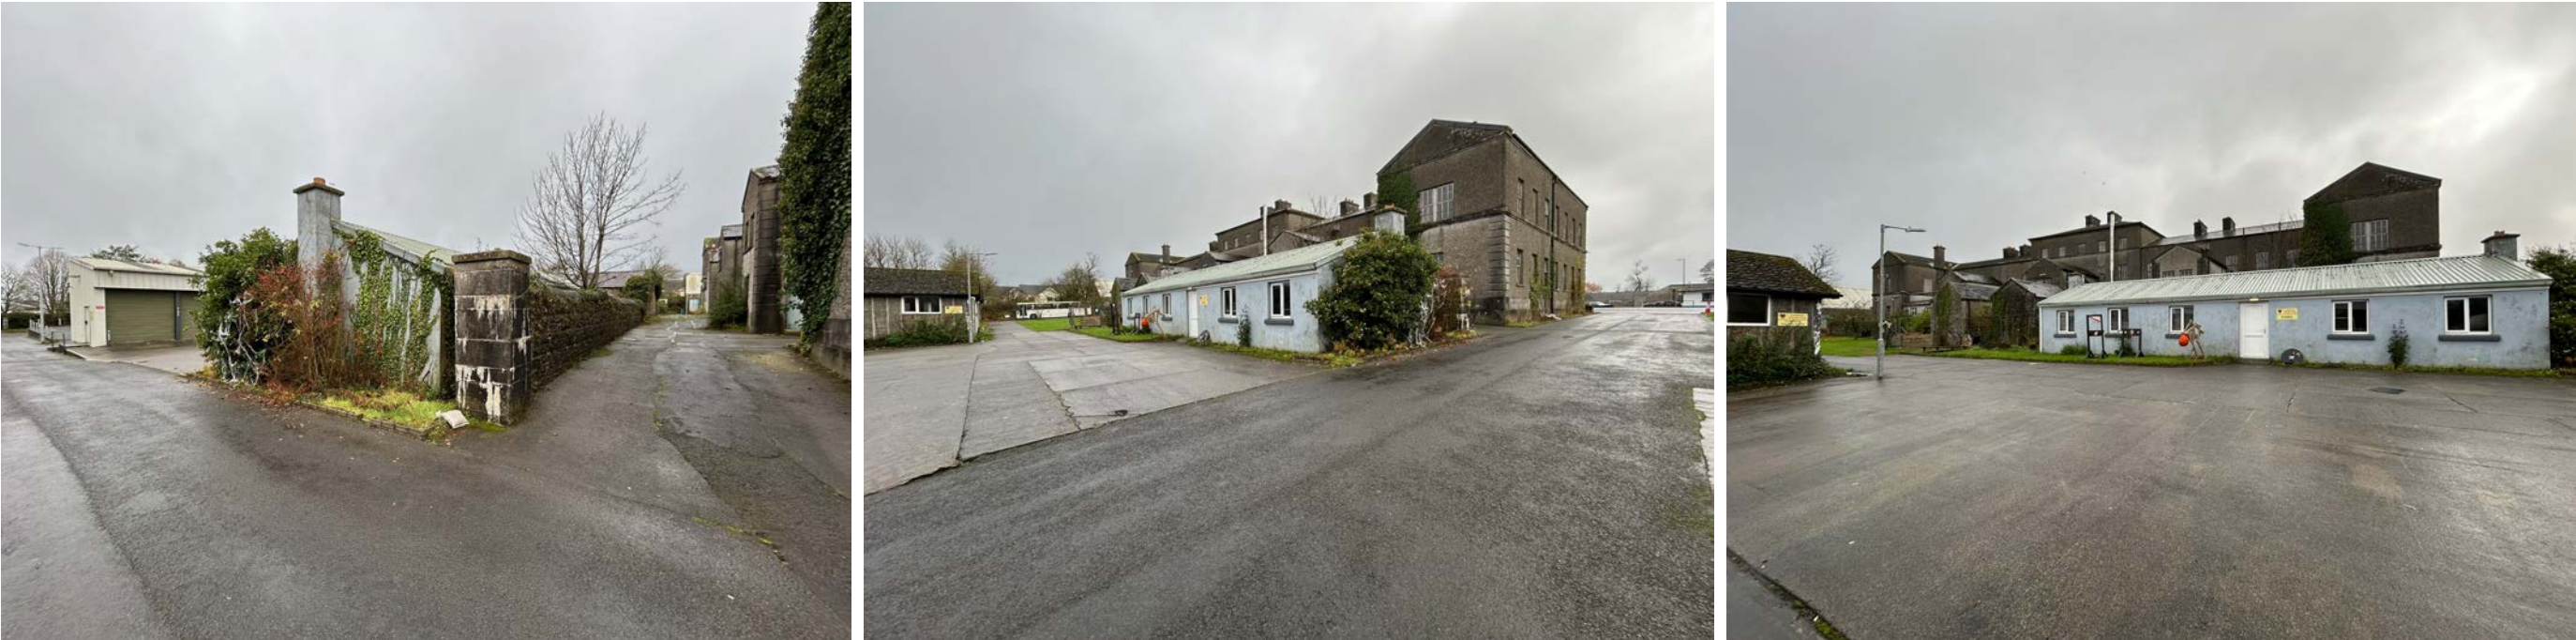
Officers Building _ South Western Context

To the south west of the Officers Building is a single storey building situated adjacent to the existing stone boundary wall.
The setting is otherwise open at this location with extents of hard-standing allowing vehicular access to the site area to the west.

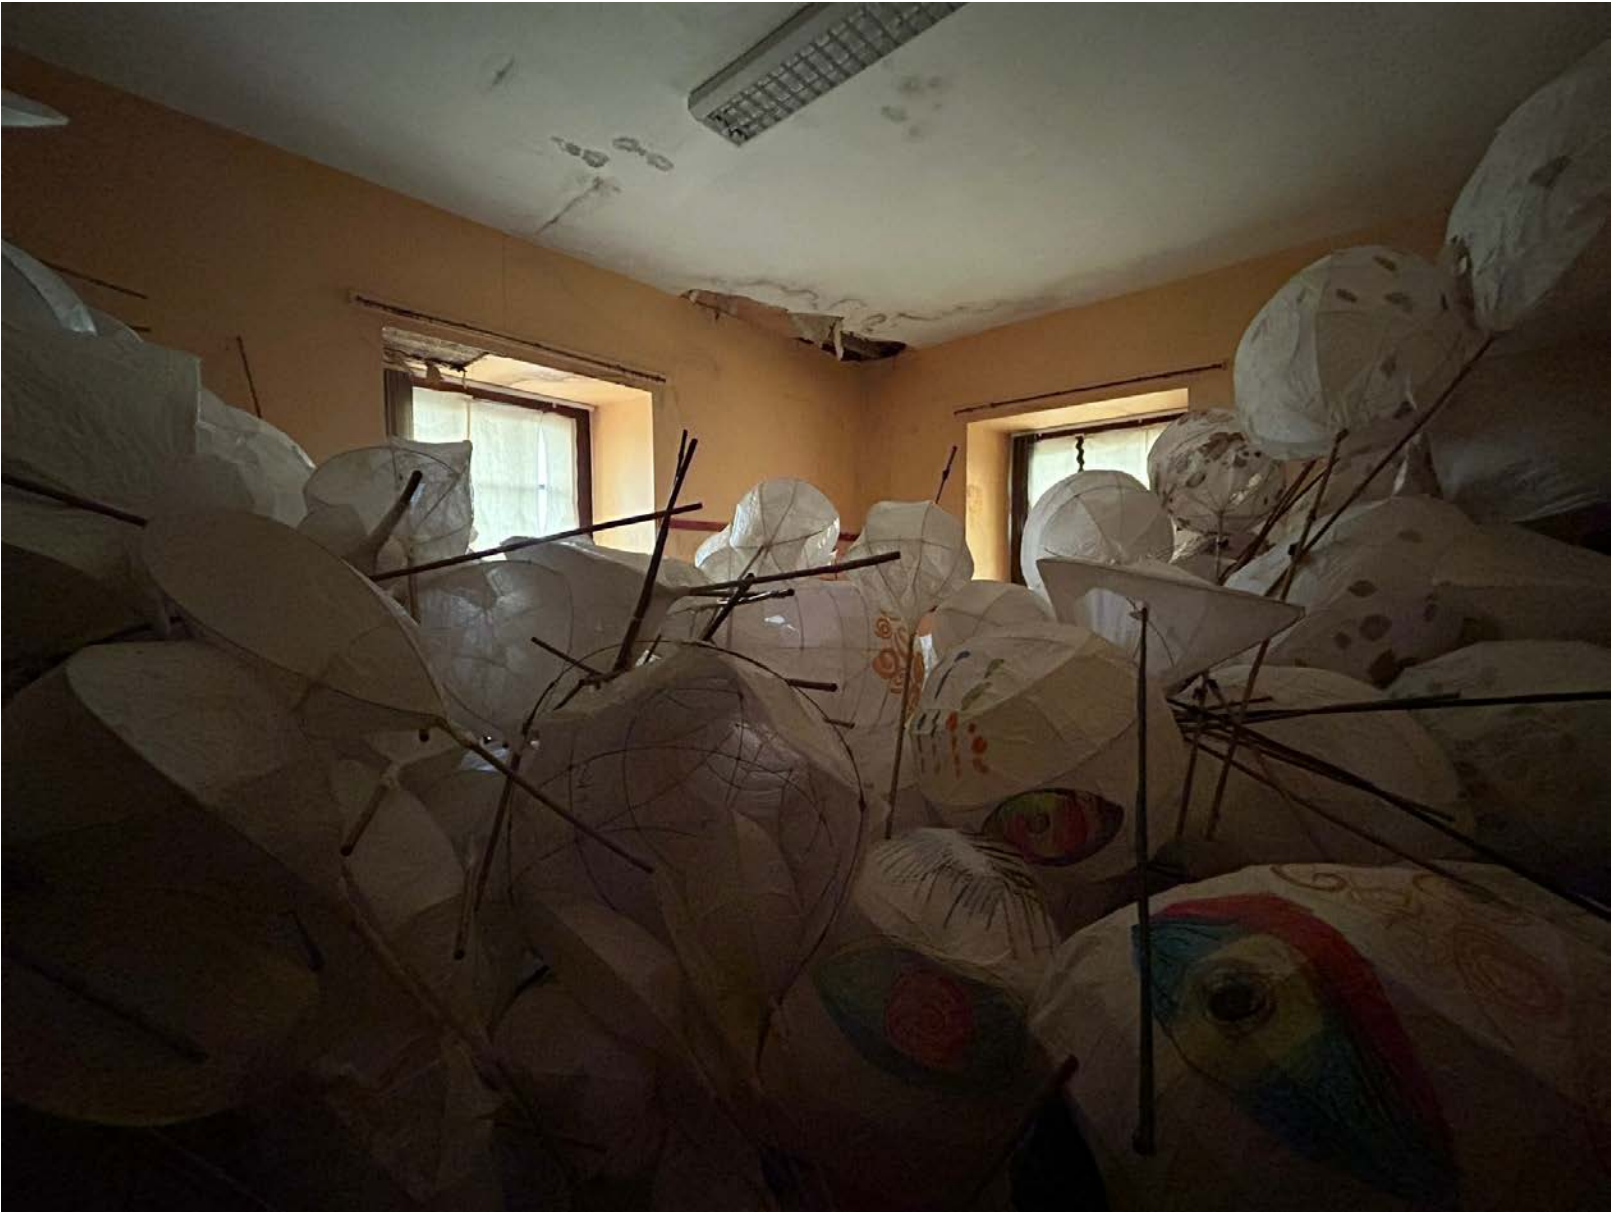
ROOM 00.S.01

Access to Room 00.S.01 is currently restricted as illustrated above. It can be assumed that the condition of the room is similar to other rooms within the building. The room is plain and unadorned in character with no ornamental historic plasterwork or timber features evident, such as cornice-work, dado rails, architraves or roses.

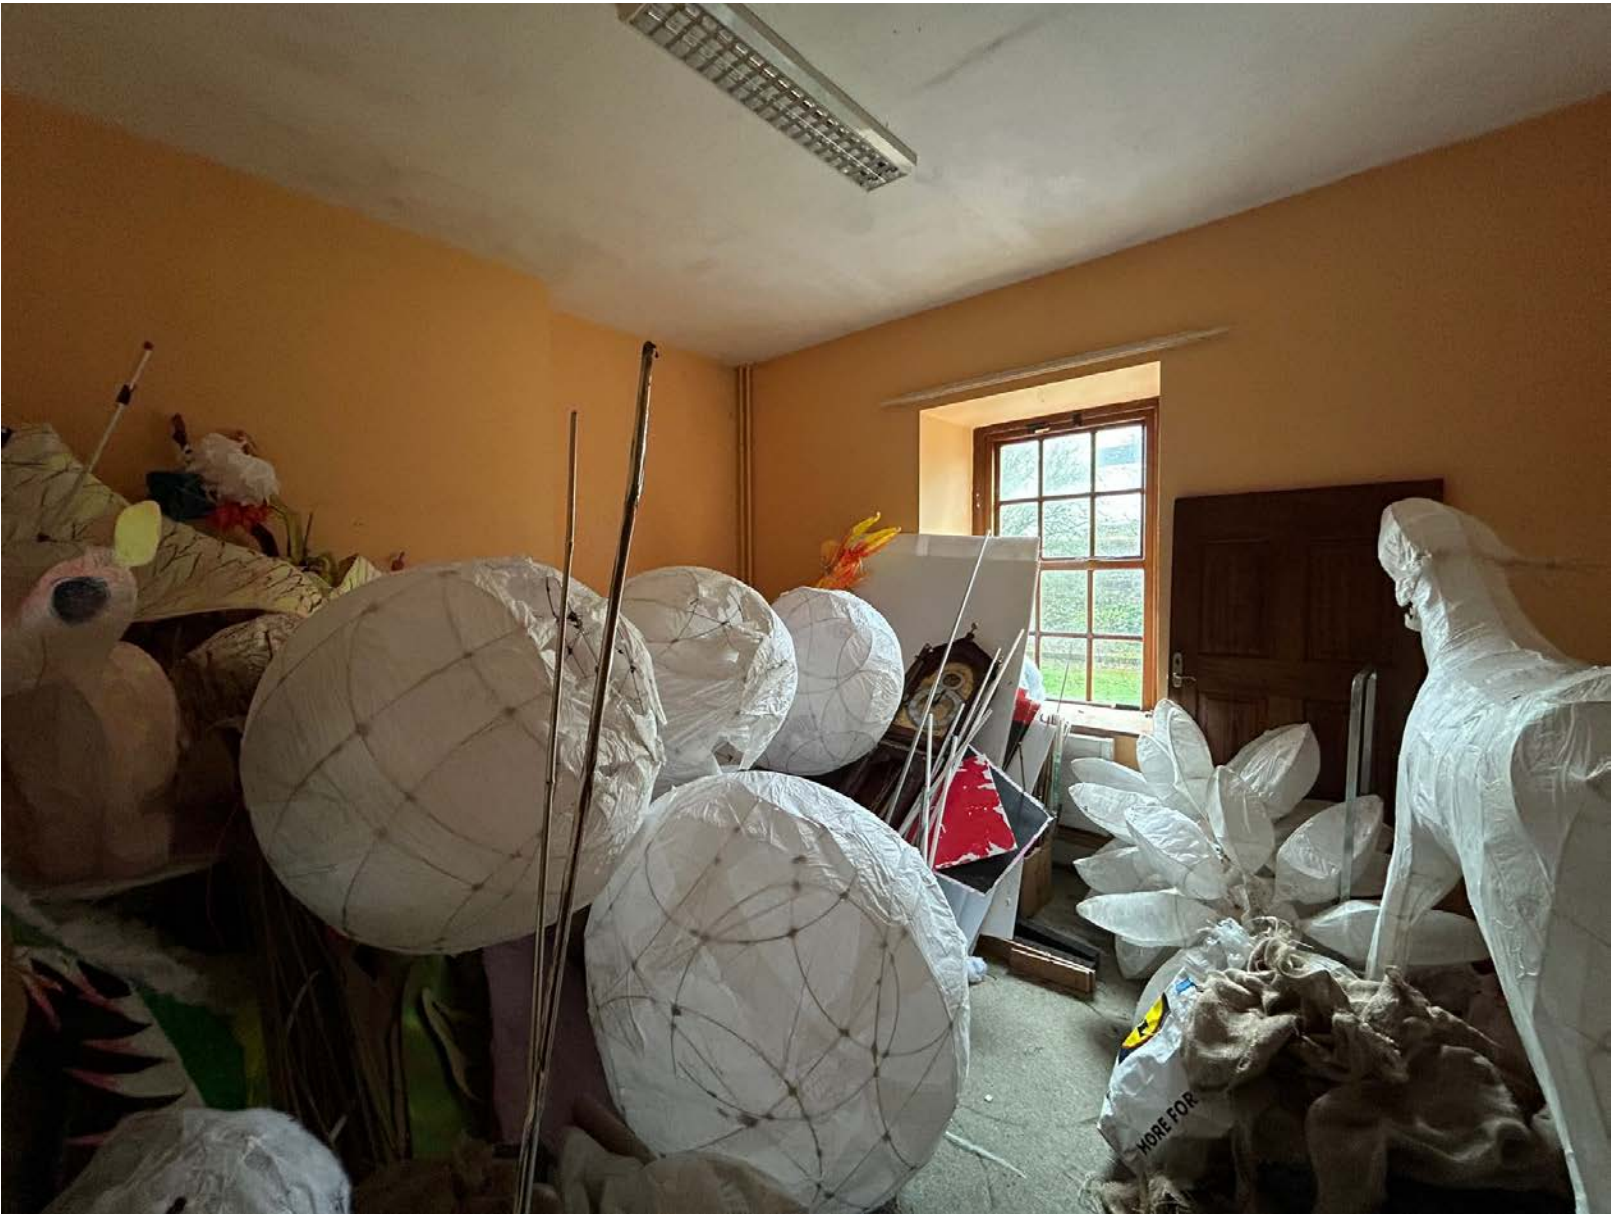
ROOM 00.S.02

Access to Room 00.S.02 is currently restricted as illustrated above. It can be assumed that the condition of the room is similar to other rooms within the building. The room is plain and unadorned in character with no ornamental historic plasterwork or timber features evident, such as cornice-work, dado rails, architraves or roses.

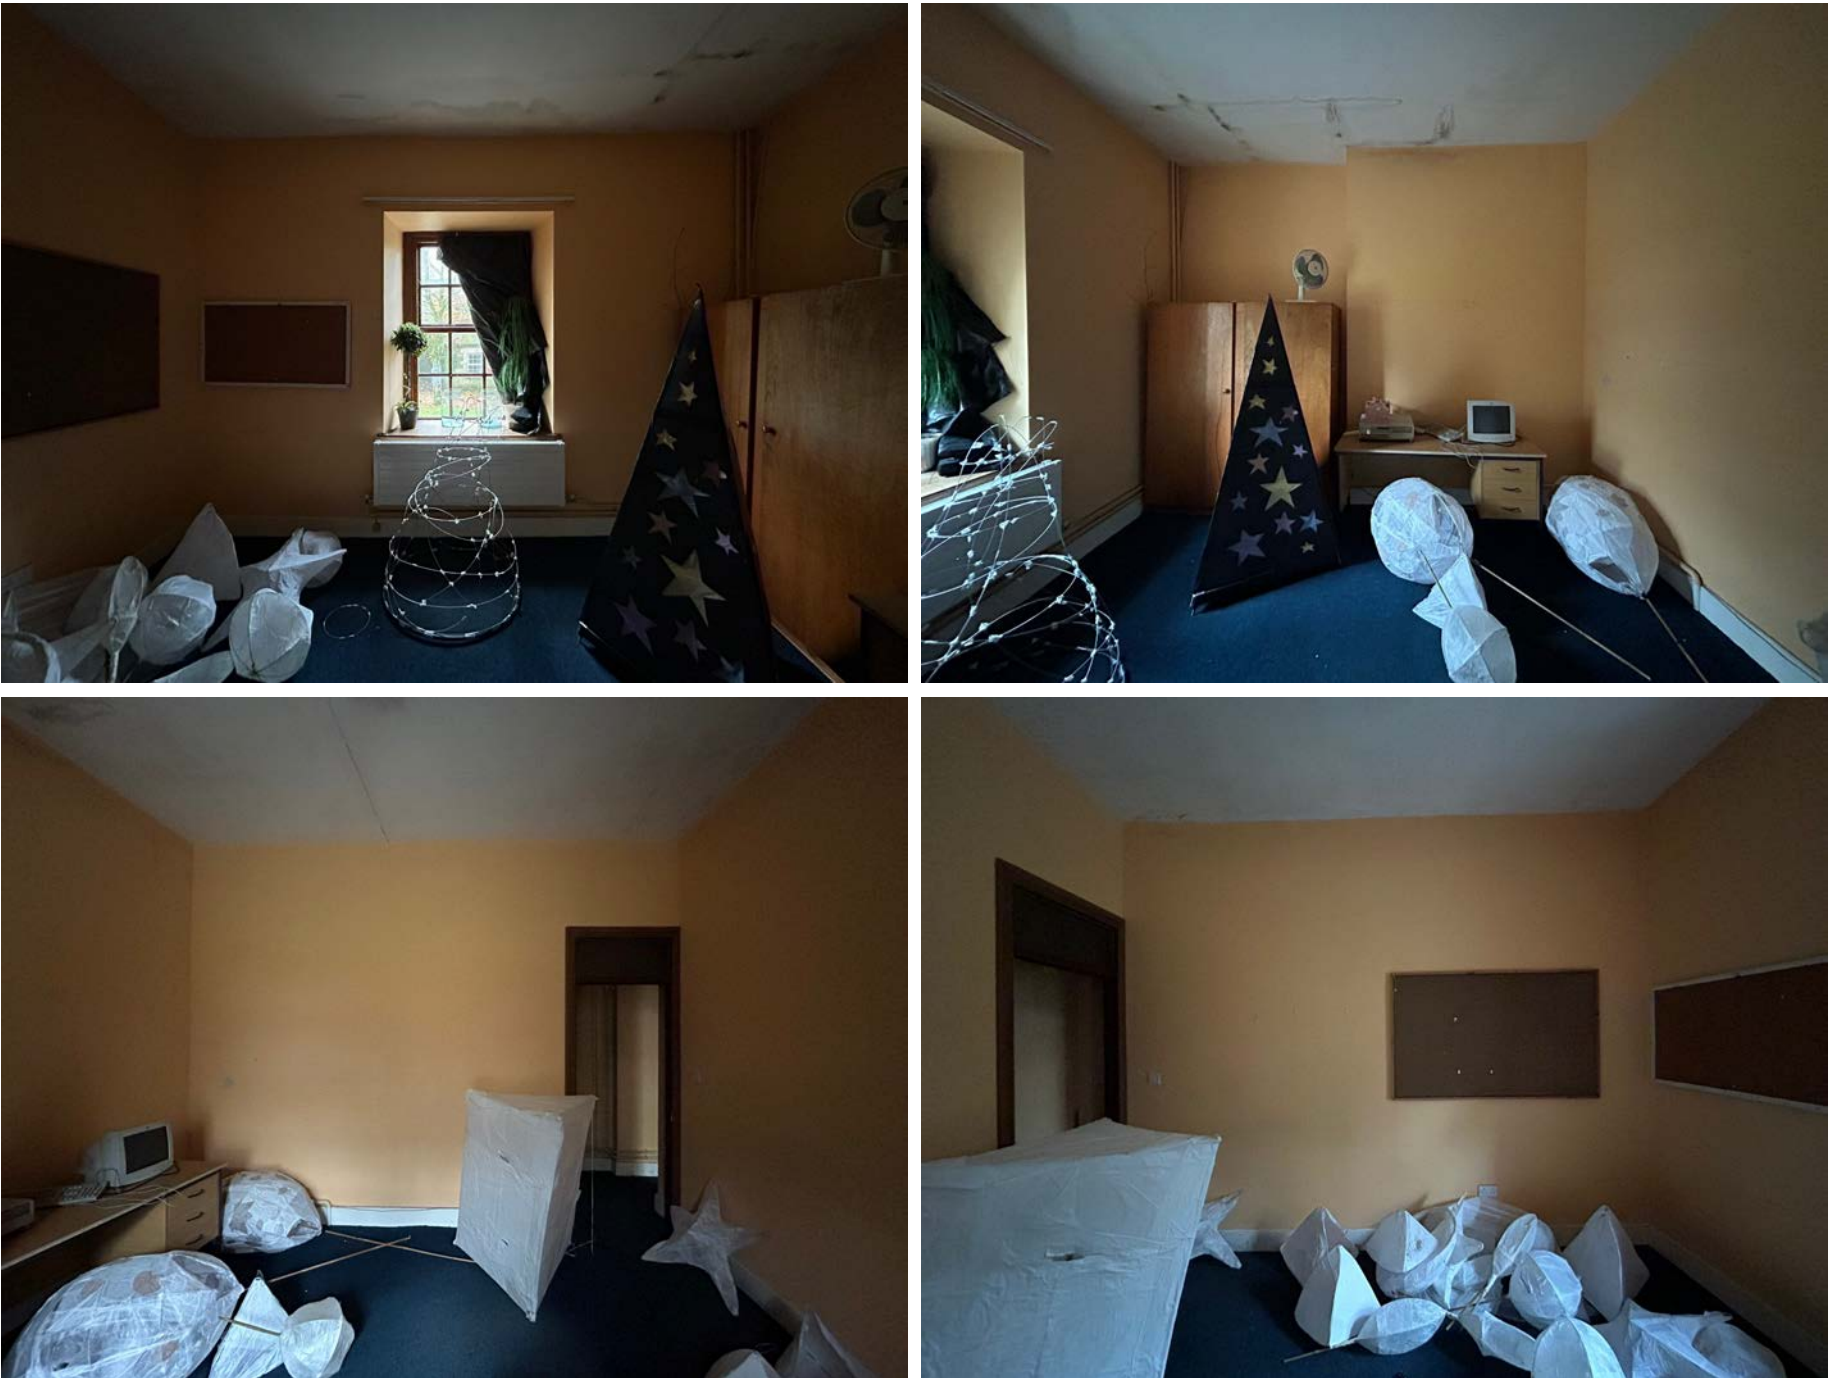
ROOM 00.S.03

Access to Room 00.S.01 is currently restricted as illustrated above. It can be assumed that the condition of the room is similar to other rooms within the building. The room is plain and unadorned in character with no ornamental historic plasterwork or timber features evident, such as cornice-work, dado rails, architraves or roses.

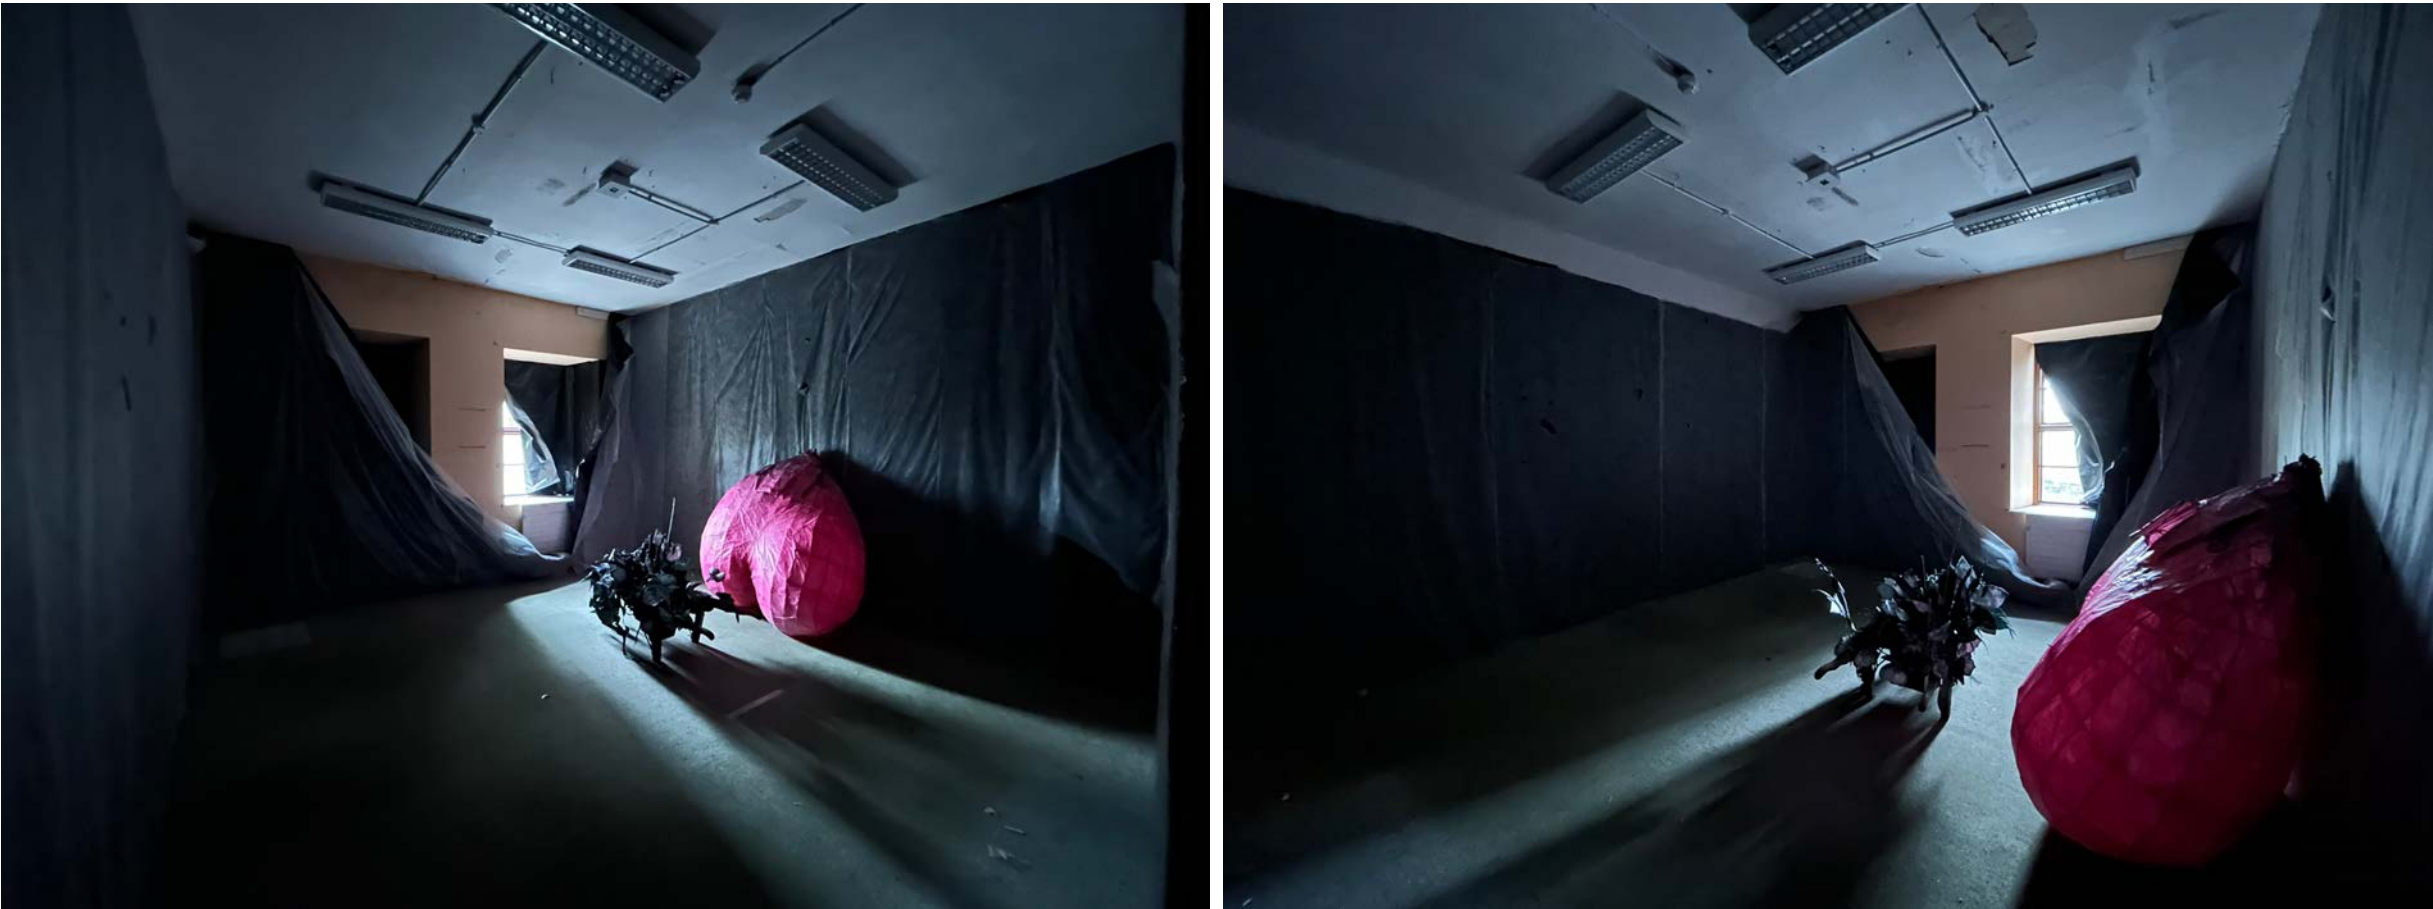
ROOM 00.M.02

Access to Room 00.M.02 is currently restricted as illustrated above. It can be assumed that the condition of the room is similar to other rooms within the building. The room is plain and unadorned in character with no ornamental historic plasterwork or timber features evident, such as cornice-work, dado rails, architraves or roses.

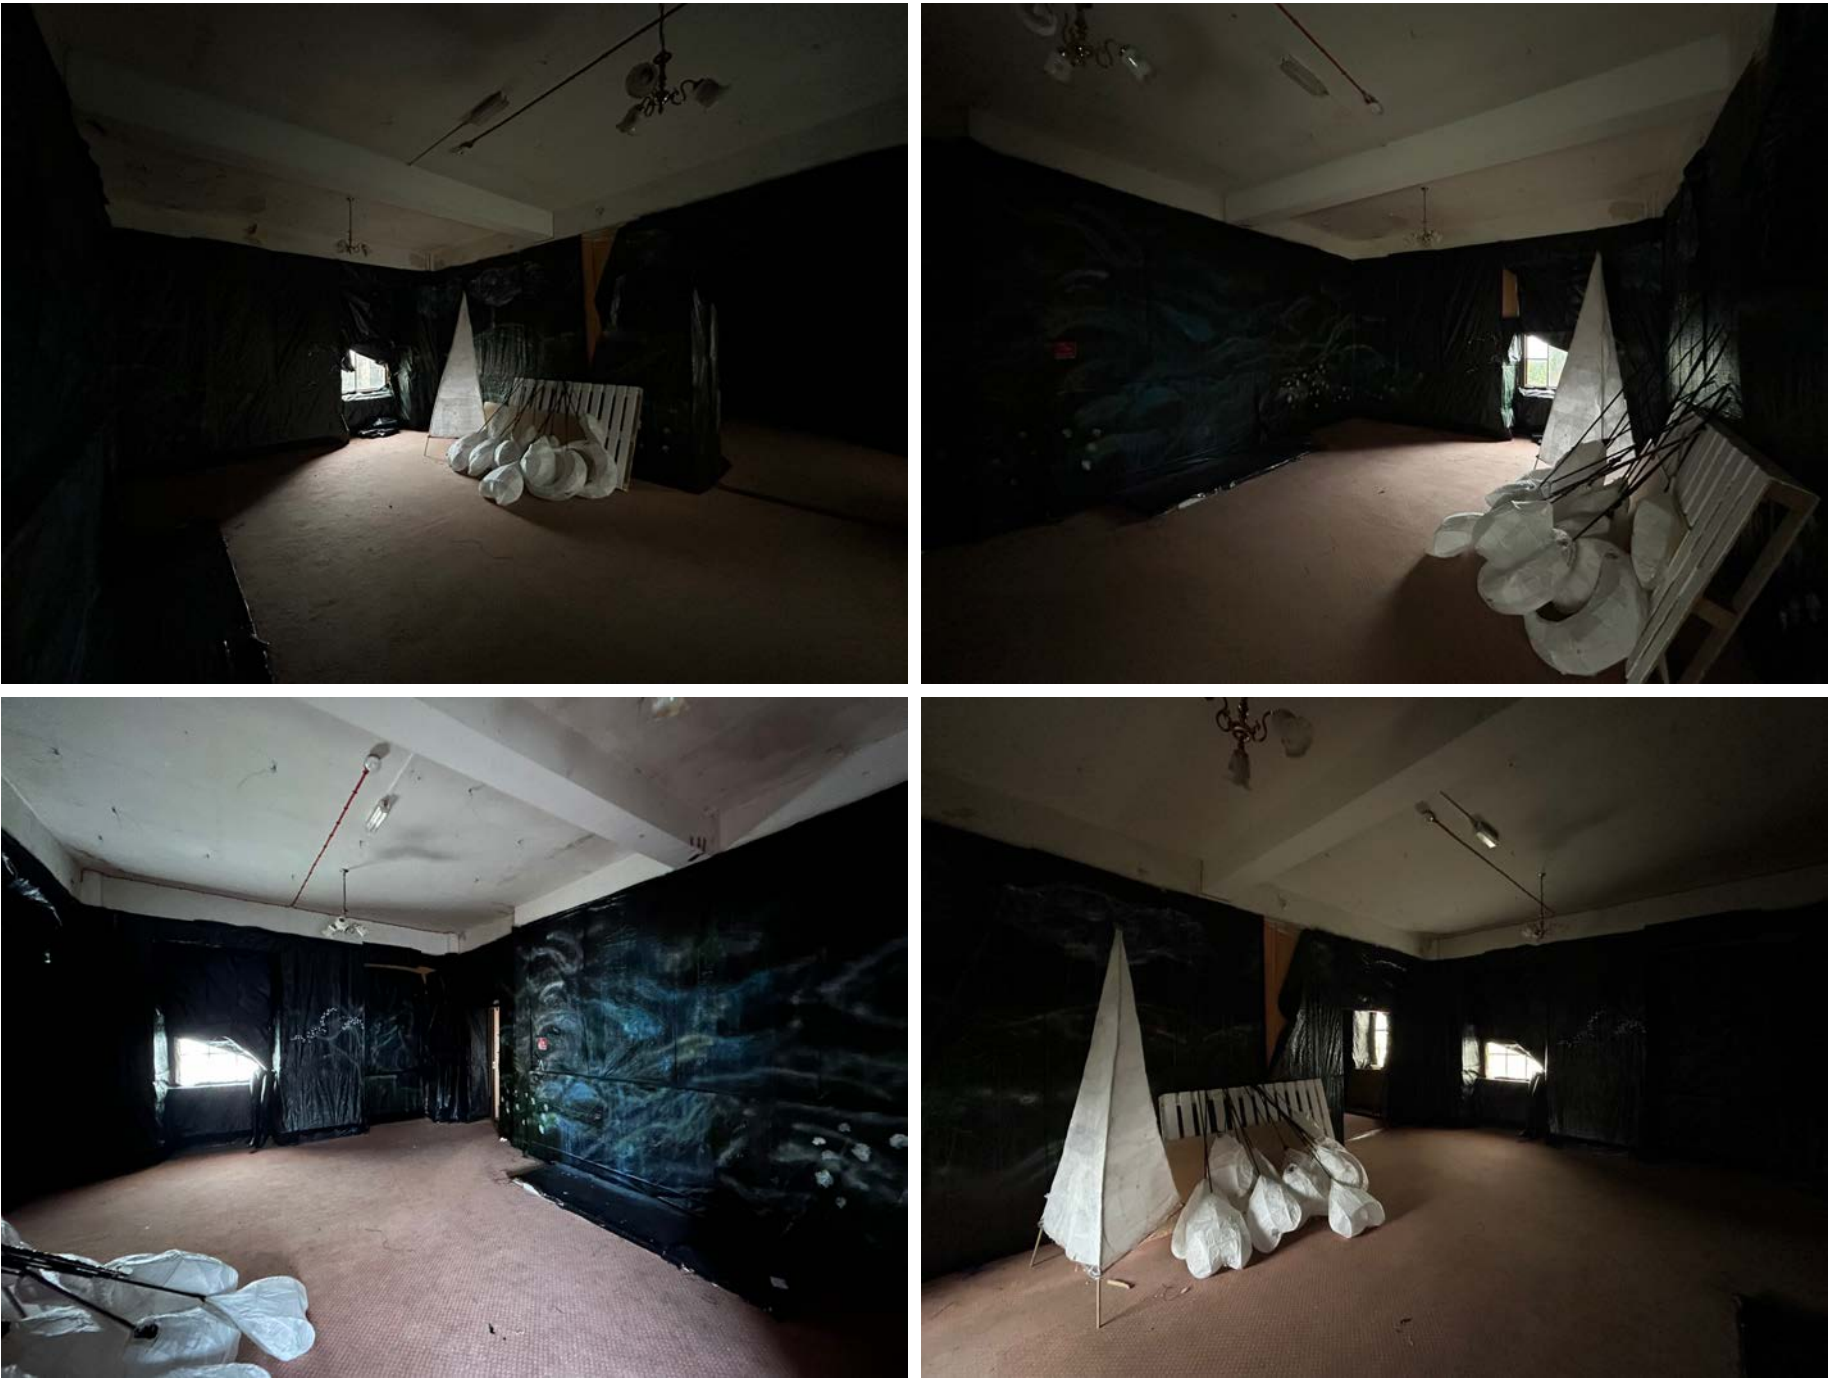
ROOM 00.M.03

Access to Room 00.M.03 is currently restricted as illustrated above. It can be assumed that the condition of the room is similar to other rooms within the building. The room is plain and unadorned in character with no ornamental historic plasterwork or timber features evident, such as cornice-work, dado rails, architraves or roses.

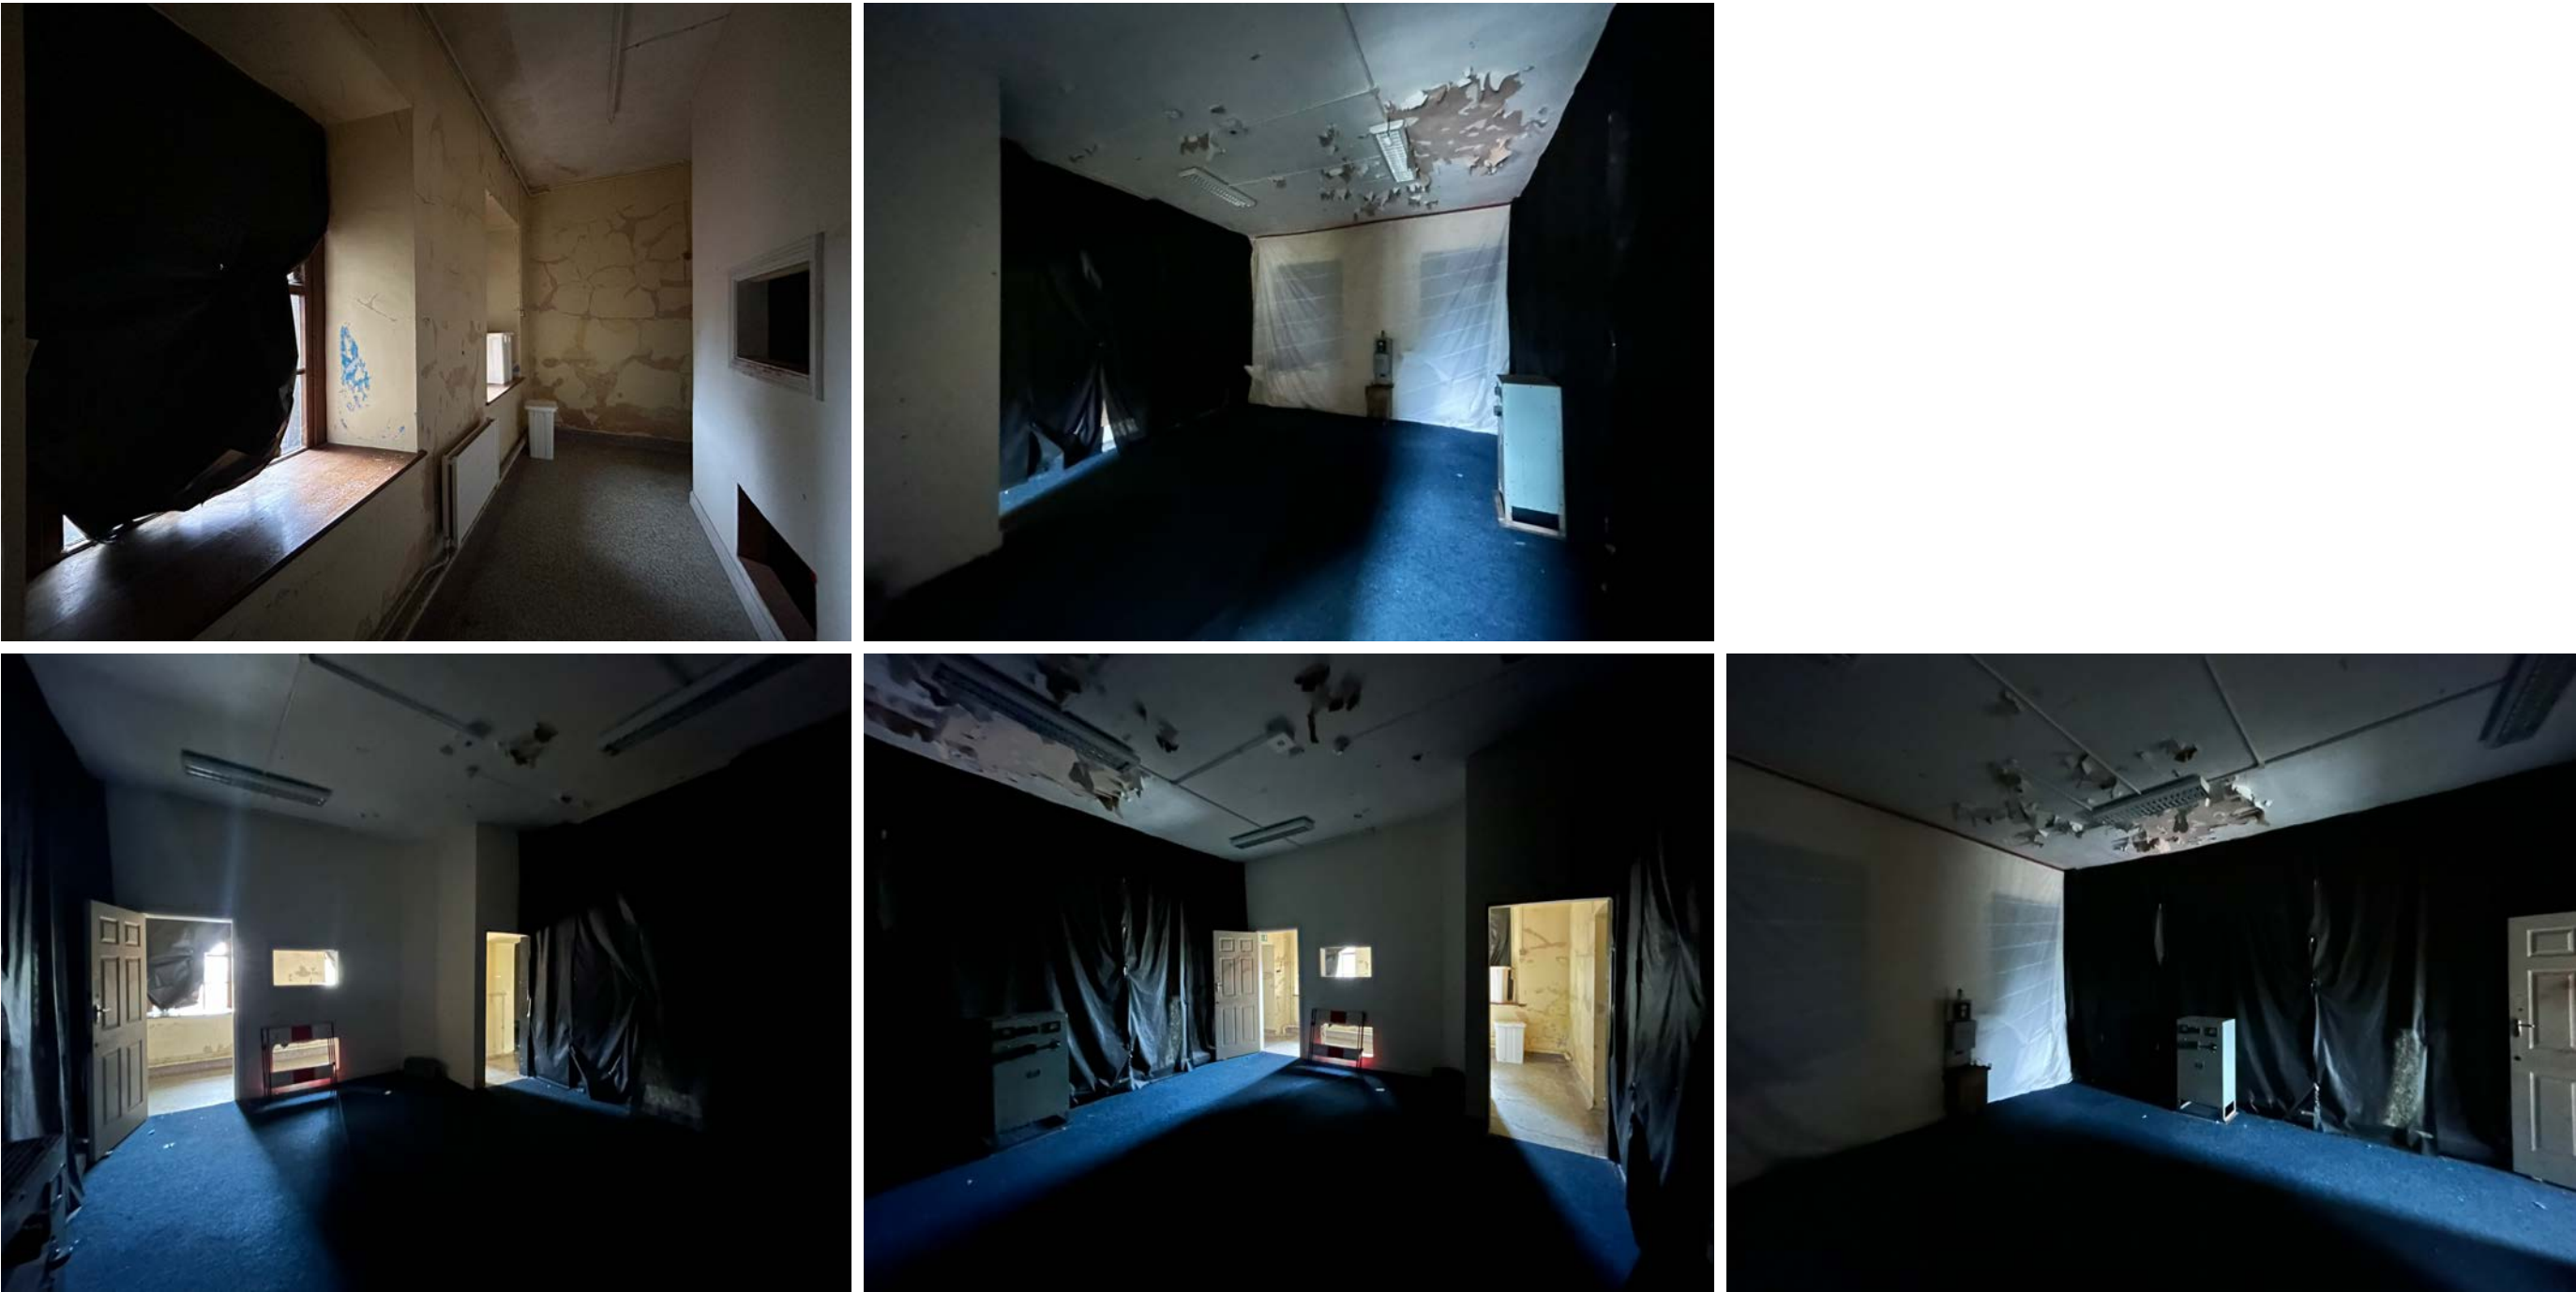
ROOM 00.M.05

Access to Room 00.M.05 is currently restricted as illustrated above. It can be assumed that the condition of the room is similar to other rooms within the building.

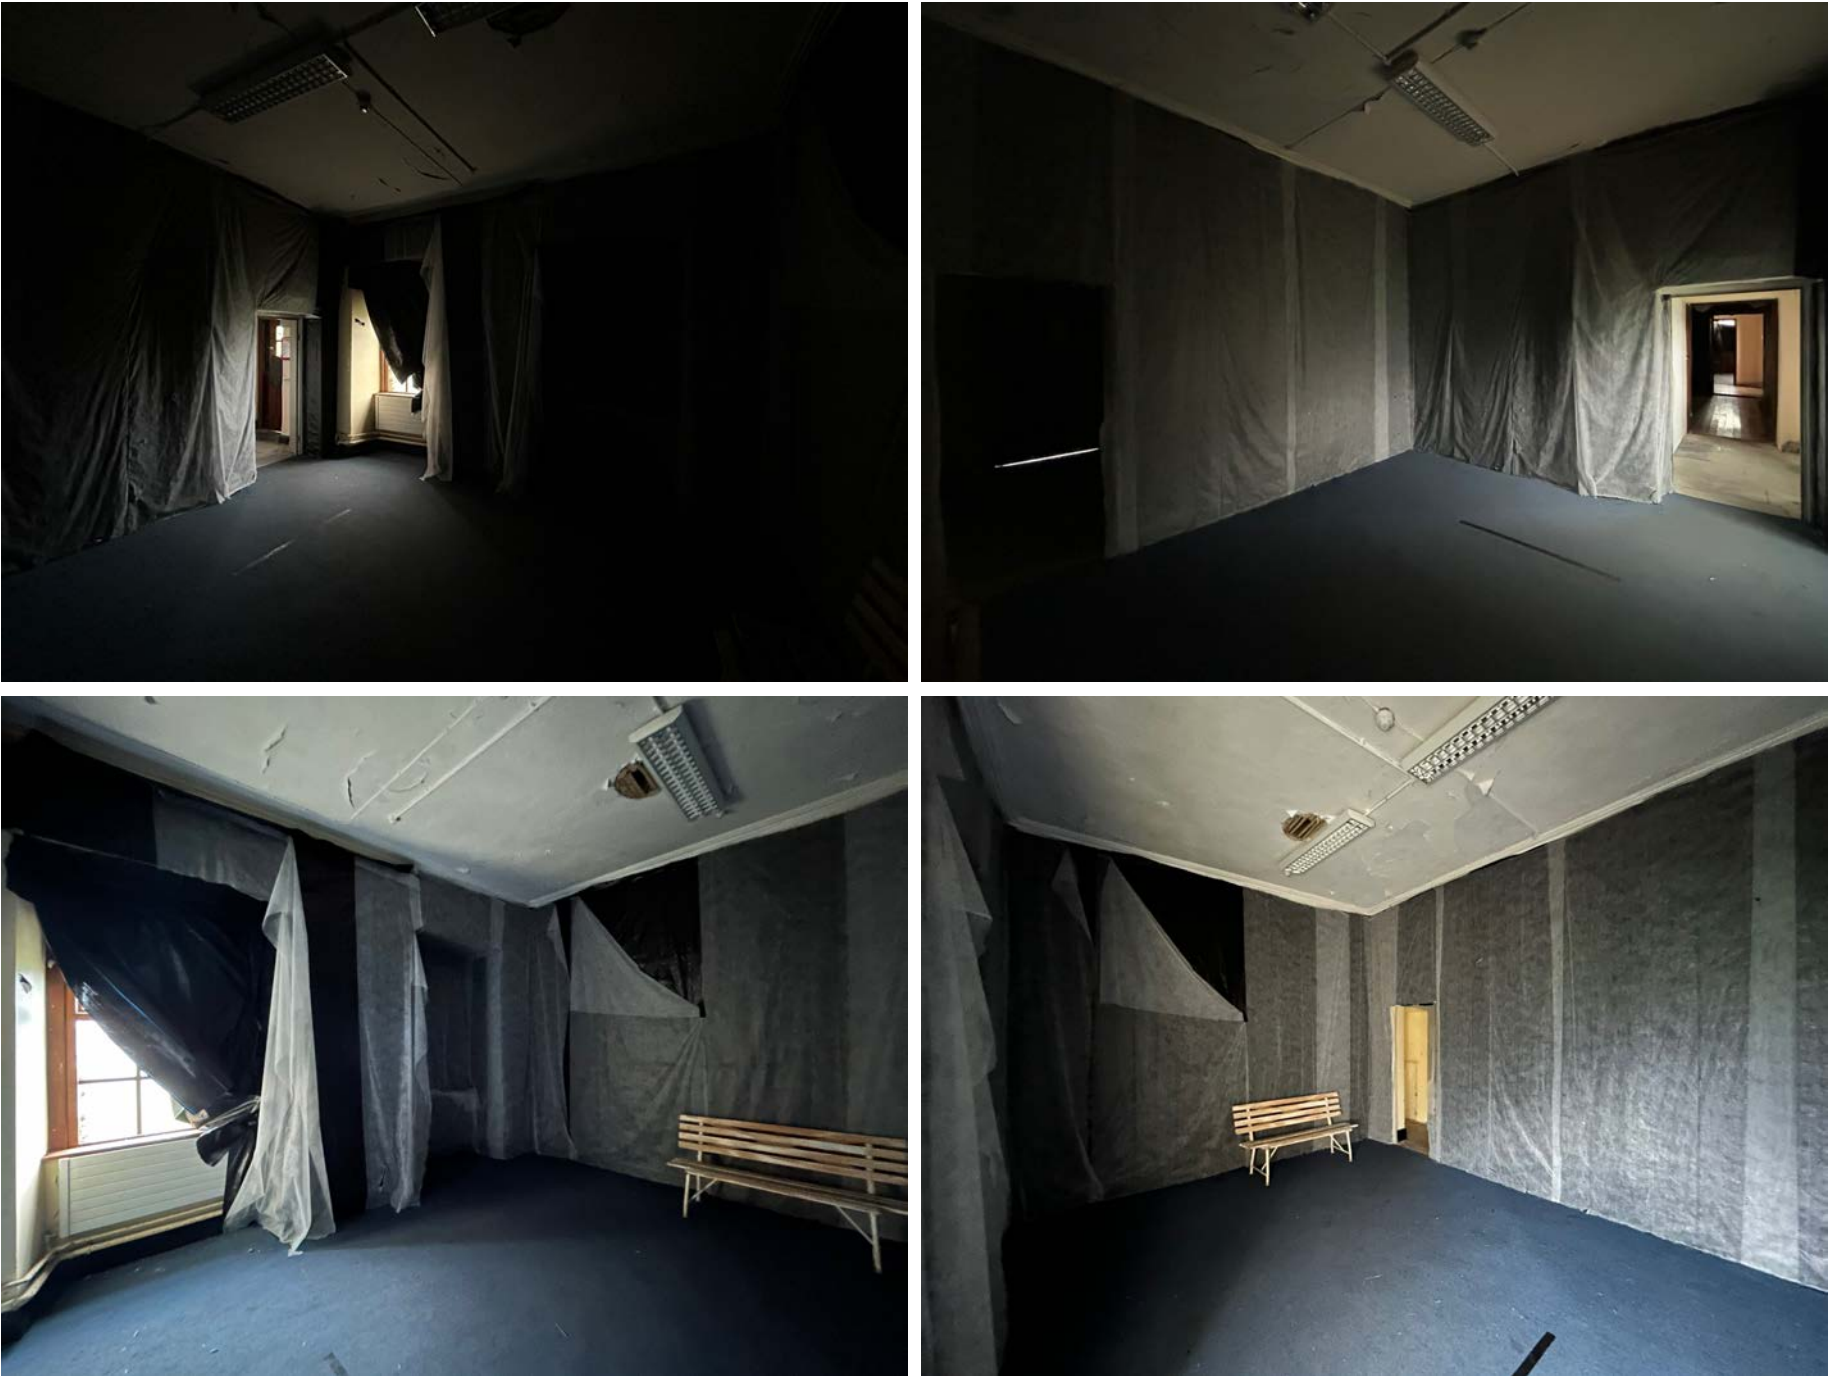
ROOM 00.M.07

Access to Room 00.M.07 is currently restricted as illustrated above. It can be assumed that the condition of the room is similar to other rooms within the building. The room is plain and unadorned in character with no ornamental historic plasterwork or timber features evident, such as cornice-work, dado rails, architraves or roses.

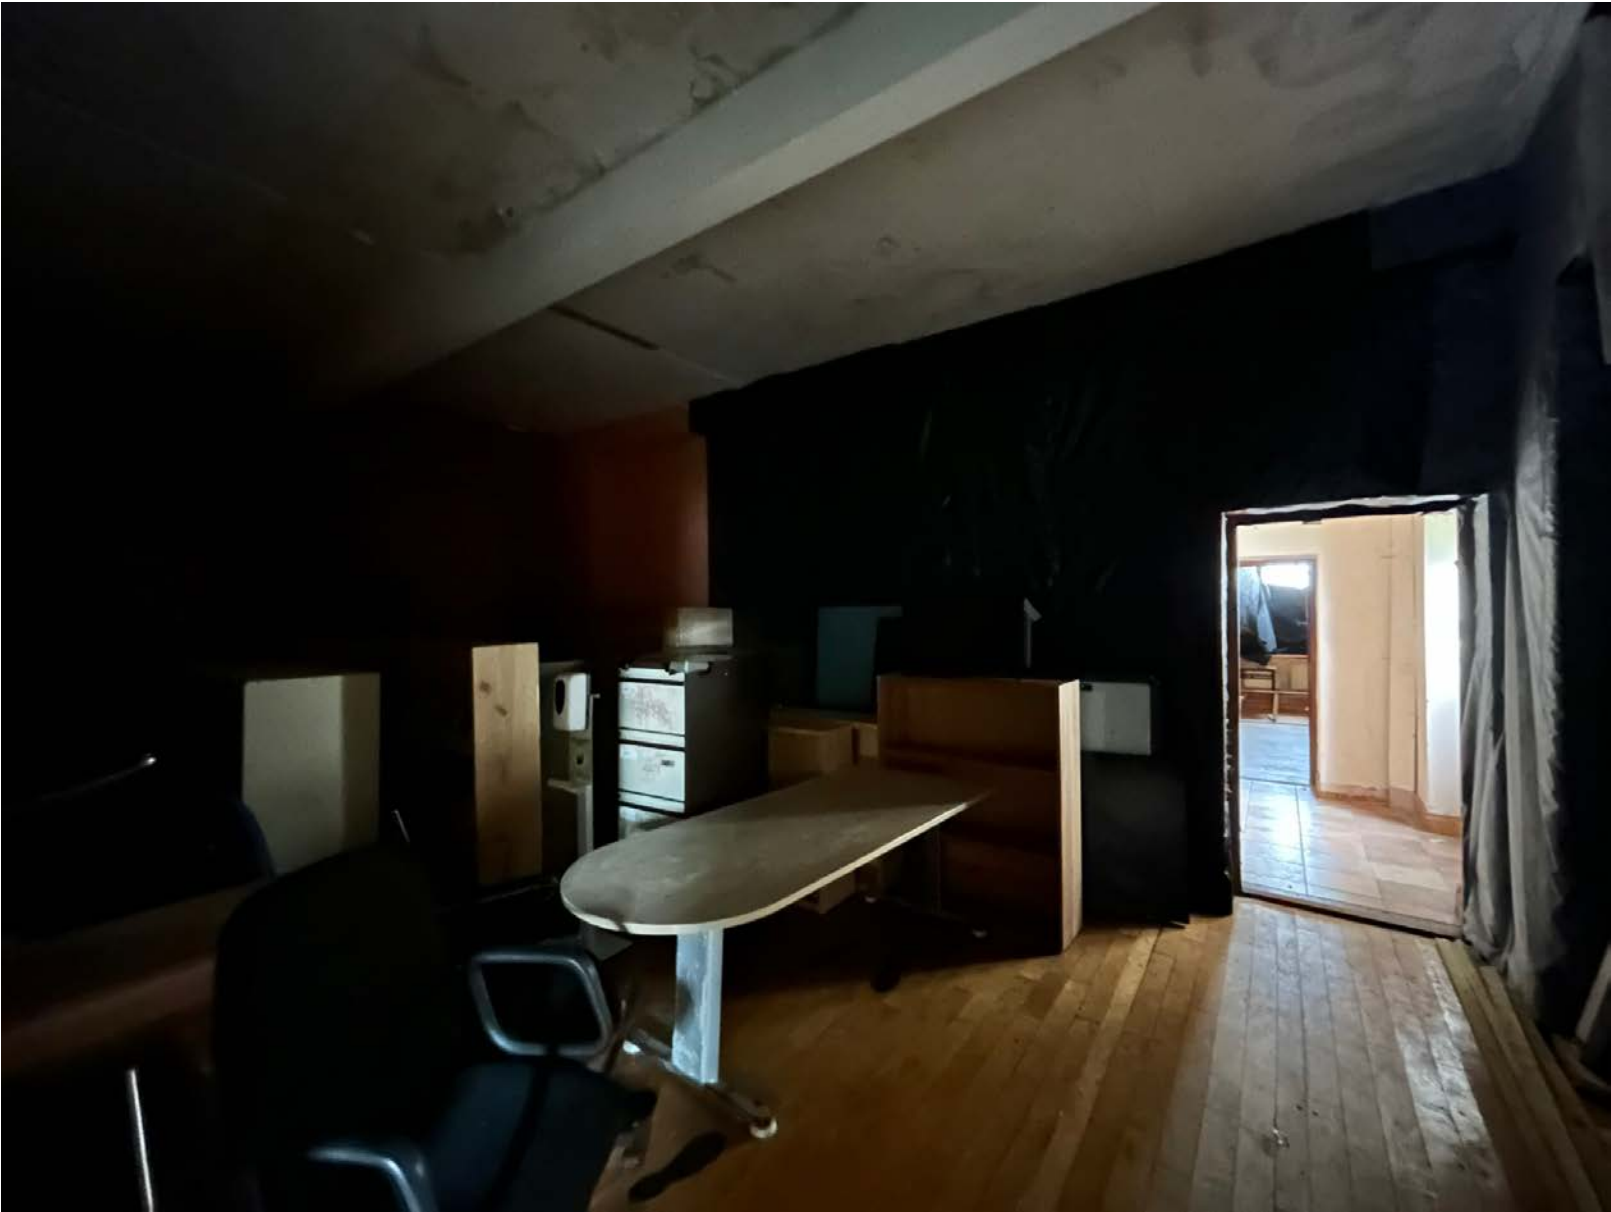
ROOM 00.M.08

Access to Room 00.M.08 is currently restricted as illustrated above. It can be assumed that the condition of the room is similar to other rooms within the building. The room is plain and unadorned in character with no ornamental historic plasterwork or timber features evident, such as cornice-work, dado rails, architraves or roses.
