OFFICERS BUILDING
LONGFORD | COUNTY LONGFORD
ARCHITECTURAL HERITAGE IMPACT ASSESSMENT REPORT

ROBIN LEE ARCHITECTURE
JANUARY 2025

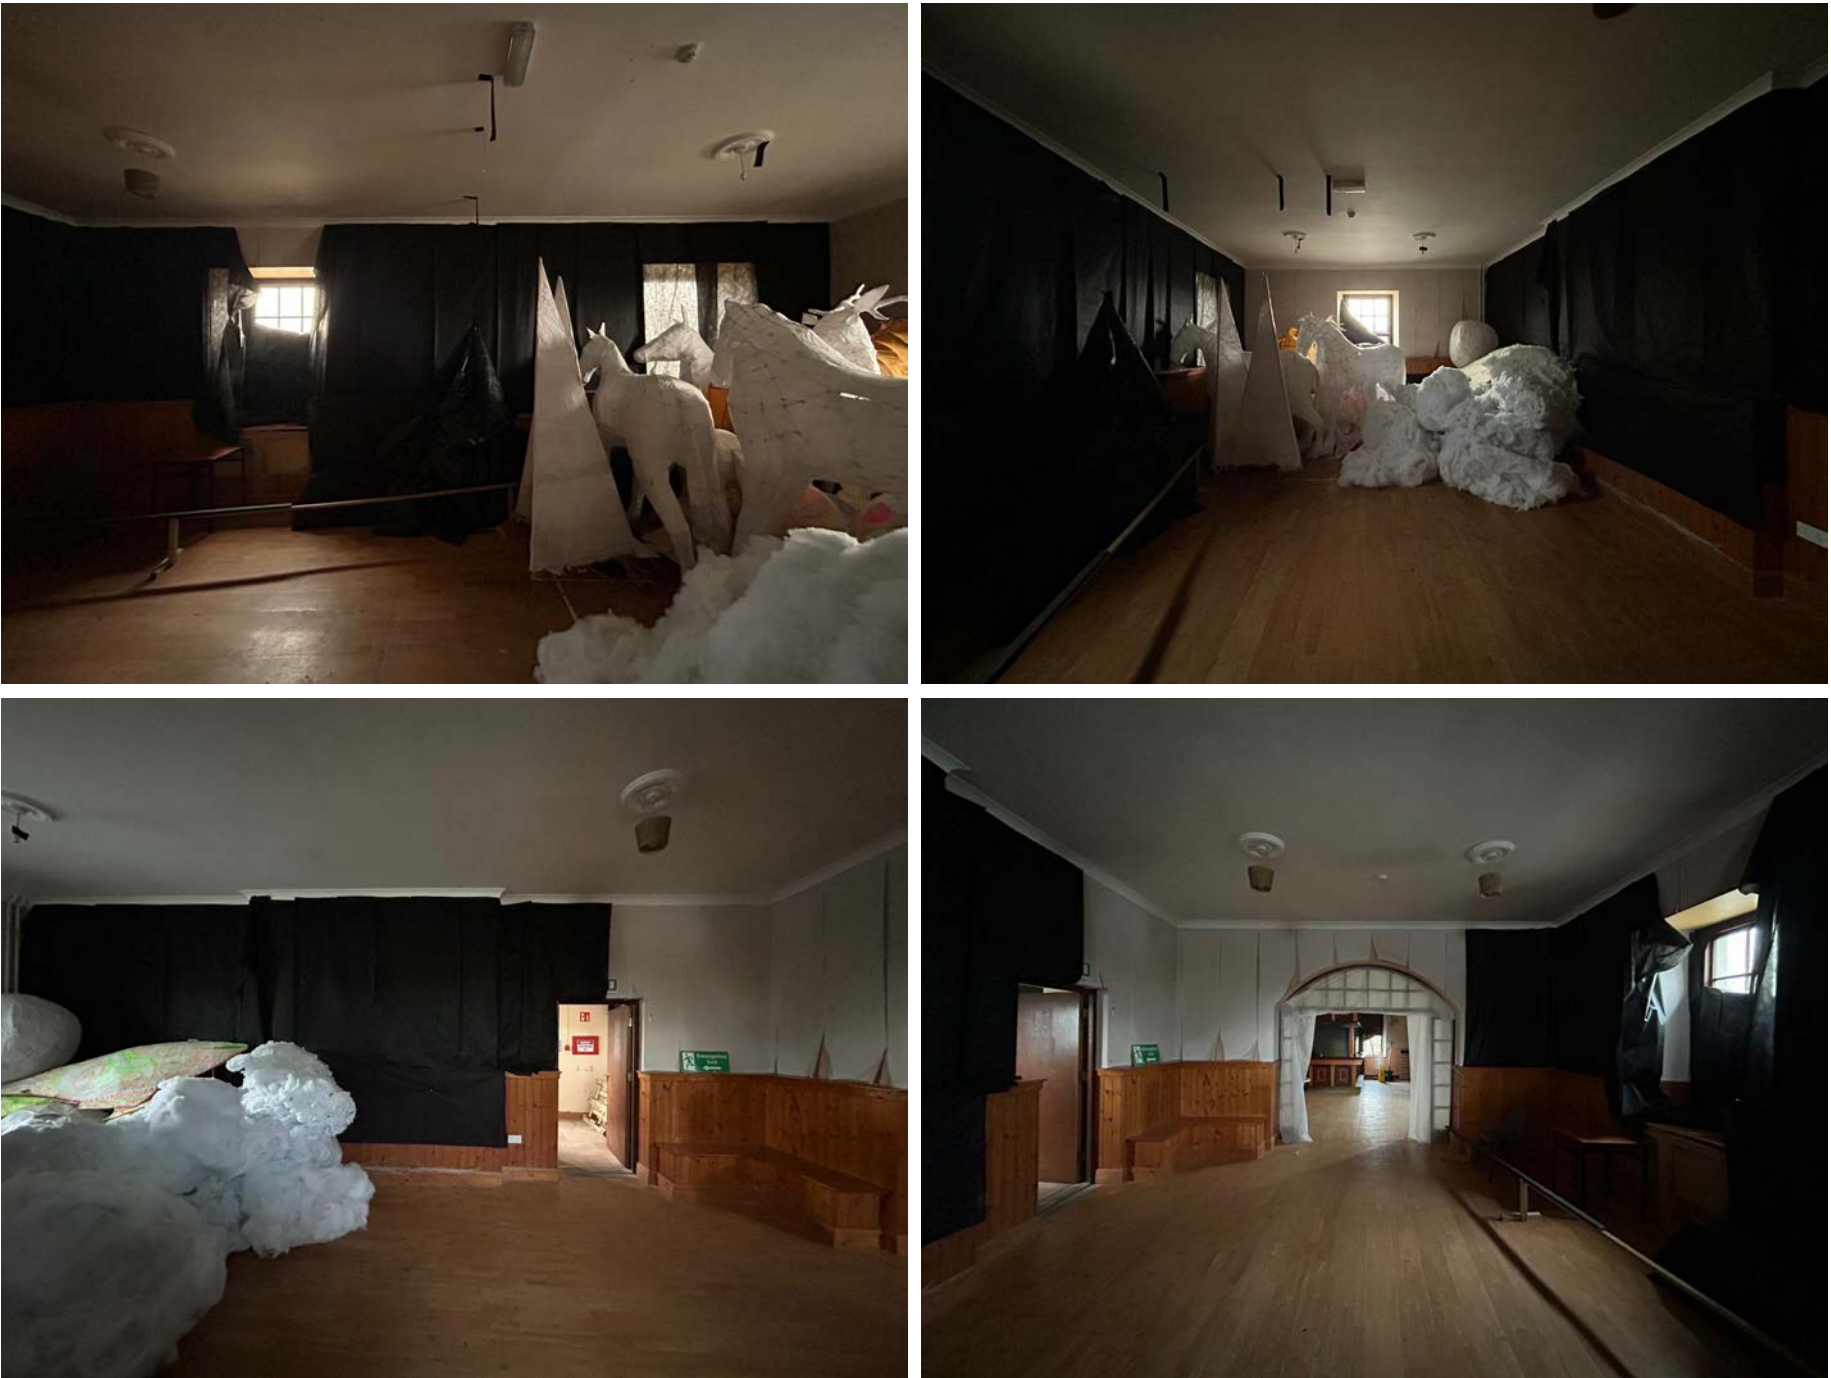
ROOM 00.N.01

Access to Room 00.N.01 is currently restricted as illustrated above. It can be assumed that the condition of the room is similar to other rooms within the building.

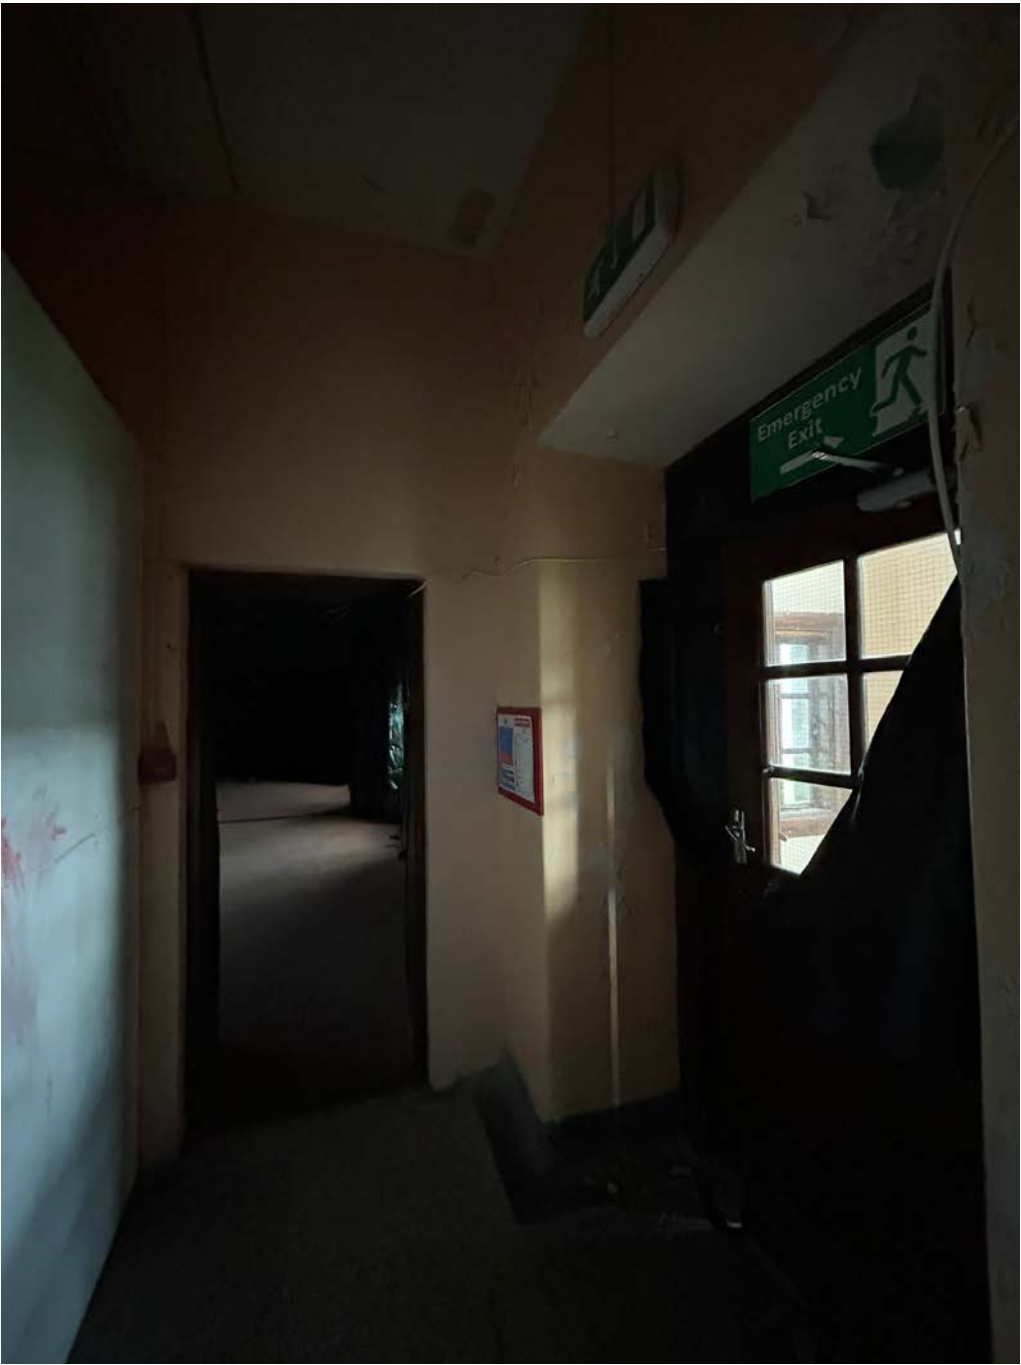
ROOM 00.ST.01

Access to Room 00.ST.01 is currently restricted as illustrated above. It can be assumed that the condition of the room is similar to other rooms within the building. The room is plain and unadorned in character with no ornamental historic plasterwork or timber features evident, such as cornice-work, dado rails, architraves or roses.

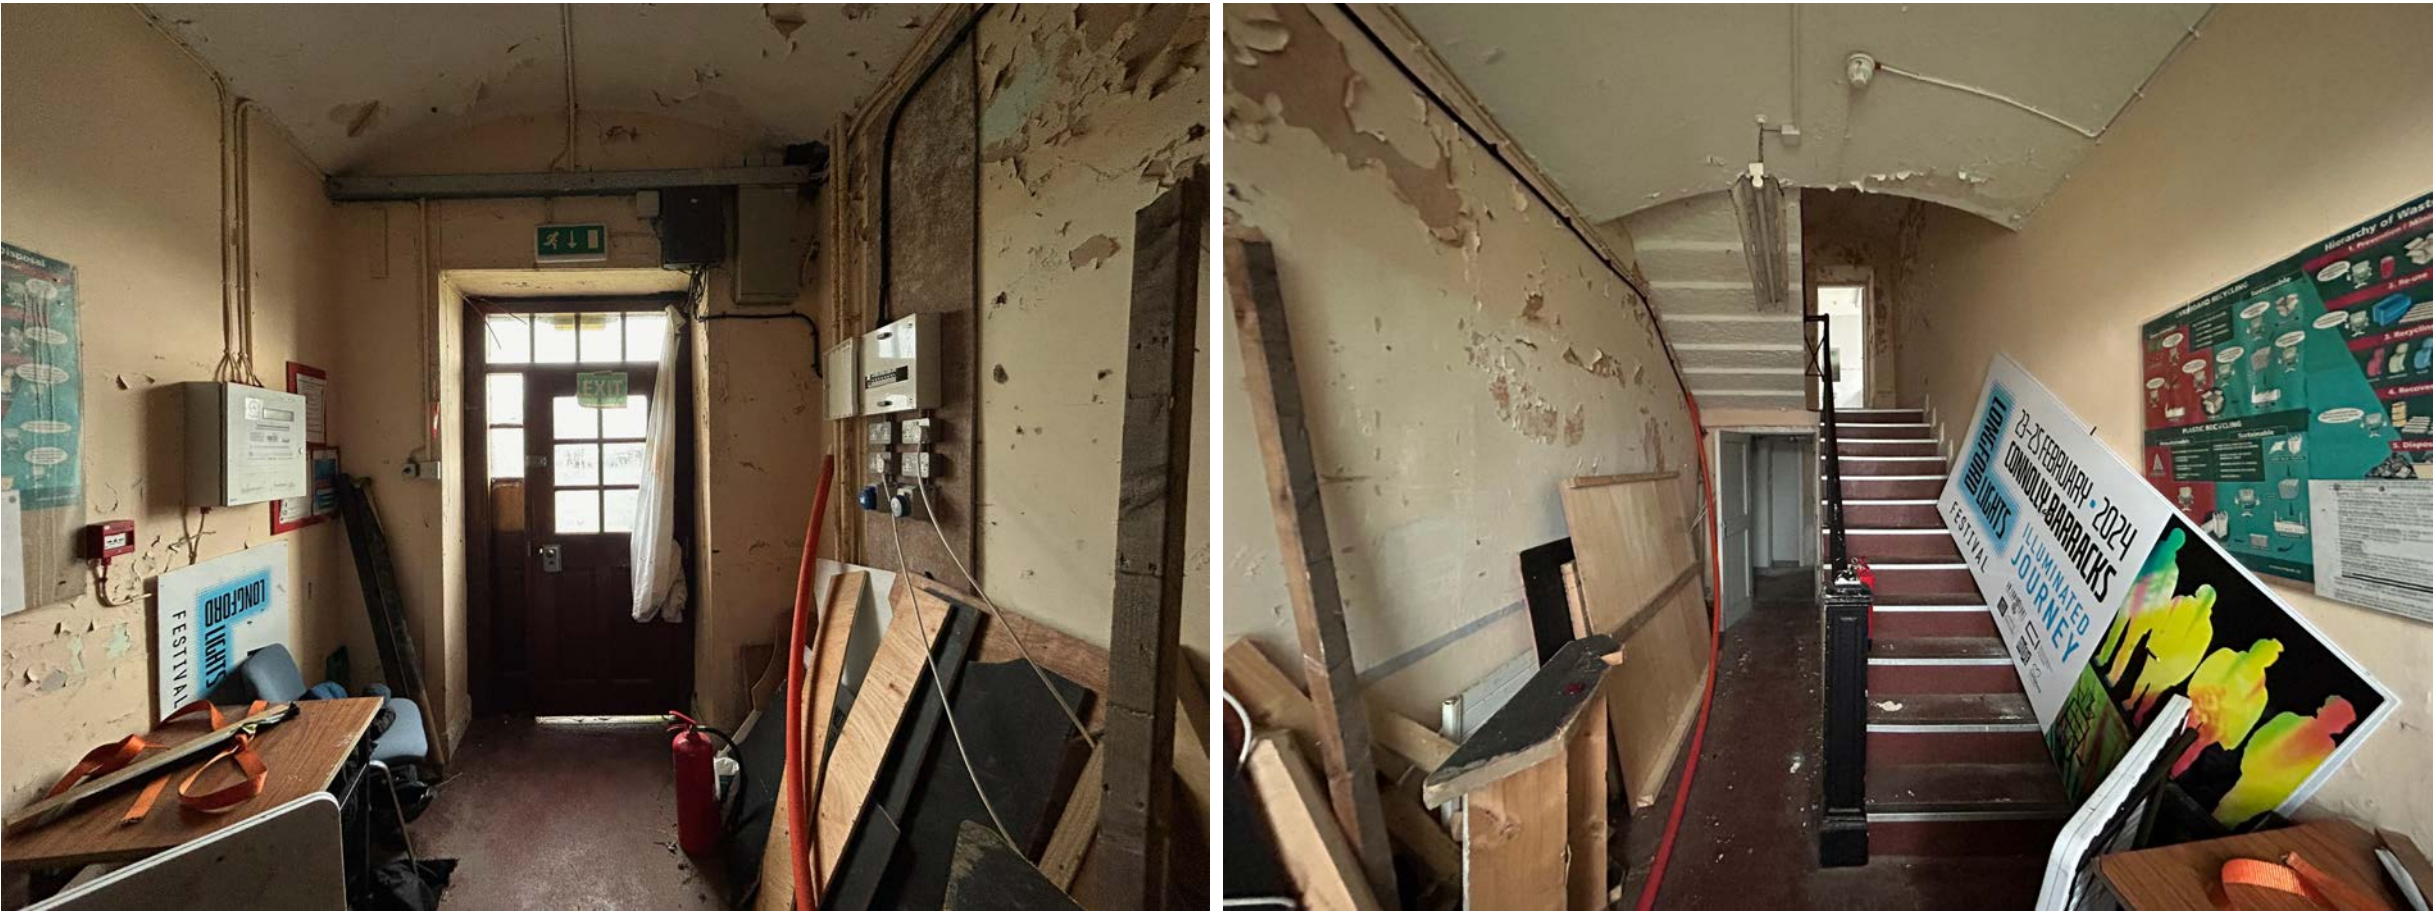
ROOM 00.ST.02

The entrance and stairwell is plain and unadorned in character with no ornamental historic plasterwork or timber features evident, such as cornice-work, dado rails, architraves or roses. Glazed timber door and fixed surround screen, timber newel post, cast ironwork to stair, cantilevered stone stair and vaulted ceiling are features of significance. Potential historic floor finishes to be uncovered.

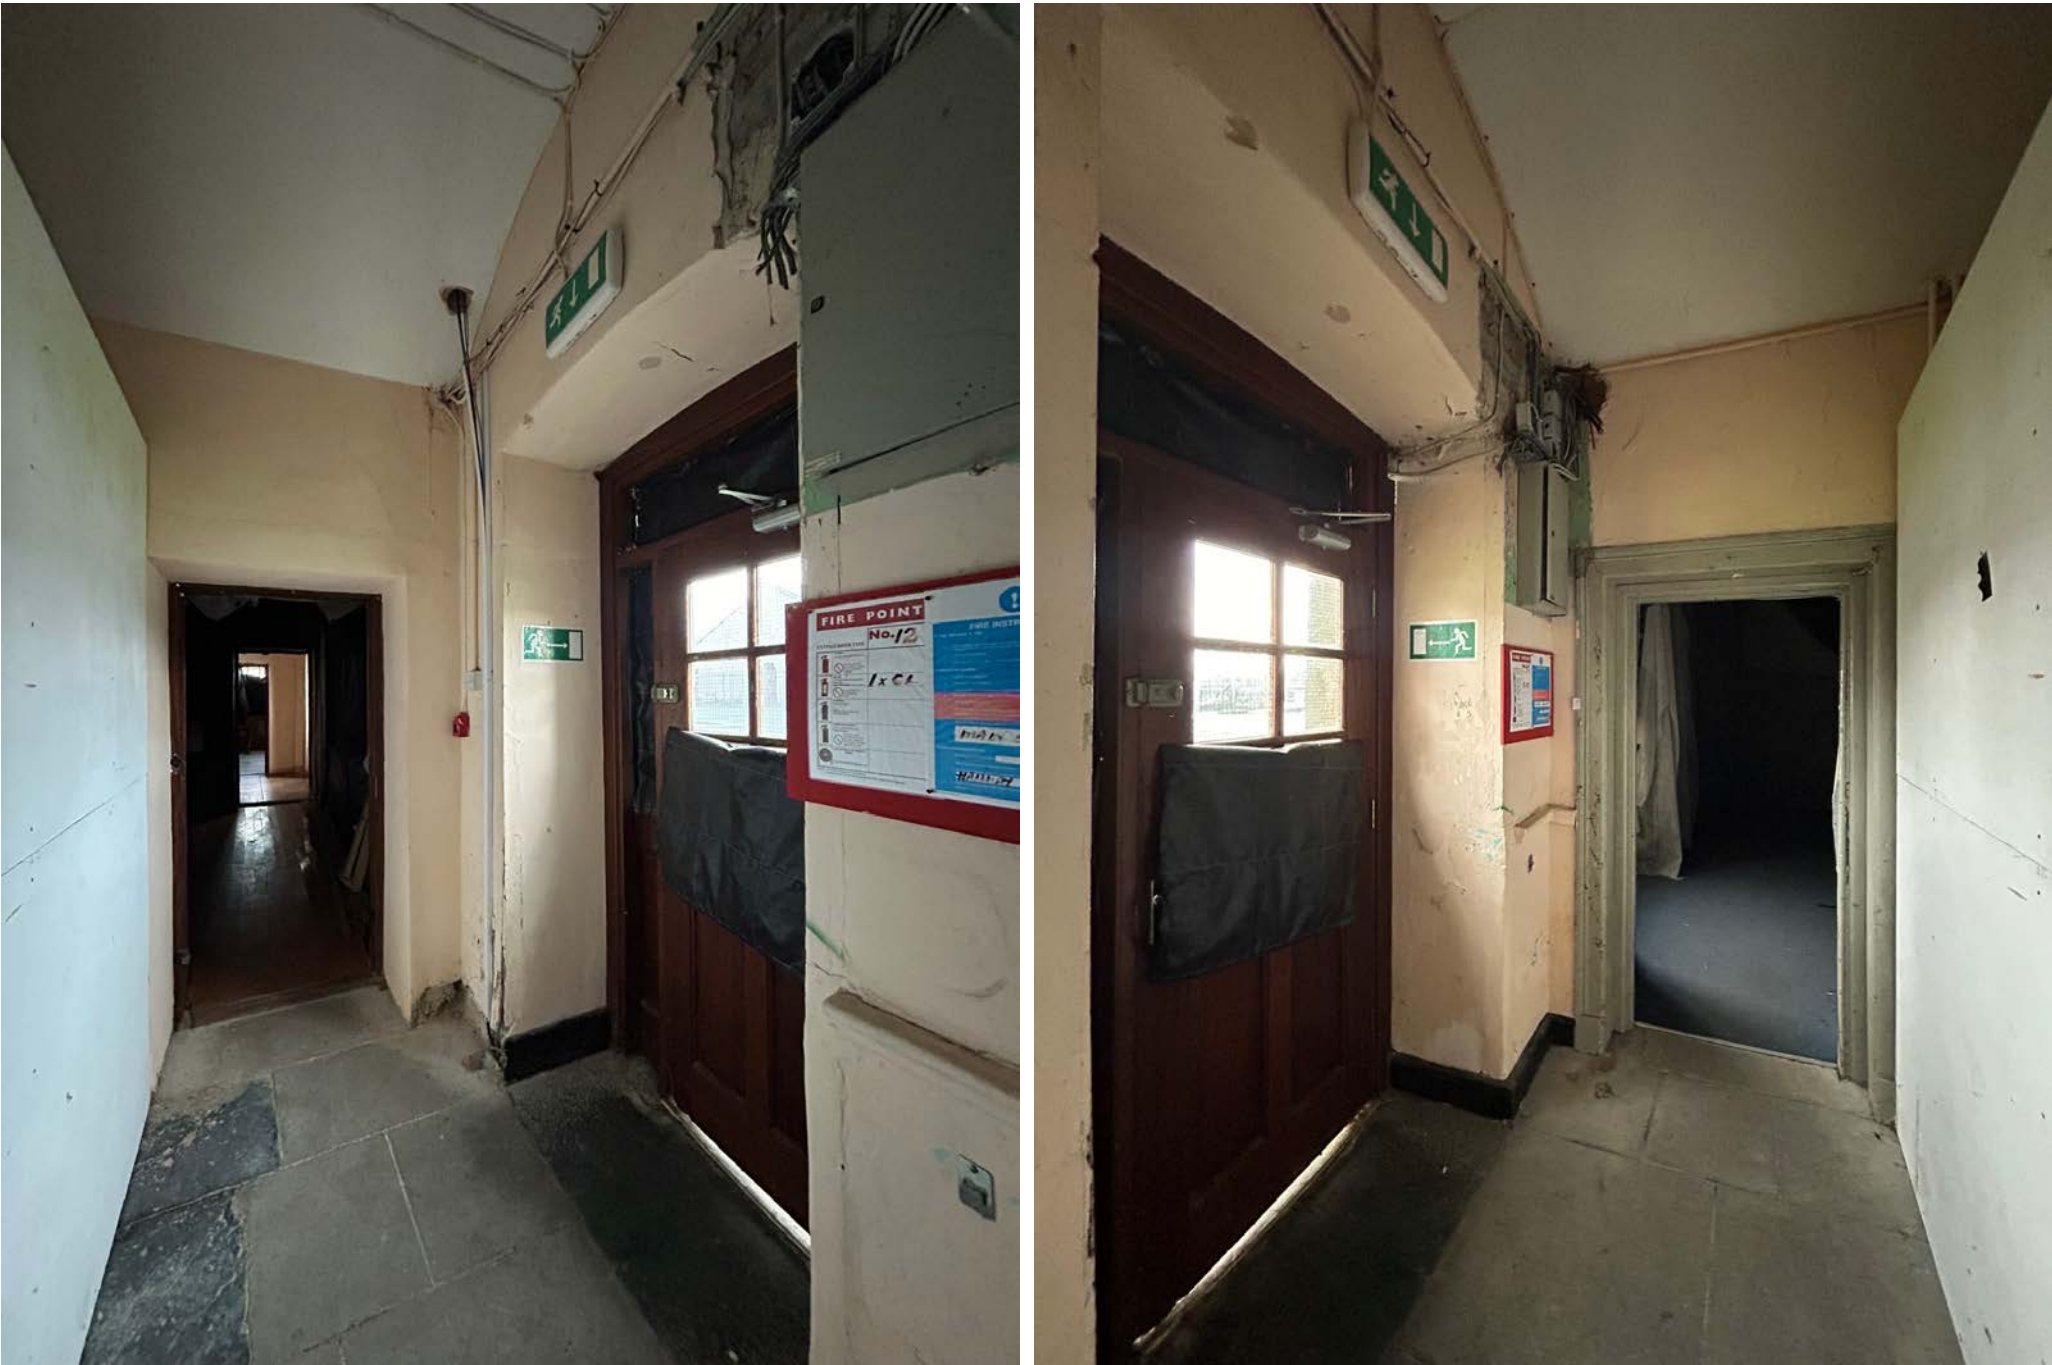
ROOM 00.ST.03

The entrance hall is plain and unadorned in character with no ornamental historic plasterwork or timber features evident, such as cornice-work, dado rails, architraves or roses. Glazed timber door and fixed surround screen and vaulted ceiling are features of significance. Historic floor finishes (stone flagstones) are features of significance.

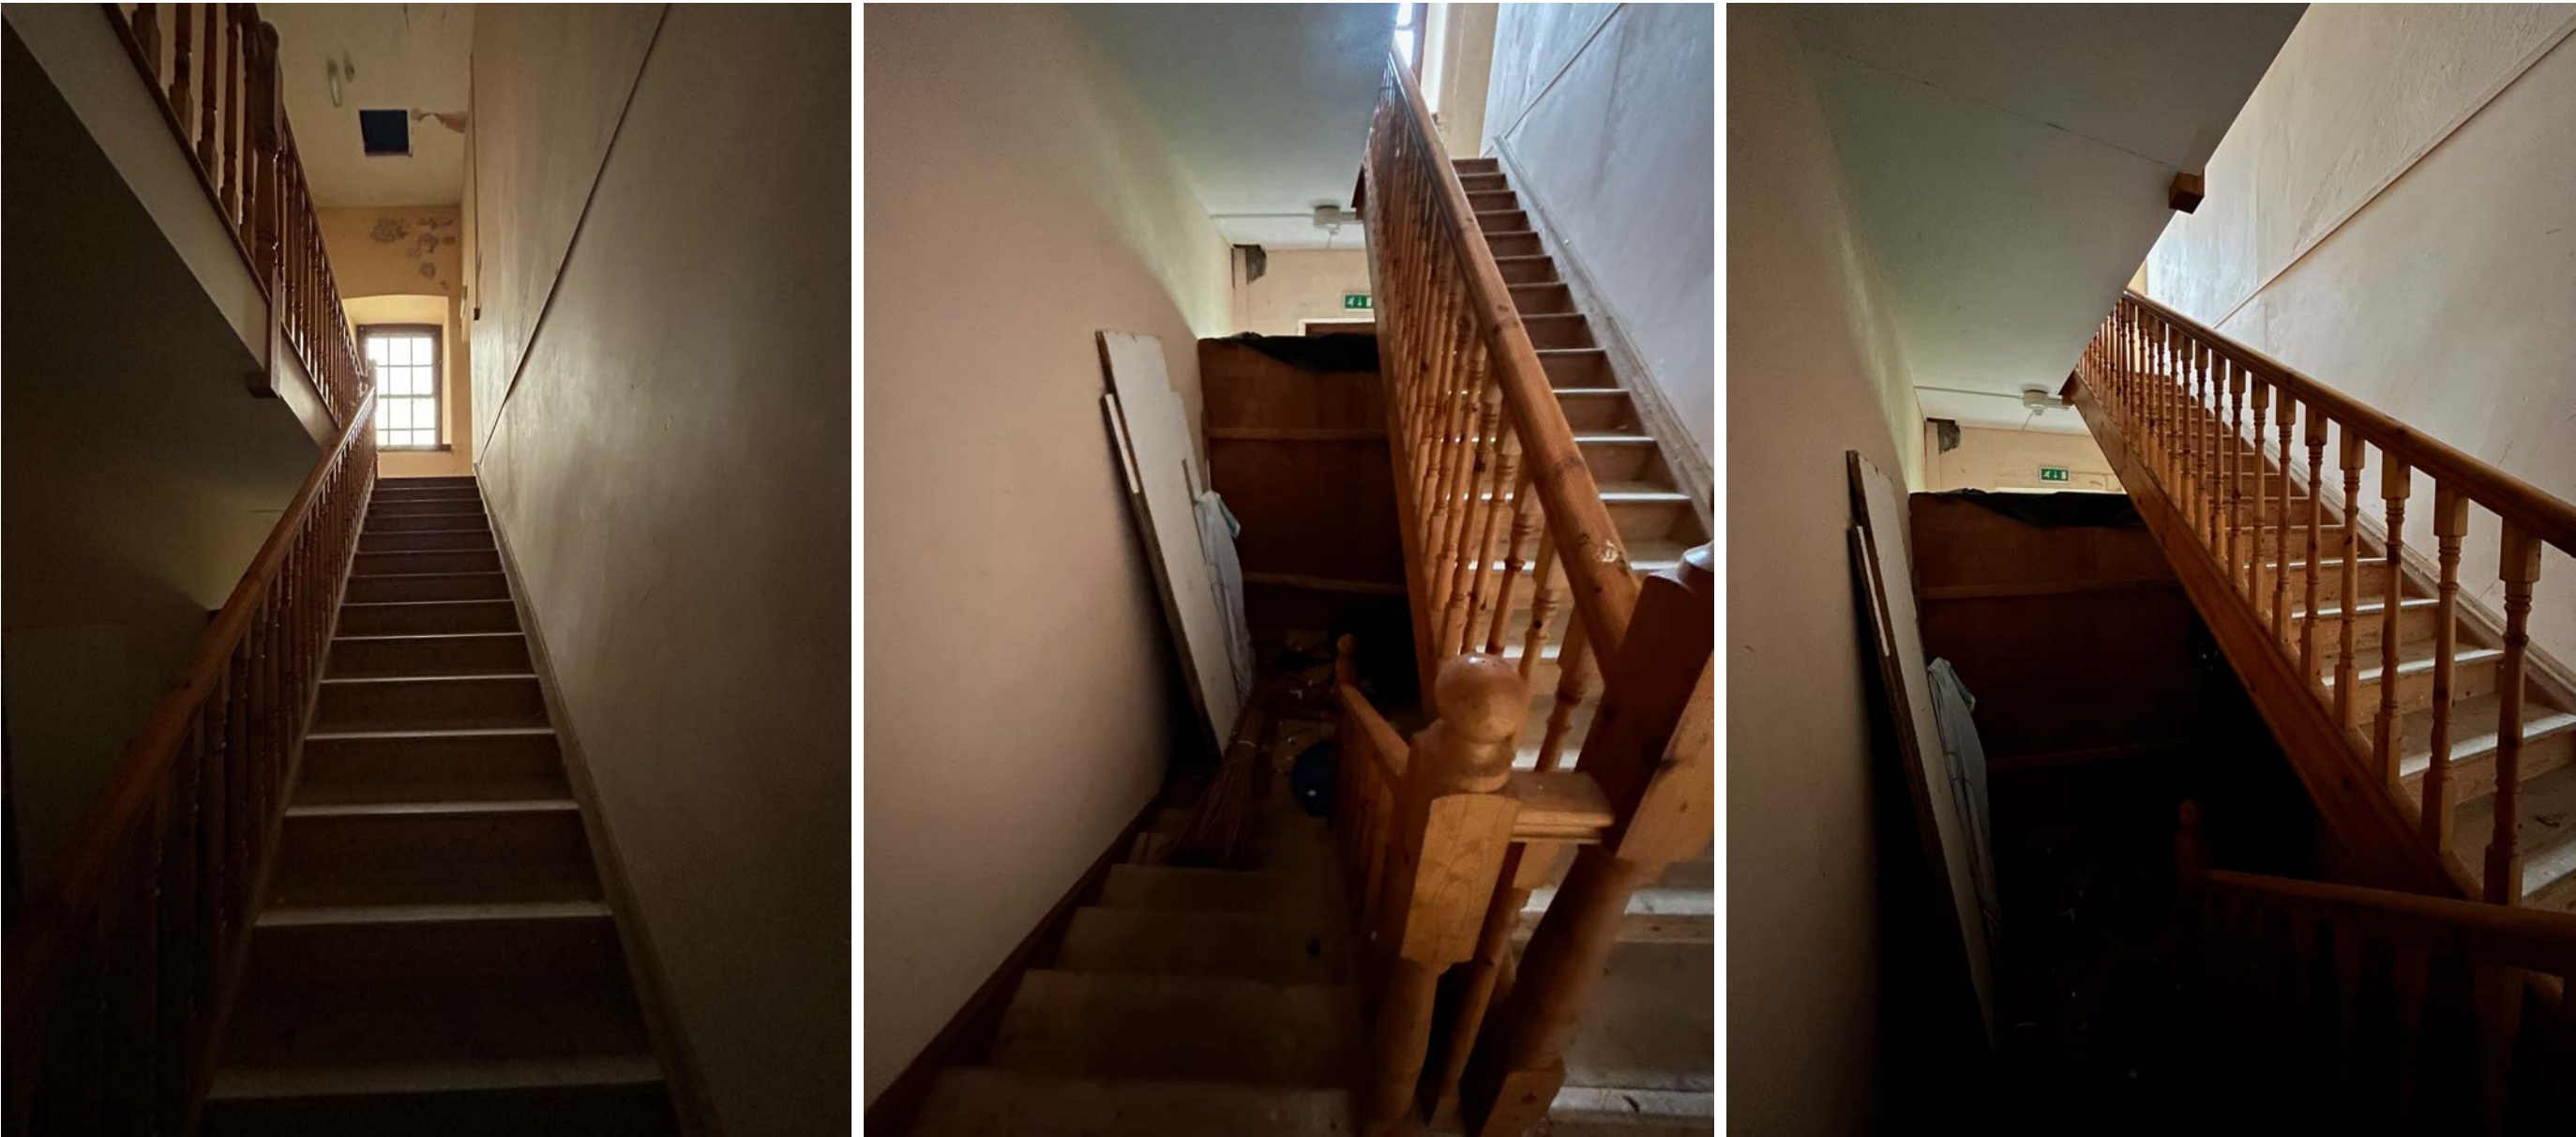
ROOM 00.ST.04

The stairwell is plain and unadorned in character with no ornamental historic plasterwork or timber features evident, such as cornice-work, dado rails, architraves or roses. Timber constructed stair, newel posts, spindles and handrails appear to be of 20th century origin and do not contribute to significance.

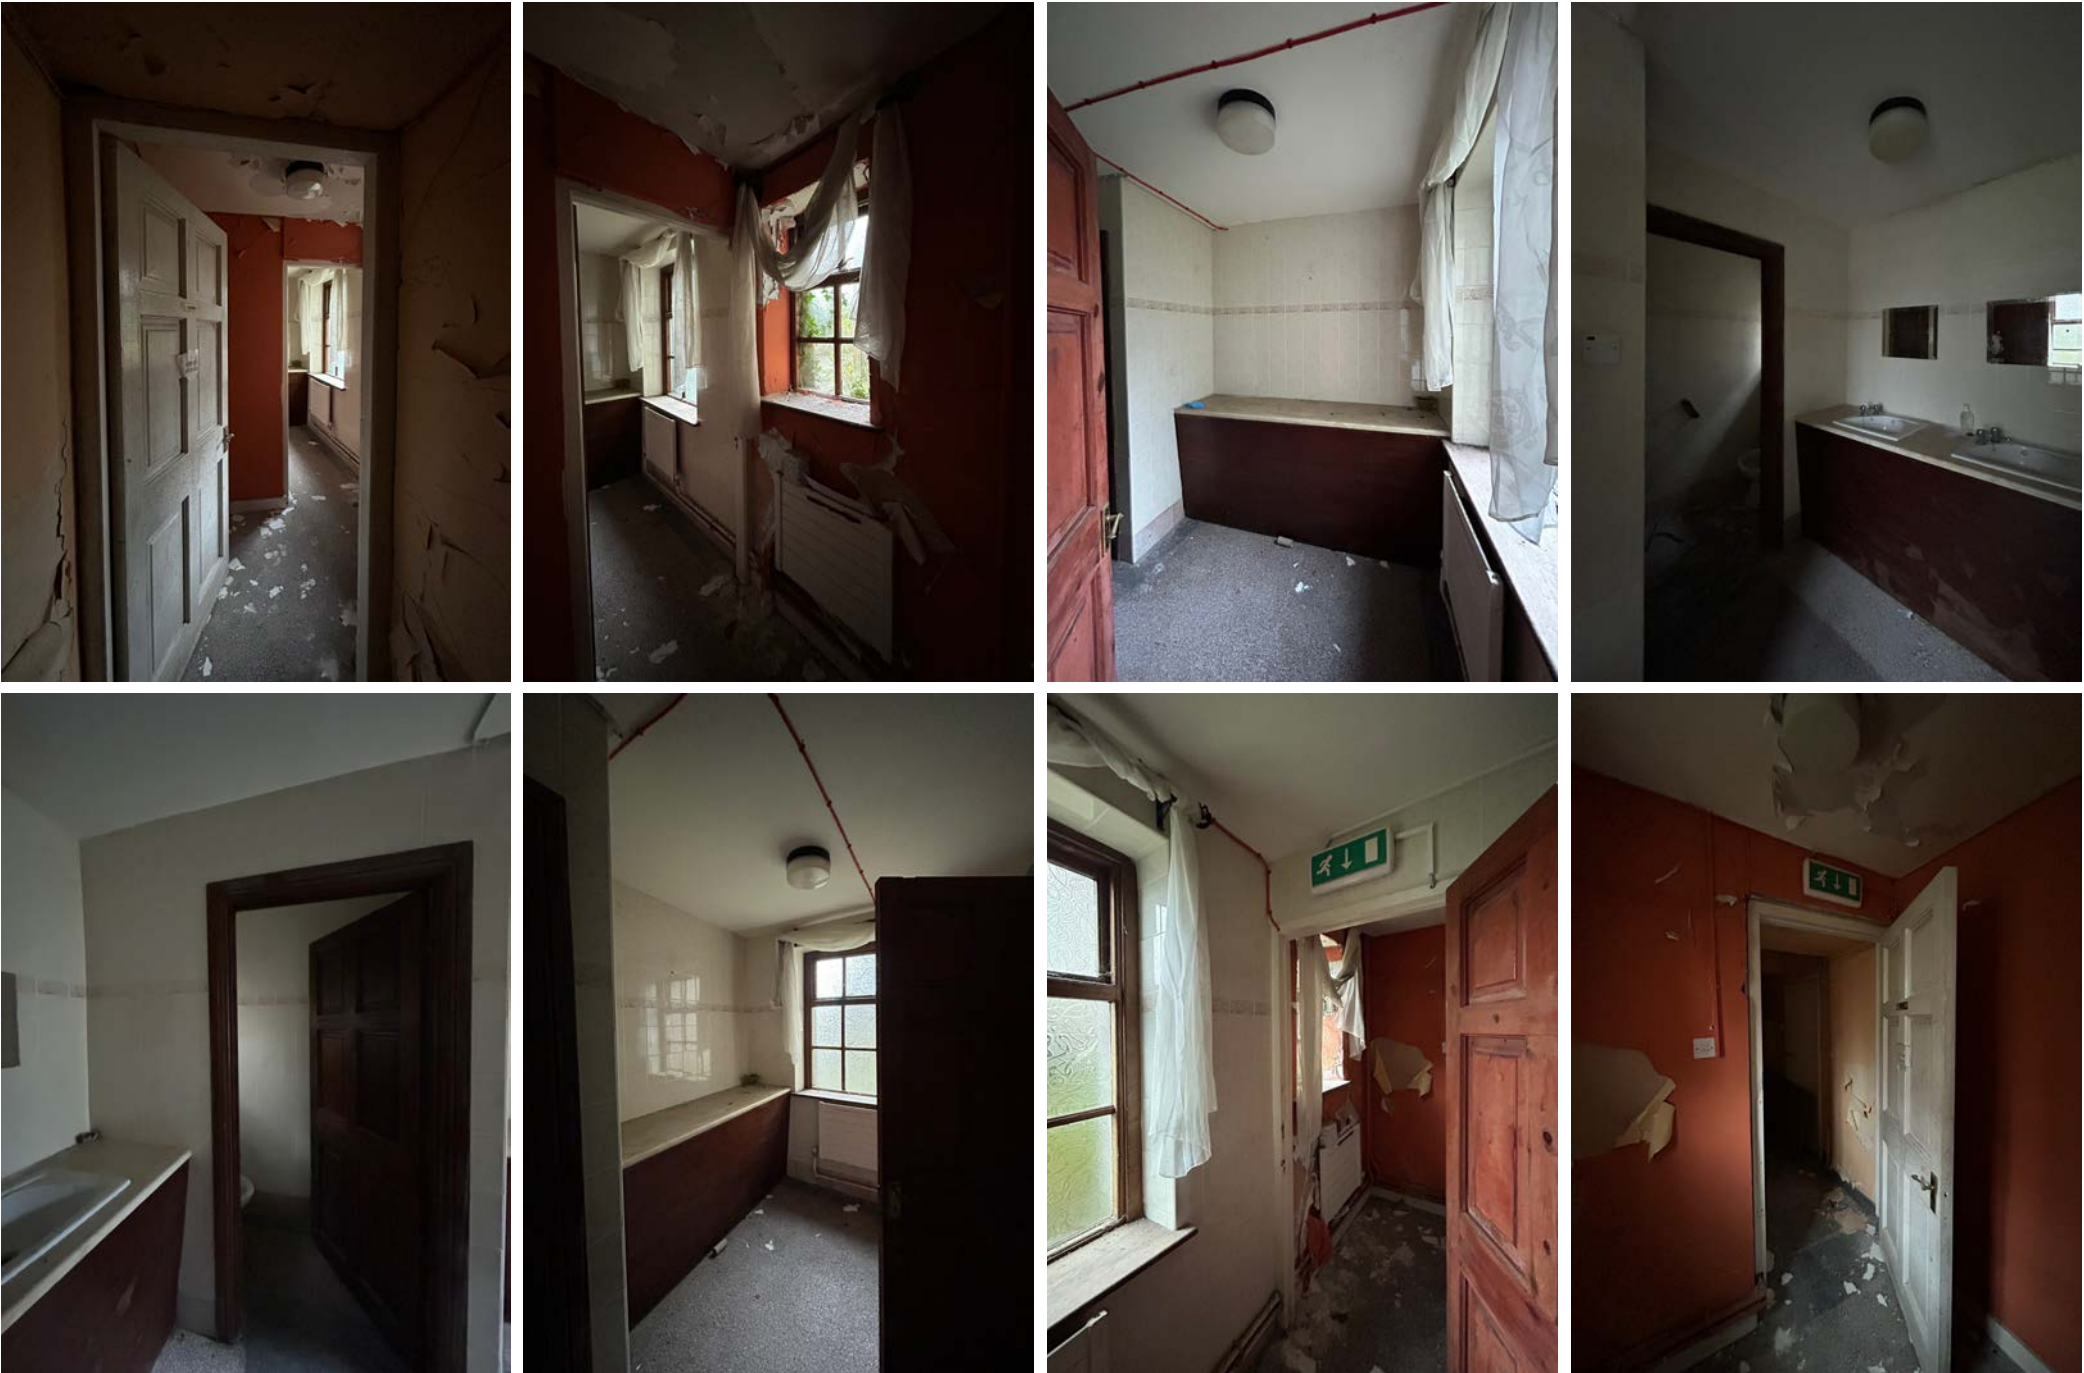
ROOM 00.A.01

The room is plain and unadorned in character with no ornamental historic plasterwork or timber features evident, such as cornice-work, dado rails, architraves or roses. Sanitaryware, fitted joinery, partitions and doors appear to be of 20th century origin and do not contribute to significance.

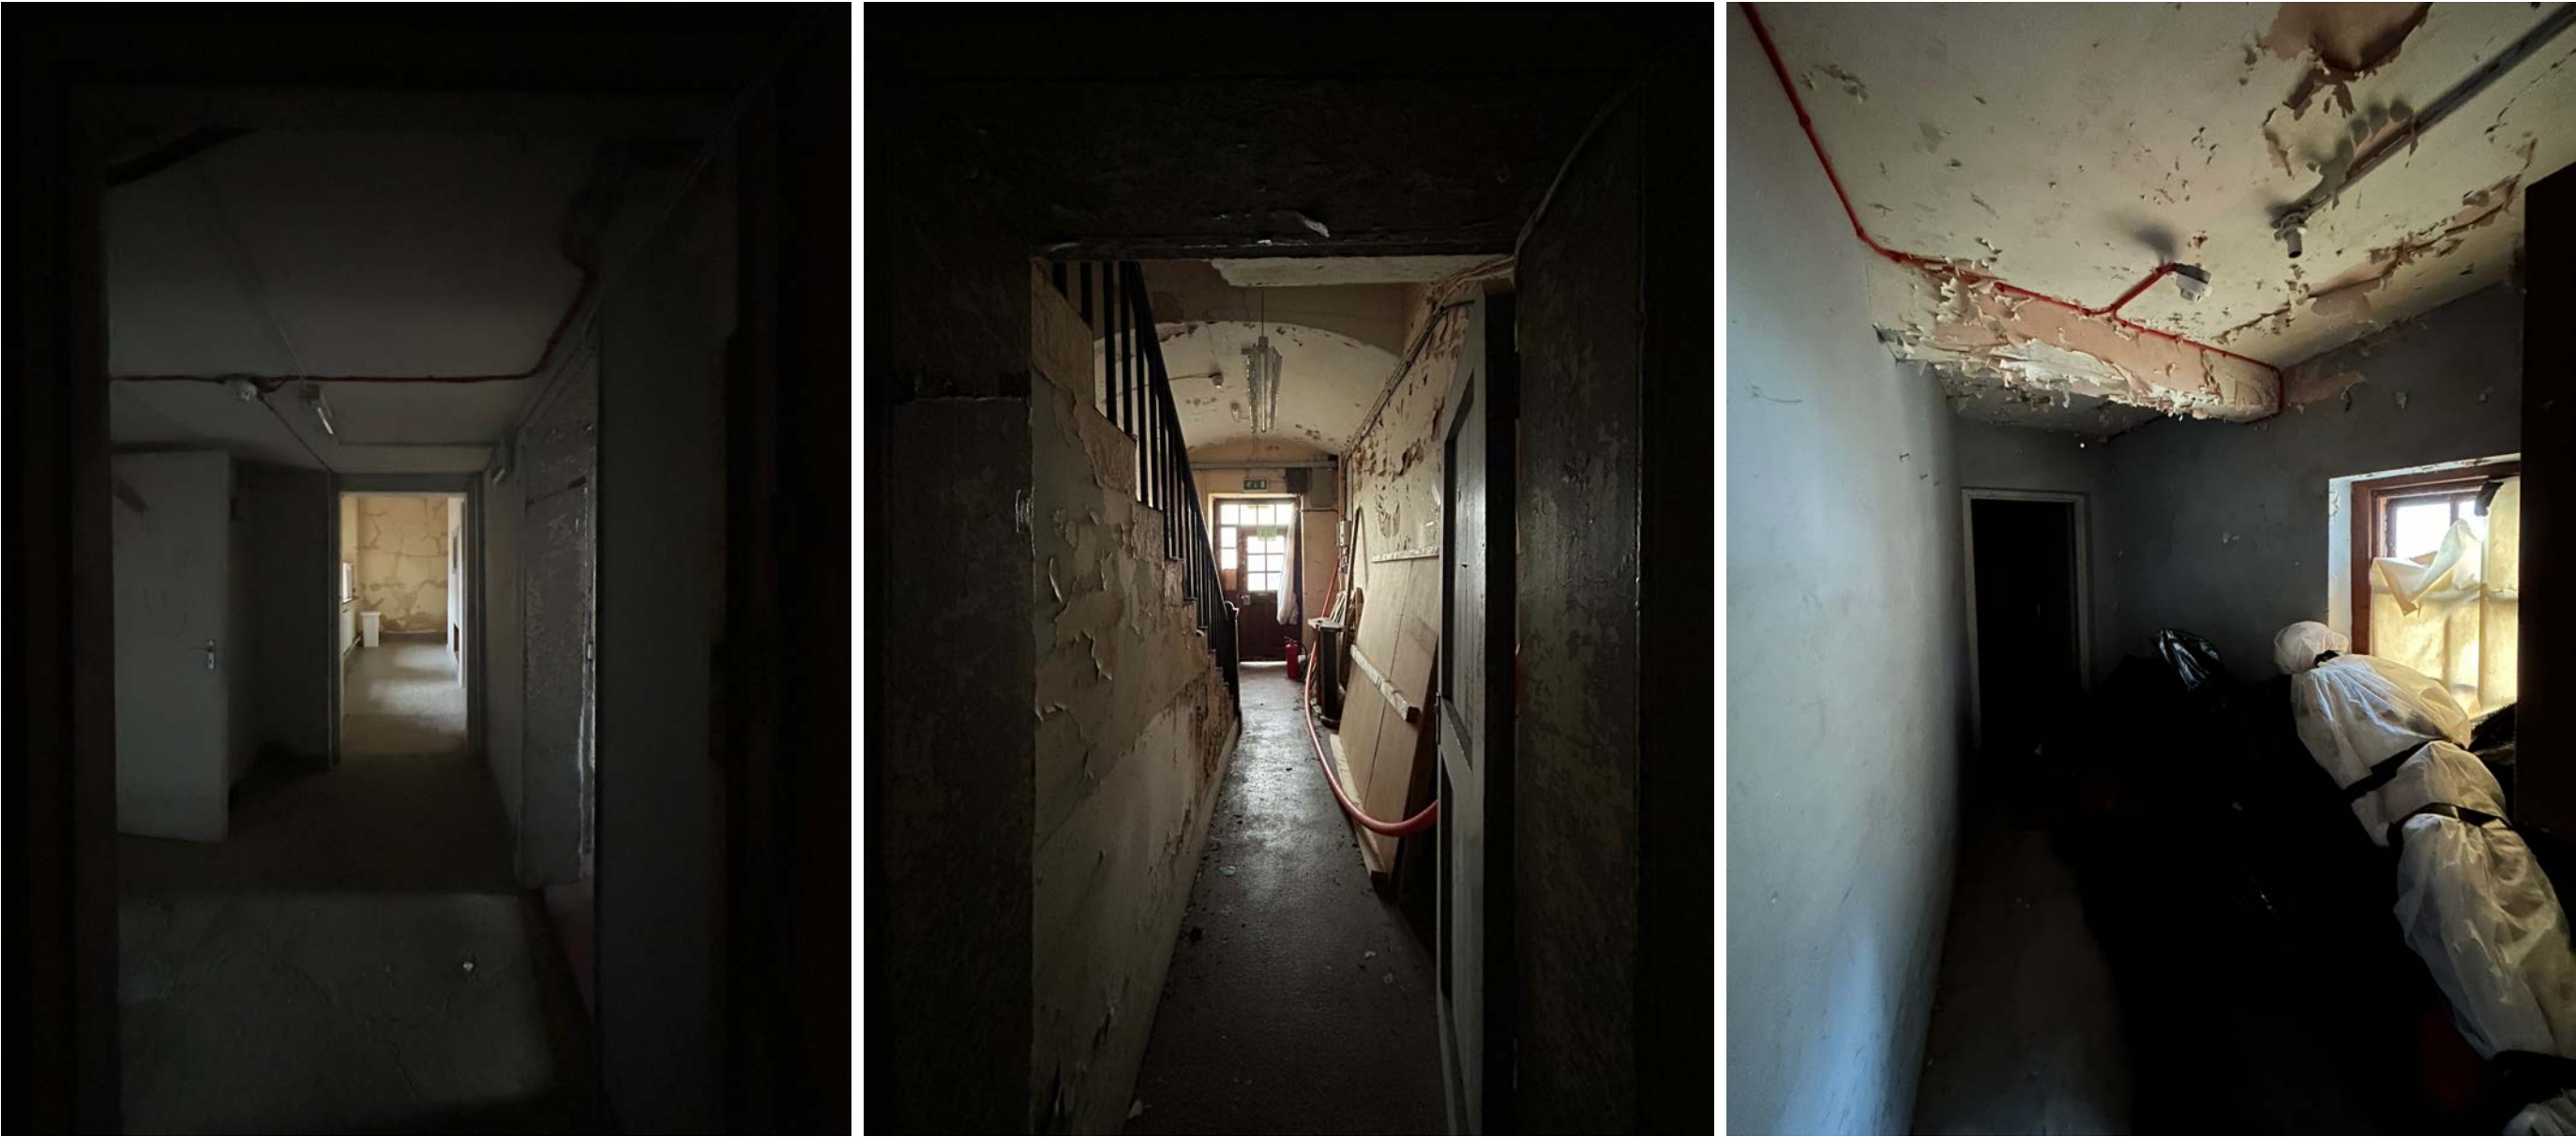
ROOM 00.A.02

The room and stairwell is plain and unadorned in character with no ornamental historic plasterwork or timber features evident, such as cornice-work, dado rails, architraves or roses. Glazed timber door and fixed surround screen, timber newel post, cast ironwork to stair, cantilevered stone stair and vaulted ceiling are features of significance. Potential historic floor finishes to be uncovered.

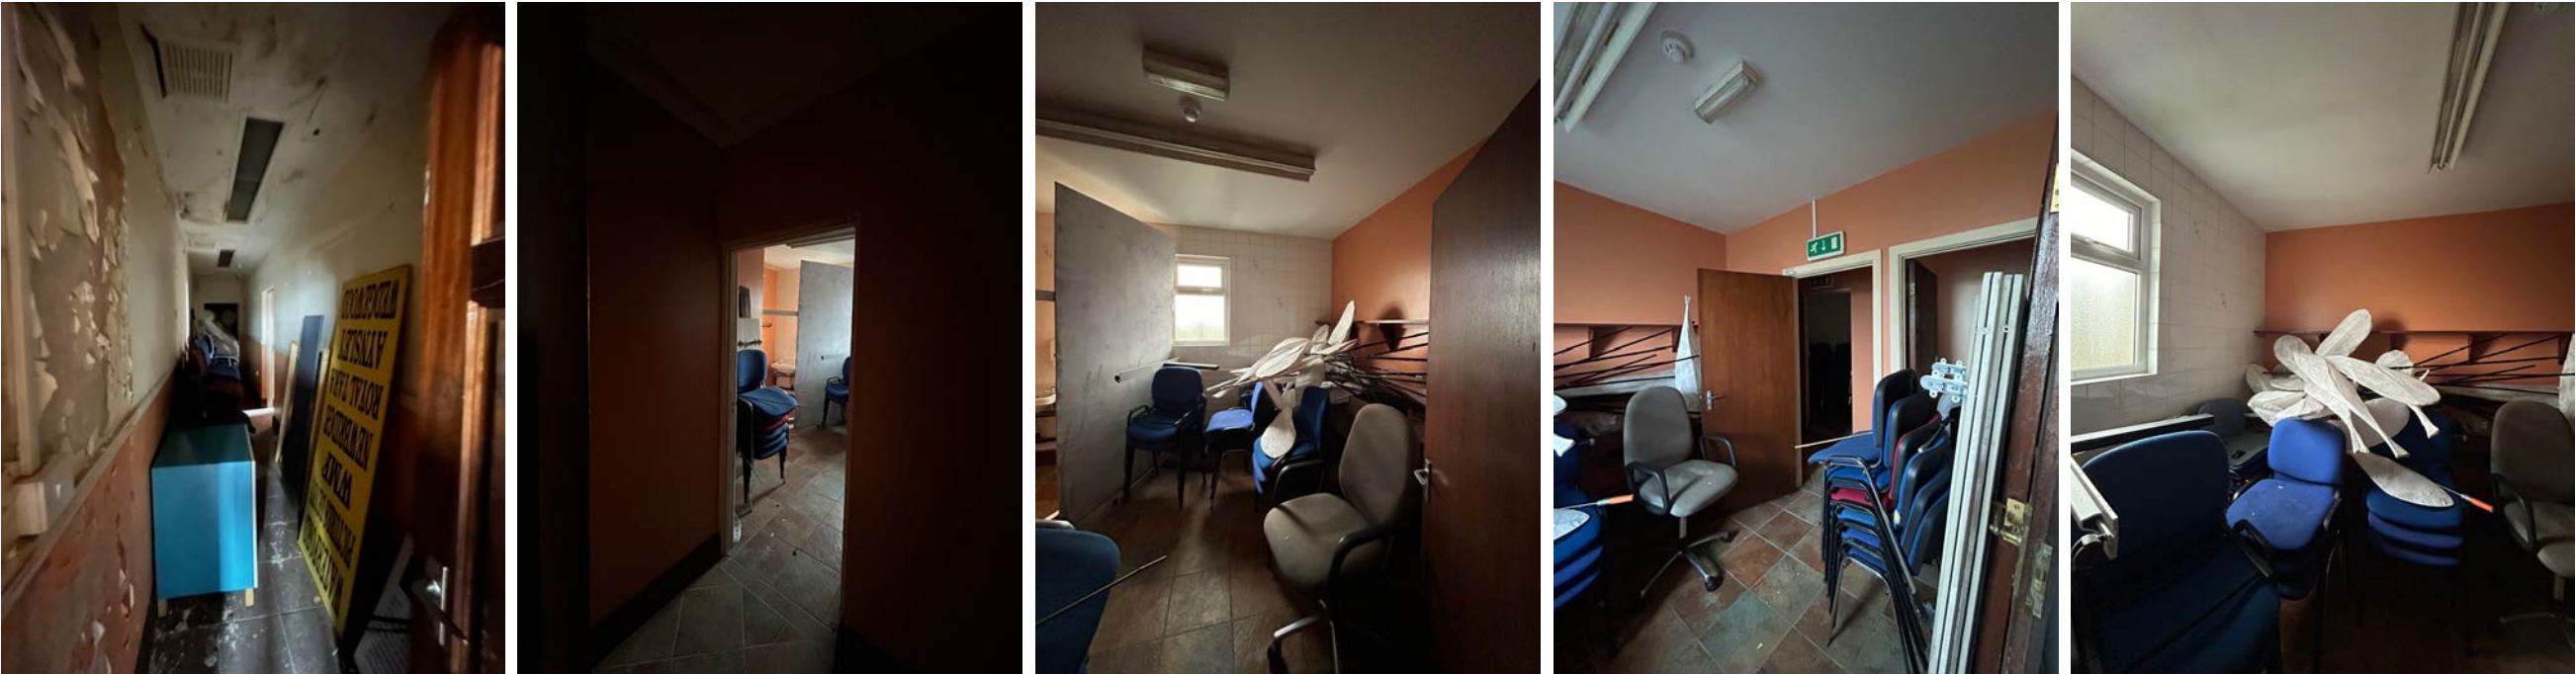
ROOM 00.A.04

The room is plain and unadorned in character with no ornamental historic plasterwork or timber features evident, such as cornice-work, dado rails, architraves or roses. Partitions and doors appear to be of 20th century origin and do not contribute to significance.

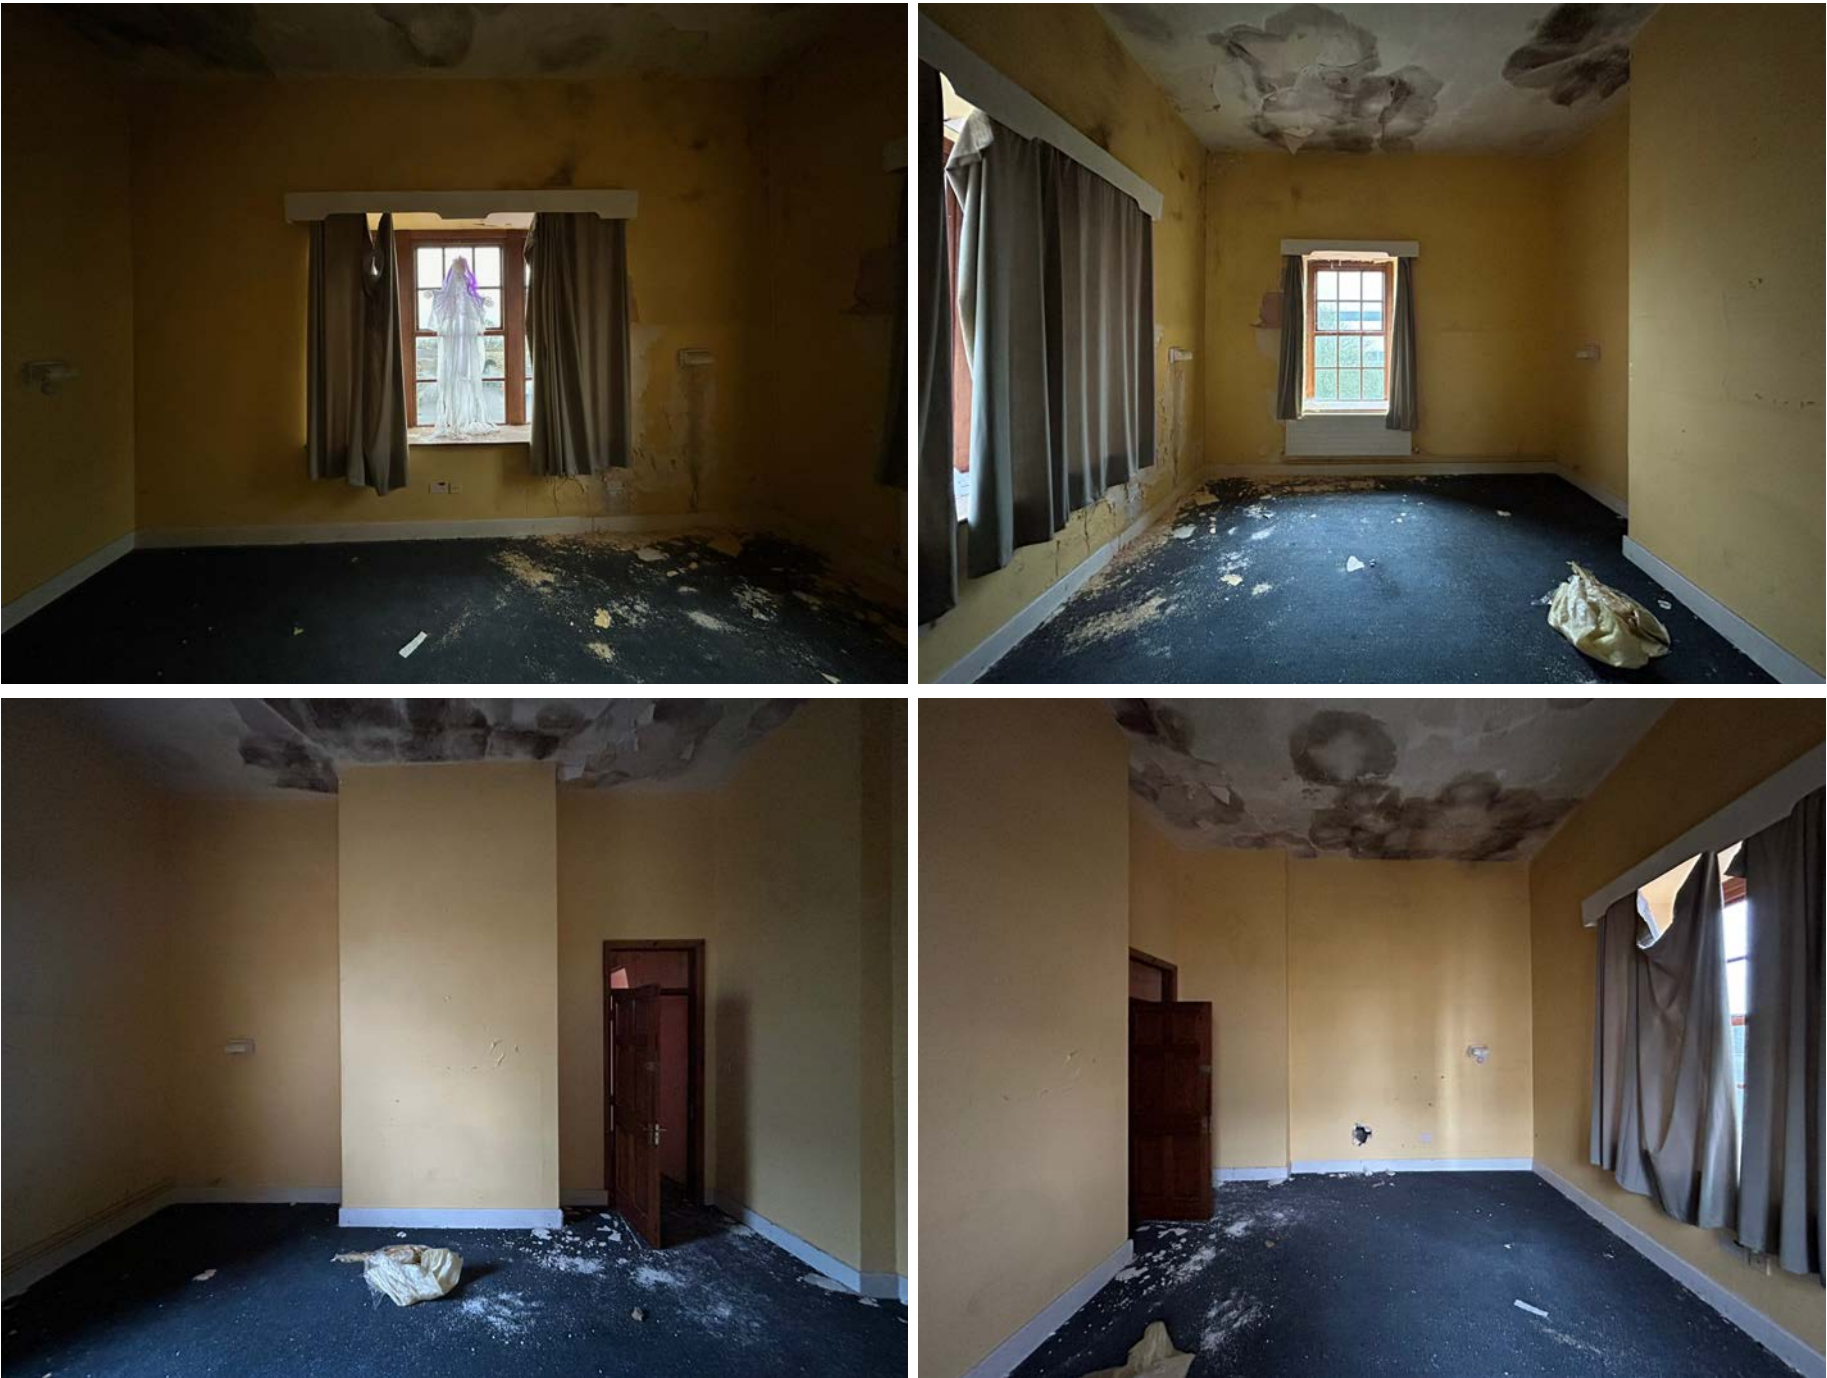
ROOM 01.S.01

The room is plain and unadorned in character with no ornamental historic plasterwork or timber features evident, such as cornice-work, dado rails, architraves or roses. The form of the chimney breast is visible but no features. Partitions and doors appear to be of 20th century origin and do not contribute to significance. Subdivision of rooms with lightweight partitions suggest the skirting boards are of 20th century origin and do not contribute to significance.
