OFFICERS BUILDING
LONGFORD | COUNTY LONGFORD
ARCHITECTURAL HERITAGE IMPACT ASSESSMENT REPORT

ROBIN LEE ARCHITECTURE
JANUARY 2025

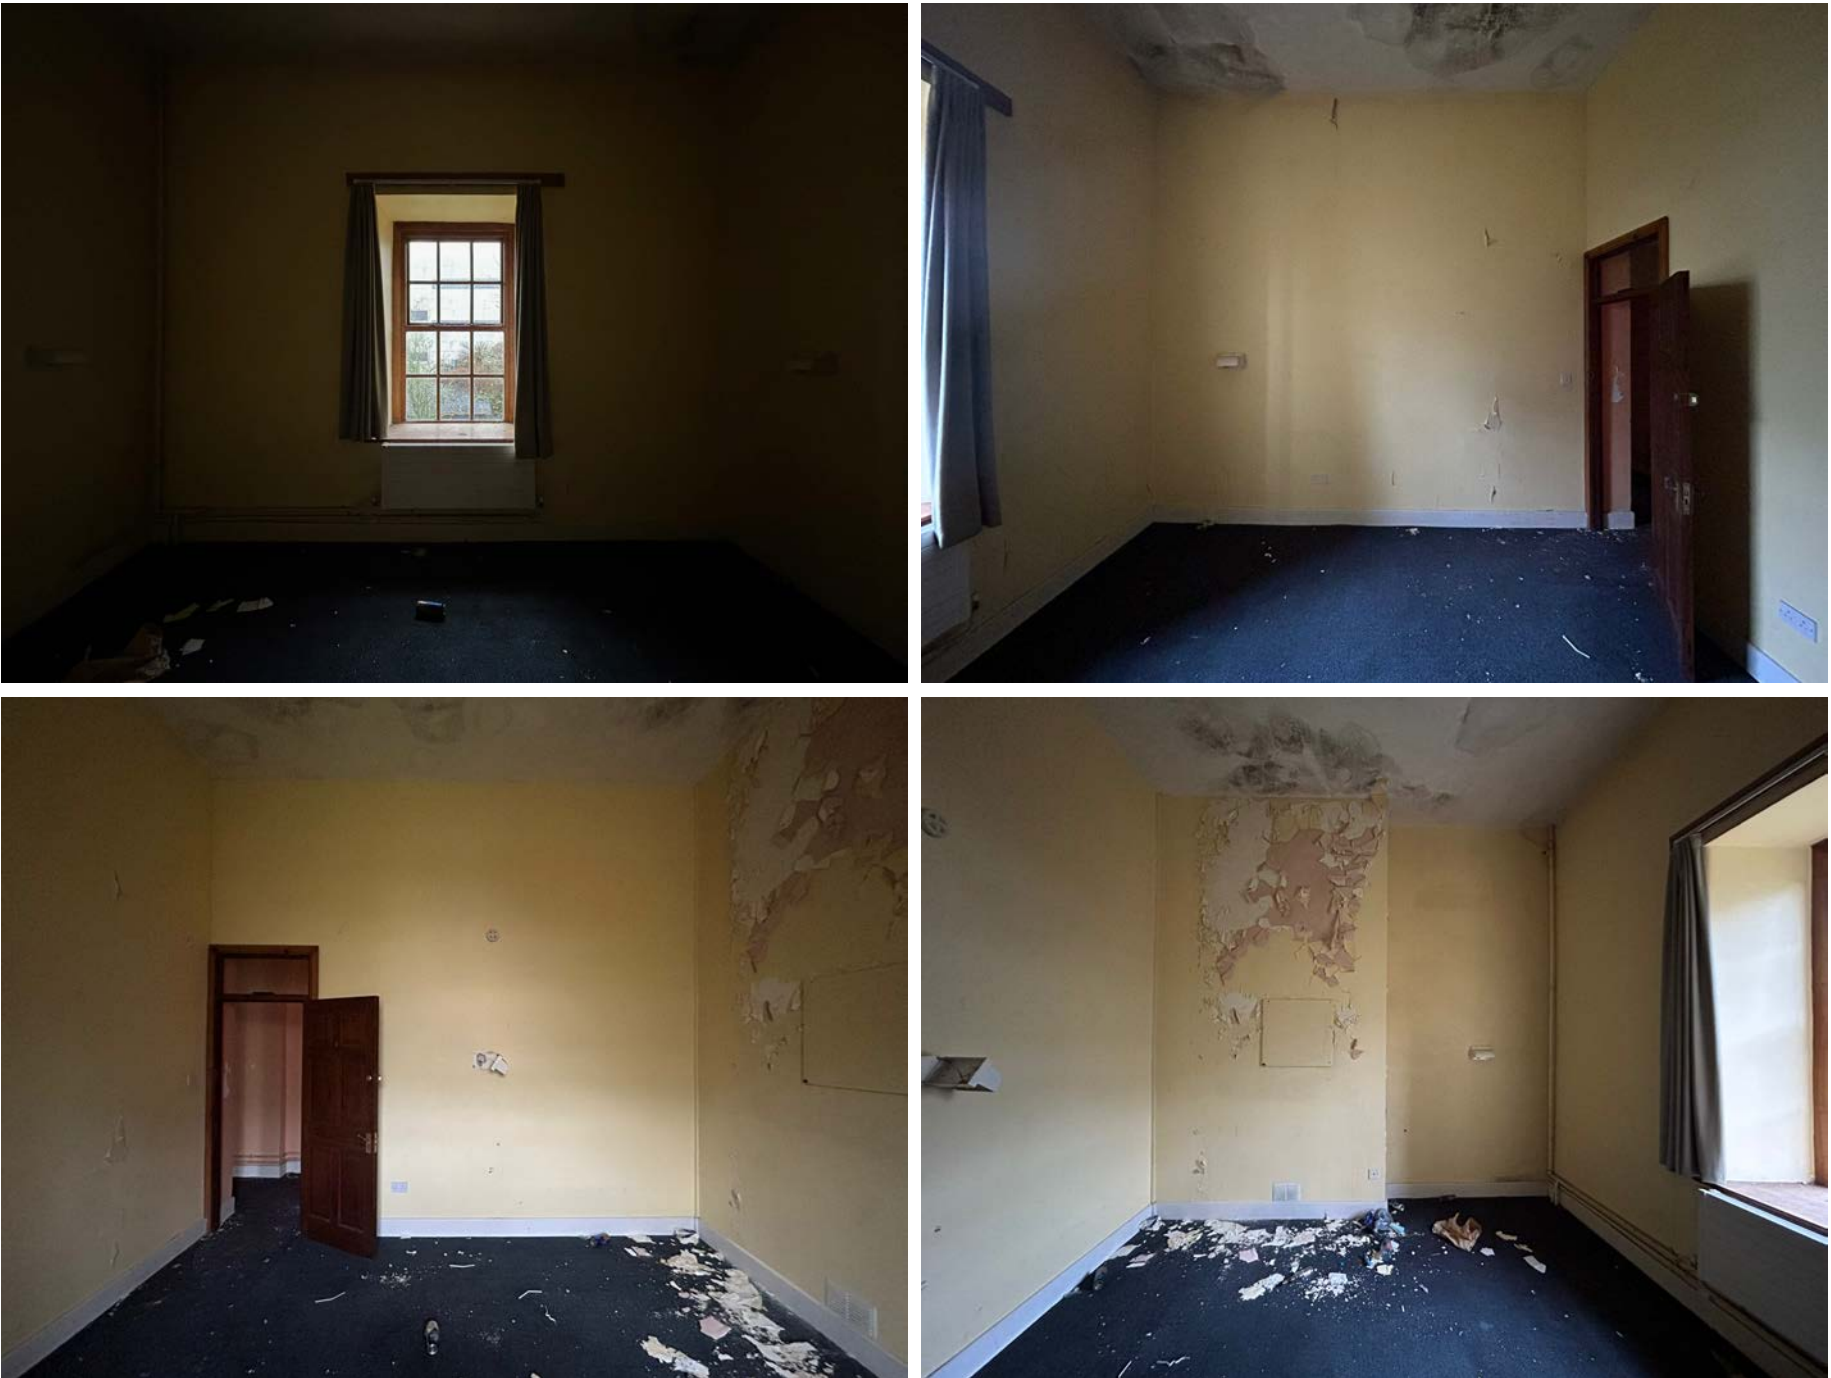
ROOM 01.S.02

The room is plain and unadorned in character with no ornamental historic plasterwork or timber features evident, such as cornice-work, dado rails, architraves or roses. The form of the chimney breast is visible but no features. Partitions and doors appear to be of 20th century origin and do not contribute to significance. Subdivision of rooms with lightweight partitions suggest the skirting boards are of 20th century origin and do not contribute to significance.

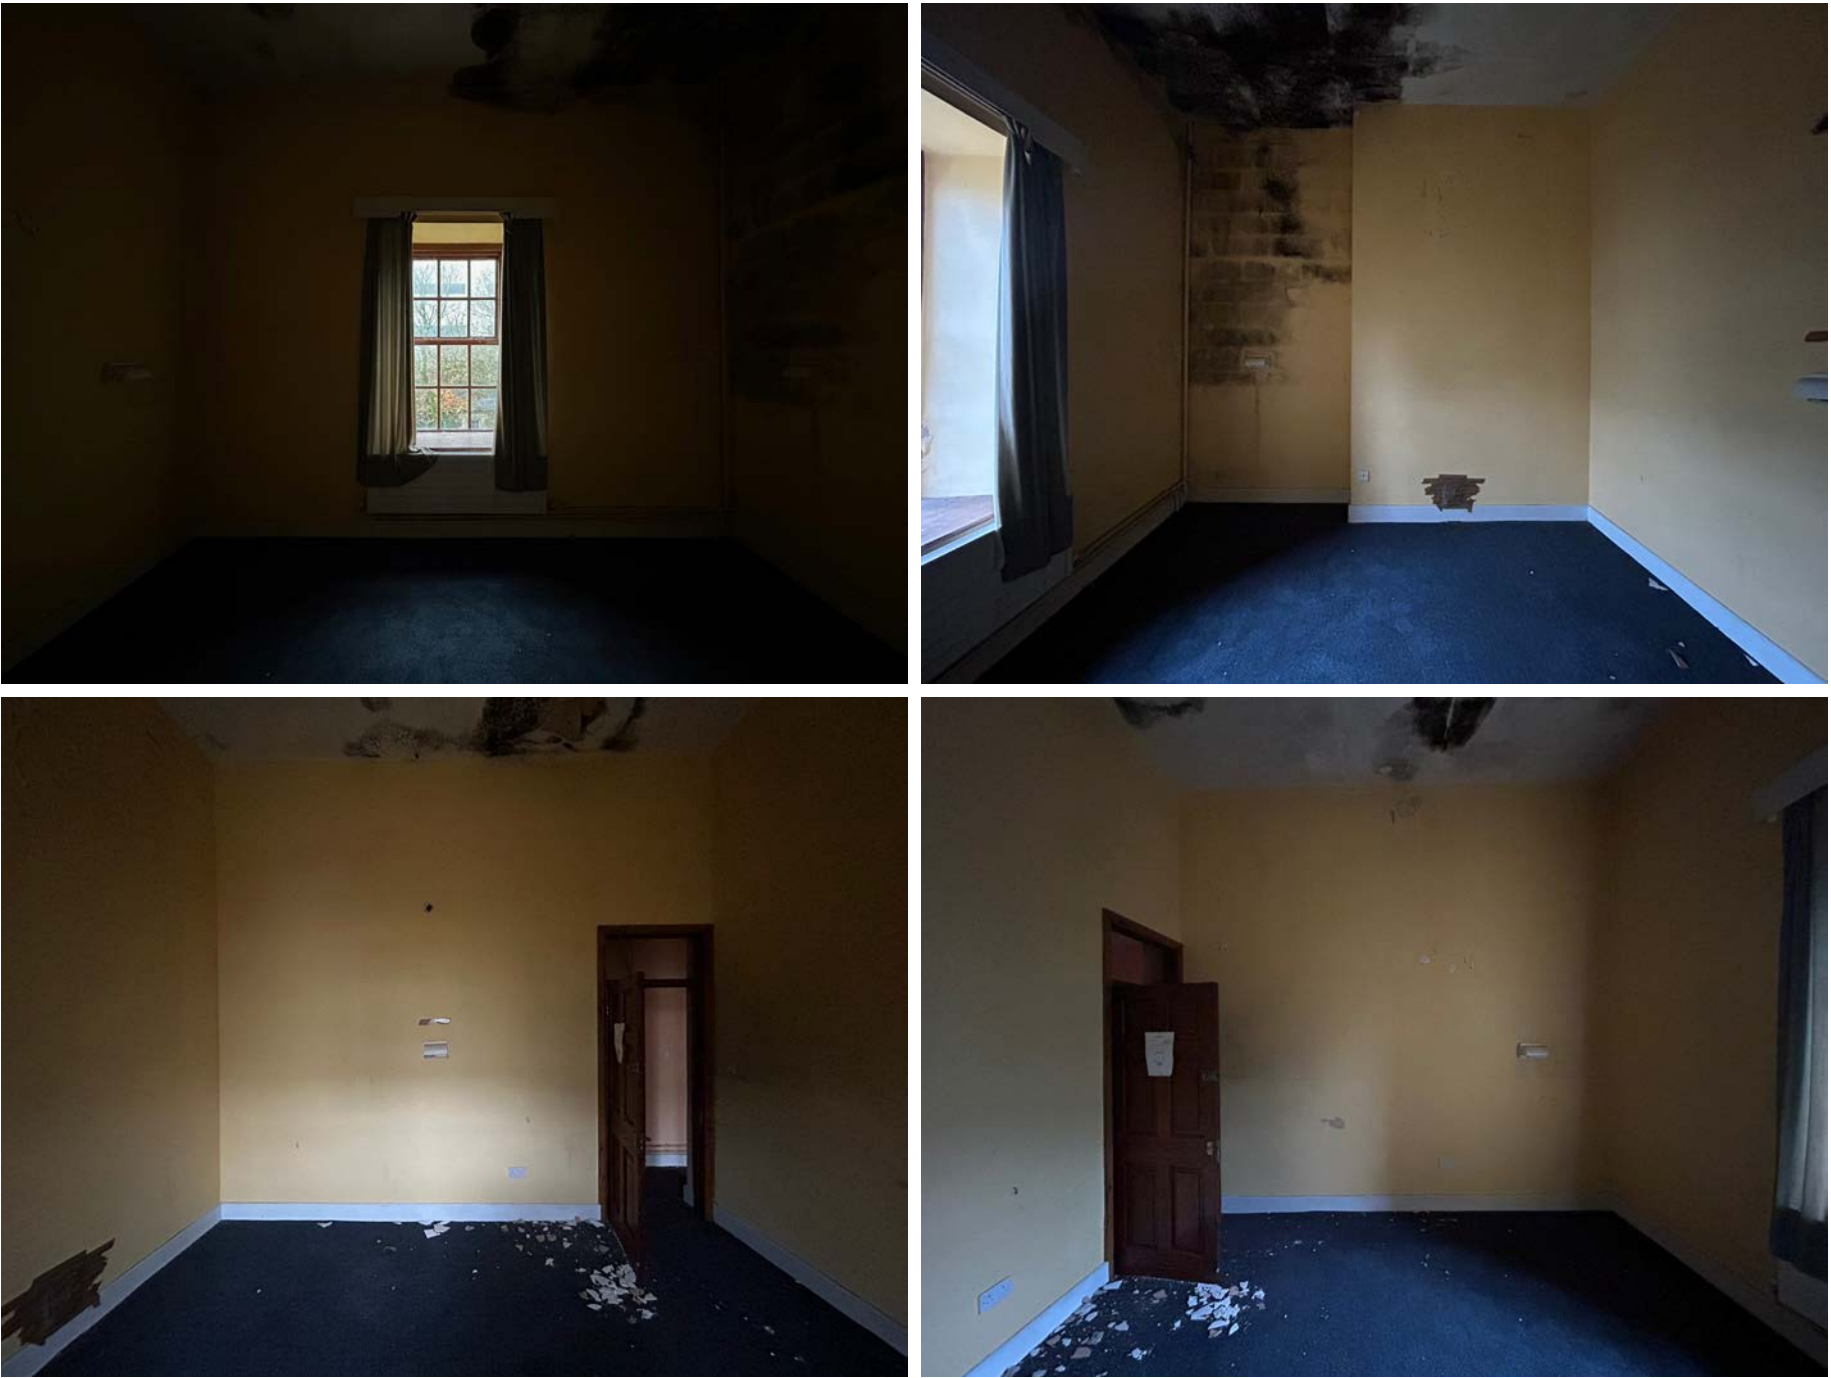
ROOM 01.S.03

The room is plain and unadorned in character with no ornamental historic plasterwork or timber features evident, such as cornice-work, dado rails, architraves or roses. The form of the chimney breast is visible but no features. Partitions and doors appear to be of 20th century origin and do not contribute to significance. Subdivision of rooms with lightweight partitions suggest the skirting boards are of 20th century origin and do not contribute to significance.

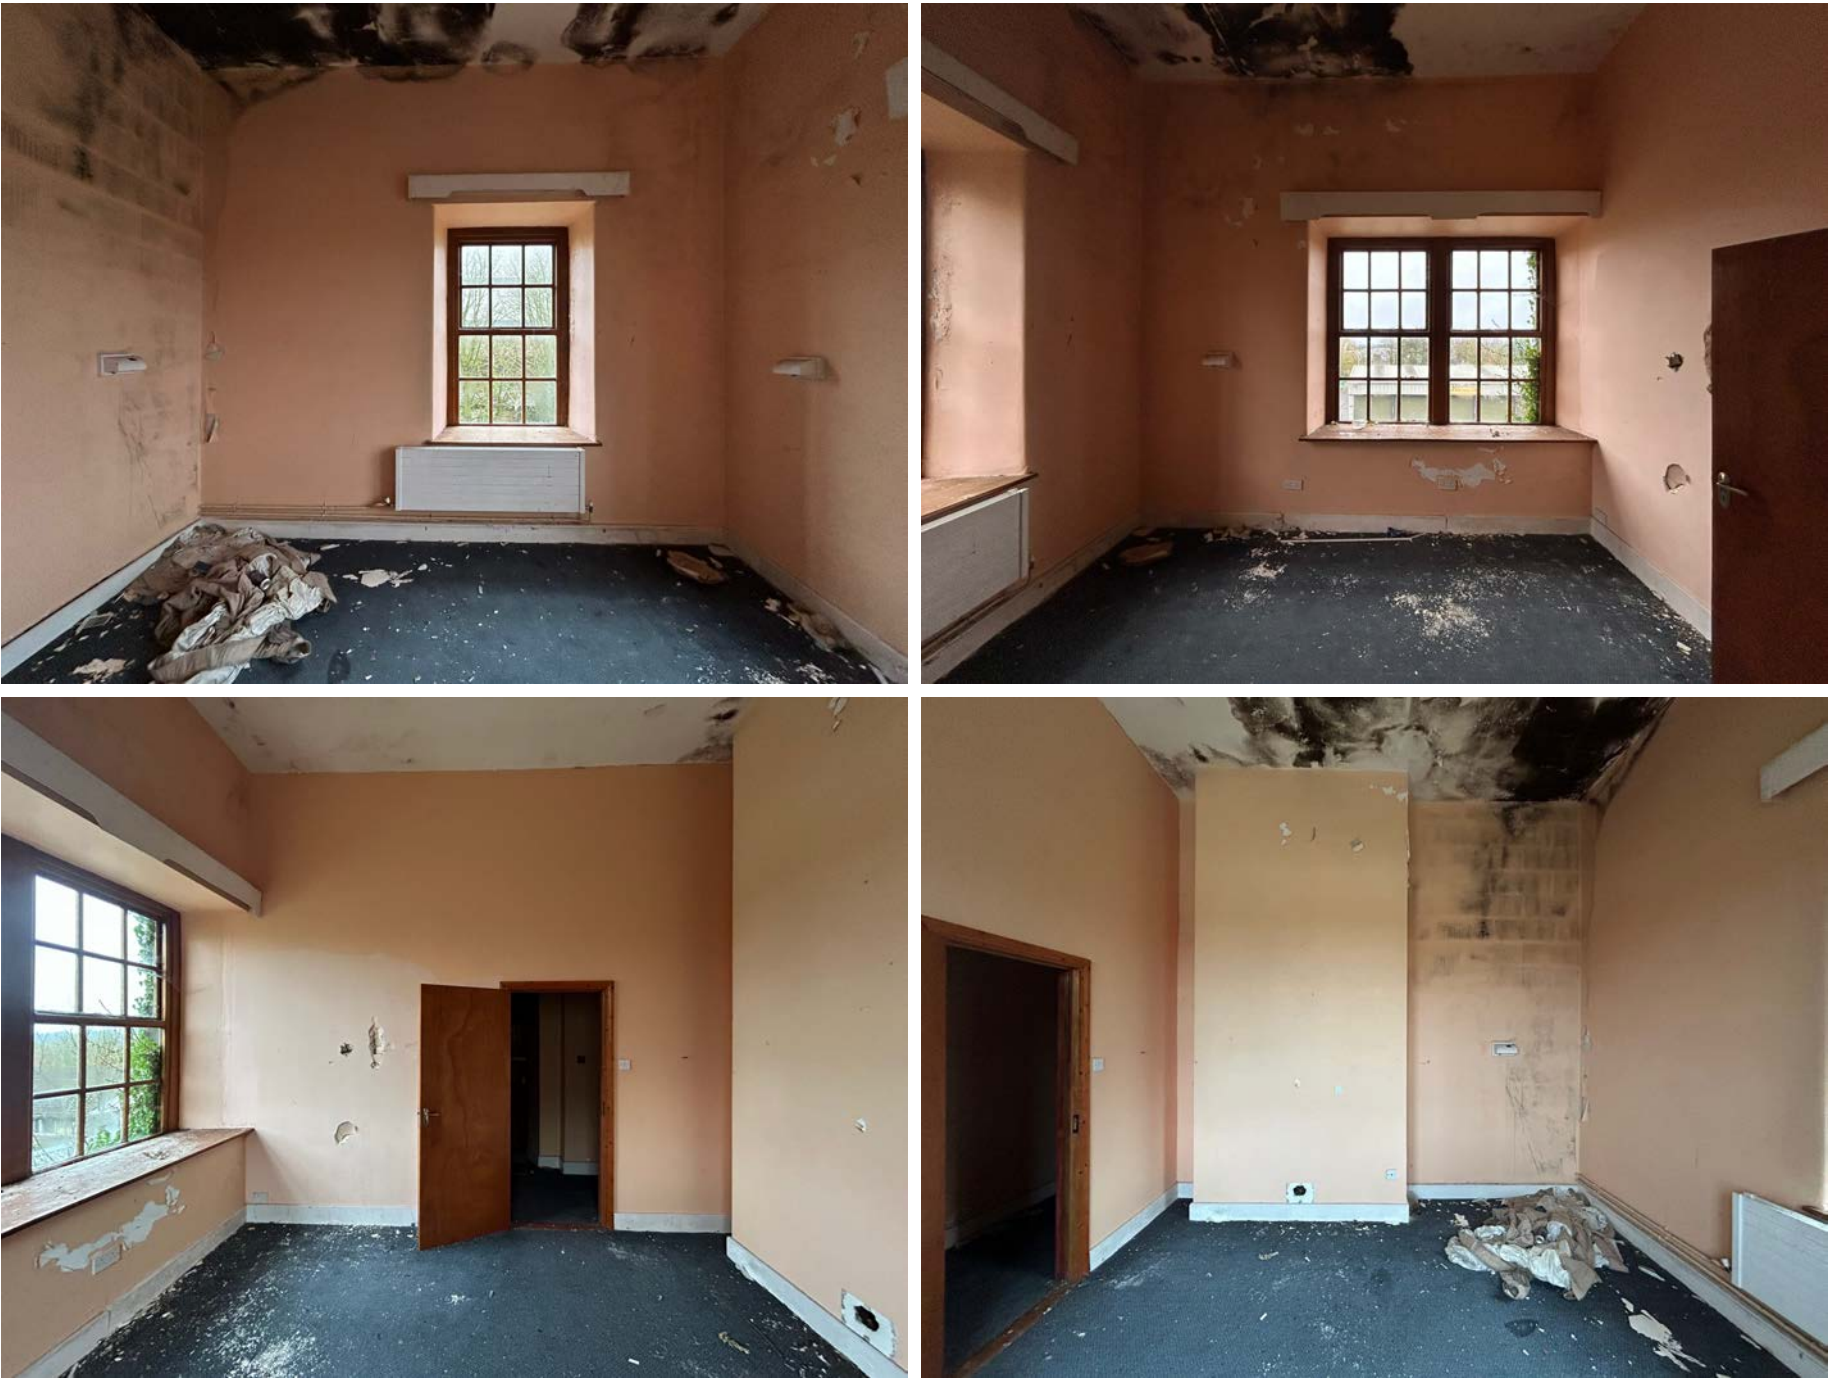
ROOM 01.S.04

The room is plain and unadorned in character with no ornamental historic plasterwork or timber features evident, such as cornice-work, dado rails, architraves or roses. The form of the chimney breast is visible but no features. Partitions and doors appear to be of 20th century origin and do not contribute to significance. Subdivision of rooms with lightweight partitions suggest the skirting boards are of 20th century origin and do not contribute to significance.

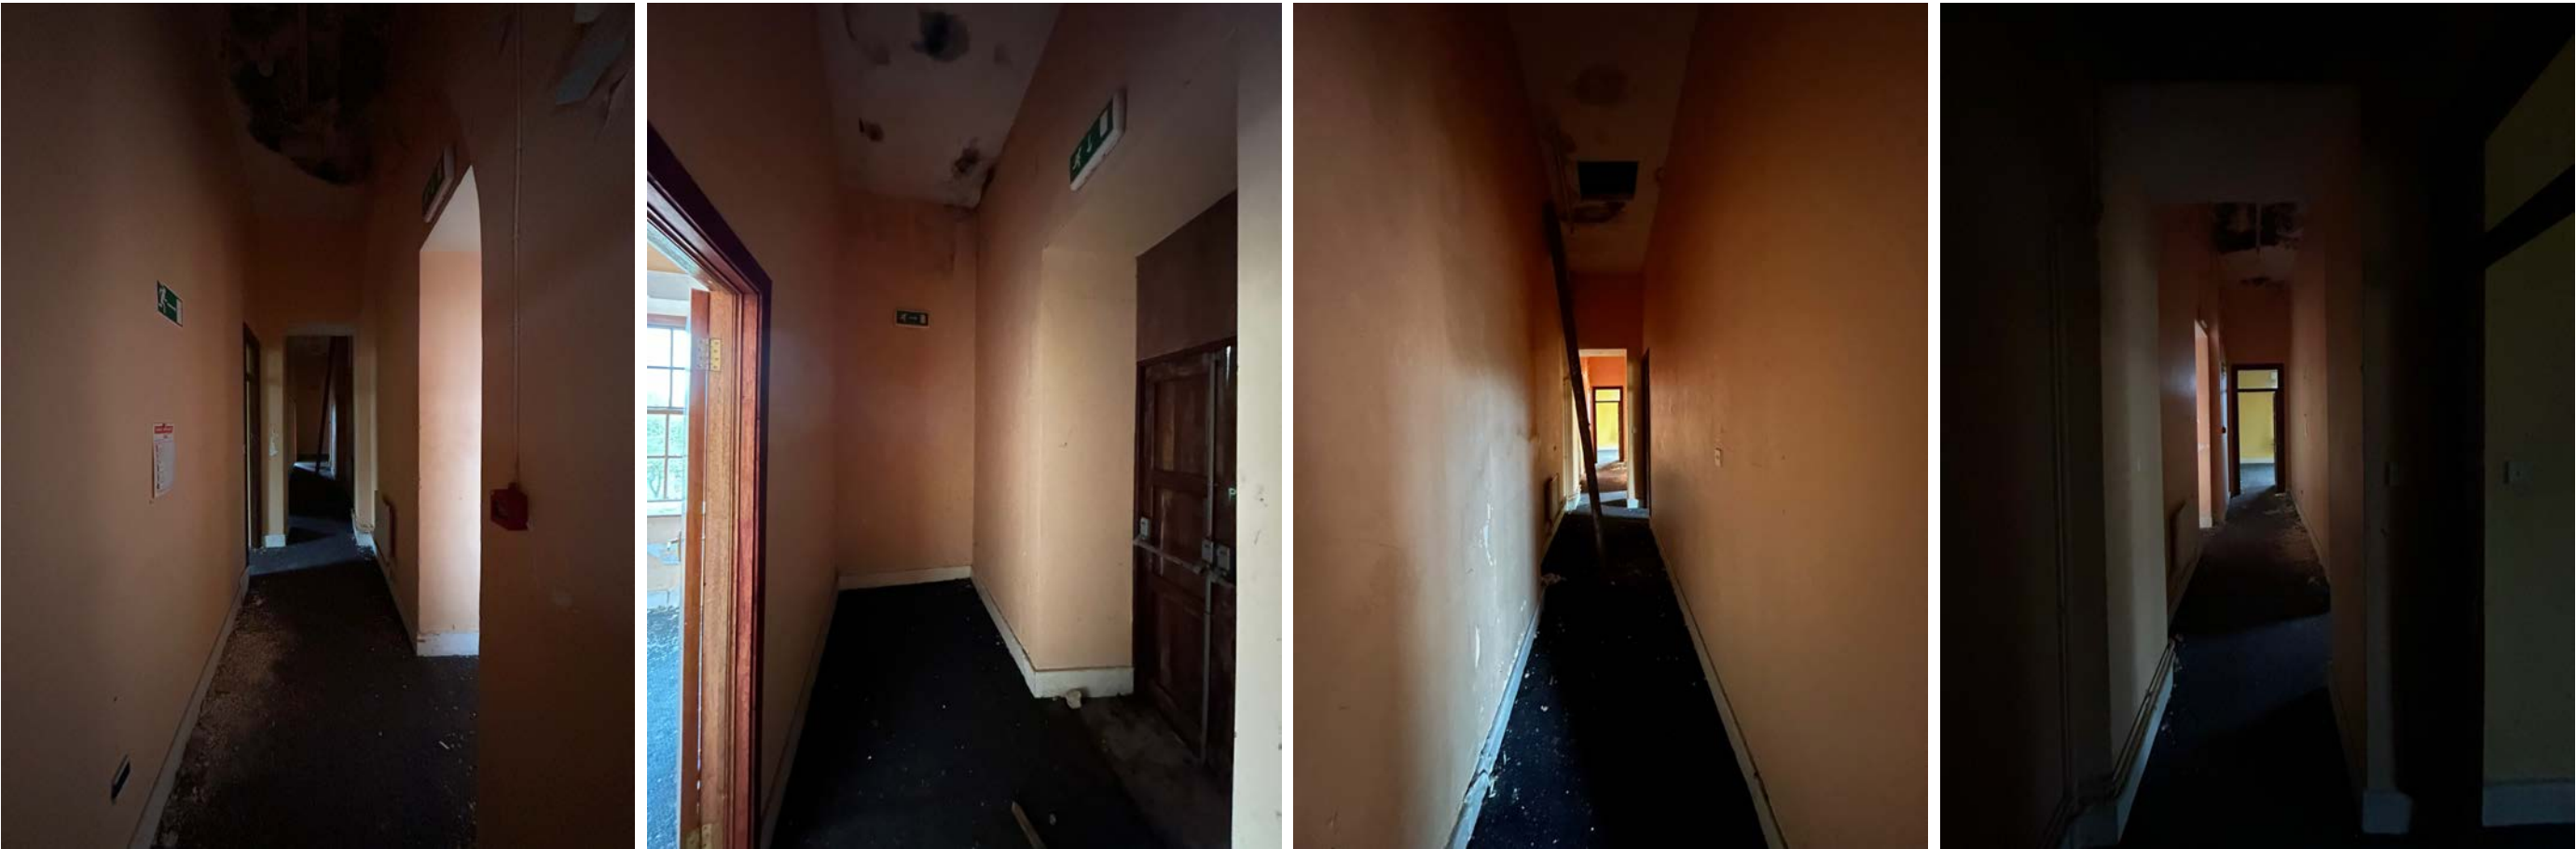
ROOM 01.S.05

The room is plain and unadorned in character with no ornamental historic plasterwork or timber features evident, such as cornice-work, dado rails, architraves or roses. Partitions and doors appear to be of 20th century origin and do not contribute to significance. Subdivision of rooms with lightweight partitions suggest the skirting boards are of 20th century origin and do not contribute to significance.

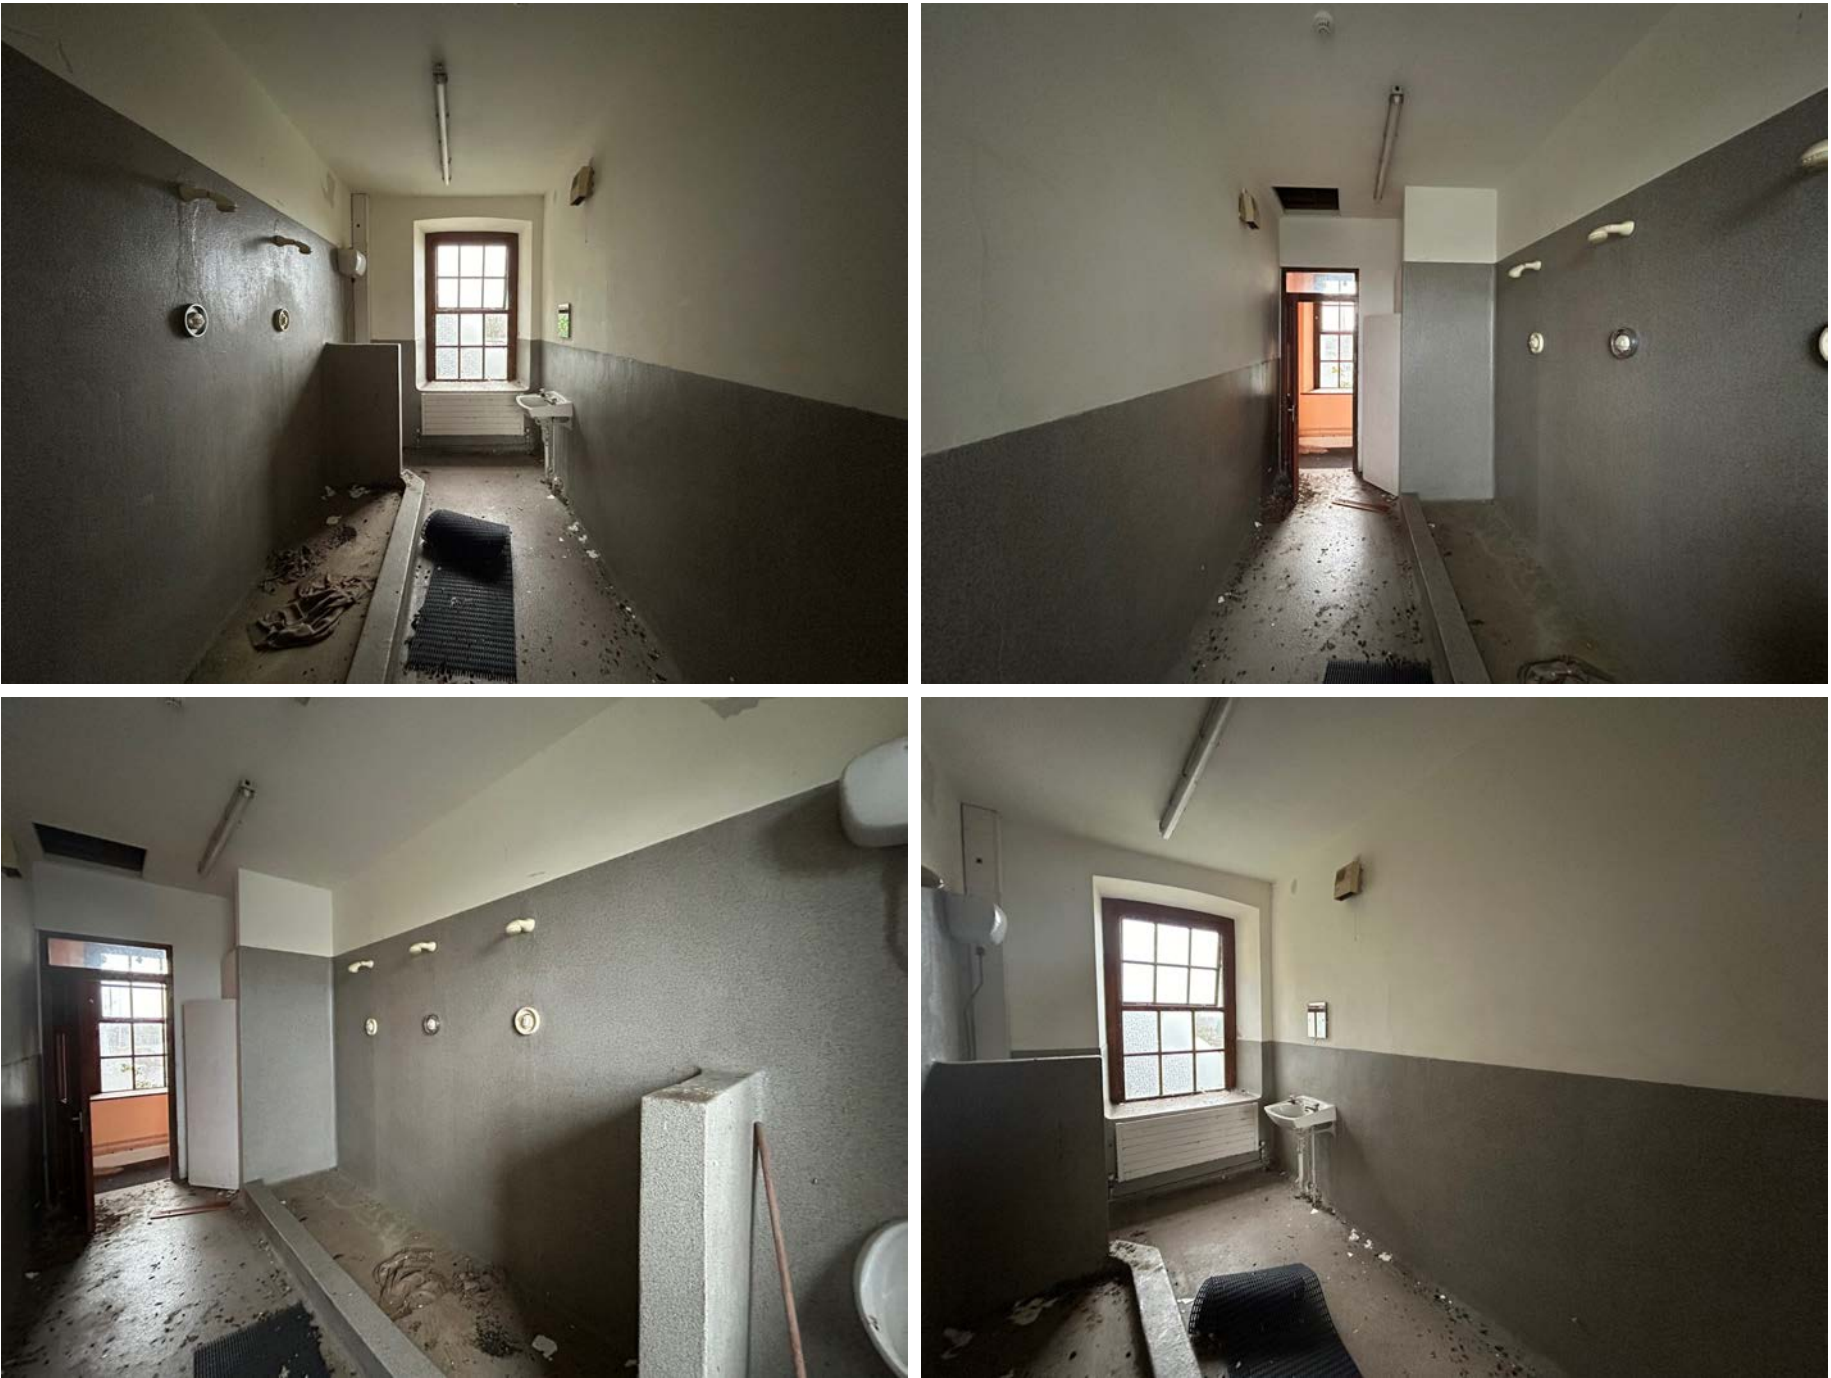
ROOM 01.M.01

The room is plain and unadorned in character with no ornamental historic plasterwork or timber features evident, such as cornice-work, dado rails, architraves or roses. Sanitaryware,, built-in showers, partitions and doors appear to be of 20th century origin and do not contribute to significance.

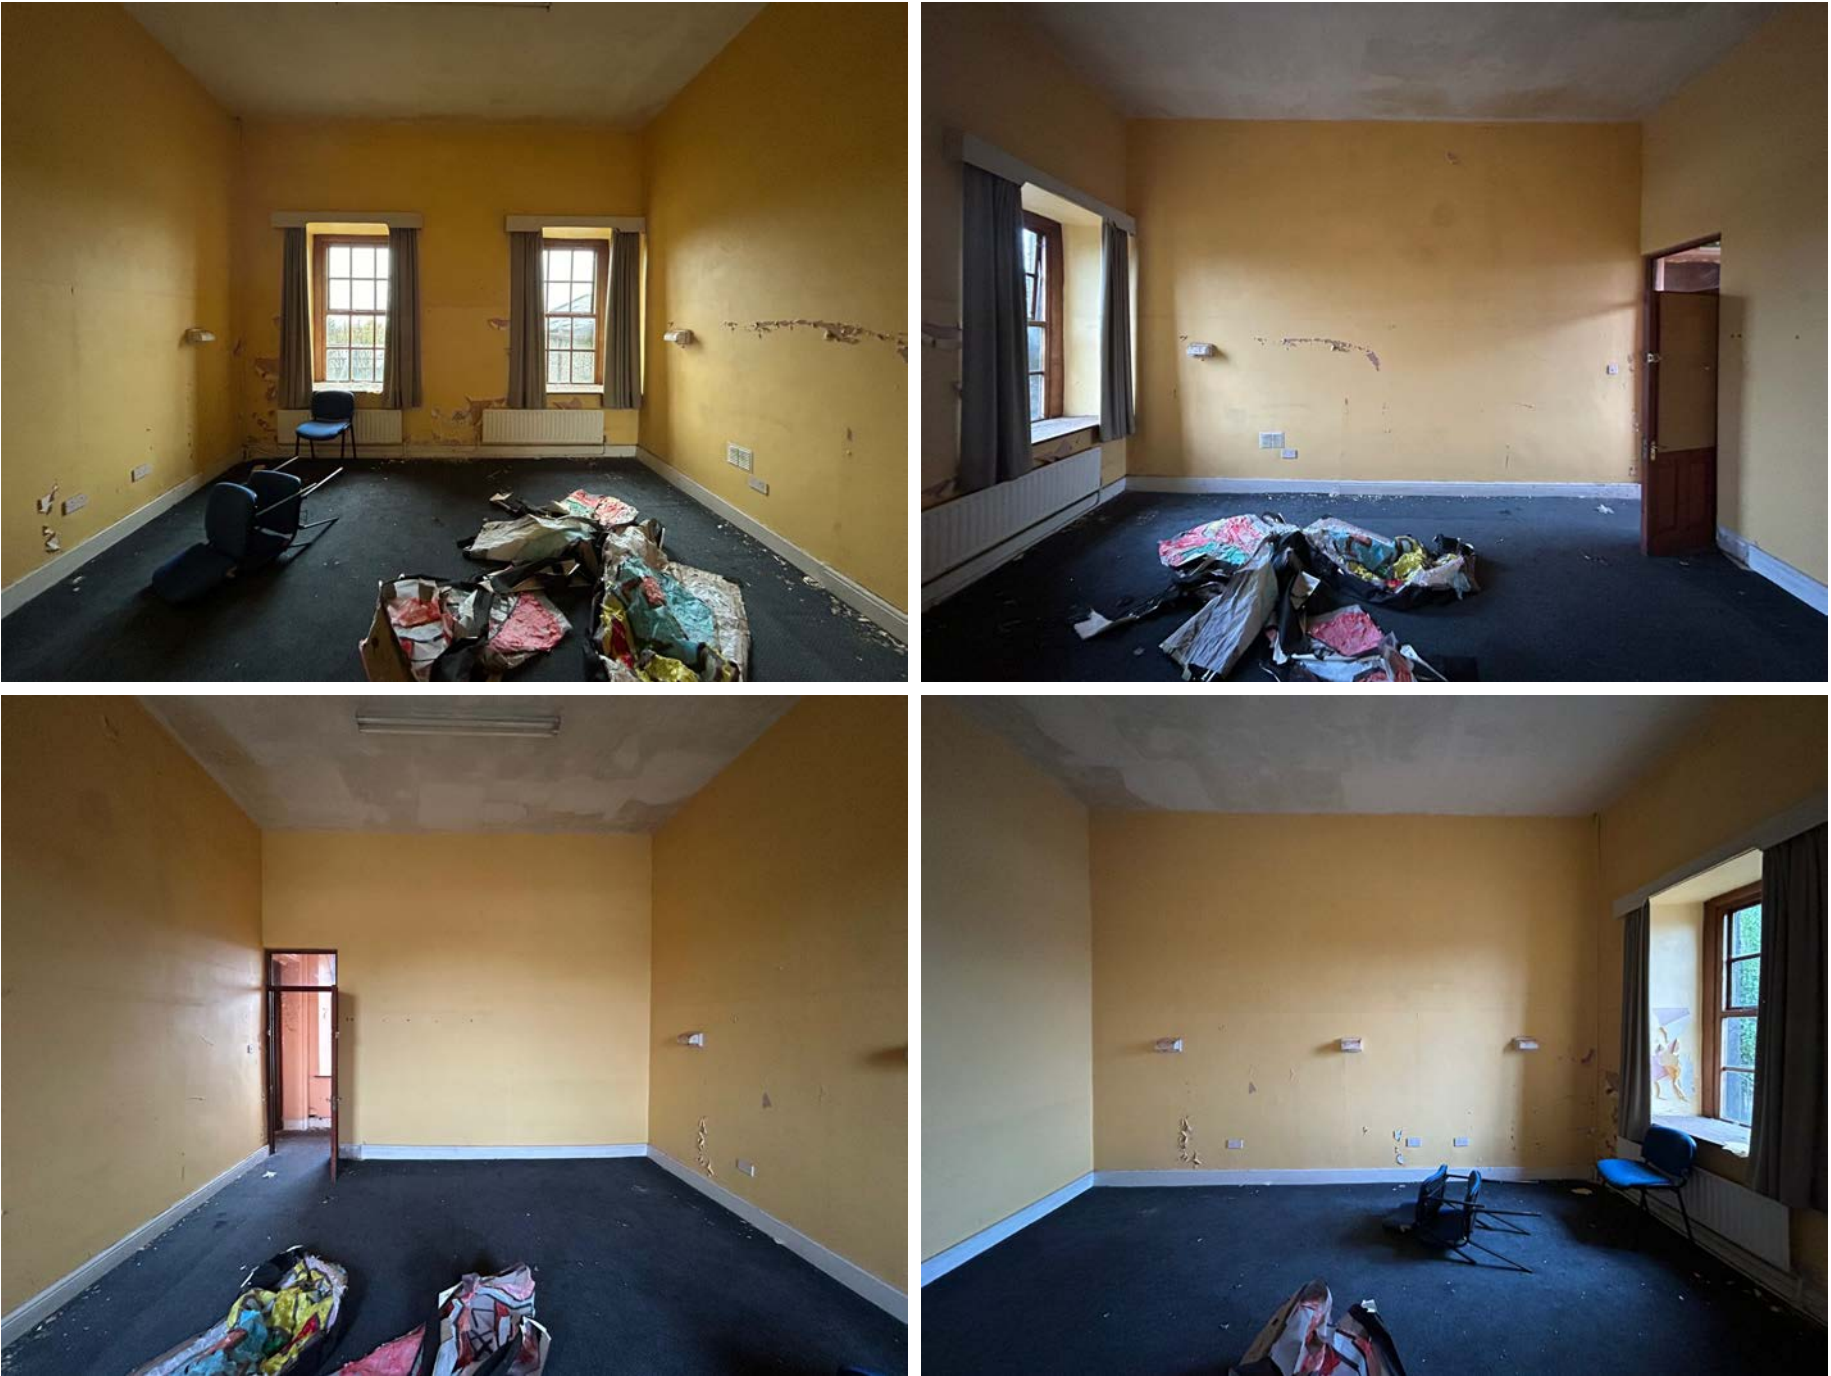
ROOM 01.M.02

The room is plain and unadorned in character with no ornamental historic plasterwork or timber features evident, such as cornice-work, dado rails, architraves or roses. Partitions and doors appear to be of 20th century origin and do not contribute to significance. Subdivision of rooms with lightweight partitions suggest the skirting boards are of 20th century origin and do not contribute to significance.

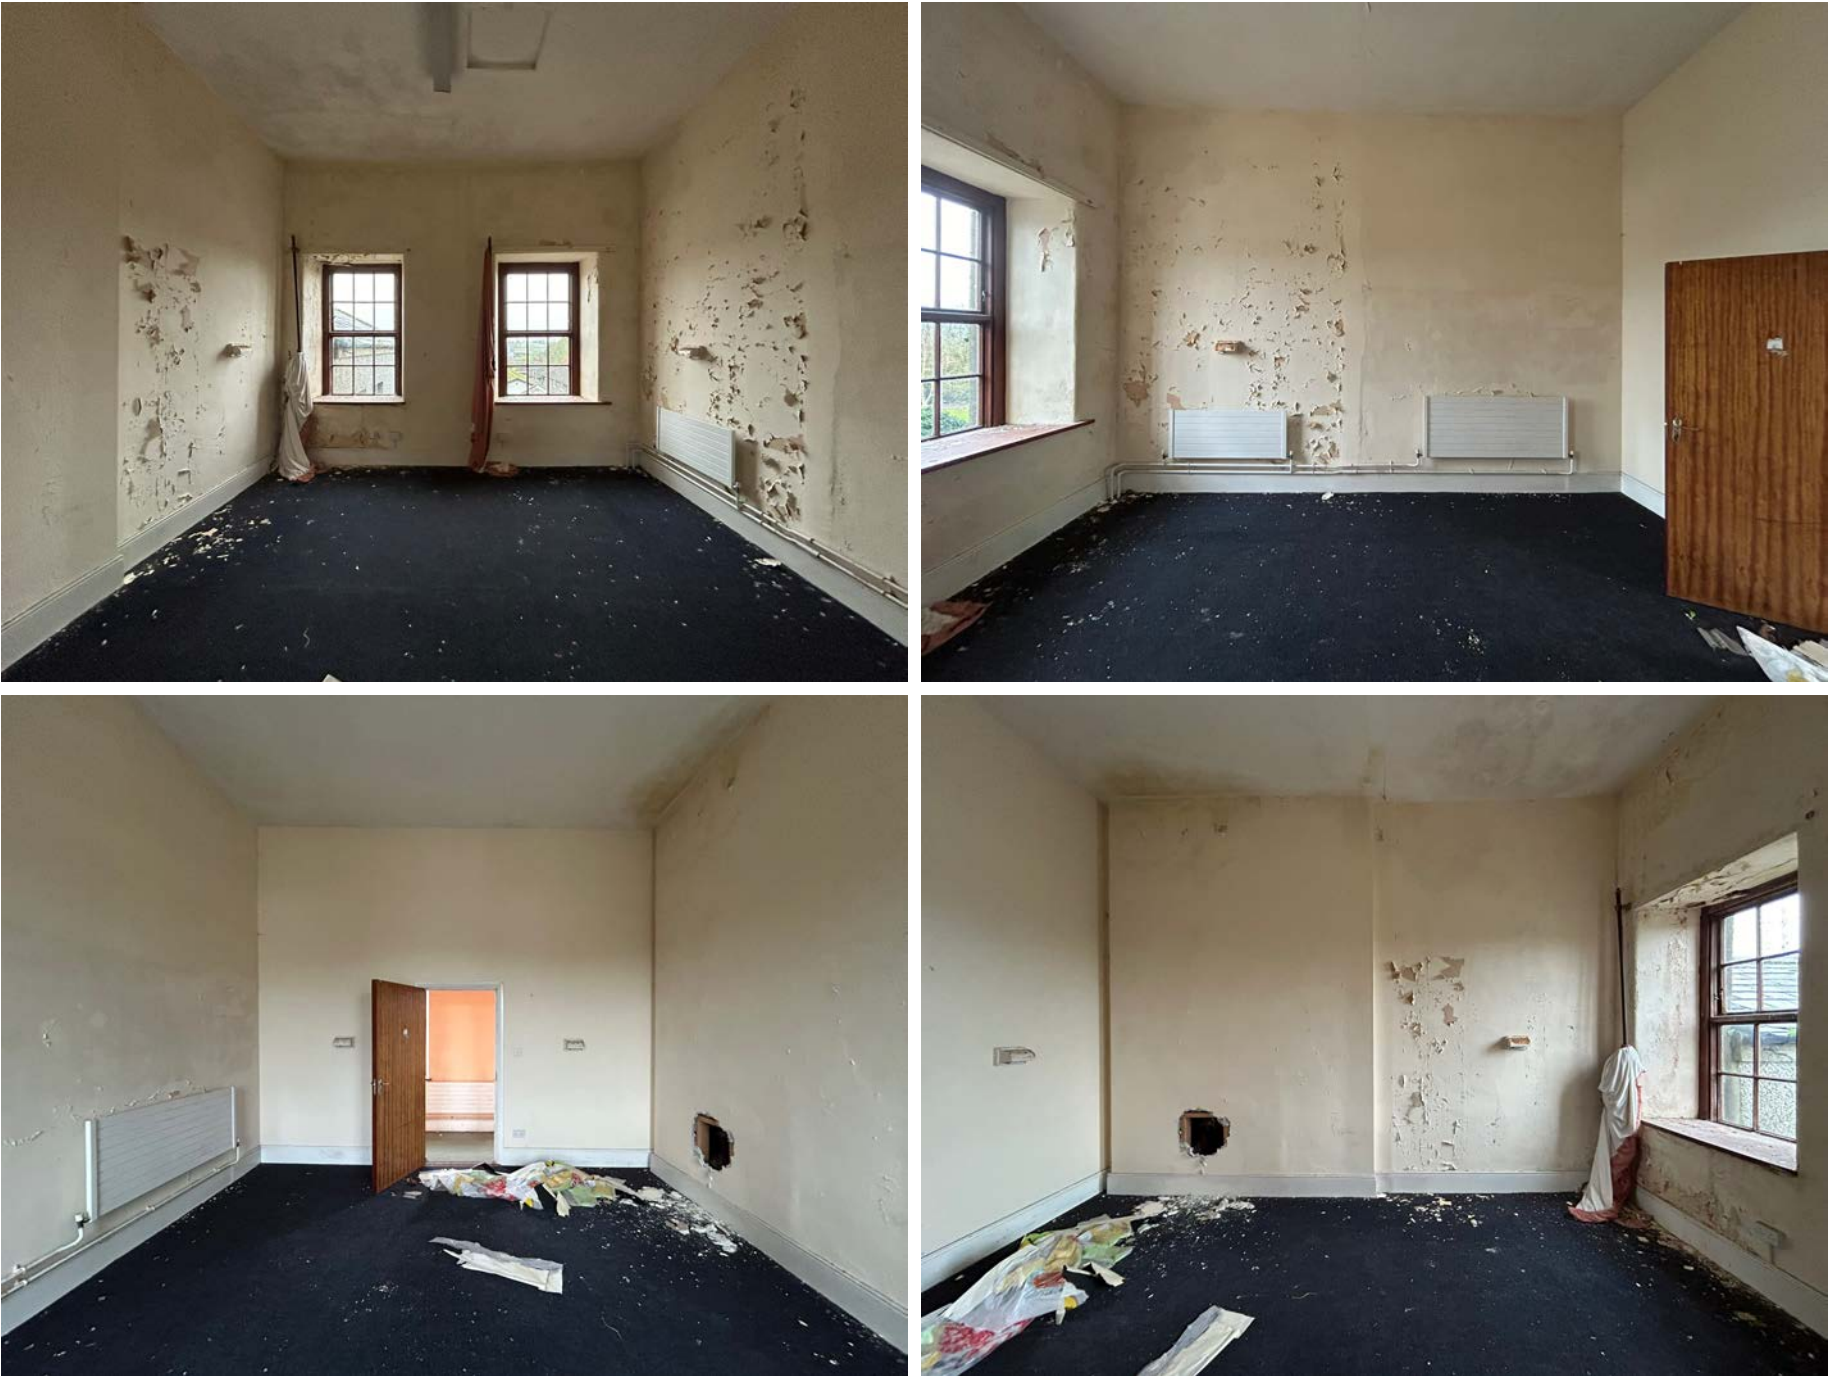
ROOM 01.M.03

The room is plain and unadorned in character with no ornamental historic plasterwork or timber features evident, such as cornice-work, dado rails, architraves or roses. Partitions and doors appear to be of 20th century origin and do not contribute to significance. Subdivision of rooms with lightweight partitions suggest the skirting boards are of 20th century origin and do not contribute to significance.

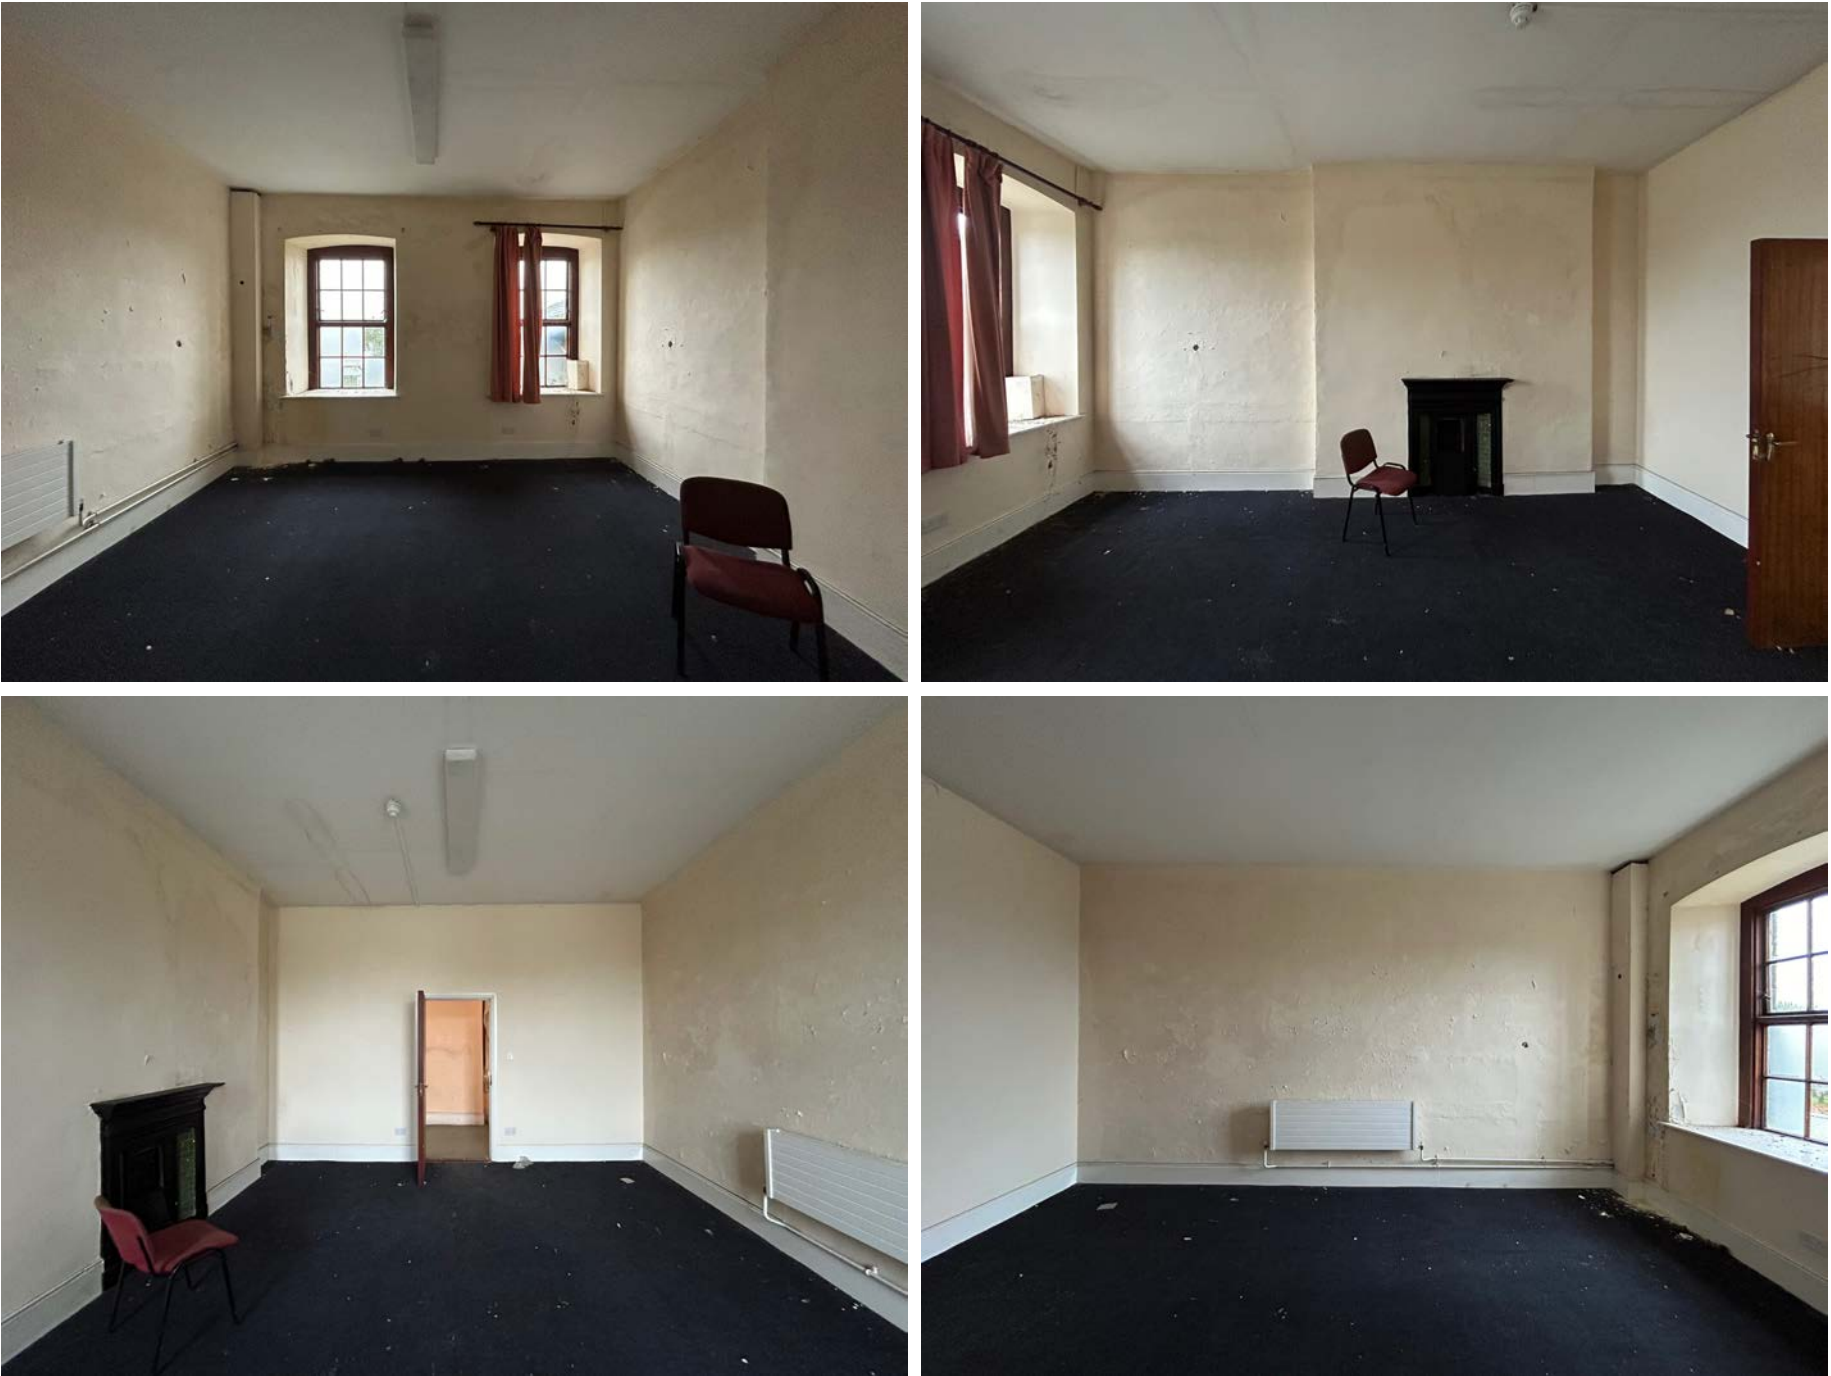
ROOM 01.M.04

The room is plain and unadorned in character with no ornamental historic plasterwork or timber features evident, such as cornice-work, dado rails, architraves or roses. Partitions and doors appear to be of 20th century origin and do not contribute to significance. Subdivision of rooms with lightweight partitions suggest the skirting boards are of 20th century origin and do not contribute to significance.
