OFFICERS BUILDING
LONGFORD | COUNTY LONGFORD
ARCHITECTURAL HERITAGE IMPACT ASSESSMENT REPORT

ROBIN LEE ARCHITECTURE
JANUARY 2025

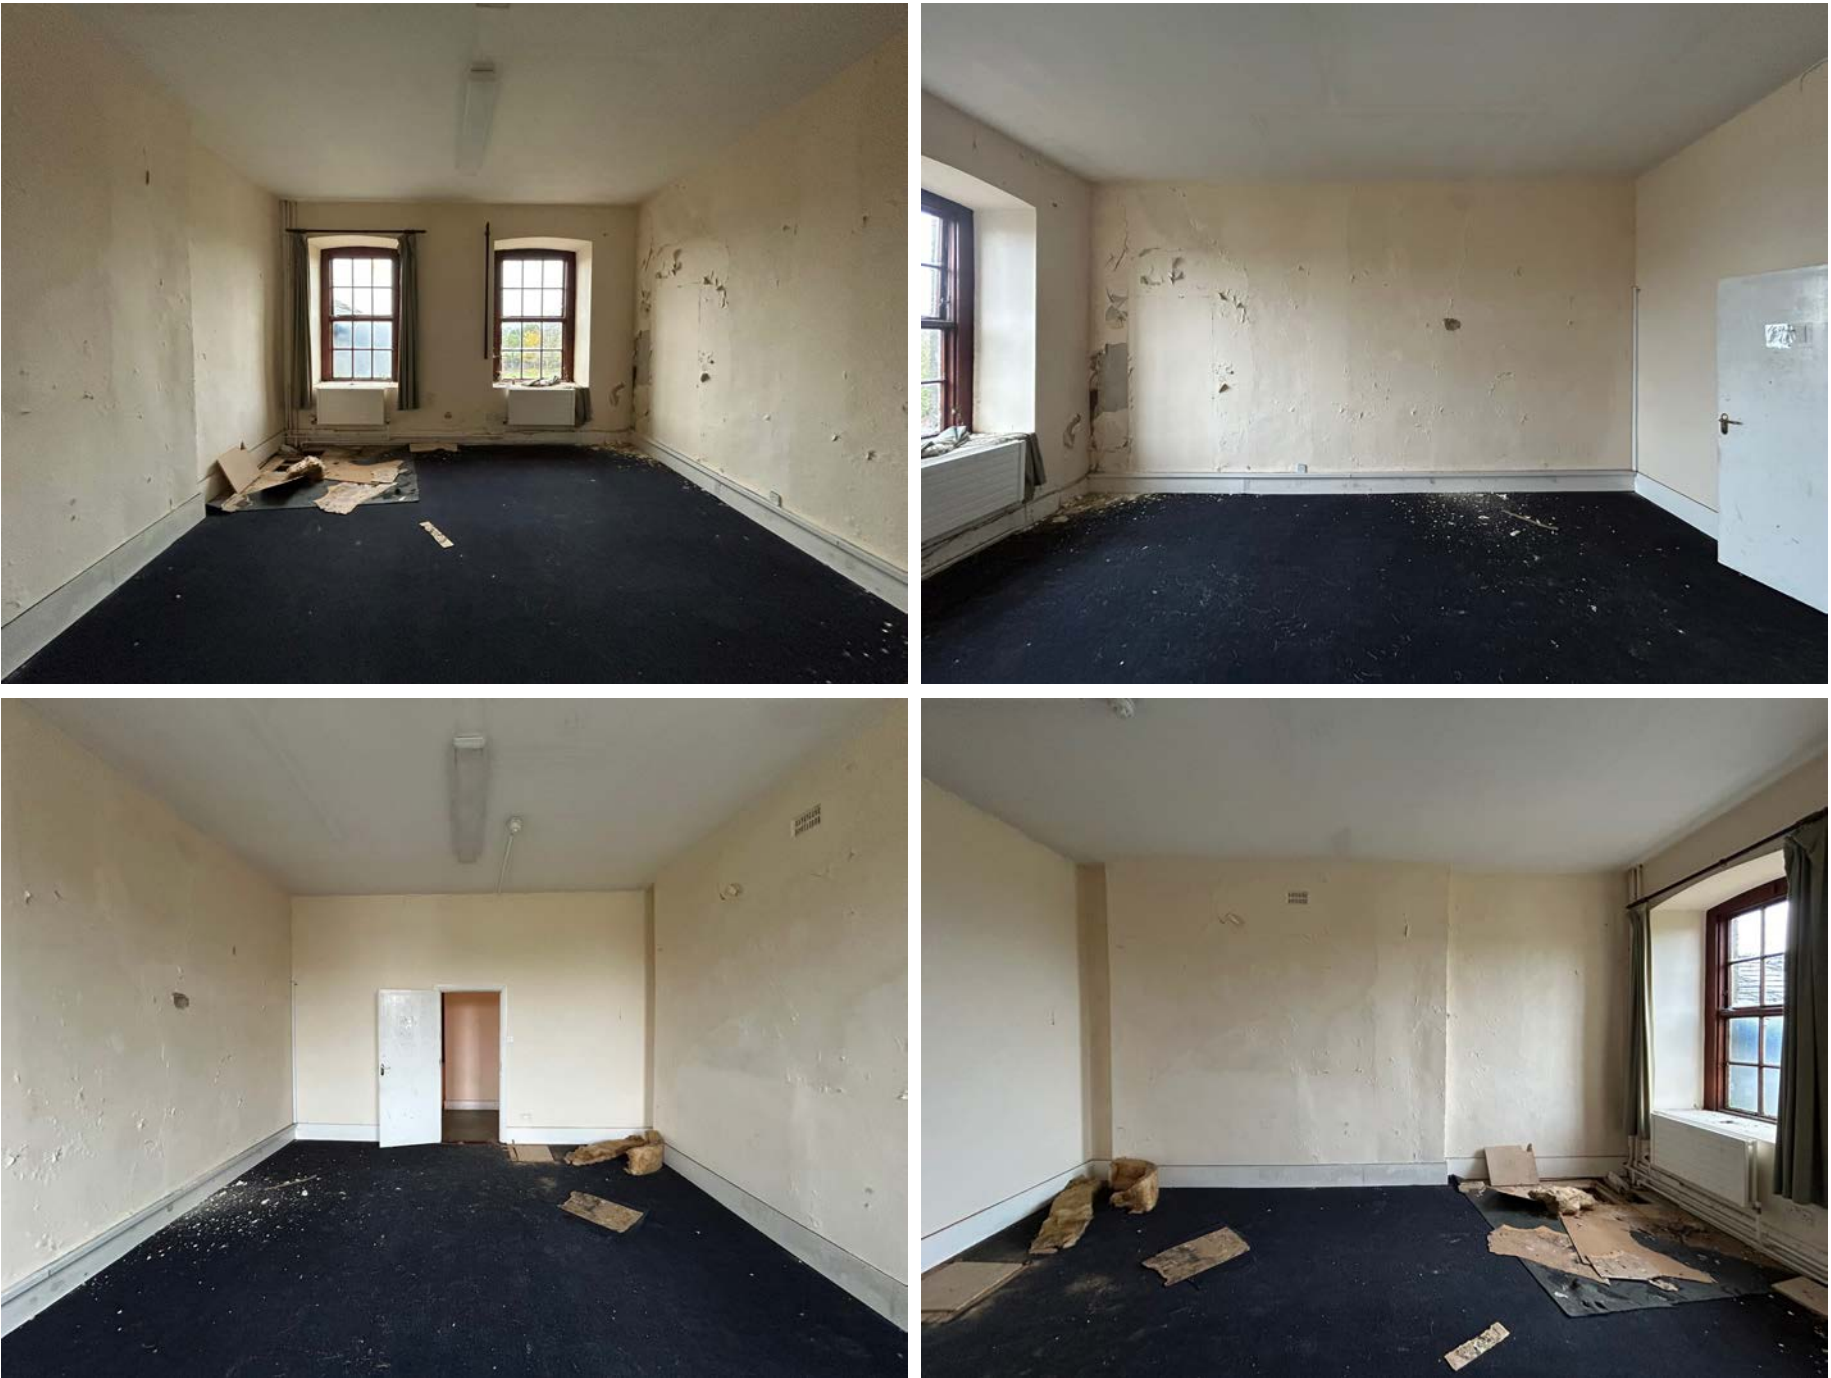
ROOM 01.M.05

The room is plain and unadorned in character with no ornamental historic plasterwork or timber features evident, such as cornice-work, dado rails, architraves or roses. Partitions and doors appear to be of 20th century origin and do not contribute to significance. Subdivision of rooms with lightweight partitions suggest the skirting boards are of 20th century origin and do not contribute to significance.

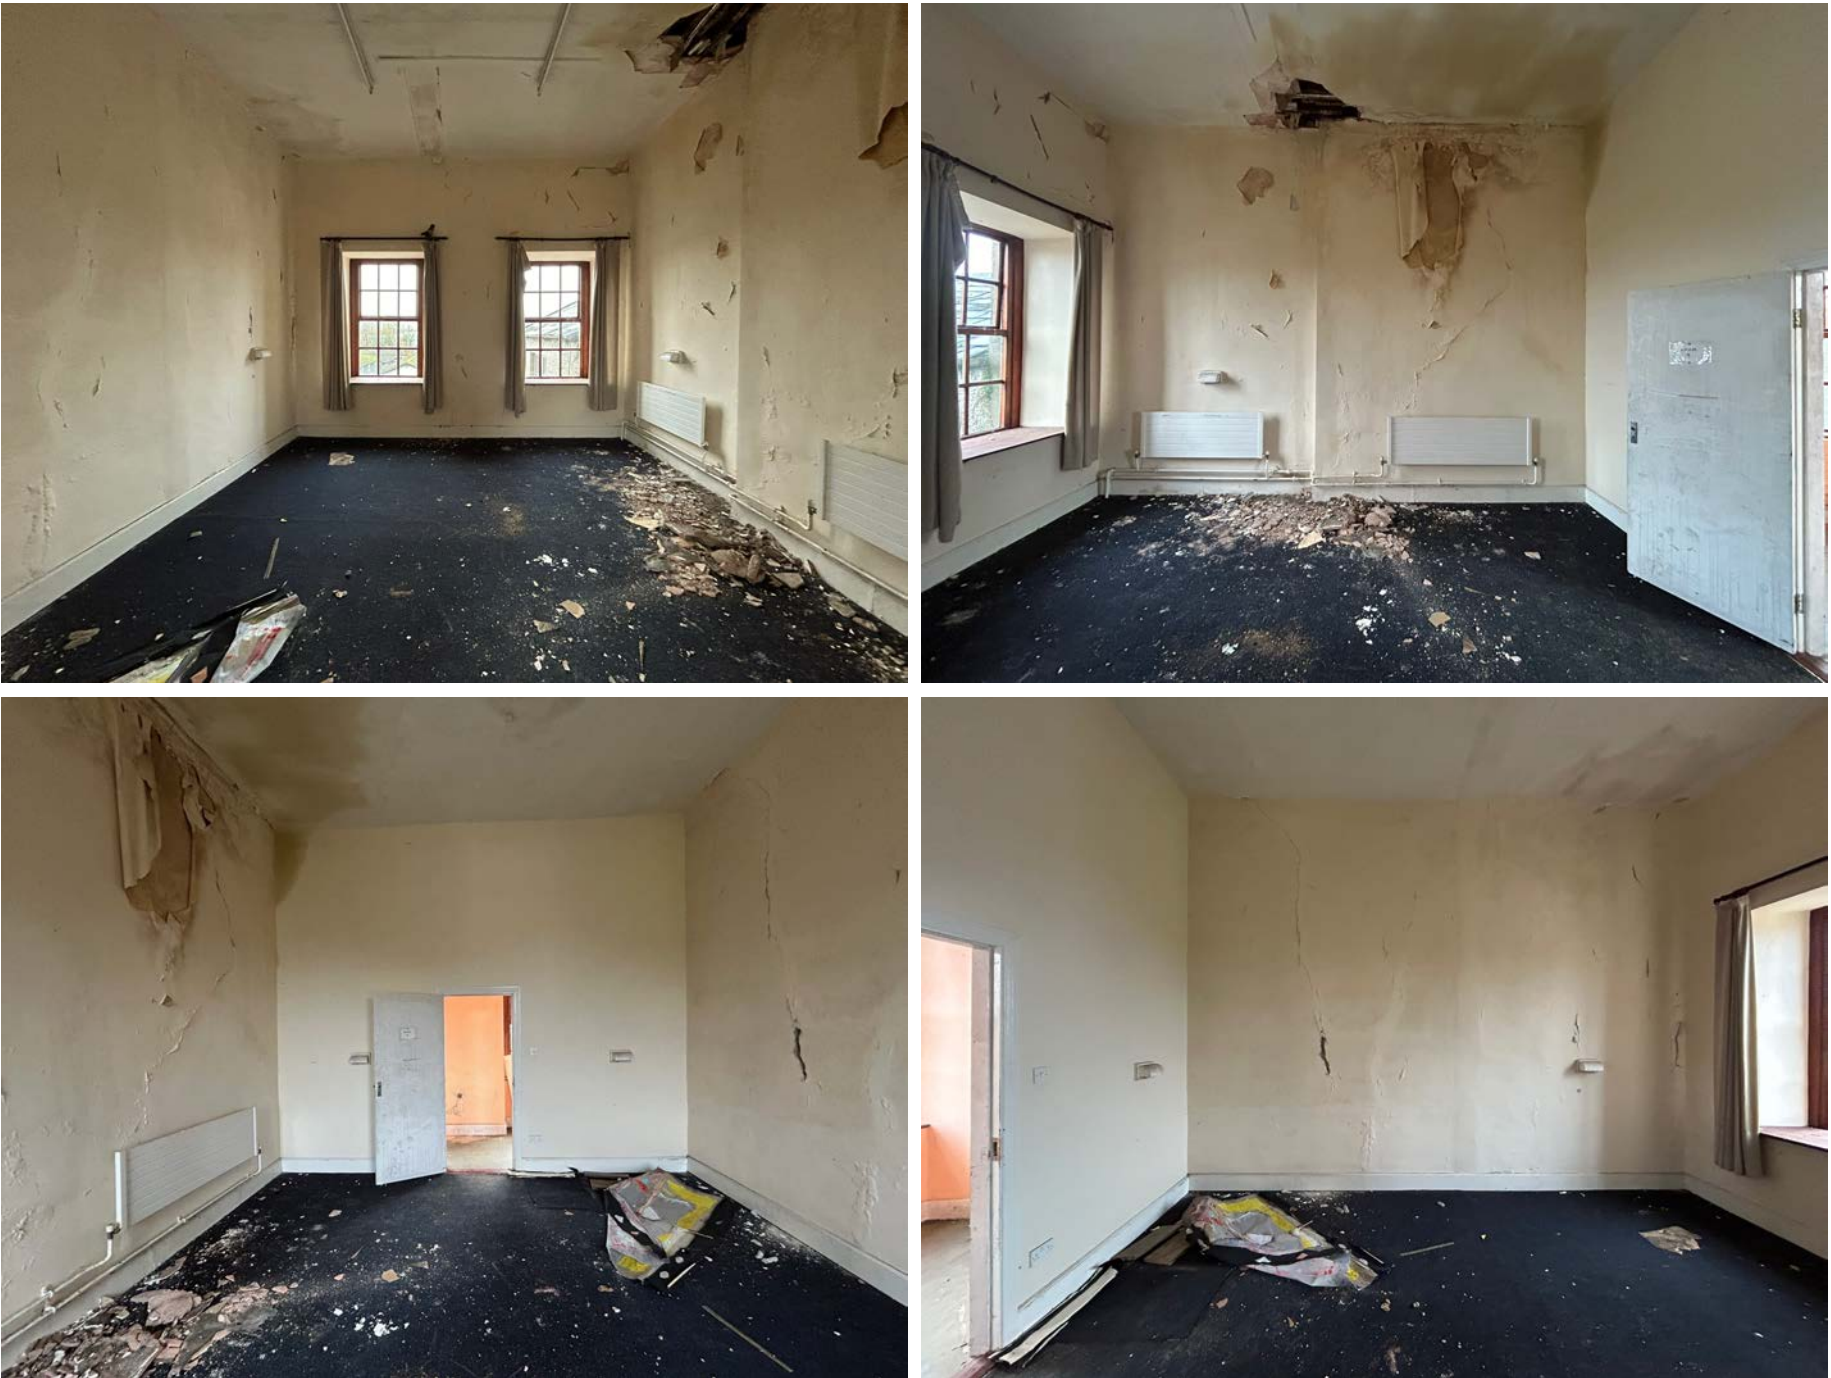
ROOM 01.M.06

The room is plain and unadorned in character with no ornamental historic plasterwork or timber features evident, such as cornice-work, dado rails, architraves or roses. Partitions and doors appear to be of 20th century origin and do not contribute to significance. Subdivision of rooms with lightweight partitions suggest the skirting boards are of 20th century origin and do not contribute to significance.

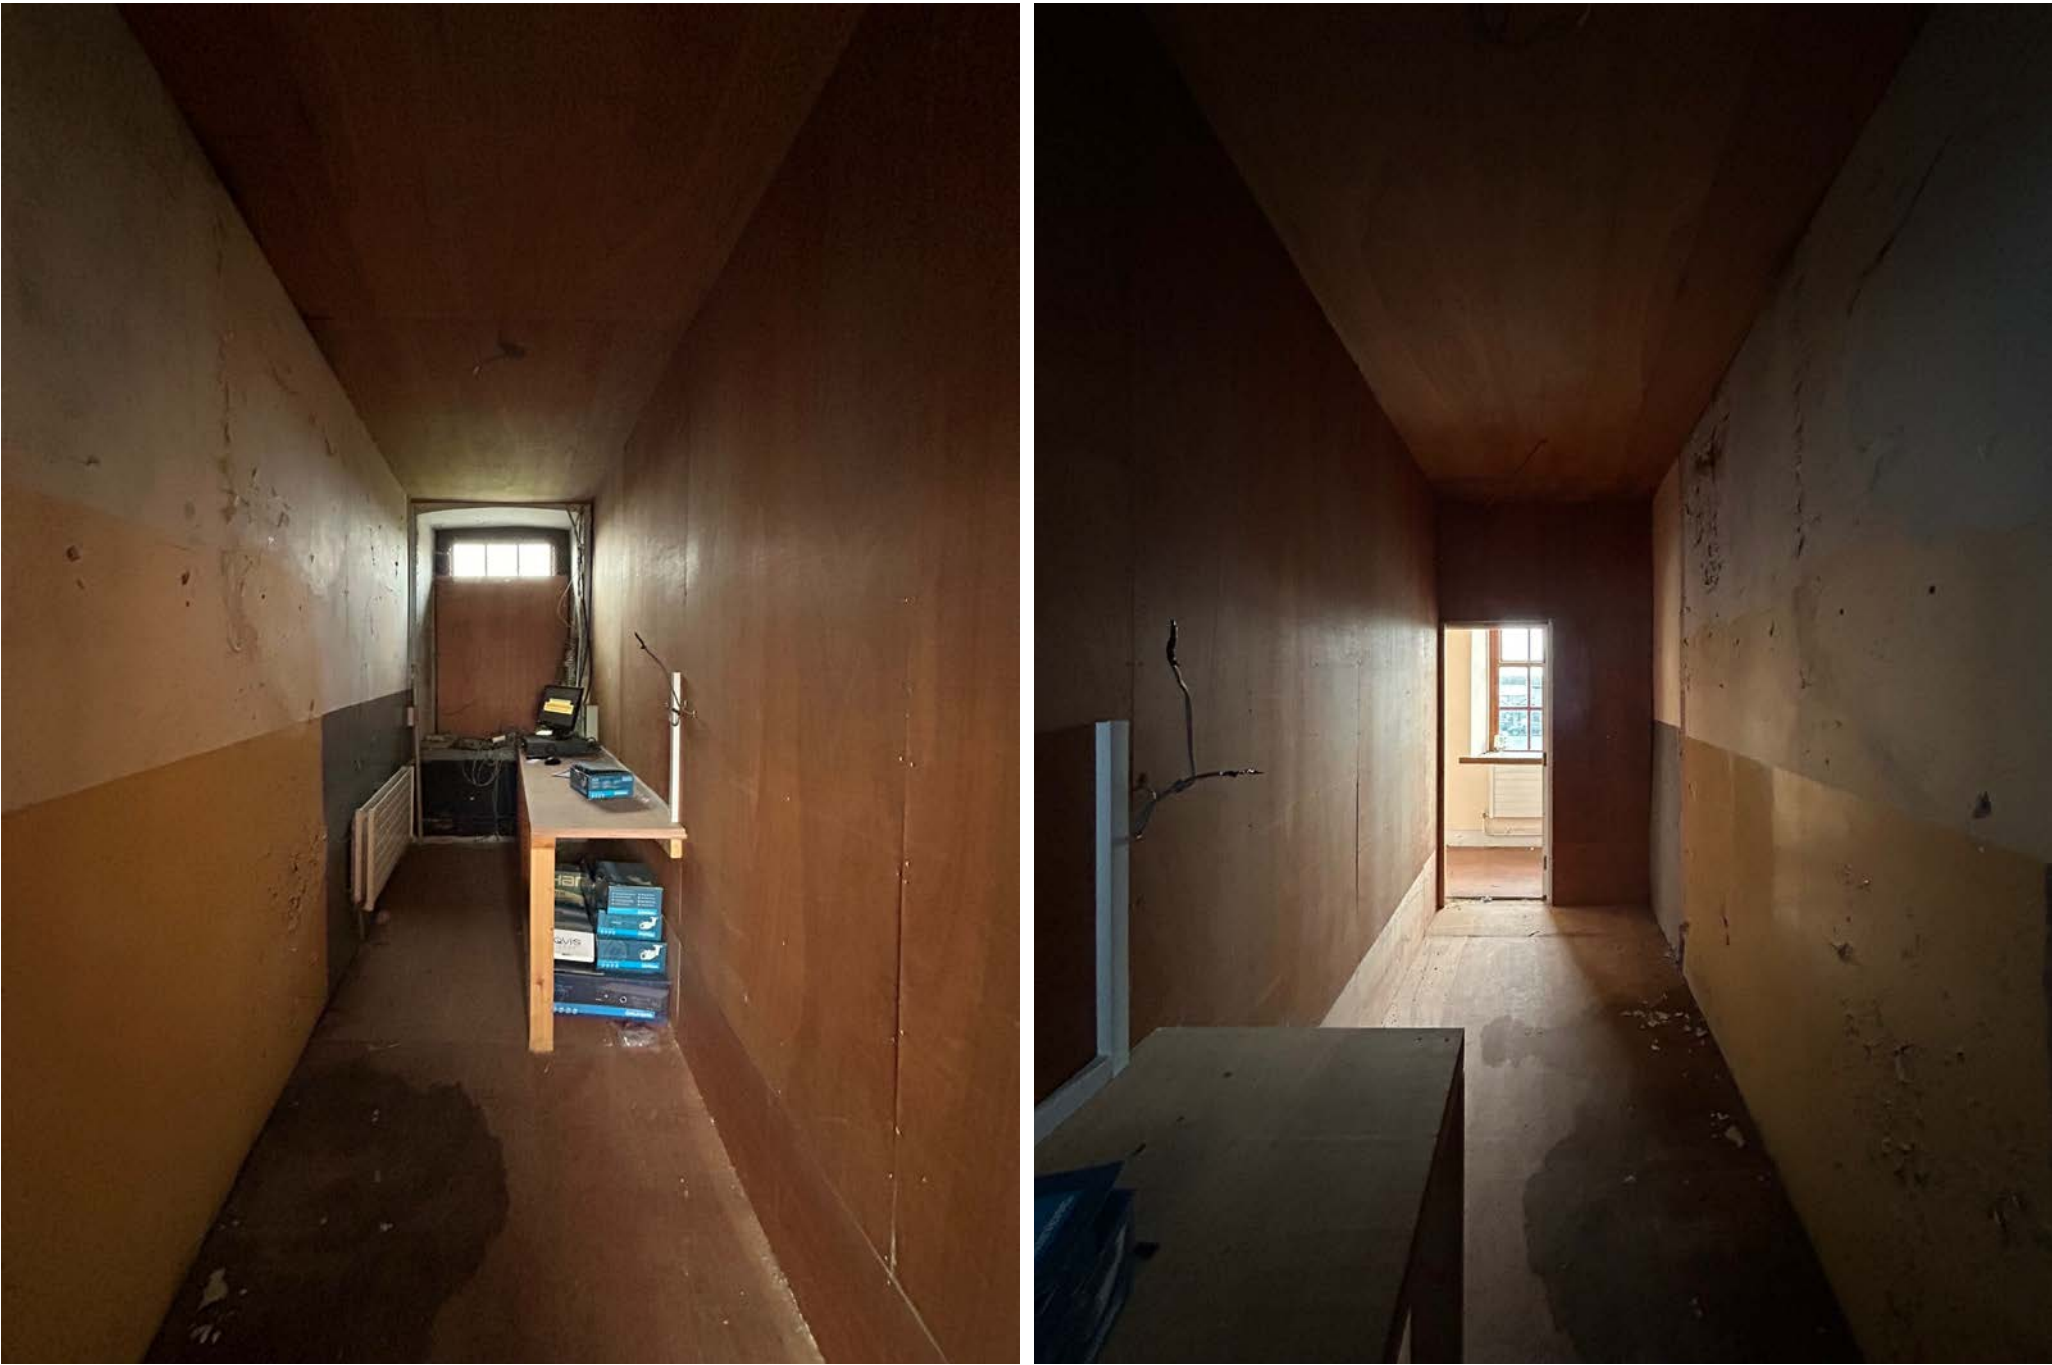
ROOM 01.M.07

The room is plain and unadorned in character with no ornamental historic plasterwork or timber features evident, such as cornice-work, dado rails, architraves or roses. Partitions and doors appear to be of 20th century origin and do not contribute to significance. Subdivision of rooms with lightweight partitions suggest the skirting boards are of 20th century origin and do not contribute to significance.

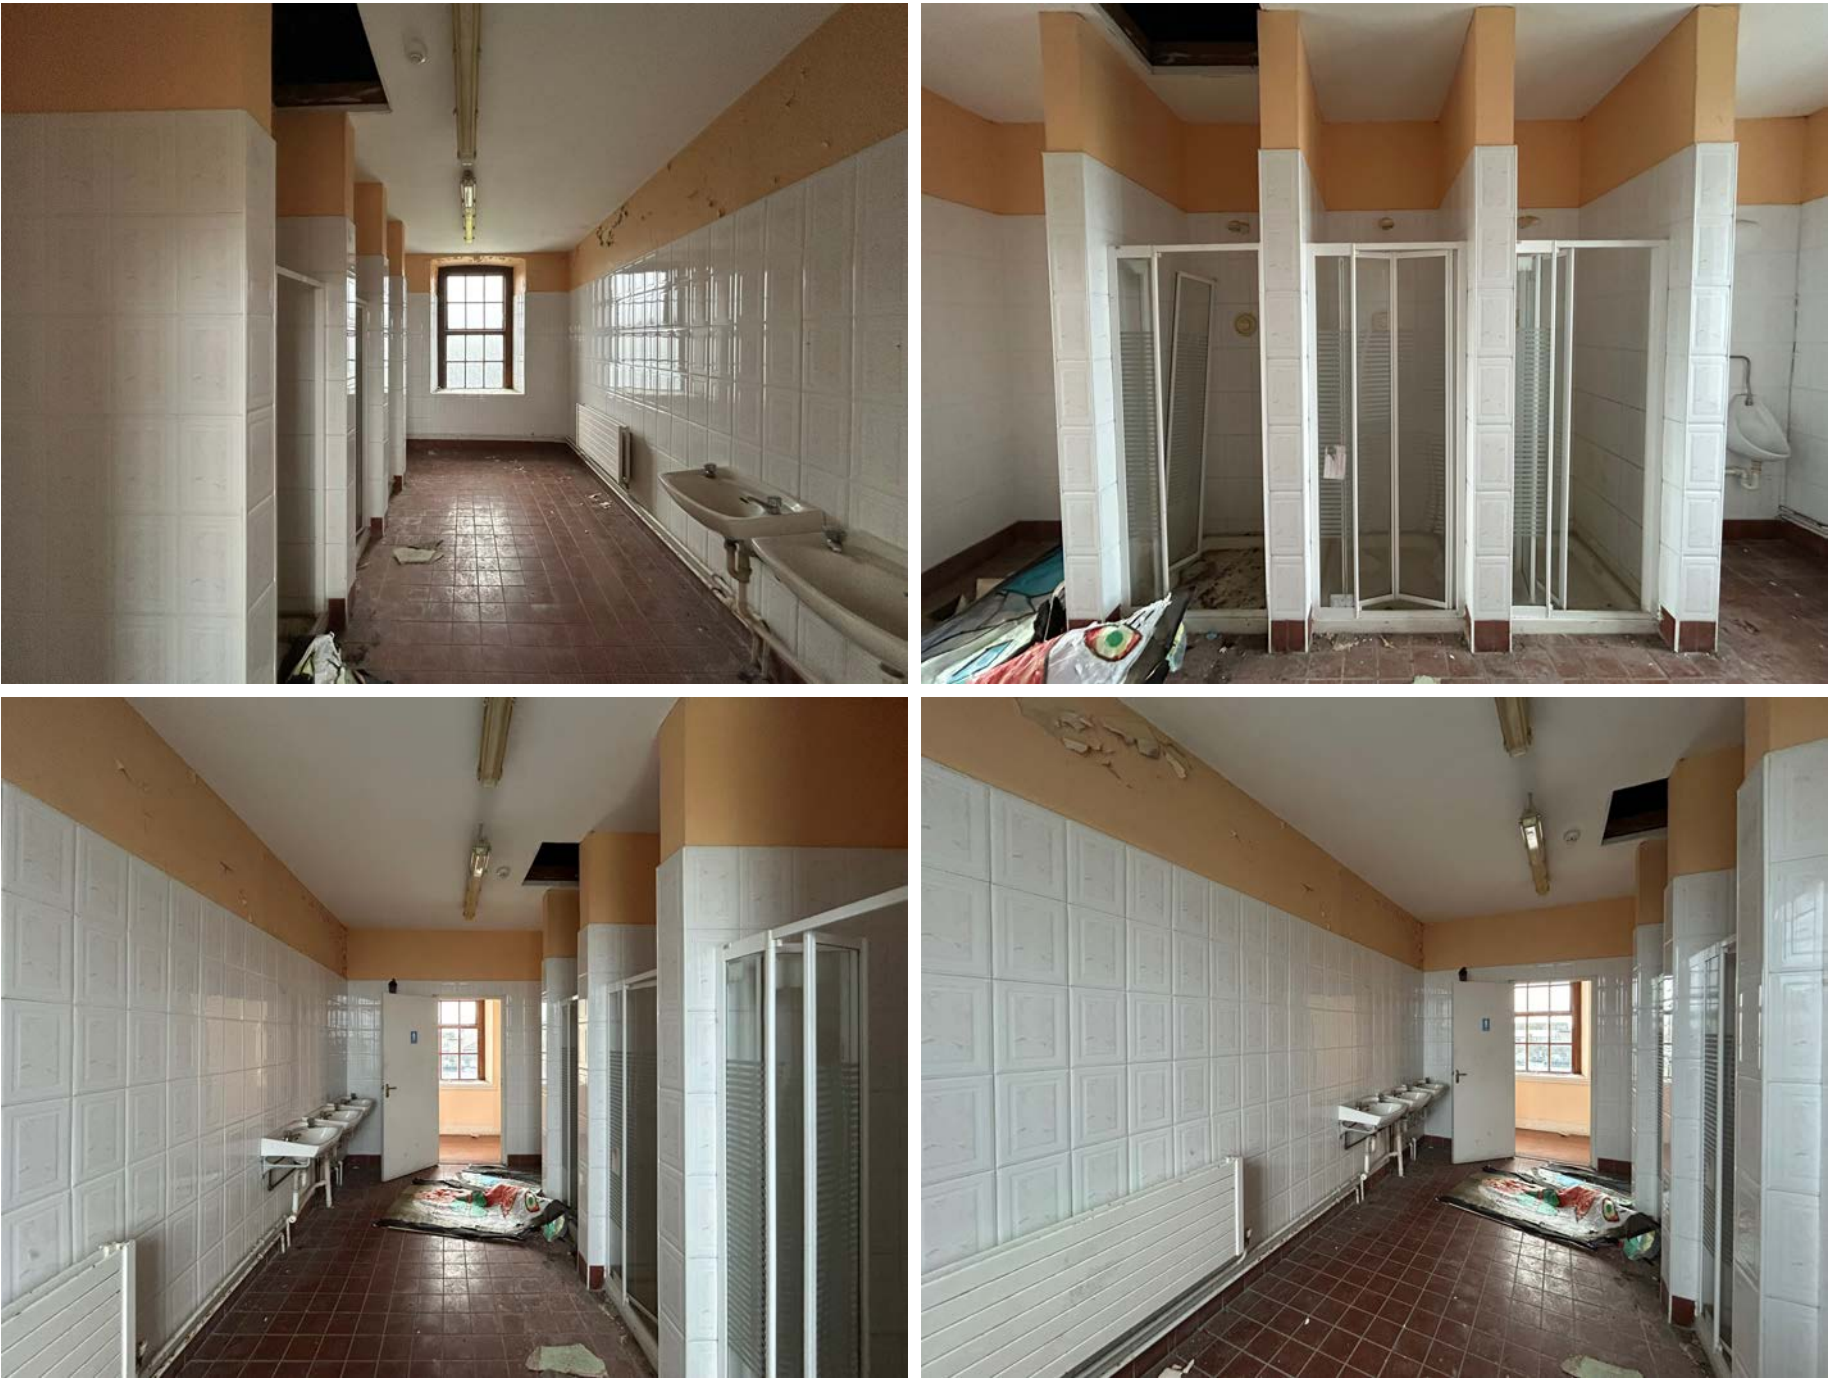
ROOM 01.M.08

The room is plain and unadorned in character with no ornamental historic plasterwork or timber features evident, such as cornice-work, dado rails, architraves or roses. Sanitaryware, built-in showers, partitions and doors appear to be of 20th century origin and do not contribute to significance.

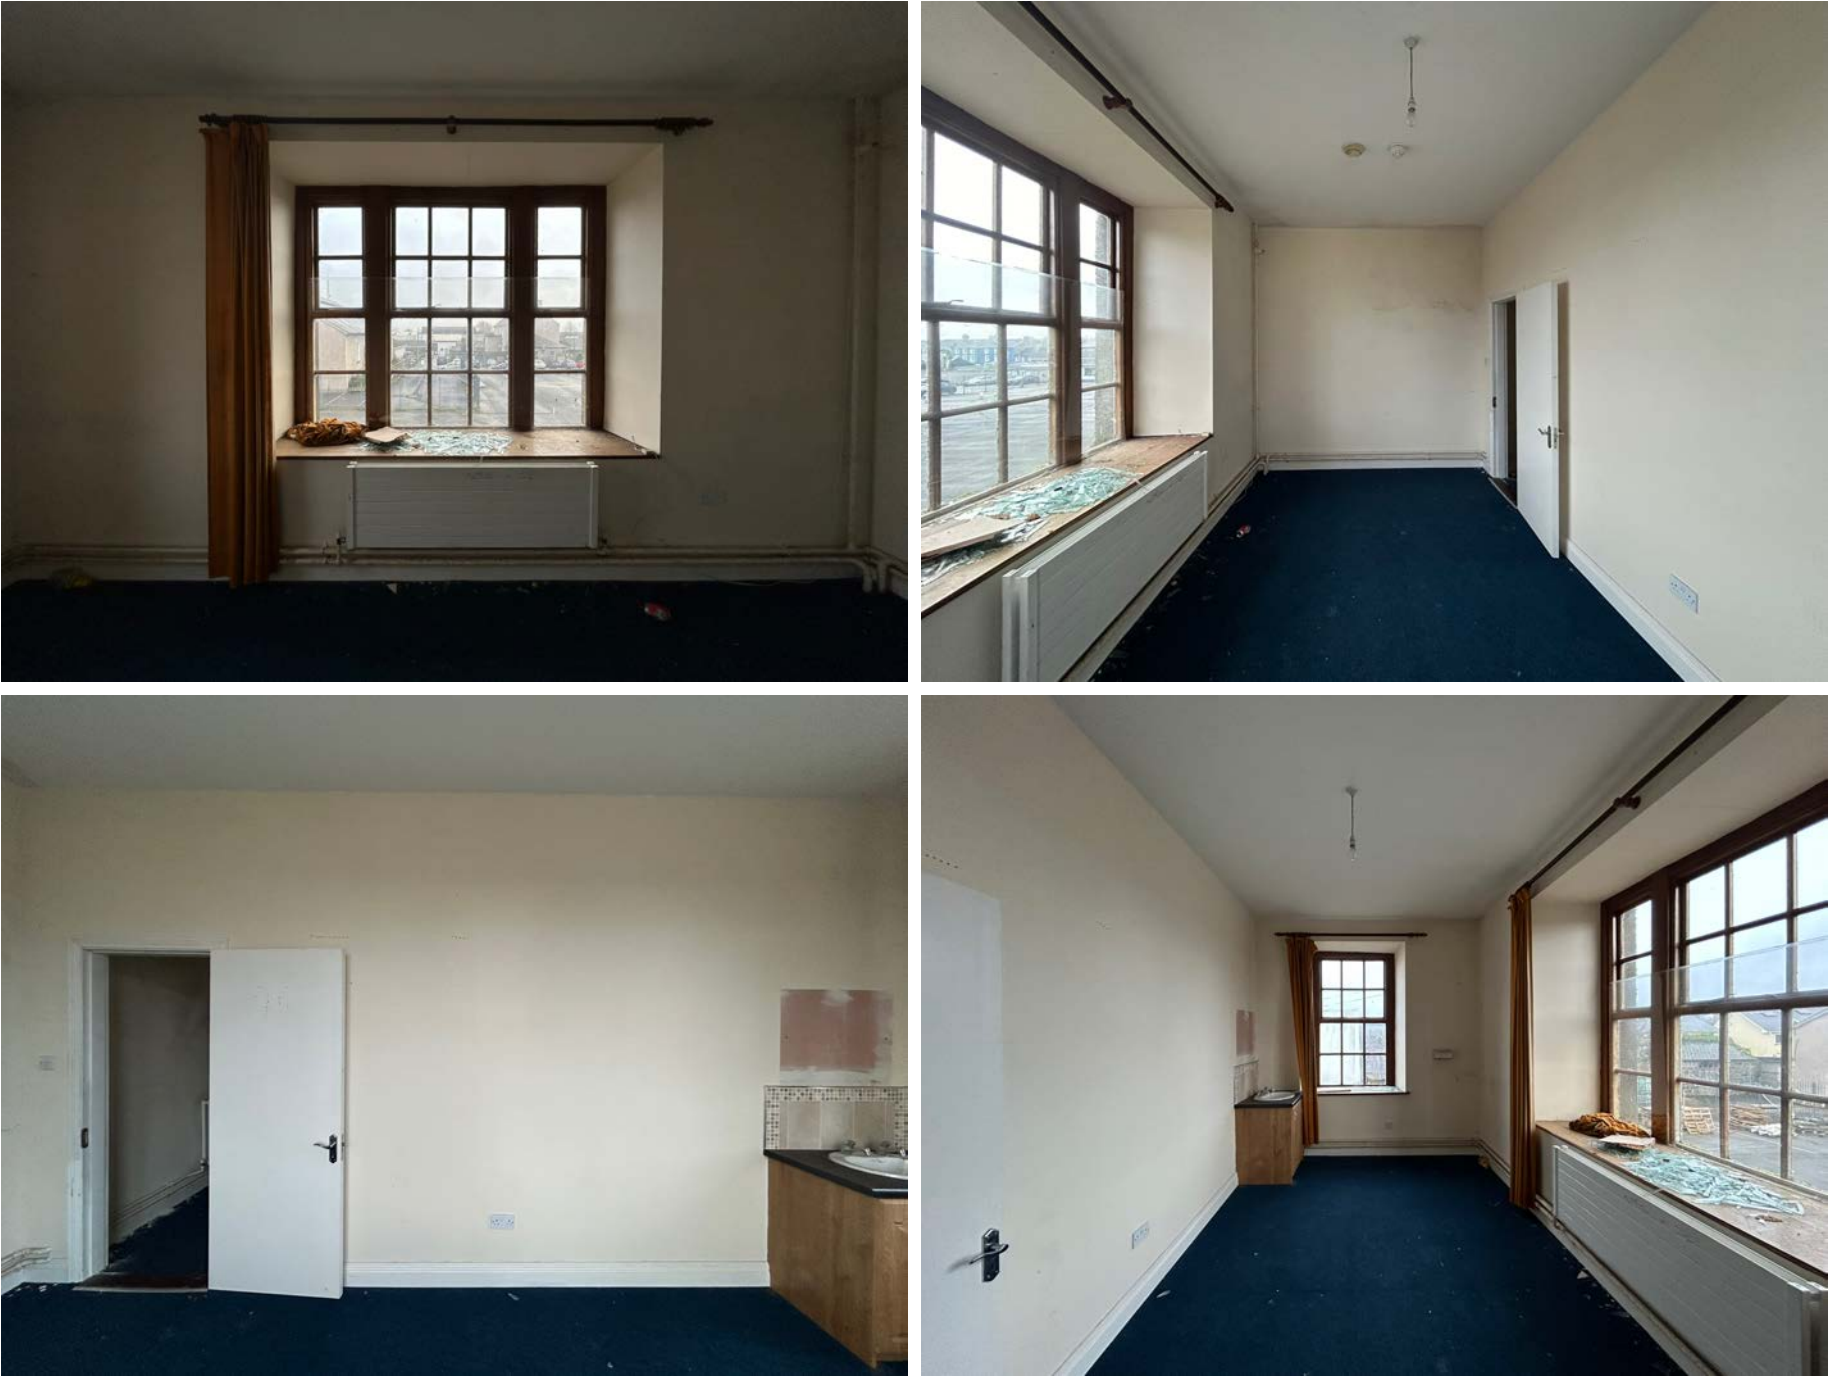
ROOM 01.N.01

The room is plain and unadorned in character with no ornamental historic plasterwork or timber features evident, such as cornice-work, dado rails, architraves or roses. Partitions and doors appear to be of 20th century origin and do not contribute to significance. Subdivision of rooms with lightweight partitions suggest the skirting boards are of 20th century origin and do not contribute to significance.

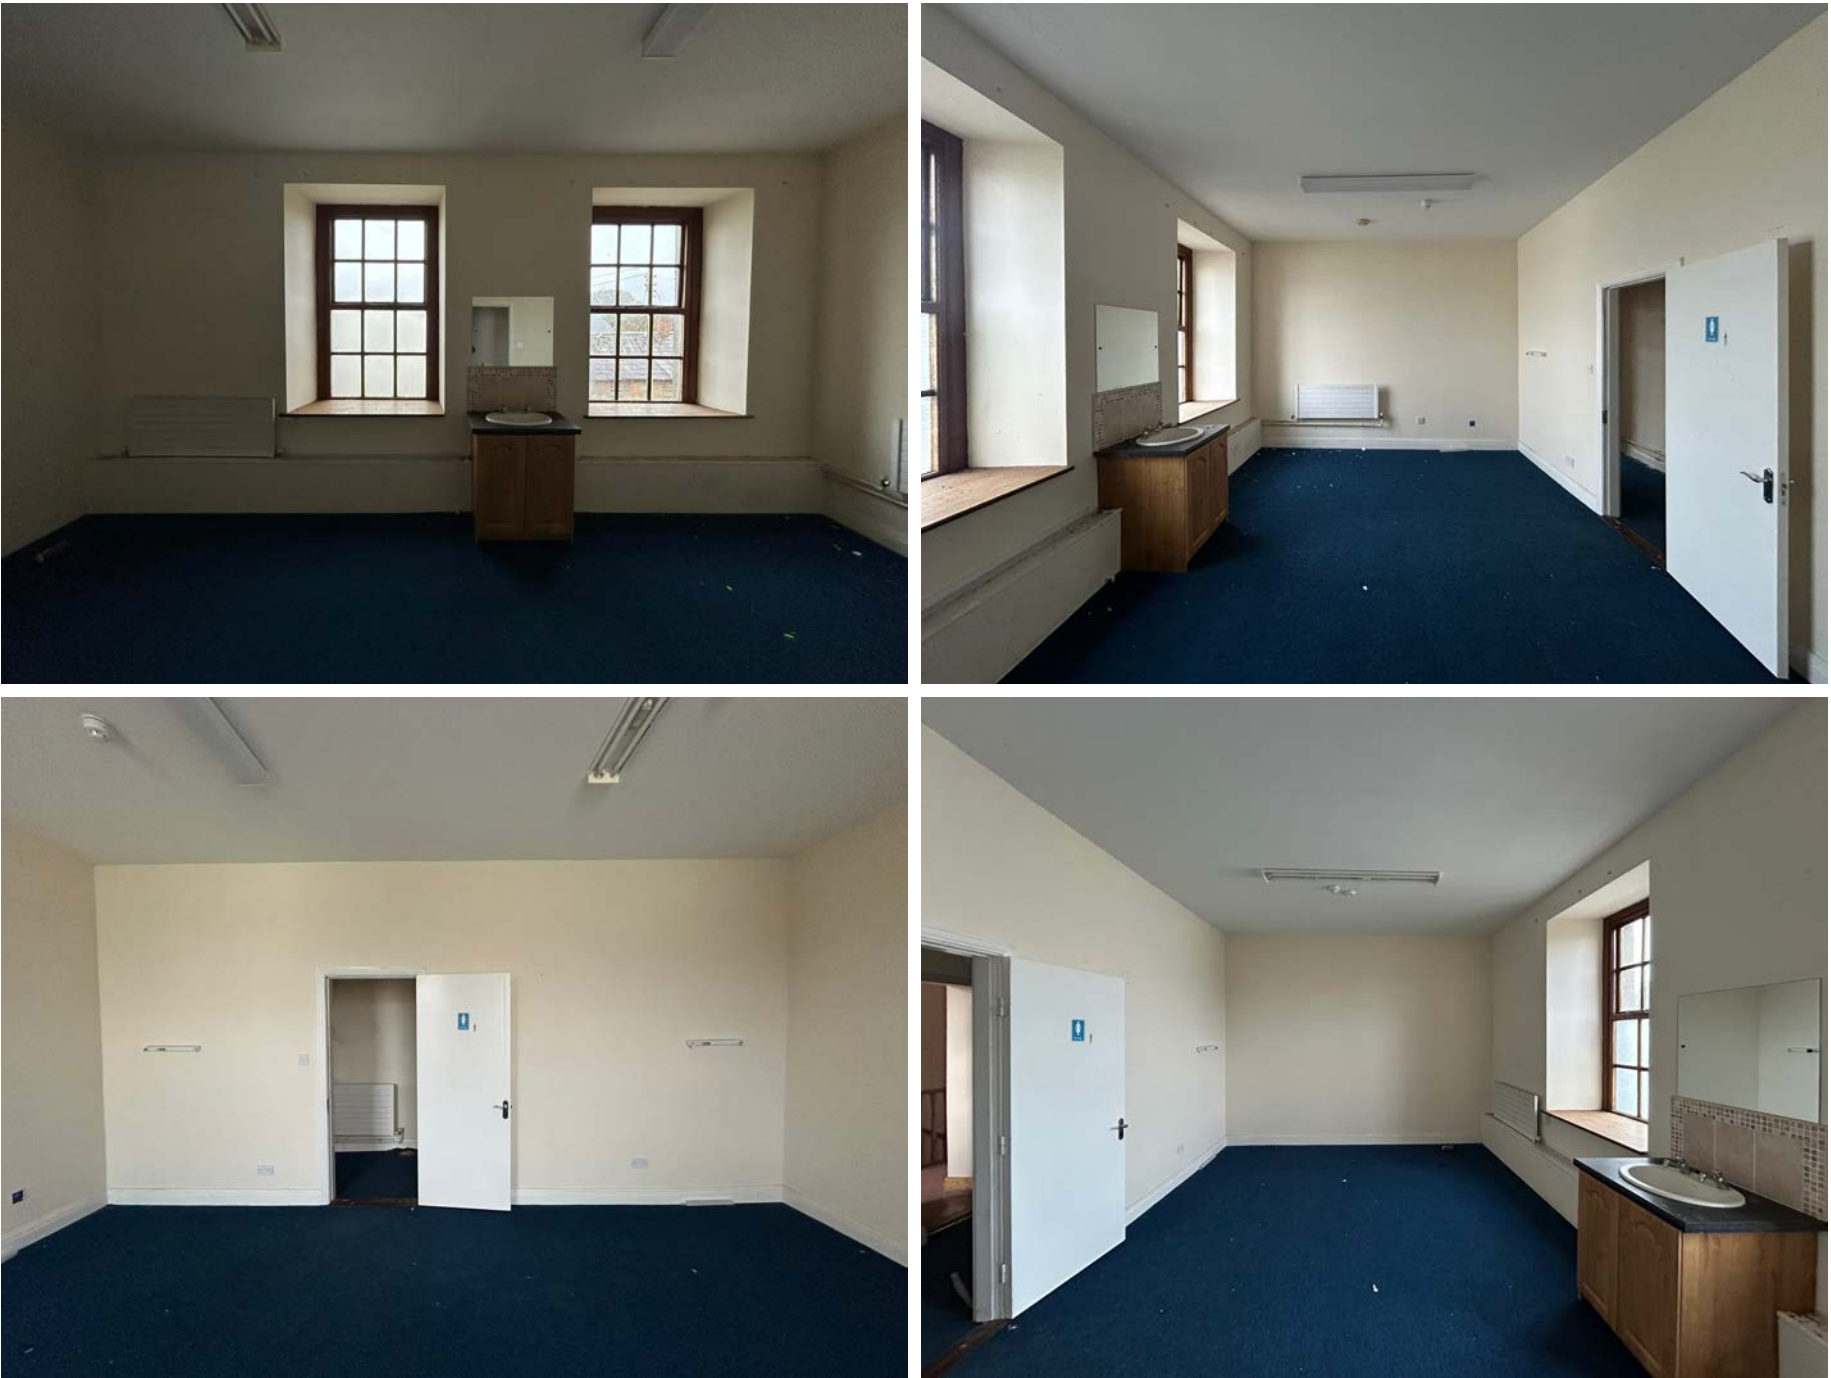
ROOM 01.N.02

The room is plain and unadorned in character with no ornamental historic plasterwork or timber features evident, such as cornice-work, dado rails, architraves or roses. Partitions and doors appear to be of 20th century origin and do not contribute to significance. Subdivision of rooms with lightweight partitions suggest the skirting boards are of 20th century origin and do not contribute to significance.

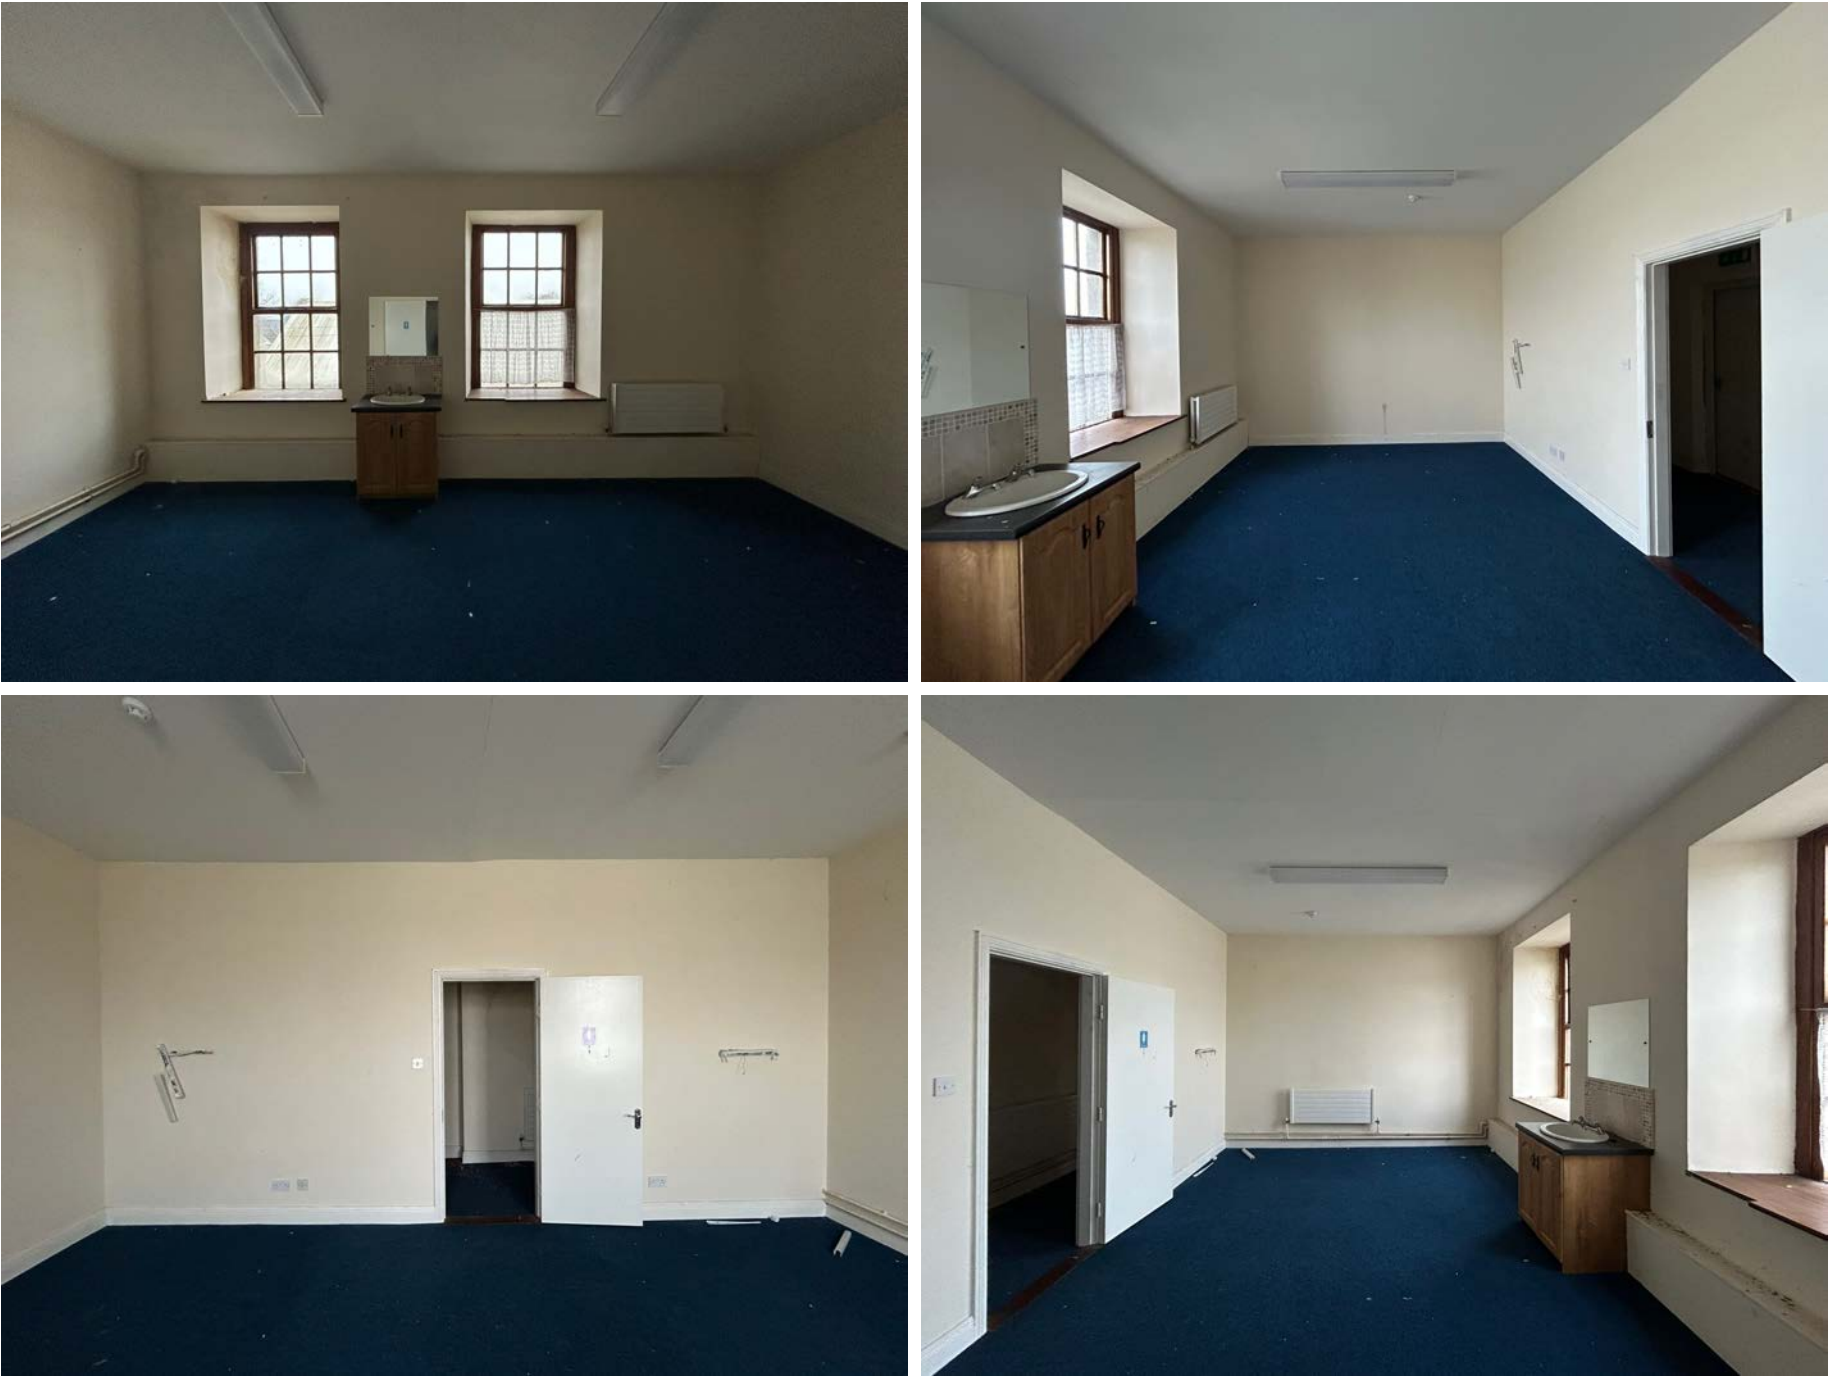
ROOM 01.N.03

The room is plain and unadorned in character with no ornamental historic plasterwork or timber features evident, such as cornice-work, dado rails, architraves or roses. Partitions and doors appear to be of 20th century origin and do not contribute to significance. Subdivision of rooms with lightweight partitions suggest the skirting boards are of 20th century origin and do not contribute to significance.

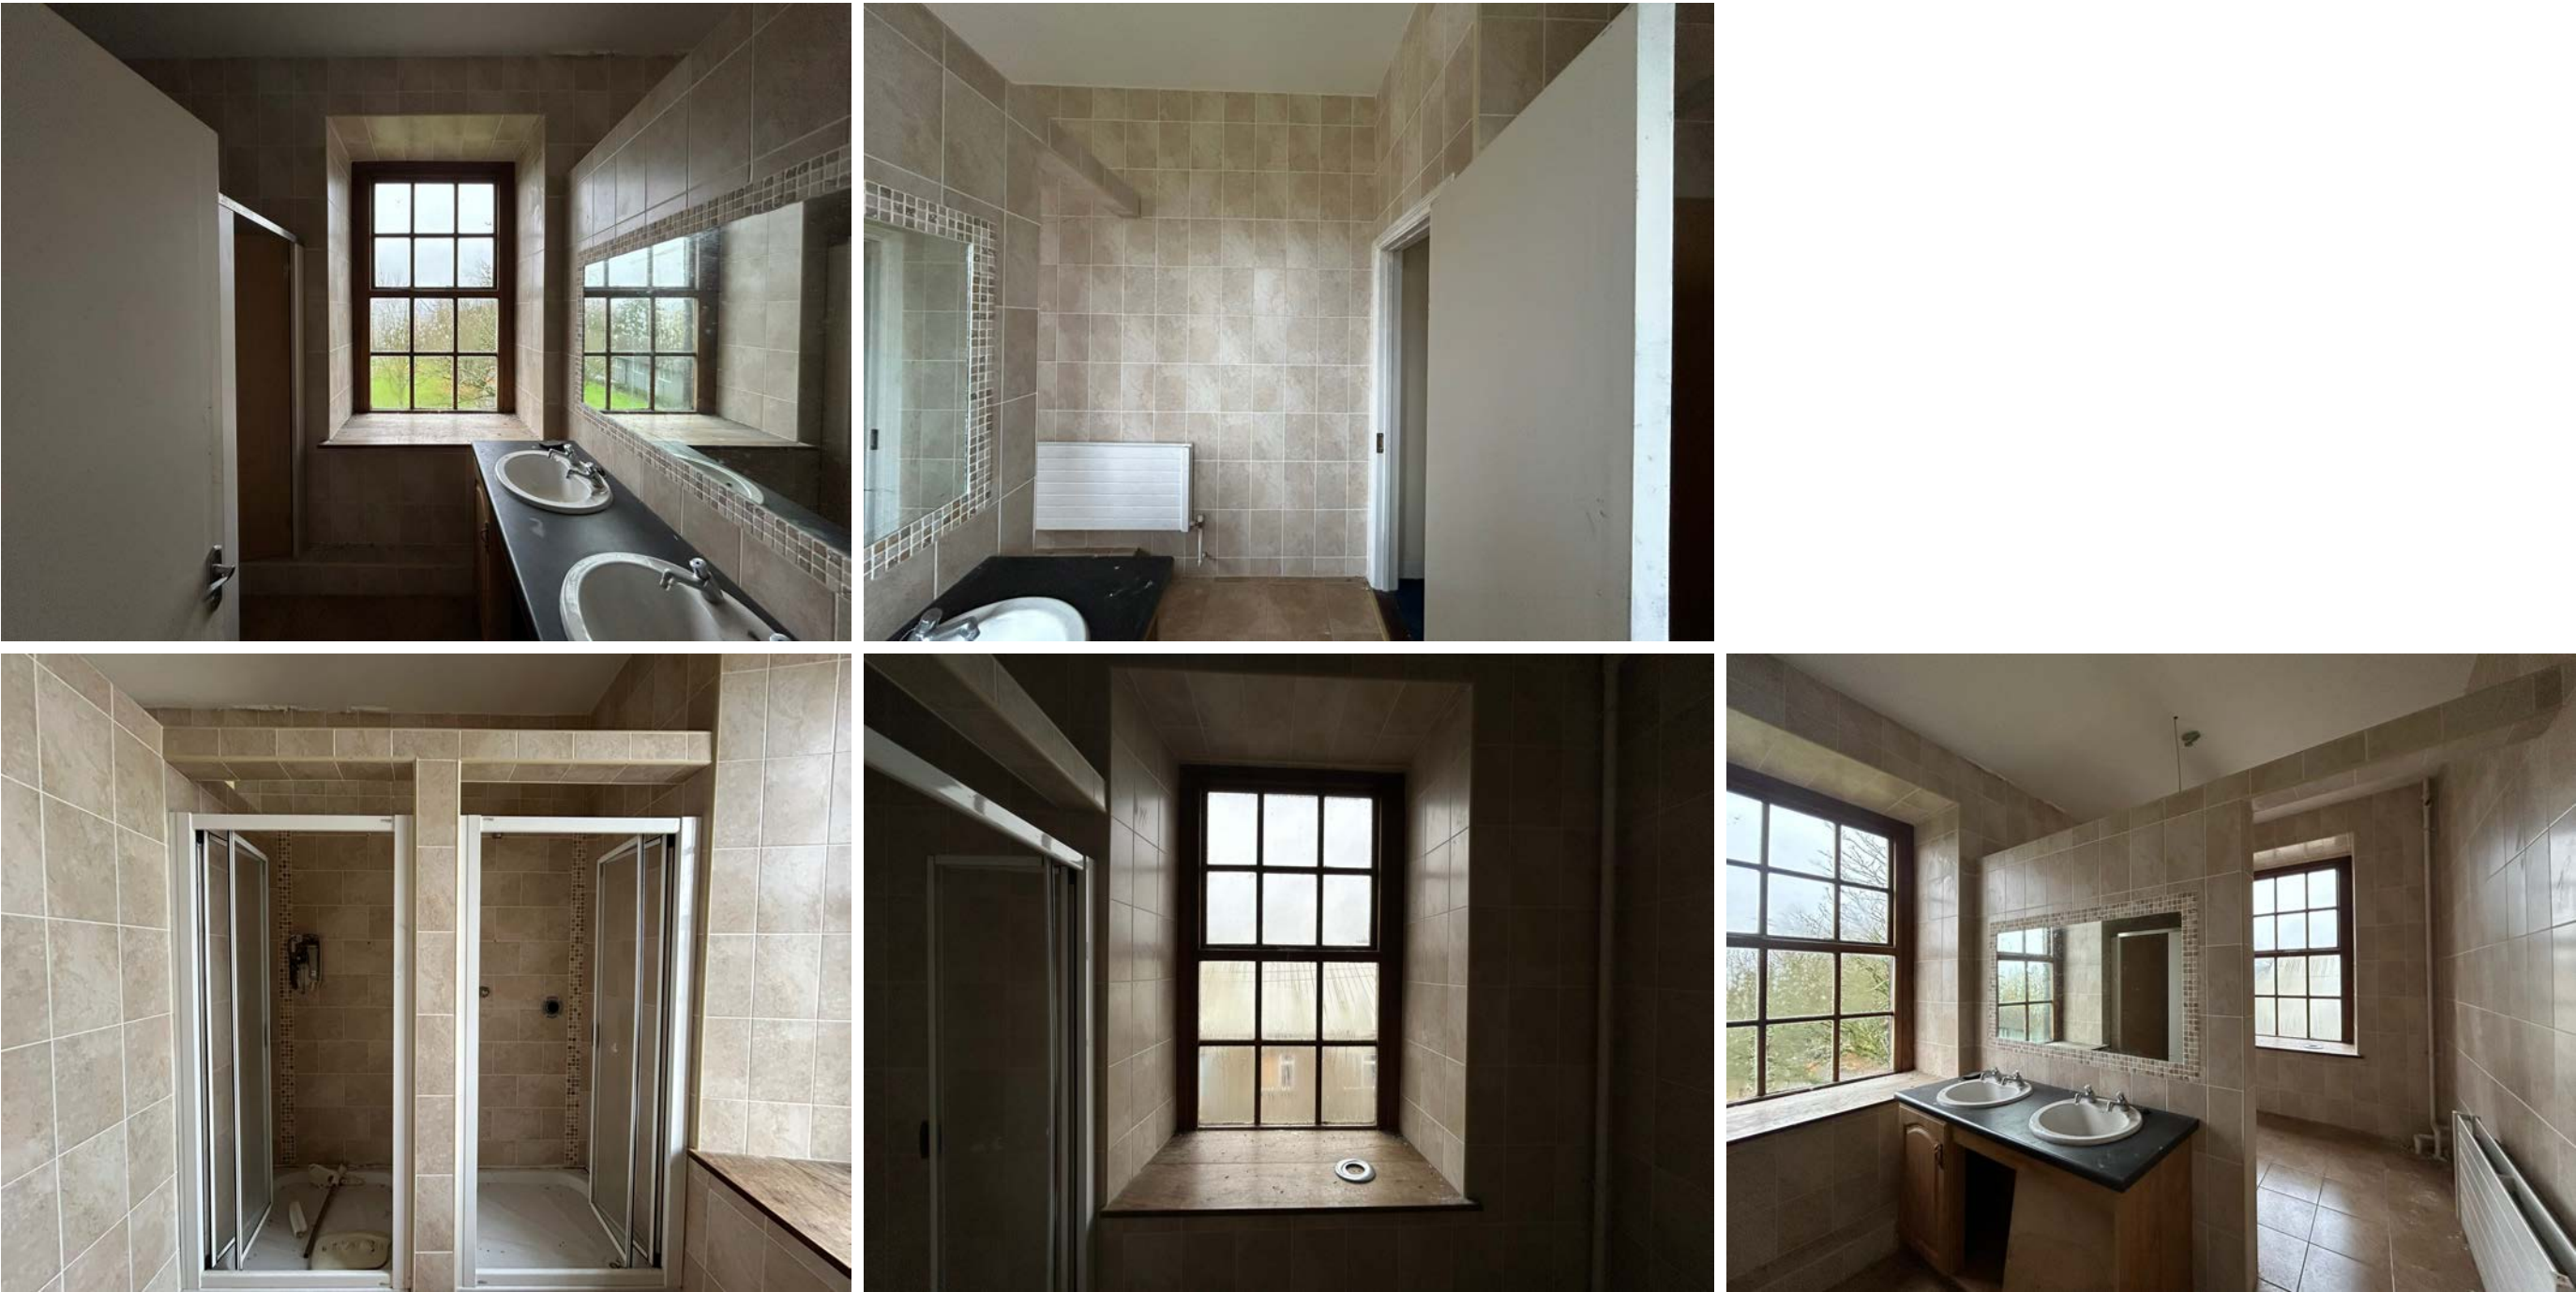
ROOM 01.N.04

The room is plain and unadorned in character with no ornamental historic plasterwork or timber features evident, such as cornice-work, dado rails, architraves or roses. Sanitaryware, built-in showers, partitions and doors appear to be of 20th century origin and do not contribute to significance.
