OFFICERS BUILDING
LONGFORD | COUNTY LONGFORD
ARCHITECTURAL HERITAGE IMPACT ASSESSMENT REPORT

ROBIN LEE ARCHITECTURE
JANUARY 2025

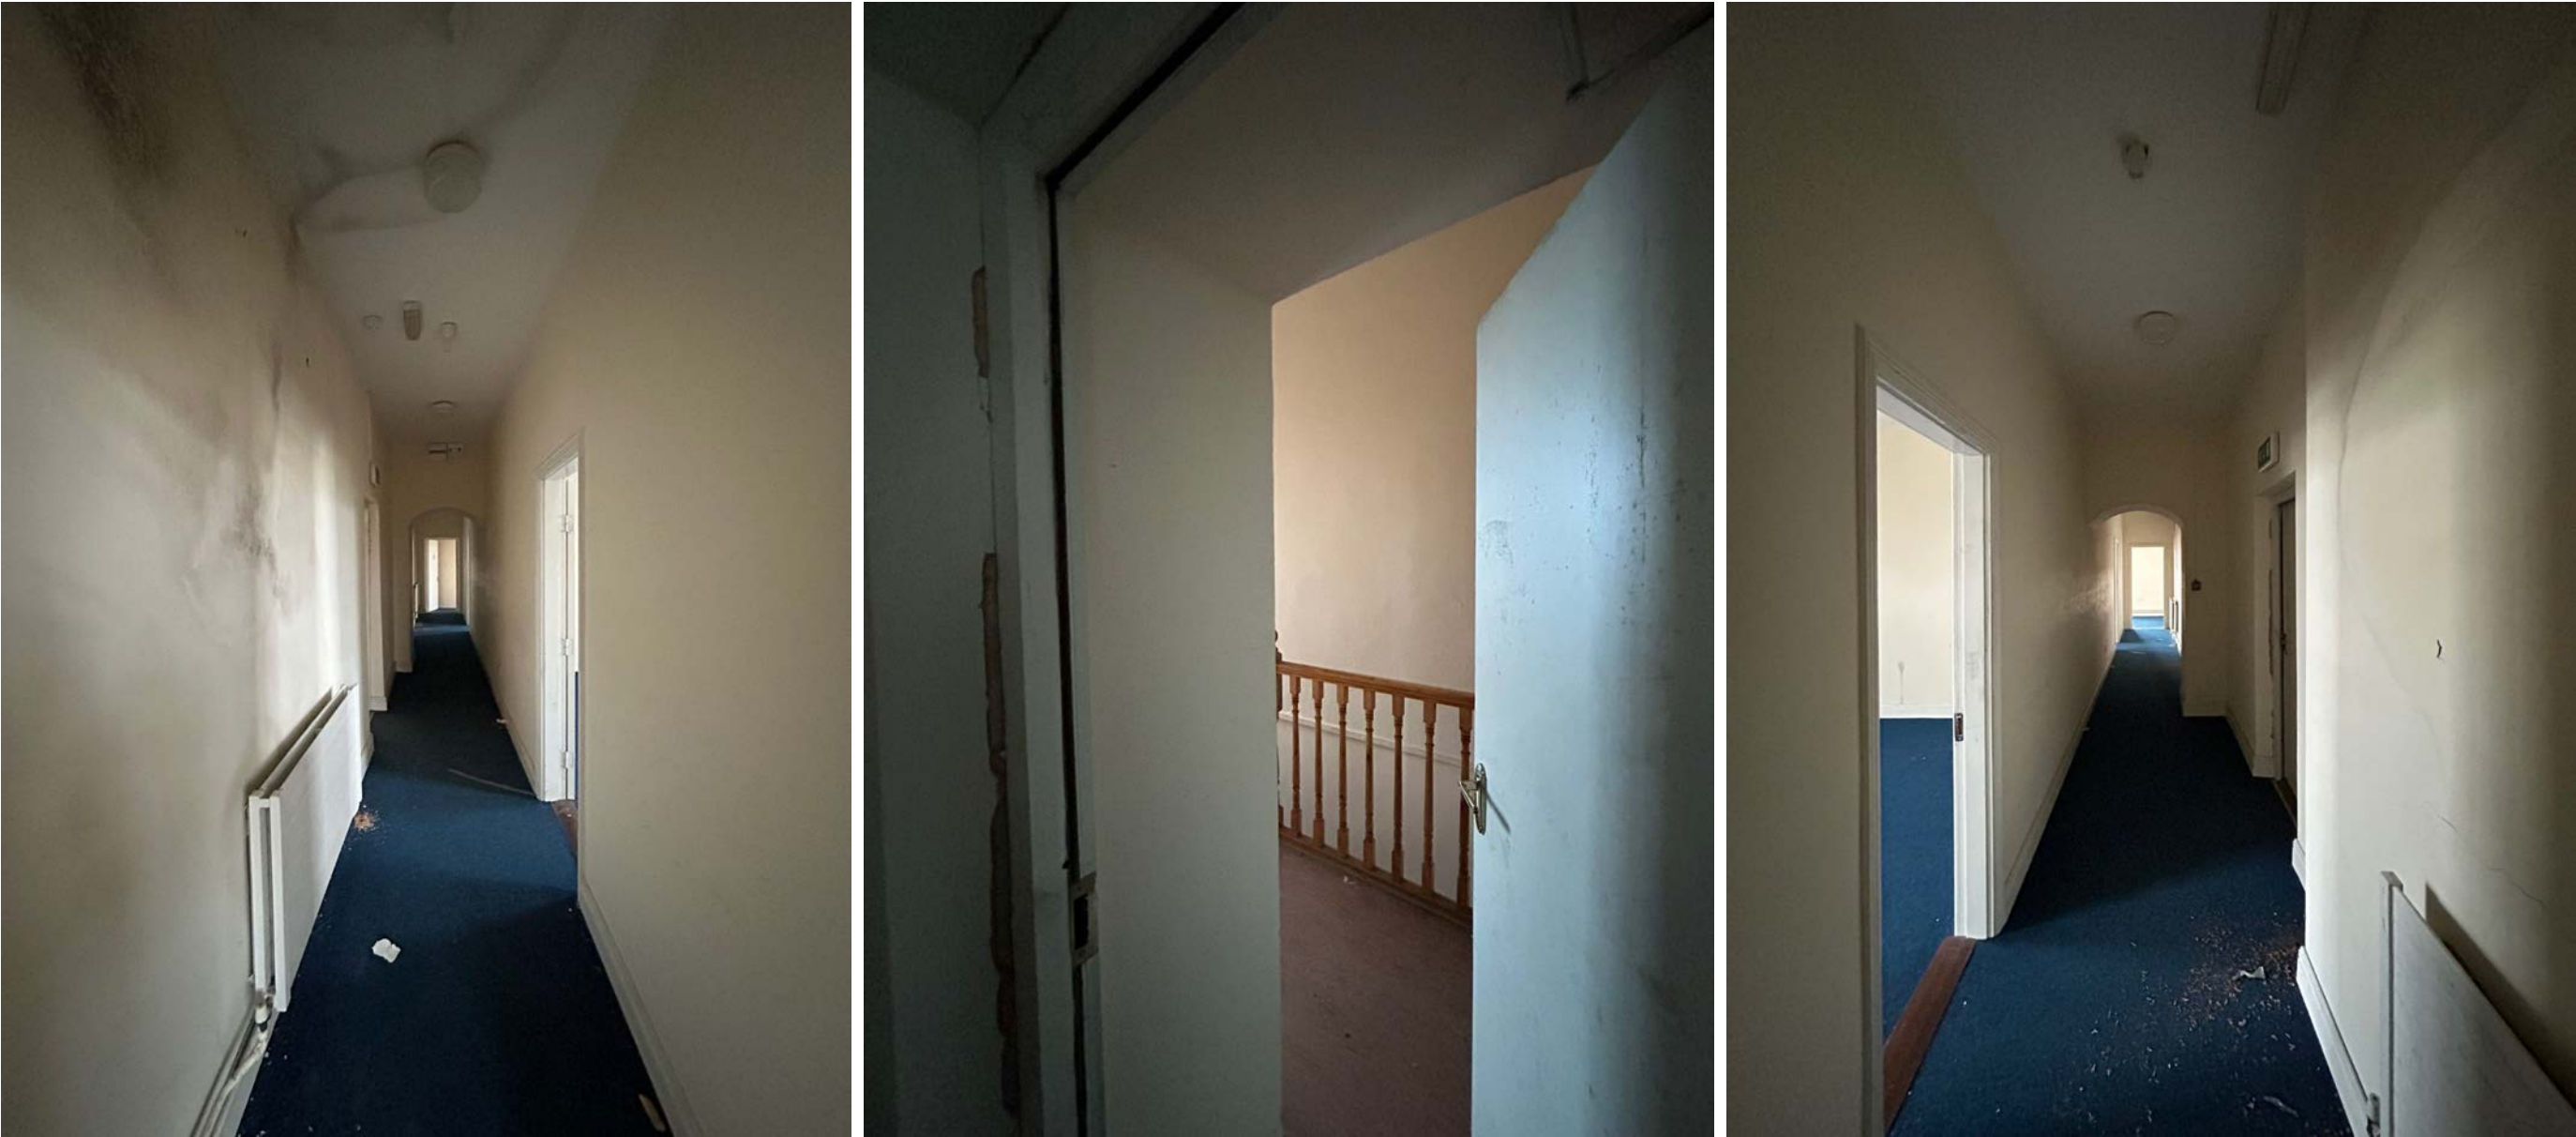
ROOM 01.N.05

The room is plain and unadorned in character with no ornamental historic plasterwork or timber features evident, such as cornice-work, dado rails, architraves or roses. Partitions and doors appear to be of 20th century origin and do not contribute to significance. Subdivision of rooms with lightweight partitions suggest the skirting boards are of 20th century origin and do not contribute to significance.

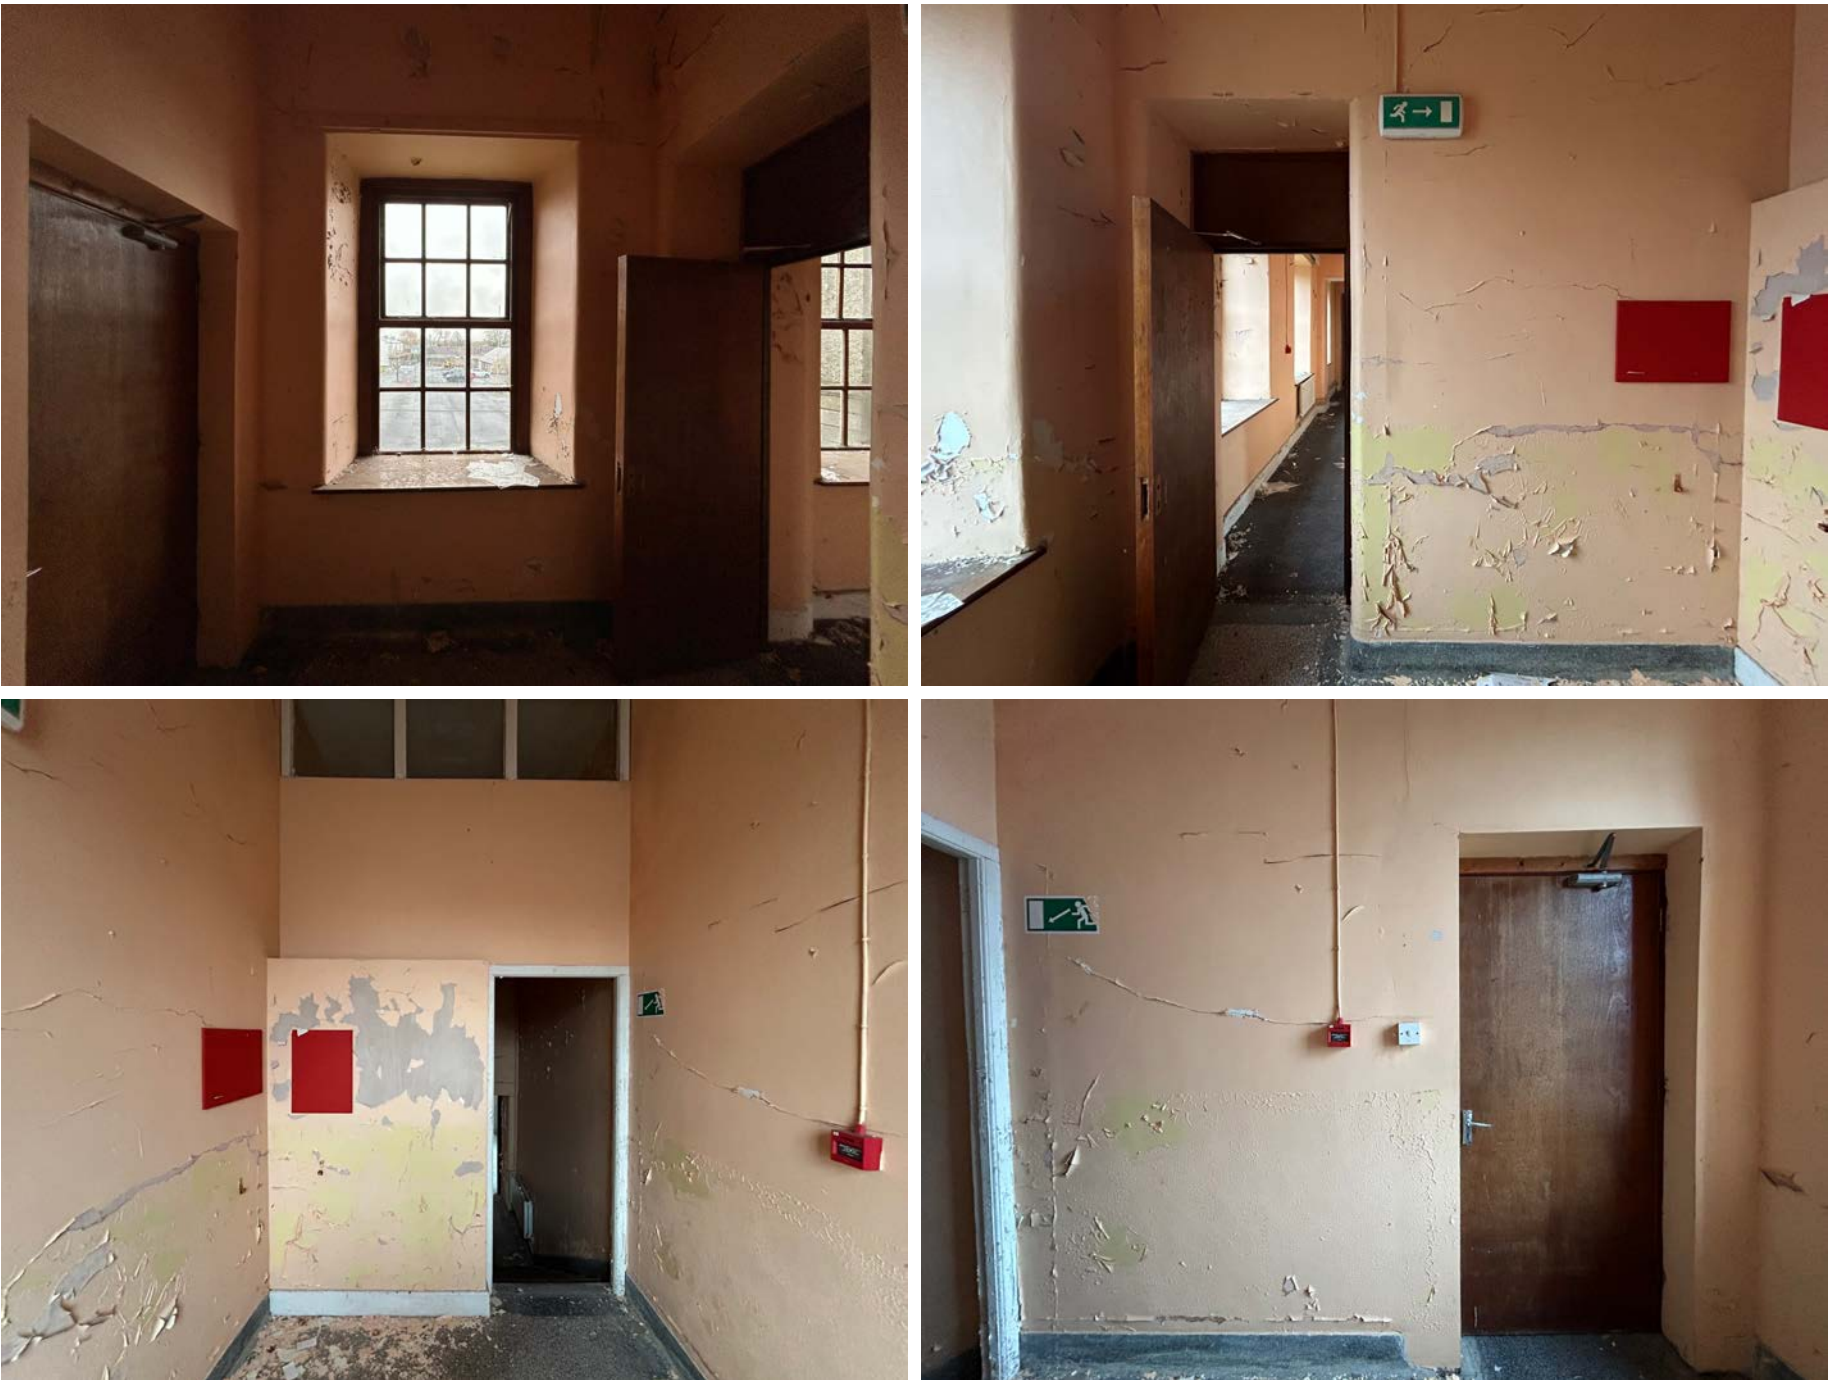
ROOM 01.ST.01

The room is plain and unadorned in character with no ornamental historic plasterwork or timber features evident, such as cornice-work, dado rails, architraves or roses. Partitions and doors appear to be of 20th century origin and do not contribute to significance. Subdivision of rooms with lightweight partitions suggest the skirting boards are of 20th century origin and do not contribute to significance.

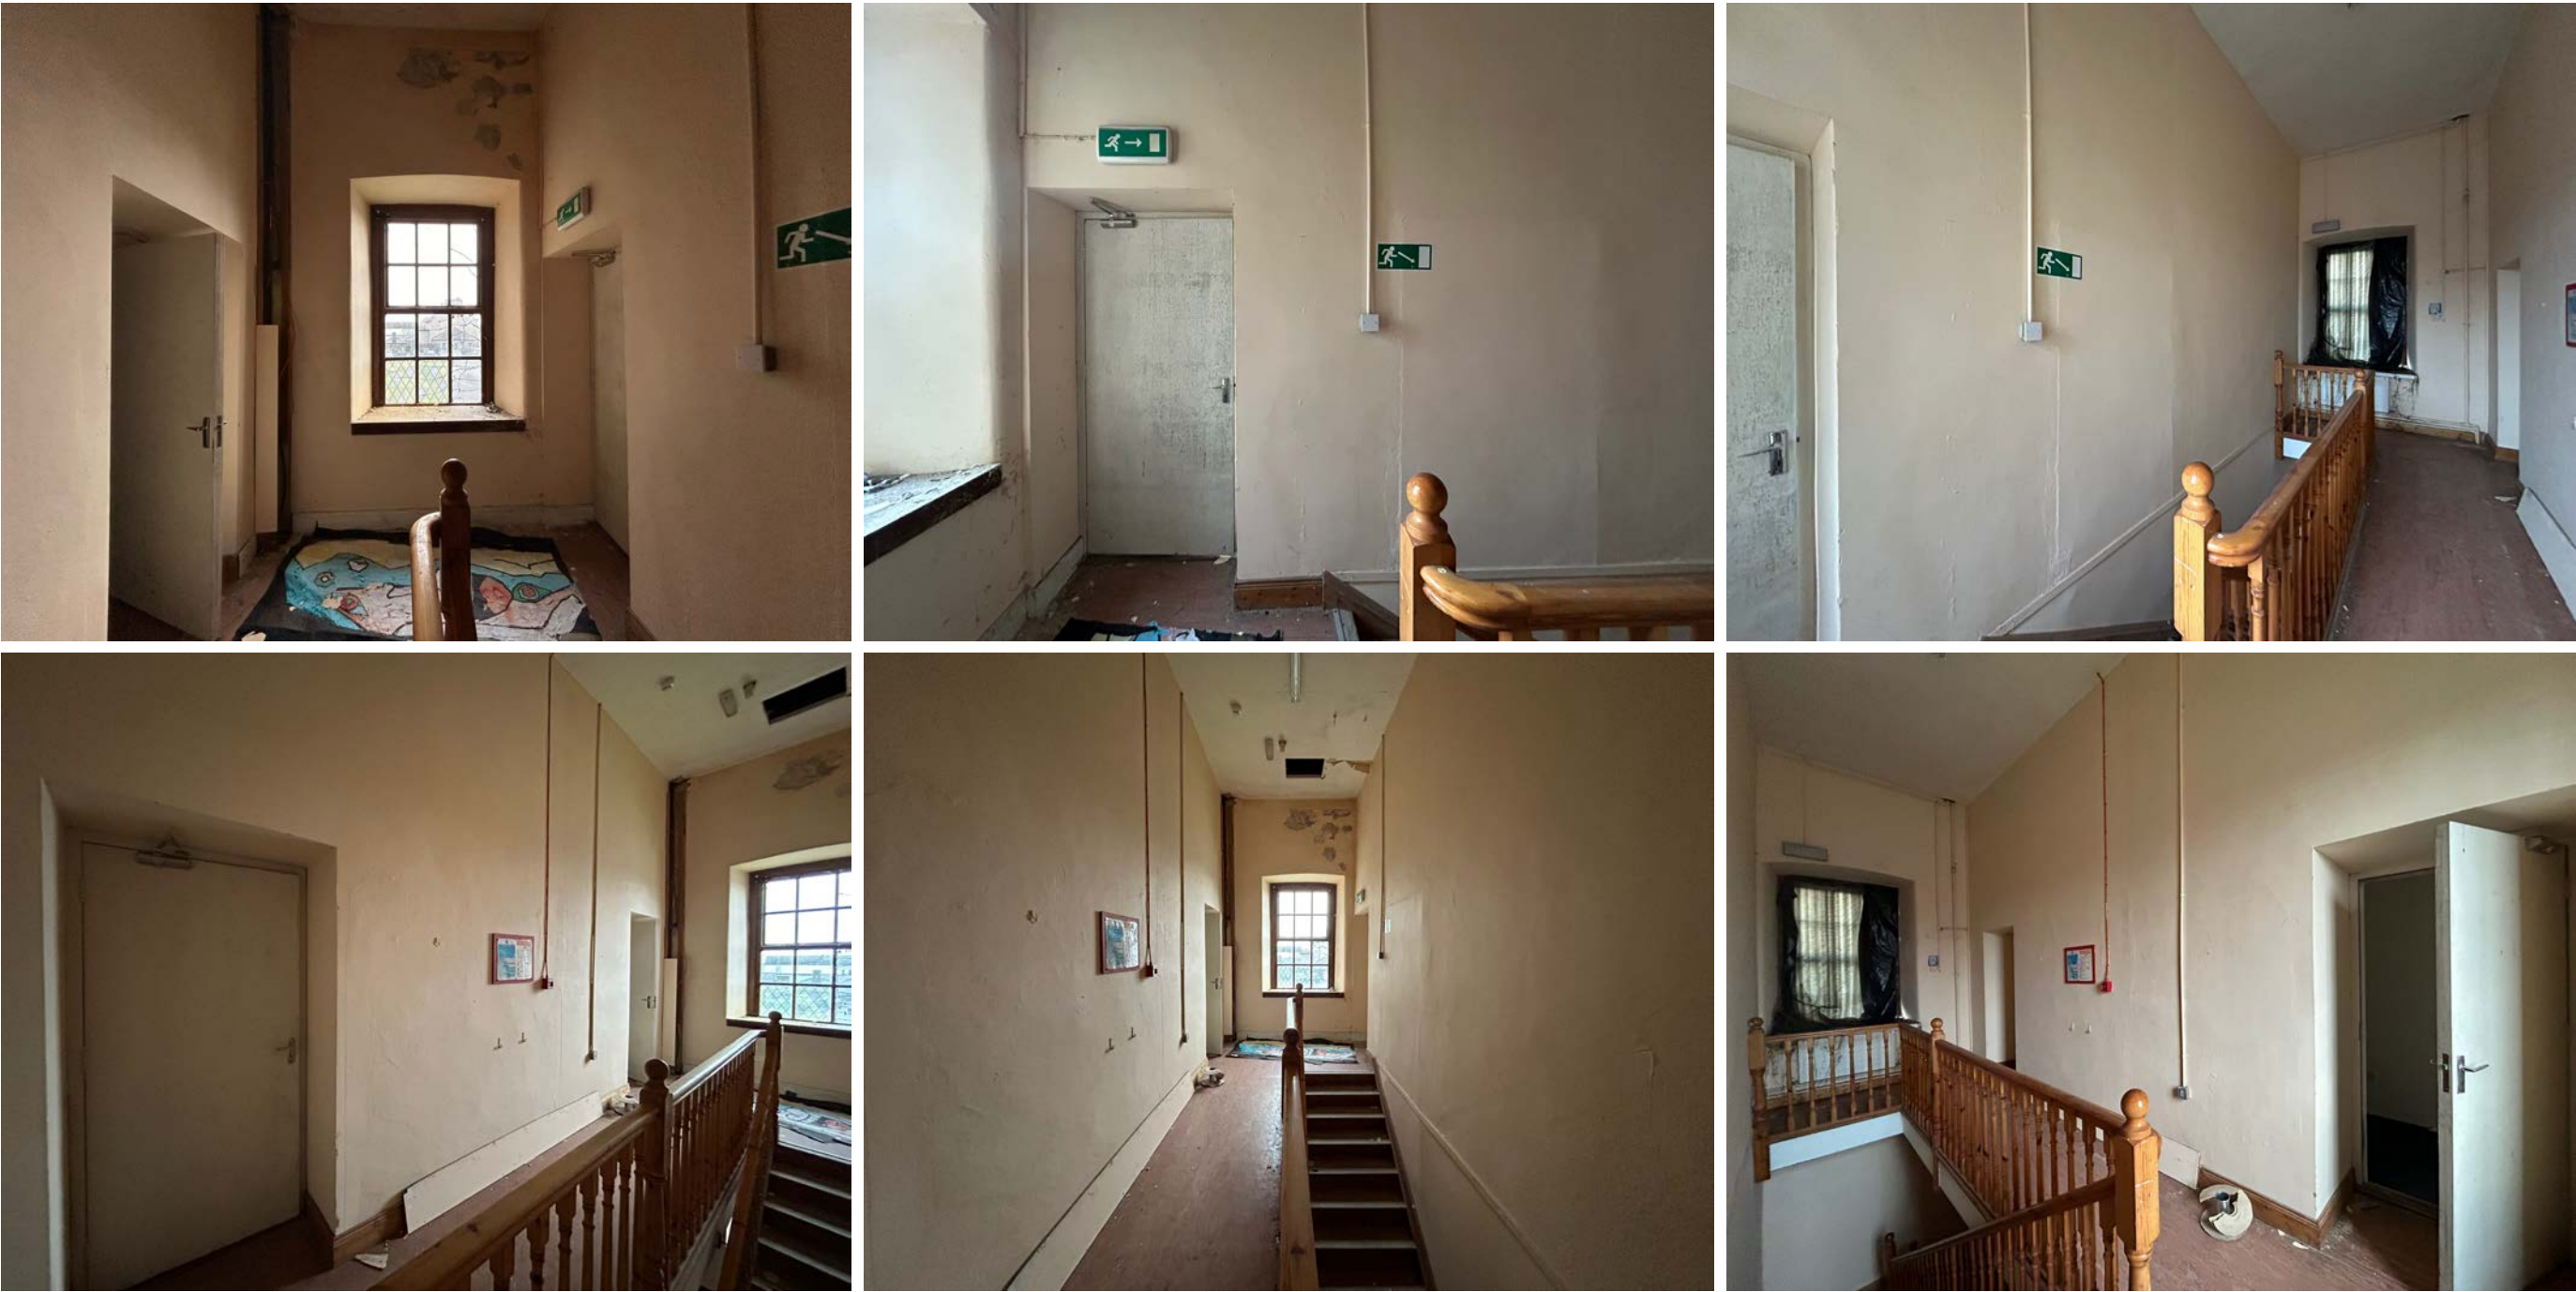
ROOM 01.ST.04

The stairwell landing is plain and unadorned in character with no ornamental historic plasterwork or timber features evident, such as cornice-work, dado rails, architraves or roses. Timber constructed stair, newel posts, spindles and handrails appear to be of 20th century origin and do not contribute to significance.

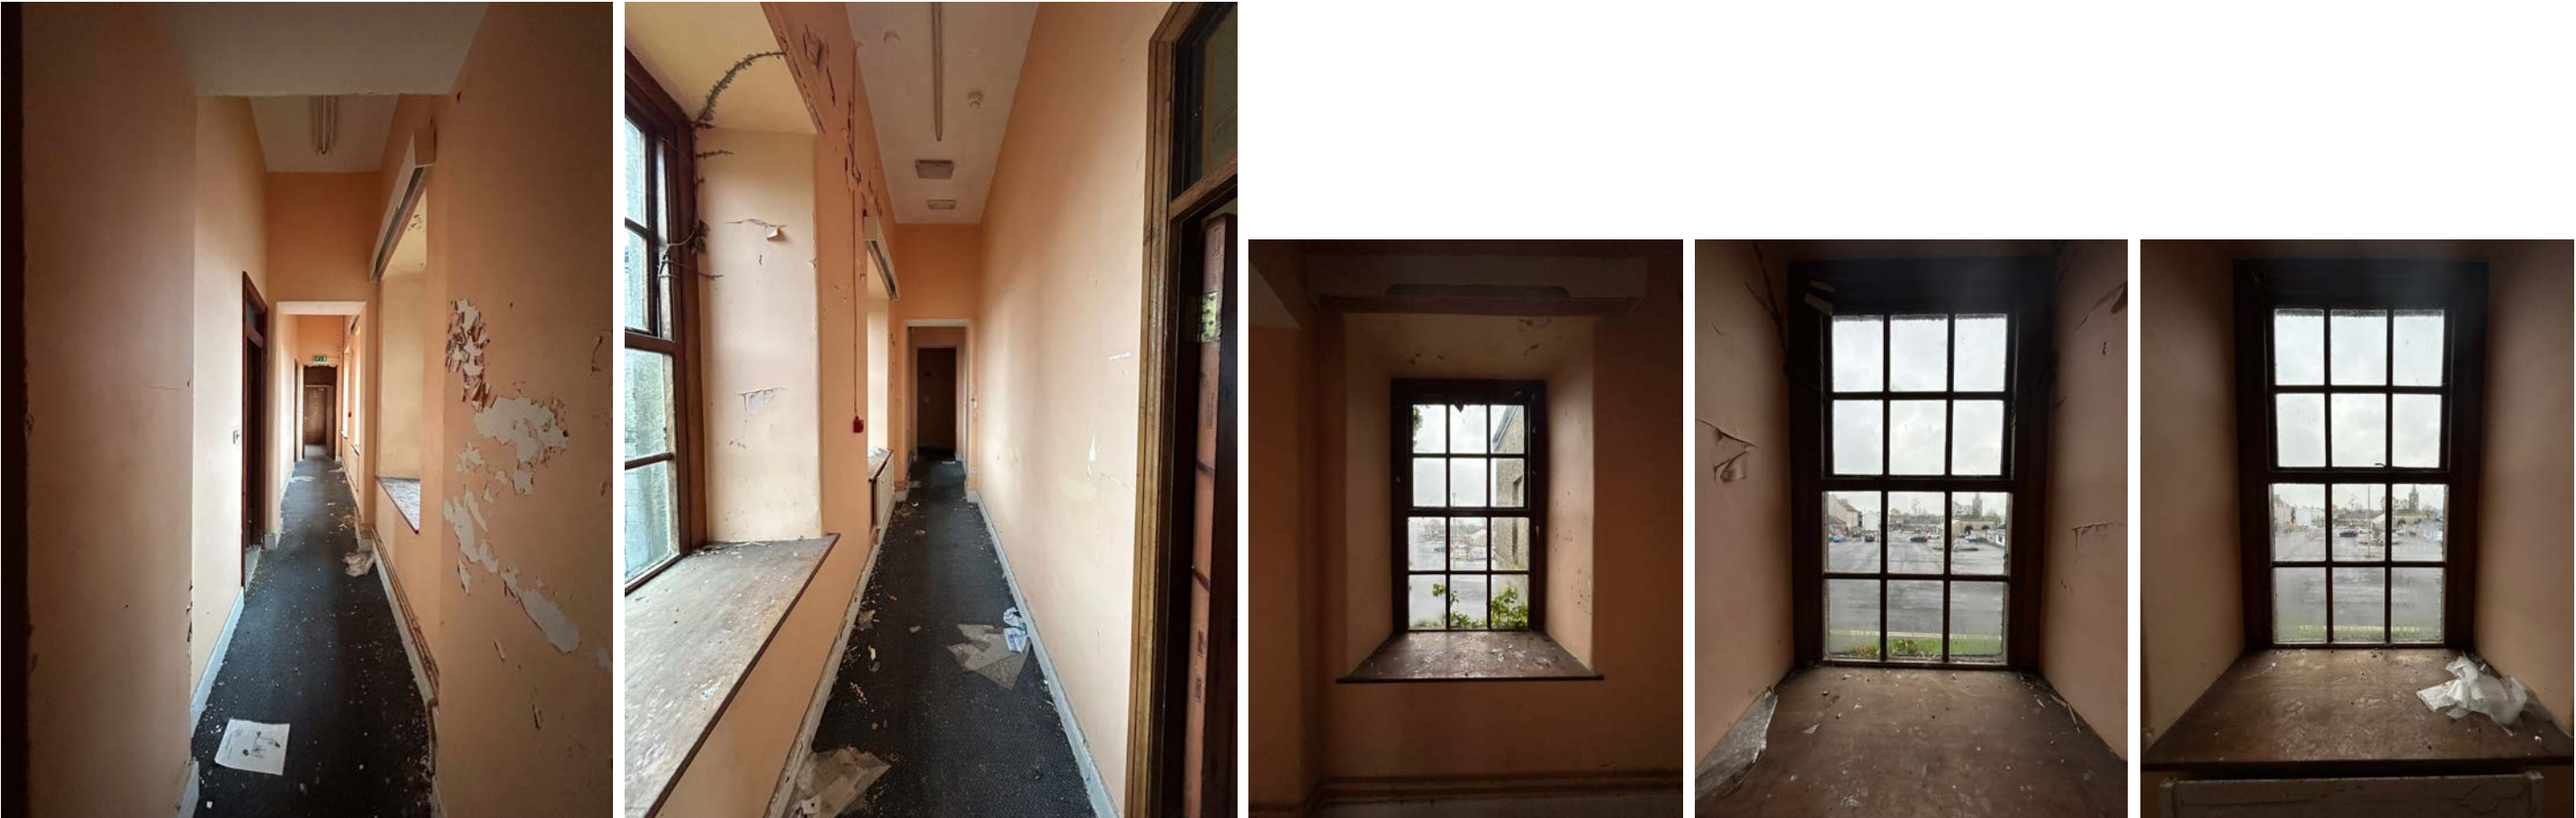
ROOM 01.C.01

The corridor is plain and unadorned in character with no ornamental historic plasterwork or timber features evident, such as cornice-work, dado rails, architraves or roses. Partitions and doors appear to be of 20th century origin and do not contribute to significance. Subdivision of rooms with lightweight partitions suggest the skirting boards are of 20th century origin and do not contribute to significance.

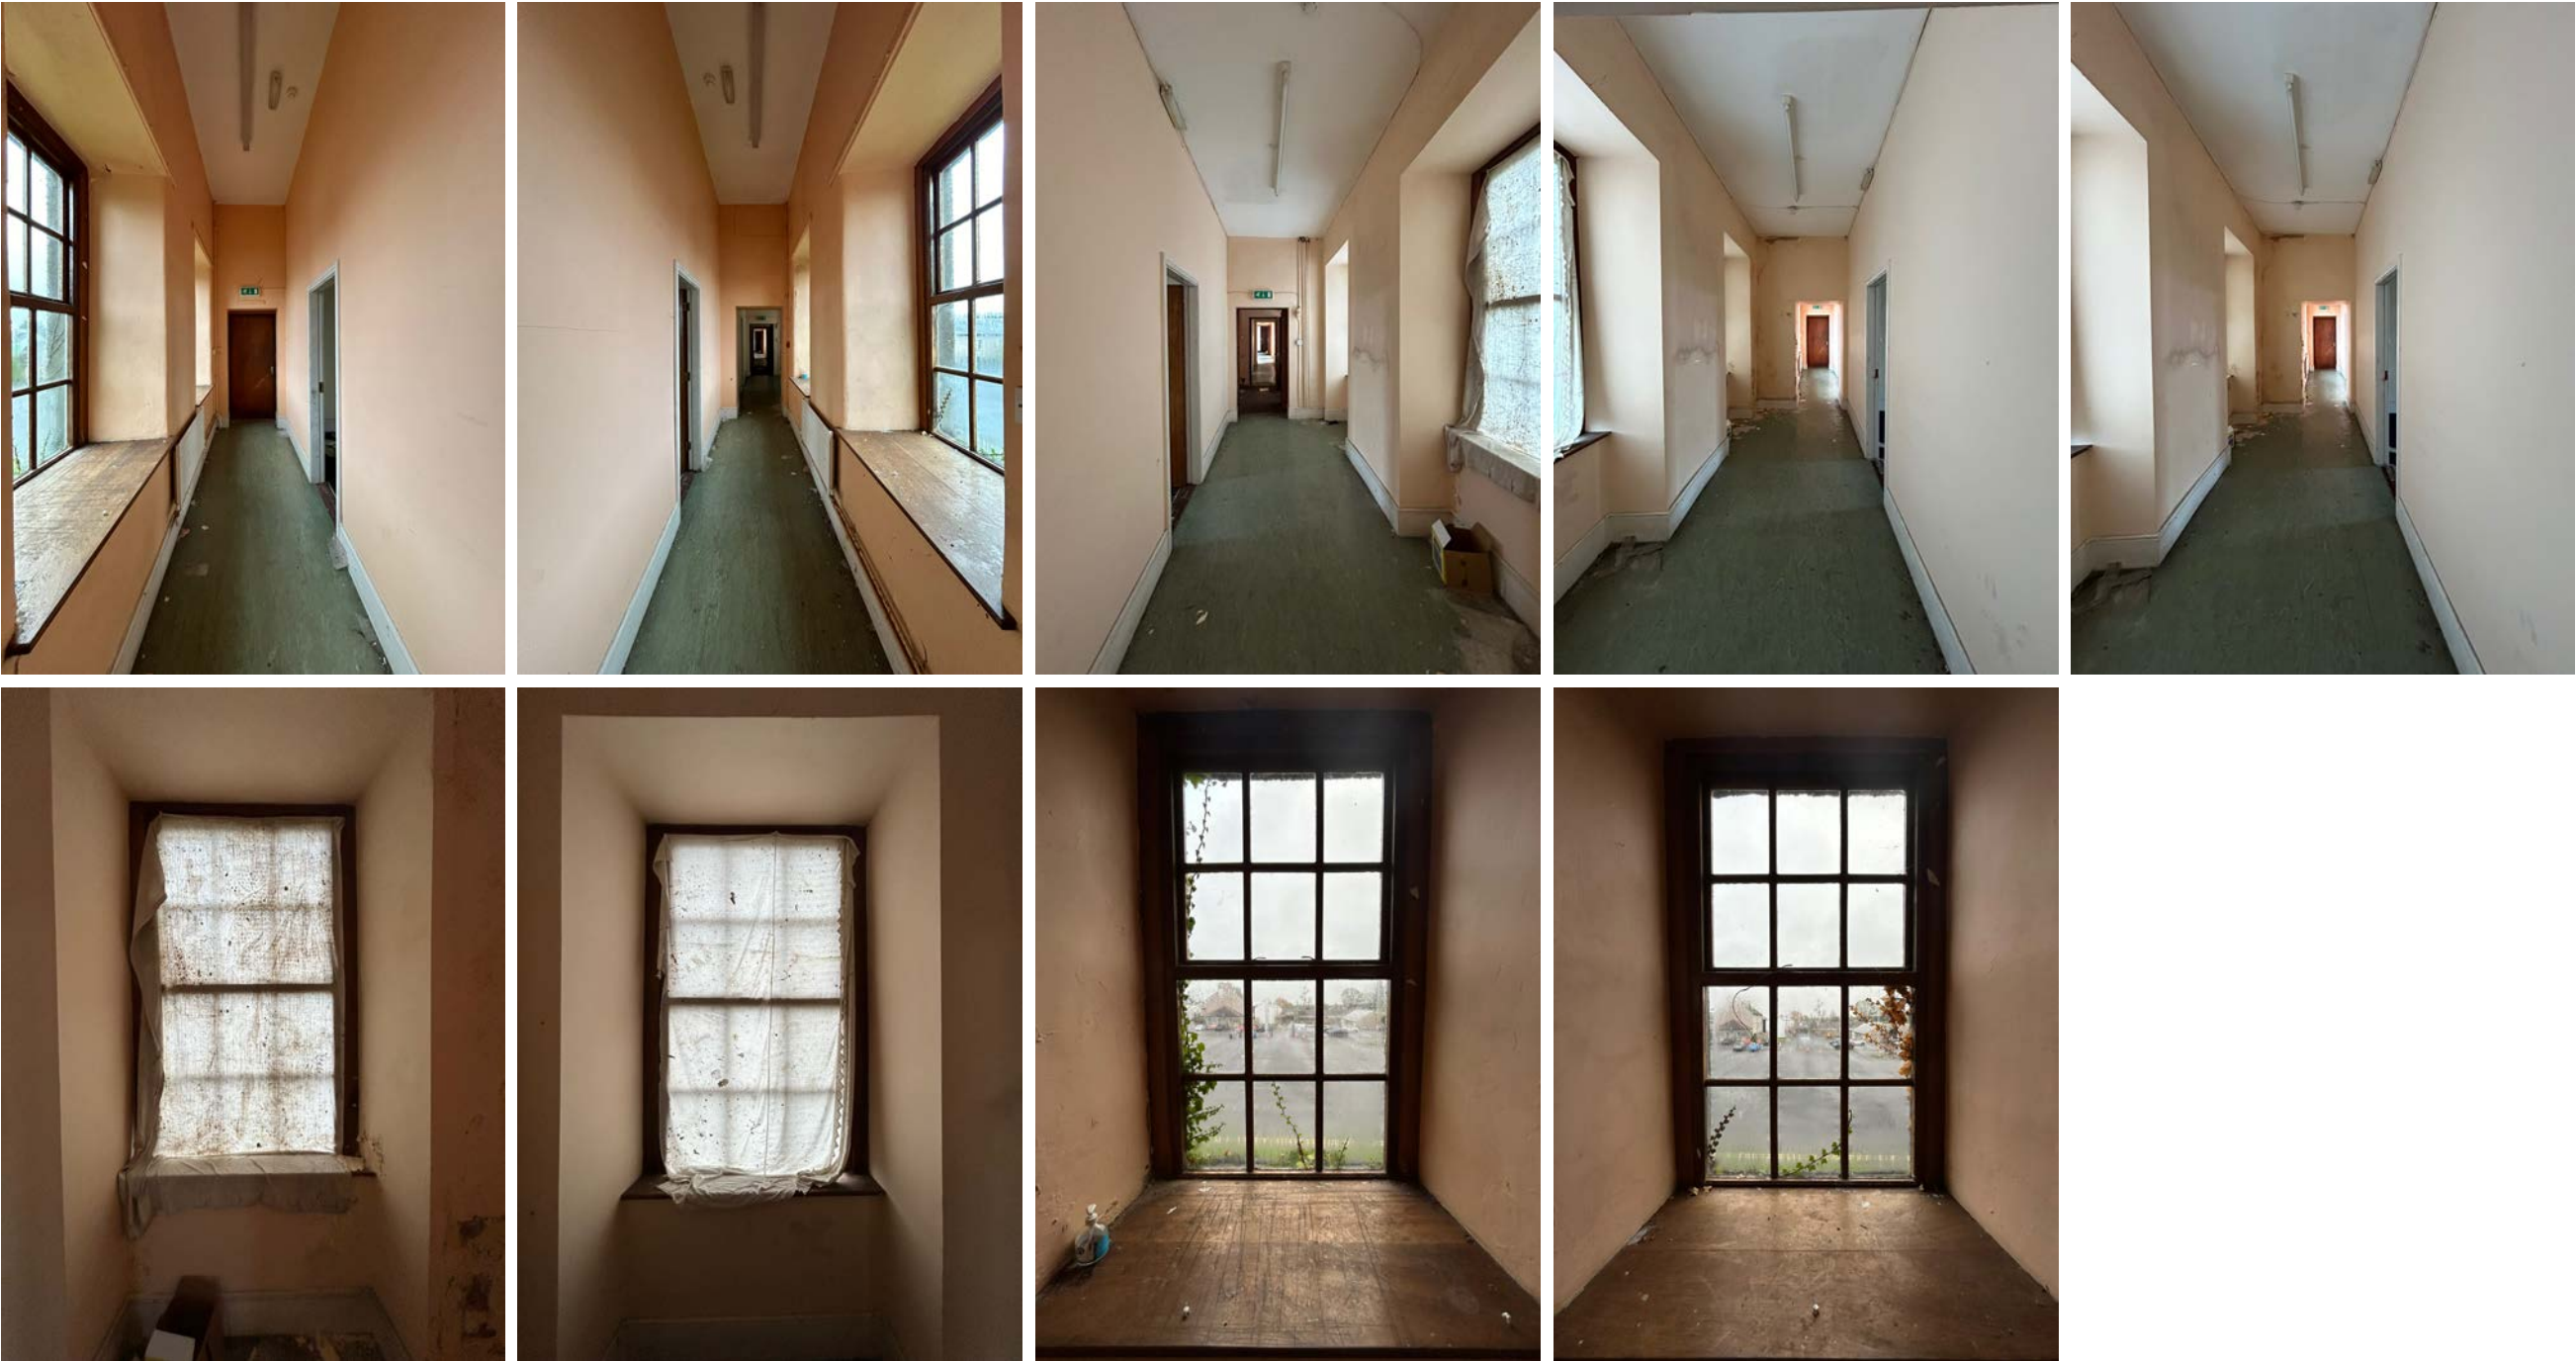
ROOM 01.C.02

The corridor is plain and unadorned in character with no ornamental historic plasterwork or timber features evident, such as cornice-work, dado rails, architraves or roses. Partitions and doors appear to be of 20th century origin and do not contribute to significance. Subdivision of rooms with lightweight partitions suggest the skirting boards are of 20th century origin and do not contribute to significance.

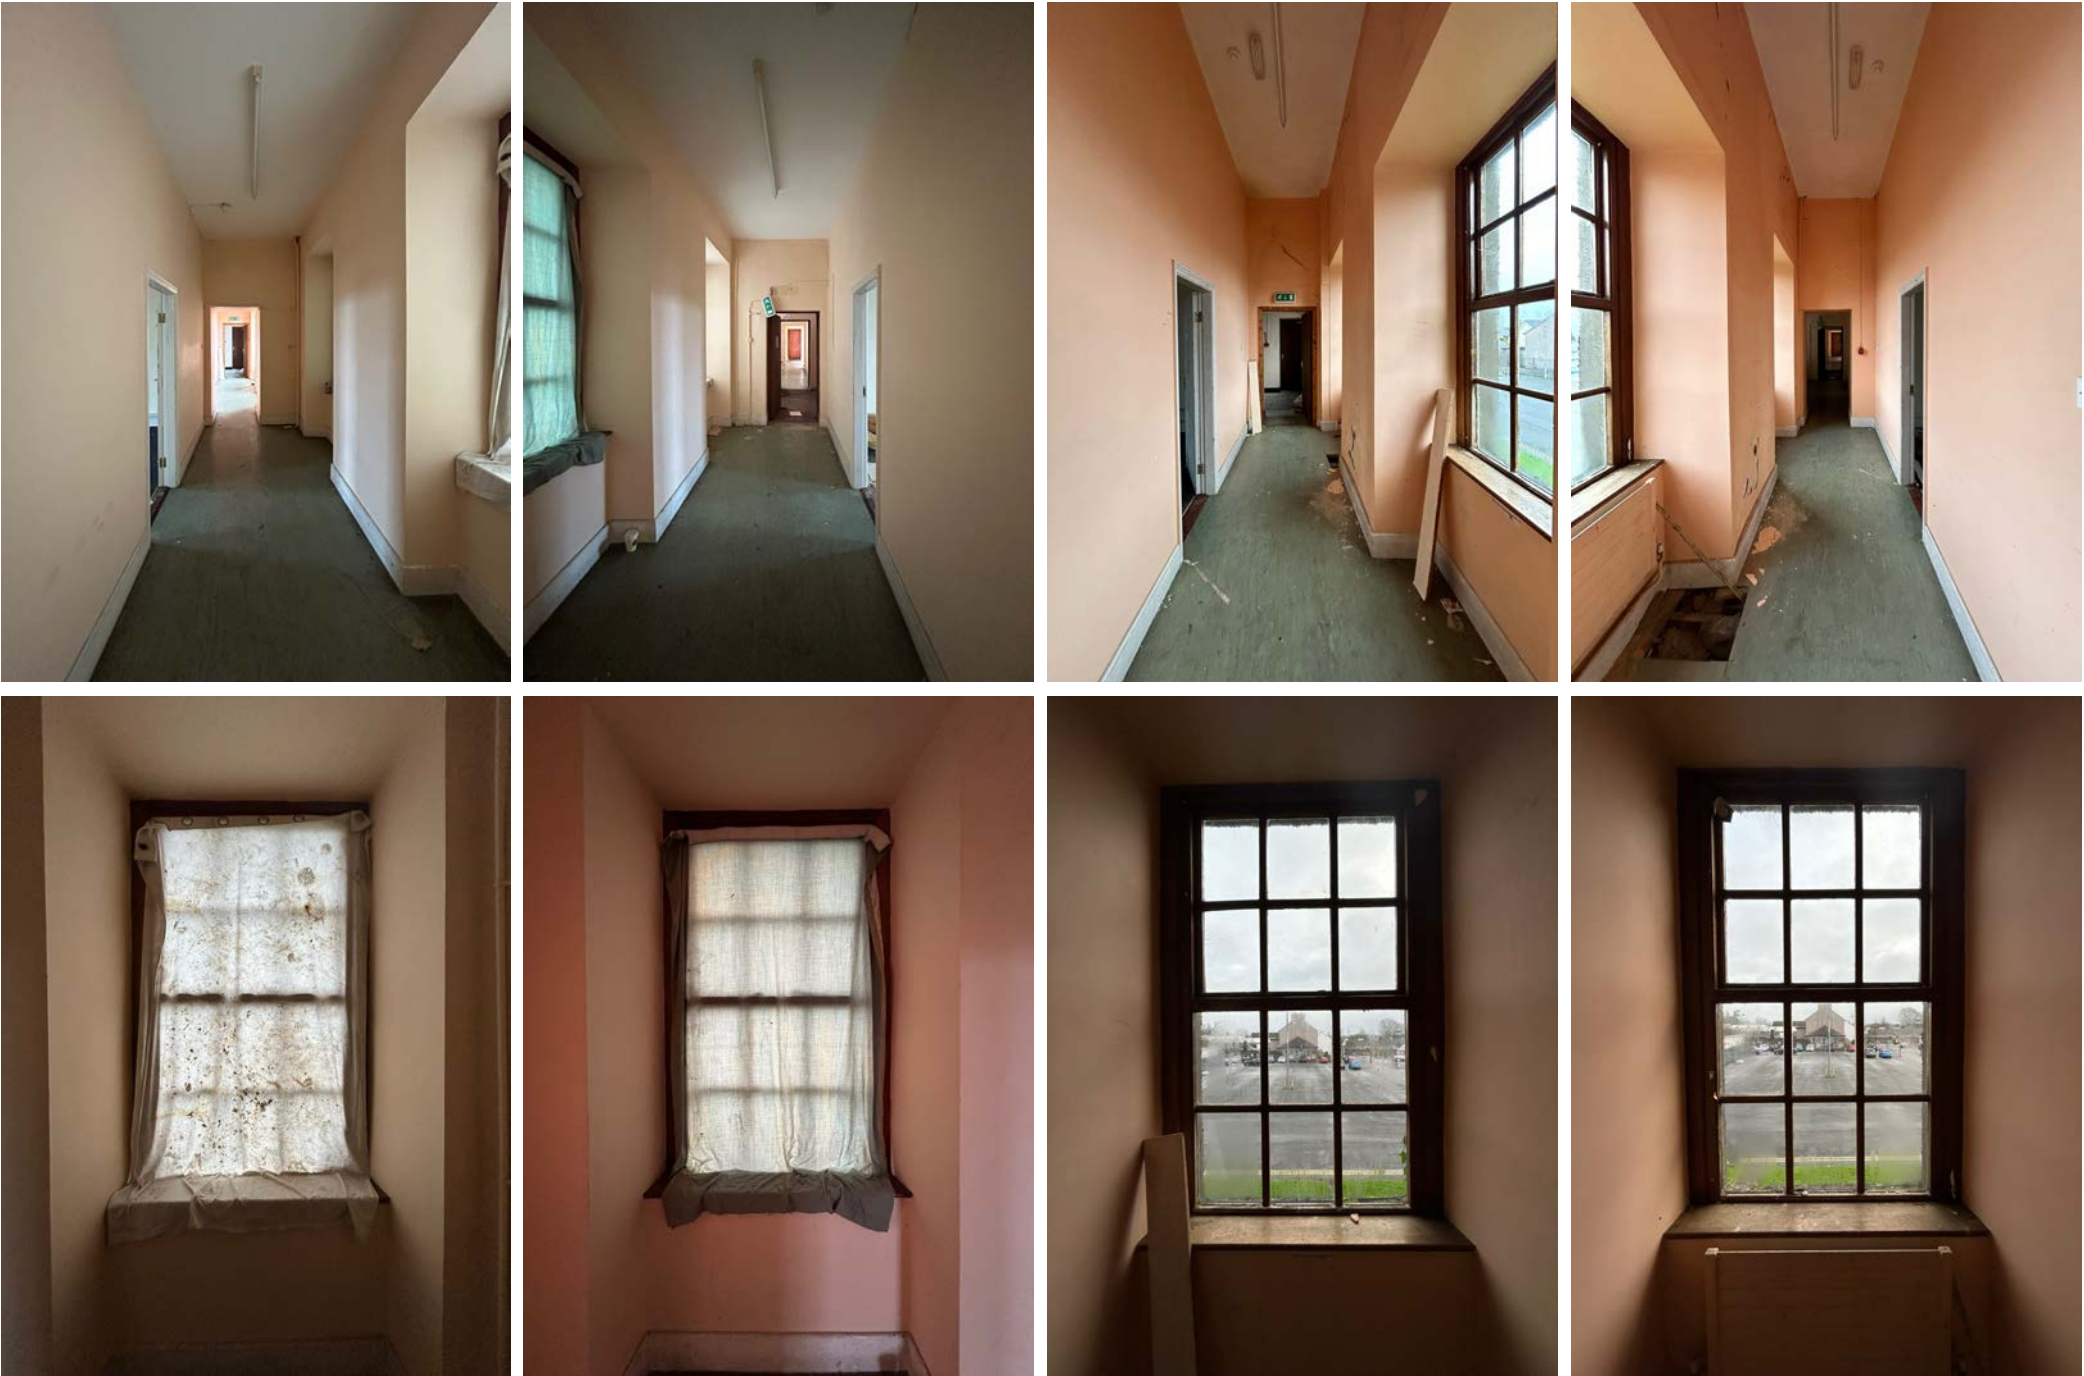
ROOM 01.C.03

The corridor is plain and unadorned in character with no ornamental historic plasterwork or timber features evident, such as cornice-work, dado rails, architraves or roses. Partitions and doors appear to be of 20th century origin and do not contribute to significance. Subdivision of rooms with lightweight partitions suggest the skirting boards are of 20th century origin and do not contribute to significance.

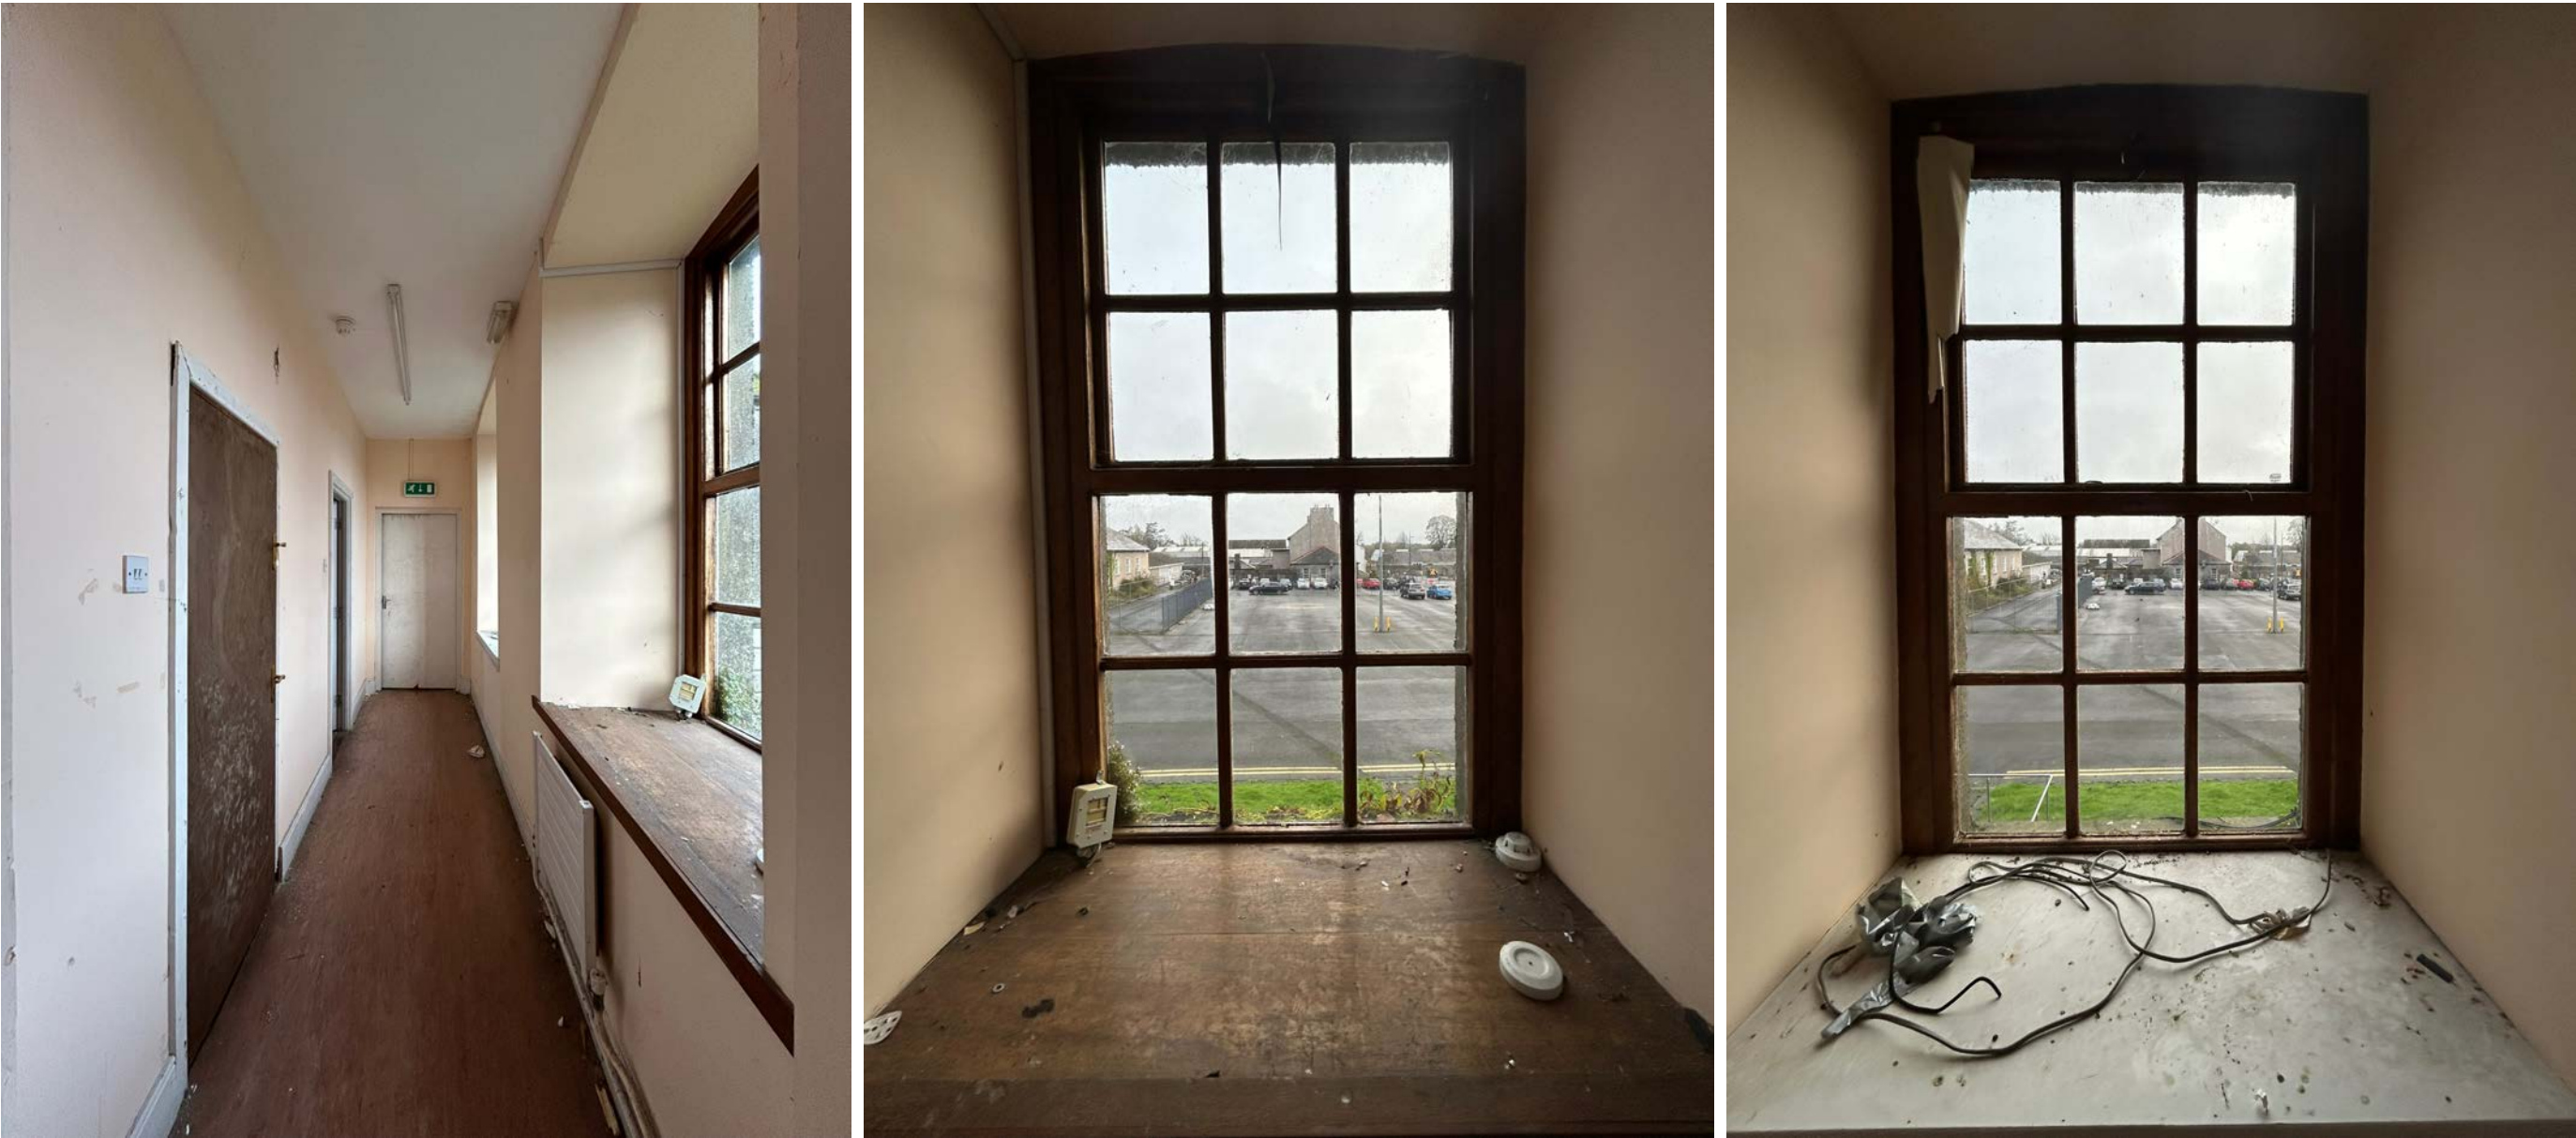
ROOM 01.C.04

The corridor is plain and unadorned in character with no ornamental historic plasterwork or timber features evident, such as cornice-work, dado rails, architraves or roses. Partitions and doors appear to be of 20th century origin and do not contribute to significance. Subdivision of rooms with lightweight partitions suggest the skirting boards are of 20th century origin and do not contribute to significance.
