OFFICERS BUILDING
LONGFORD | COUNTY LONGFORD
ARCHITECTURAL HERITAGE IMPACT ASSESSMENT REPORT

ROBIN LEE ARCHITECTURE
JANUARY 2025

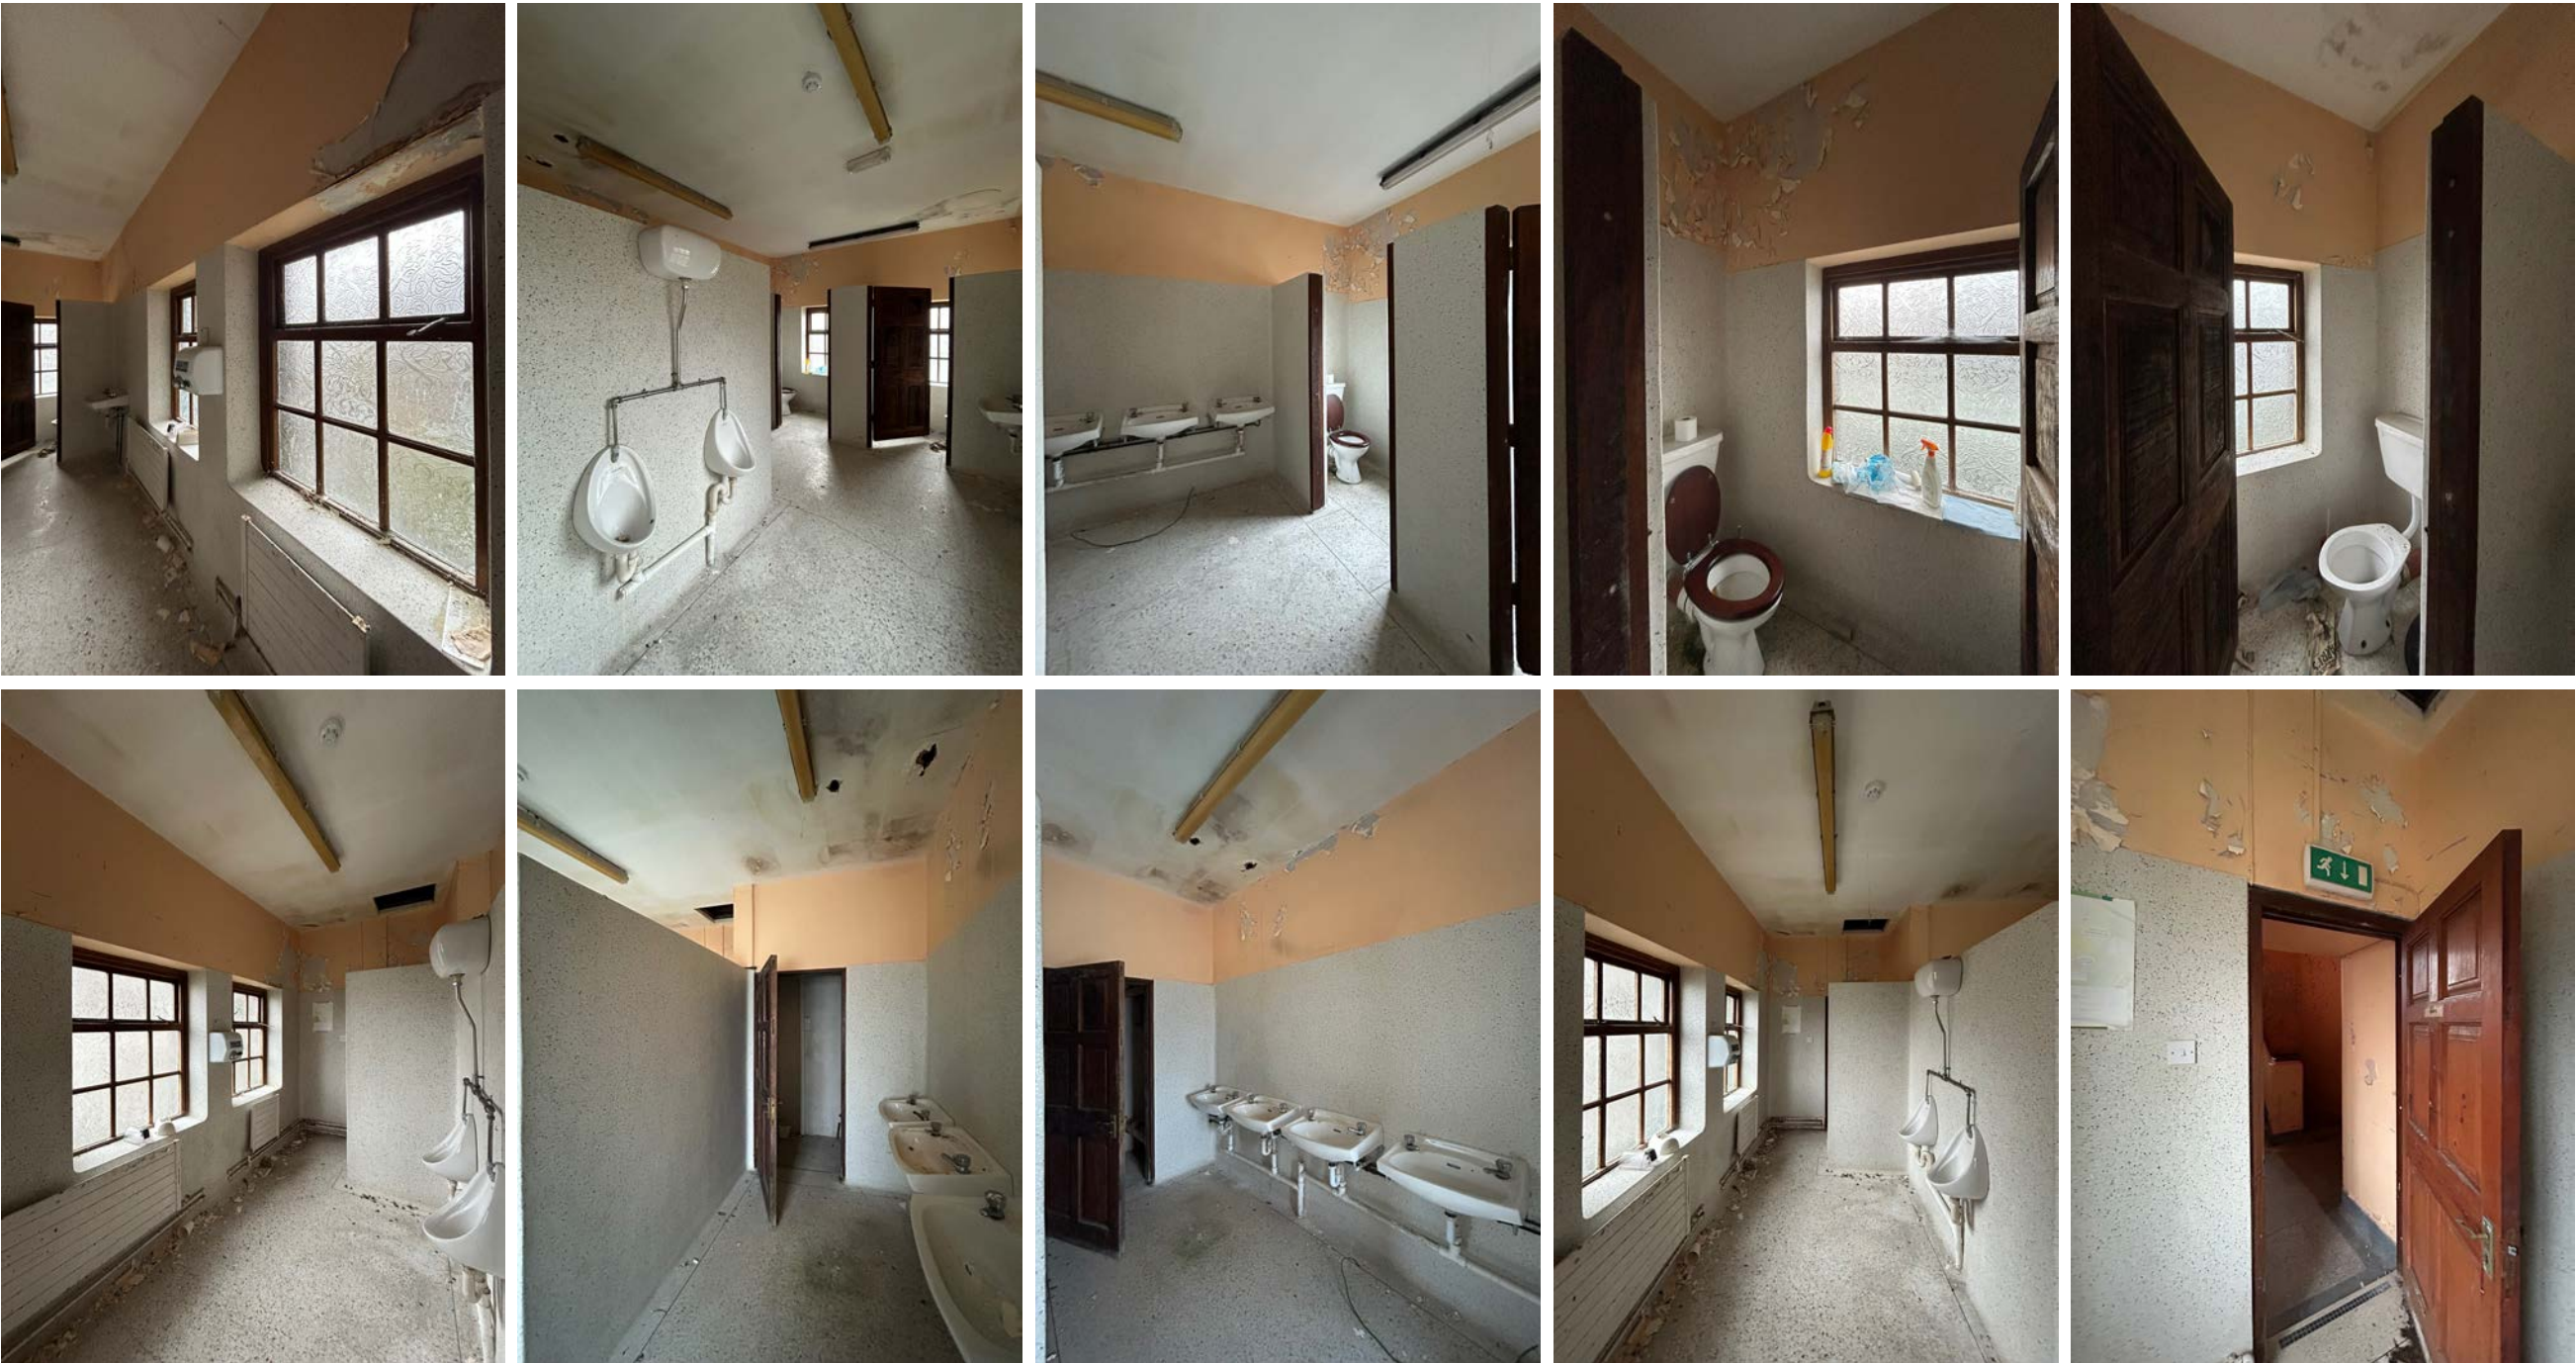
ROOM 01.A.01

The room is plain and unadorned in character with no ornamental historic plasterwork or timber features evident, such as cornice-work, dado rails, architraves or roses. Sanitaryware, built-in showers, partitions and doors appear to be of 20th century origin and do not contribute to significance.

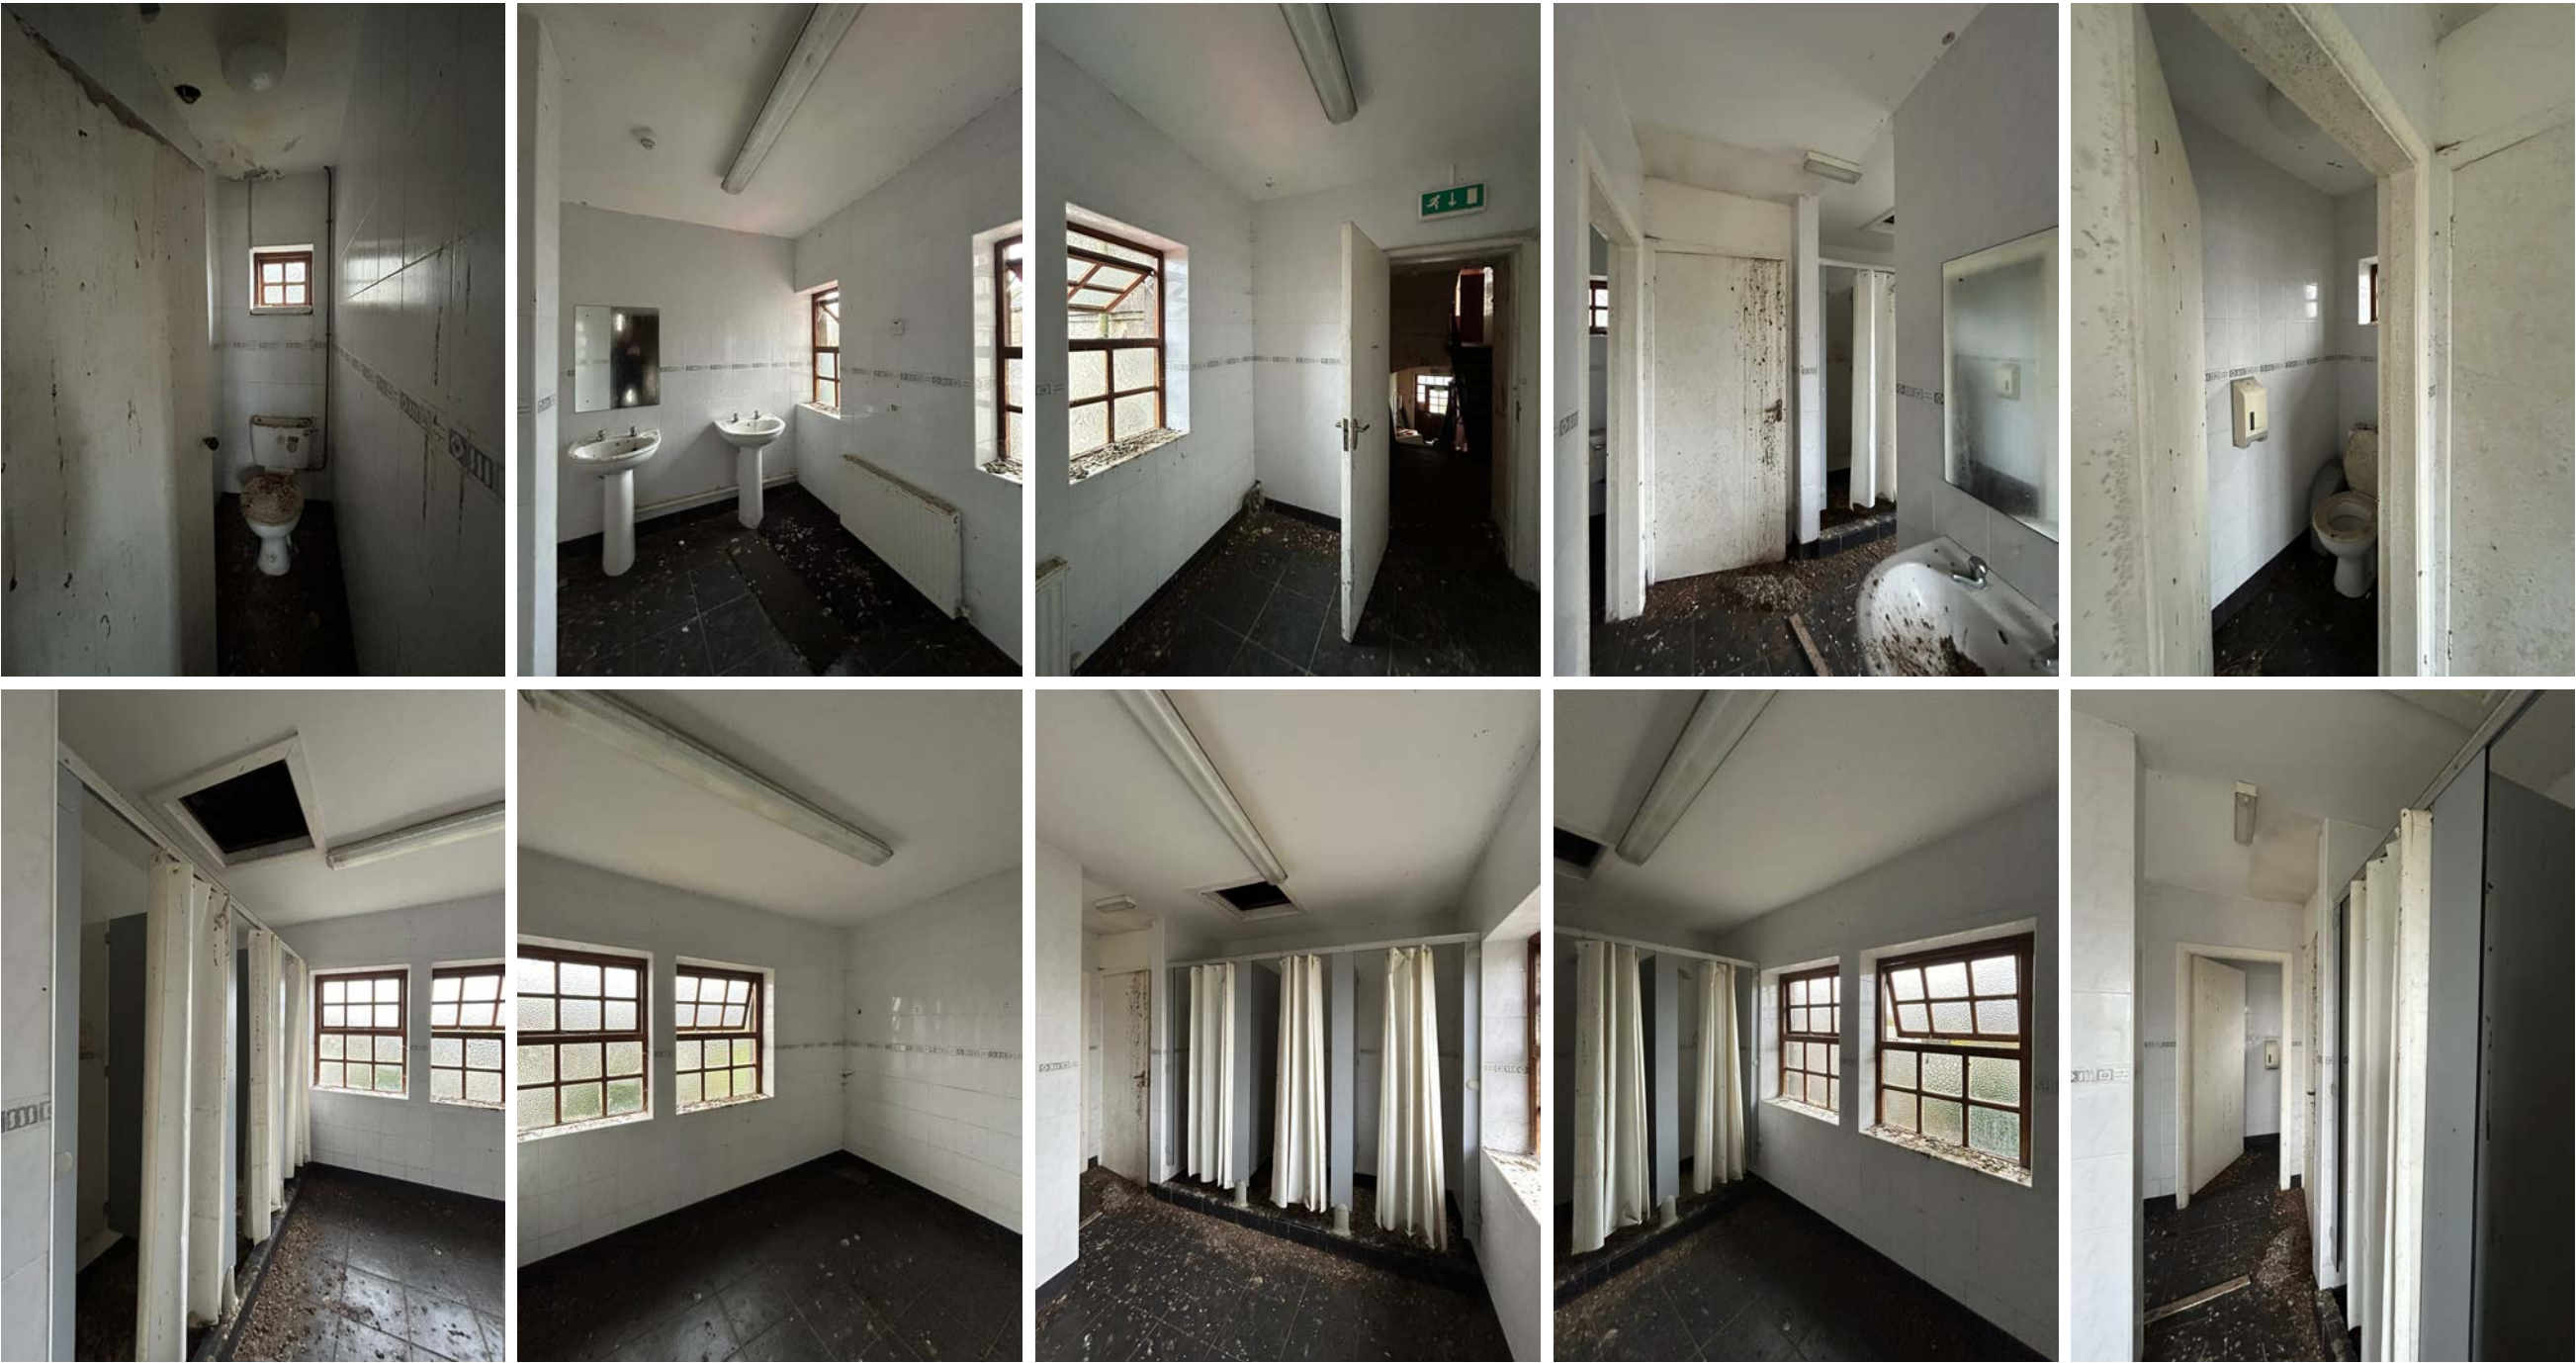
ROOM 01.A.02

The room is plain and unadorned in character with no ornamental historic plasterwork or timber features evident, such as cornice-work, dado rails, architraves or roses. Sanitaryware, built-in showers, partitions and doors appear to be of 20th century origin and do not contribute to significance.

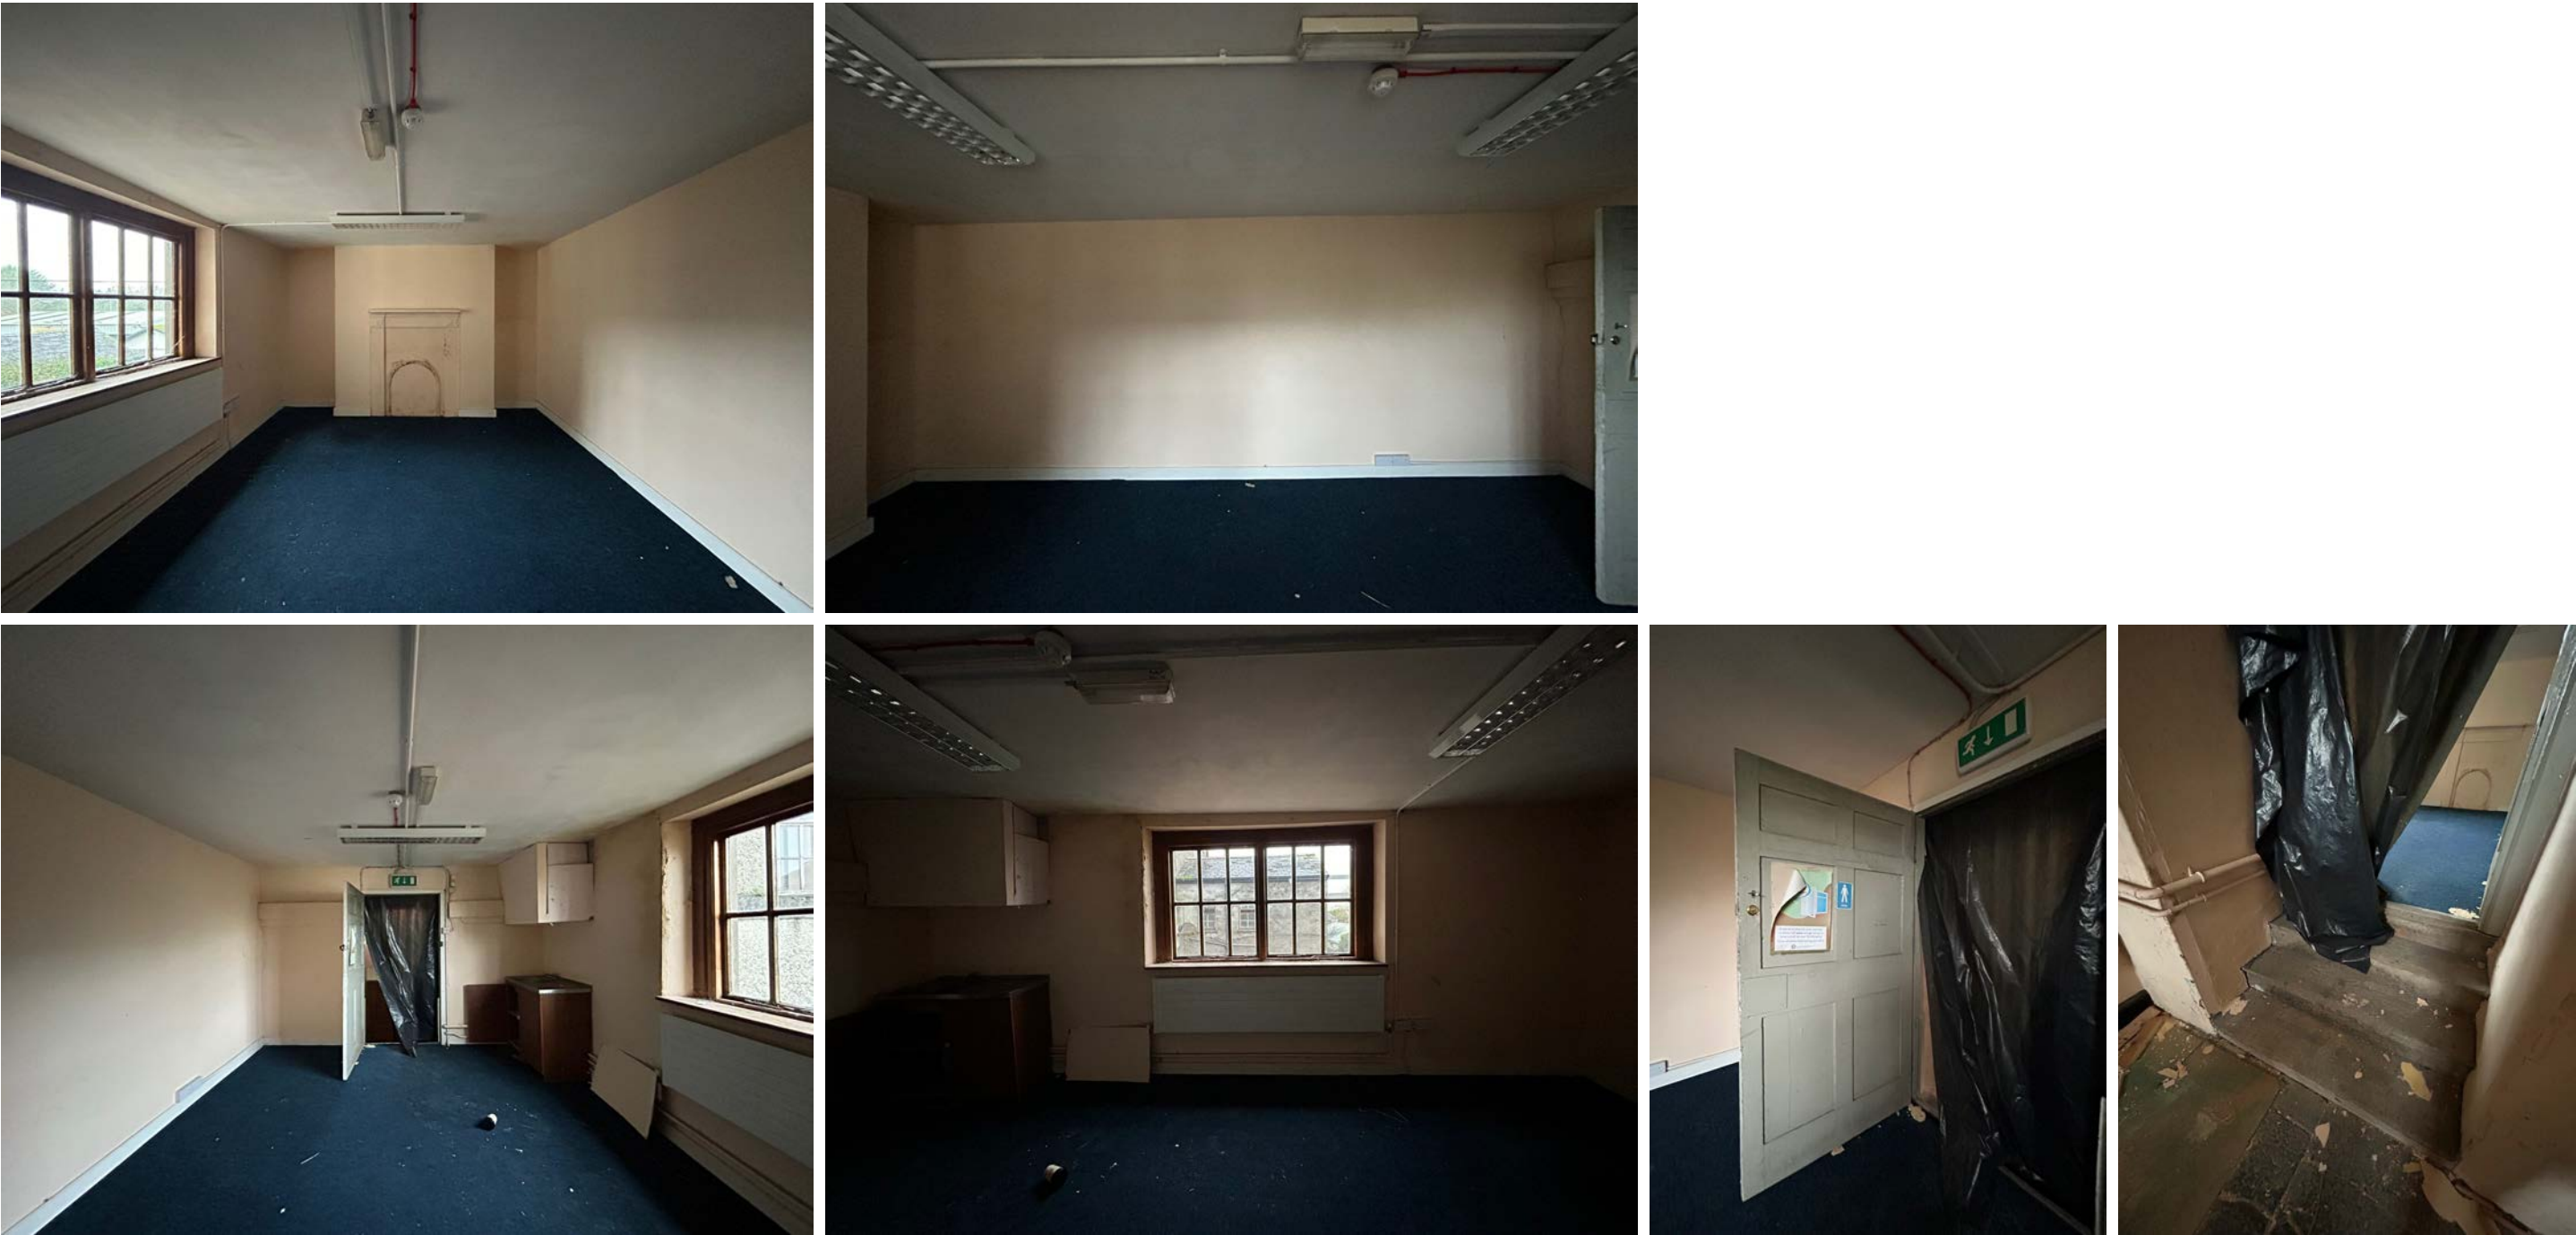
ROOM 01.A.03

The room is plain and unadorned in character with no ornamental historic plasterwork or timber features evident, such as cornice-work, dado rails, architraves or roses. Partitions and doors appear to be of 20th century origin and do not contribute to significance. Subdivision of rooms with lightweight partitions suggest the skirting boards are of 20th century origin and do not contribute to significance..

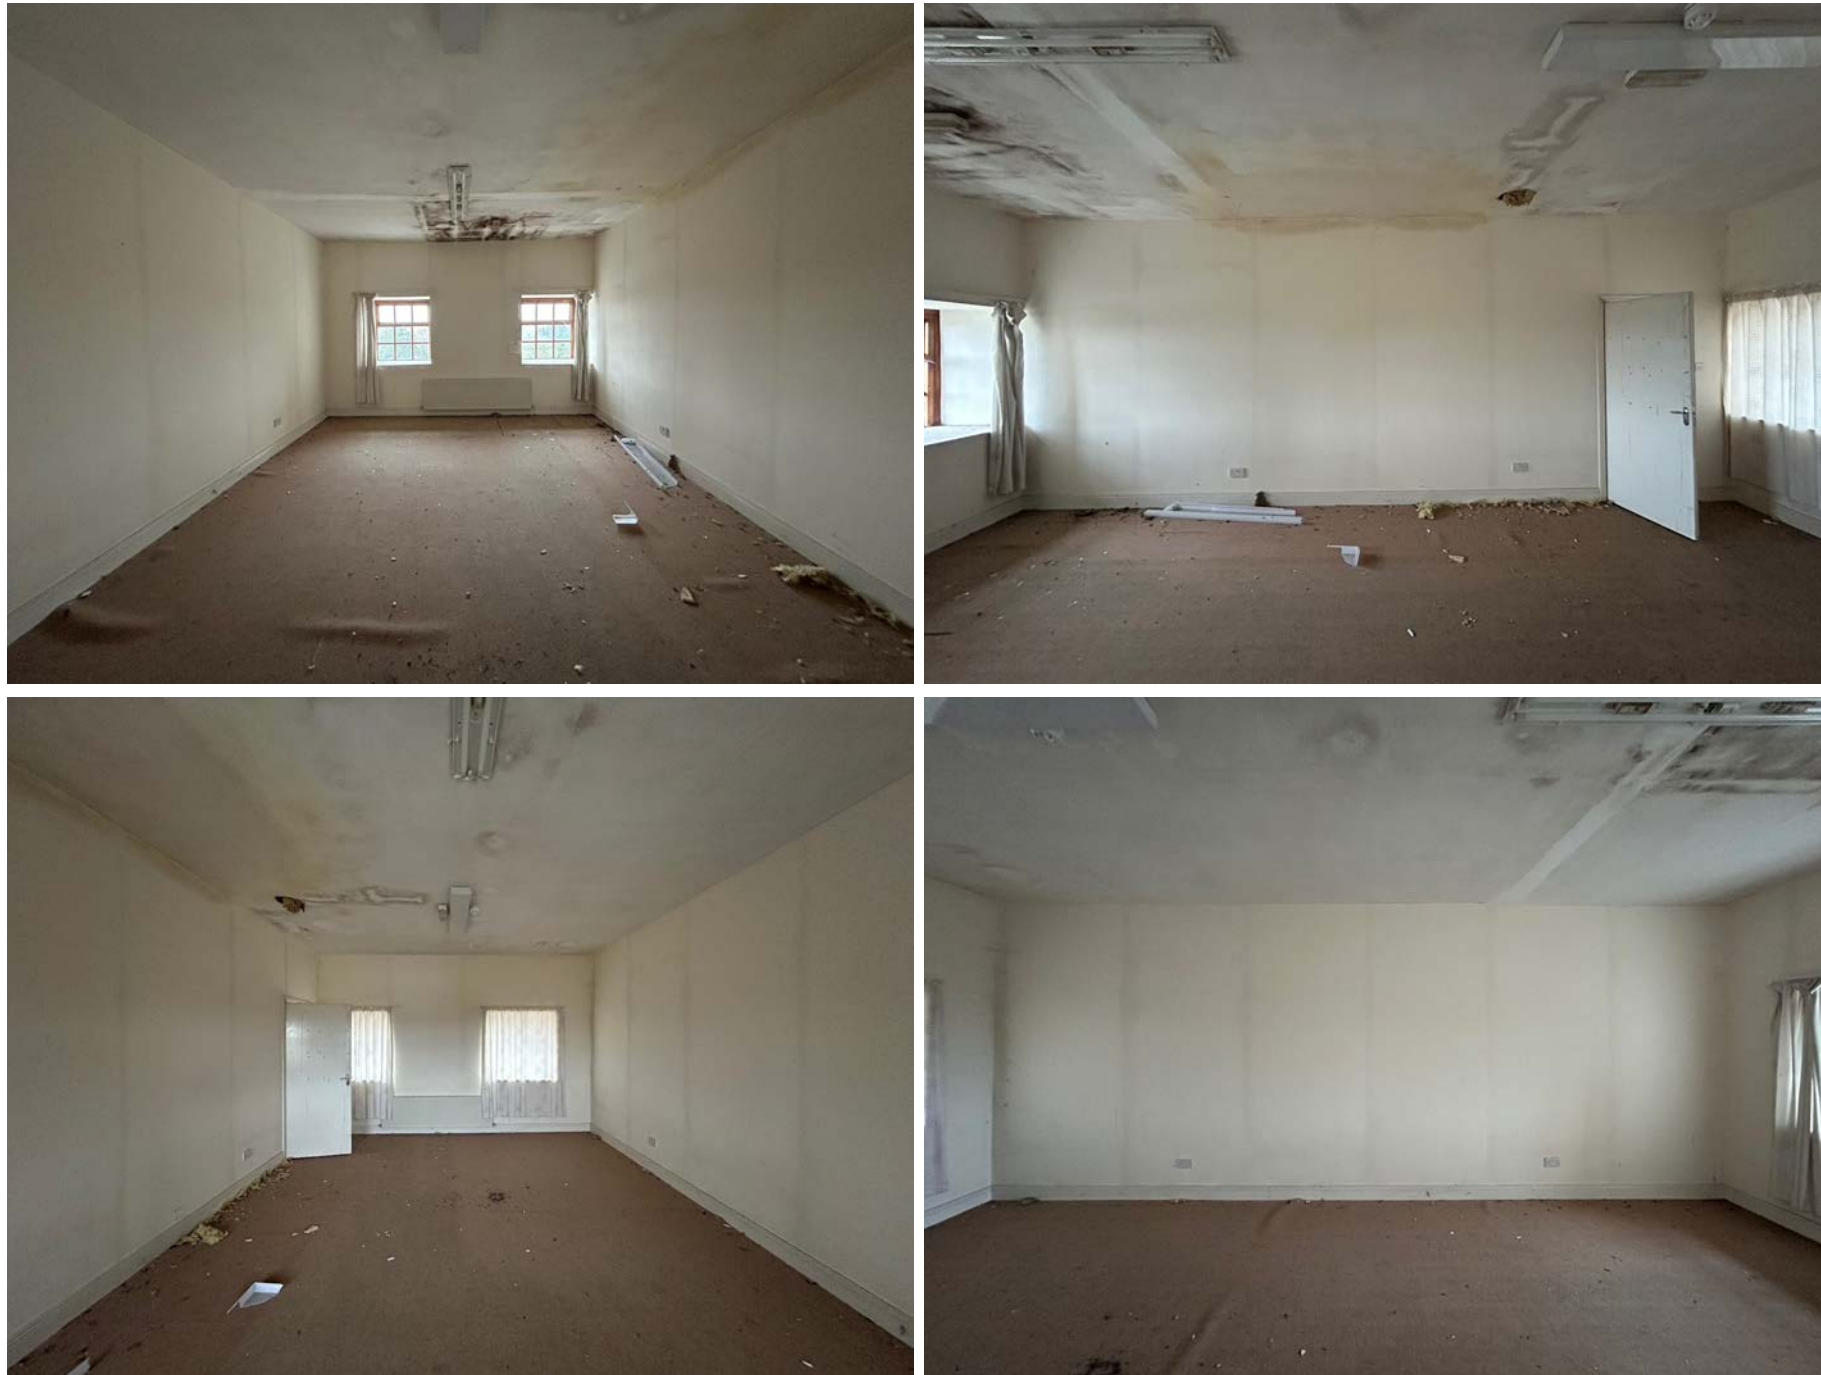
ROOM 02.M.01

The room is plain and unadorned in character with no ornamental historic plasterwork or timber features evident, such as cornice-work, dado rails, architraves or roses.

Partitions and doors appear to be of 20th century origin and do not contribute to significance. Subdivision of rooms with lightweight partitions suggest the skirting boards are of 20th century origin and do not contribute to significance.

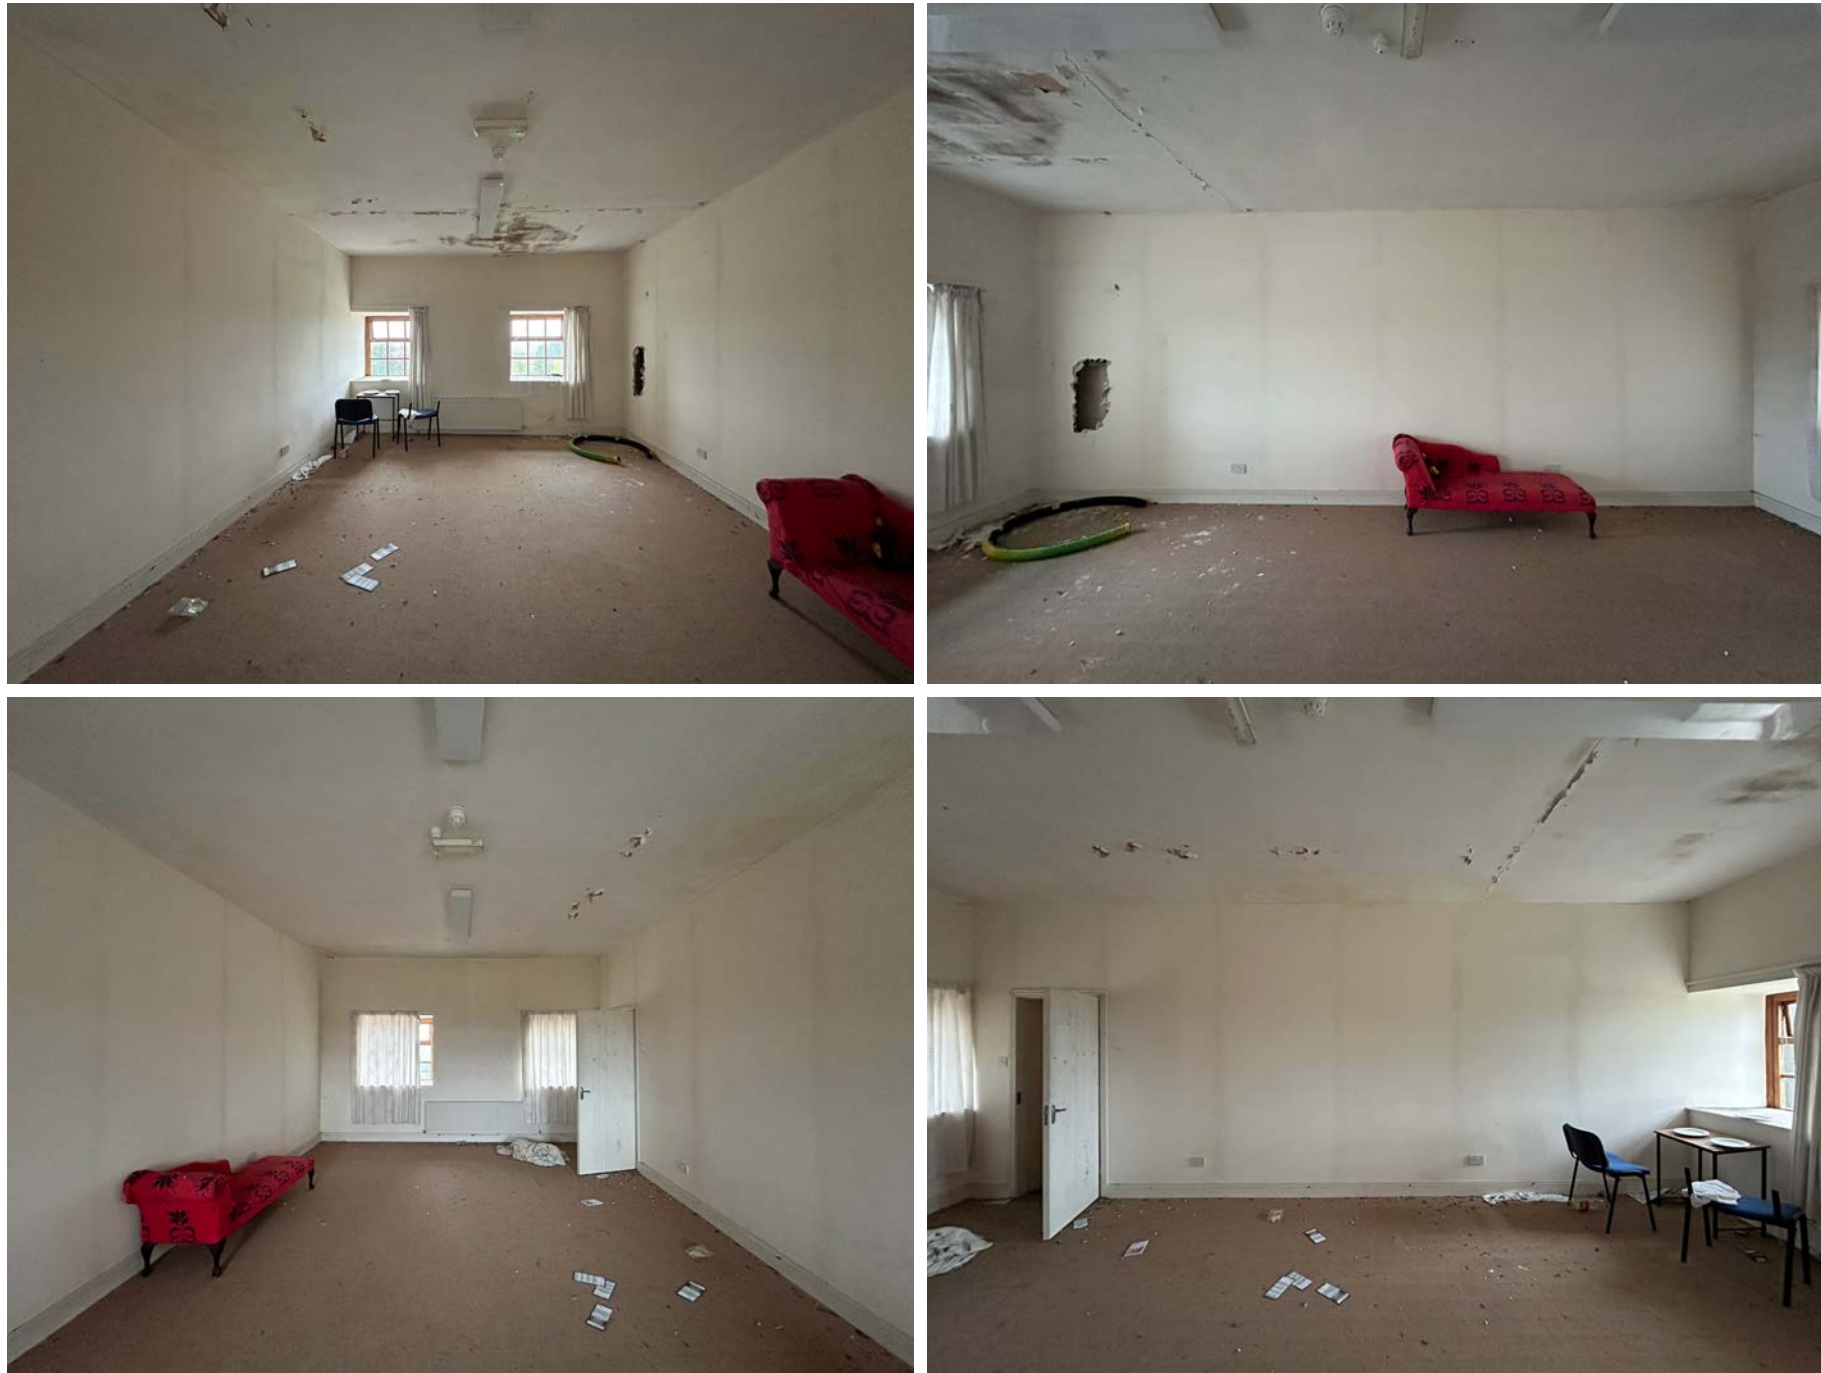
ROOM 02.M.02

The room is plain and unadorned in character with no ornamental historic plasterwork or timber features evident, such as cornice-work, dado rails, architraves or roses.

Partitions and doors appear to be of 20th century origin and do not contribute to significance. Subdivision of rooms with lightweight partitions suggest the skirting boards are of 20th century origin and do not contribute to significance.

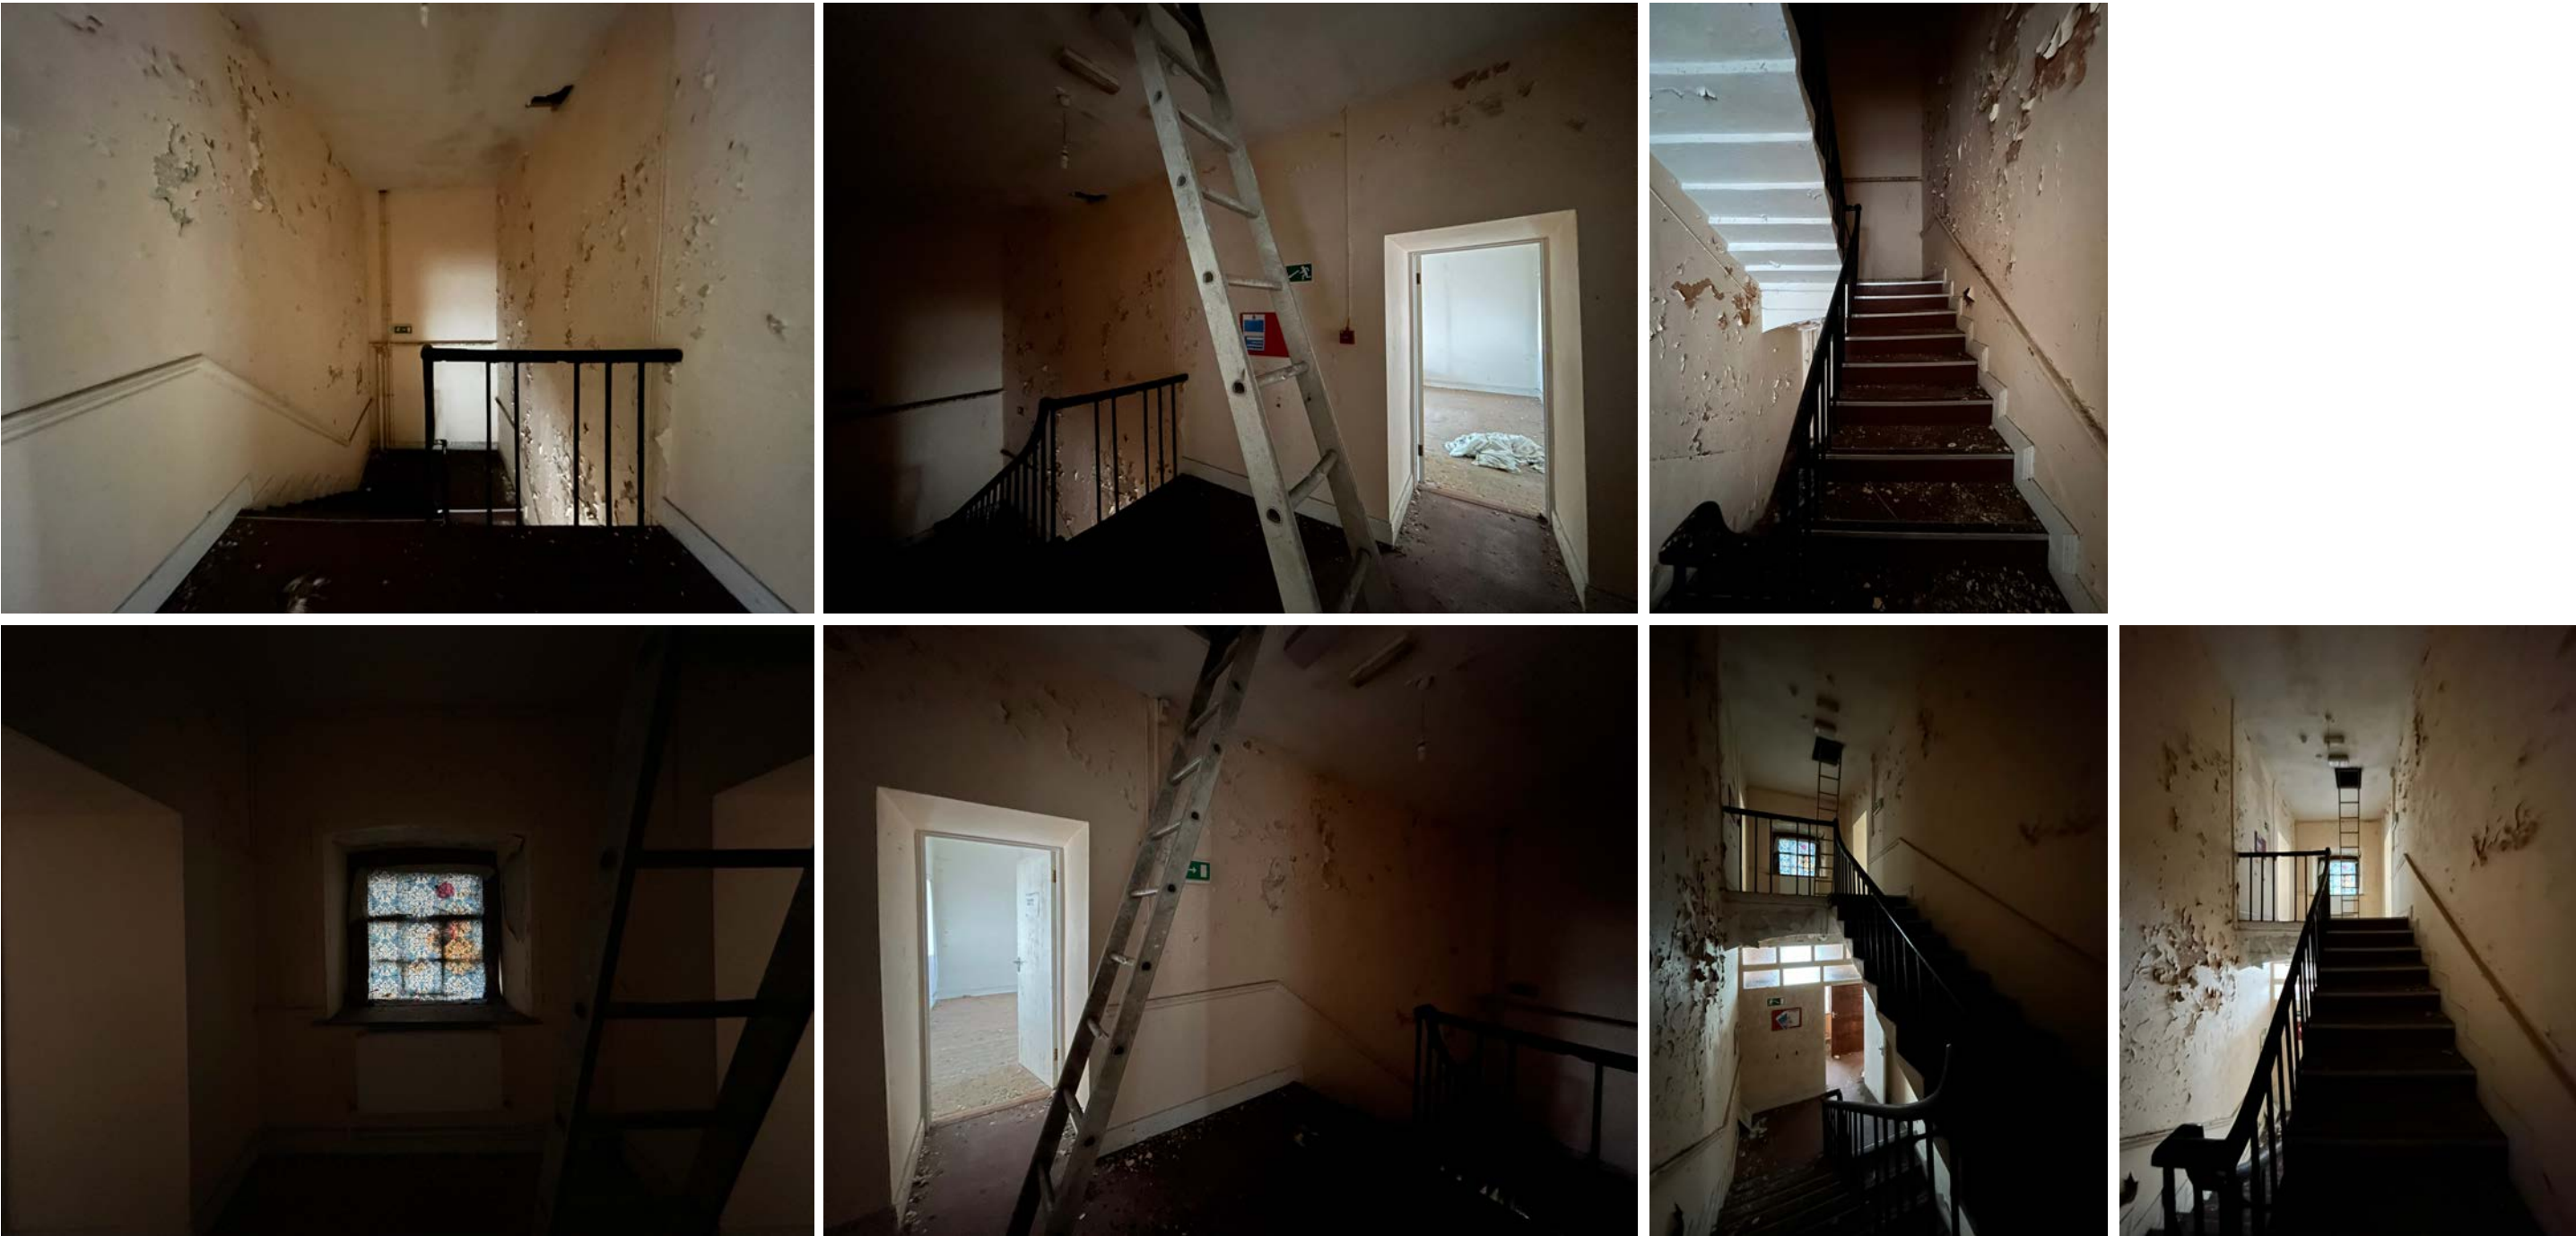
ROOM 01.C.03

The room is plain and unadorned in character with no ornamental historic plasterwork or timber features evident, such as cornice-work, dado rails, architraves or roses. Cast ironwork to stair, timber handrail, and cantilevered stone stair are features of significance. Potential historic floor finishes to be uncovered.

The cast iron balustrades and timber hand rails within the existing staircase will be protected during the works and retained, with replacement balustrades and handrails to be introduced where missing. A detailed drawing and written specification for the conservation and refurbishment of the staircases will be submitted to the planning authority for review and agreement prior to the commencement of work in this part of the building.
