Archaeological Impact Assessment & Building Appraisal Former Convent of Mercy Ballymahon, Co. Longford

Applicant: Longford County Council
Issue Date: April 2025
Prepared by: Marion Sutton & Philip Kenny, Shanarc Archaeology Ltd.

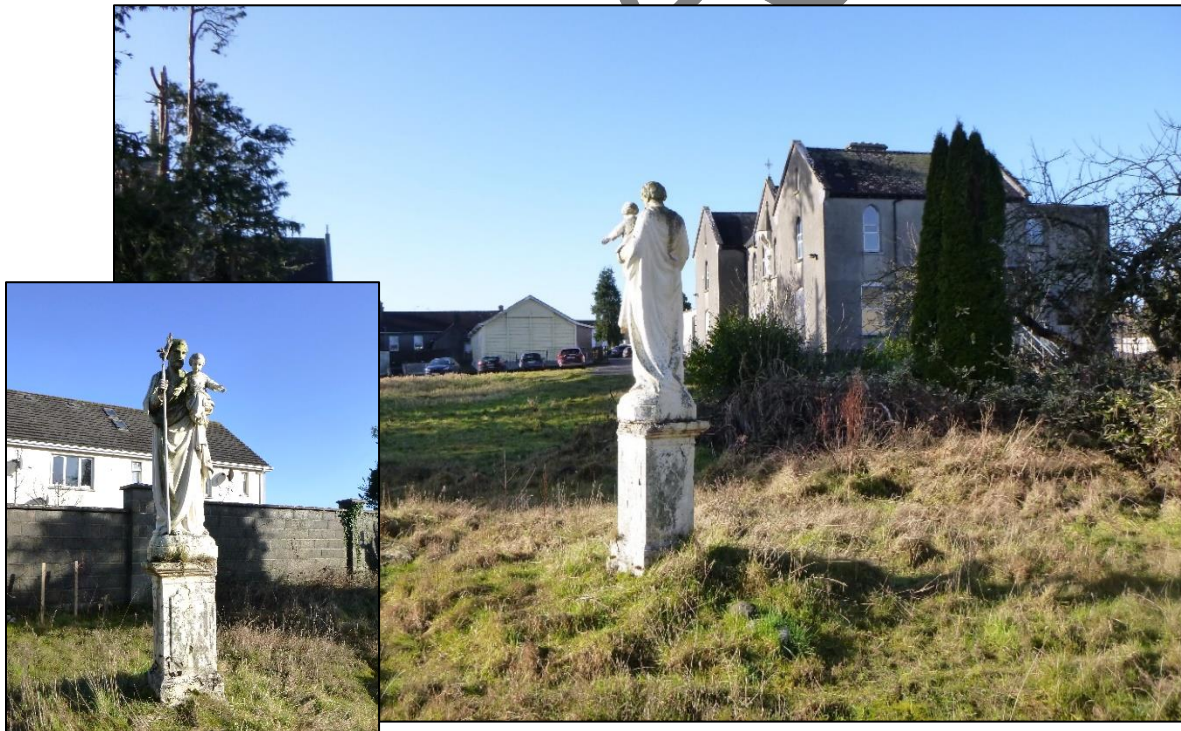
A catholic statue of moulded concrete, painted white, stands on a white painted concrete plinth, near the E corner of the site (Plate 9). It is unlikely to stand in its original position as a result of post 1999 changes. As evidenced from historic aerial photos, the statue was one of two that stood in the gardens; a grotto also stood in the east corner of the former gardens, near the convent glasshouses, which was relocated to the grounds of the Mercy Secondary School, possibly as part of the Church View residential development, and certainly by the early 2000s.

Plate 9 View W from E corner of site across sloping garden on the E and SE sides of convent, with surviving statue (in centre and in inset) (05.02.2025).

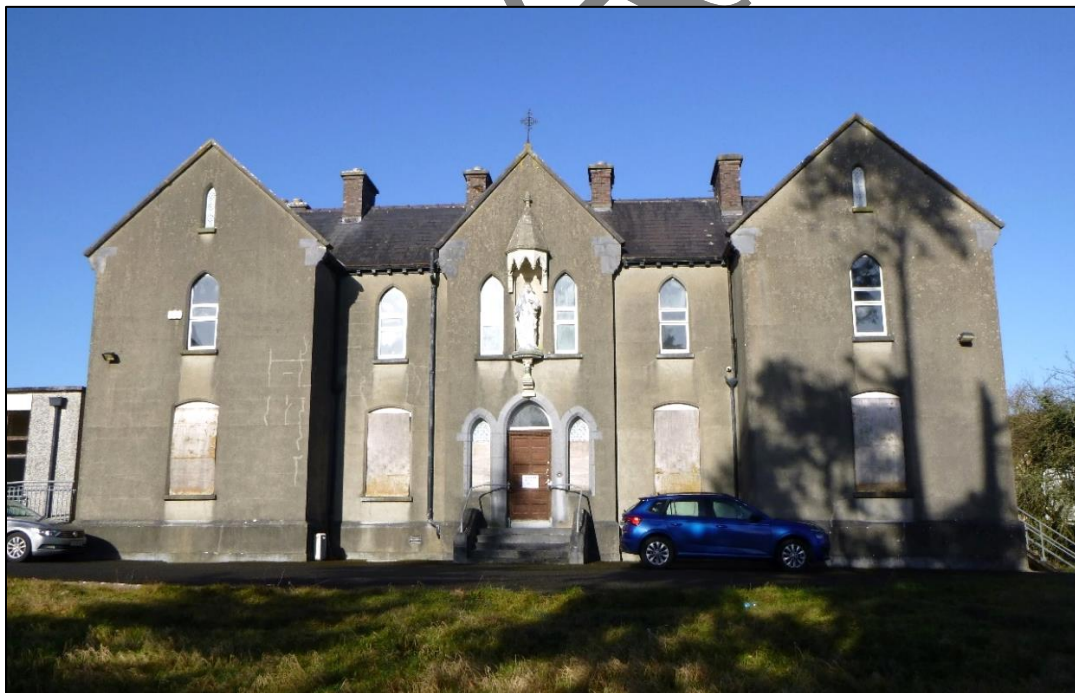
The front elevation (Plate 13) is a five-bay, two storey over basement façade with attic storey, having a central three-bay gable-fronted breakfront, with finial, and a projecting single-bay gable to either end, all on a vented projecting plinth with a punch dressed limestone basecourse. The central entrance is accessed by a flight of cut limestone steps and side walls topped with later handrails, having a pointed arched door ope flanked on either side with pointed arched window opes, all with worked limestone surrounds. A timber panelled door has a timber framed overlight; the flanking windows are timber framed with textured glass. Larger, segmental headed ground floor windows, now boarded, have replacement aluminium frames. First floor, pointed arched window opes have replaced aluminium frames. A central, first floor, round headed niche above the entrance has a trefoil and pendant decorated canopy with pointed roof, containing a statue on a cut limestone base at sill level, on a marble column with capital supported on a console bracket. The attic storey has pointed arched opes with ventilated infills. Exposed worked limestone decorates the base of roof pitches, with carved brackets carrying projecting stone coping above gables. Metal ventilation grills and metal and glass lightwell covers at the foot of the façade provide light to basement level windows.

Plate 13 Front (SE) elevation of convent (05.02.2025).

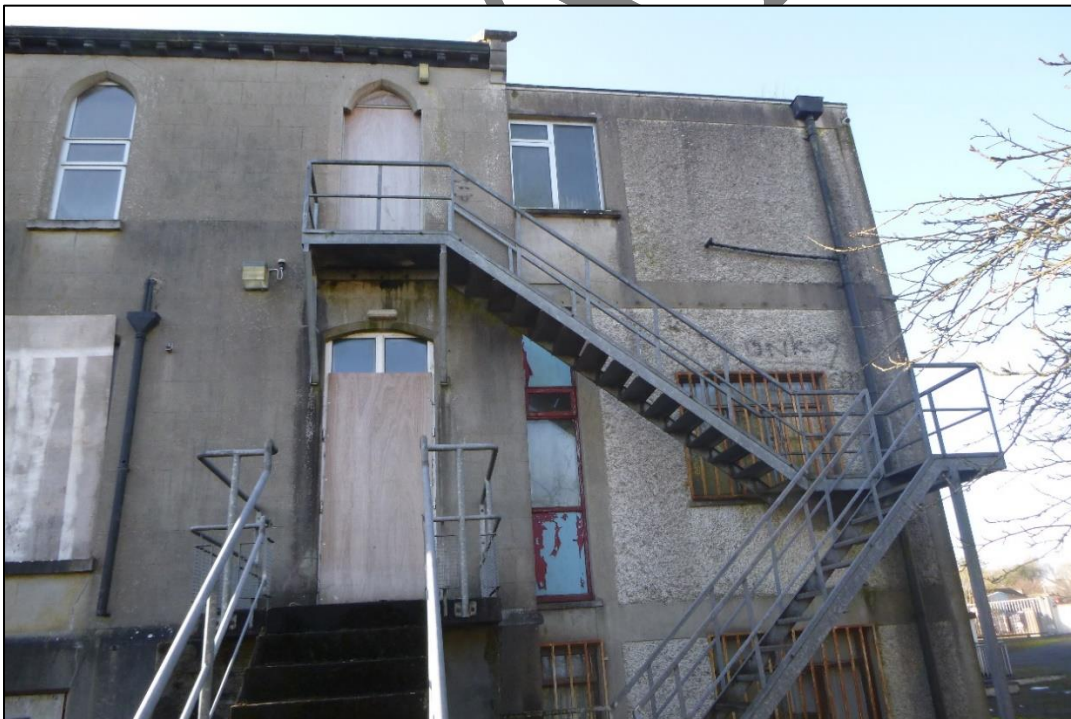
The NE side elevation (Plate 14) is a three-bay, two storey façade over an exposed basement, with two later fire escape stairs added. Ground floor and first floor window opes are identical to the front façade, having replacement aluminium frames. The north window ope to both floors have been modified, to provide door opes, having later doors, to the fire escape stairs (Plate 15). The ground floor fire escape is a mass concrete and concrete block structure providing cover to a slightly lower basement level square headed door ope that is likely a modified square headed window ope. The basement level windows are square headed and boarded. A concrete lined, rectangular sunken feature at ground level outside the south basement window is filled with rubbish; its function is unknown. A 20th century two-storey over basement pebble-dashed addition infills the convent's NE corner, having square headed timber framed windows to basement and ground floor and square headed aluminium framed window at first floor. Basement level windows and one ground floor window are barred.

Plate 15 NE elevation of convent with 20th century addition to N corner; fire escape stairs from modified window opes (05.02.2025).

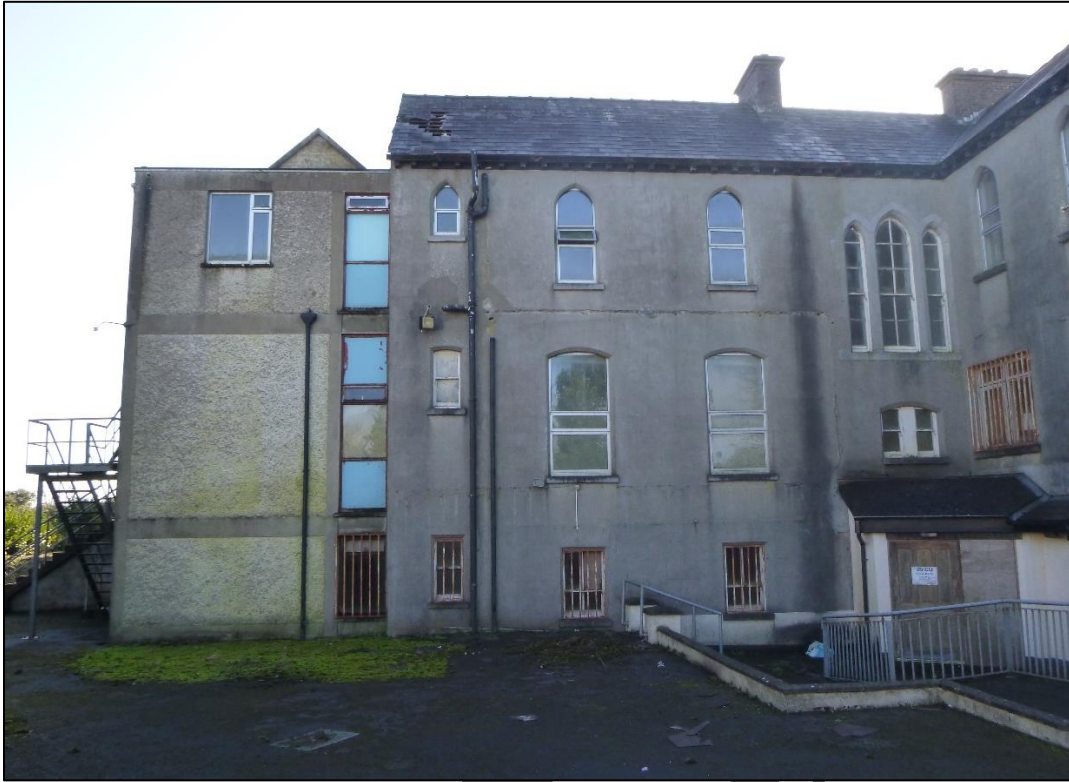
The rear NW facing elevation (Plate 16) comprises a rear 19th century, four-bay, two-storey over exposed basement range, with a 20th century two-storey over basement corner infill addition abutting the NE gable. The pitched gable lacks the carved stone brackets and stone coping at the roof edge that is apparent on the gables of the front range. Basement level windows are square headed, the E window being smaller and at slightly higher level in the façade (carried through at first and ground floor level), all with barred 2 over 2 light timber sliding sash windows (Plate 17). The present basement entrance is a very modern addition, resulting from post 2005-6 modification. The window opes in the central two bays at ground and first floor level match those on the front (SE) and NE elevation, also having replacement aluminium frames, with distinctly different window opes above the basement entrance marking the position of the internal stairwell (Plate 18). The ground floor window is a smaller segmental headed ope with two timber sliding sash windows. The uppermost window is a tripartite pointed arched ope with worked limestone surrounds and timber sliding sash windows with textured glass. Of interest is the finish to the worked stone surround in the angle with the long SW range; part of the worked stone appears to be covered, and could suggest the window pre-dates the north end of the SW range.

Plate 16 NW rear elevation of convent with 20th century addition at N corner to left of image (05.02.2025).

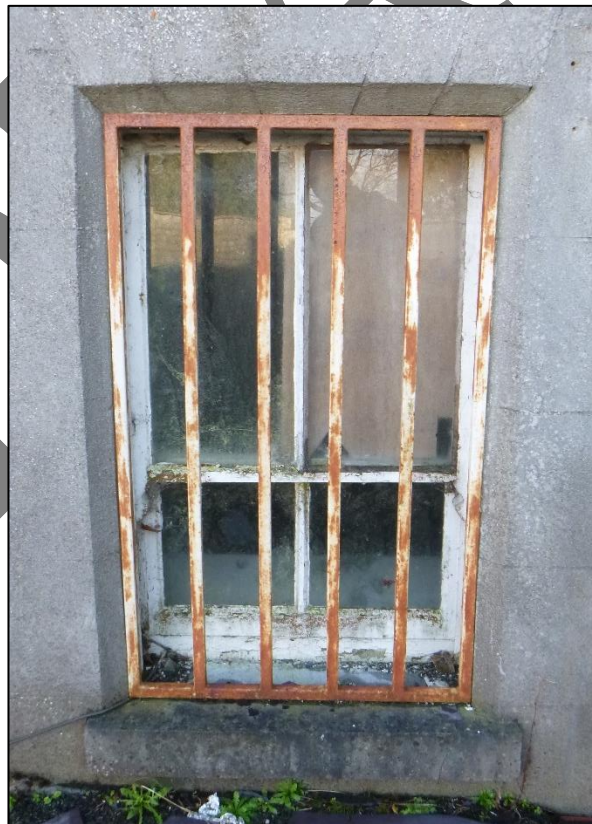
Plate 17 Close up of basement level timber sliding sash window on NW rear elevation of convent (05.02.2025).

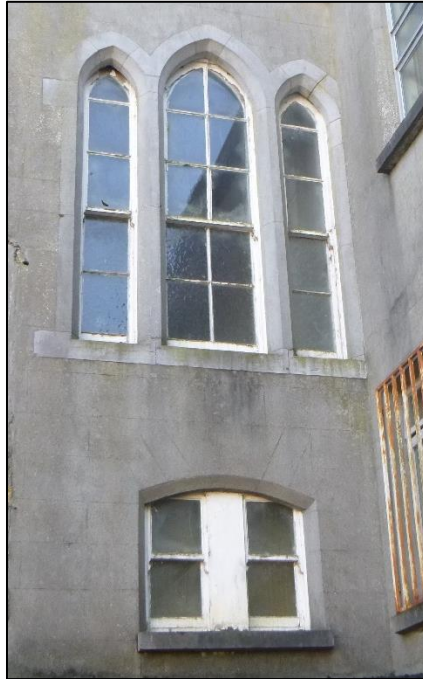
Plate 18 Timber sliding sash windows at stairwell on NW rear elevation of convent (05.02.2025).

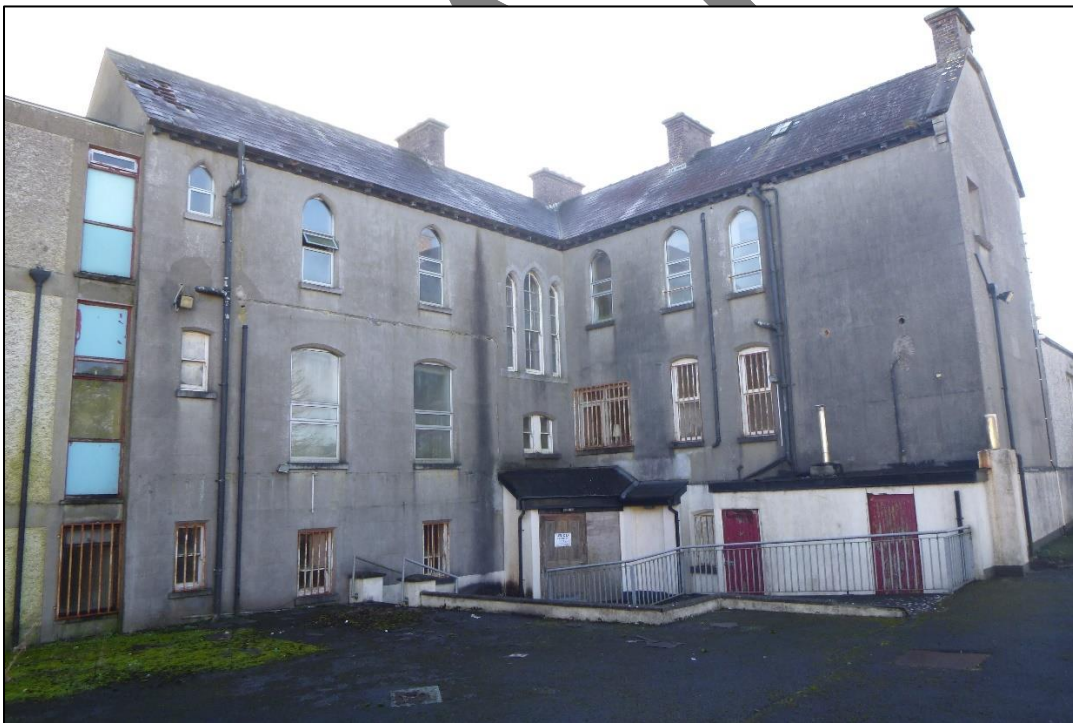
The rear NE facing elevation (Plate 19) forms part of the long SW range of the convent, comprising a 19th century, three-bay, two-storey over basement elevation, with a modern outbuilding (boiler room) abutting the façade at basement level. The fenestration or window arrangement is less symmetrical than other façades, with bays positioned closer, and the north end of the façade lacking opes. A single basement window ope is segmental headed, barred and boarded from the interior. At ground floor level windows are also barred, with a distinctly different square headed window ope with straight sided reveals and possible concrete sill positioned above the basement entrance, having a casement timber frame and reinforced glass; this may be a modified window. Two narrow, segmental headed window opes at ground floor level have replacement PVC frames. First floor, pointed arched window opes have replaced aluminium frames.

Plate 19 Rear NW and NE facing elevations of convent with basement access at centre image (05.02.2025).

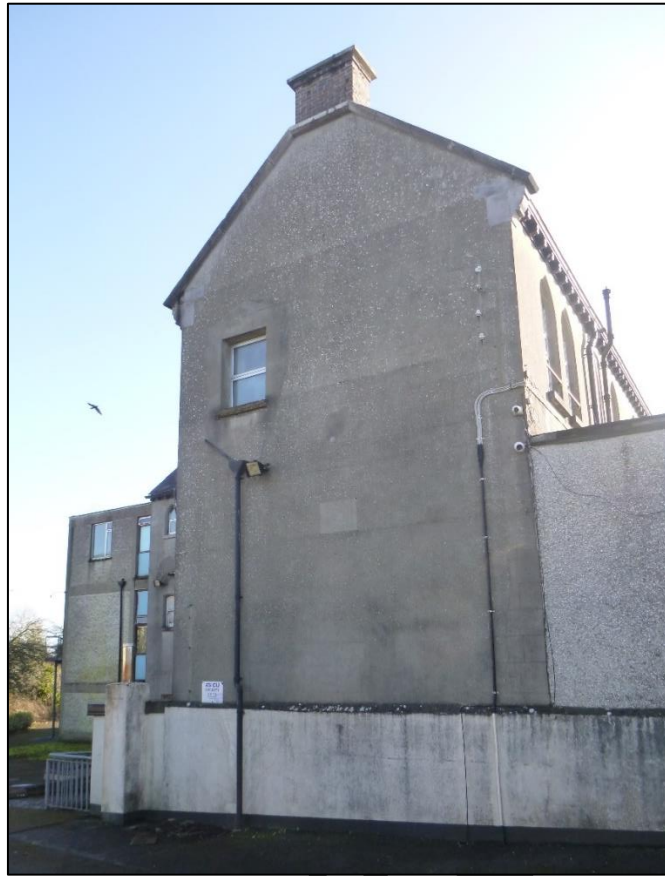
The rear gable of the long SW range (Plate 20) has decorative carved stone brackets and stone coping at the roof edge, but a flattened pitch at the ridgeline, distinct from all other gables. A single square headed window ope with straight sided reveals, concrete sill and aluminium frame is a later intervention at first floor level. A slightly projecting painted wall at the base continues beneath the base of the pebble-dashed annex; this wall is likely original to the convent, with the re-used section below the annex originally delineating the open basement level passage on the SW range.

Plate 20 Rear NW gable end of SW range, with later window ope; painted wall at base continuing outside image to right beneath the modern annex is original to convent (05.02.2025).

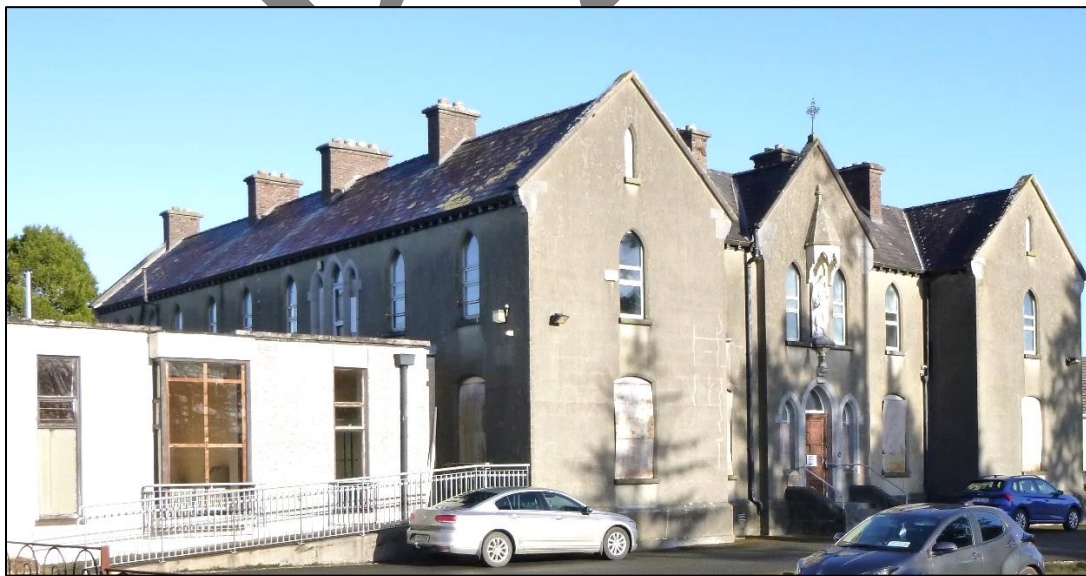
The long SW elevation of the 19th century convent is a 10-bay, two-storey over basement range abutted by a single storey over part basement 1970s annex (Plate 21). The annex obscures the whole of the basement level, and all but a single, boarded, segmental headed ground floor window ope with replacement aluminium frame at the S end. Historic photos of the convent show that all ground floor windows were segmental headed; a side entrance door, accessed by a flight of steps, was also segmental headed, providing access to an internal corridor oriented NE-SW that runs the length of the front range. First floor, pointed arched window opes have replaced aluminium frames, with a tripartite pointed arched ope with worked limestone surround at first floor (above the former side door) marking the position of an internal corridor at first floor level.

Plate 21 Modern single-storey annex abutting SW elevation of convent (05.02.2025).

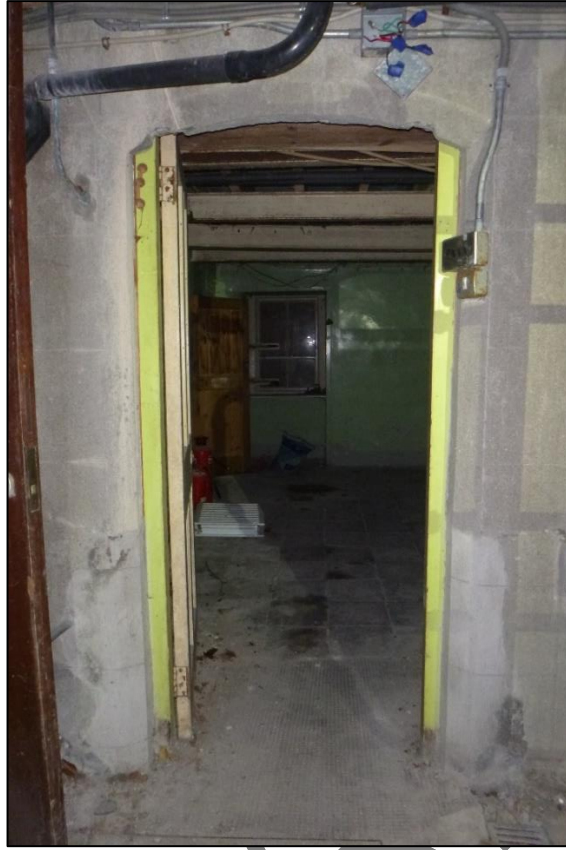
Plate 26 Sample modified window ope on SW elevation at basement level, accessing extended basement level to 1970s annex (18.02.2025).

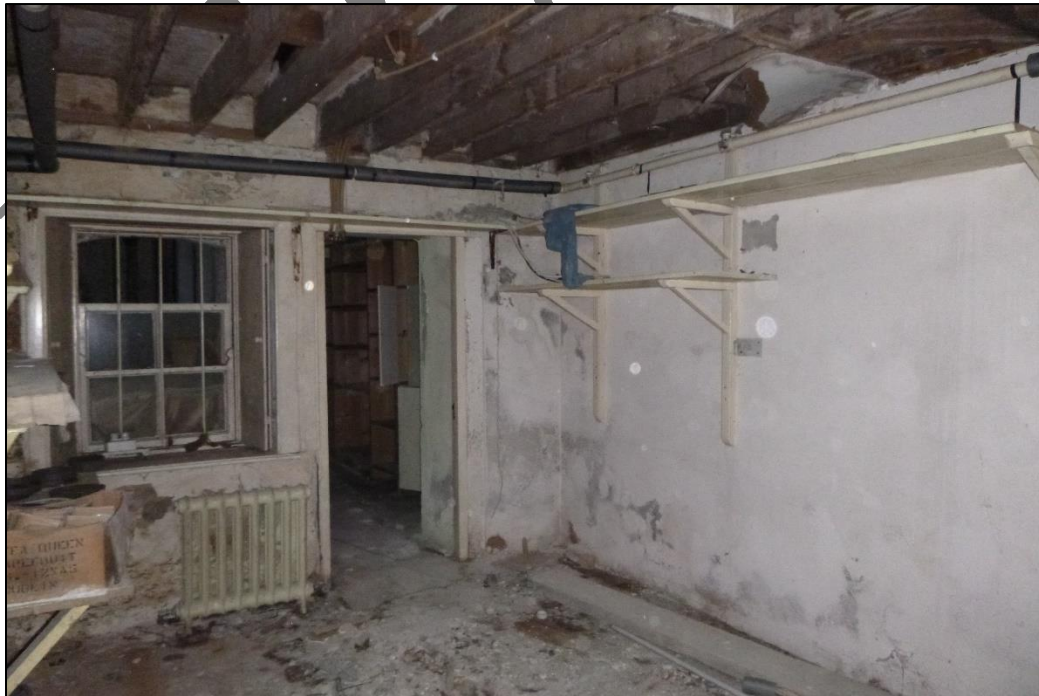
Plate 27 Basement level storeroom at NW end of SW range with original window ope and modified ope at door in original SW elevation; exposed joists above (18.02.2025).

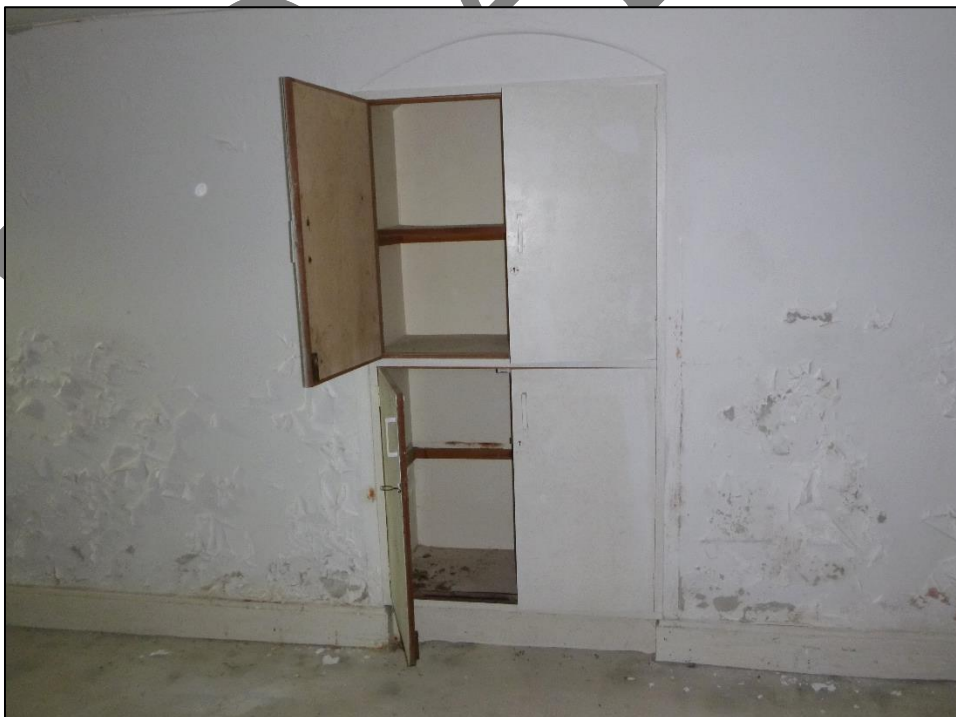
Plate 29 Infill cupboard in basement level corridor (SE wall) marking location of former segmental arched door opening (18.02.2025).

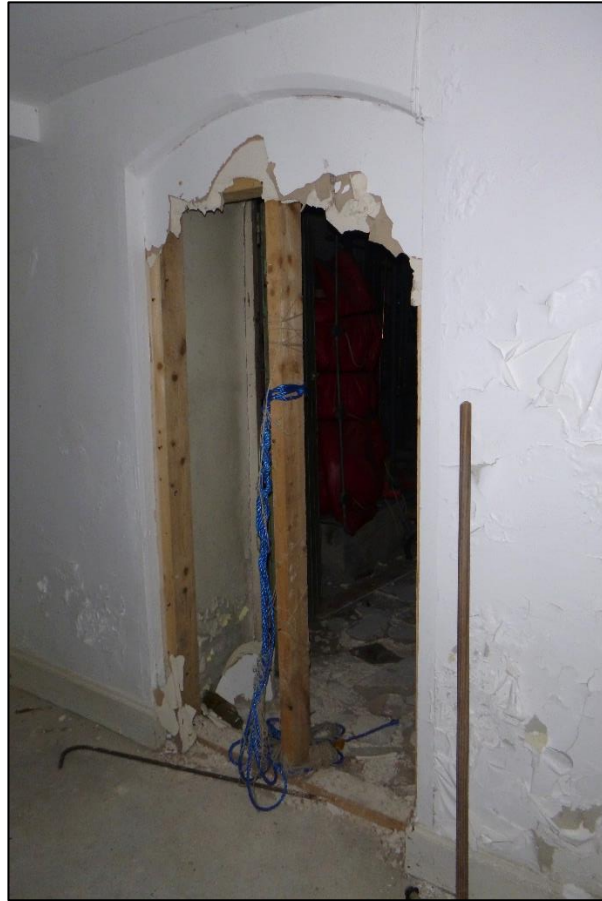
Plate 30 Sample blocked segmental arched door opening in basement level corridor (SE wall) (18.02.2025).

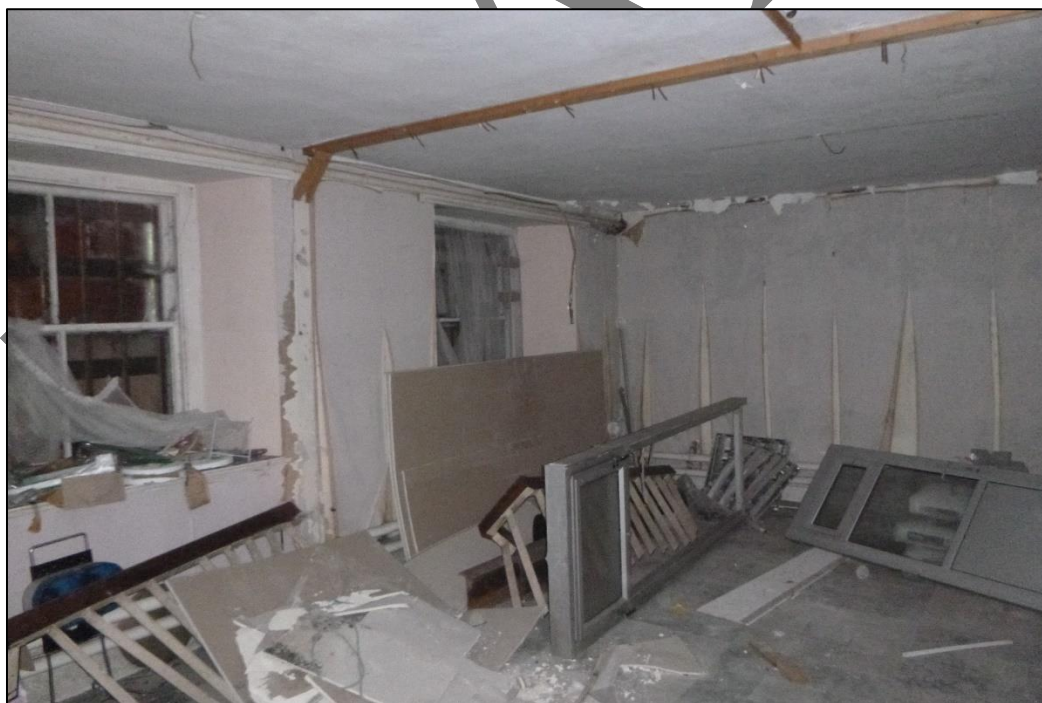
Plate 35 Basement level changing room to NE corner of front range with original window opes and timber sash windows in NE elevation; former room partitions demolished (18.02.2025).

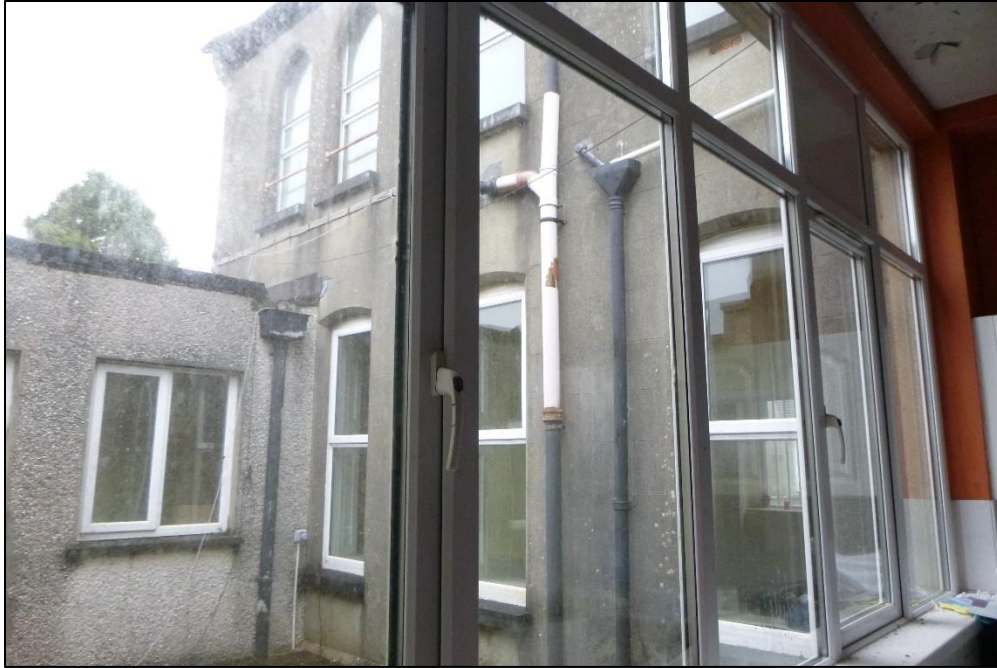
Plate 36 Segmental headed ground floor windows with PVC frames in SW elevation overlooking annex yard (18.02.2025).

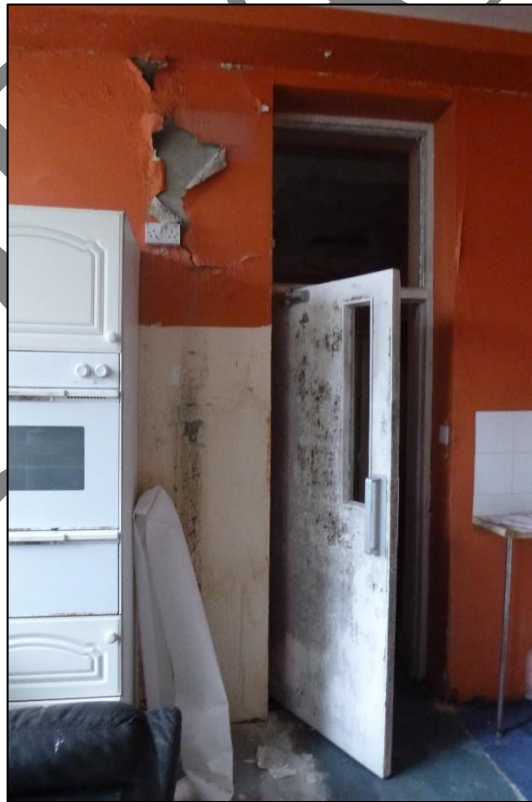
Plate 37 Ground floor annex kitchen with peeling paint on original SW external elevation and modified window opening at doorway (18.02.2025).

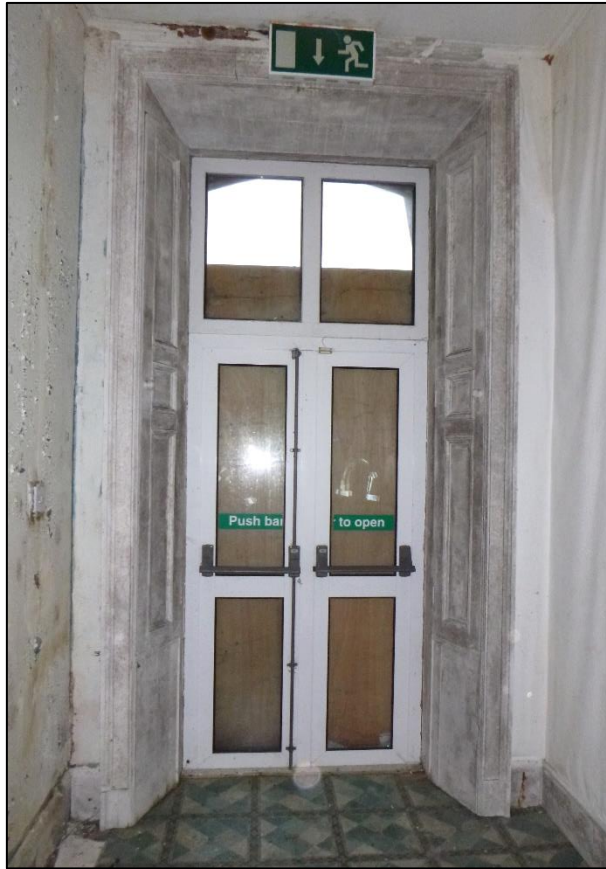
Plate 42 PVC fire escape at NE end of corridor with original timberwork internal to embrasure (18.02.2025).

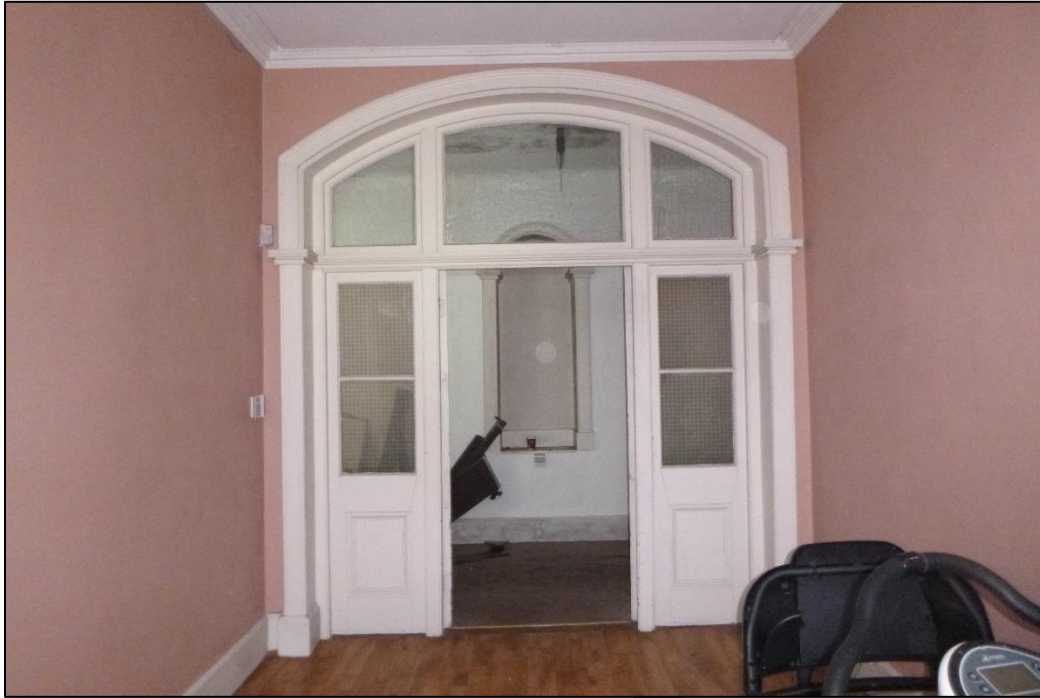
Plate 48 Interior wide arched original door and frame between hall and main corridor (18.02.2025).

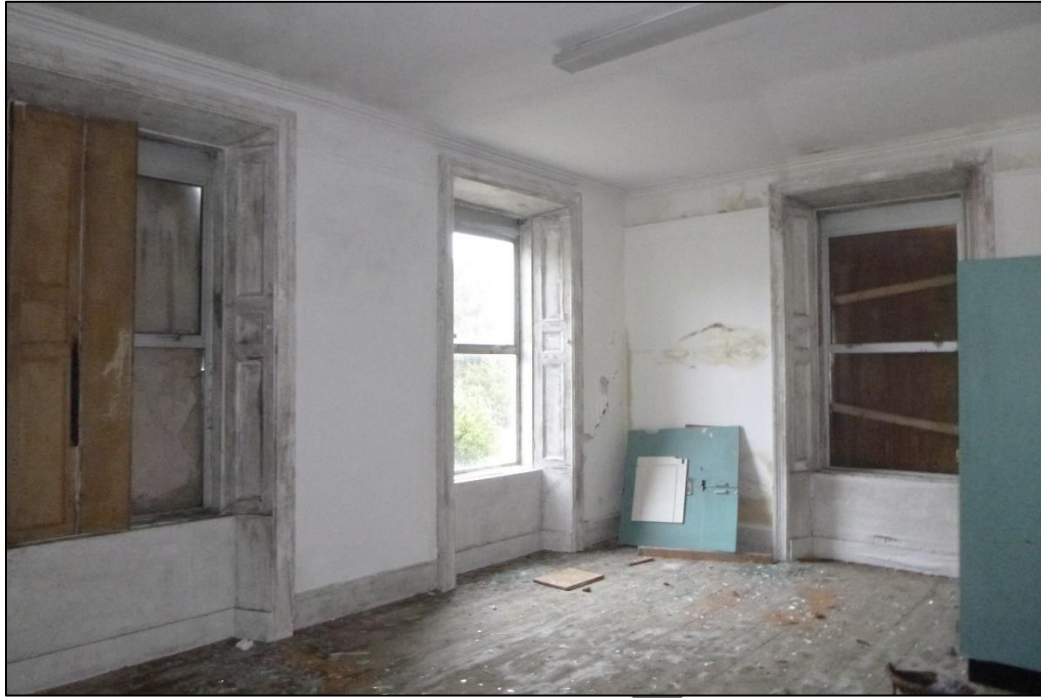
panelled door, one original window embrasure with timber shutters and replacement aluminium frame on the SE elevation, cornice moulding and dado rail height wall mounding incorporating a square headed moulded surround (Plate 49). A former community room (Figure 4) at the NE end of the range has a timber floor, square headed door ope with timber 4-panelled door, three original window embrasures with timber shutters and replacement aluminium frames on the NE and SE external elevations and cornice moulding and panel to walls (Plate 50); a cast iron fireplace mantle with fireplace hood, decorated cheek tiles and tiled hearth is positioned on the internal SW wall (related grate currently sitting centrally in the room) (Plate 51); a blocked door ope into the room on the NW wall is evident on the wall face in the main corridor.

Plate 50 Community room at NE end of front range with original shuttered window embrasures, replacement aluminium window frames and timber floor (18.02.2025).

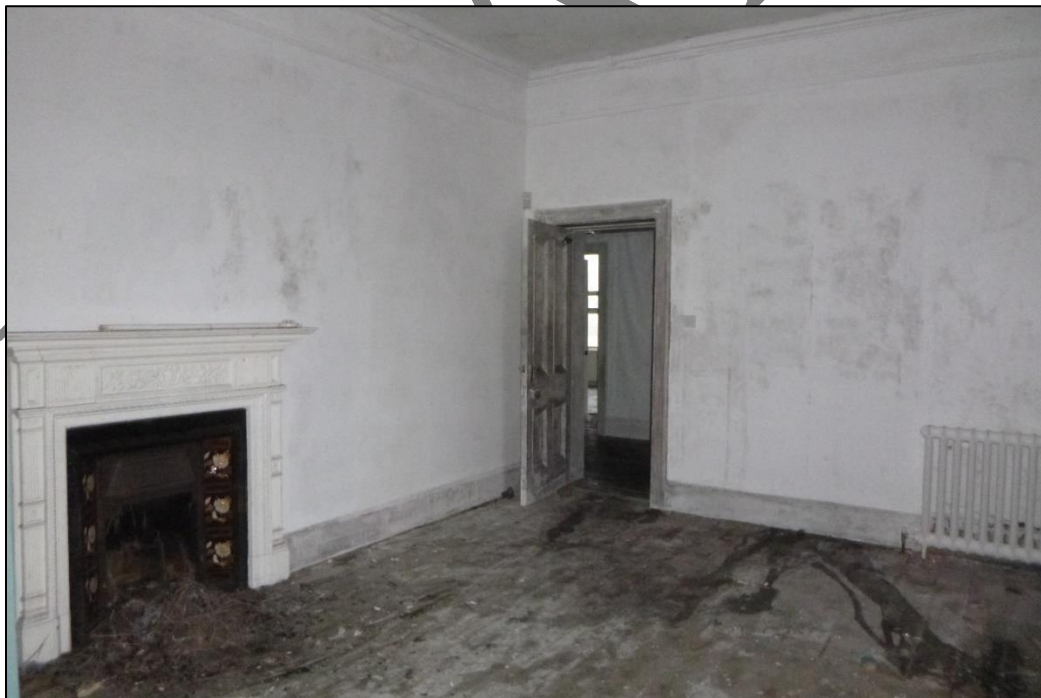
Plate 51 Community room at NE end of front range with fireplace and timber 4-pannelled door (18.02.2025).

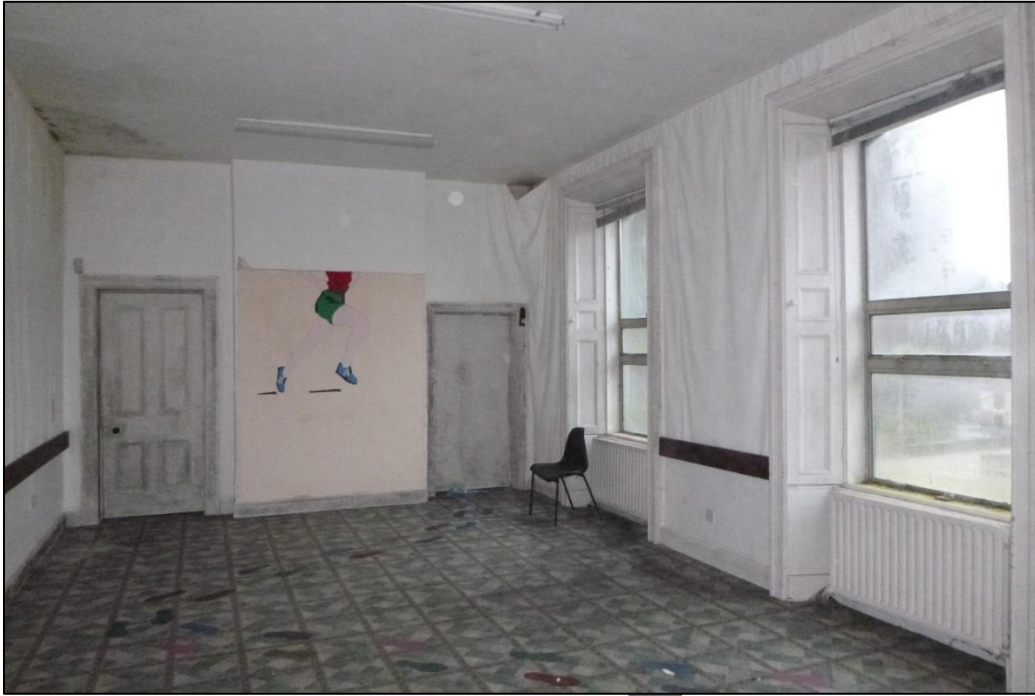
Plate 52 Former refectory room in rear range (view toward stairwell) with original shuttered window embrasures and replacement aluminium window frames on NW external elevation (18.02.2025).

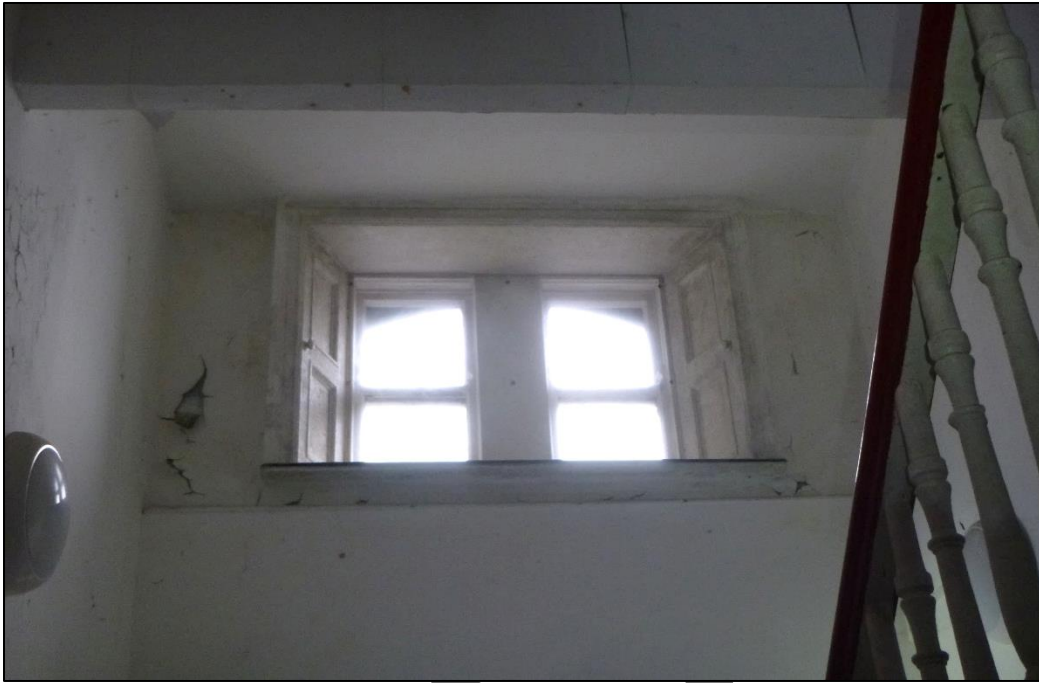
The stairwell is wholly located in the rear NE-SW oriented range, at the SW end, running from basement, through ground floor to first floor level, comprising three flights. Lighting at basement level is via a small square headed embrasure with original timber lining, shutters and architrave, positioned high above the basement entrance on the NW elevation of the rear range (Plate 54). Access from the landing at ground floor level was via a segmental arched ope across the full width of the stairwell, currently blocked with painted plasterboard (Plate 55). A square headed tripartite window on the NW elevation of the rear range lights the first floor landing, having original timber elements including timber tracery on spandrels and above pointed arches, timber sliding sash windows and textured glass (Plate 56). A timber and glass screen in a segmental arched ope across the full width of the stairwell provides access to the first floor corridor of the front range (Plate 57). A modified door ope also accesses the long SW range off the landing; a square headed

Plate 54 Small window in NW elevation of rear range lighting stairwell from high in basement level (18.02.2025).

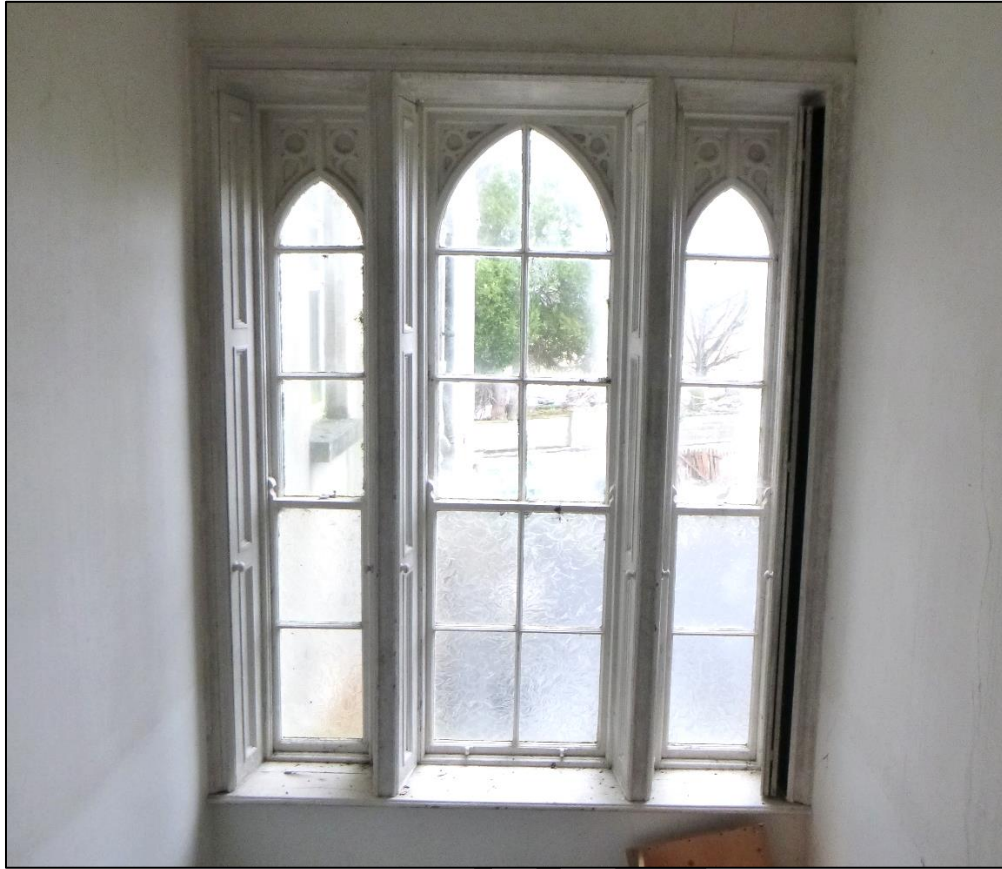
Plate 56 Tripartite window in NW elevation of rear range lighting stairwell at first floor level with original timber detail and decoration (18.02.2025).

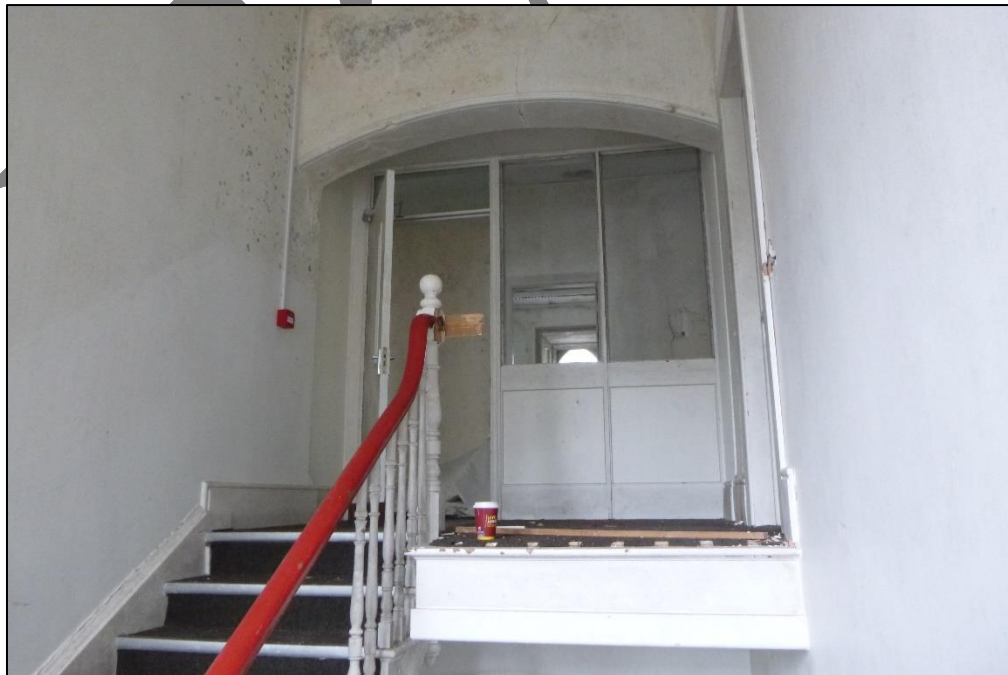
Plate 57 Stairwell landing at first floor level showing wide segmental arched ope to first floor in front range (18.02.2025).

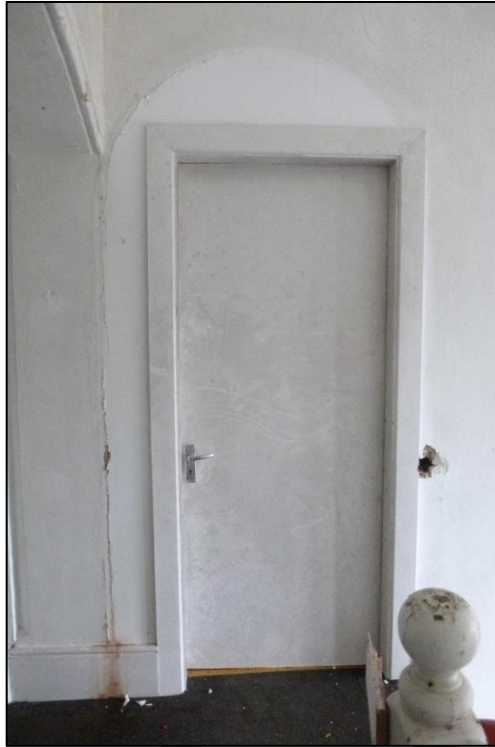
door ope has been inserted, with jambs off-line, into an earlier arched door ope on the NE facing elevation of the long SW range (Plate 58). The original arched ope embrasure is visible on the opposite side of the wall, from a corridor in the SW range.

Plate 58 Modified door ope in NE facing elevation of long SW range at first floor stairwell landing (18.02.2025).

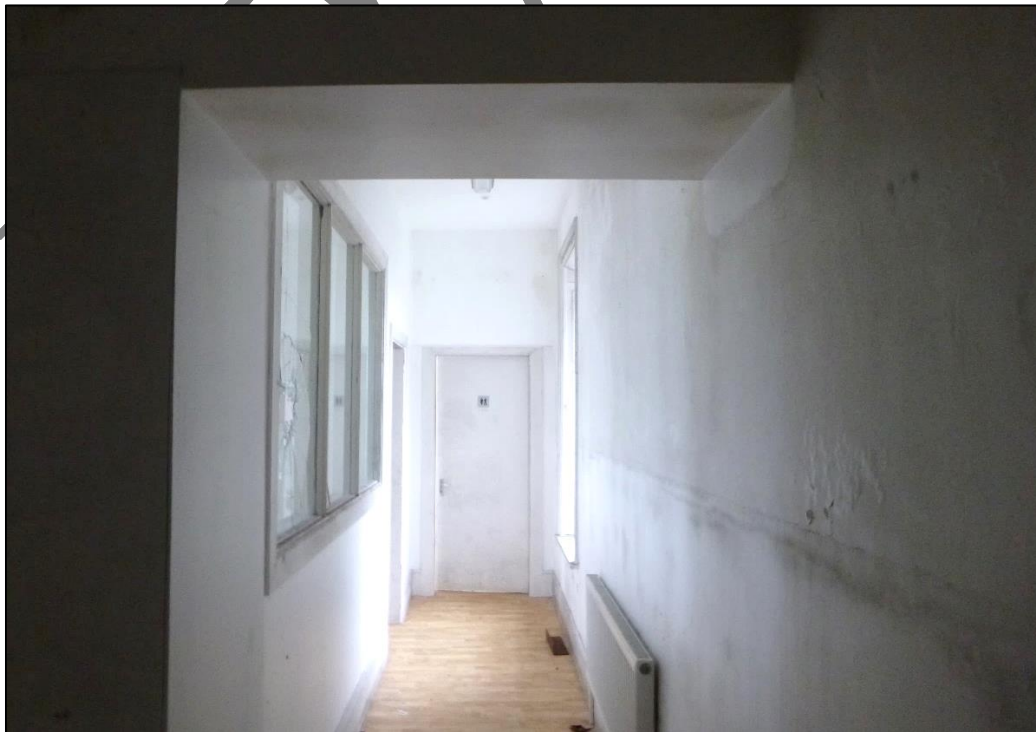
The first floor rooms in the NW end of the long SW range (to NW side of central corridor) have been subject to internal layout changes, a stud and plasterboard partition with reinforced glass extending to the rear of the lift shaft providing a corridor to toilets at the NW end of the range (Plate 59). Window embrasures on the external NE facing wall have original timber elements, including shutters, with some evidence of later repairs. A room off the corridor to the rear of the lift shaft, used as a kitchen, has two window embrasures with original timber shutters on the SW facing elevation (Plate 60), with a timber dado rail, and a square headed long ope in the internal NW wall, which could be an infilled earlier door ope. The toilet space at the NW end of the range has a partial false ceiling, a hatch in the ceiling to the attic space, later internal stud and plasterboard partition walls, with most window embrasures on the NE and SW elevations having original timber shutters. A square headed window ope in the NW gable is a later intervention and likely dates to a similar period to the toilet refurbishment (Plate 61). Earlier dividing walls may have been removed during refurbishment, with a possible surviving stub surviving on the NE elevation at the ope to a disabled toilet.

Plate 59 Corridor with later partition wall accessing toilets at NW end of long SW range (18.02.2025).

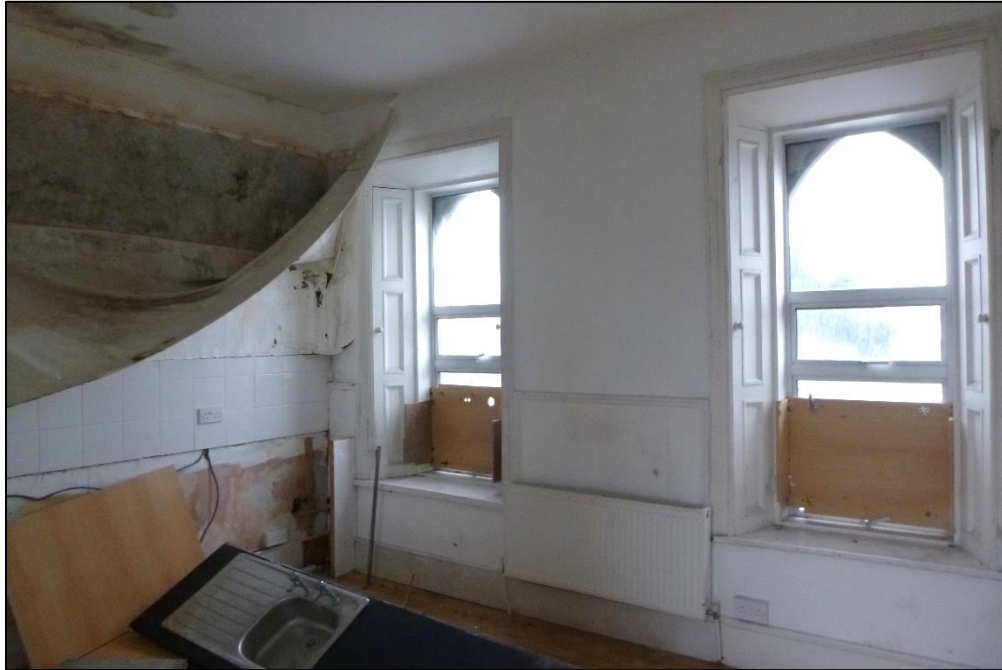
Plate 60 Former kitchen space at rear of lift shaft, view to window ope on SW elevation (18.02.2025).

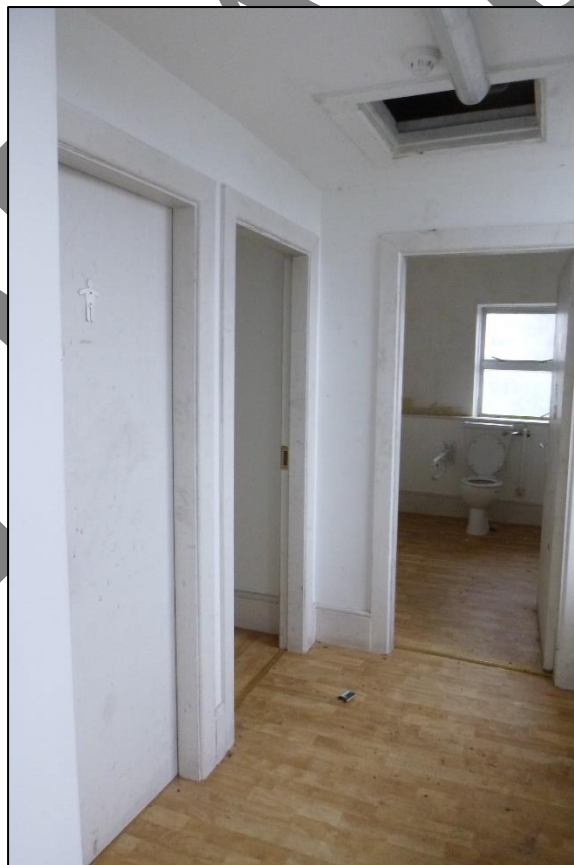
Plate 61 Later partition walls forming toilets in NW end of SW range, view to later window ope in NW gable (18.02.2025).

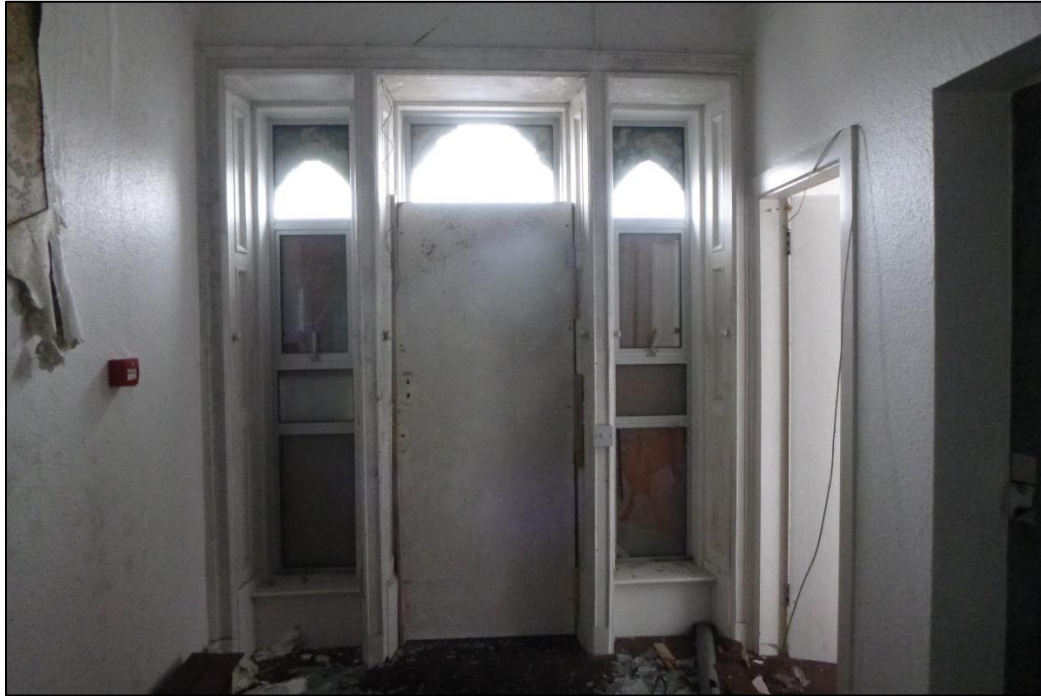
Plate 62 Tripartite window at SW end of first floor corridor next door open to hot water cylinder and lift shaft (18.02.2025).
