Archaeological Impact Assessment & Building Appraisal Former Convent of Mercy Ballymahon, Co. Longford

Applicant: Longford County Council
Issue Date: April 2025
Prepared by: Marion Sutton & Philip Kenny, Shanarc Archaeology Ltd.

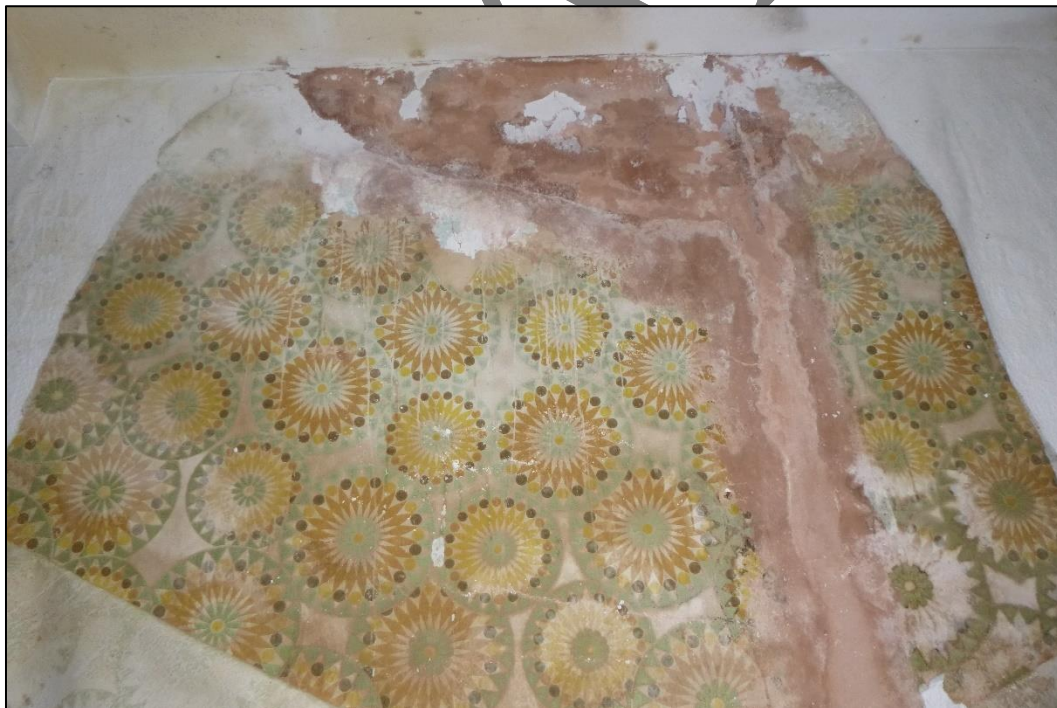
Plate 63 Sample earlier wall paper exposed on SE wall of corridor by tripartite window (18.02.2025).

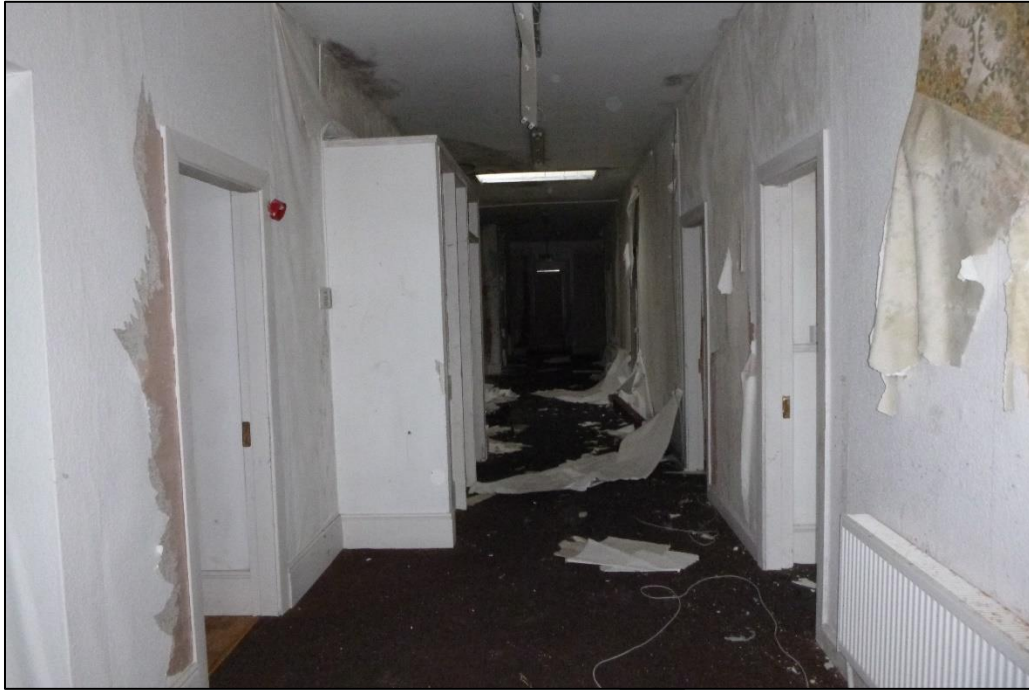
Plate 64 View NE along first floor corridor from SW end (18.02.2025).

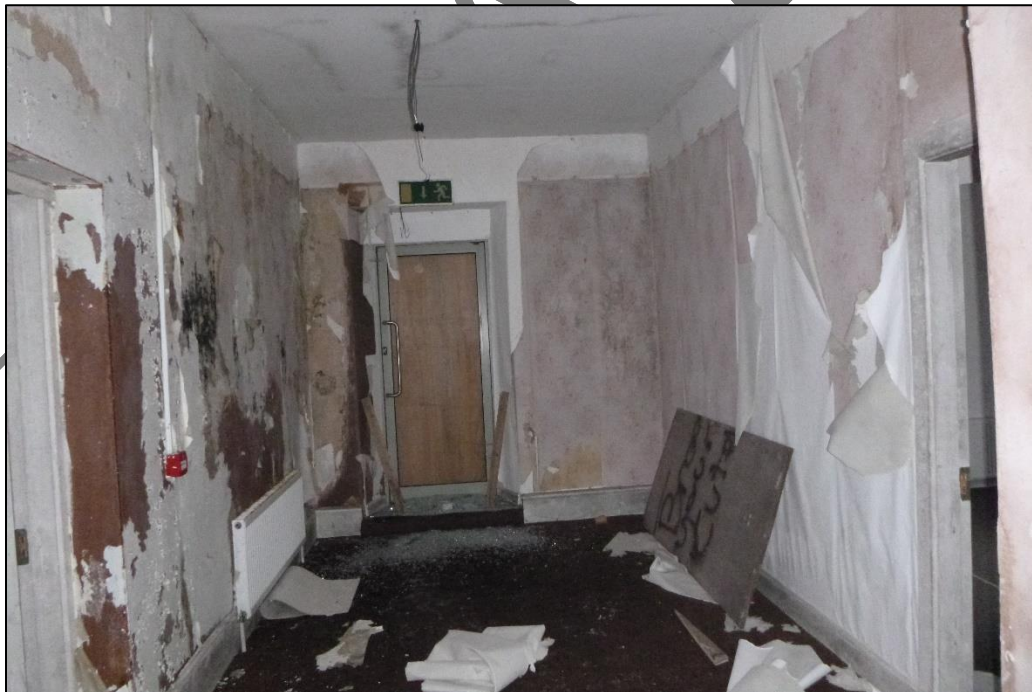
Plate 65 NE end of first floor corridor to later aluminium framed fire escape door (18.02.2025).

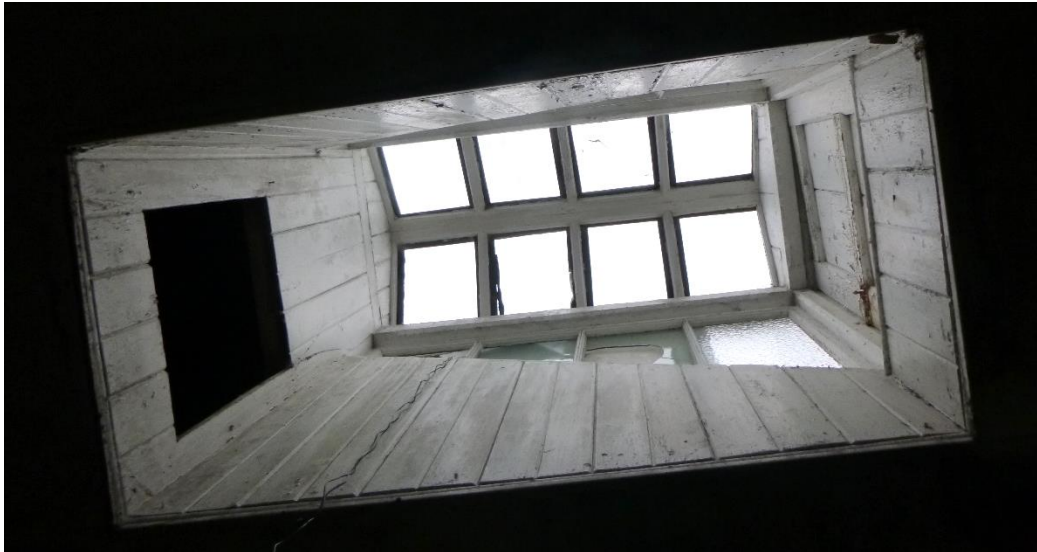
The lift shaft at the SW end of the first floor corridor has an adjacent square headed door ope into a small room with hot water cylinder, a later intervention, next to a square headed tripartite window at the SW end of the corridor with original timber shutters in embrasures and replacement aluminium window frames (Plate 62). The corridor has textured white wallpaper throughout, from the last phase of refurbishment, and older wallpaper beneath is exposed in places, including on the SE wall neat the tripartite window (Plates 63 and 64) and at the NE end, where there is an aluminium framed fire escape door inserted into a former window ope (Plate 65). A rectangular, pitched timber rooflight is positioned roughly centrally along the corridor, having an ope into the attic on the SE side and a latched door accessing the external roof valley on the NW side (Plate 66).

Plate 66 Timber roof light located centrally along first floor corridor (18.02.2025).

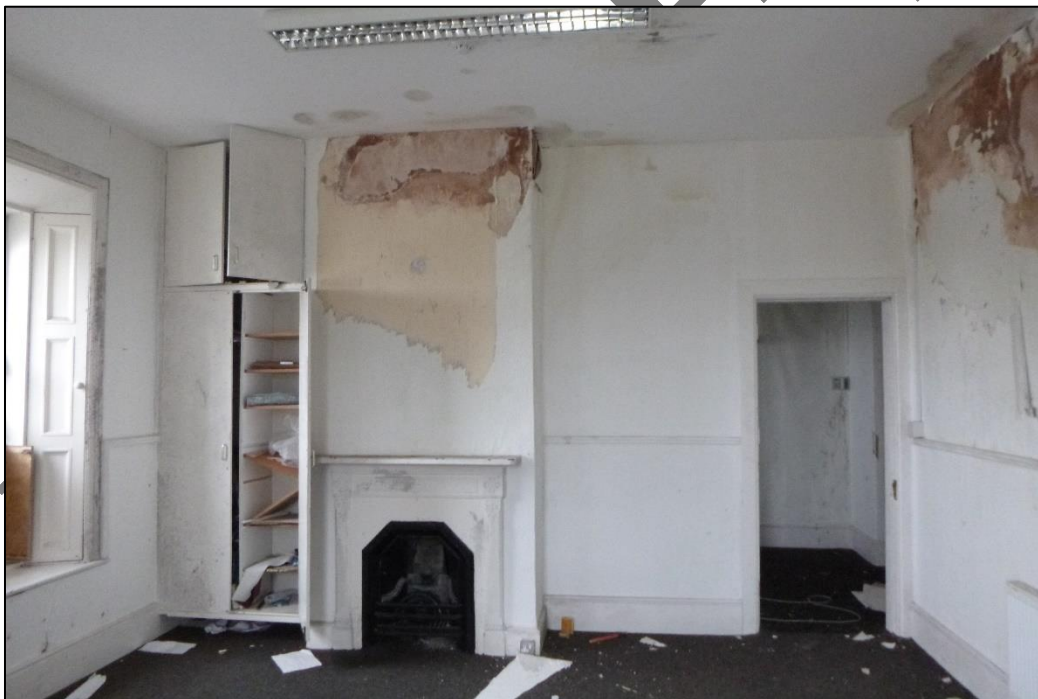
The first floor rooms to the front range are symmetrical, comprising large room in the SW corner with three window embrasures with original timber shutters and existing chipboard lining on the external SW and SE facing elevations. A chimney breast and a cast iron fireplace mantle and surround with grate are positioned on the internal NW wall (Plate 67),

Plate 67 SW corner room to front range with chimneybreast and cast iron fireplace on internal NW wall (18.02.2025).

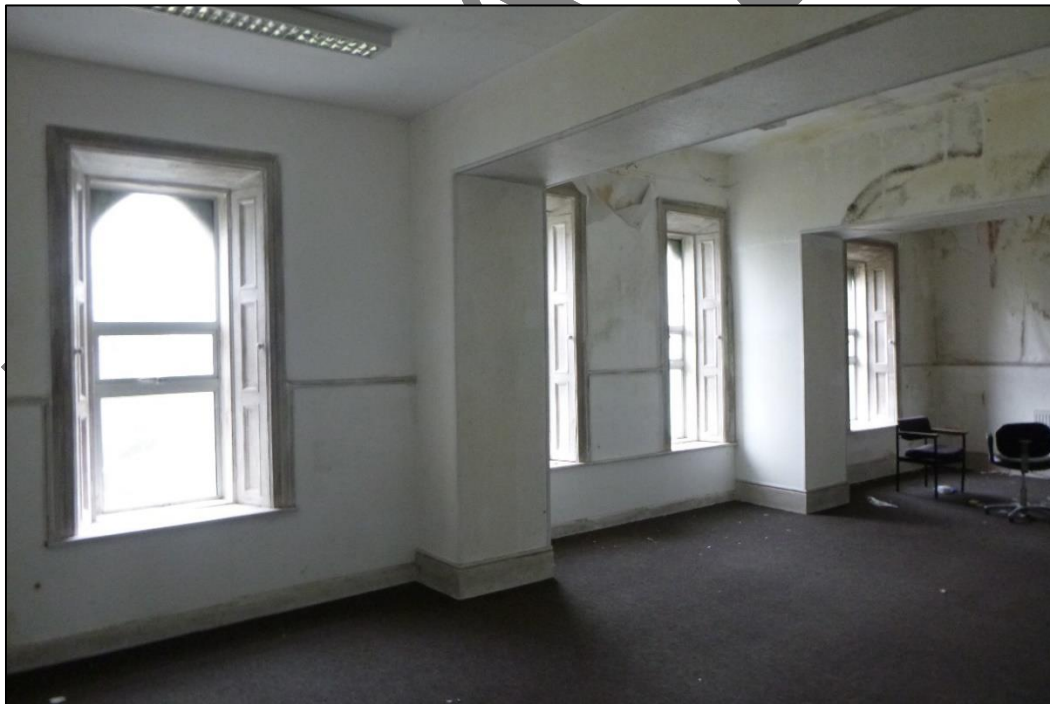
Plate 69 Enlarged central front room to front range with projecting stubs of original internal dividing walls, view to SW (18.02.2025).

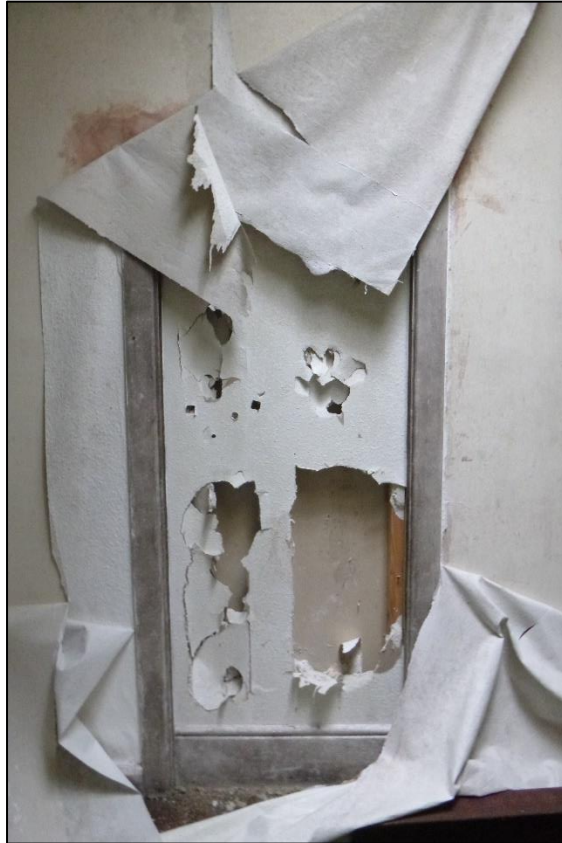
Plate 70 Blocked up door ope from corridor into former middle room in front range (18.02.2025).

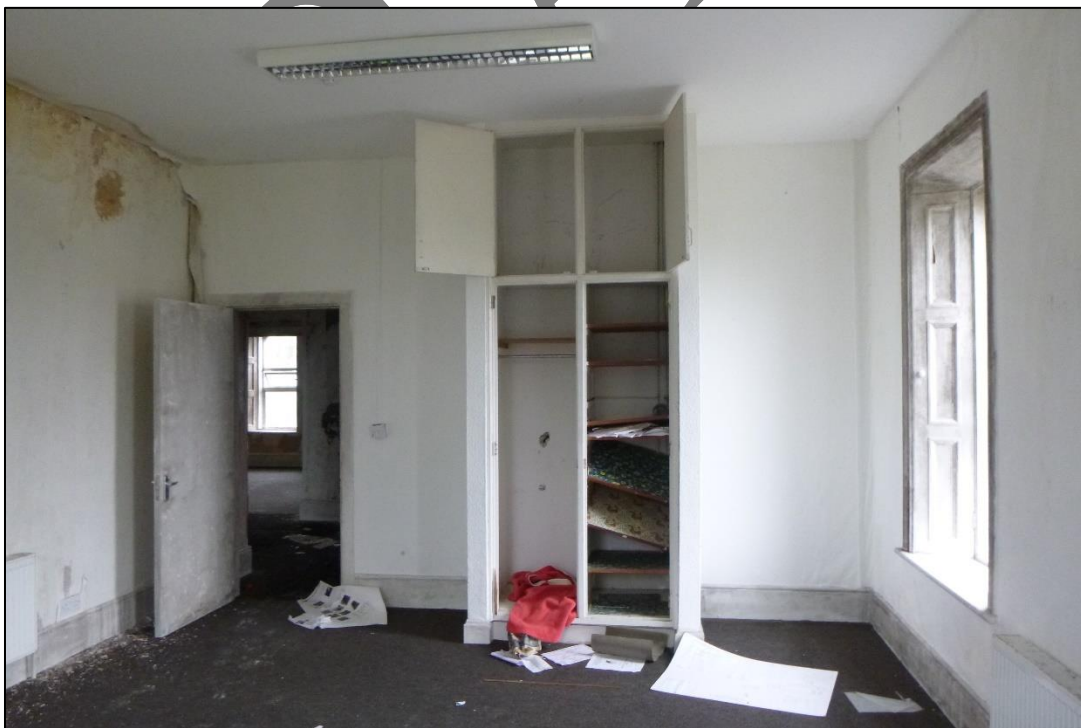
Plate 71 NE corner room to front range, view to later NW internal partition wall (18.02.2025).

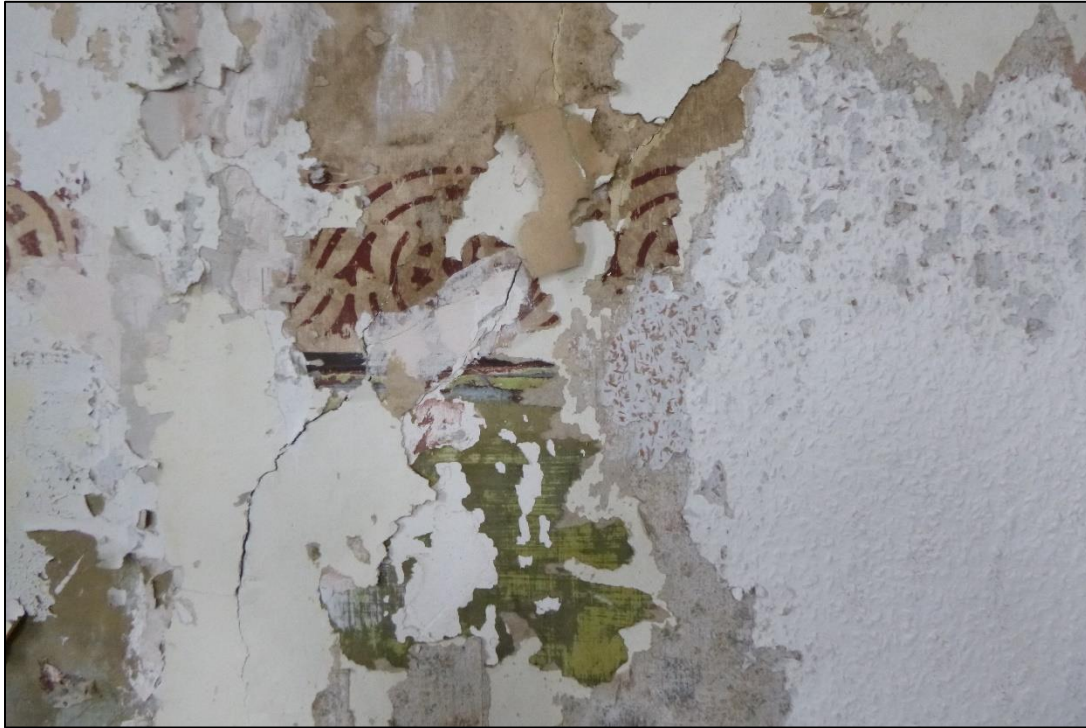
with possible hand-painted earlier wallpaper exposed beneath textured white wallpaper on the internal NE wall next to a scar of a possible former internal room division (Plate 68). Dado rail to all walls. Three smaller rooms positioned centrally in the front range have been opened to create a single larger room by the removal of internal walls; projecting stubs of the original dividing walls remain on the external SE elevation and internal NW wall and across the ceiling (Plate 69). The room has four window embrasures with original timber shutters in the SE (front) elevation, dado rail to all walls, evidence of existing chipboard lining to walls and textured white wallpaper. A blocked original door ope to the middle space on the internal NW wall is visible from the corridor (Plate 70). The front room in the NE corner has three window embrasures on the external SE and NE facing elevations, two on the NE retaining original timber shutters. The internal NW wall, with projecting cupboard, is a narrow stud and plasterboard partition wall, a later intervention indicating the room at the NE end of the first floor corridor was once larger (Plate 71), likely installed during the addition of the 20th century infill extension at the NE corner of the convent. Possible hand-painted earlier wallpaper is exposed beneath textured white wallpaper on the internal SW wall (Plate 72).

Plate 72 NE corner room to front range with early wallpaper on internal SW wall (18.02.2025).

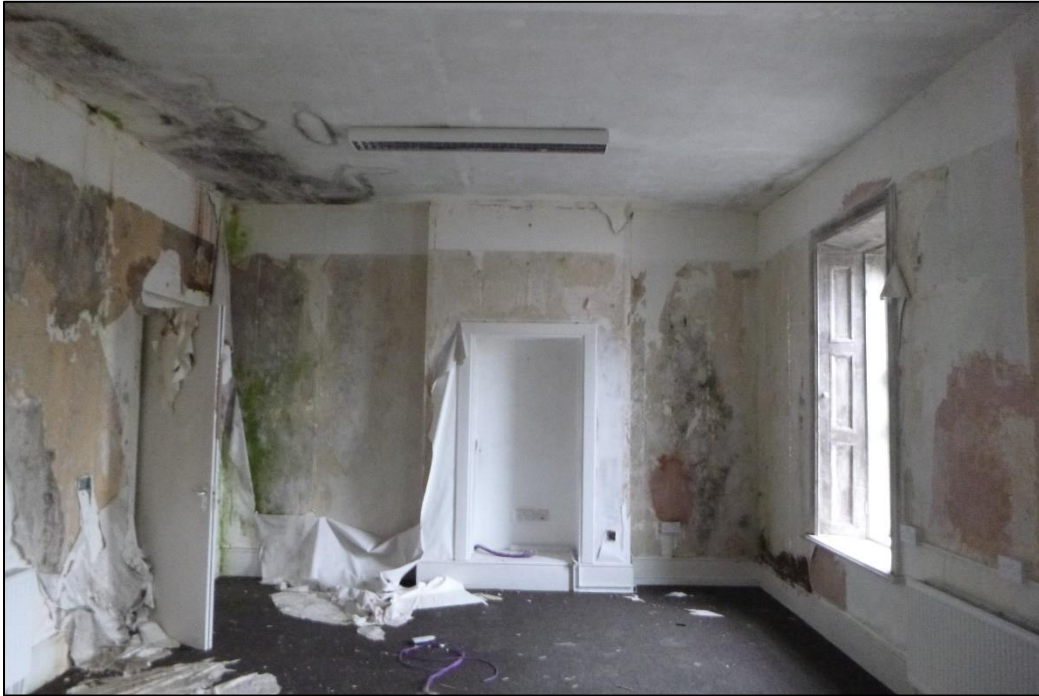
The first floor room in the rear range (to the NW side of central corridor) has three square headed window embrasures on the external NW facing elevations, the larger two retaining original timber shutters, the smaller having a lowered ceiling above with a hatch to the attic space (Plate 73) showing a concrete block gable wall forming the NE internal wall (Plate 75), added during the addition of the 20th century infill extension at the NE corner of the convent. The attic hatch shows original timber roof frame and lime mortar torching to underside of roof slate (Plate 75). There is a scar of a possible former internal NW-SE oriented room division centrally in the room, and a modified fireplace ope in the chimney breast on the SW wall (Plate 74).

Plate 74 SW internal wall of room to rear range with chimneybreast and modified fireplace ope (18.02.2025).
