REF: AHIA REPORT, OLD POST OFFICE LONGFORD

Architectural Heritage Impact Assessment (Conservation Report, Repair and Methodology)

Project Title: Renovation, Alterations at the Old Post Office, Longford to house a **new tourist office**.

Site Address: 43 Main Street, Longford, Co. Longford. Eircode: N39 FD45

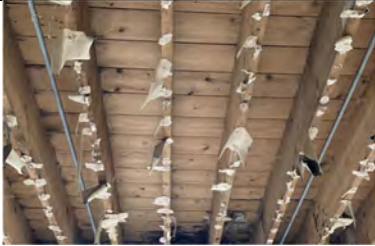
Element 11	Photo	Condition Description
<i>Upper Floors</i>

There are sections upper timber floors that are in good condition (as in this photo) however there are areas where whole sections of the floors were rotten and have fallen away. Refer to site visit record for details. Rotten timber sections to be fully removed. New timber joists, boards to be provided to reinstate upper floors fully.
Proposed Conservation works & methodology	Repairs to be carried out to timber floor structure in accordance with structural engineer's recommendations retaining existing timber and replacing defective timbers ensuring that replacement is on a like for like basis. Follow steps outlined above (element 07) for dealing with rot/ fungal and insect infestation. Recondition existing timber boarded finish with new matching boarded finishes for new areas to reinstate timber boarded floor finishes to the upper levels.

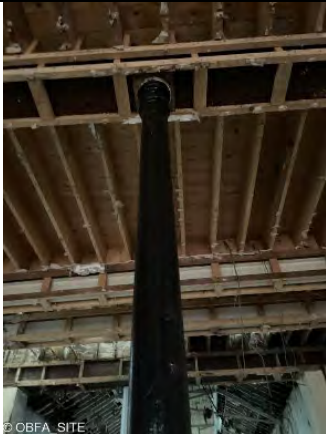
05	Cast Iron Column	Description	Comments

Cast Iron column in Ground floor open room- front. Understand it is not original but this it adds character as long as left exposed "Architectural" significance.	Fire protection with proprietary system (intumescent paint) so that cast iron column can be left fully exposed.
06	Timber boarded upper floors & joists	Description	Comments

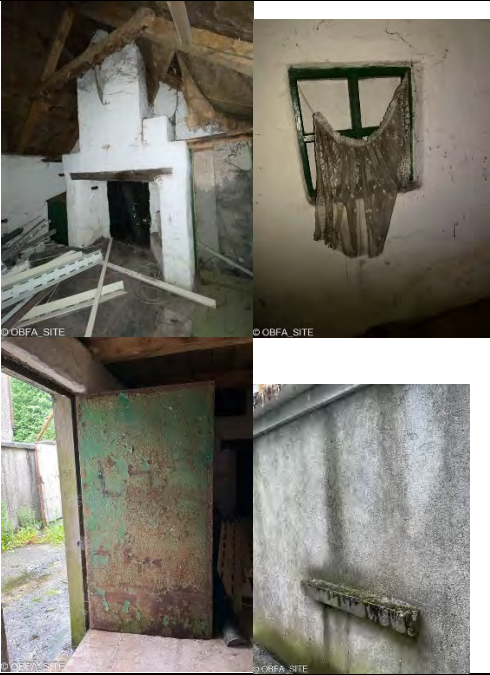
The original Post office plans do not have this feature. We understand that this was created as a museum chimney display.	As it is a "fake" do not consider that these fake elements need to be retained. They can be removed if it suits the brief to enable a better use of space. Any blocked-up openings should either be reopened or old redundant cills removed (if retained blocked up).
11	Historic lean-to structures	Description	Comments

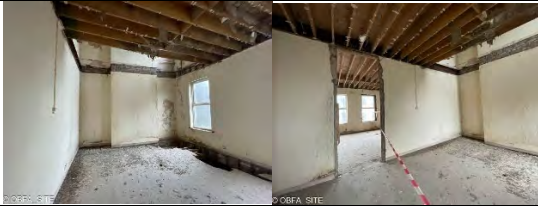
19	Room 01- 1st Floor level	Description	Comments

Ceiling & floor to be reinstated.	Detail of subdivision of rooms to be carefully considered by LCC to provide good quality spaces.
20	2 nd floor landing	Description	Comments

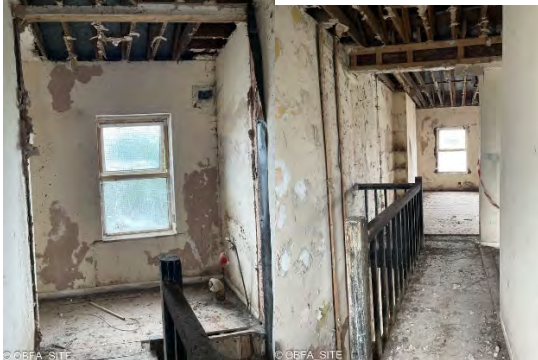
Ceilings & finishes to be reinstated.	Detail of fire enclosure around stairwell at 1 st floor level to be carefully considered by LCC.
21	Room 01 2nd floor level	Description	Comments

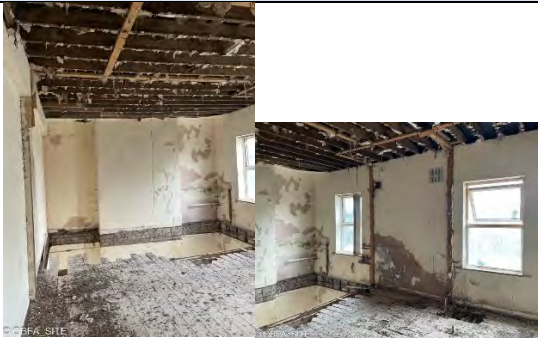
Ceiling & floor to be reinstated.	Detail of subdivision of rooms to be carefully considered by LCC to provide good quality spaces.
22	Room 02- 2 nd floor level	Description	Comments

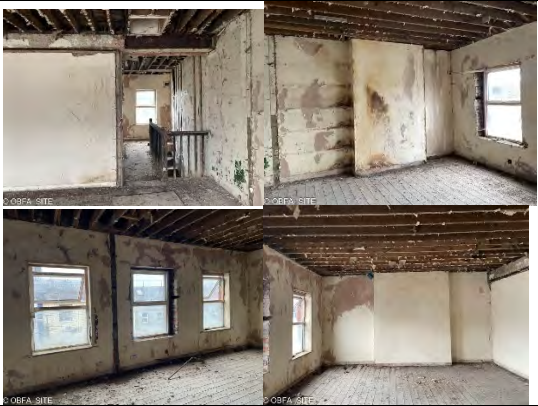
Ceilings & finishes to be reinstated.	Detail of subdivision of rooms to be carefully considered by LCC to provide good quality spaces.
23	Exposed Ceiling over 2 nd Floor level	Description	Comments

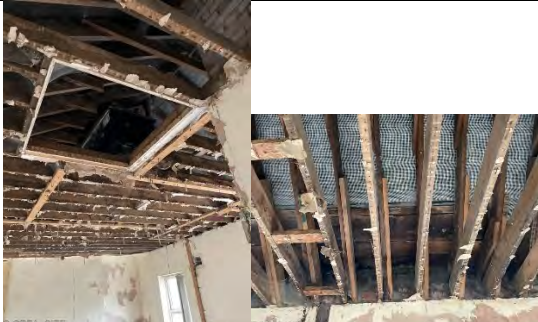
Ceilings & finishes to be reinstated.	Propose re-using opening for any new access hatch to collar ceiling. Insulation materials between and above joists should be fully breathable-ensuring that roof cross ventilation is maintained.

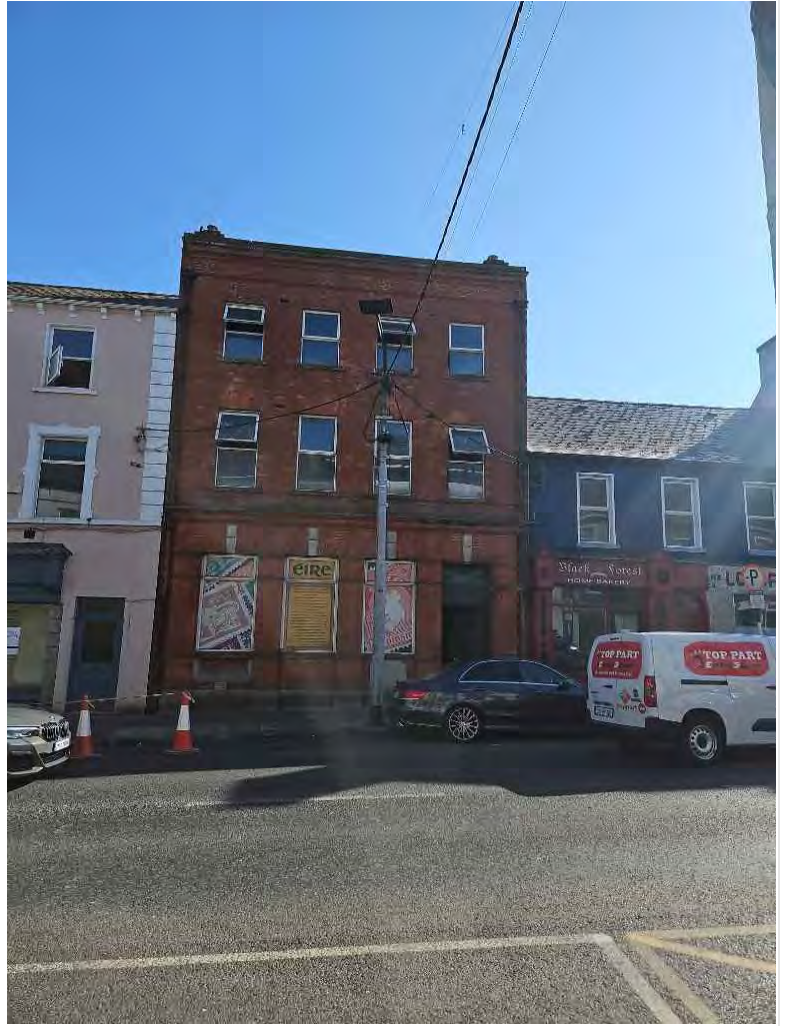
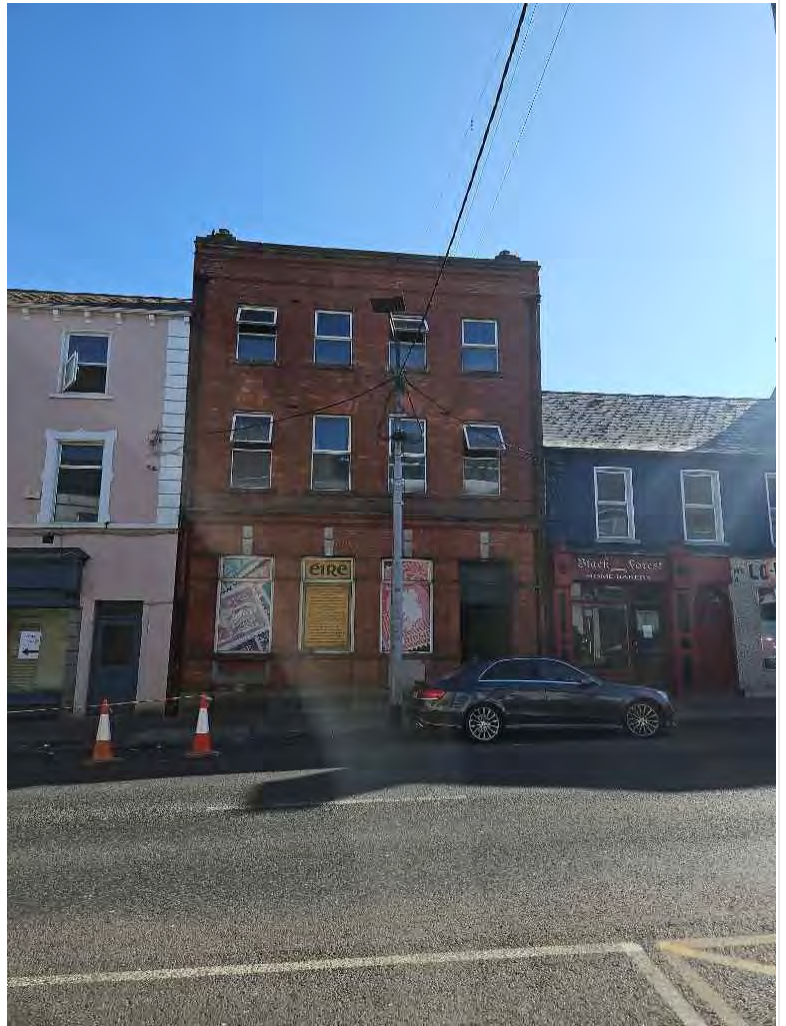
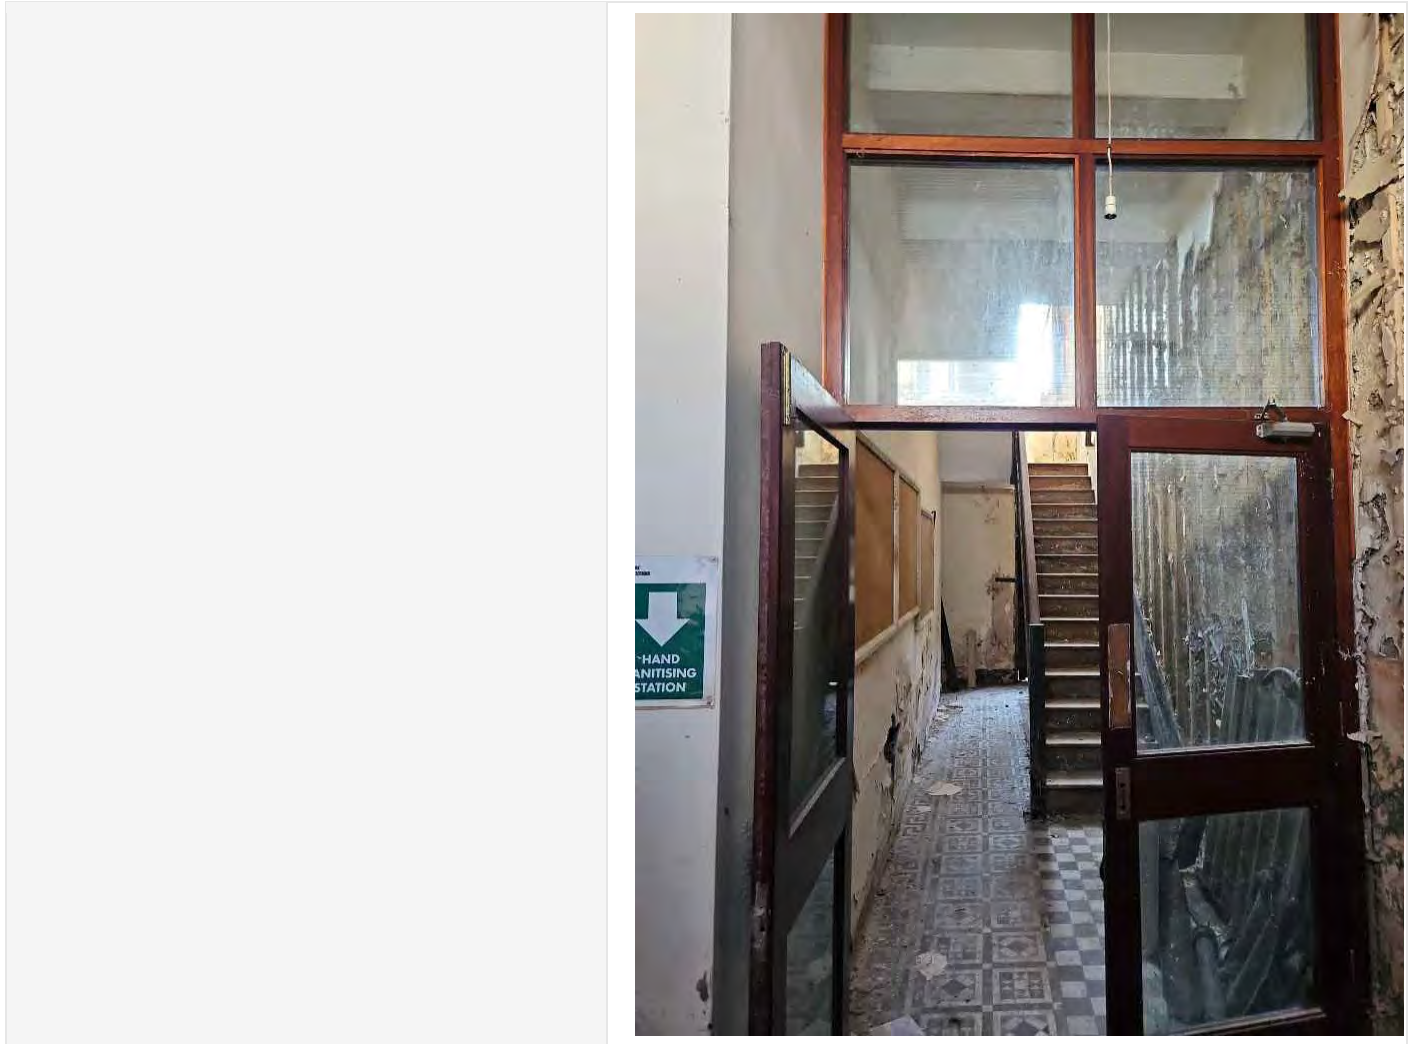
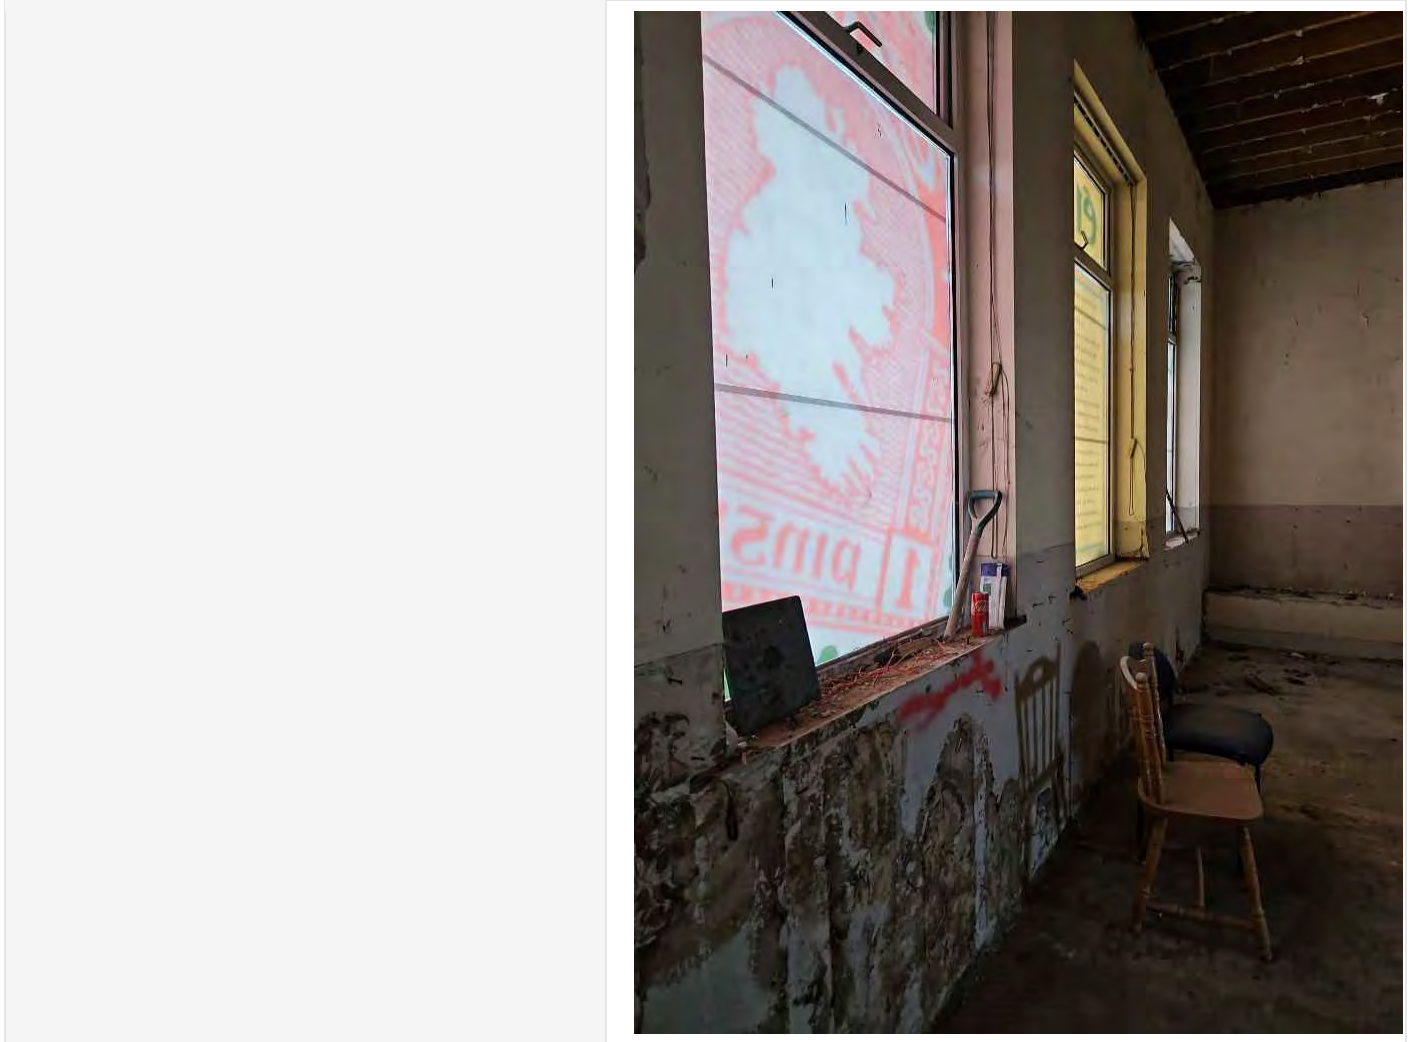
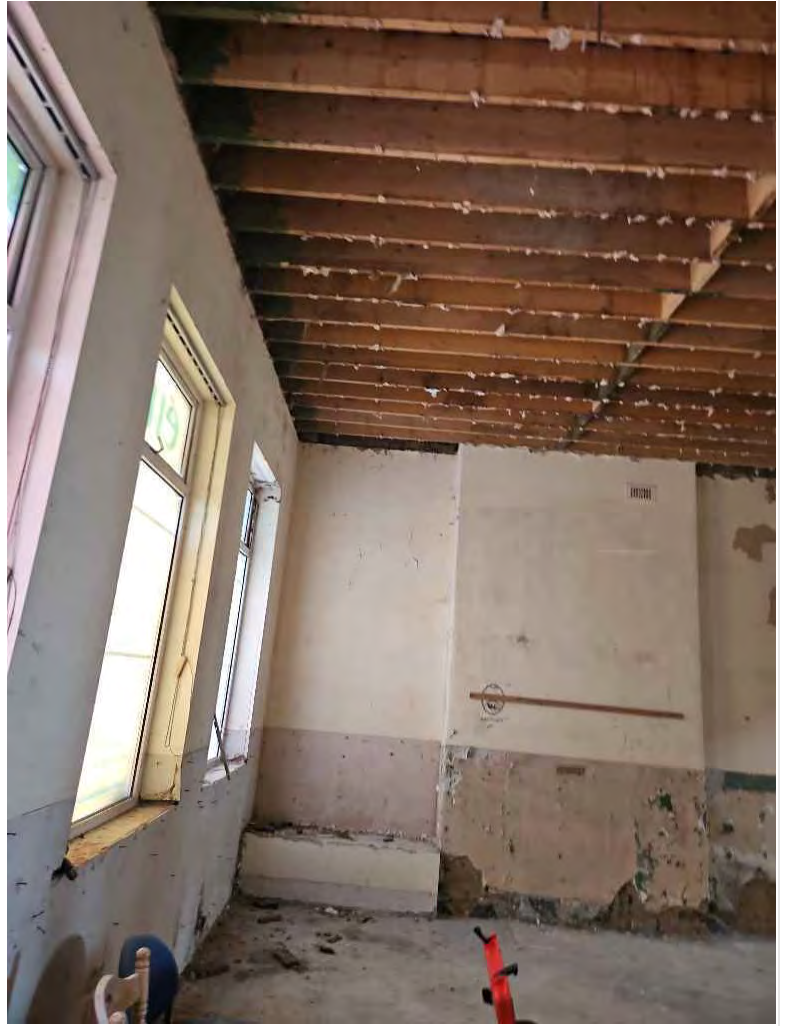
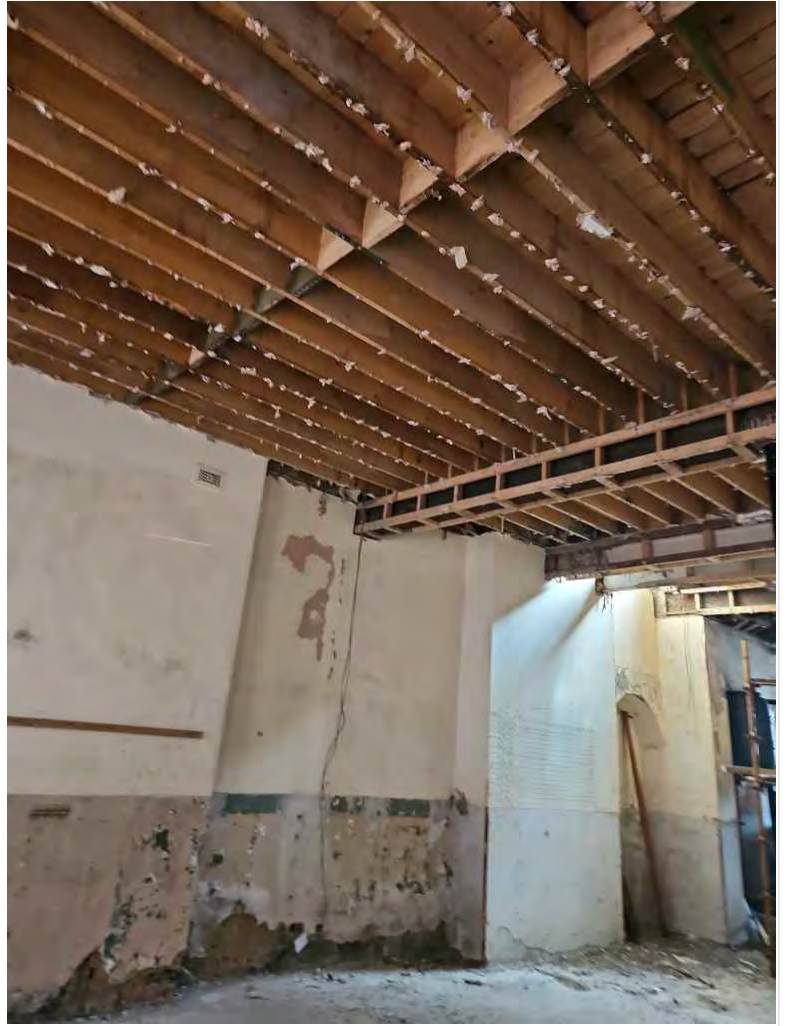
Photo(s)

Photo Guidance:	Minimum photos per visit - Front, Back and Side of the Building, Identify Unit/House Number, Photo Unit(s)/House(s) in sequence.
TGD Part A	STRUCTURE 2012
Unit(s) Number(s) Inspected:	1 Unit
Description of Observation(s):	<p>Movement in the front and rear wall was identified in the past. Bracing of front and rear wall (5no) at first floor level identified by two tie bars passing through the building at first floor level.</p> <p>All timber elements of the structure (floors, stairs, window reveals and heads, all timber lintel) require replacement due to wet and dry rot.</p> <p>The single storey roof structure has failed and requires replacement.</p> <p>Repairs to the main structure roof was complete some time in the recent past (20 years) by the presence of the modern day roof membrane</p> <p>Main roof structure requires replacement due to wet and dry rott.</p> <p>Structural crack present in render of party wall at 2nd floor. Repairs of the brick wall behind same is required</p> <p>Sand and cement mortar in the joints of the red brick on front elevation is holding moisture within the facade, replacement of same with a lime mortar render is required.</p>
