REF: AHIA REPORT, OLD POST OFFICE LONGFORD

Architectural Heritage Impact Assessment (Conservation Report, Repair and Methodology)

Project Title: Renovation, Alterations at the Old Post Office, Longford to house a **new tourist office**.

Site Address: 43 Main Street, Longford, Co. Longford. Eircode: N39 FD45

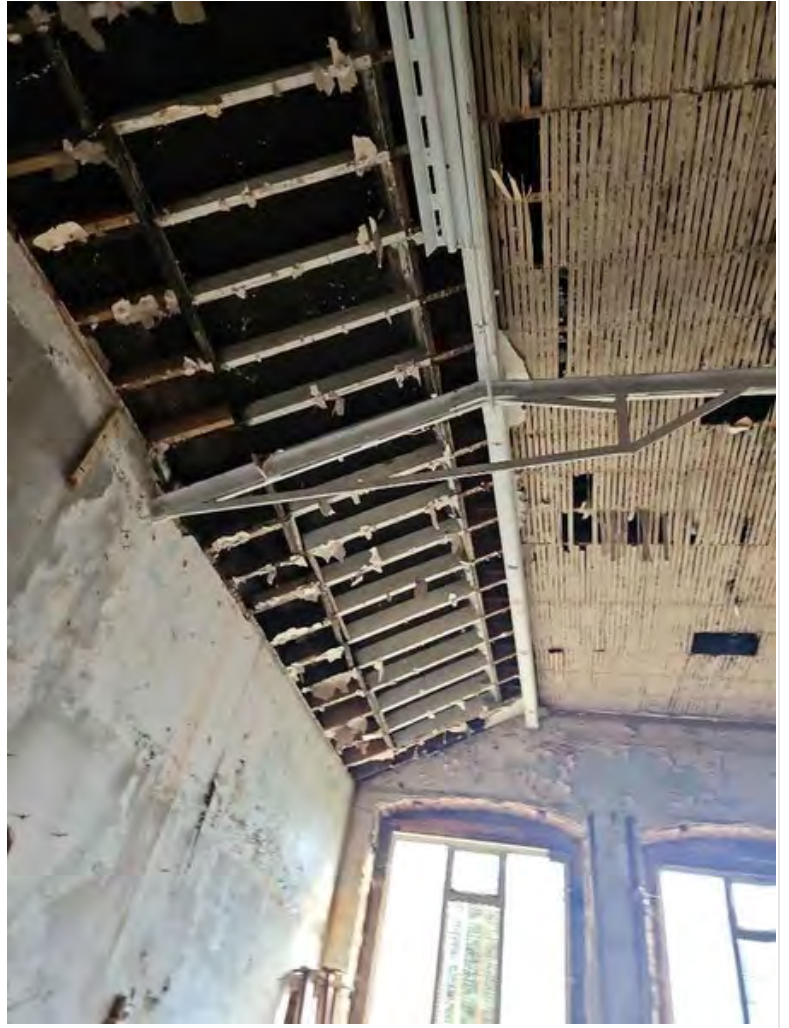
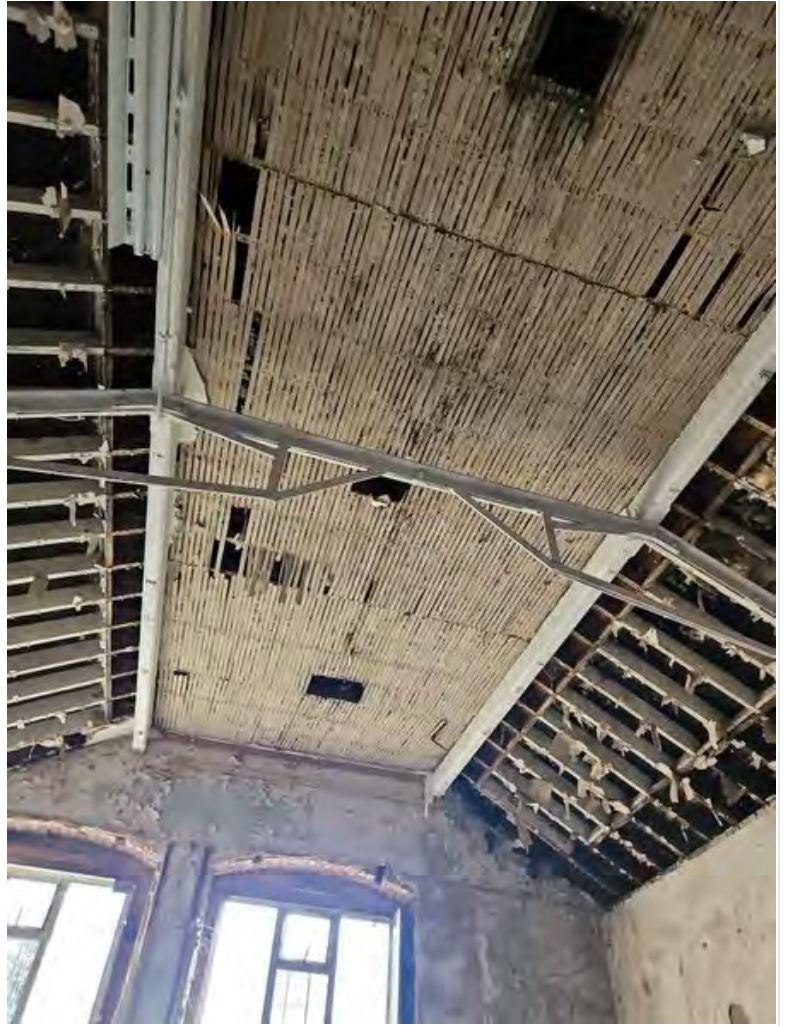
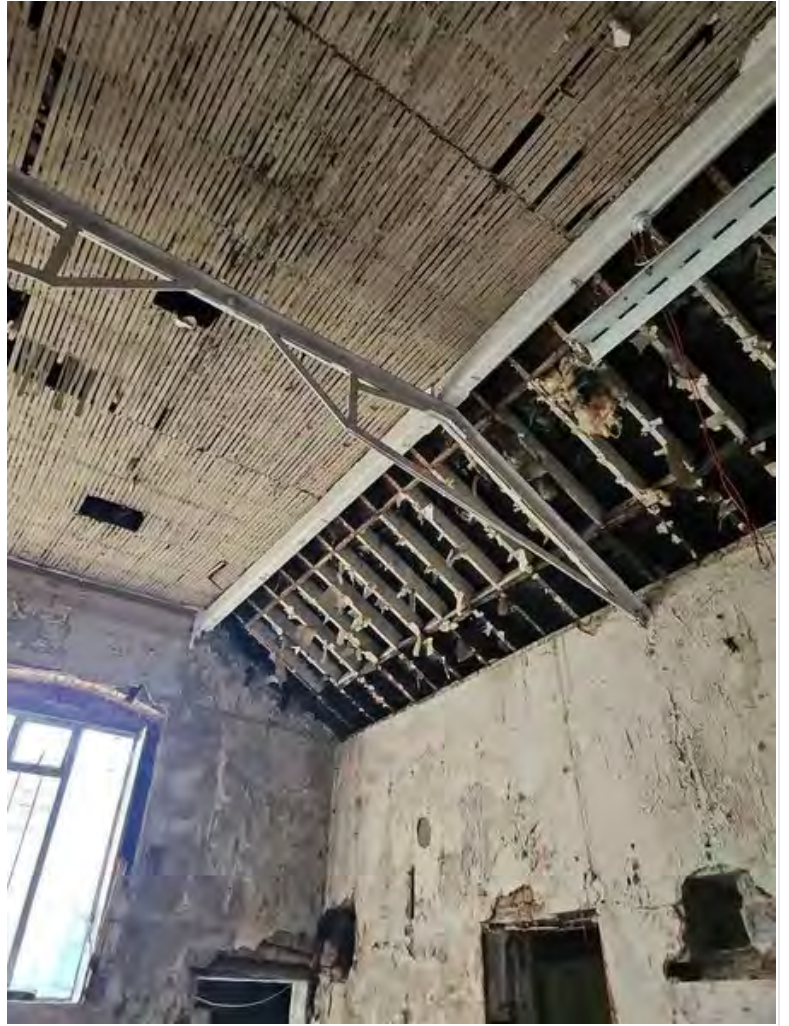
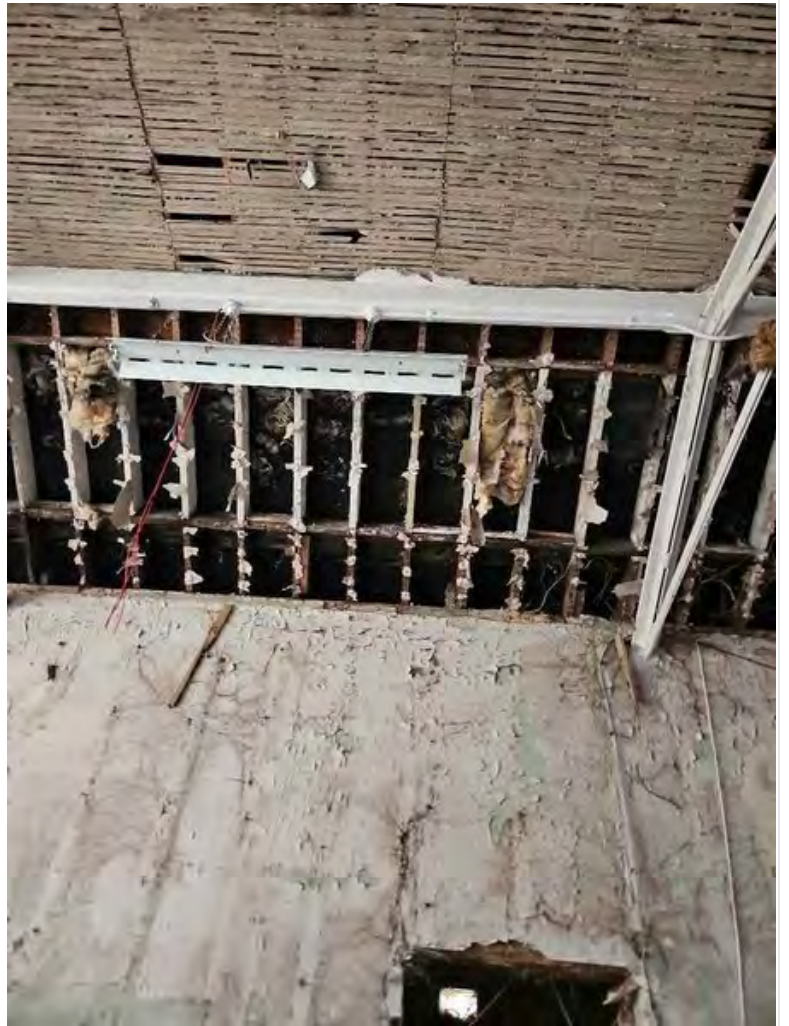
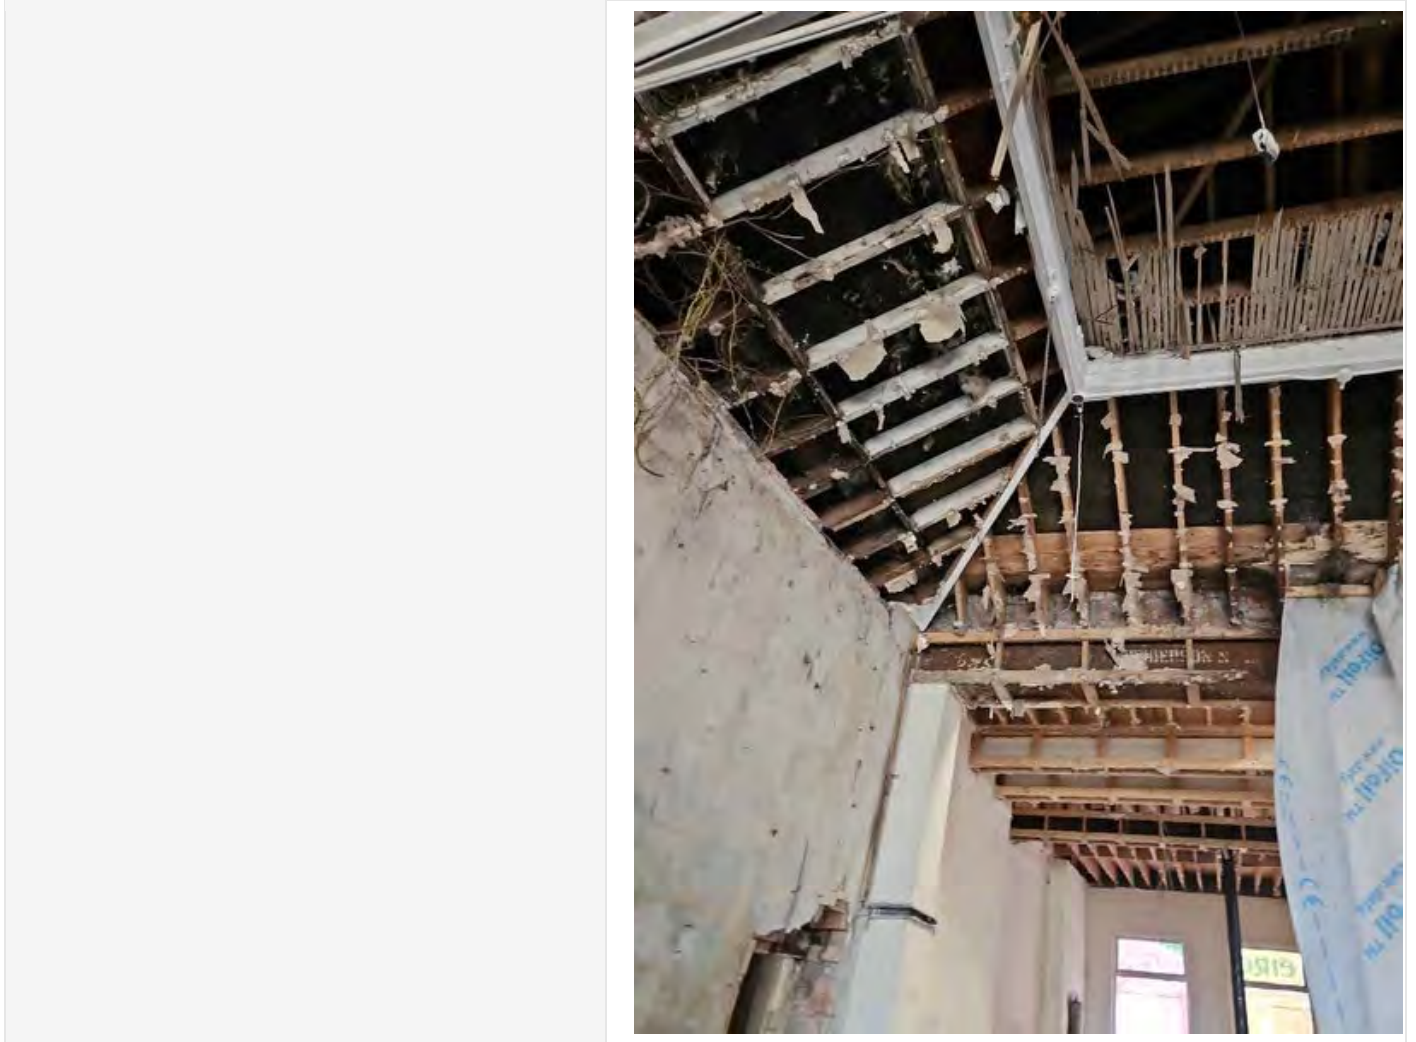
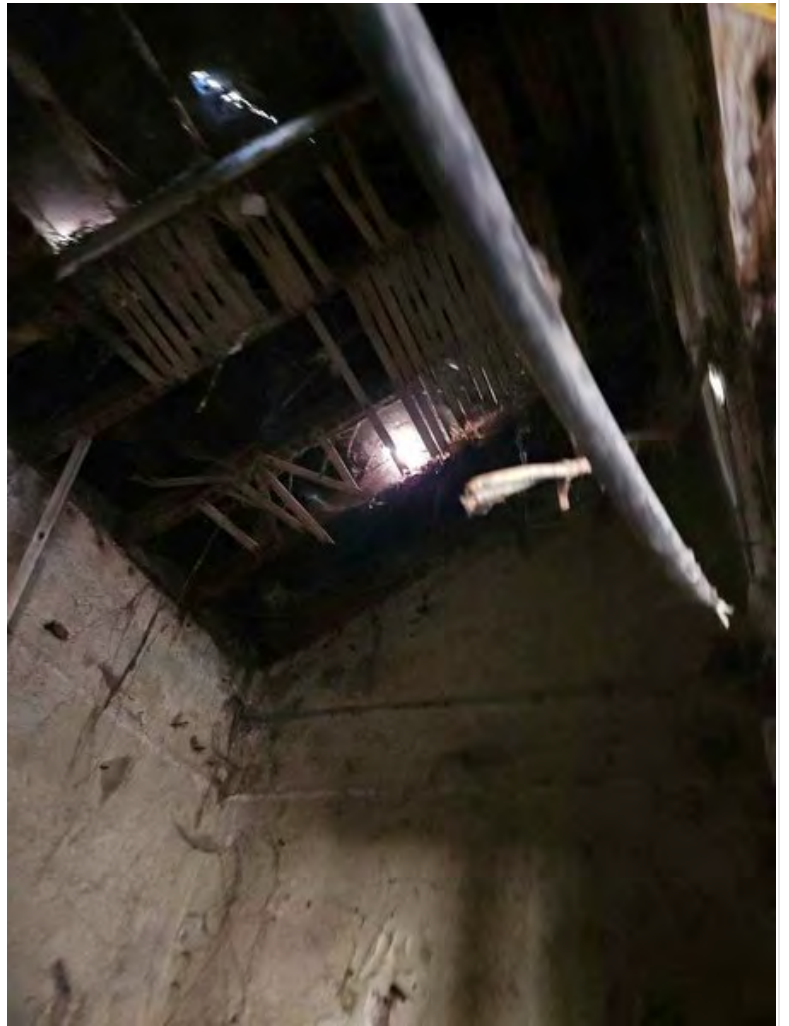
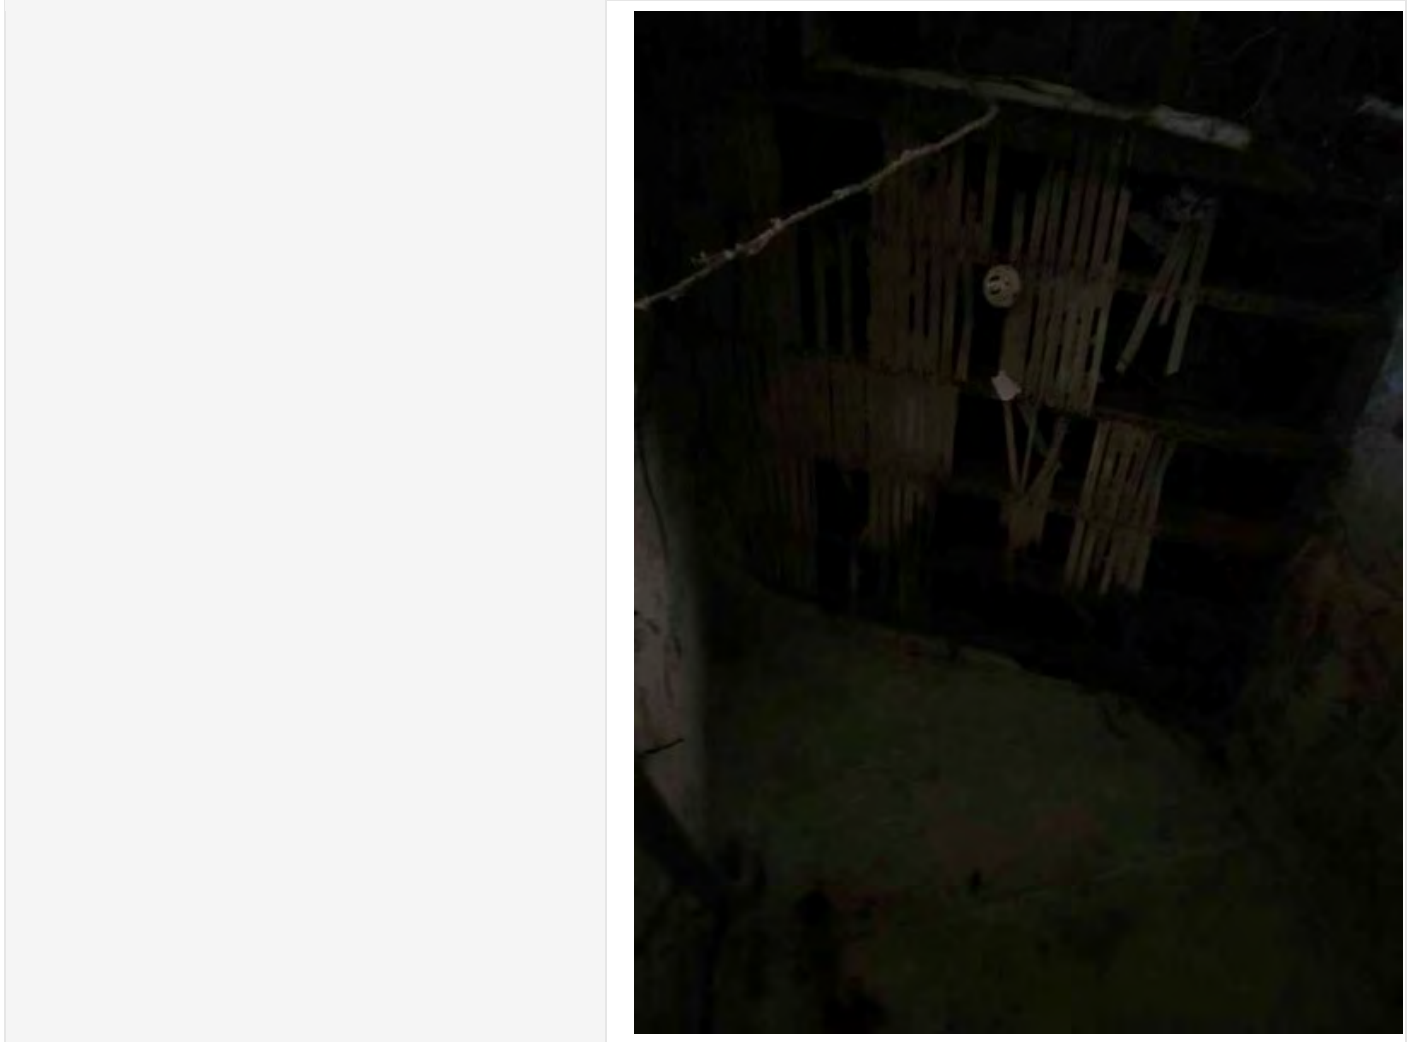
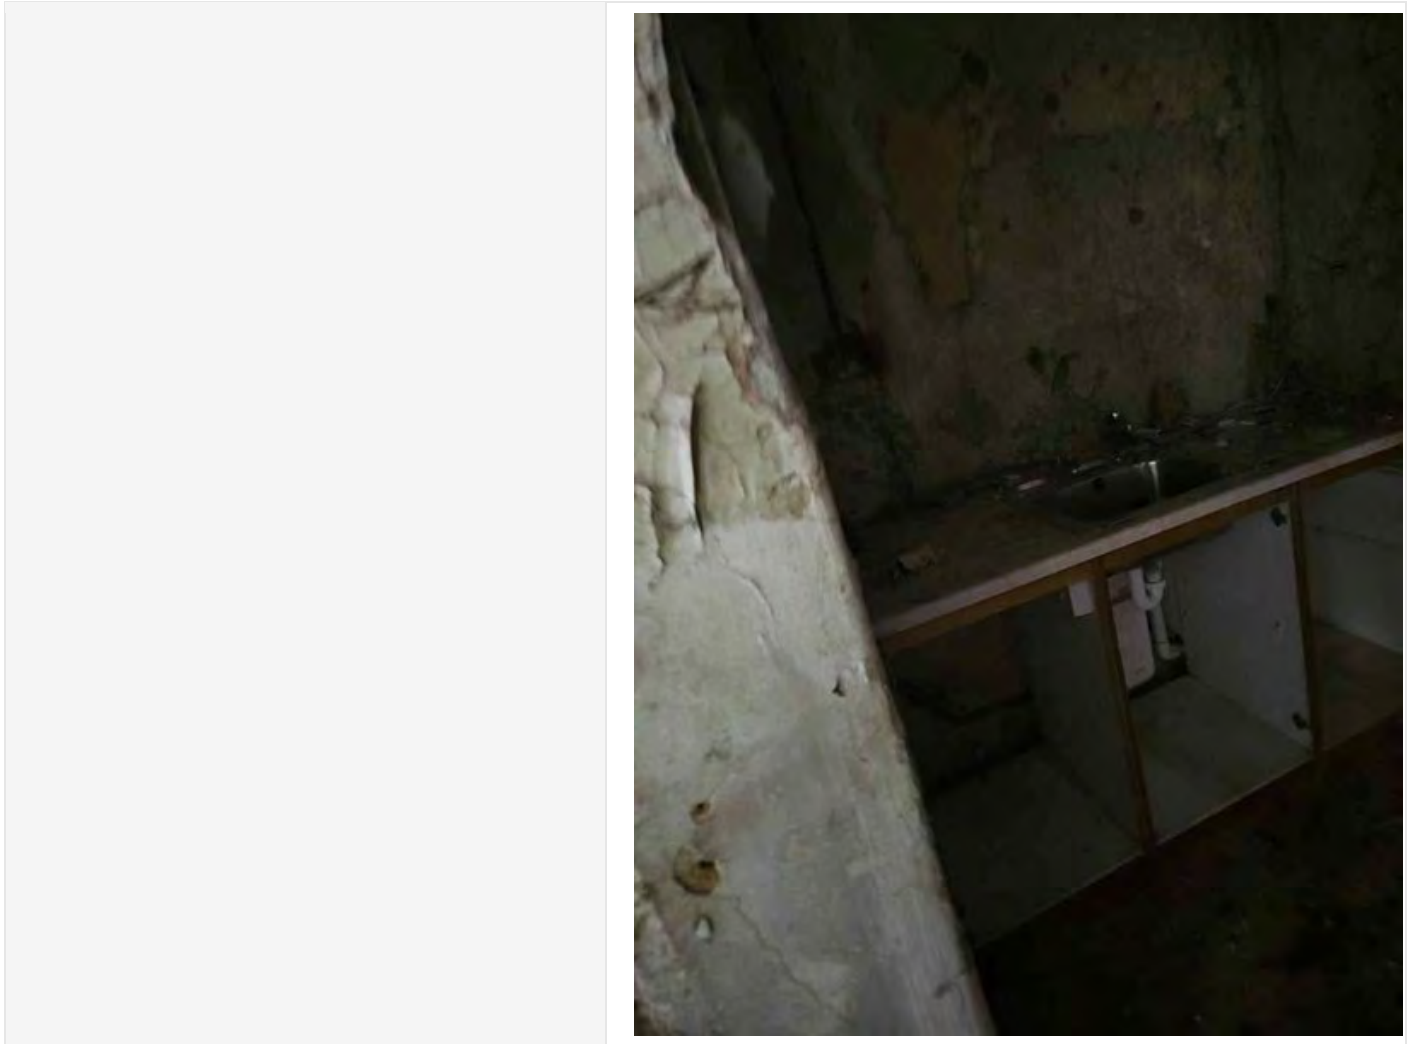
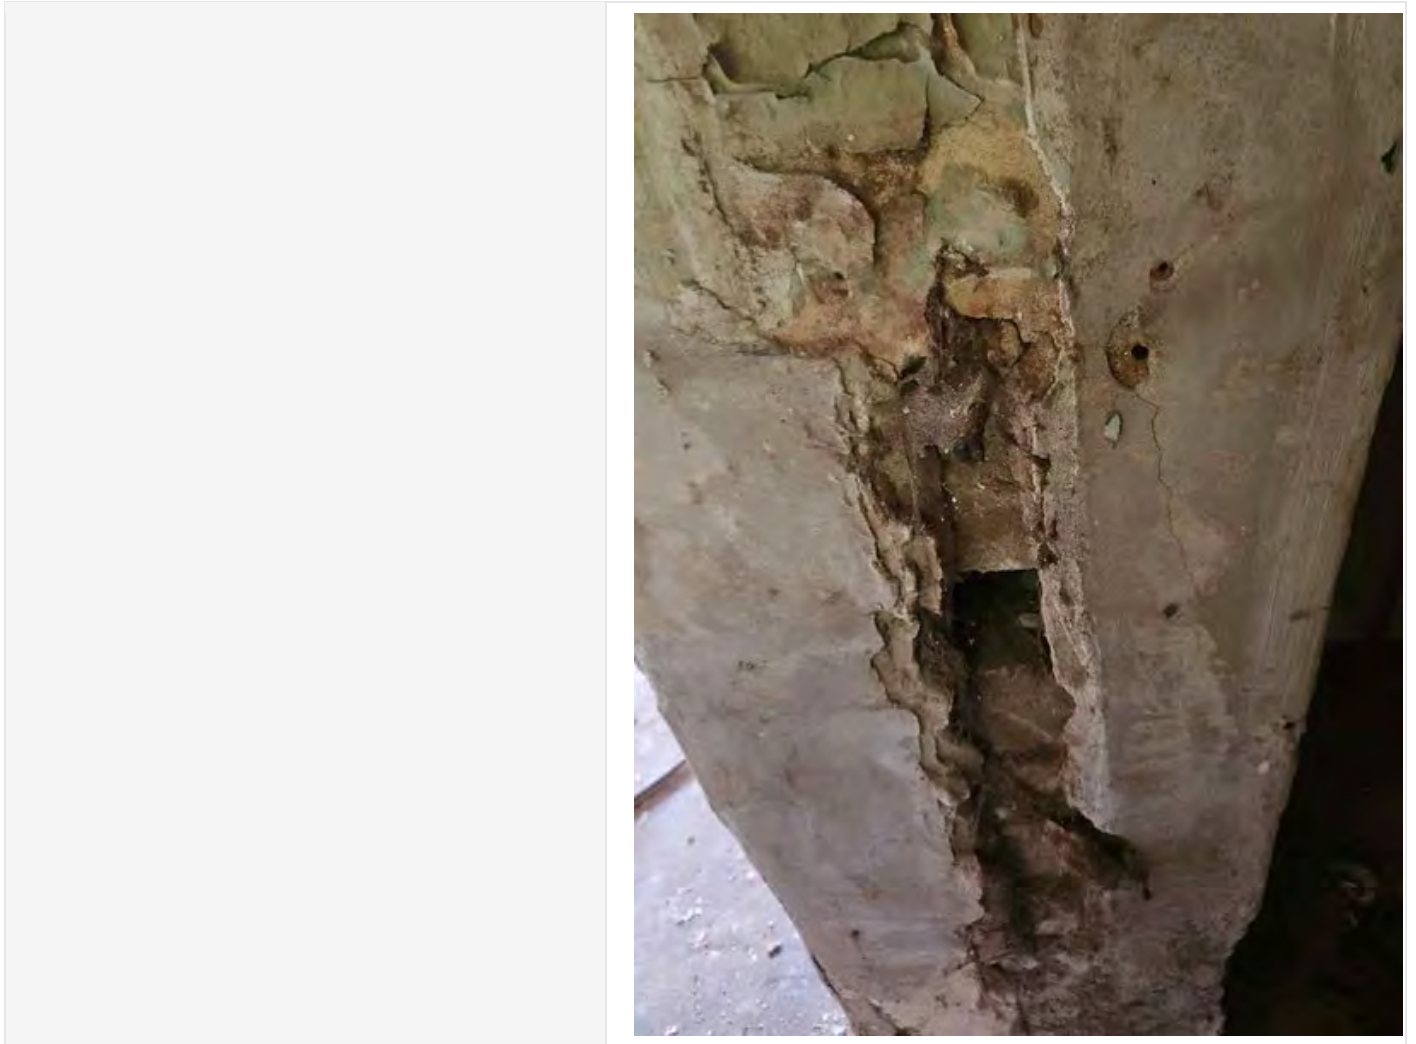
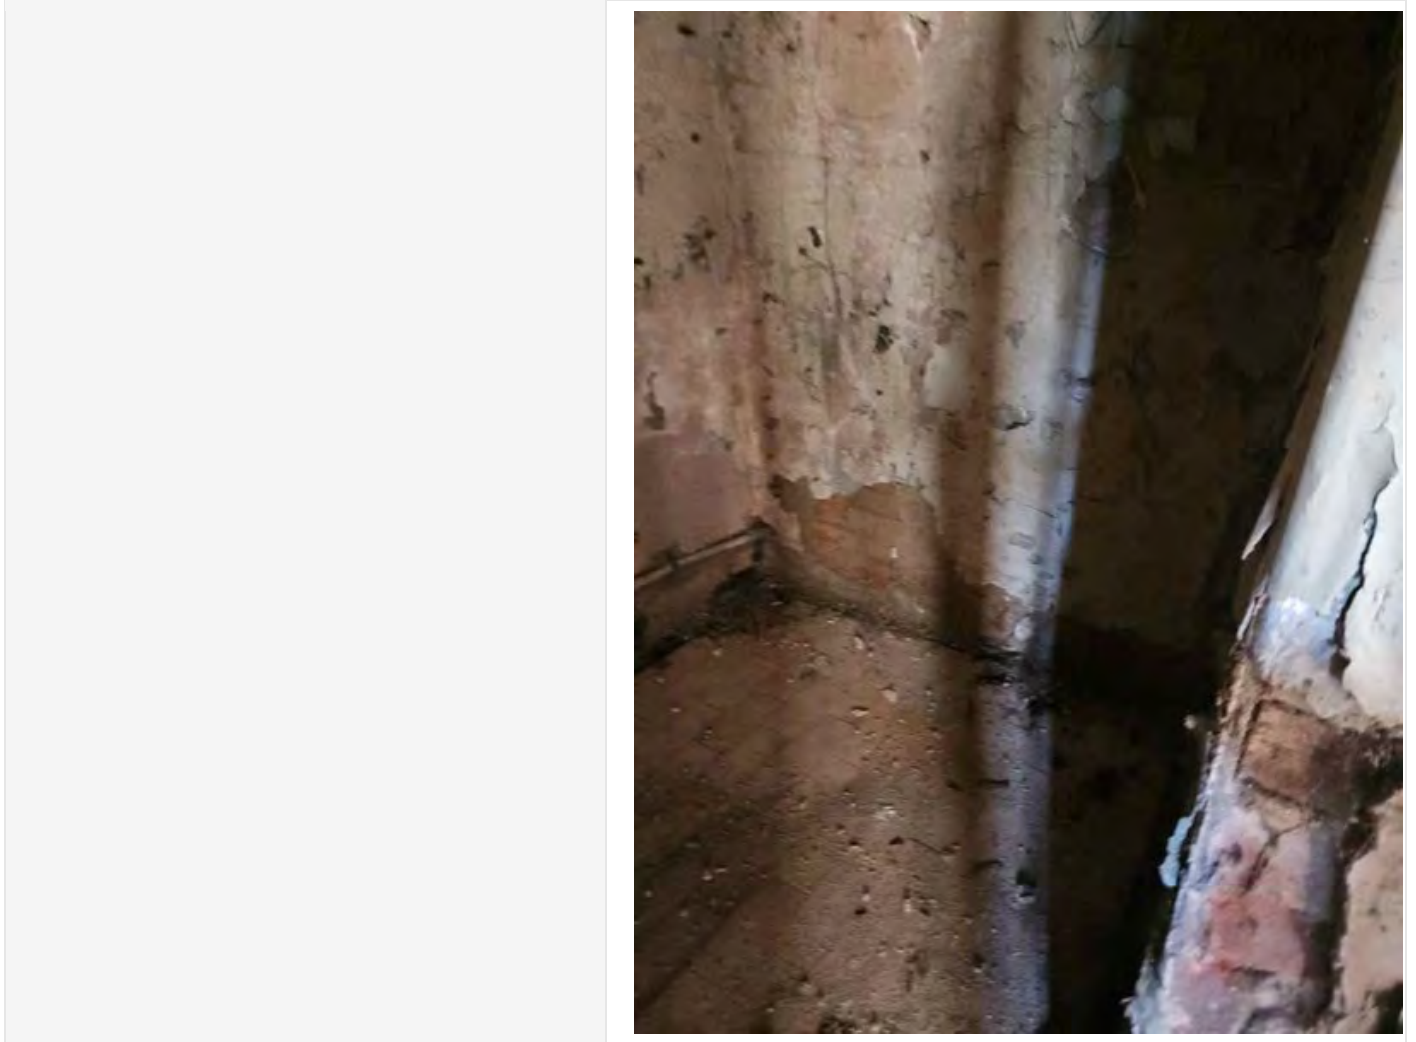
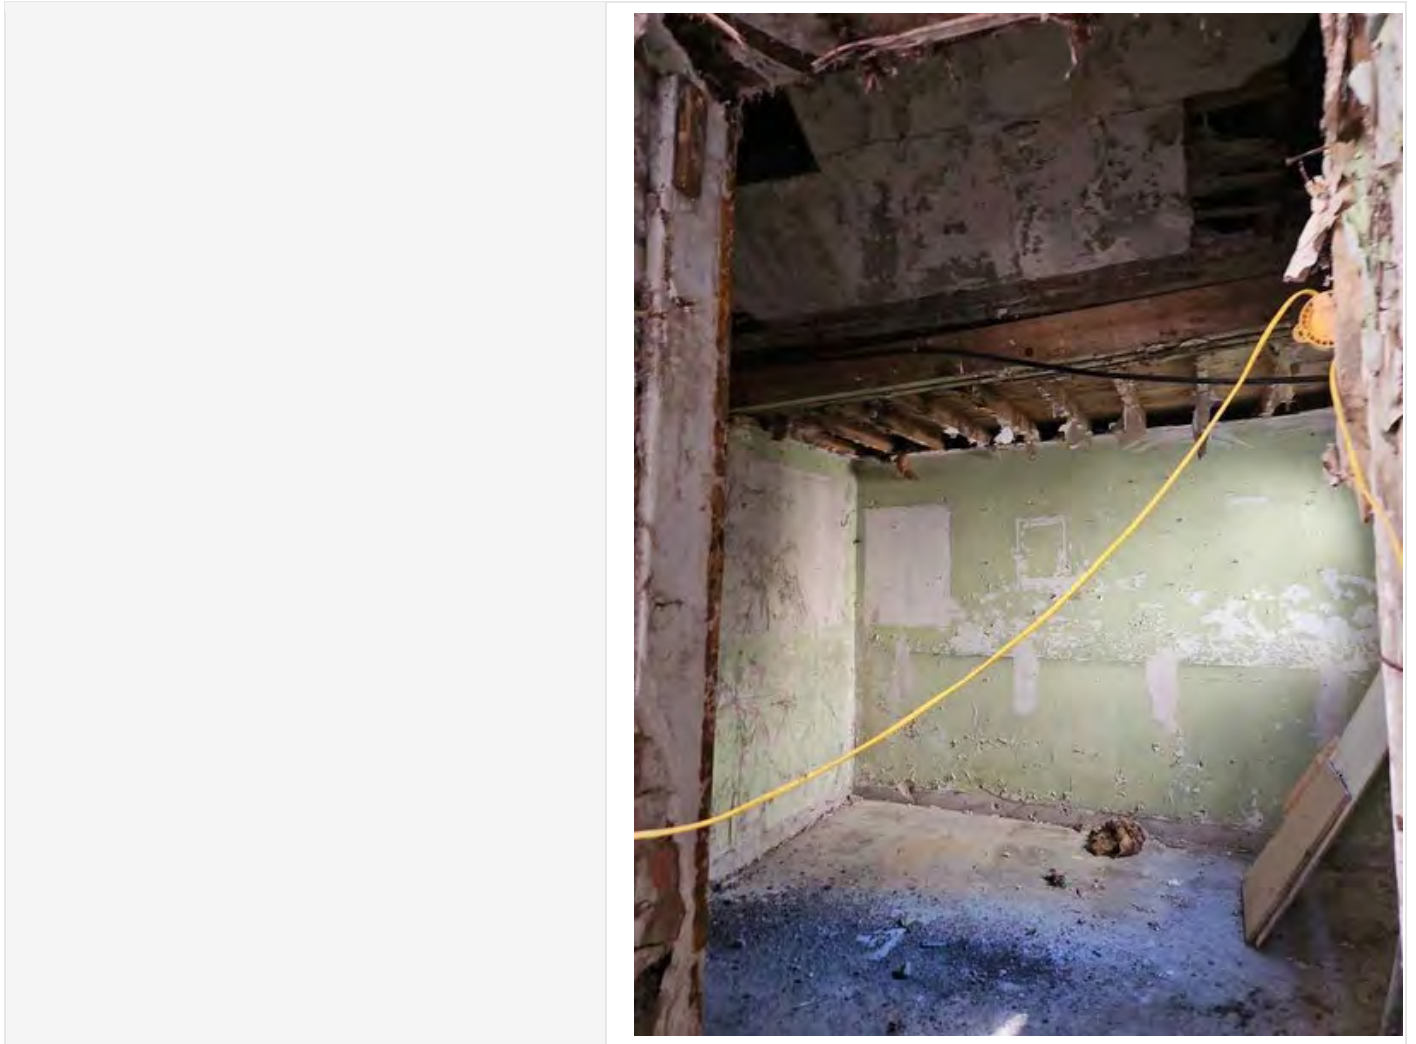
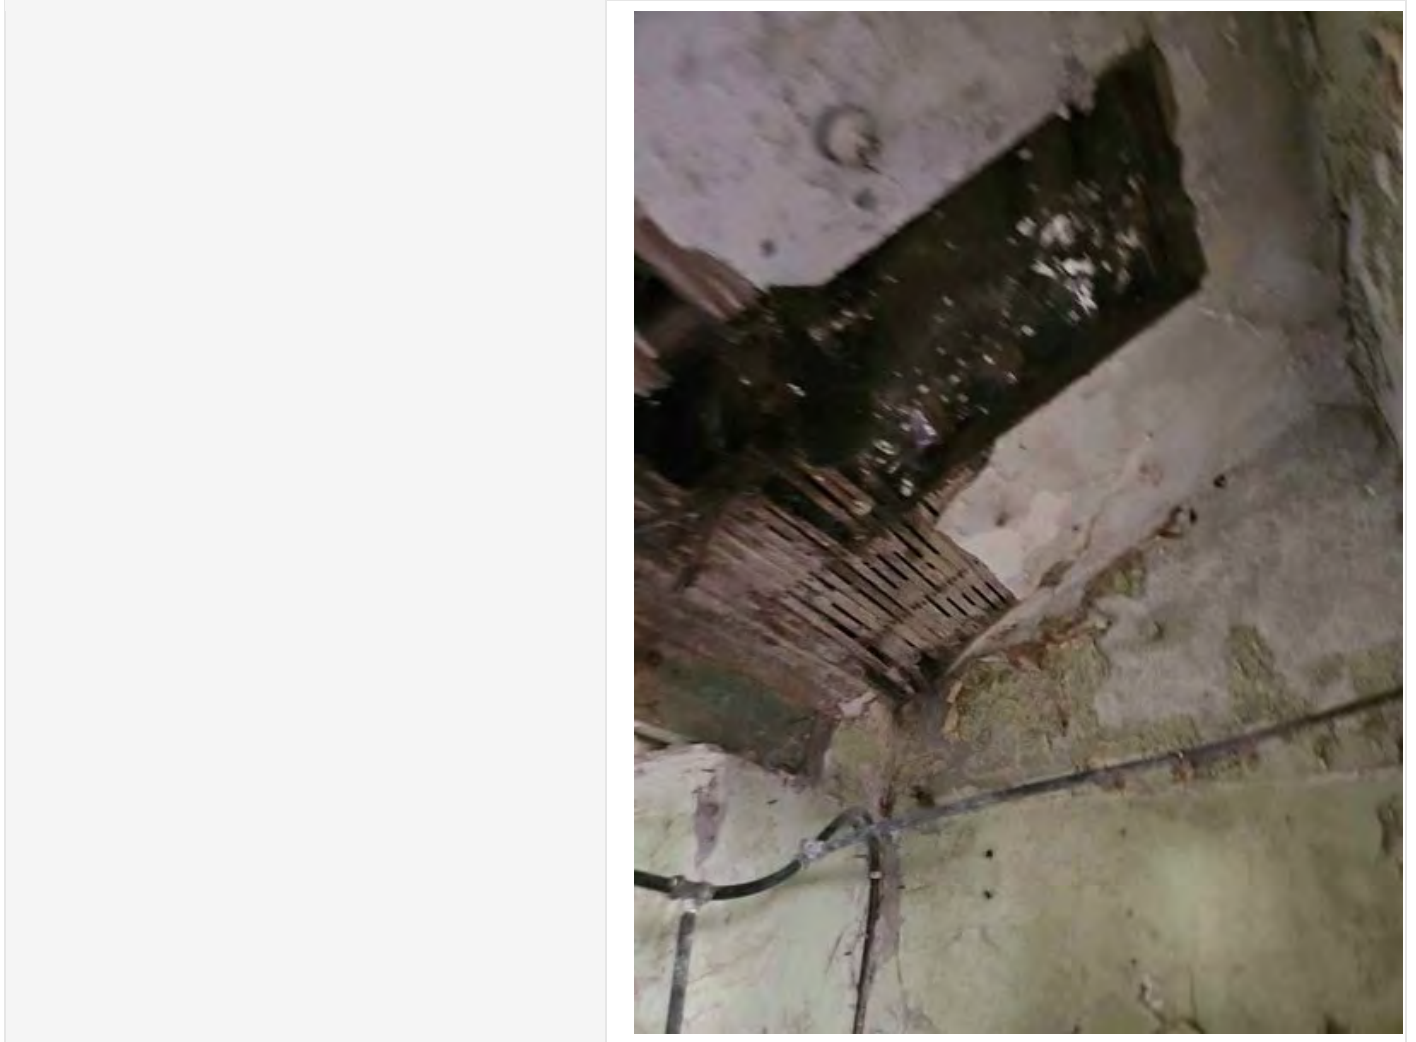
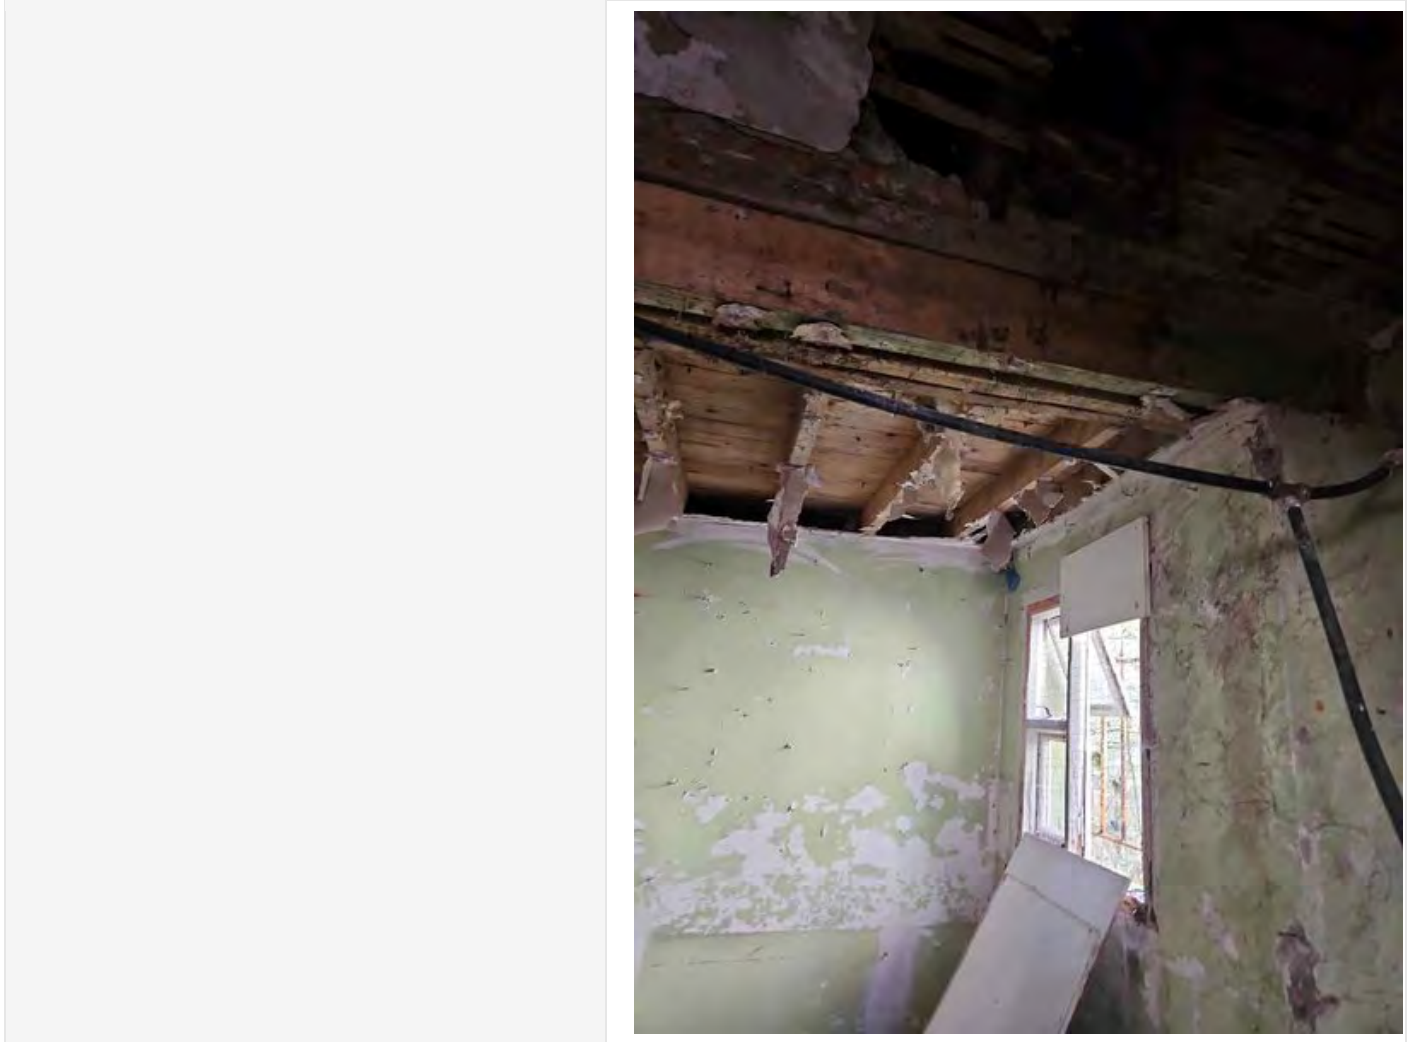
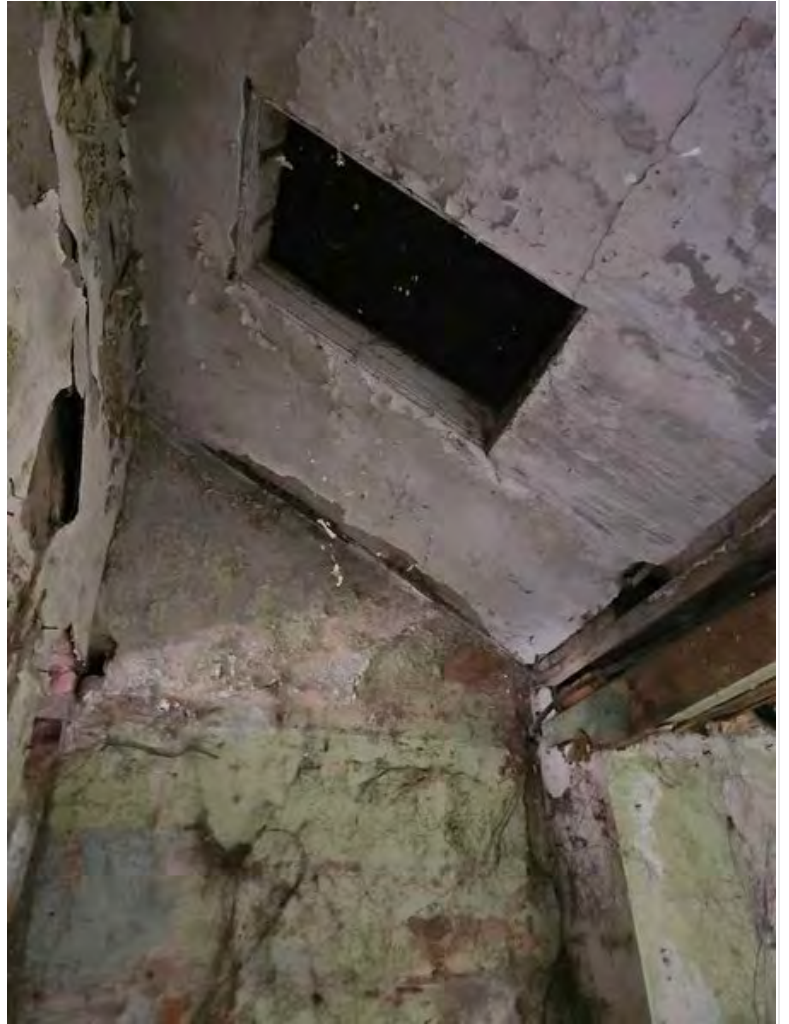
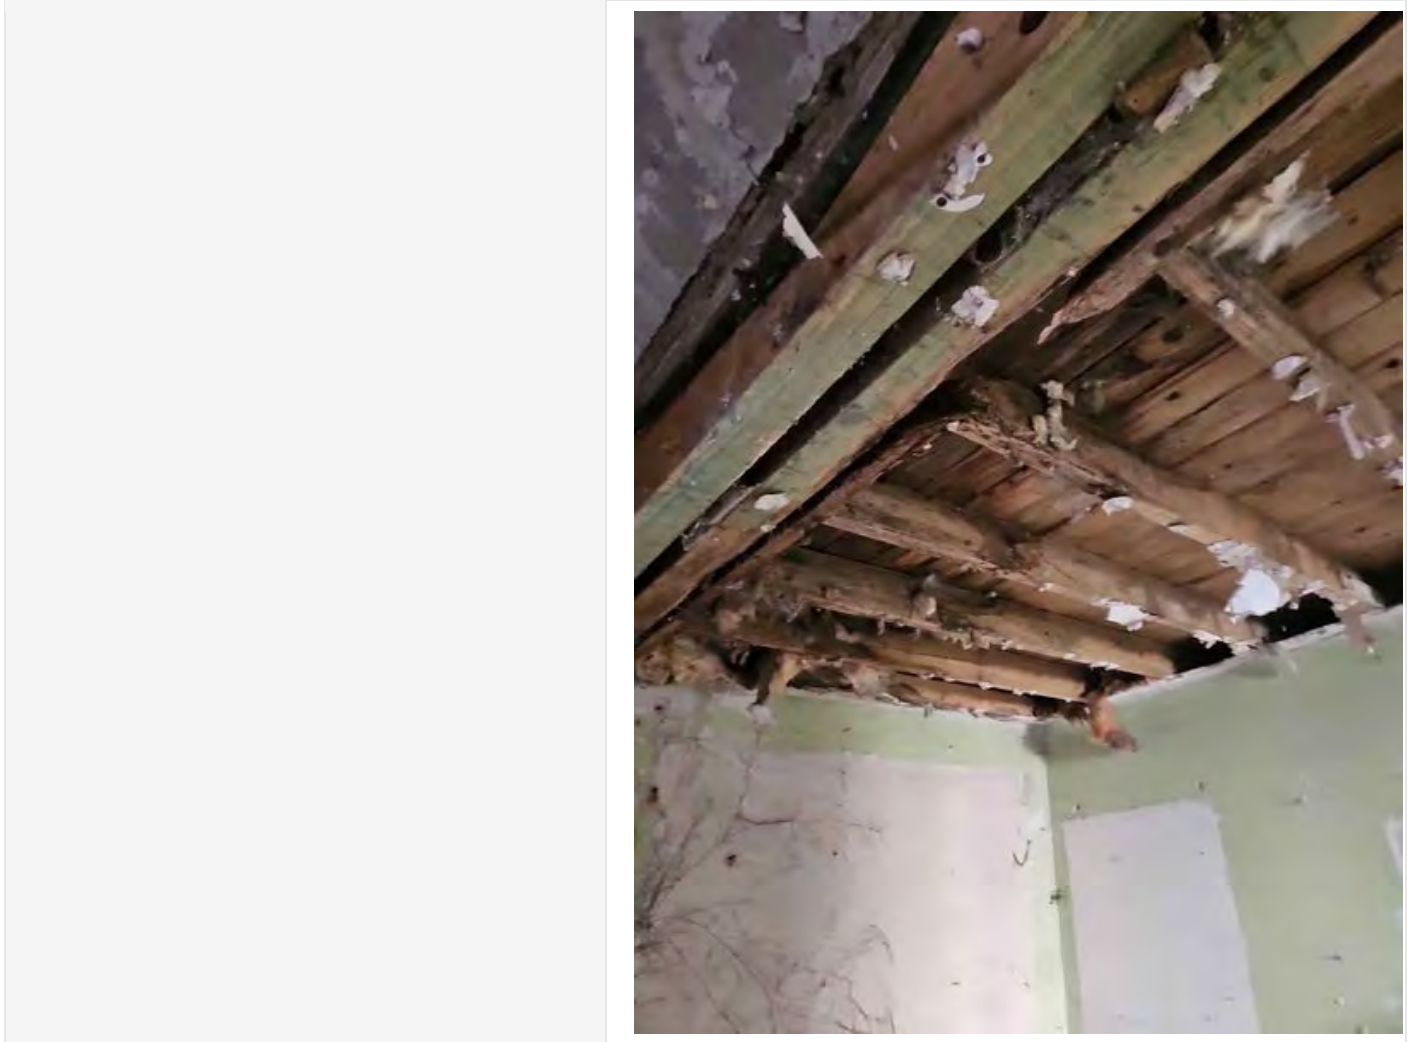
Photo Guidance:	Minimum photos per visit - Front, Back and Side of the Building, Identify Unit/House Number, Photo Unit(s)/House(s) in sequence.
TGD Part A	STRUCTURE 2012
Unit(s) Number(s) Inspected:	1 Unit
Description of Observation(s):	<p>Movement in the front and rear wall was identified in the past. Bracing of front and rear wall (5no) at first floor level identified by two tie bars passing through the building at first floor level.</p> <p>All timber elements of the structure (floors, stairs, window reveals and heads, all timber lintel) require replacement due to wet and dry rot.</p> <p>The single storey roof structure has failed and requires replacement.</p> <p>Repairs to the main structure roof was complete some time in the recent past (20 years) by the presence of the modern day roof membrane</p> <p>Main roof structure requires replacement due to wet and dry rott.</p> <p>Structural crack present in render of party wall at 2nd floor. Repairs of the brick wall behind same is required</p> <p>Sand and cement mortar in the joints of the red brick on front elevation is holding moisture within the facade, replacement of same with a lime mortar render is required.</p>
