REF: AHIA REPORT, OLD POST OFFICE LONGFORD

Architectural Heritage Impact Assessment (Conservation Report, Repair and Methodology)

Project Title: Renovation, Alterations at the Old Post Office, Longford to house a **new tourist office**.

Site Address: 43 Main Street, Longford, Co. Longford. Eircode: N39 FD45

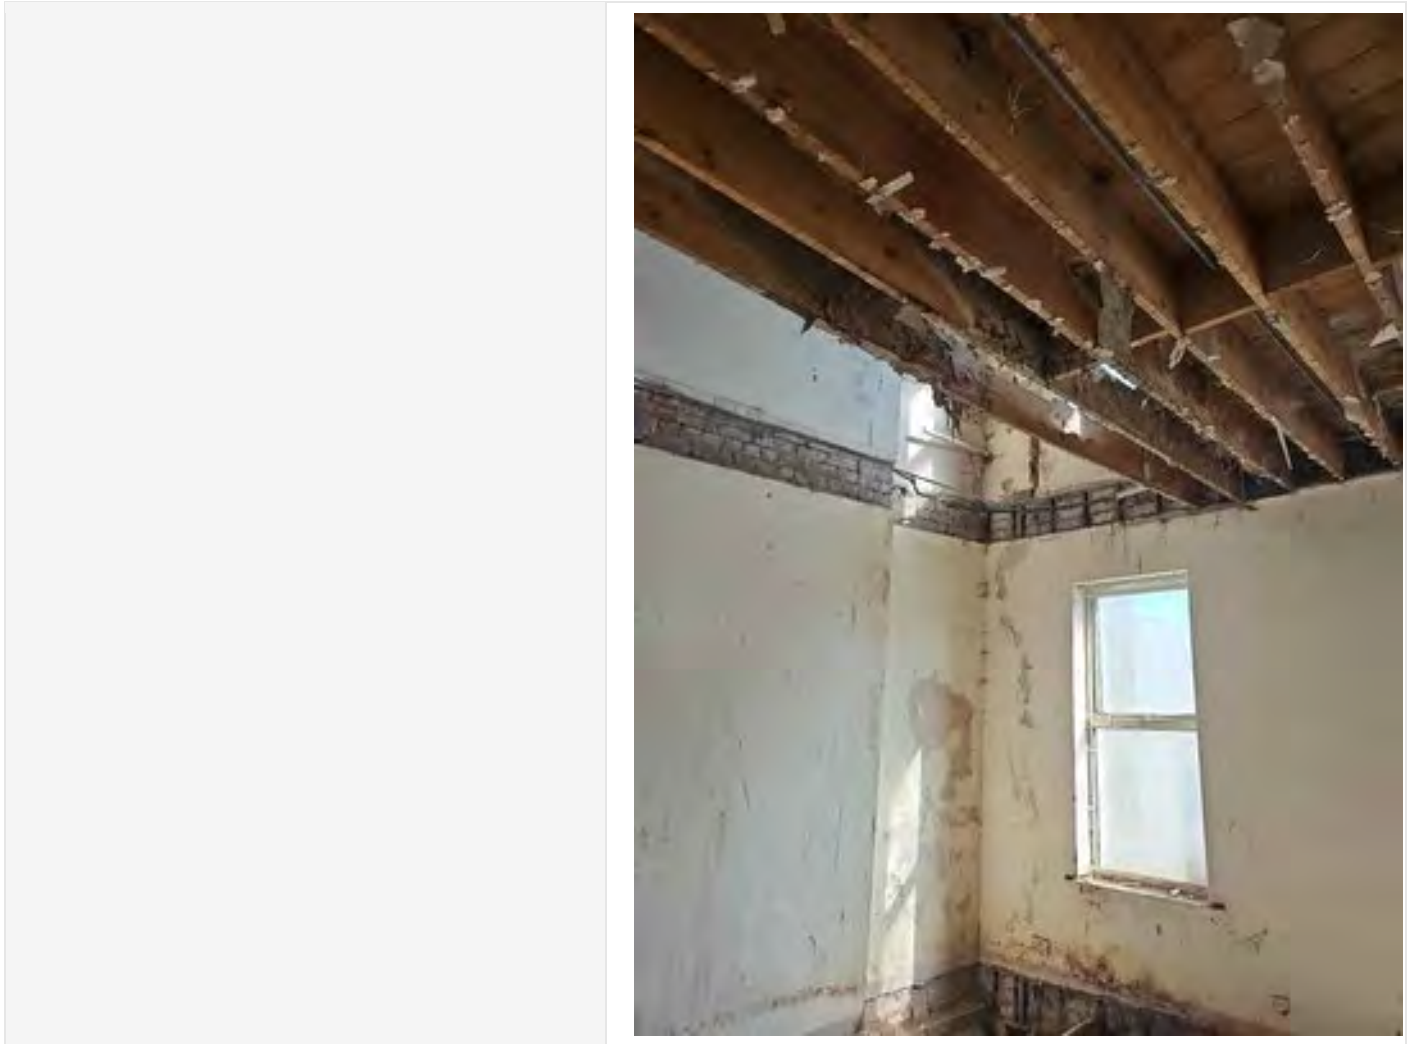
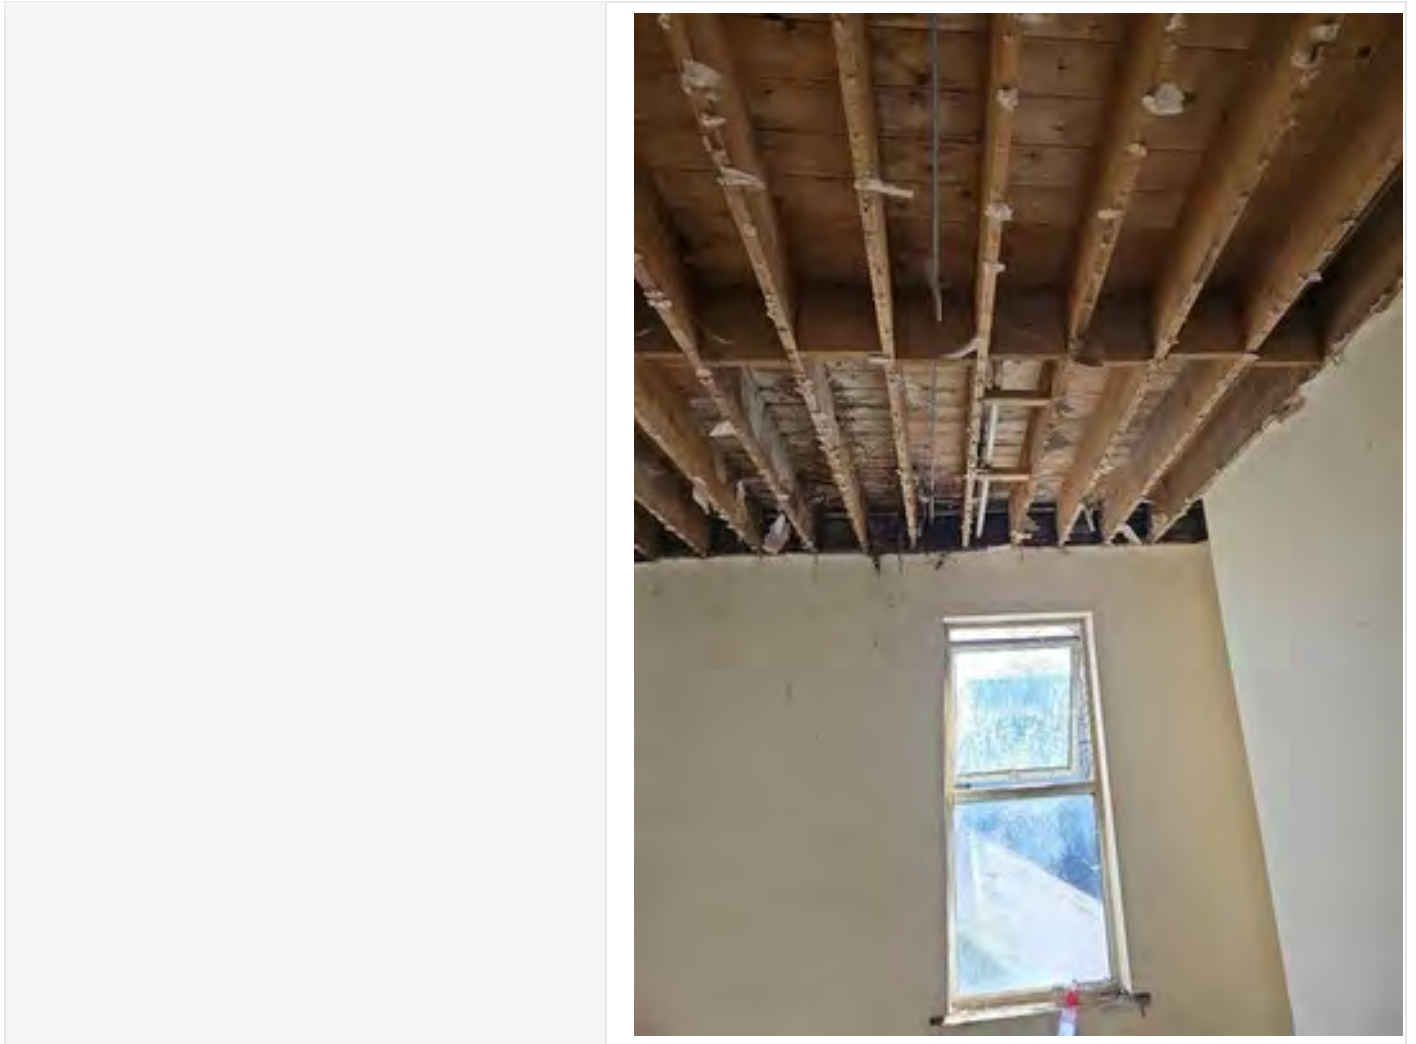
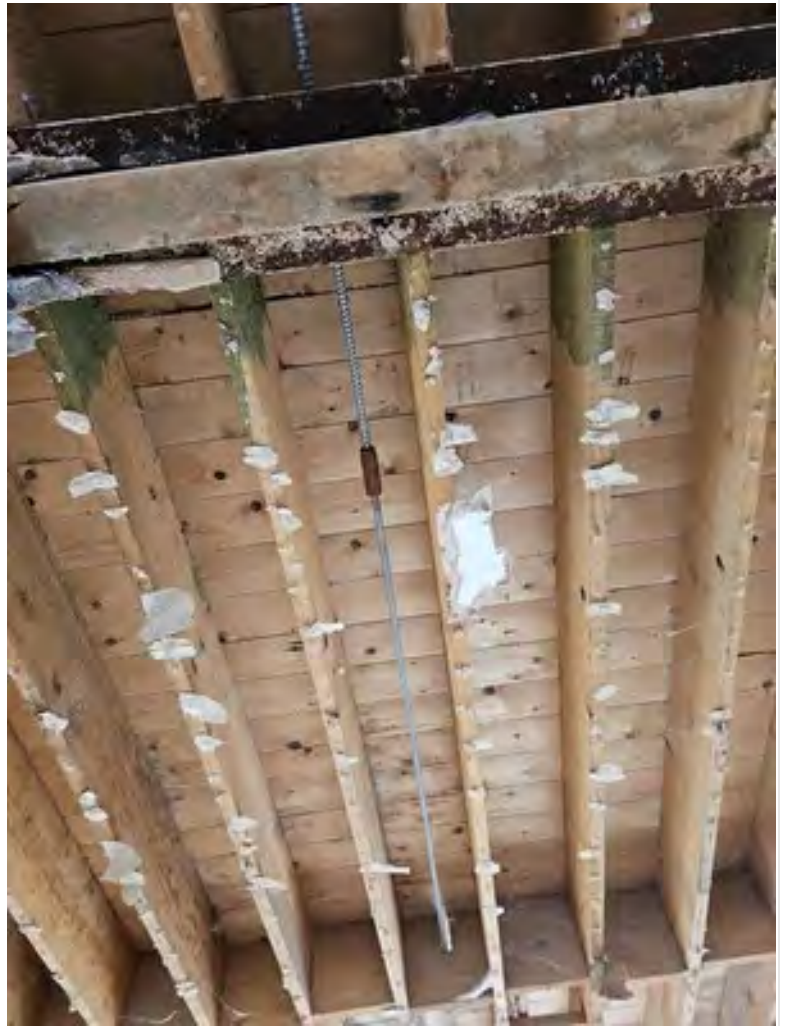
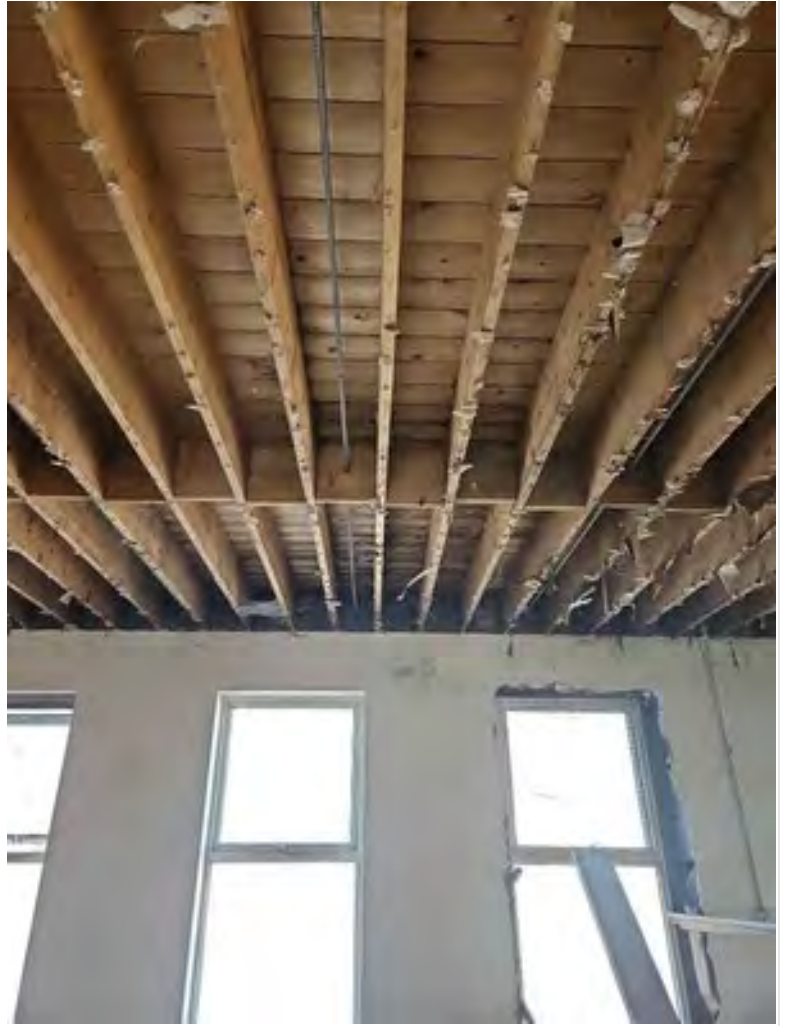
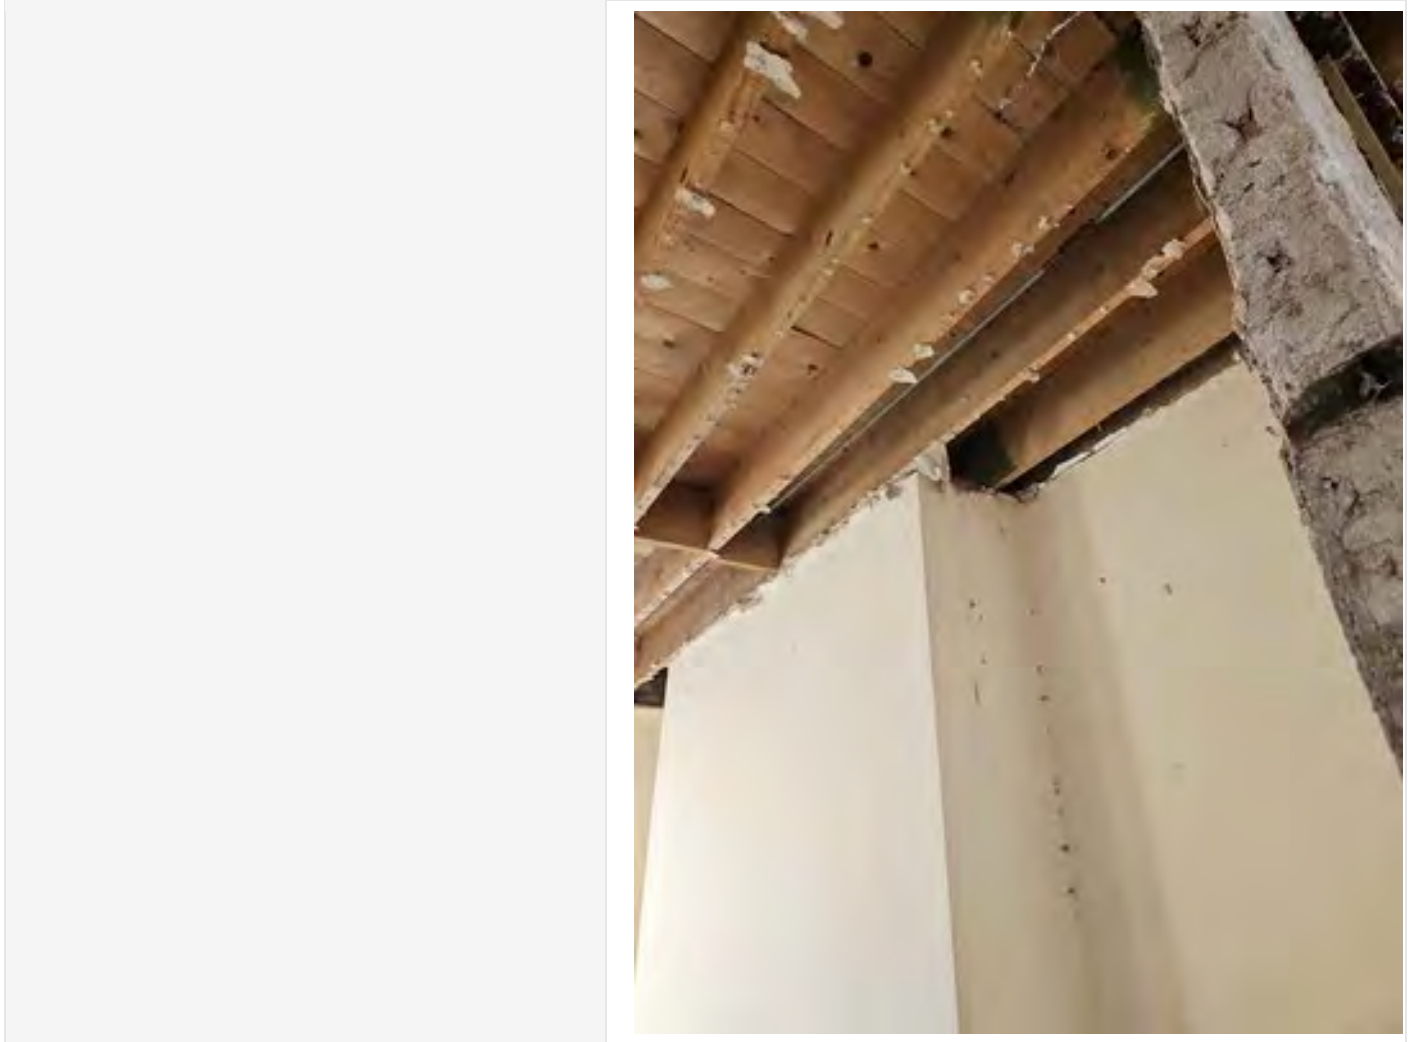
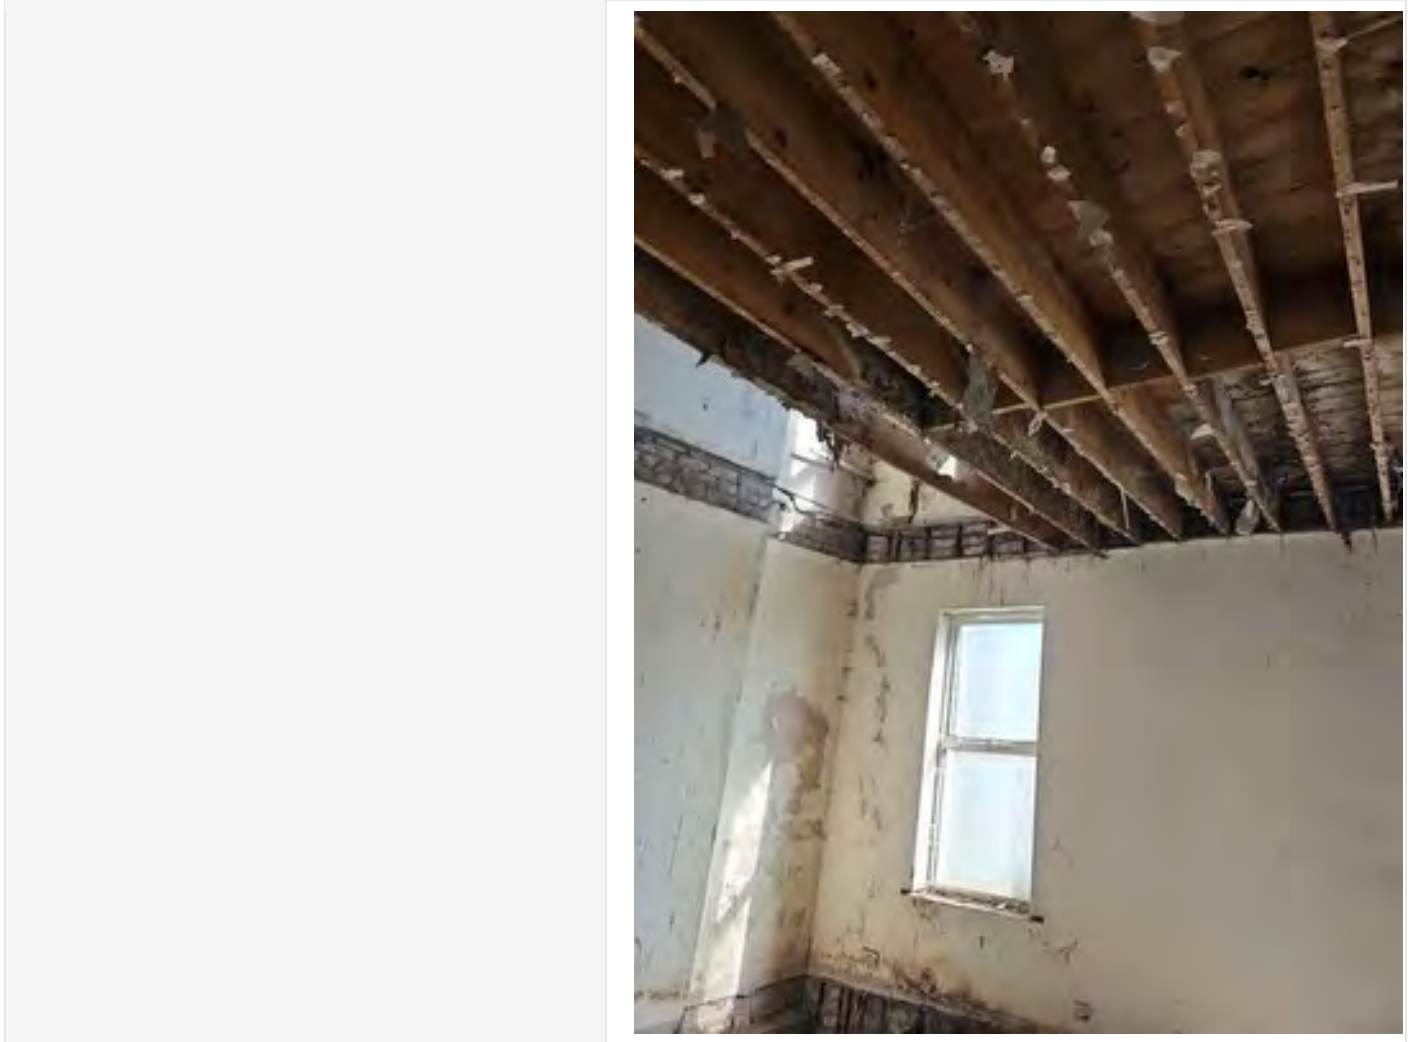
Photo Guidance:	Minimum photos per visit - Front, Back and Side of the Building, Identify Unit/House Number, Photo Unit(s)/House(s) in sequence.
TGD Part A	STRUCTURE 2012
Unit(s) Number(s) Inspected:	1 Unit
Description of Observation(s):	<p>Movement in the front and rear wall was identified in the past. Bracing of front and rear wall (5no) at first floor level identified by two tie bars passing through the building at first floor level.</p> <p>All timber elements of the structure (floors, stairs, window reveals and heads, all timber lintel) require replacement due to wet and dry rot.</p> <p>The single storey roof structure has failed and requires replacement.</p> <p>Repairs to the main structure roof was complete some time in the recent past (20 years) by the presence of the modern day roof membrane</p> <p>Main roof structure requires replacement due to wet and dry rott.</p> <p>Structural crack present in render of party wall at 2nd floor. Repairs of the brick wall behind same is required</p> <p>Sand and cement mortar in the joints of the red brick on front elevation is holding moisture within the facade, replacement of same with a lime mortar render is required.</p>

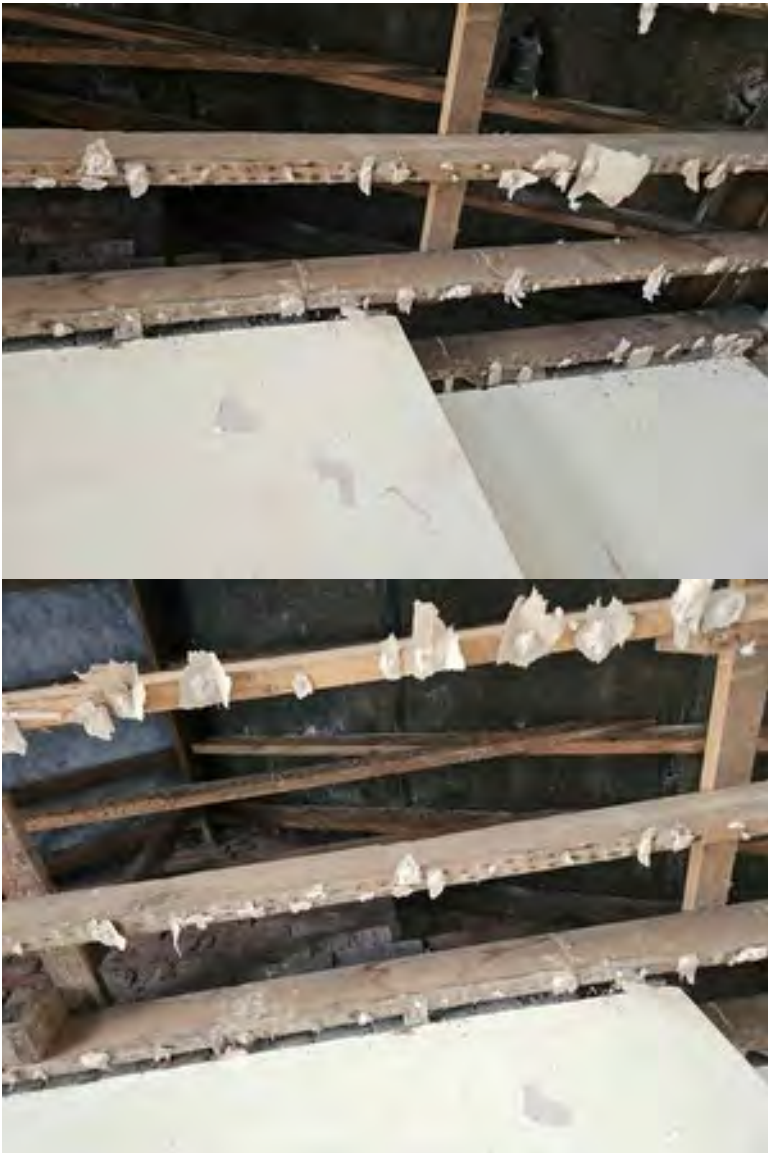
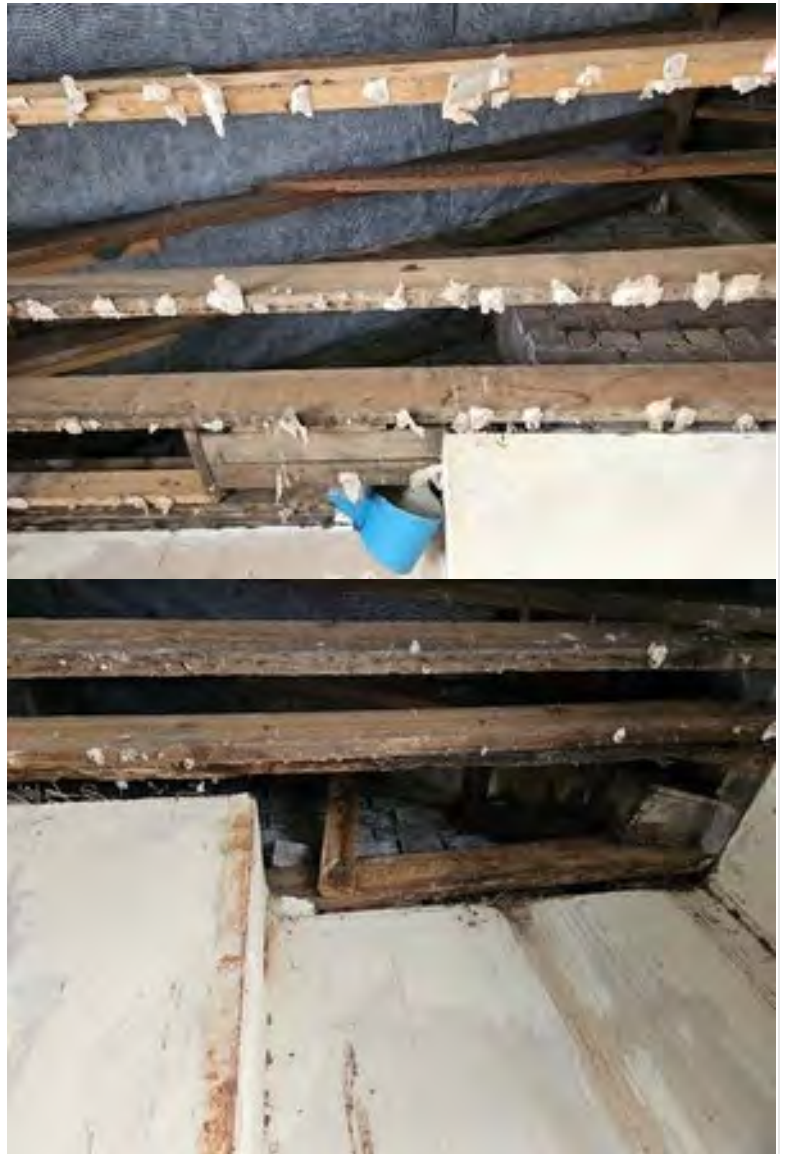
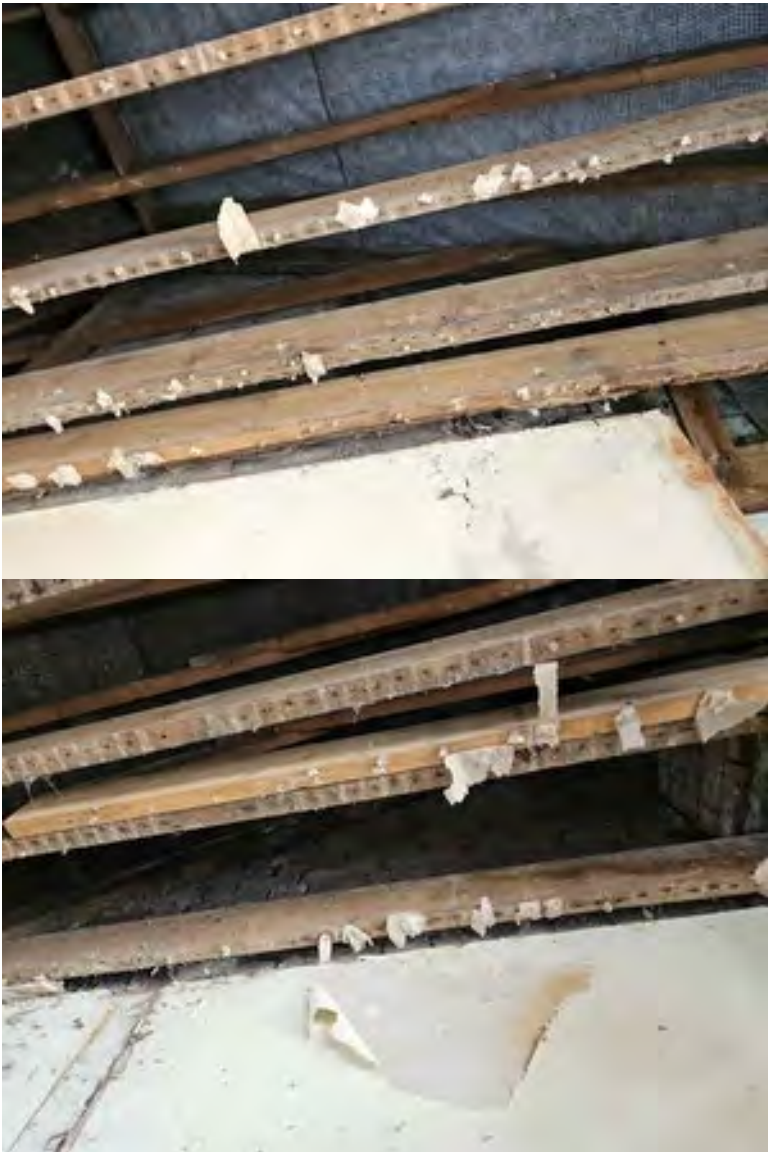
TGD Part B	FIRE SAFETY 2017 VOLUME 2 DWELLING HOUSES
Unit(s) Number(s) Inspected:	1 Unit
Description of Observation(s):	Due to the age profile of the property No fire proofing present on party walls. Fire proofing to party walls is required
Photo(s)

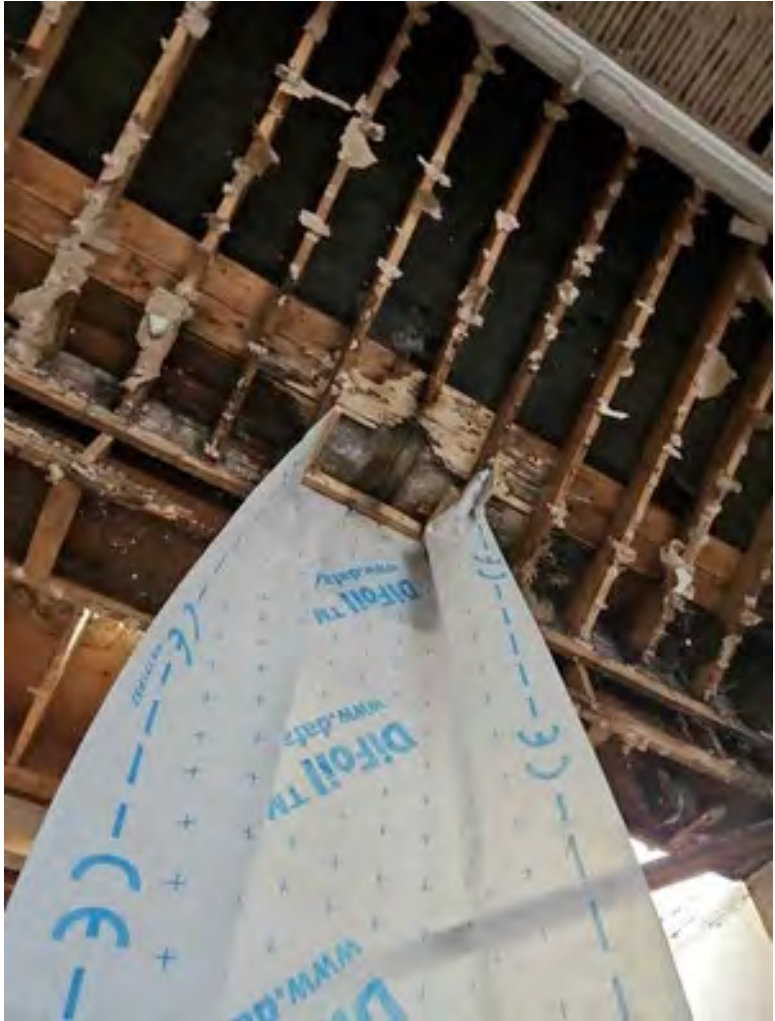
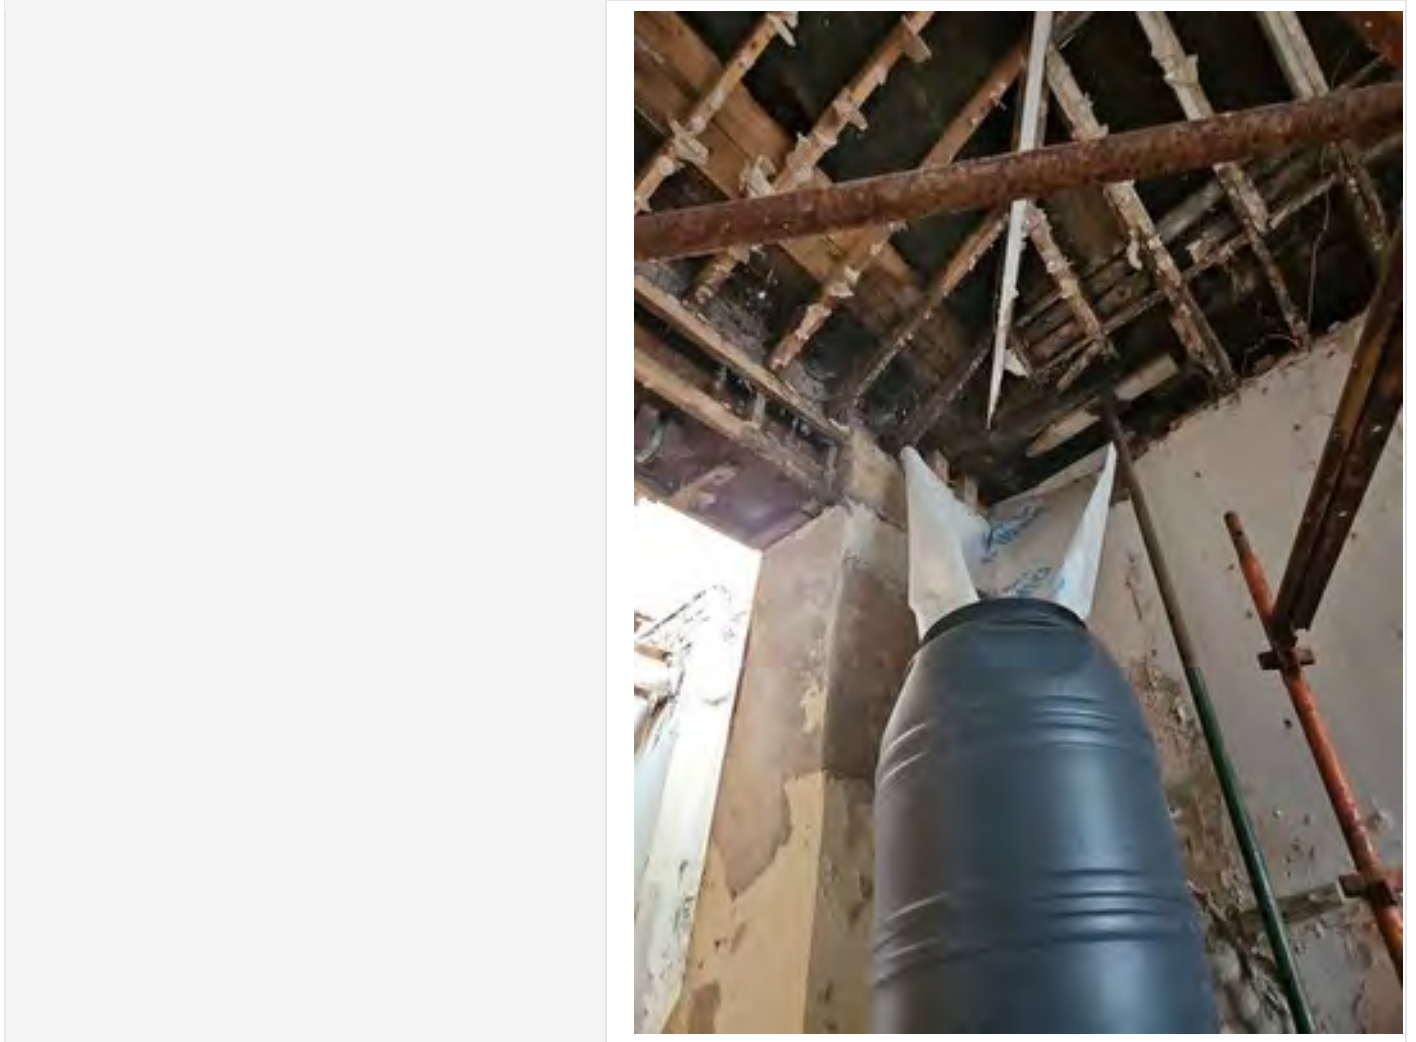
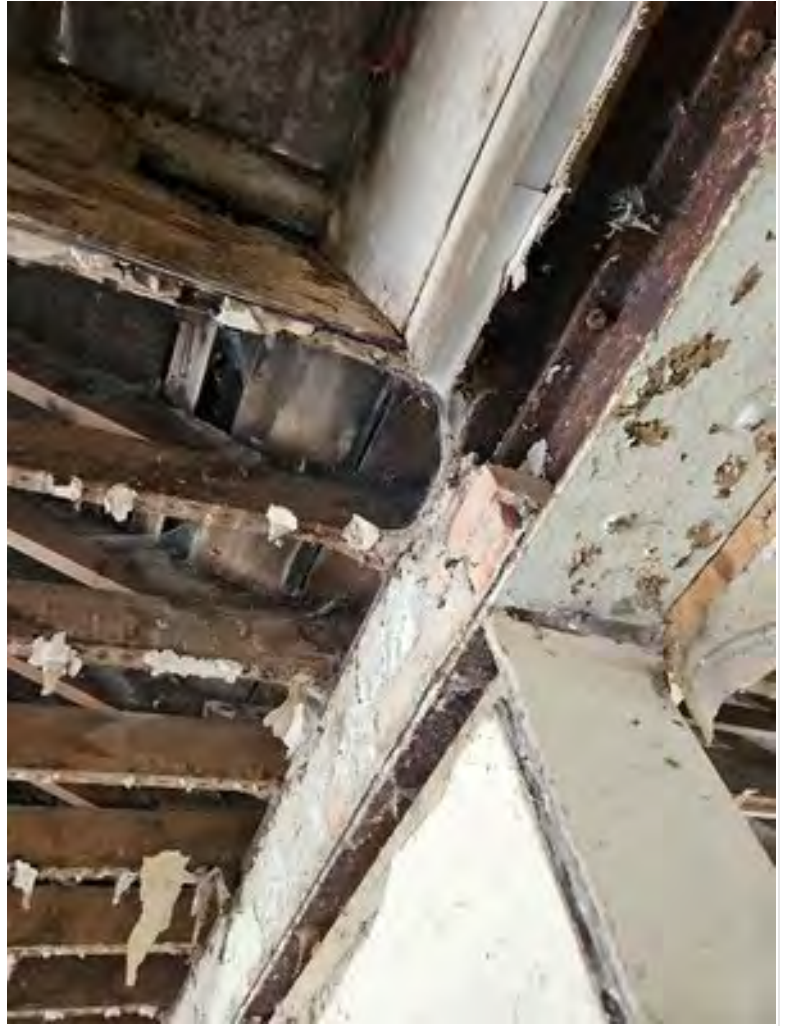
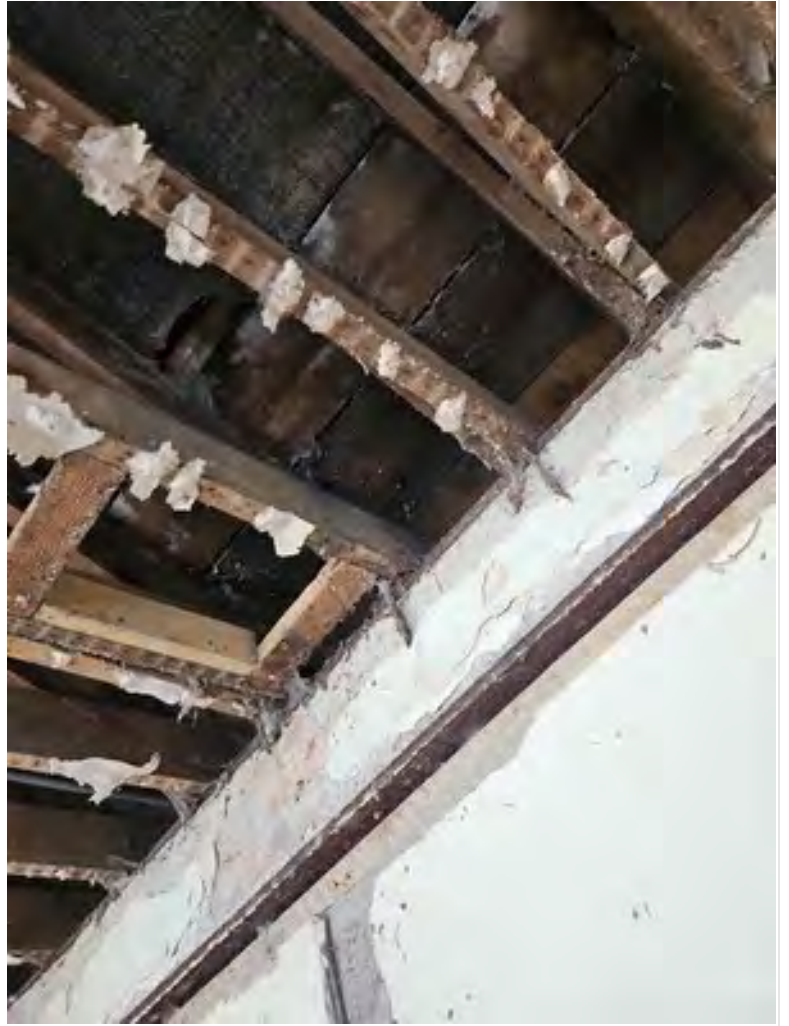
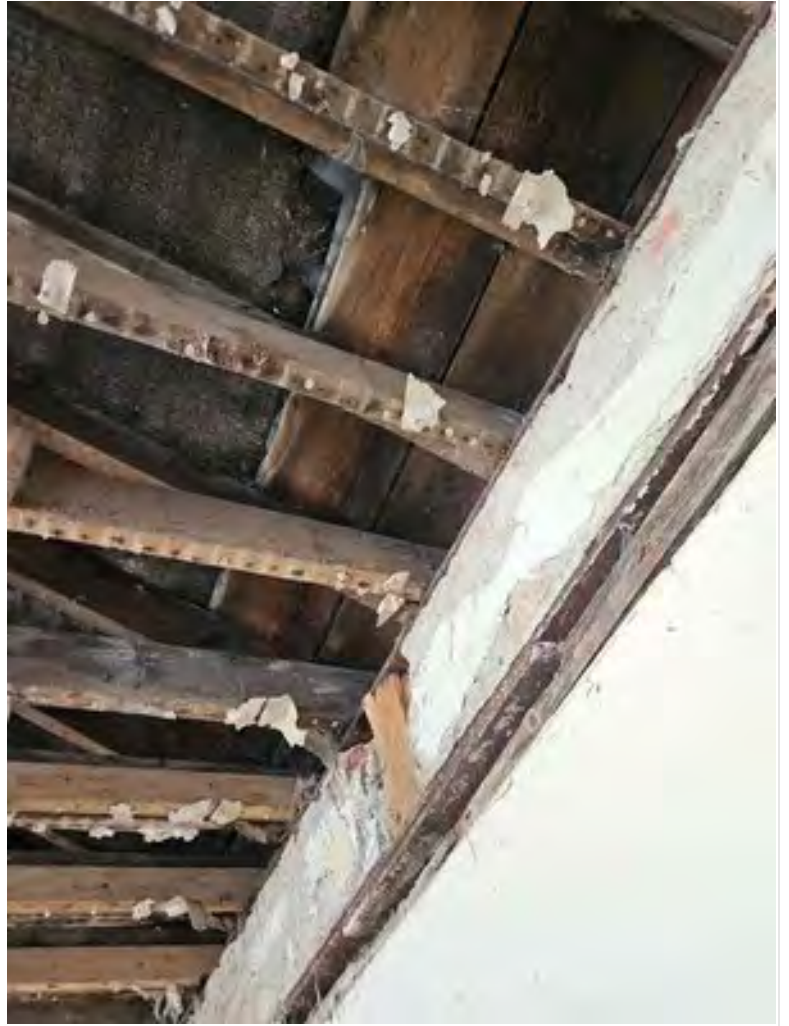
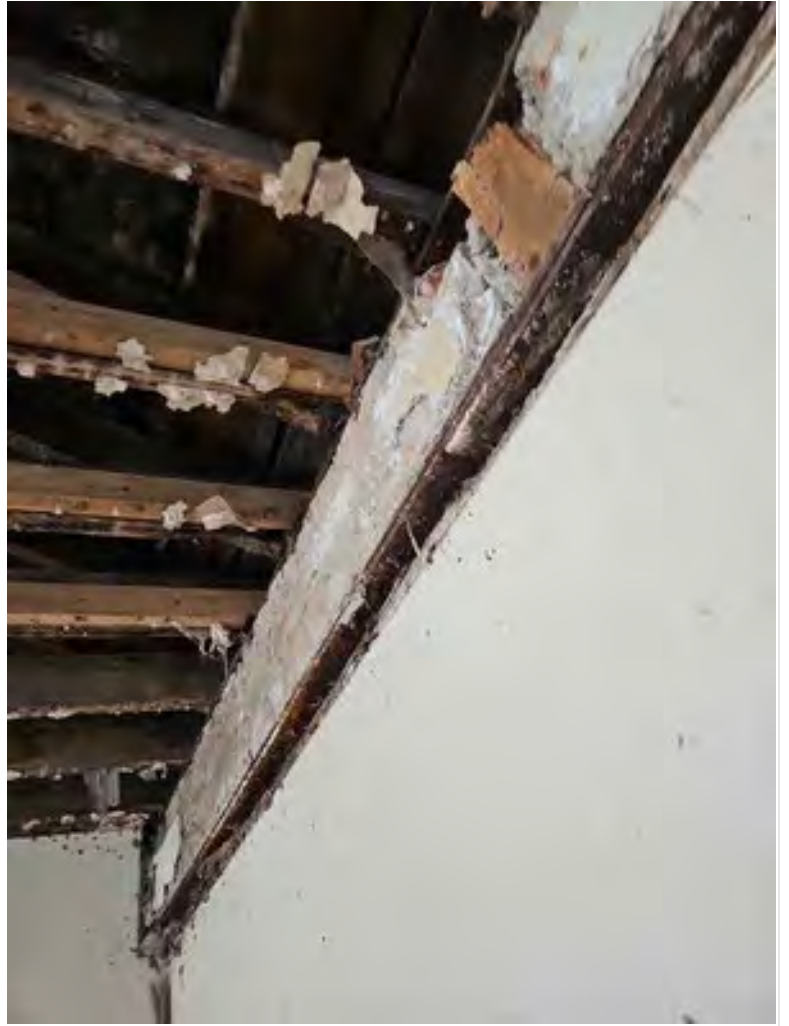
TGD Part C	SITE PREPERATION AND RESISTANCE TO MOISTURE
Unit(s) Number(s) Inspected:	1 Unit
Description of Observation(s):	<p>Property of this age profile will not contain any DPCs or resistance to moisture in walls, floors or around opes.</p> <p>Original Roof membrane has failed at valleys between the different roofs.</p> <p>Replacement of all roof membranes will be required.</p> <p>Holes in roofs visible</p>
Photo(s)
