REF: AHIA REPORT, OLD POST OFFICE LONGFORD

Architectural Heritage Impact Assessment (Conservation Report, Repair and Methodology)

Project Title: Renovation, Alterations at the Old Post Office, Longford to house a **new tourist office**.

Site Address: 43 Main Street, Longford, Co. Longford. Eircode: N39 FD45

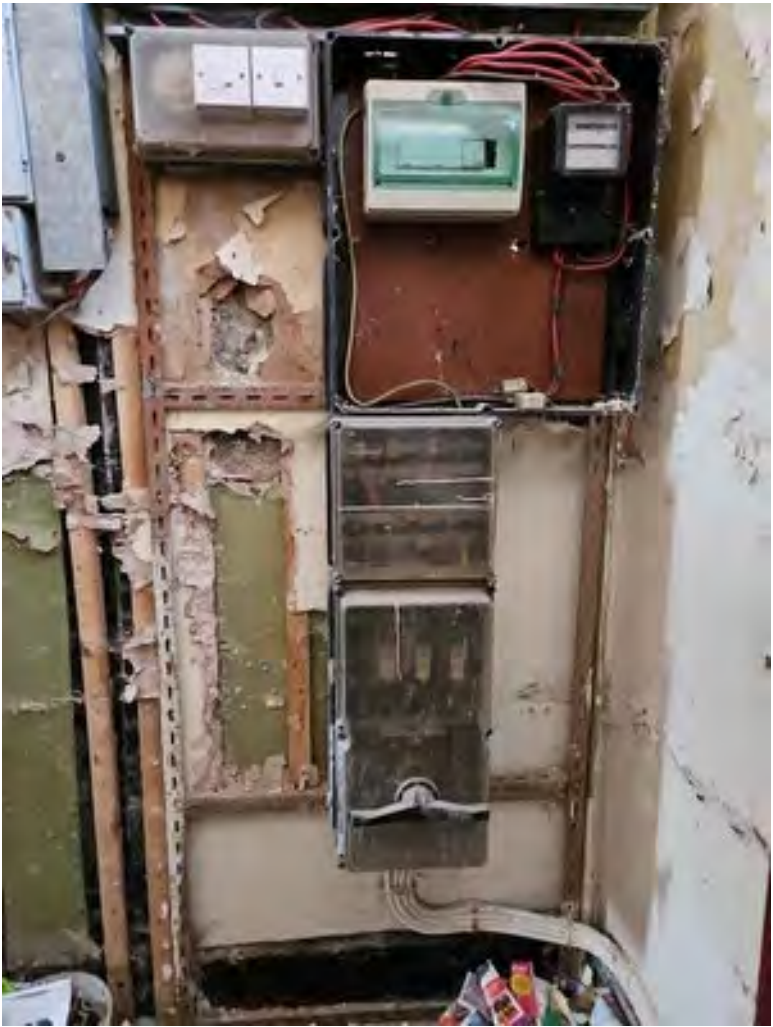
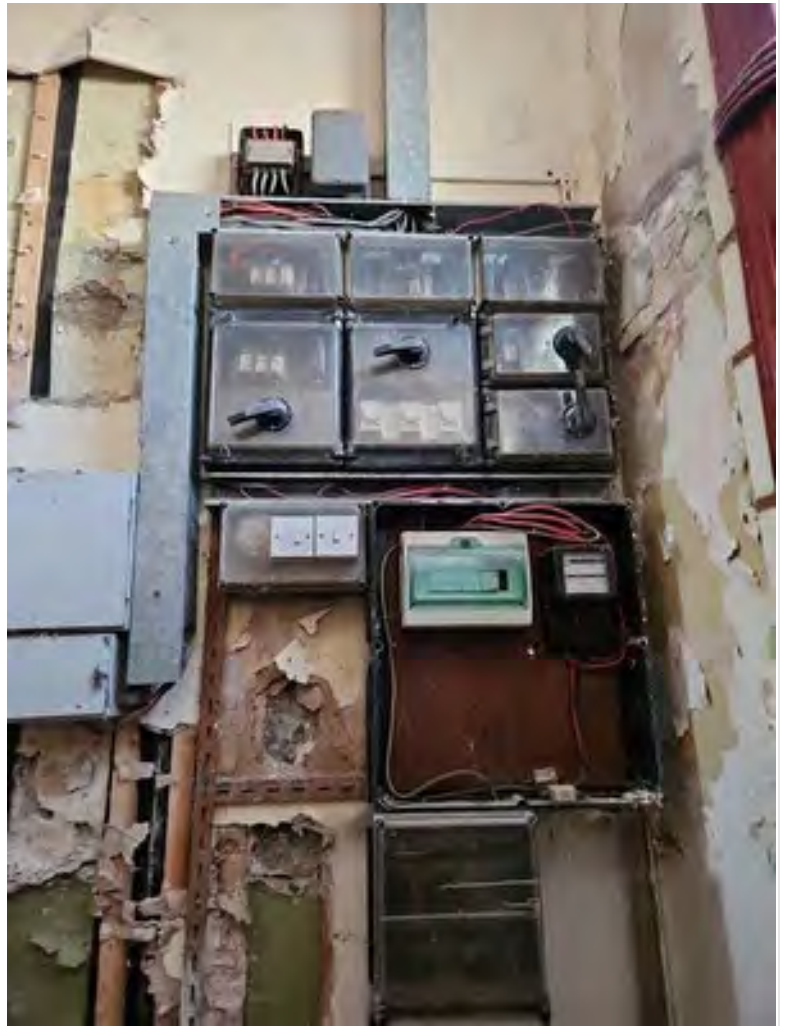
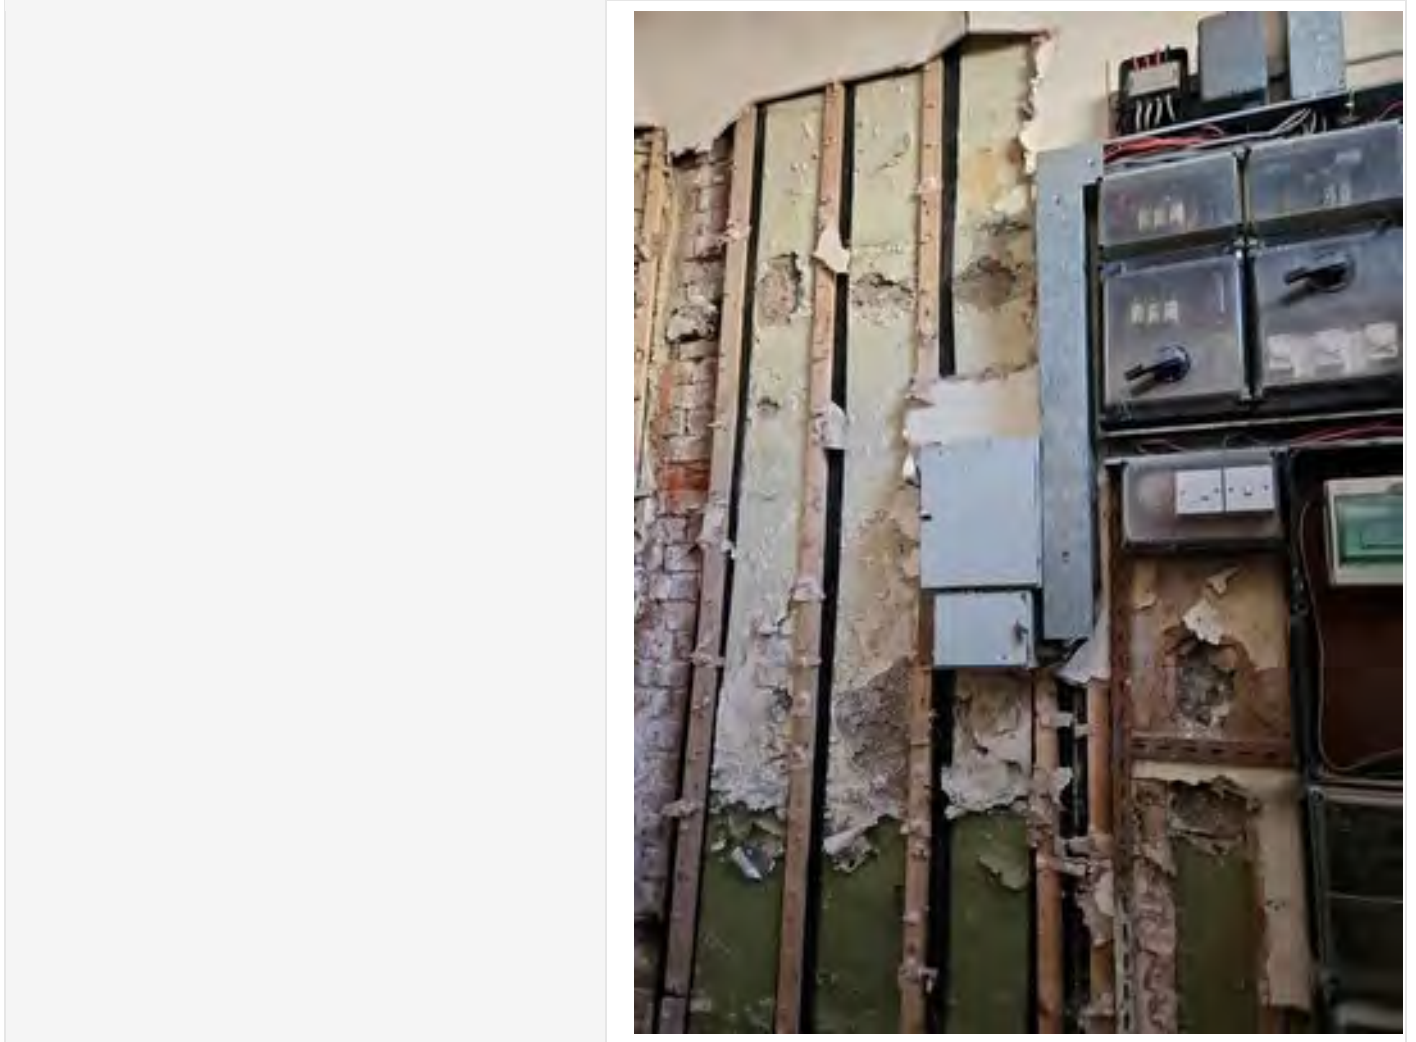
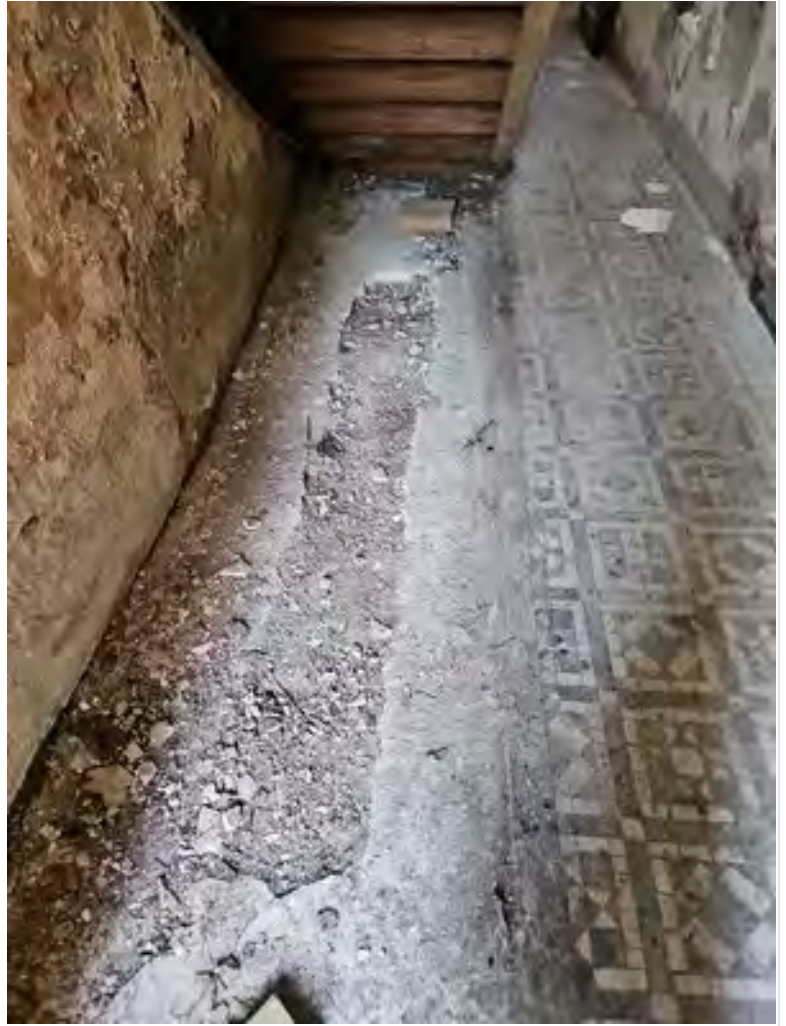
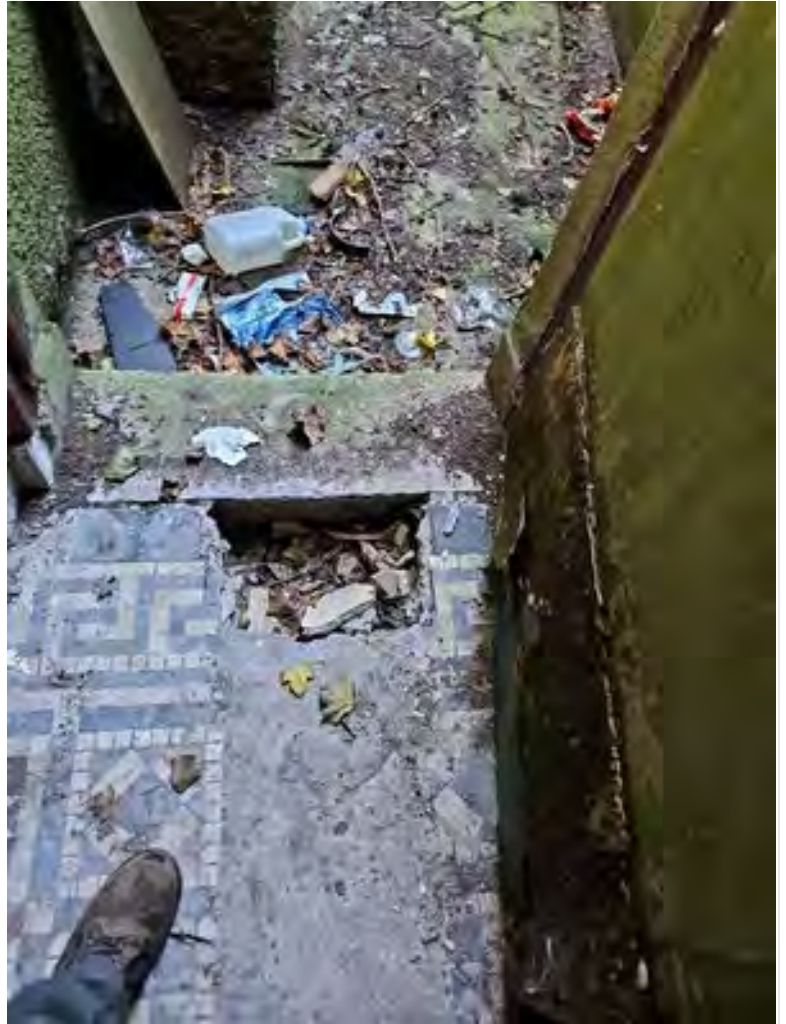
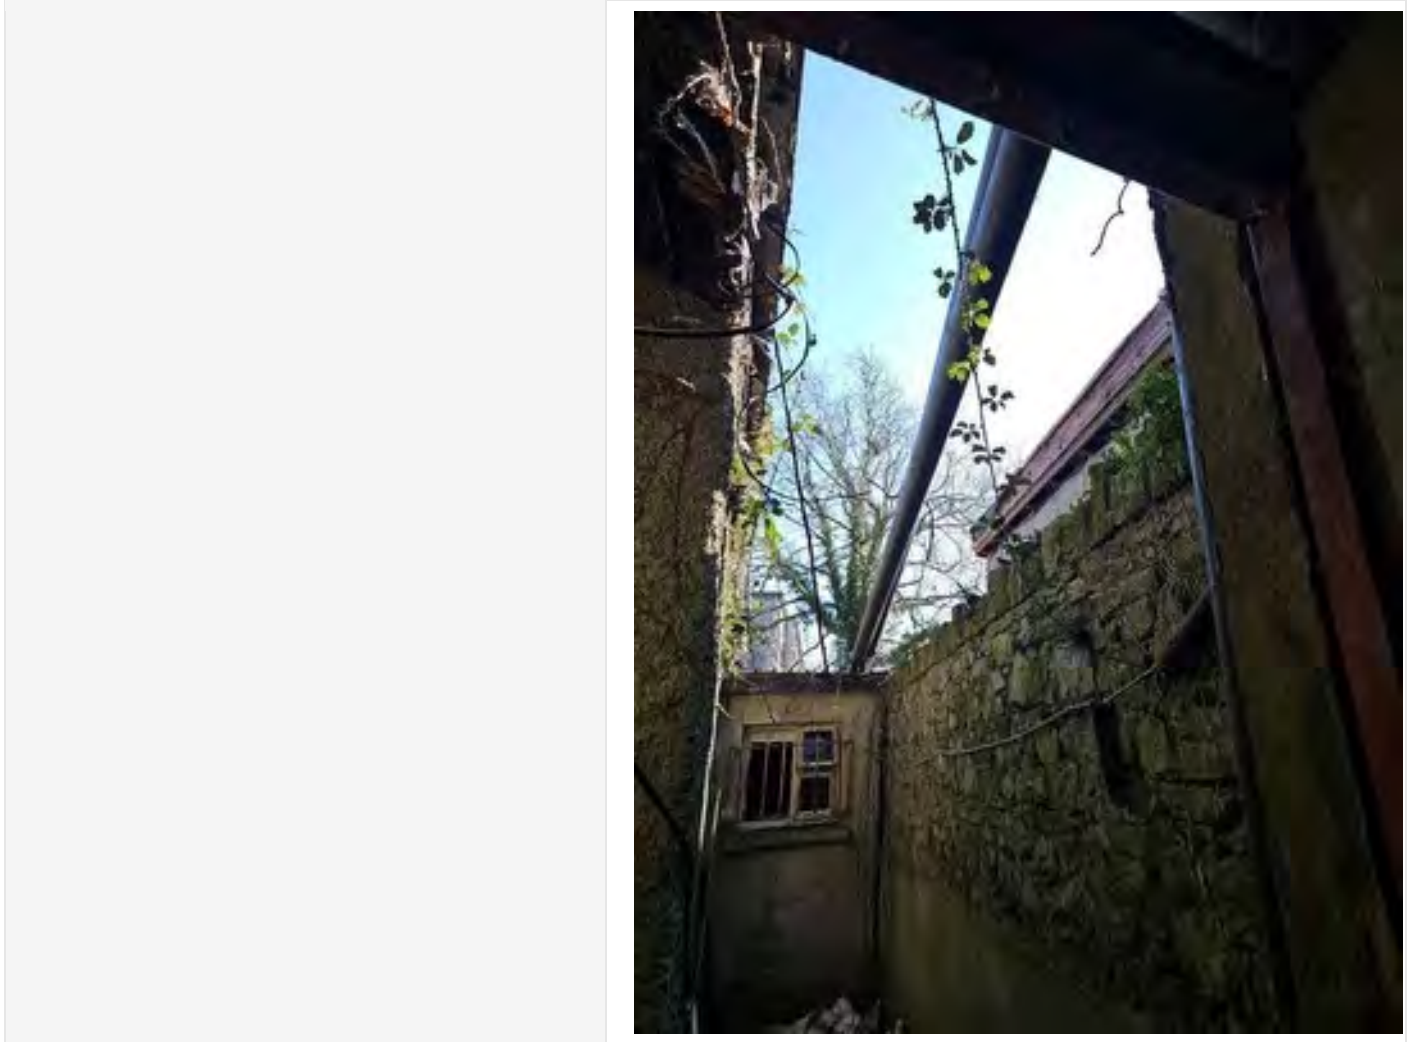
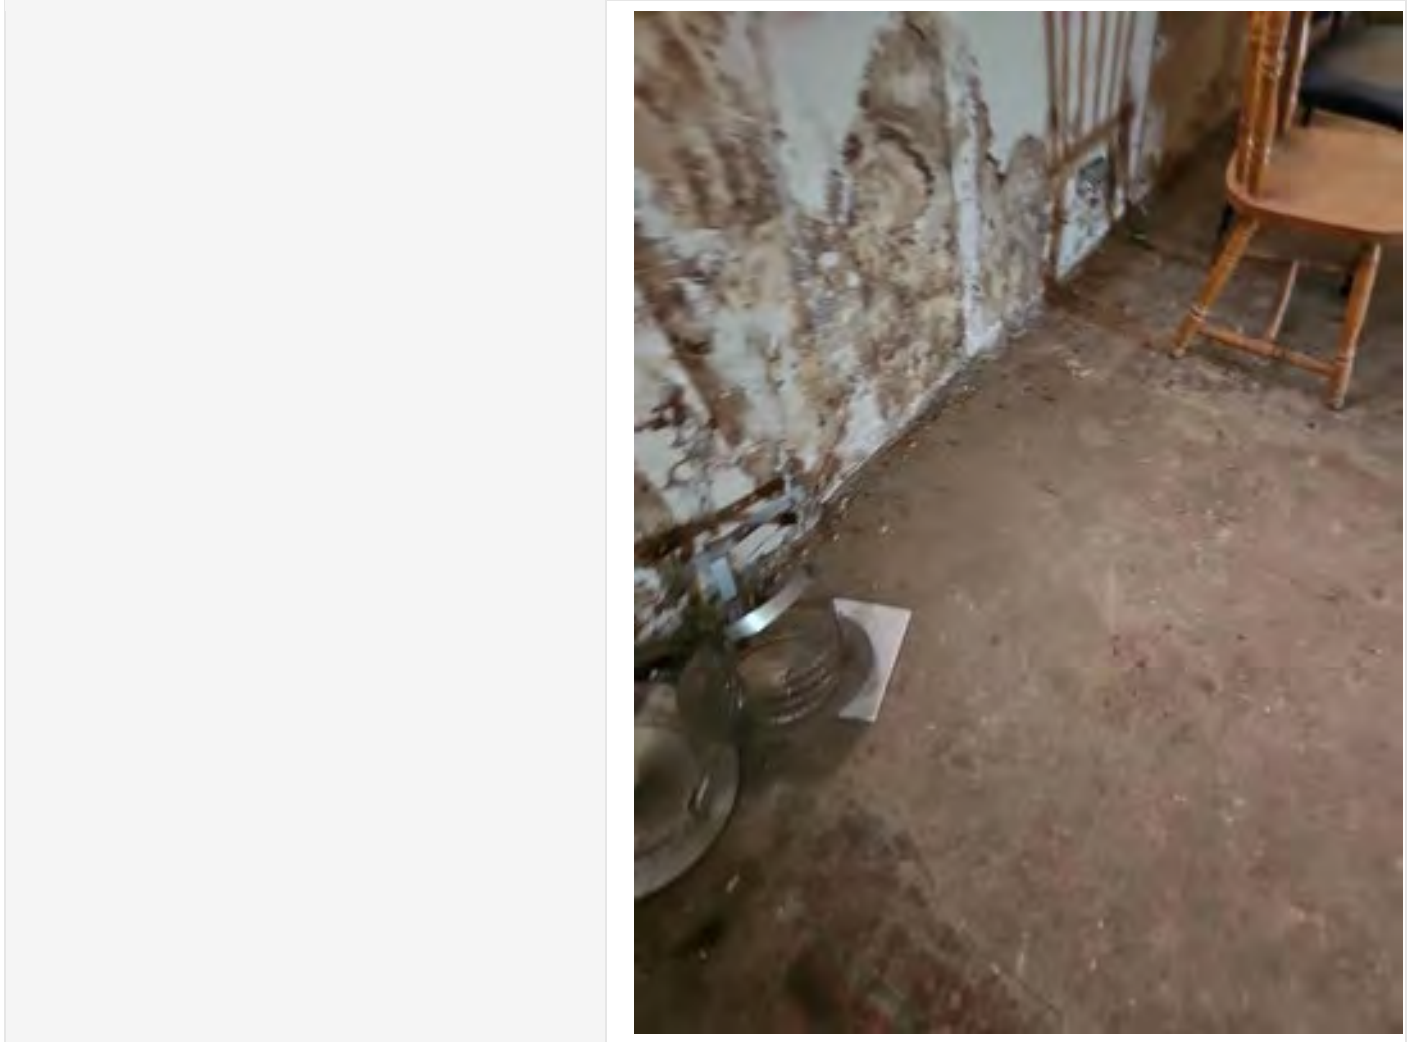
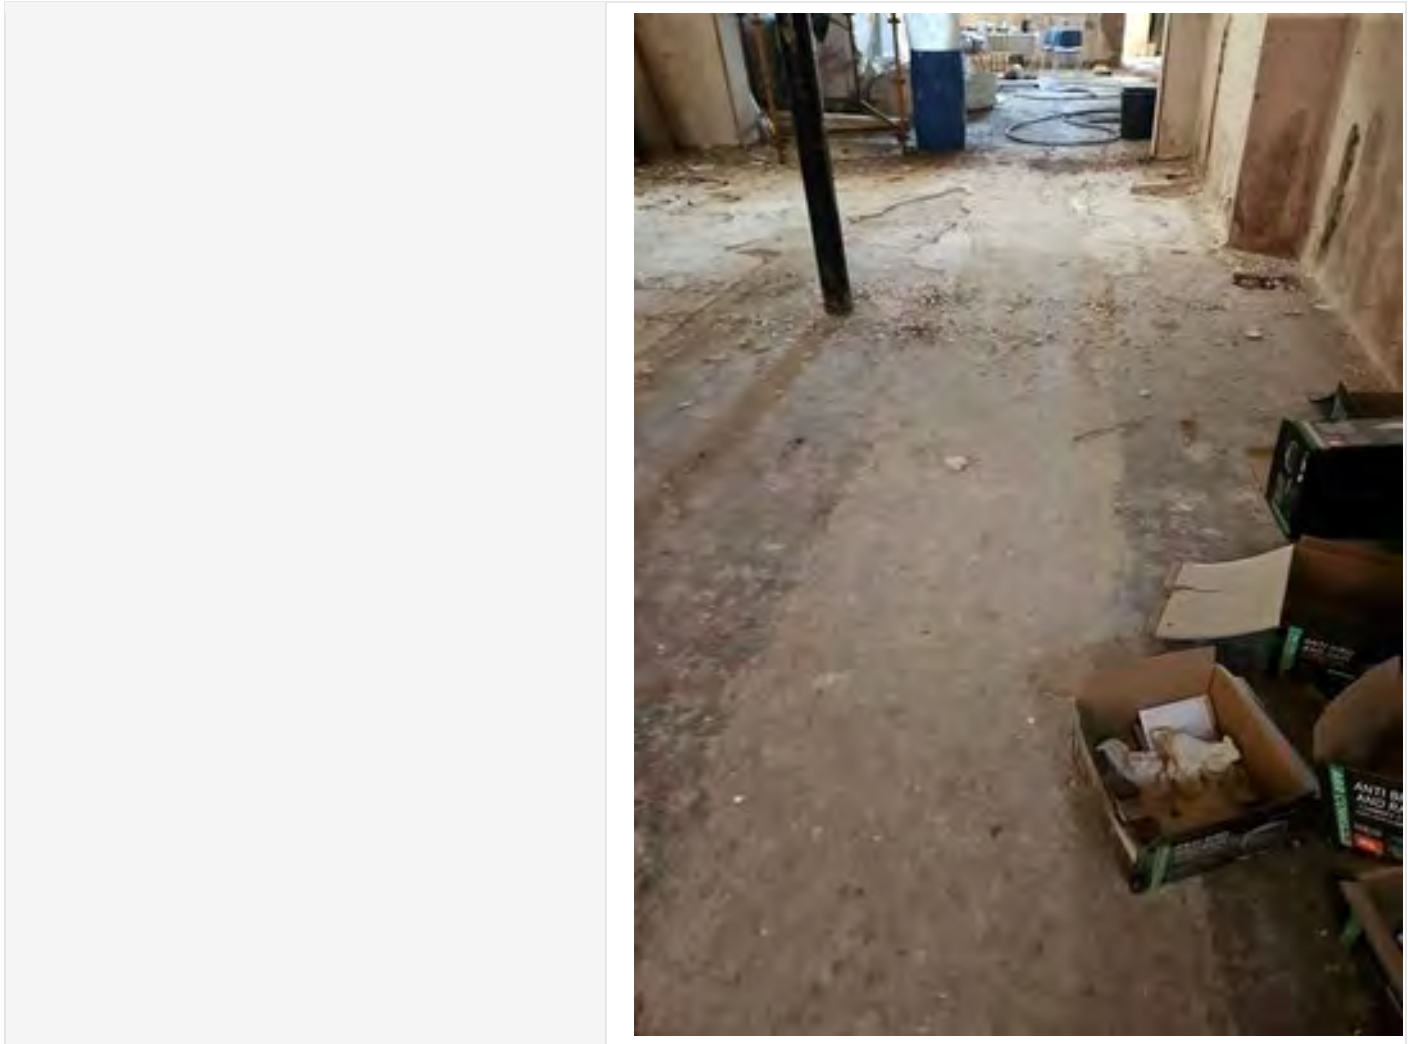
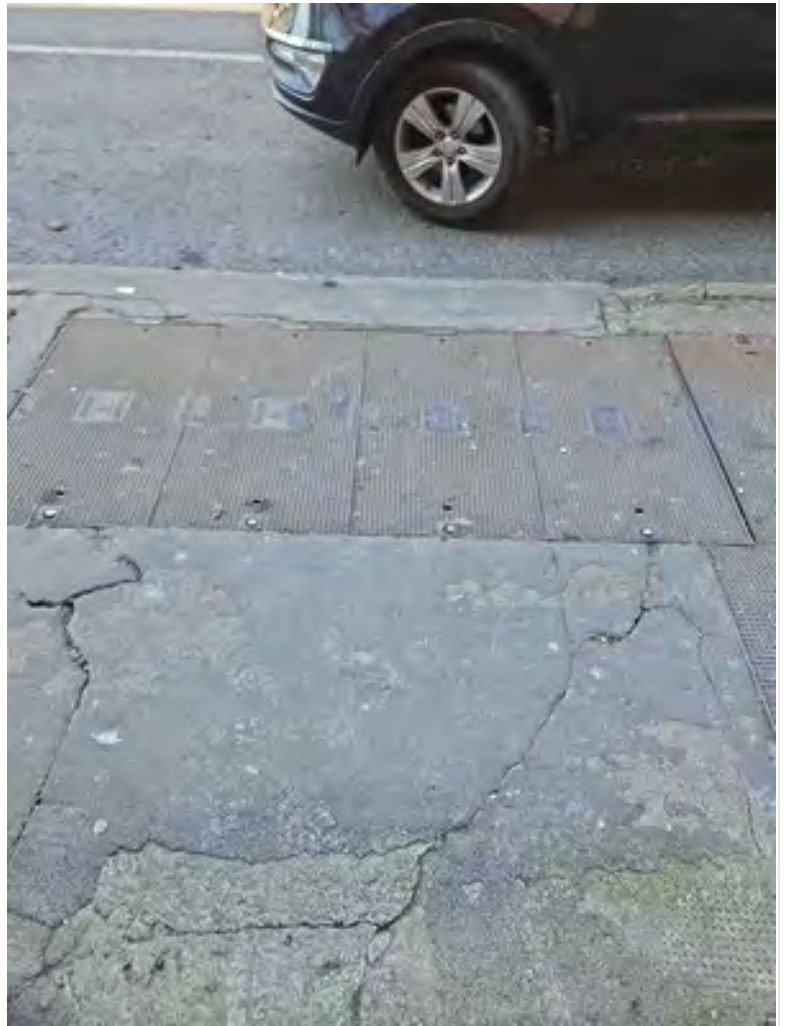
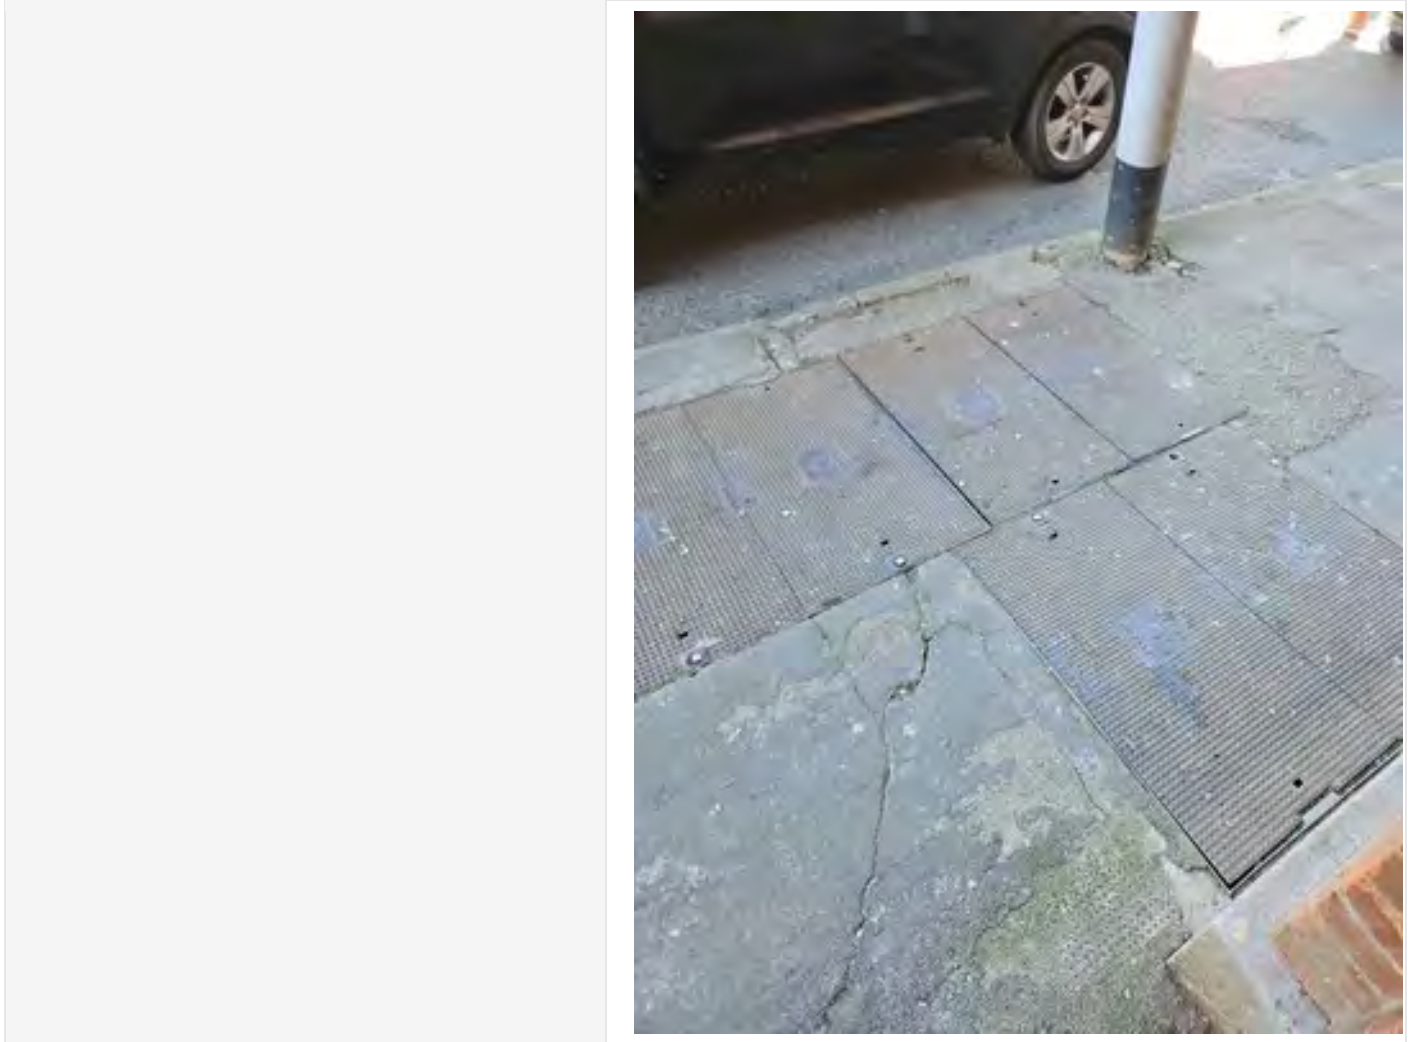
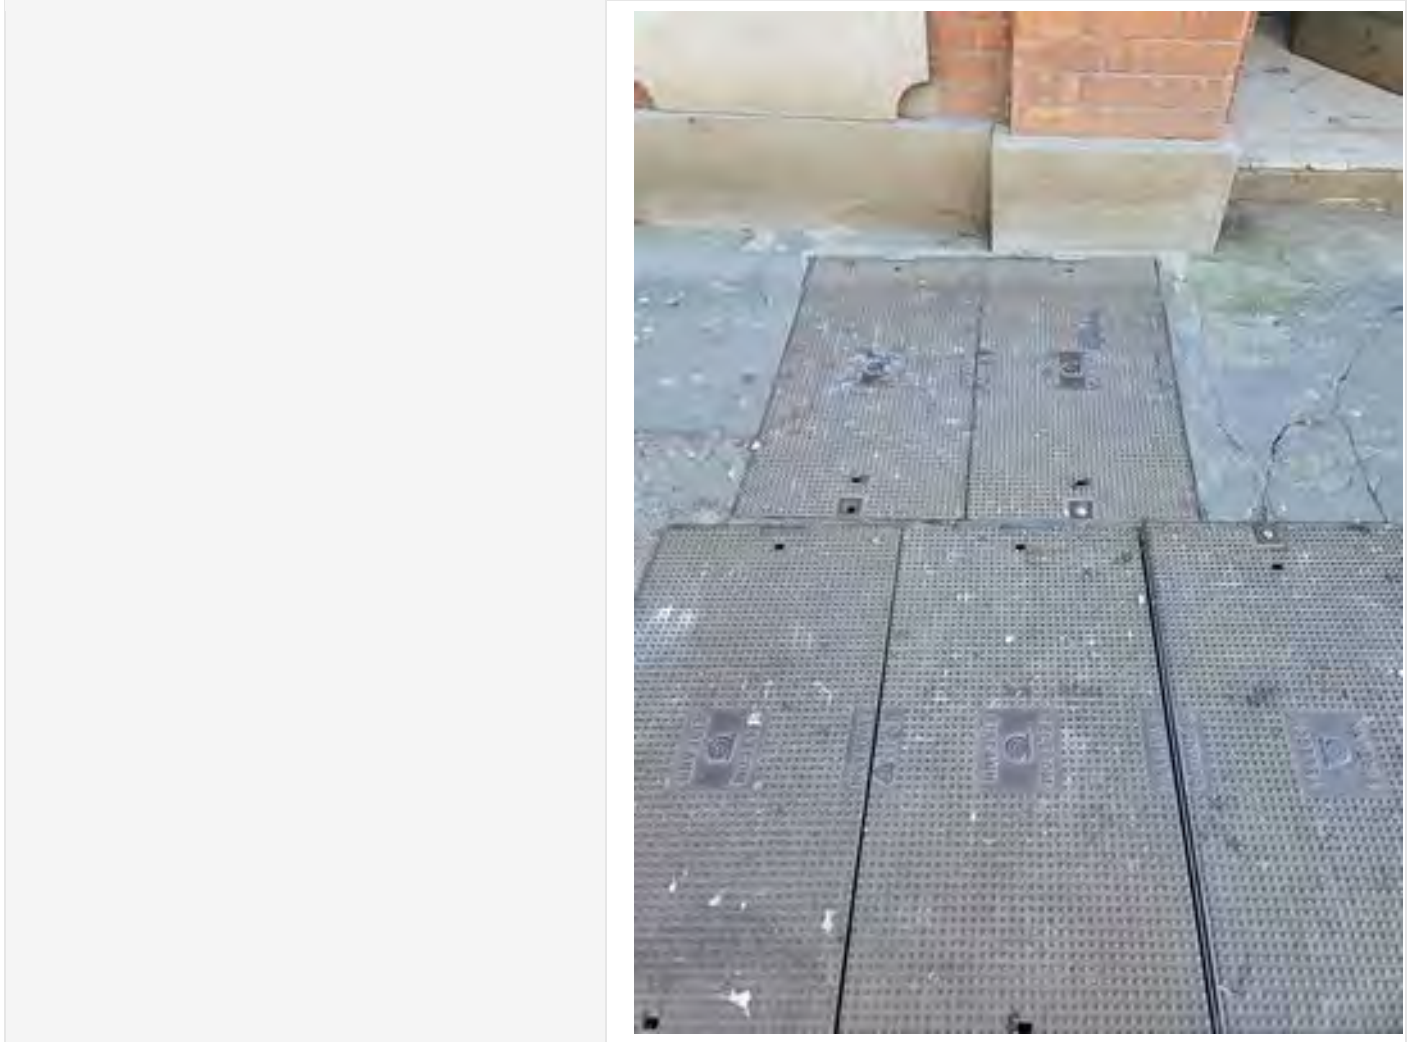
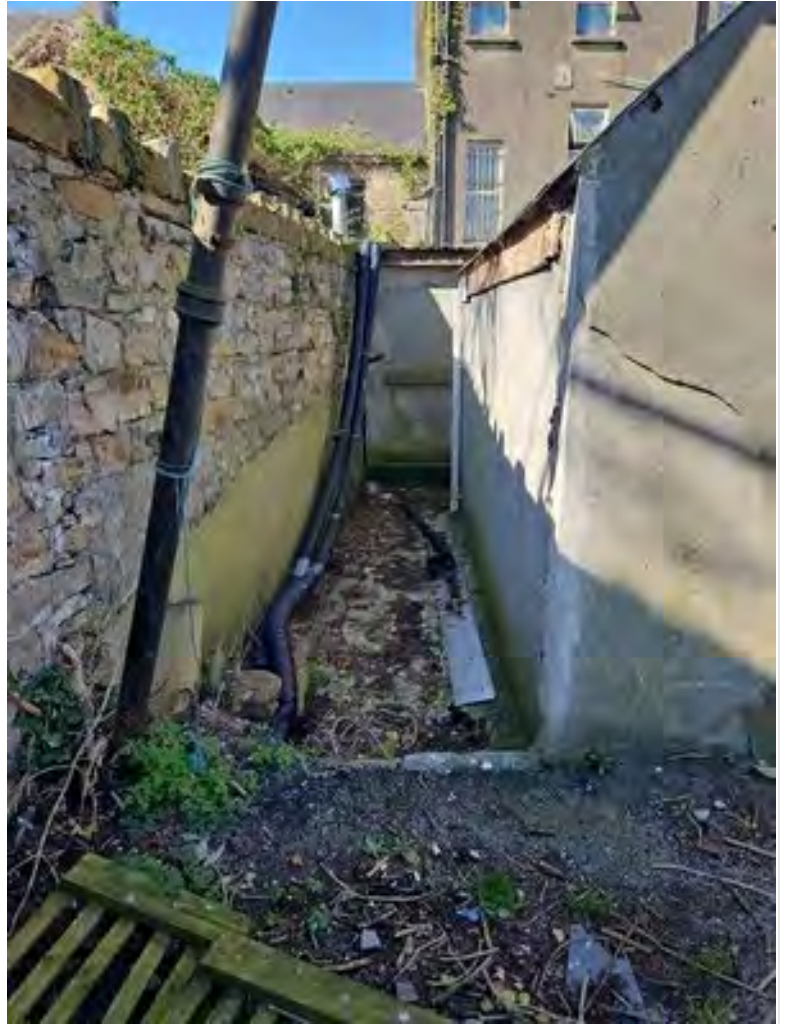
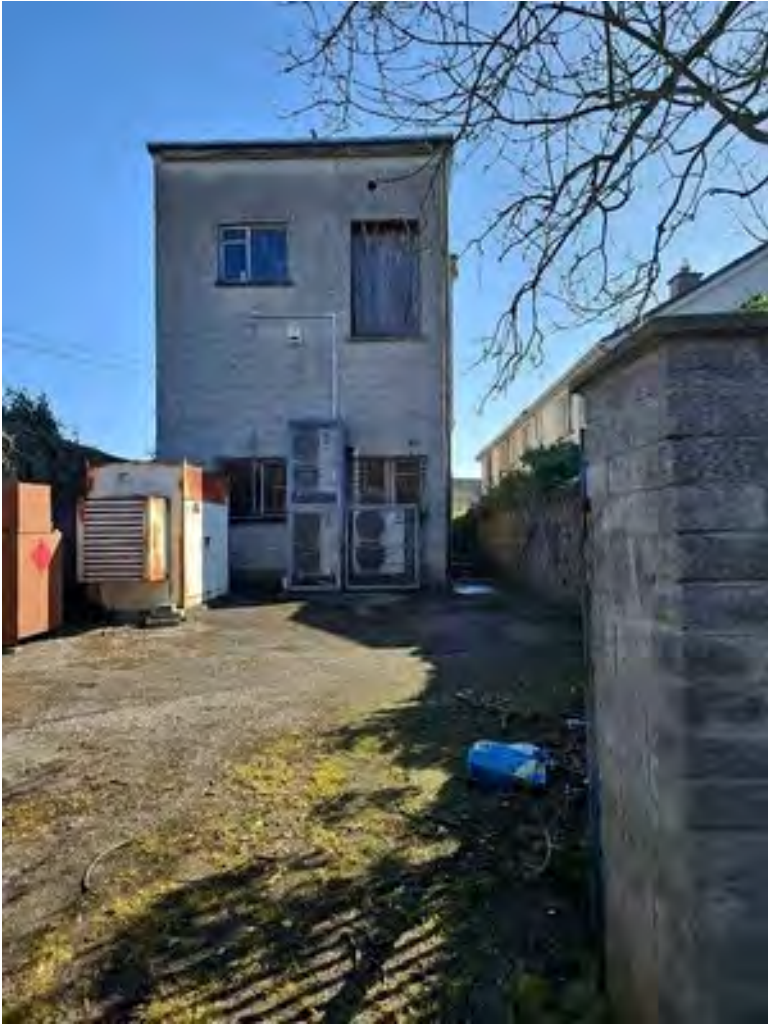
TGD Part D	MATERIALS AND WORKMANSHIP
Unit(s) Number(s) Inspected:	1 Unit
Description of Observation(s):	<p>Complete replacement of the electrical installation is required.</p> <p>Live Eircom infrastructure is passing through premises to the Eircom exchange to the rear of the property</p>
Photo(s)

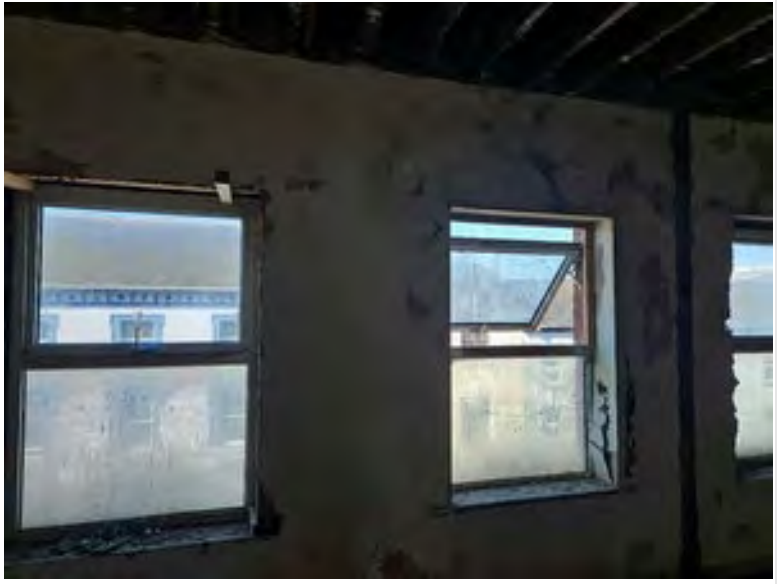
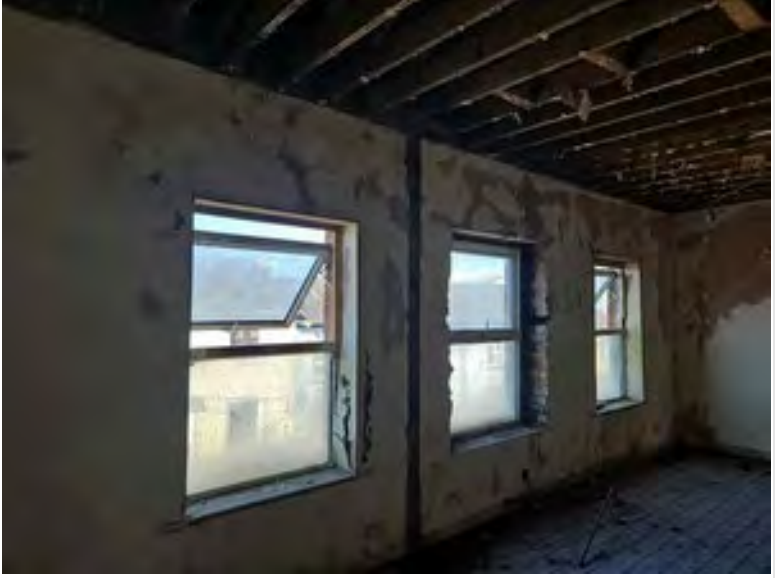
TGD Part E	SOUND
Unit(s) Number(s) Inspected:	Not applicable
Description of Observations	
Photo(s)	
Are Actions Required?	N/A
Has the Client/Contractor been notified?	N/A
Required Actions/Additional Comments	
TGD Part F	VENTILATION 2009
Unit(s) Number(s) Inspected:	1 Unit
Description of Observation(s):	Passive Ventilation provided by window opening only
Photo(s)

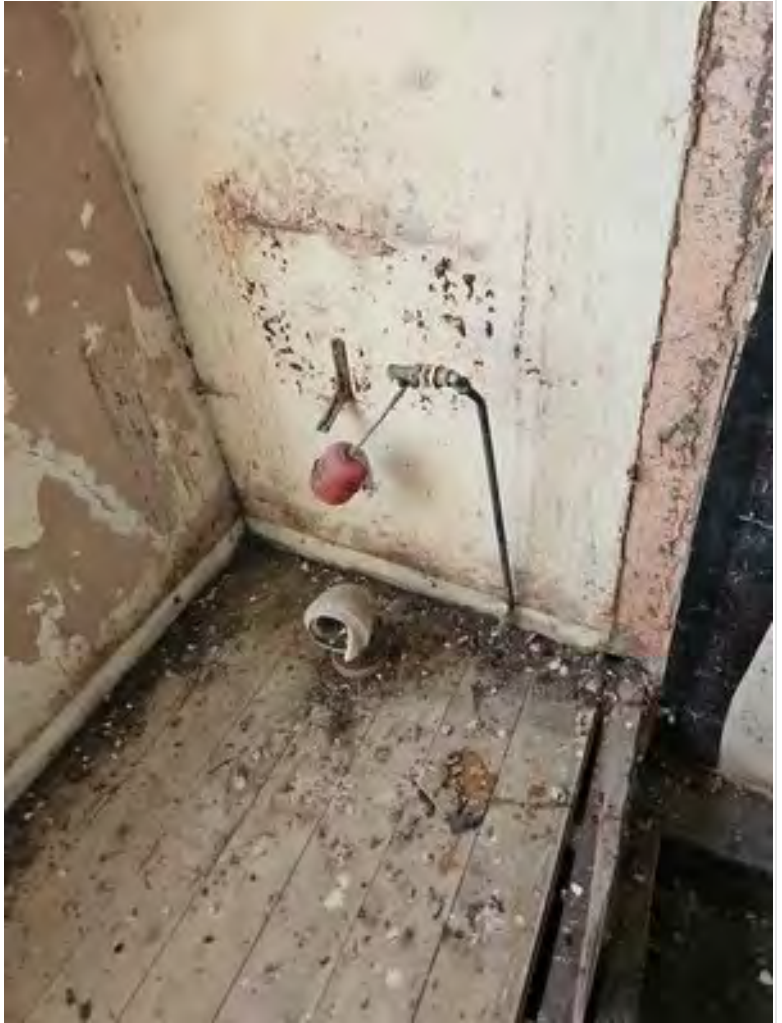
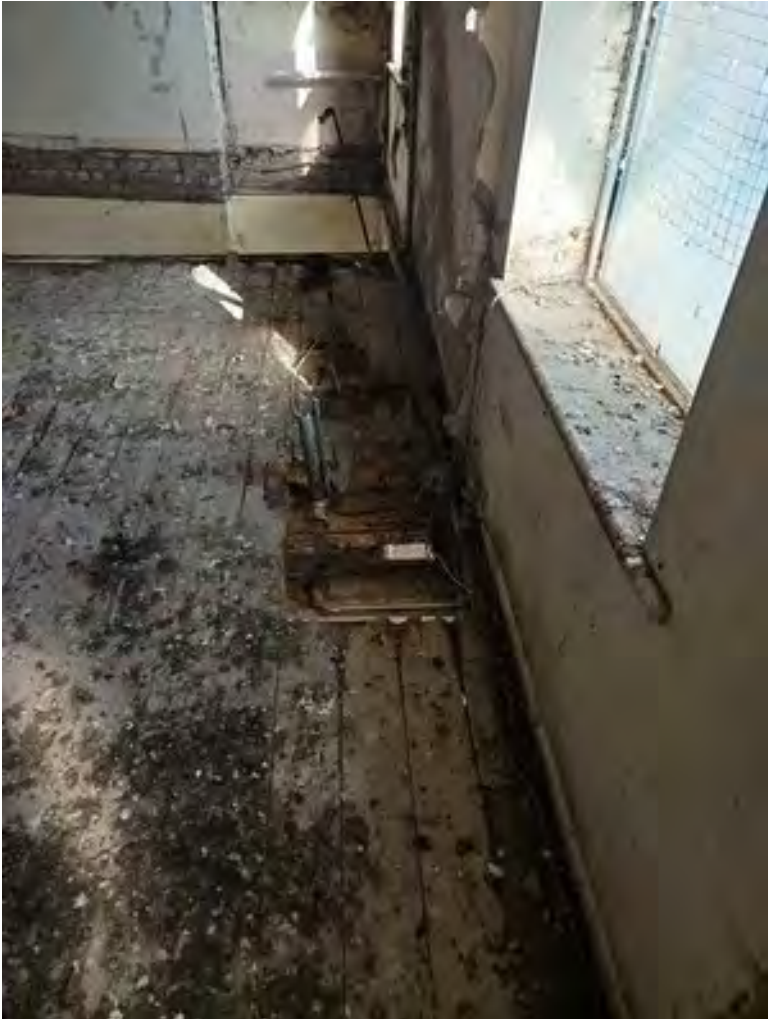
TGD Part G	HYGEINE 2008
Unit(s) Number(s) Inspected:	1 Unit
Description of Observation(s):	Not hygiene facilities provided. Hygiene facilities removed as part of the building clear out
Photo(s)

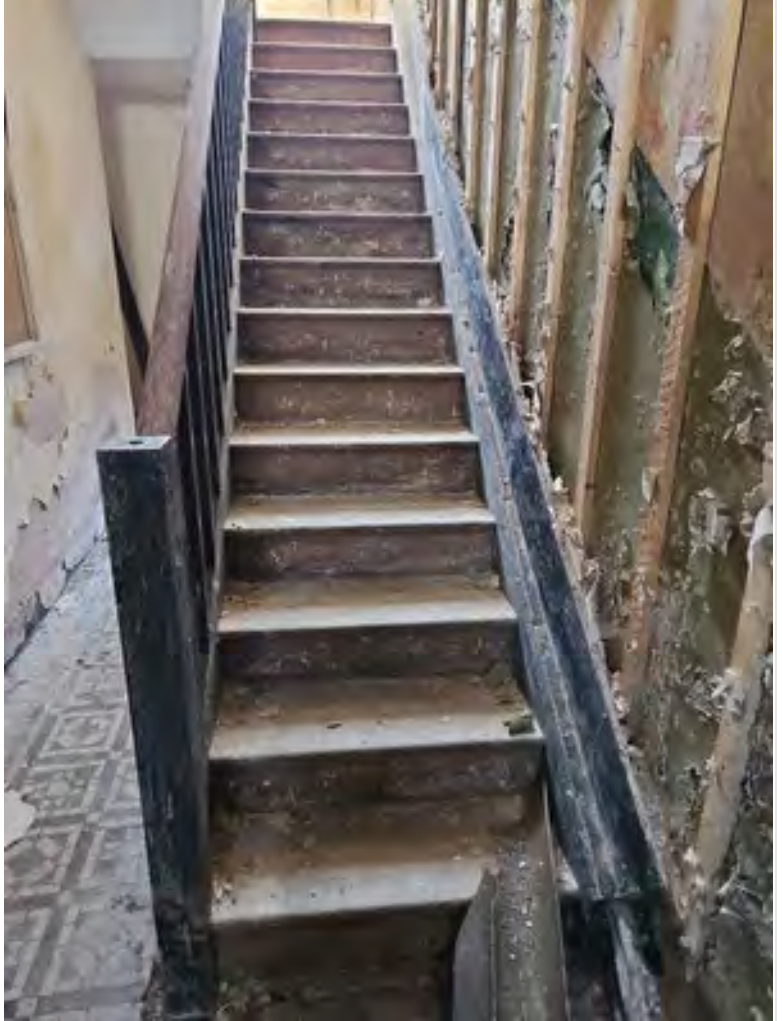
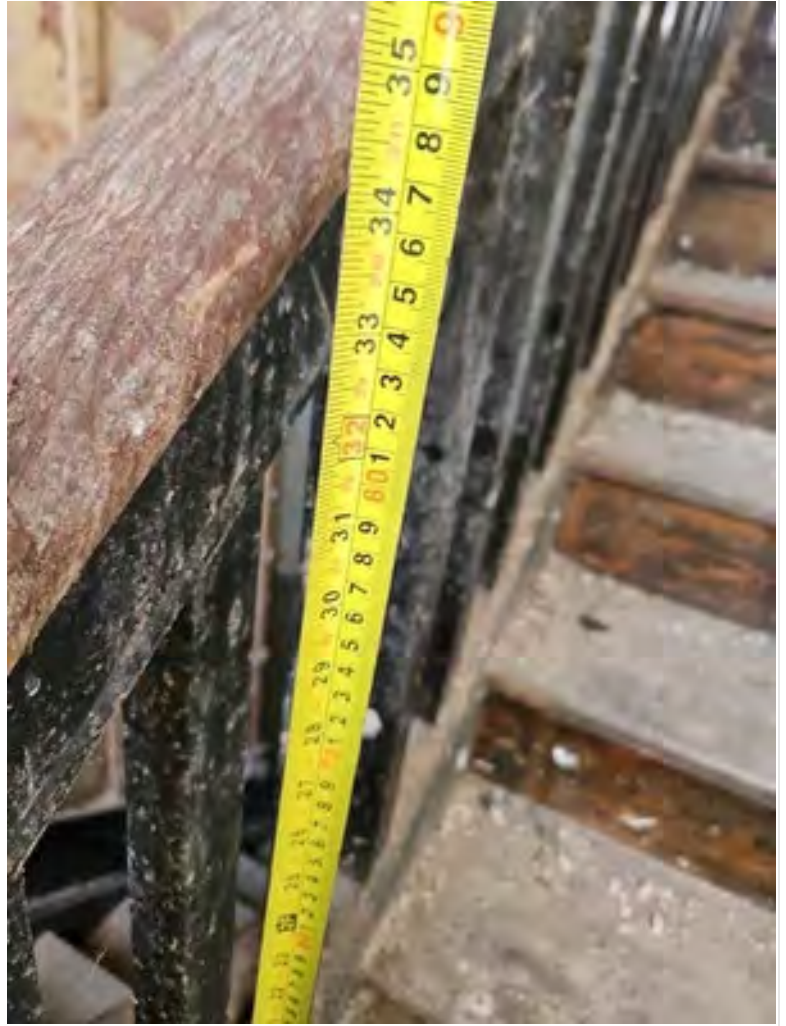
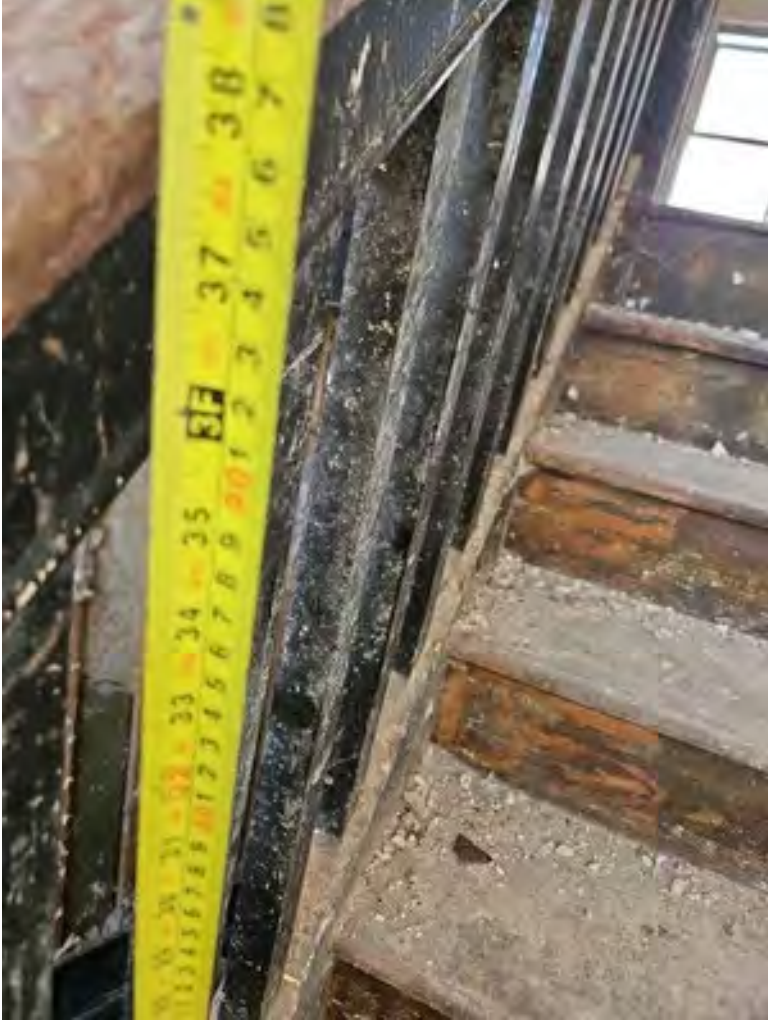
TGD Part K	STAIRWAYS, LADDERS, RAMPS AND GUARDS 2014
Unit(s) Number(s) Inspected:	1 Unit
Description of Observation(s)	Stairs present in building. Stairs not compliant for public use.
Photos(s)
