REF: AHIA REPORT, OLD POST OFFICE LONGFORD

Architectural Heritage Impact Assessment (Conservation Report, Repair and Methodology)

Project Title: Renovation, Alterations at the Old Post Office, Longford to house a **new tourist office**.

Site Address: 43 Main Street, Longford, Co. Longford. Eircode: N39 FD45

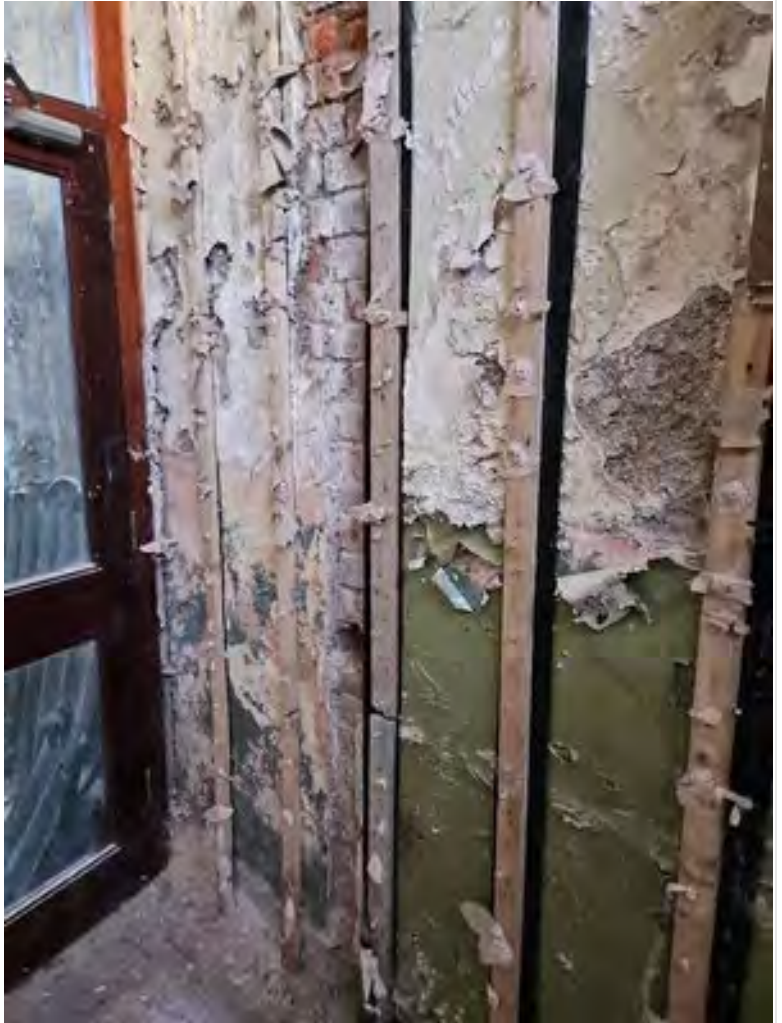
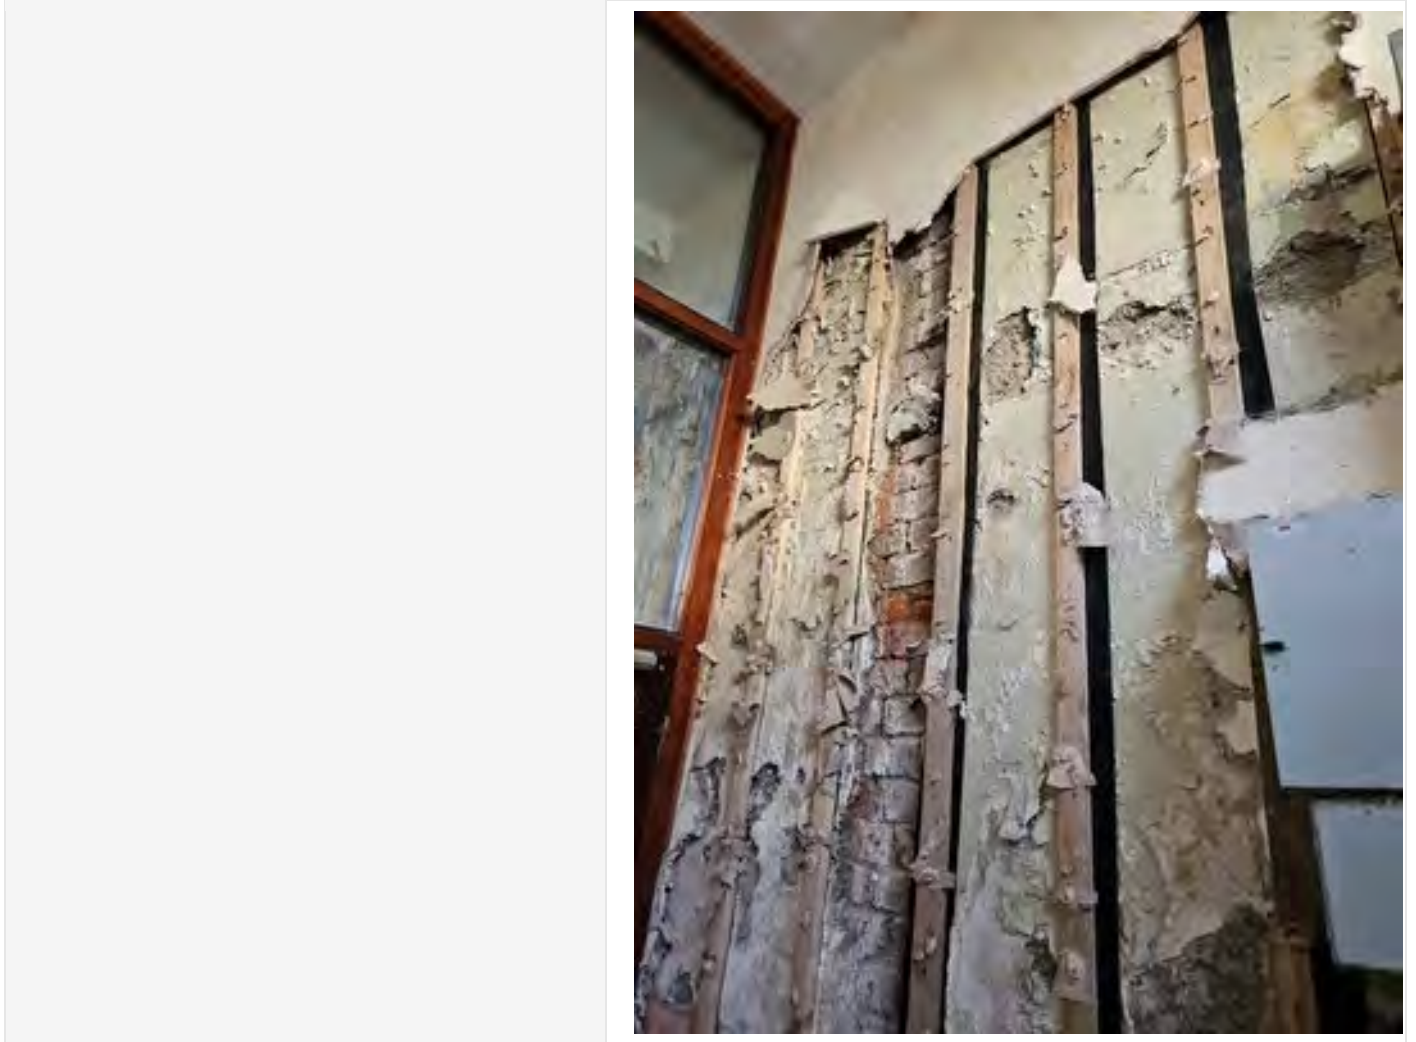
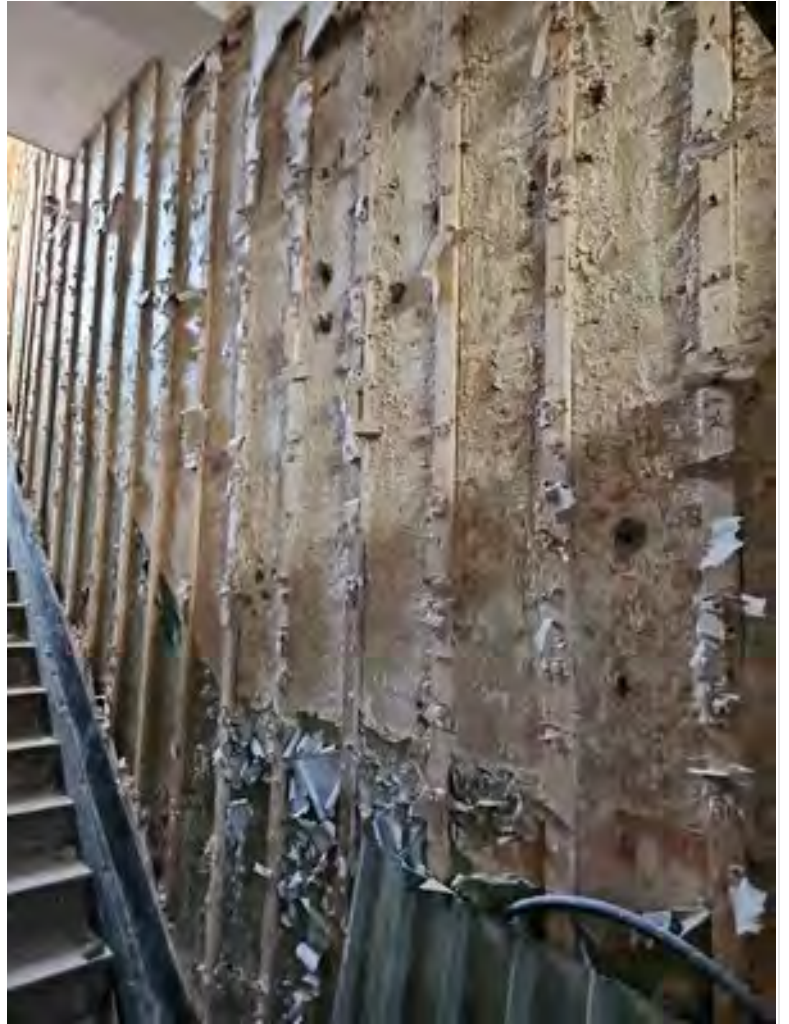
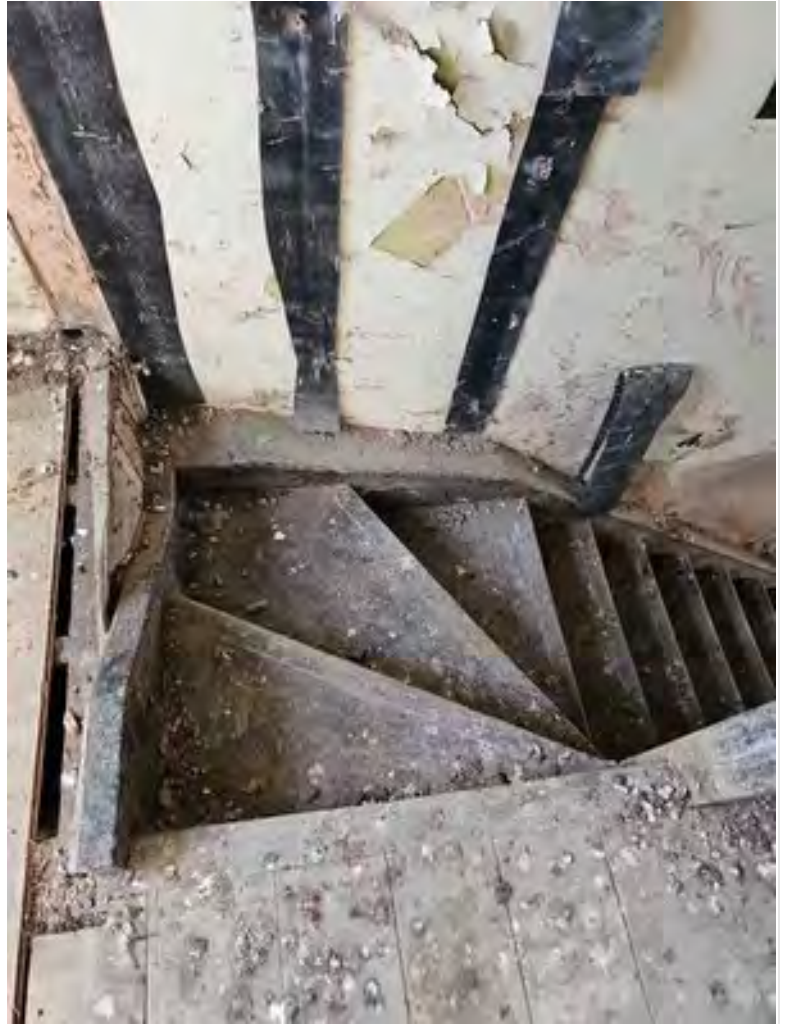
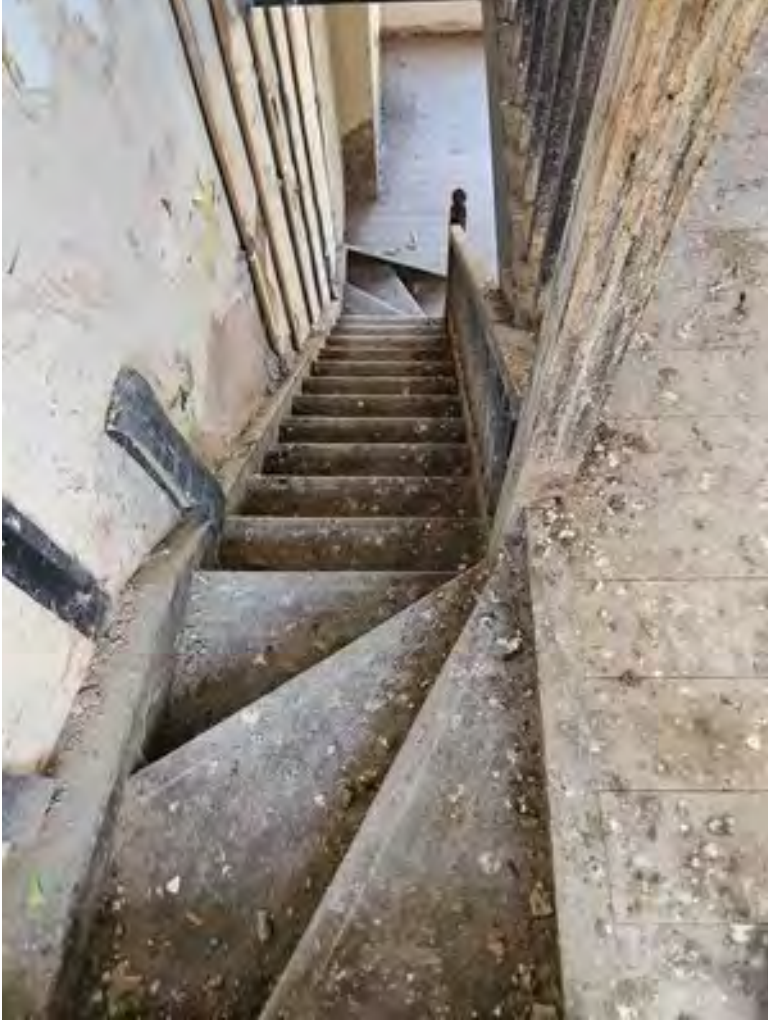
TGD Part L	CONSERVATION OF FUEL AND ENERGY DWELLINGS
Unit(s) Number(s) Inspected:	1 Unit
Description of Observation(s):	Thermal insulation not present in property
Photo(s)

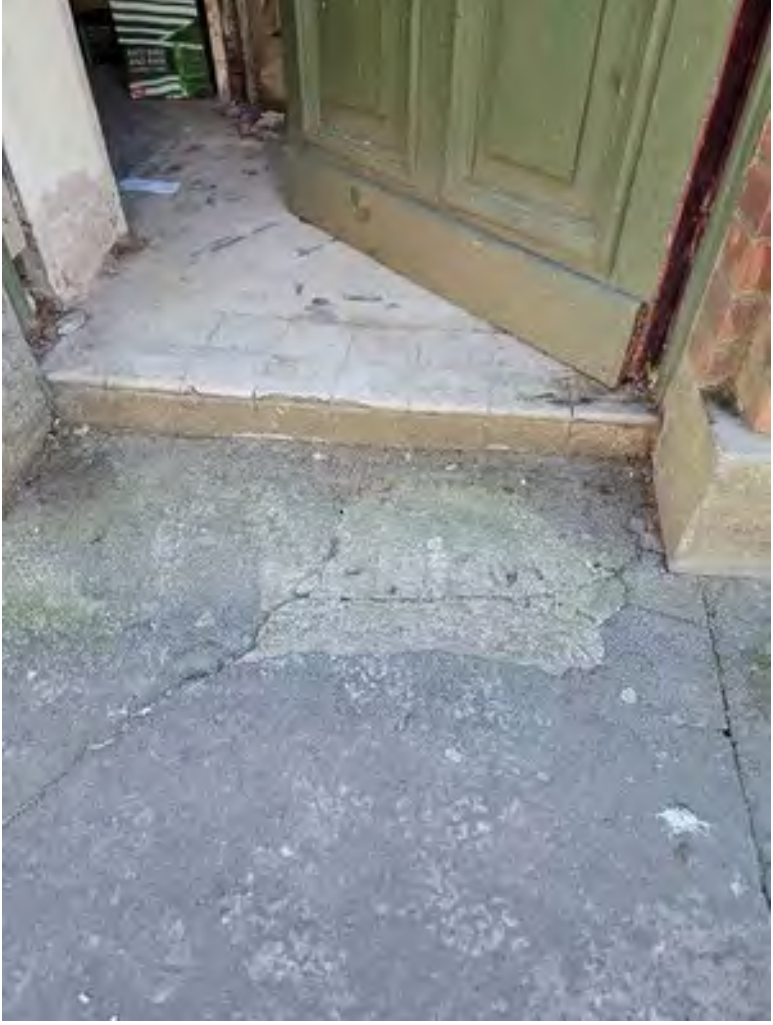
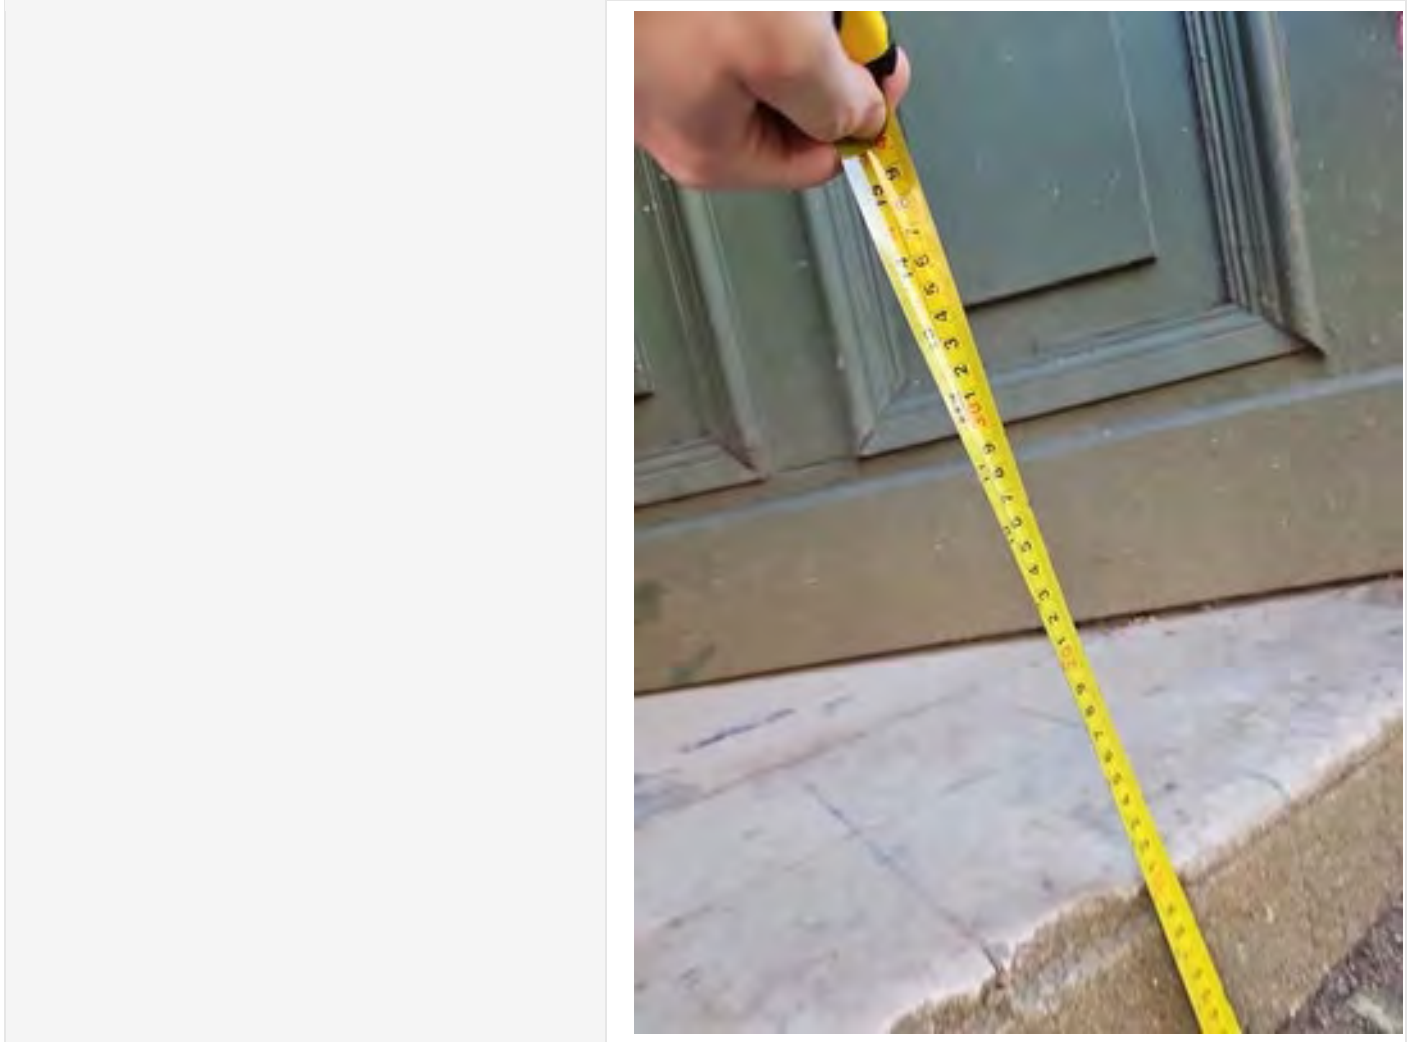
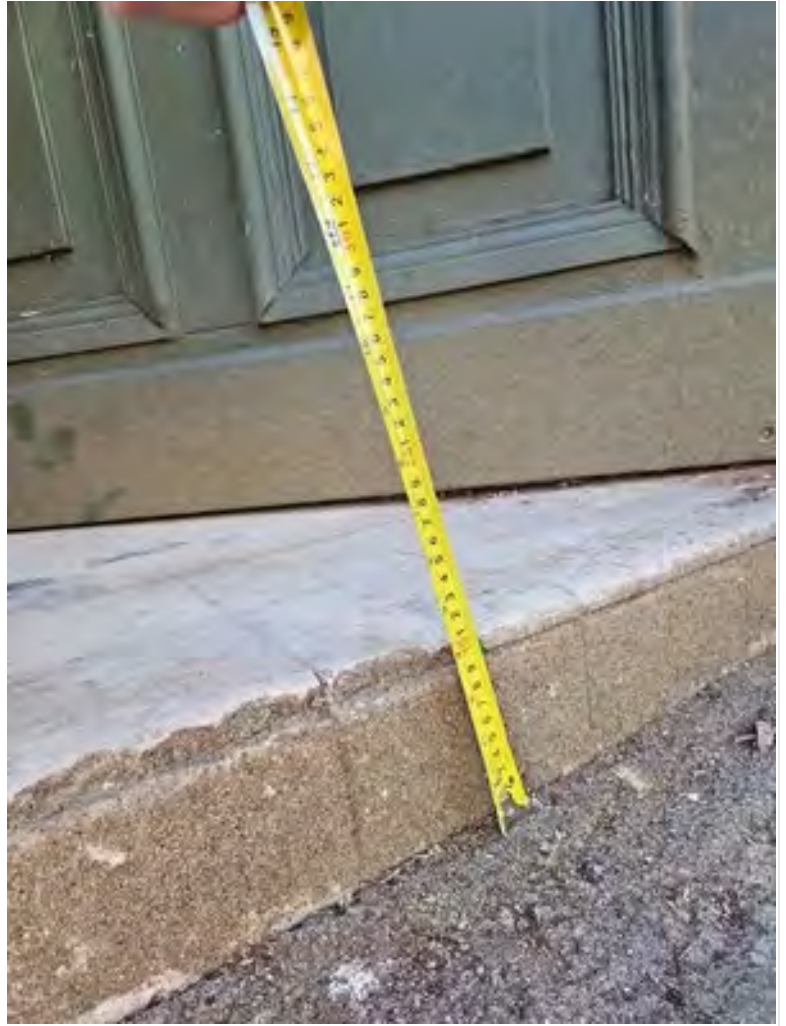
TGD Part M	Access And Use
Unit(s) Number(s) Inspected:	1 Unit
Description of Observation(s):	Property constructed prior to TGD M. Stepped access provided
Photo(s)

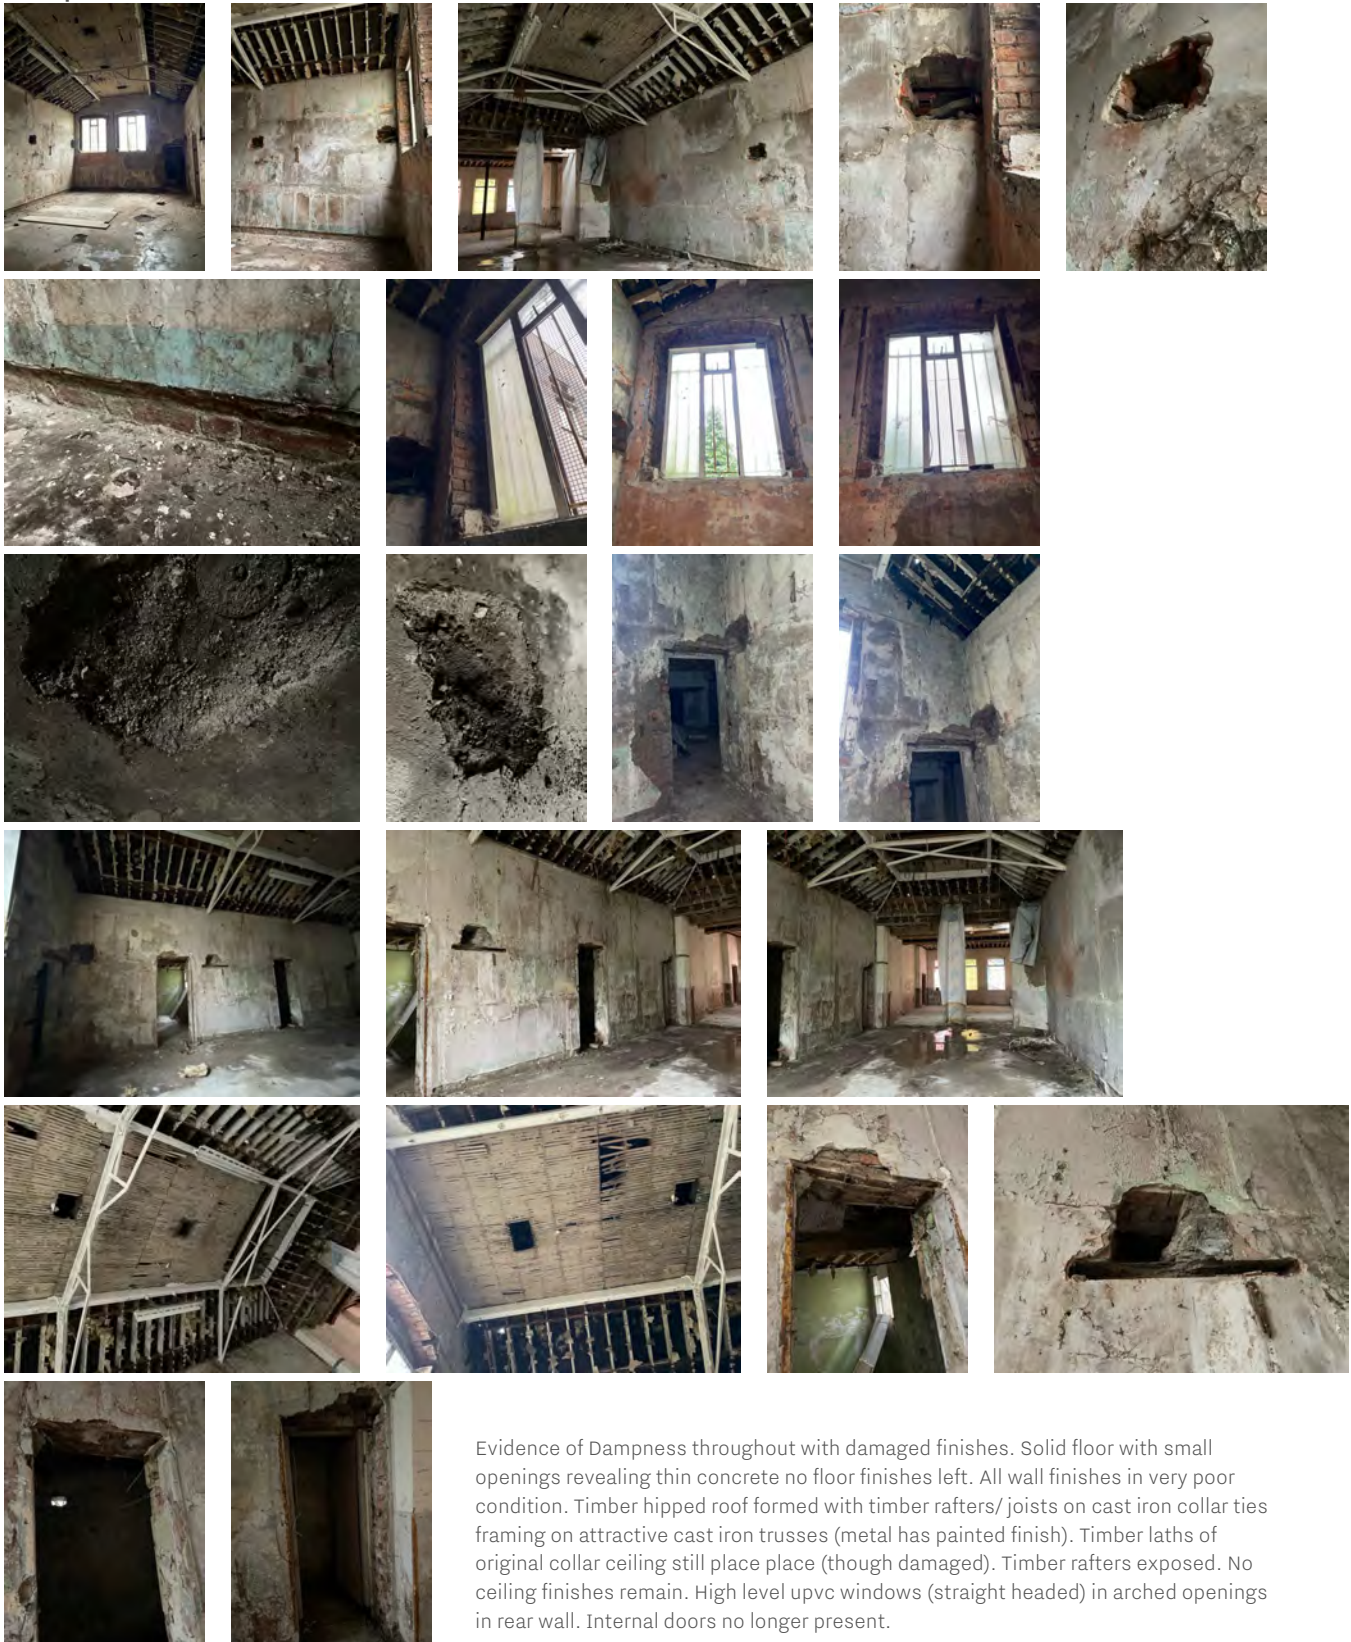
GFL toilet

Evidence of Dampness throughout with damaged finishes- serious water ingress from lean to roof visible overhead. Lean to pitched roof black roof membrane, timber rafters and timber laths visible all seriously damaged. Modern tiled floor finish visible. Openings without doors (from main rear room and also opening from hall blocked up). Modern plasterboard/ painted finishes to level few hundred mm over openings with older lime finishes visible over. Brick masonry substrate visible on external walls where plaster finishes have fallen away. WHB & WC still in place. No ceiling finishes exist apart from damaged timber laths.

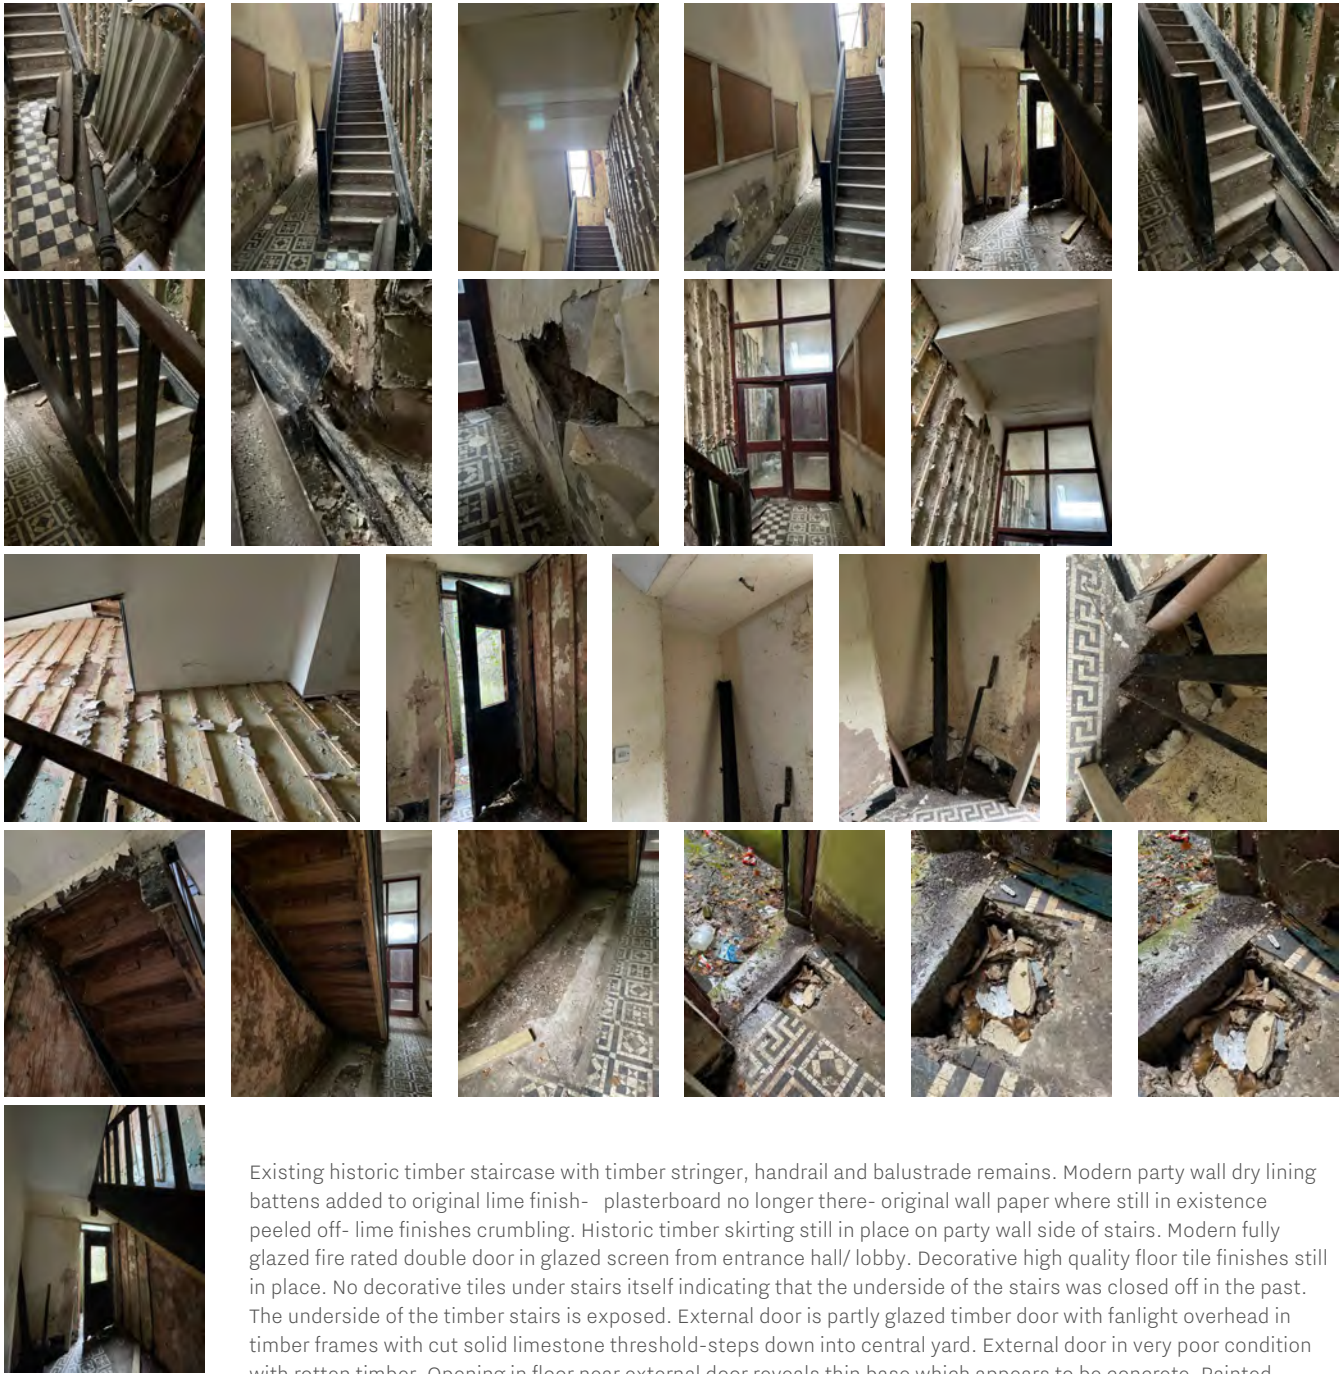
GFL Stairway- hall

Existing historic timber staircase with timber stringer, handrail and balustrade remains. Modern party wall dry lining battens added to original lime finish- plasterboard no longer there- original wall paper where still in existence peeled off- lime finishes crumbling. Historic timber skirting still in place on party wall side of stairs. Modern fully glazed fire rated double door in glazed screen from entrance hall/ lobby. Decorative high quality floor tile finishes still in place. No decorative tiles under stairs itself indicating that the underside of the stairs was closed off in the past. The underside of the timber stairs is exposed. External door is partly glazed timber door with fanlight overhead in timber frames with cut solid limestone threshold-steps down into central yard. External door in very poor condition with rotten timber. Opening in floor near external door reveals thin base which appears to be concrete. Painted ceilings overhead appear to be modern plasterboard. Wall finishes to internal wall appear to be painted plaster (lime) and have severely bolstered. Existing cast iron rainwater goods elements- in parts- left loose at bottom of stairs.

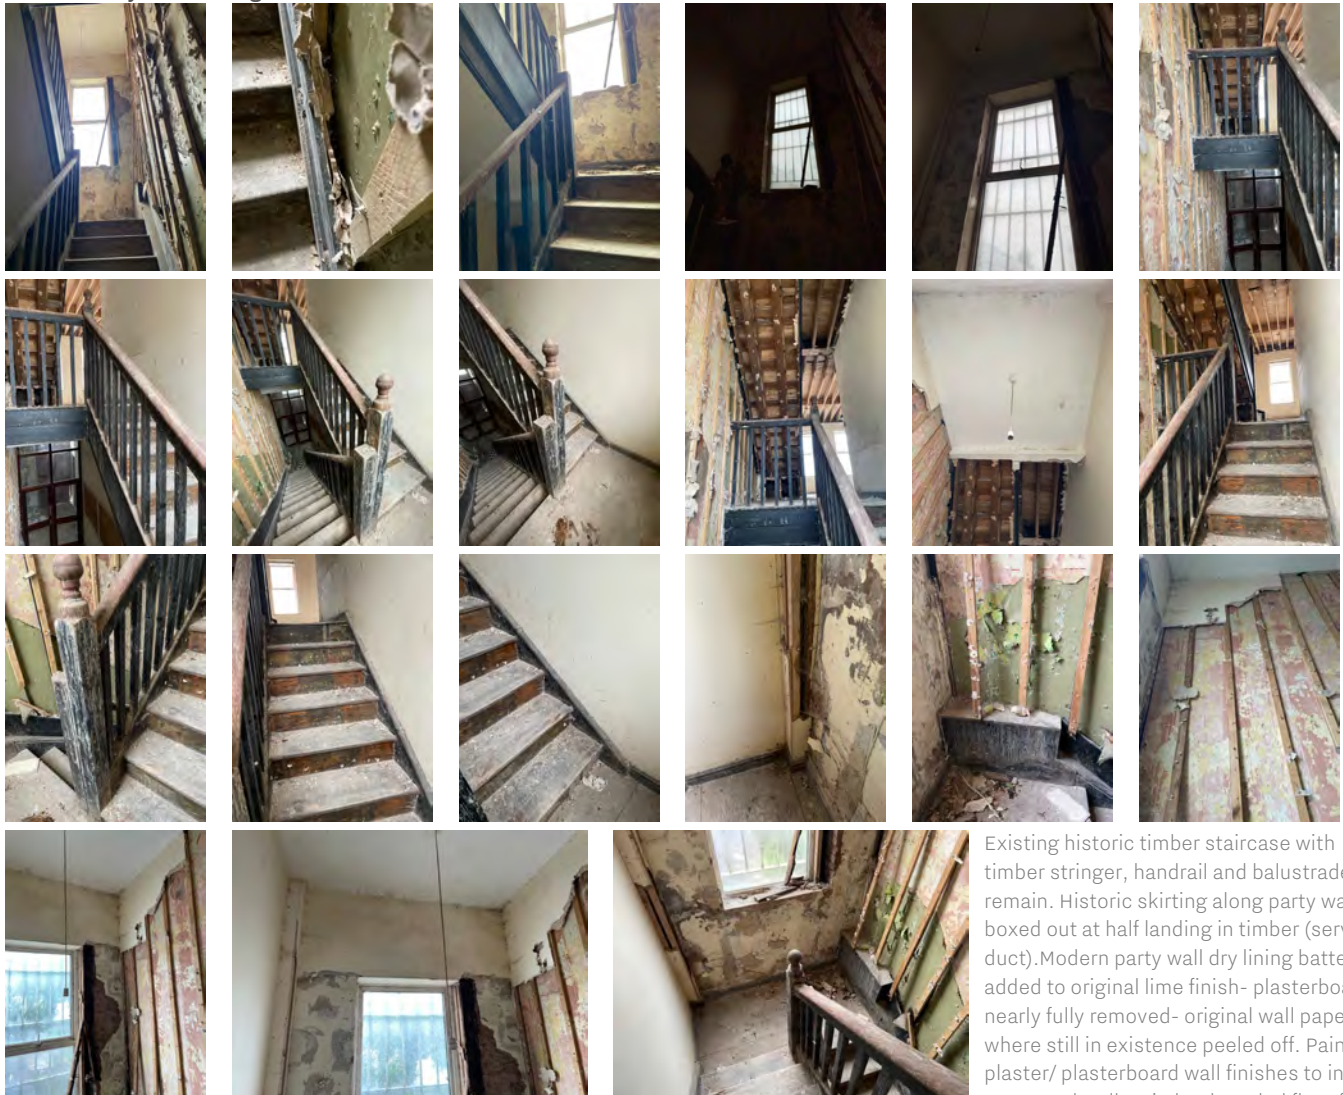
GFL Stairway half landing

Existing historic timber staircase with timber stringer, handrail and balustrade remain. Historic skirting along party wall boxed out at half landing in timber (service duct). Modern party wall dry lining battens added to original lime finish- plasterboard nearly fully removed- original wall paper where still in existence peeled off. Painted plaster/ plasterboard wall finishes to internal & external walls. Timber boarded floor finish to half landing.

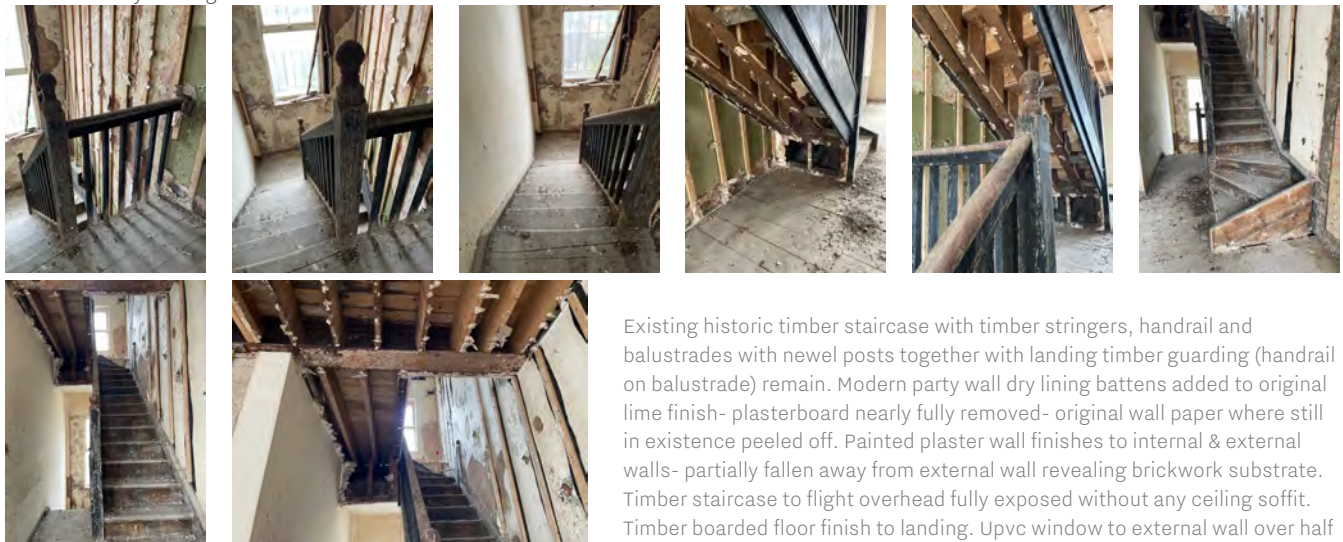
1st FL Stairway landing

Existing historic timber staircase with timber stringers, handrail and balustrades with newel posts together with landing timber guarding (handrail on balustrade) remain. Modern party wall dry lining battens added to original lime finish- plasterboard nearly fully removed- original wall paper where still in existence peeled off. Painted plaster wall finishes to internal & external walls- partially fallen away from external wall revealing brickwork substrate. Timber staircase to flight overhead fully exposed without any ceiling soffit. Timber boarded floor finish to landing. Upvc window to external wall over half landing. Small modern service duct formed in plasterboard in corner of half landing.

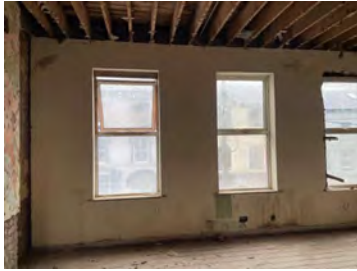
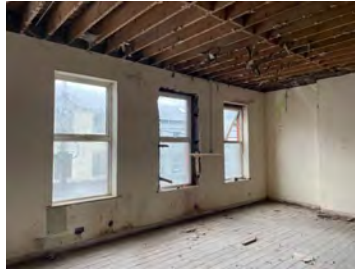
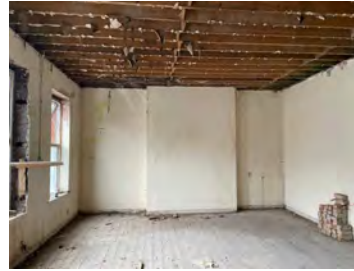
FFL Room 02

Existing chimney with blocked up hearth on southern party wall. External wall to front façade has modern dry lining with painted plasterboard finishes. UPVC windows to front façade. Northern party wall has chimney breast - wall finishes painted plaster. Northern party wall has chimney breast - wall finishes painted plaster. Modern steel beam visible above top of internal partition with full height internal opening under steel beam- part of internal wall without finishes revealing substrate formed in brickwork in timber frames.

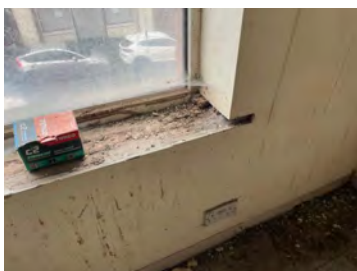
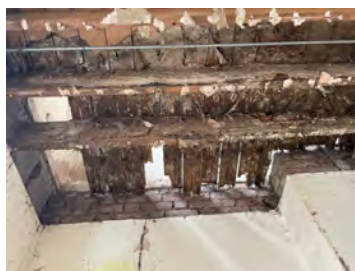
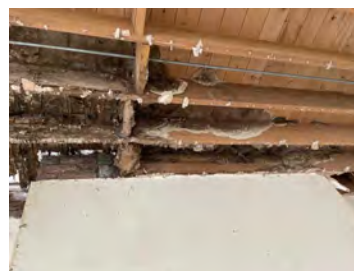
Timber joisted upper boarded floor on timber joists visible overhead. No ceiling finishes remain. A number of steel rods have been inserted between the joists to tie the front façade back to the rear façade- threaded through modern steel beam.

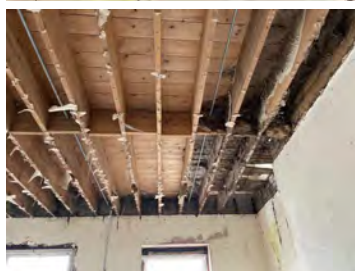
The timber floor overhead is severely damaged beside the northern party wall- worst part near the front facade where rot infestation is visible- and a section of the upper floor boards has disintegrated.

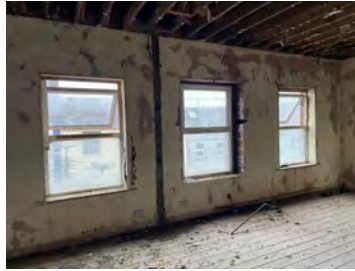
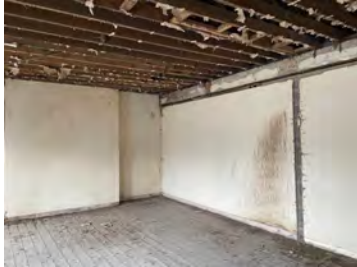
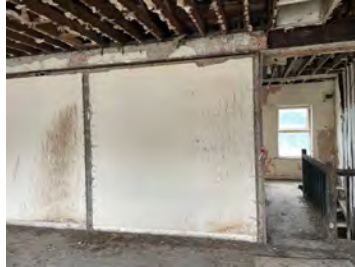
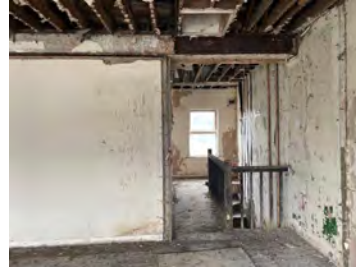
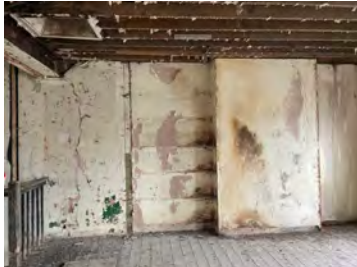
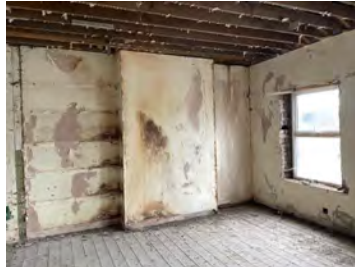
2nd FL Room 02

Existing chimney breast on southern party wall with painted plaster finishes to ceiling level - finishes appear modern and in poor condition. External wall to front façade has modern dry lining with painted plasterboard finishes-to ceiling level. Upvc windows to front façade.

Existing chimney breast on northern party wall with painted plaster finishes to ceiling level - finishes appear modern and in poor condition near front facade. There is a modern steel beam visible at top of internal partition underneath the ceiling joists with timber packing joists. There is a full height internal opening under steel beam between this room and the landing area. This partition has painted plaster finishes. There is are timber studs along the face of front and internal wall indicating line of partition no longer there- likely to have been a modern stud partition.

The timber boarded floor in this room is severely damaged with a disintegration of the floor boards and joists (large holes) at junction of front façade and party wall (north west corner). Timber boarded floor finish remains.

Pitched roof with modern roofing felt on timber rafter cut roof with timber collar ties visible above timber joisted ceiling as all ceiling finishes no longer present. There is a timber lightwell for an old rooflight no longer there can be seen near the steel beam over opening from landing area.

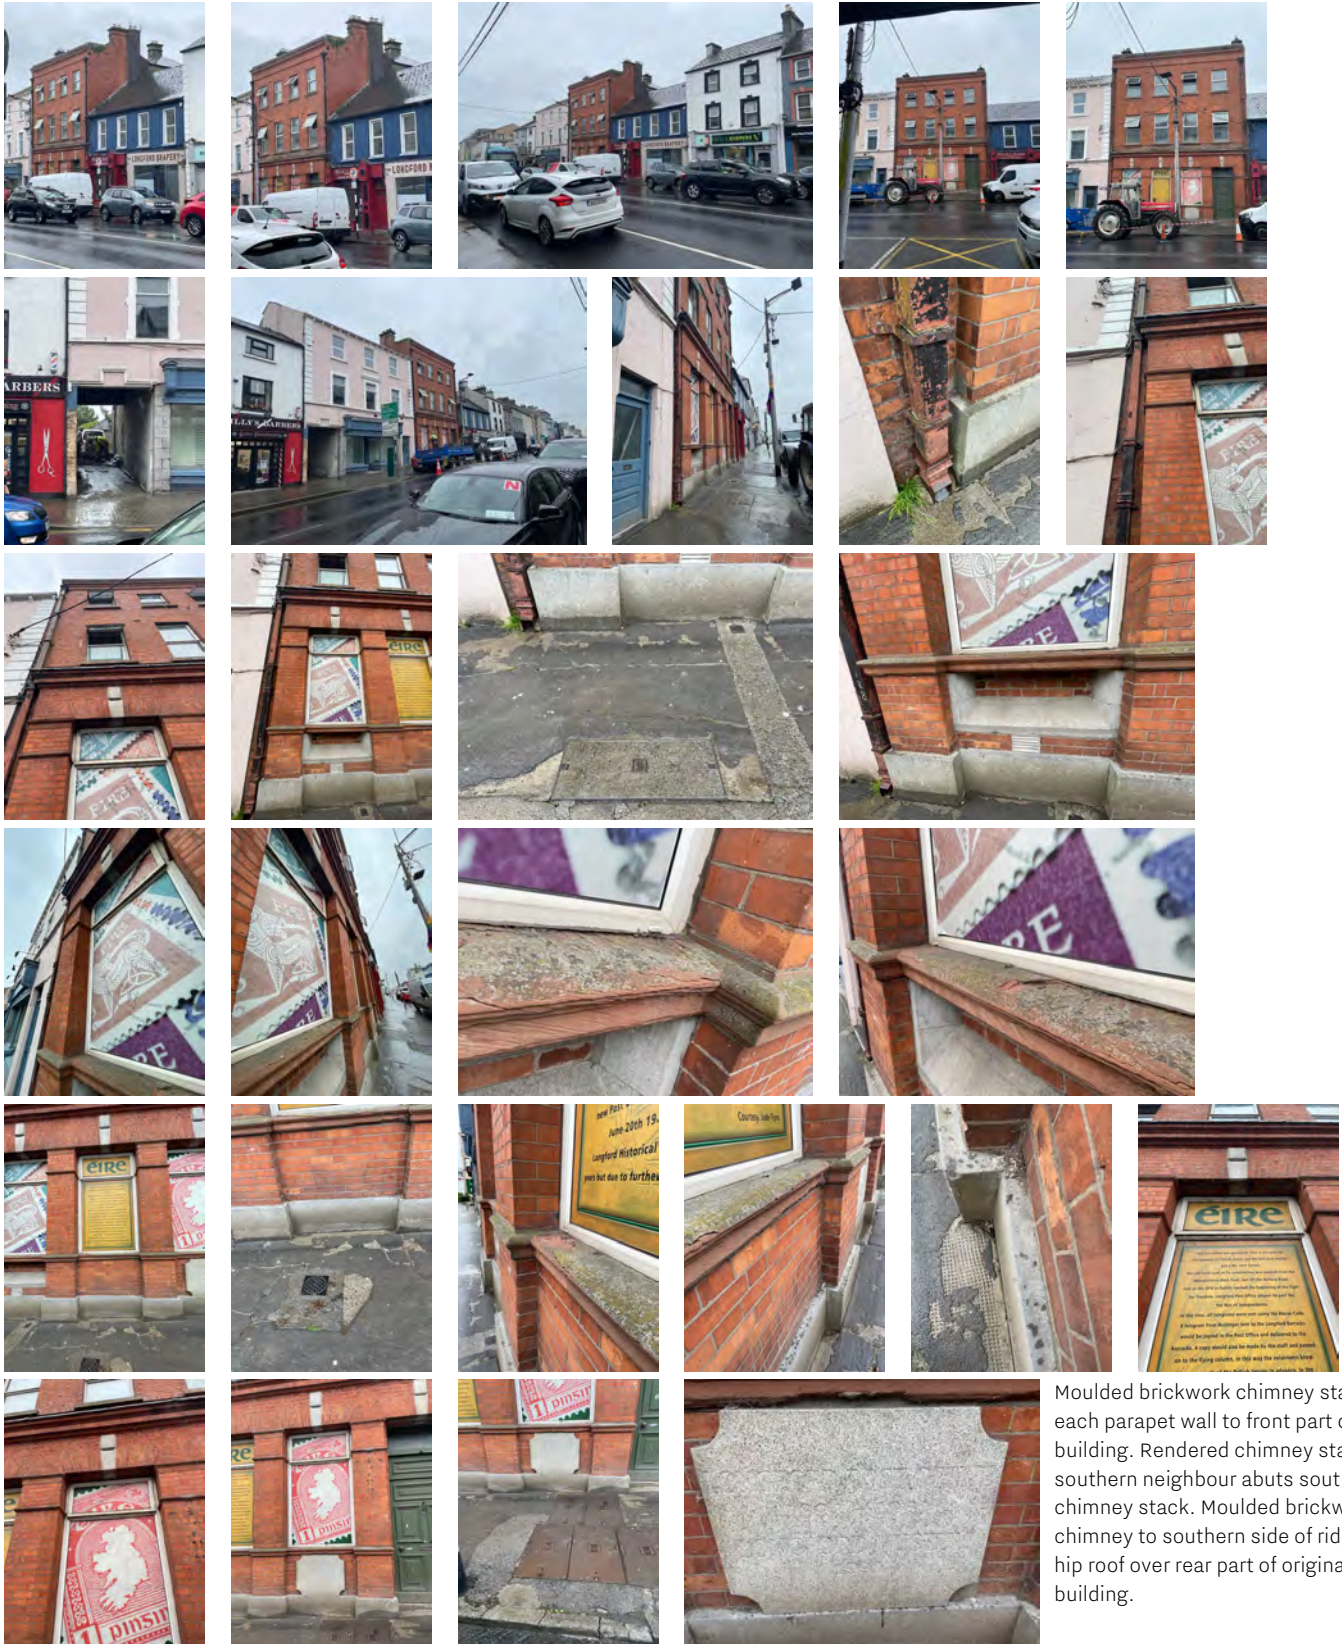
External Street Facade

Moulded brickwork chimney stacks on each parapet wall to front part of building. Rendered chimney stack of southern neighbour abuts southern chimney stack. Moulded brickwork chimney to southern side of ridge of hip roof over rear part of original building.

Handsome classical 3 storey street facade with square headed openings formed in original red brickwork (flemish bond) with parapet eaves over decorative projecting carved stone framing band on moulded brickwork corbel. Brickwork facade projects at ground floor level capped with lead flashing on projecting cornice of moulded sandstone / terracotta over stepped brickwork corbels on brickwork frieze supported on brickwork pilasters with moulded string courses between ground floor openings. Moulded sandstone / terracotta sill course to ground floor windows. Cut dressed limestone plinths, cut limestone apron panels under ground floor windows. Heads of ground floor openings formed with flat brickwork arches and cut limestone keystones. There is a decorative granite commemorative plaque over the limestone plinth to the left hand side of the entrance door- the text is very worn appears to indicate 1894 as construction date. Upper level windows with brickwork flat arch heads and stone cills. There is a red brickwork platband aligned with 1st floor cills. All windows are replacement upvc. The entrance door is original historic timber panelled door with fanlight over in timber frames.

Sandstone sill terracotta sill course worn- cracked in places. Brickwork pilaster string projecting string course eroded to south side of main entrance door. There are a considerable number of services in the existing footpath- especially a large group of telecom cast iron manhole covers outside the main entrance door.

Existing main entrance door has modern tiled threshold with step up from the street. The timber frames of the main entrance door are damaged with missing sections at low level.

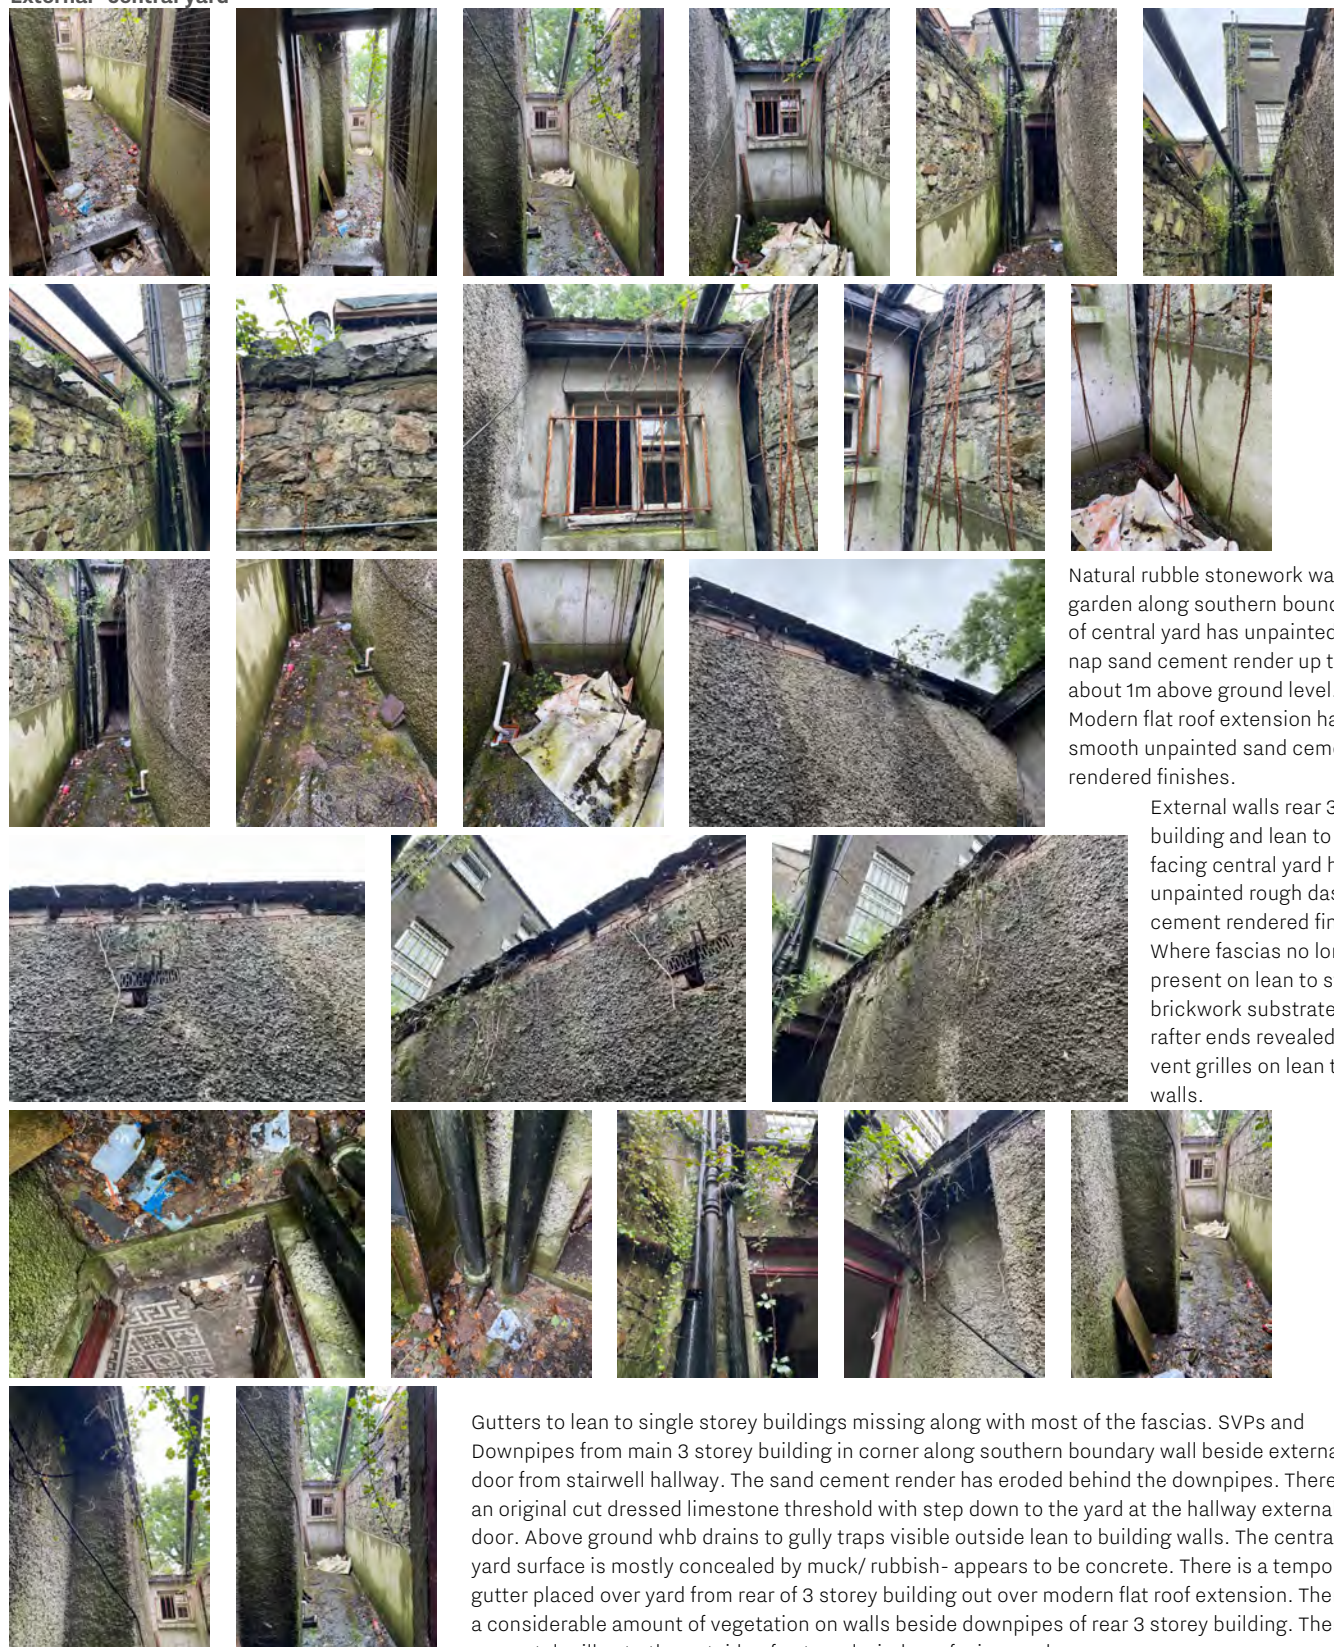
External- central yard

Natural rubble stonework wall garden along southern boundary of central yard has unpainted nap sand cement render up to about 1m above ground level. Modern flat roof extension has smooth unpainted sand cement rendered finishes.

External walls rear 3 storey building and lean to structures facing central yard have unpainted rough dash sand cement rendered finishes. Where fascias no longer present on lean to structures brickwork substrate between rafter ends revealed. Cast iron vent grilles on lean to masonry walls.

Gutters to lean to single storey buildings missing along with most of the fascias. SVPs and Downpipes from main 3 storey building in corner along southern boundary wall beside external door from stairwell hallway. The sand cement render has eroded behind the downpipes. There is an original cut dressed limestone threshold with step down to the yard at the hallway external door. Above ground whb drains to gully traps visible outside lean to building walls. The central yard surface is mostly concealed by muck/ rubbish- appears to be concrete. There is a temporary gutter placed over yard from rear of 3 storey building out over modern flat roof extension. There is a considerable amount of vegetation on walls beside downpipes of rear 3 storey building. There are metal grilles to the outside of external windows facing yard.
