REF: AHIA REPORT, OLD POST OFFICE LONGFORD

Architectural Heritage Impact Assessment (Conservation Report, Repair and Methodology)

Project Title: Renovation, Alterations at the Old Post Office, Longford to house a **new tourist office**.

Site Address: 43 Main Street, Longford, Co. Longford. Eircode: N39 FD45

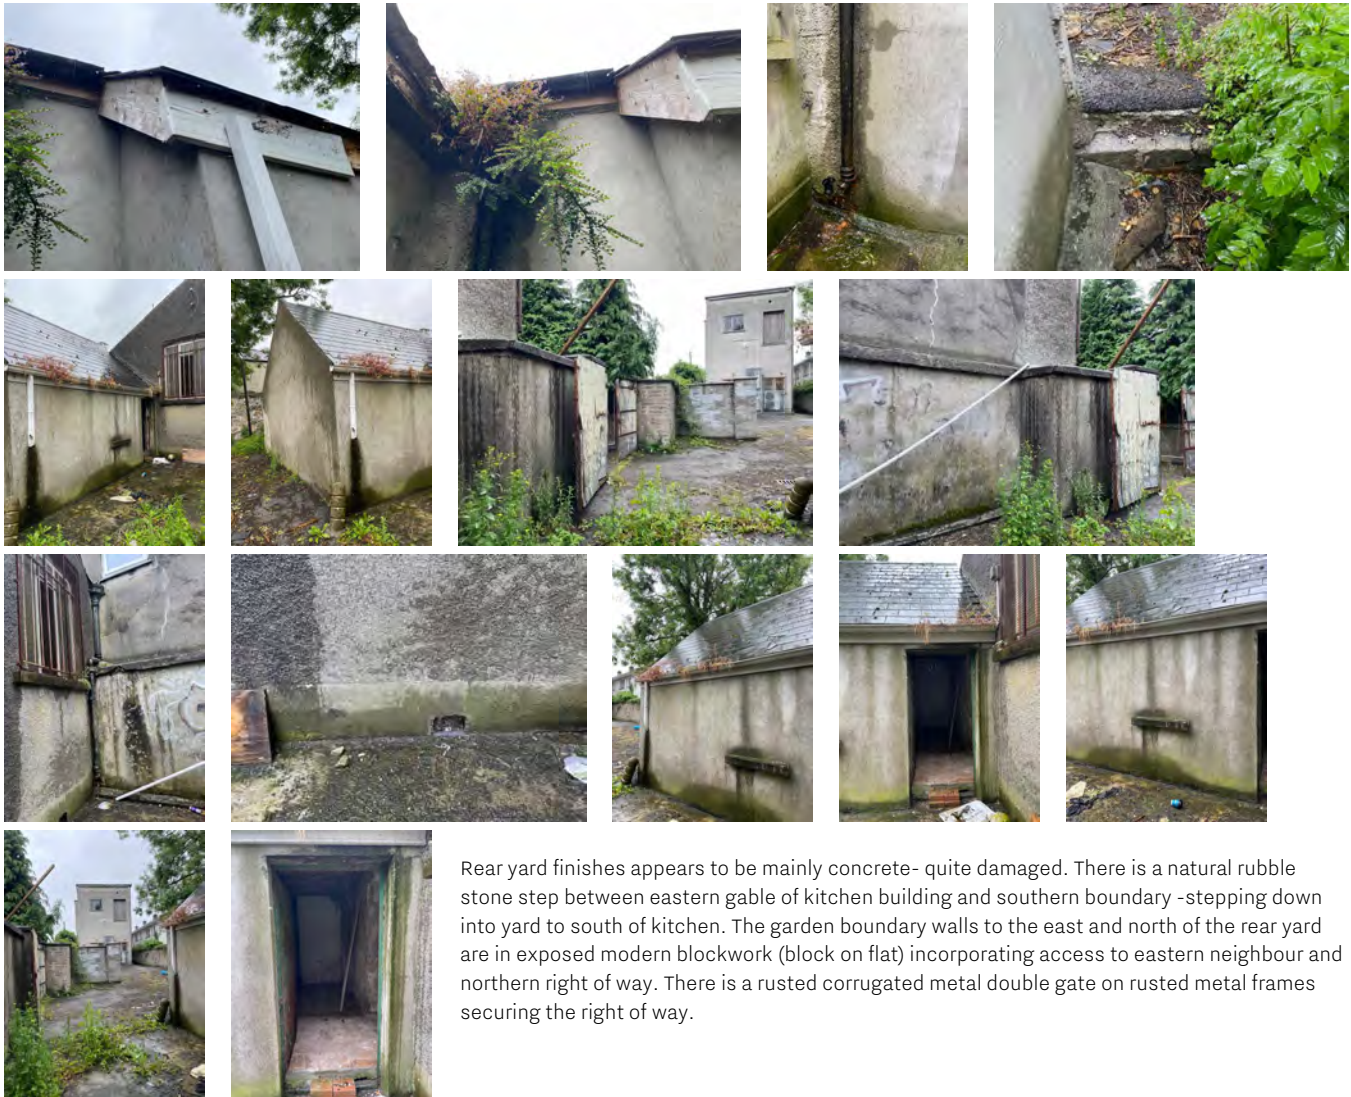
Rear gable wall of large open plan room has unpainted dashed cement render finish. The high level external windows have metal security grilles. The old kitchen rear single storey building has unpainted smooth cement render finish. The window cill is visible on north kitchen wall where window blocked up. The pitched roof finishes appear to be modern fibre cement slate. There are upvc rainwater goods to the old kitchen building- the northern gutter is full of vegetation- southern gutter is mostly missing- the downpipe is broken. There is no chimney visible externally over the old kitchen.

There is a cast iron Soil vent stack to the south of the kitchen building near the southern boundary wall.

Window cills are visible on south kitchen wall and east of extension where windows blocked up externally. Rainwater downpipes to the south of the old kitchen are overgrown with vegetation. Temporary plastic pipes placed over flat roof extension presumably for surface water drainage. Upvc downpipe and part fascia to south of kitchen-gutters & upvc fascias mostly missing.

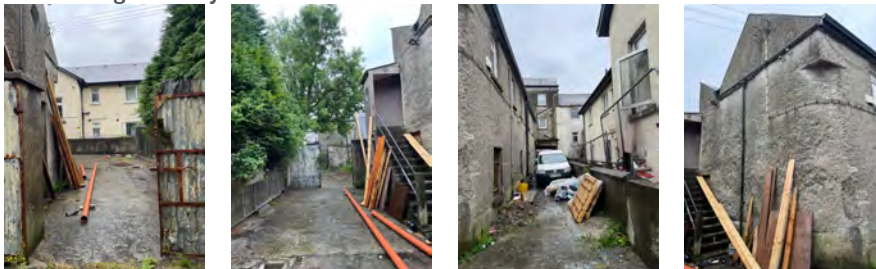
External Right of Way

There was resurfacing work taking place to the surface of the existing right of way near the street/ under the existing archway on the day of visit. The surface is generally concrete . The right of way has a lot of rubbish. There was fit out work going on to the ground floor unit to the north of the property.
