**Pobail Le Cheile  
Regeneration Project  
Ballymahon, Co. Longford  
Engineering Services Report**

| Document Control Sheet | |
|---|---|
| Document Reference | TR01 Engineering Services Report |
| Client: | Longford County Council |

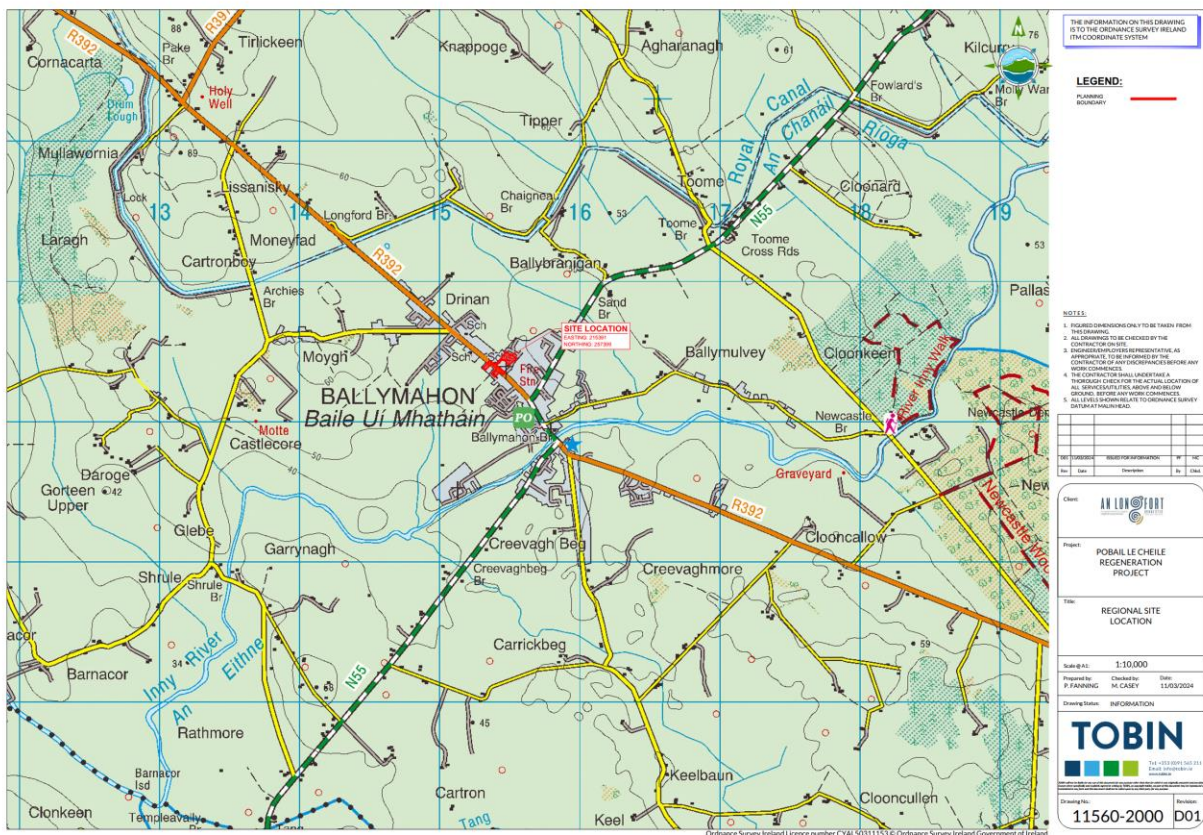
Figure 1-1: Site Location drawing 11560-2000

The project is located at three existing sites within the centre of Ballymahon town. Two of the sites are located on the southern side of the R392 and the final site is located on the western side of the Church View street.

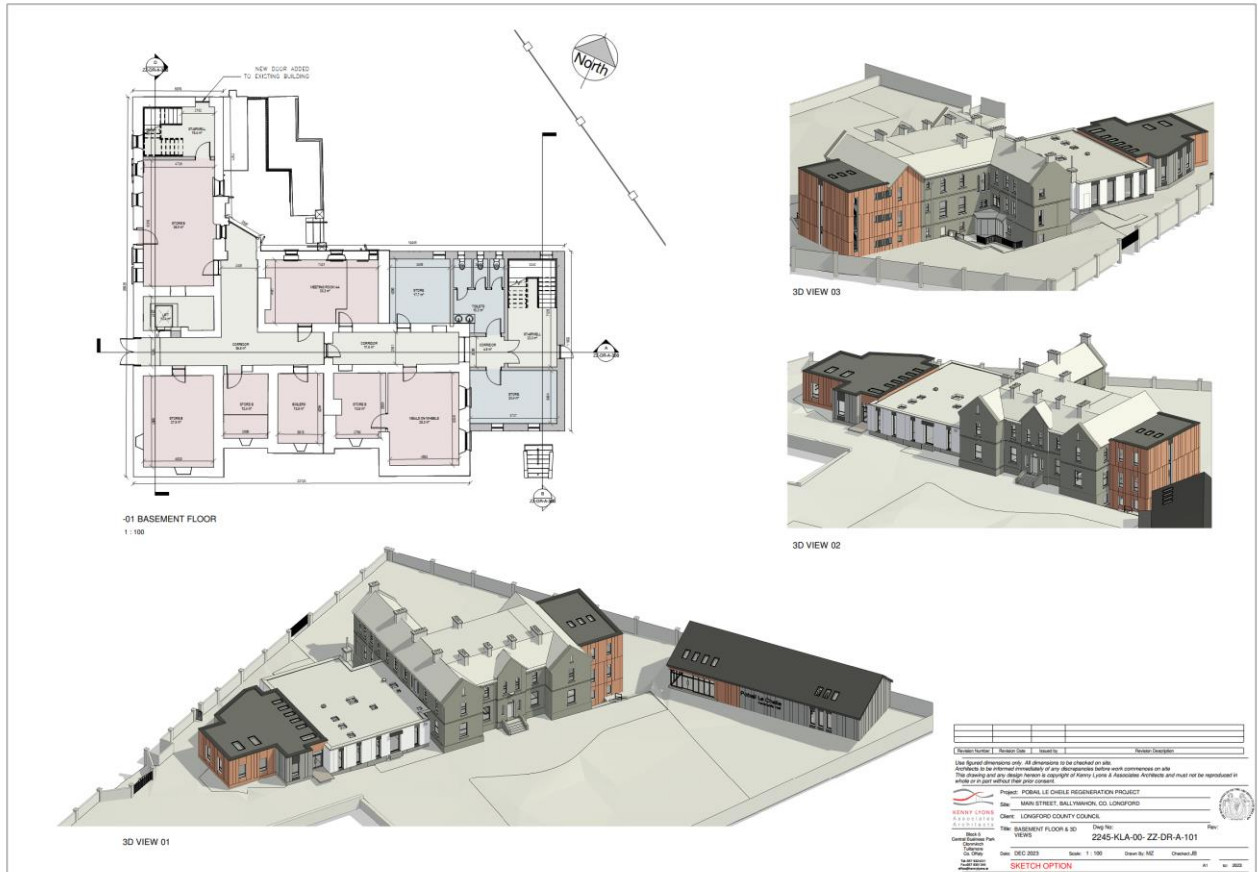
The convent building regeneration works involves the demolition of two existing extensions, construction of two new extensions, new car parking facilities, a new stand alone building and upgrading of drainage infrastructure.

Figure 1-4: Convent building, drawing 2245-KLA-00-ZZ-DR-A-101

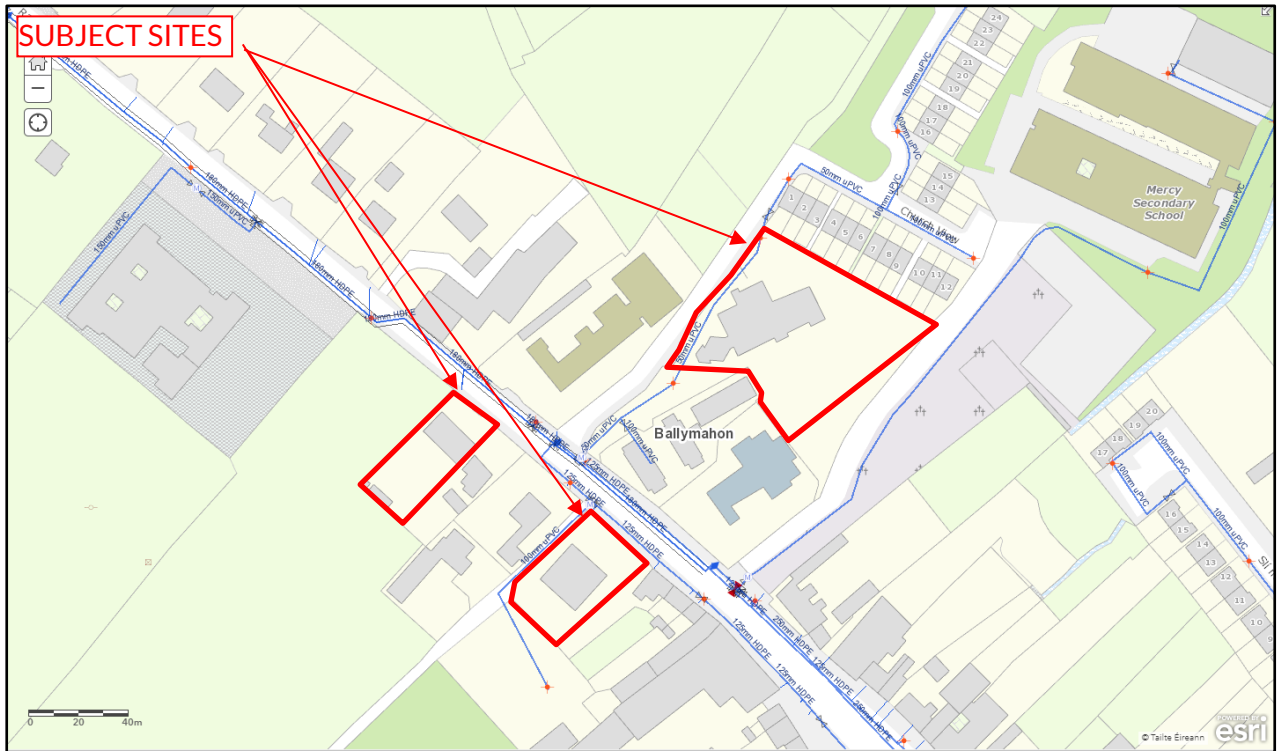
Uisce Eireann’s records indicate a 180mm HDPE and 125mm HDPE pipes traversing beneath the R392 and a 50mm uPVC travelling through the Convent House site.

There is currently potable water already serving the three sites. Further investigations is required discover the location of the existing connection and its size.

Figure 3-1: Uisce Eireann's Potable Water Records

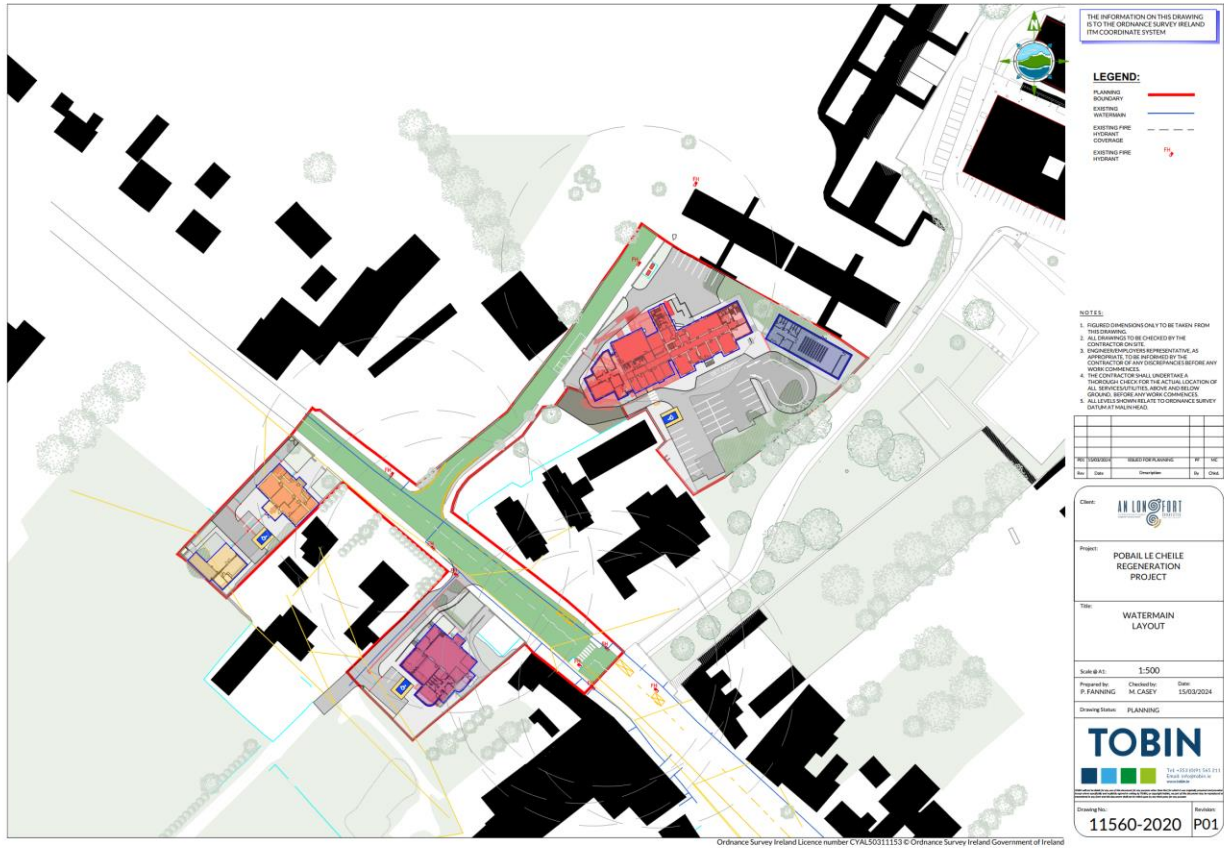
It is proposed to maintain the existing potable water connections on all three sites, therefore no new connections are required.

Figure 3-2: Watermain Layout, drawing 11560-2020

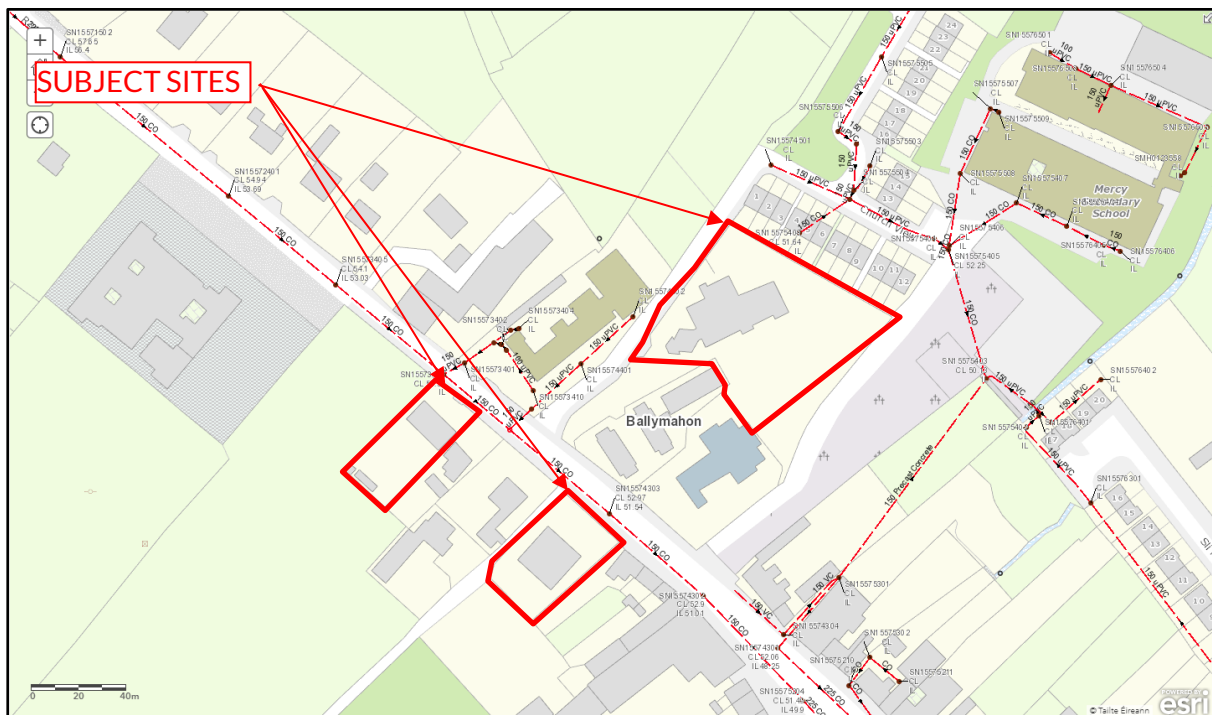
Uisce Eireann’s records indicate the presence of an existing 150mm Concrete pipe traversing underneath the R392 road.

Presently both the school house and library discharge foul and surface water runoff to the foul pipe located within the R392 road.

The convent building from review of the GPR maps, discharges both its foul and surface water through the boundary wall located at the Northeast corner. Possibly discharging into the 150mm foul concrete pipe located within Mercy Secondary School’s land.

Figure 4-1: Uisce Eireann's Wastewater Records

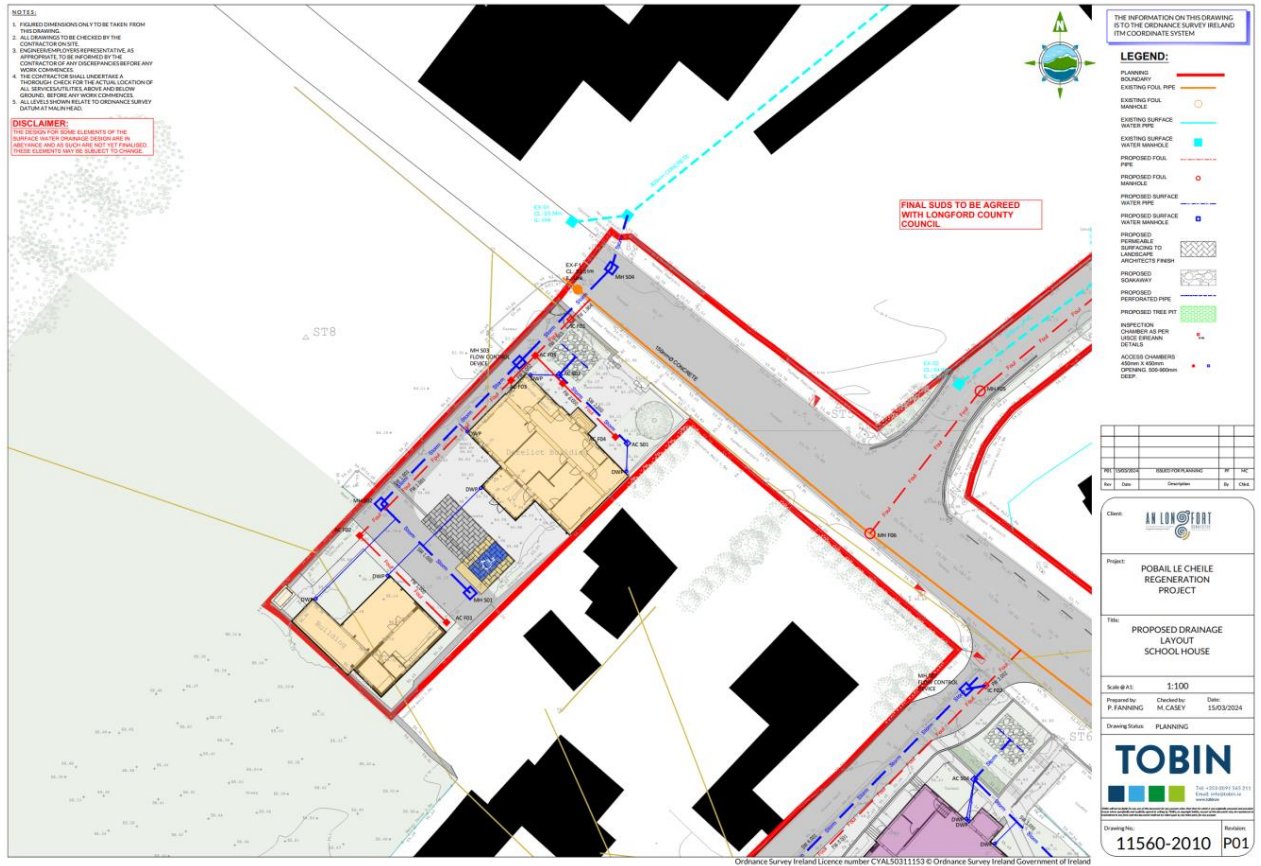
It is proposed to lay new collector and carrier pipes internally on all sites. These new pipes will only collect wastewater discharge from the buildings. Once collected, the underground pipes will convey the wastewater effluent into the existing discharge manhole on the site and will reuse the existing foul connection pipe, thus discharging the wastewater into the existing Uisce Eireann infrastructure, with the exception of the Convent House.

Figure 4-2: Proposed School House Drainage, drawing 11560-2010

For further information on the proposed Wastewater layout please refer to drawings 11560-2010, 11560-2011 and 11560-2012.

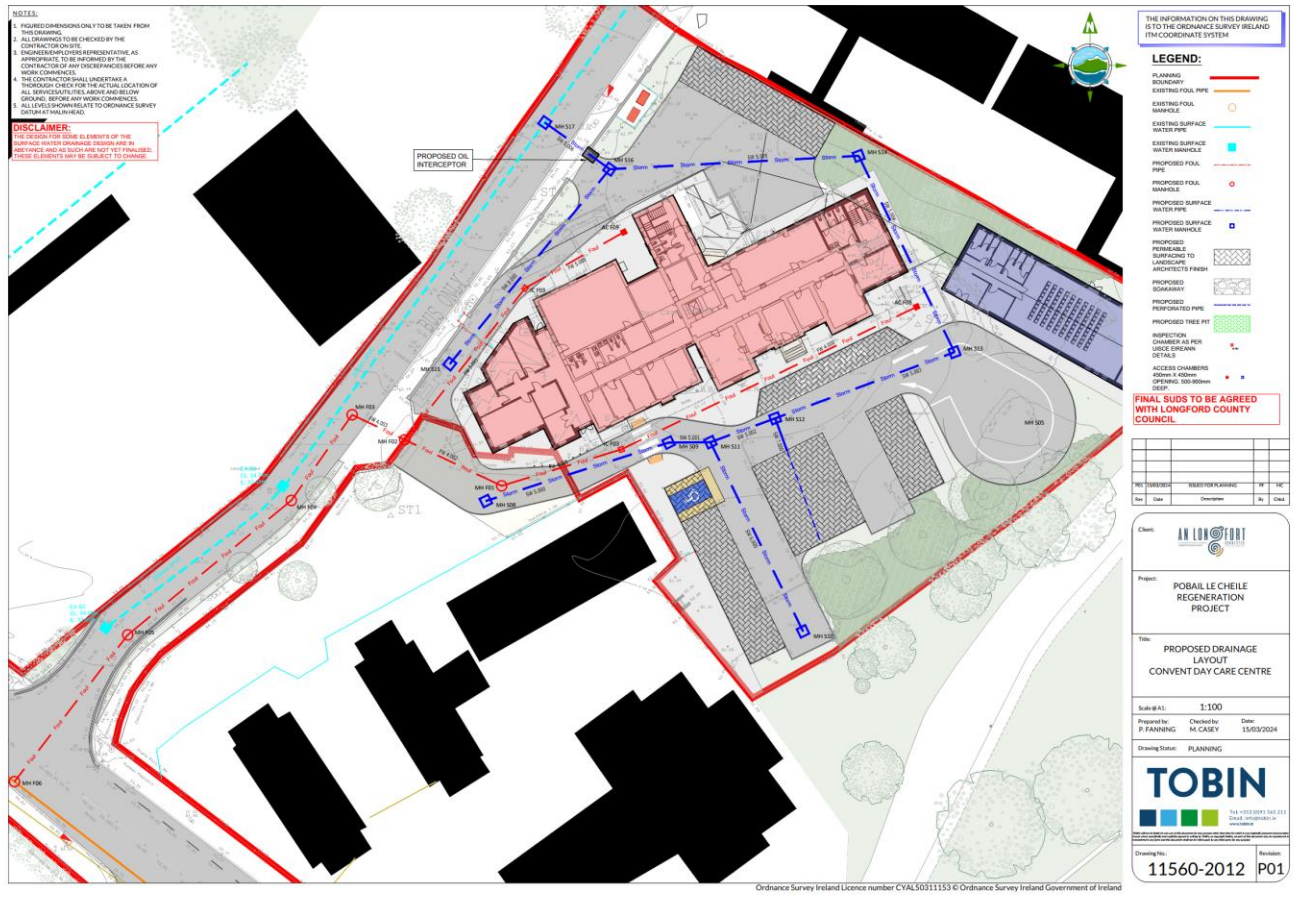
It is proposed to construct a new discharge public pipe along the Church View road for the convent House to discharge the wastewater effluent into the 150mm Concrete pipe located in the R392.

Figure 4-3: Proposed Convent Drainage, drawing 11560-2012

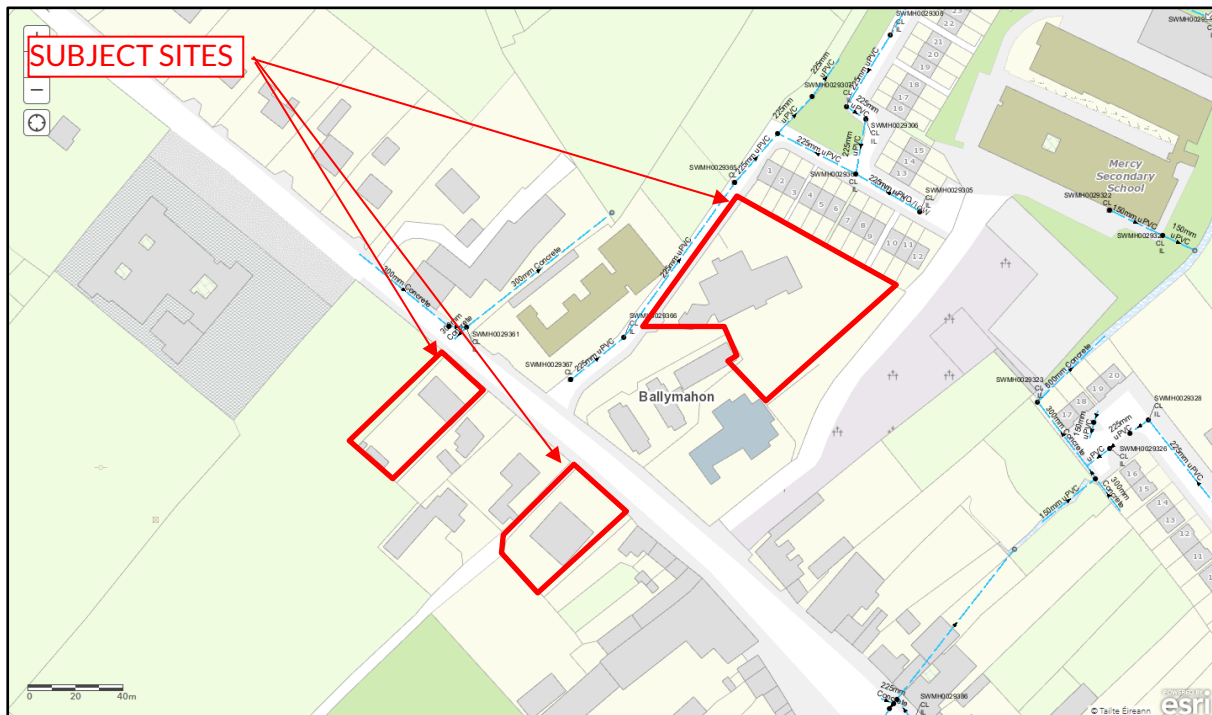
Longford County Council's records indicate the presence of a 300mm Concrete public surface water pipe traversing through the existing garage across from the School House site and appears to continue falling Northeasterly. The records also indicate a 225mm uPVC pipe traversing along church View, which continues falling Northeasterly.

Figure 5-1: Longford County Council's Surface Water Record Maps

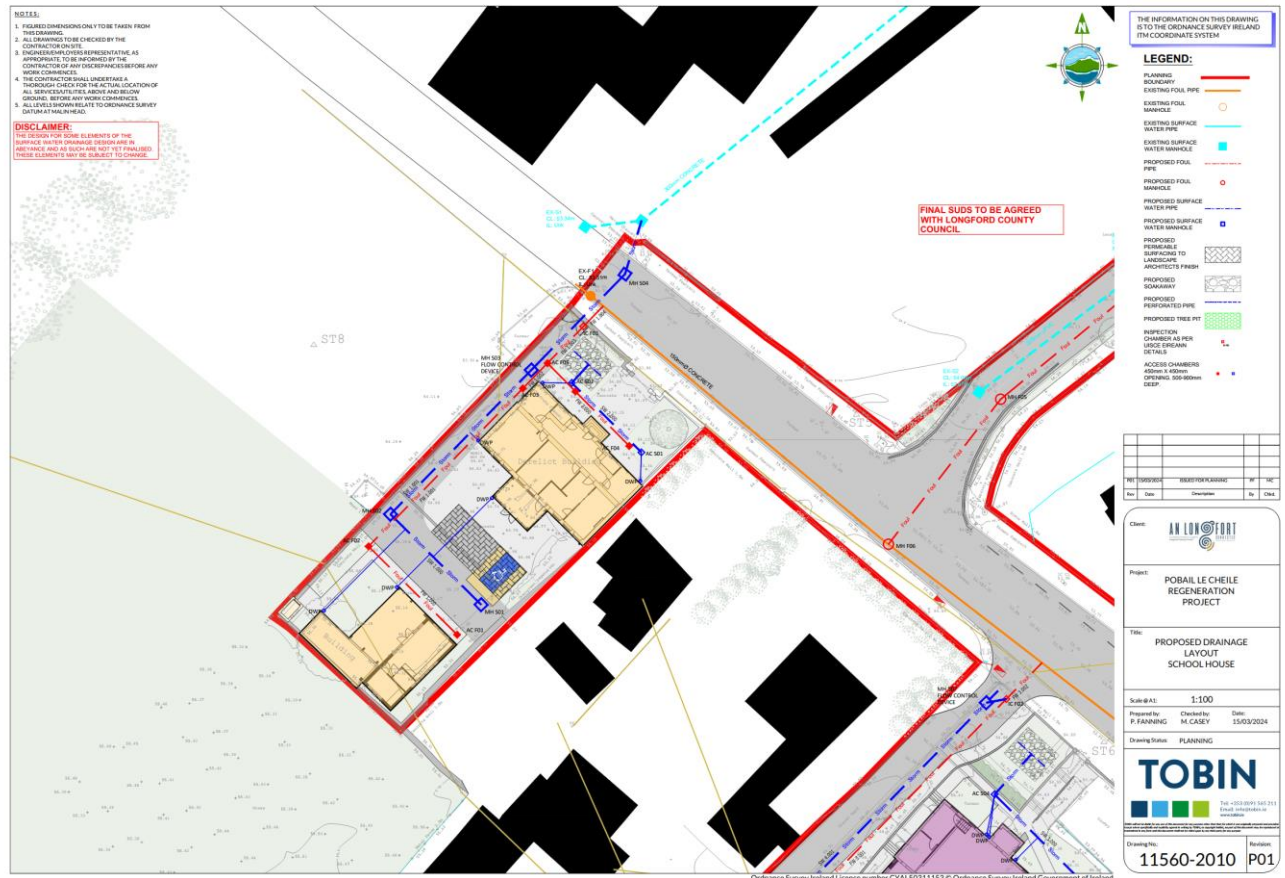
It is proposed to discharge the School House site into the existing 300mm concrete public pipe located in the R392 road.

Figure 5-2: Proposed School House Drainage, drawing 11560-2010

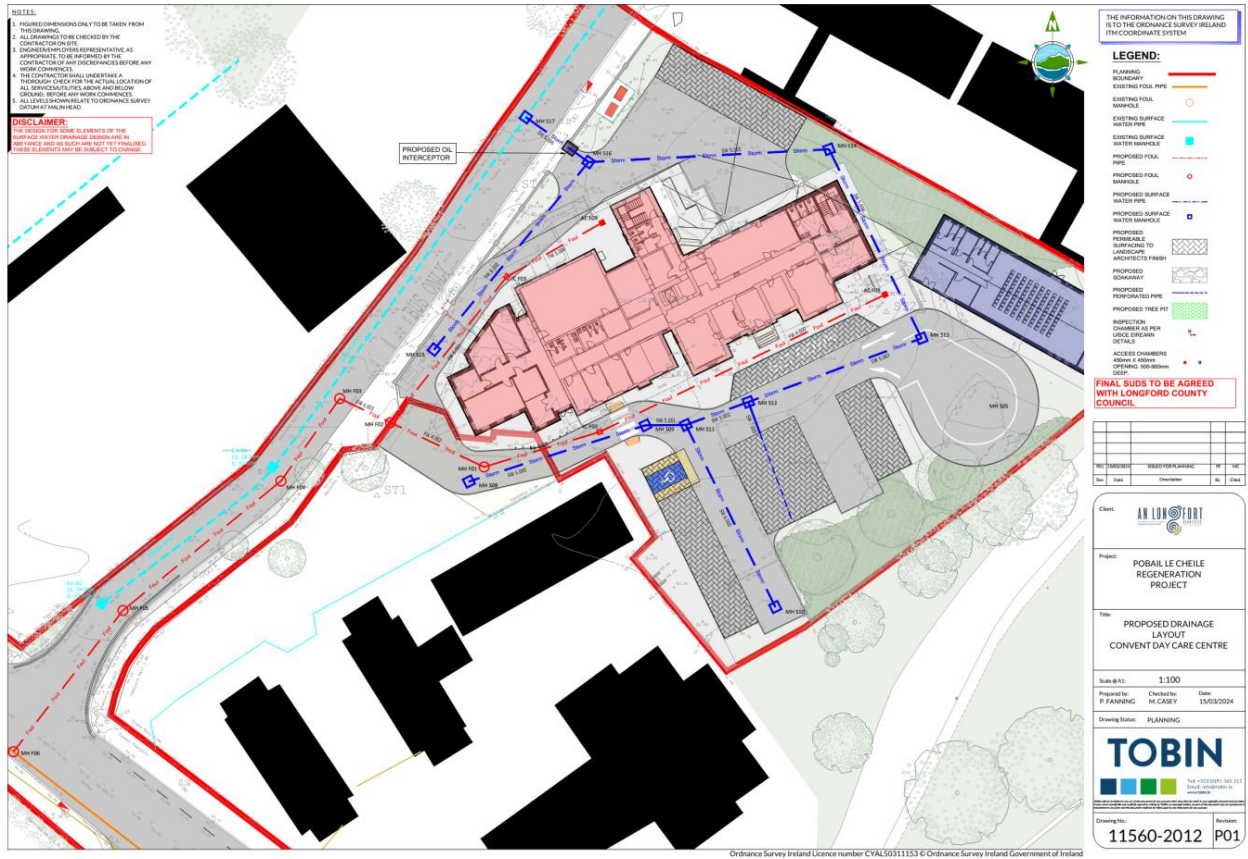
It is proposed to discharge the Convent house site into the existing 225mm uPVC pipe, located within the Church View road.

Figure 5-3: Proposed Convent Drainage, drawing 11560-2012

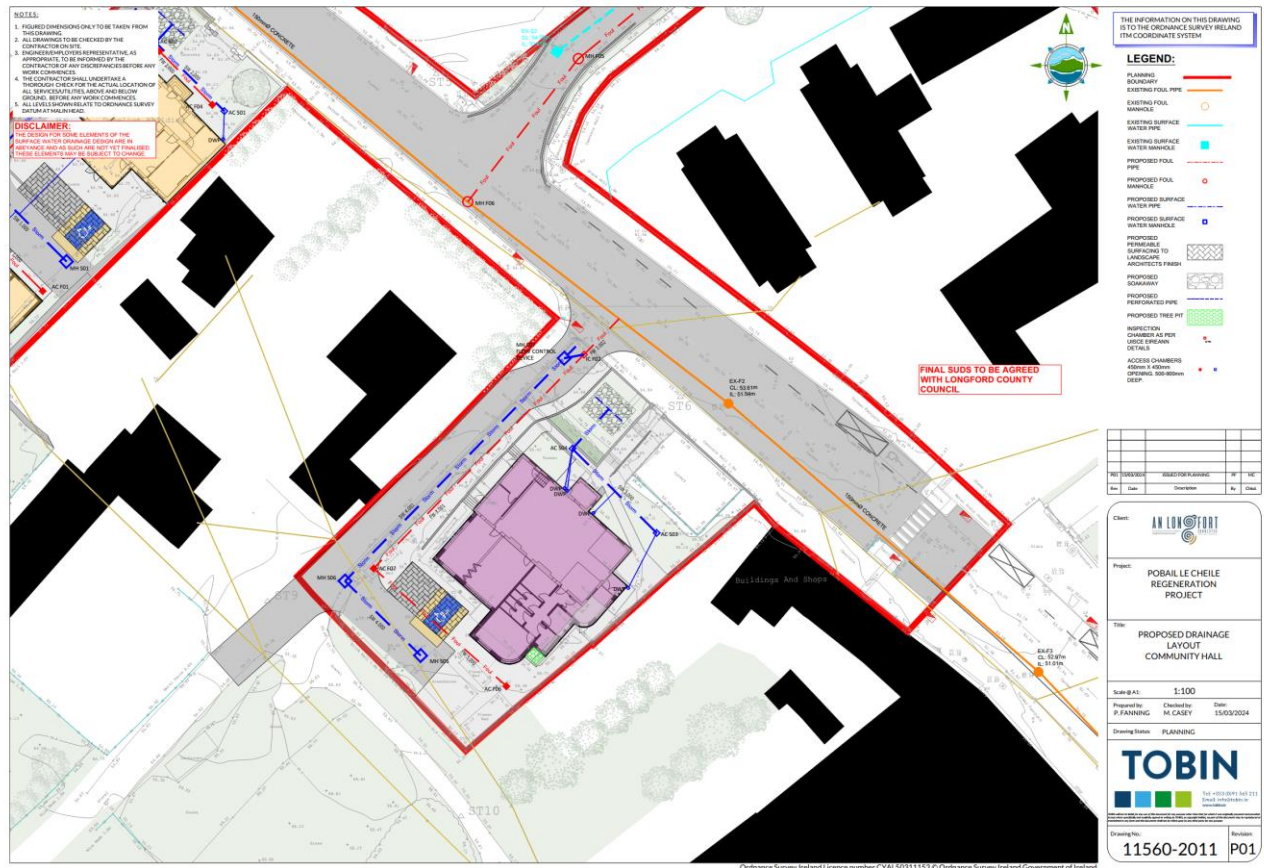
It is proposed to construct a discharge surface water manhole on the Library site, with a pipe extended out past the manhole for connection into a future public surface water pipe. The surface water will however temporarily discharge into the foul pipe located in the R392 road until such time as a connection can be made.

Figure 5-4: Proposed Library Drainage, drawing 11560-2011

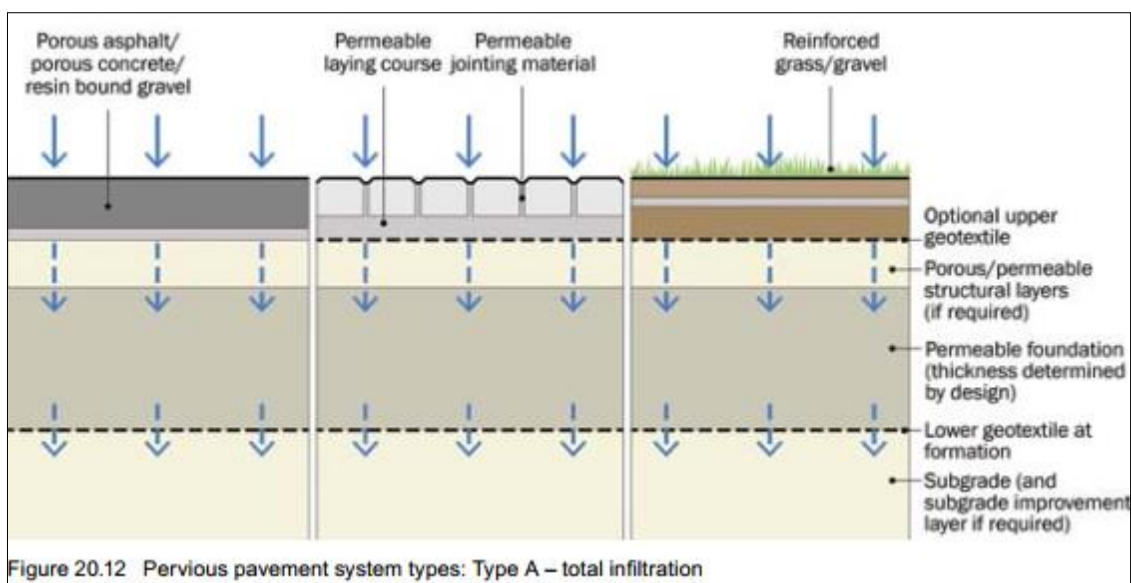
It is proposed to install permeable surfacing within the car parking areas of the sites. The water, once permeated into the pavement, will be allowed to infiltrate into the ground. The inclusion of the permeable paving will slow the surface water run off at source, treat the surface water runoff and provide storage. Refer to figure below.

Figure 5-5: Typical Cross Section of infiltration permeable paving (Extract from CIRA SuDs Manual)

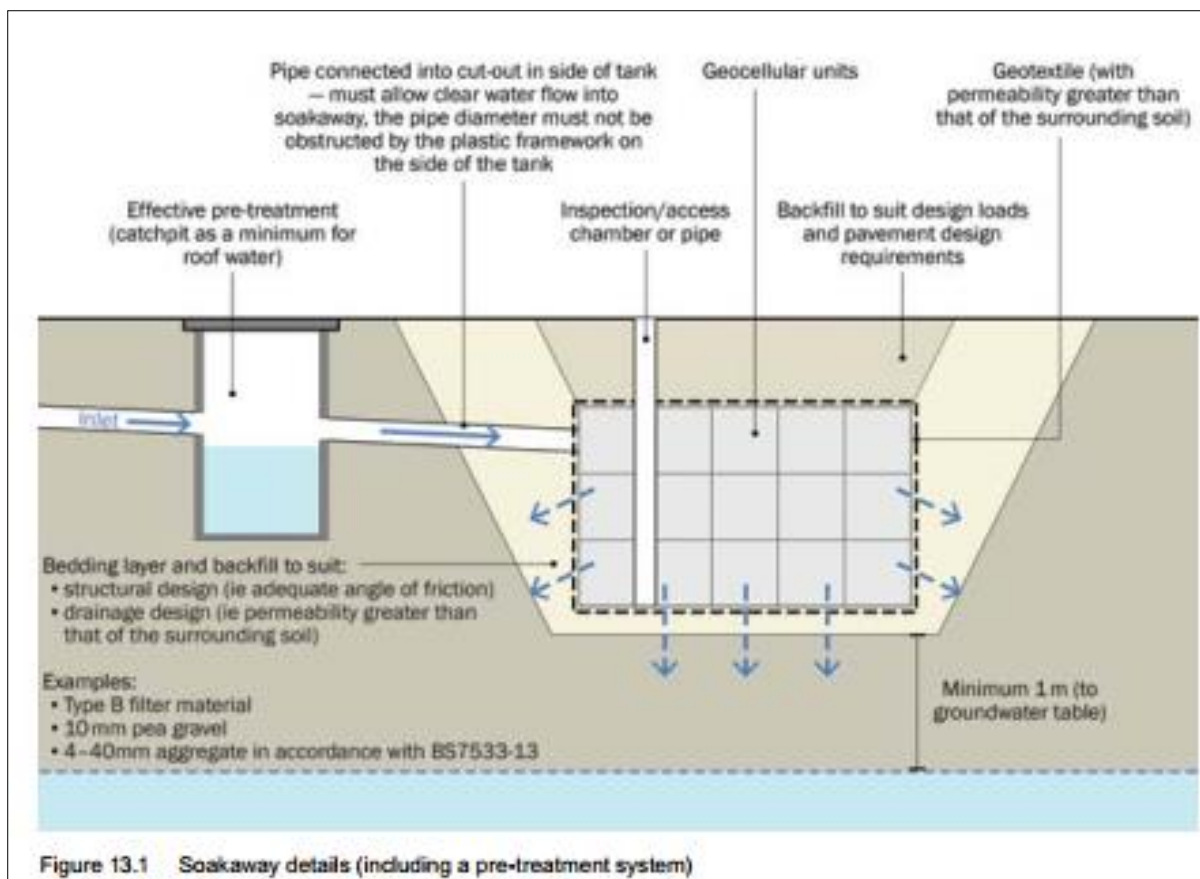
It is proposed to construct soakaways on the School house and Library sites, which will cater for surface water runoff from half of the existing roof and the entire front hardstanding areas. The surface water will be collected through downpipes, underground pipes and directed to a perforated pipe within the soakaway. The collected water will be allowed to infiltrate into the groundwater.

Figure 5-6: Typical Cross Section of a Soakaway (Extract from CIRA SuDs Manual)
