**Pobail Le Cheile  
Regeneration Project  
Ballymahon, Co. Longford  
Engineering Services Report**

Document Control Sheet	
Document Reference	TR01 Engineering Services Report
Client:	Longford County Council
Project Reference	11560

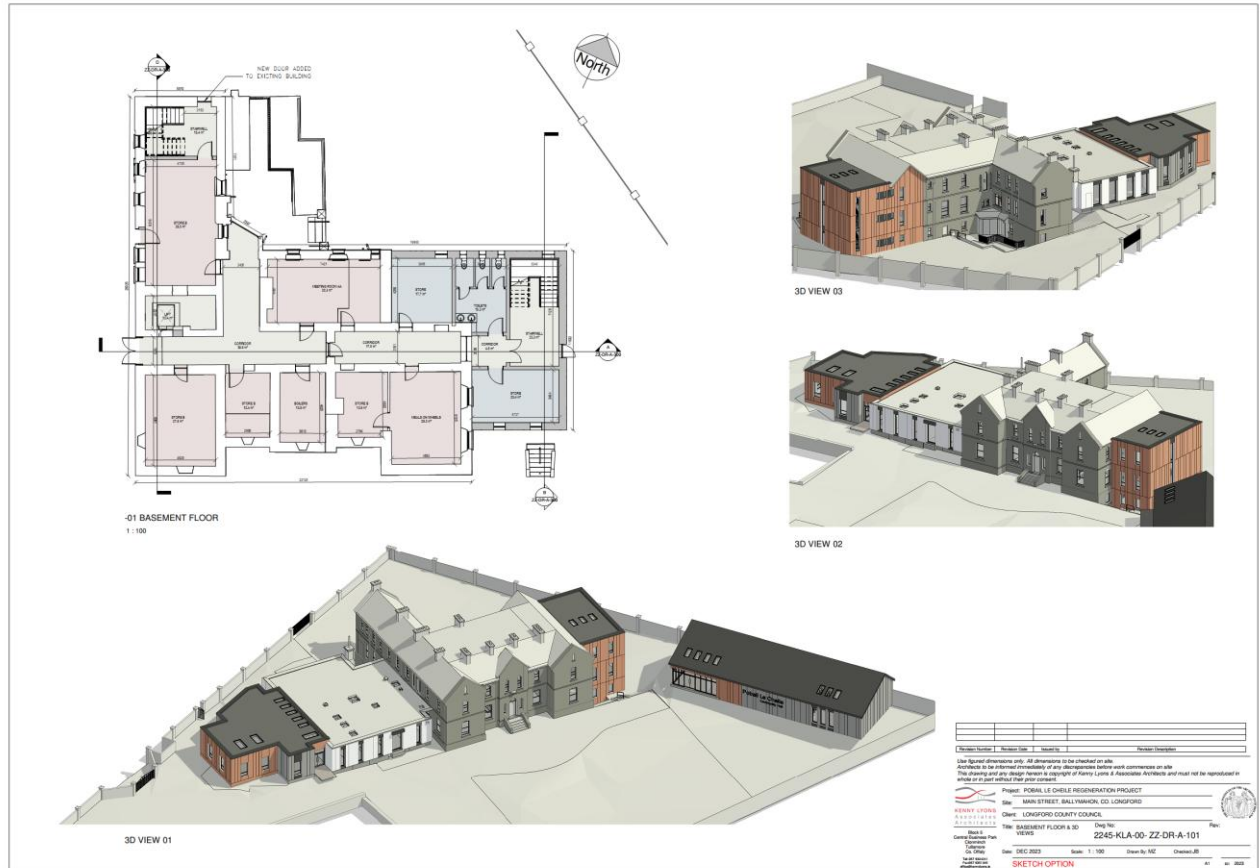
Figure 1-2: Convent building, drawing 2245-KLA-00-ZZ-DR-A-101

The convent building regeneration works involves the demolition of two existing extensions, construction of two new extensions, new car parking facilities, a new standalone building and upgrading of drainage infrastructure.

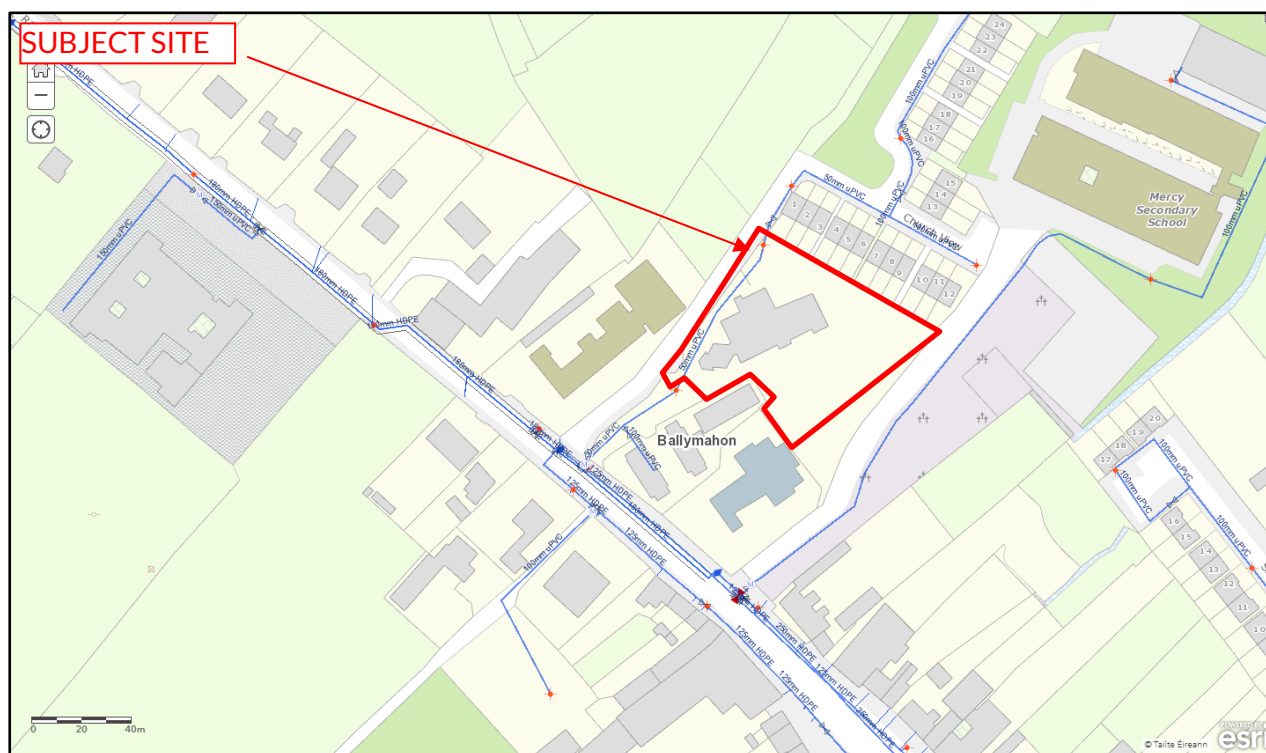
Figure 3-1: Uisce Eireann's Potable Water Records

Uisce Eireann's records indicate a 180mm HDPE and 125mm HDPE pipes traversing beneath the R392 and a 50mm uPVC travelling through the Convent House site.

There is currently potable water already serving the site. Further investigations is required discover the location of the existing connection and its size.

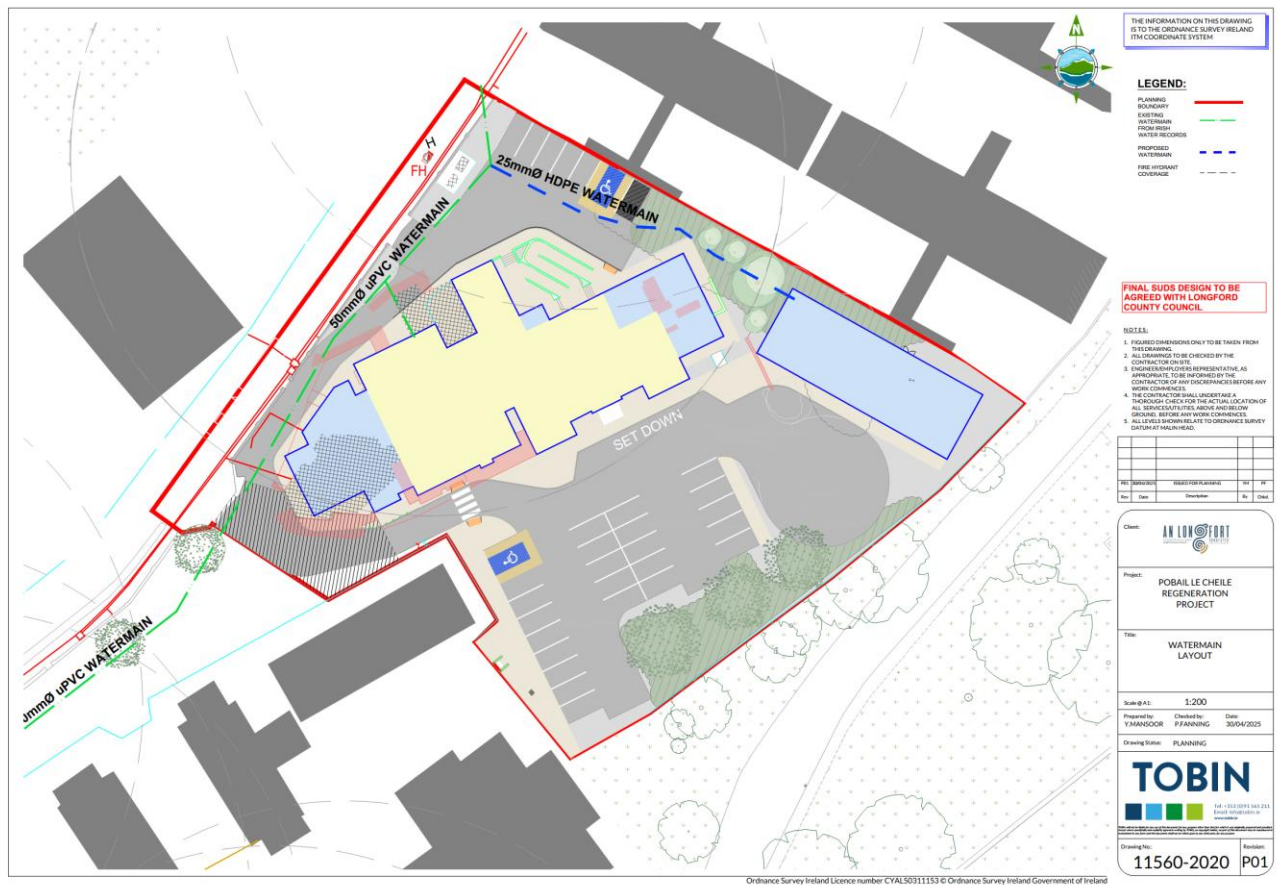
**Figure 3-2: Watermain Layout, drawing 11560-2020**

It is proposed to maintain the existing potable water connection on the site, therefore no new connections are required.

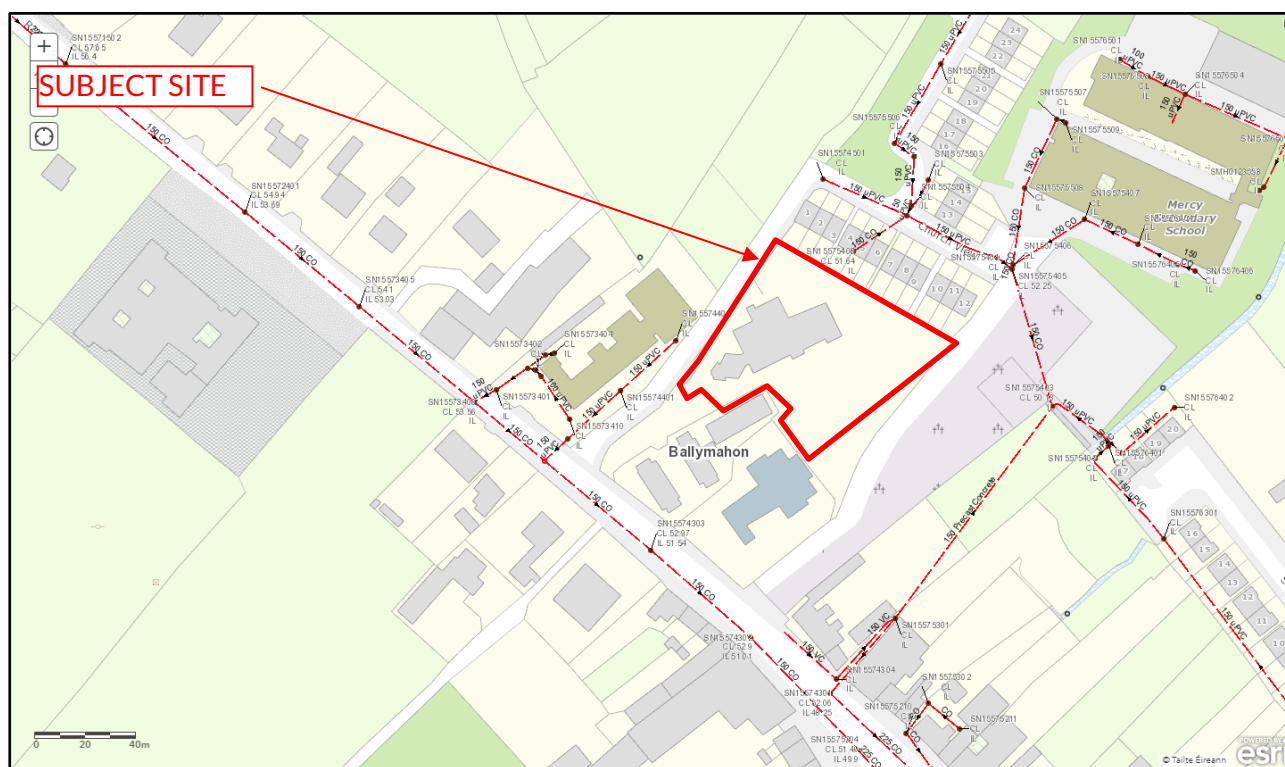
Figure 4-1: Uisce Éireann's Wastewater Records

Uisce Éireann's records indicate the presence of an existing 150mm Concrete pipe traversing underneath the R392 road.

The convent building from review of the GPR maps, discharges both its foul and surface water through the boundary wall located at the Northeast corner. Possibly discharging into the 150mm foul concrete pipe located within Mercy Secondary School's land.

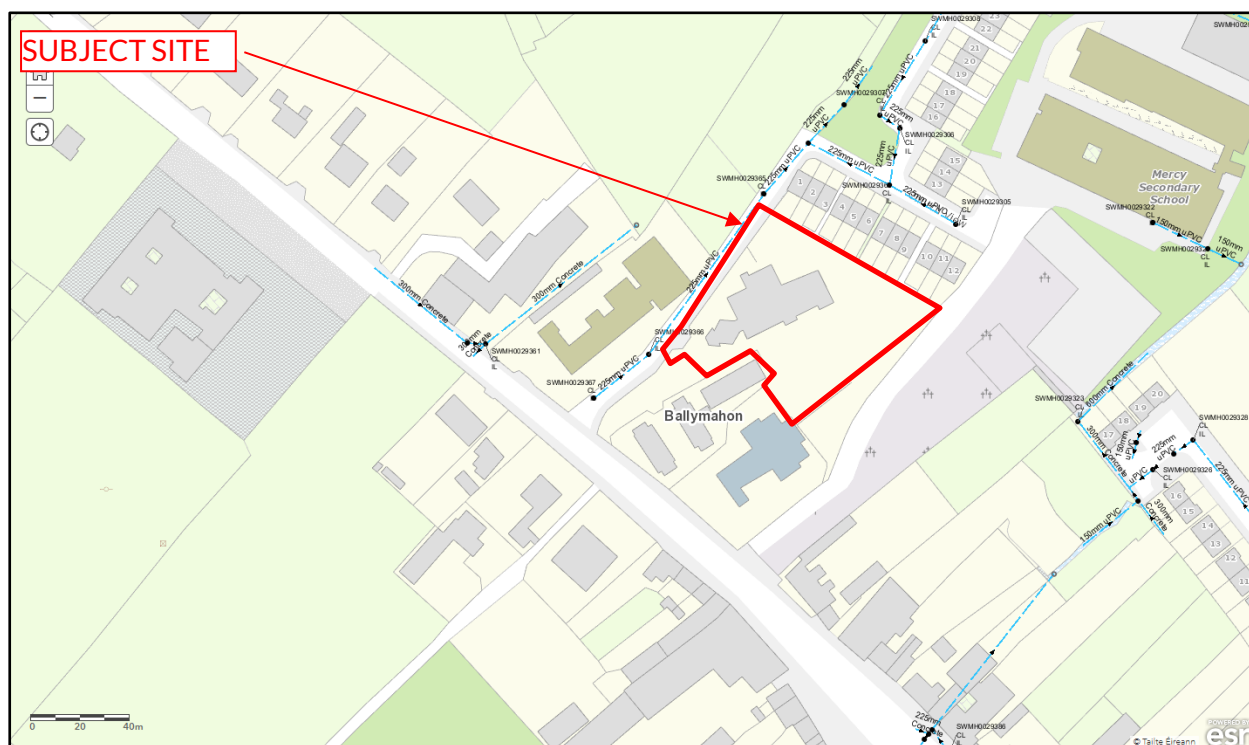
Figure 5-1: Longford County Council's Surface Water Record Maps

Longford County Council's records indicate the presence of a 300mm Concrete public surface water pipe traversing through the existing garage across from the School House site and appears to continue falling Northeasterly. The records also indicate a 225mm uPVC pipe traversing along church View, which continues falling Northeasterly.

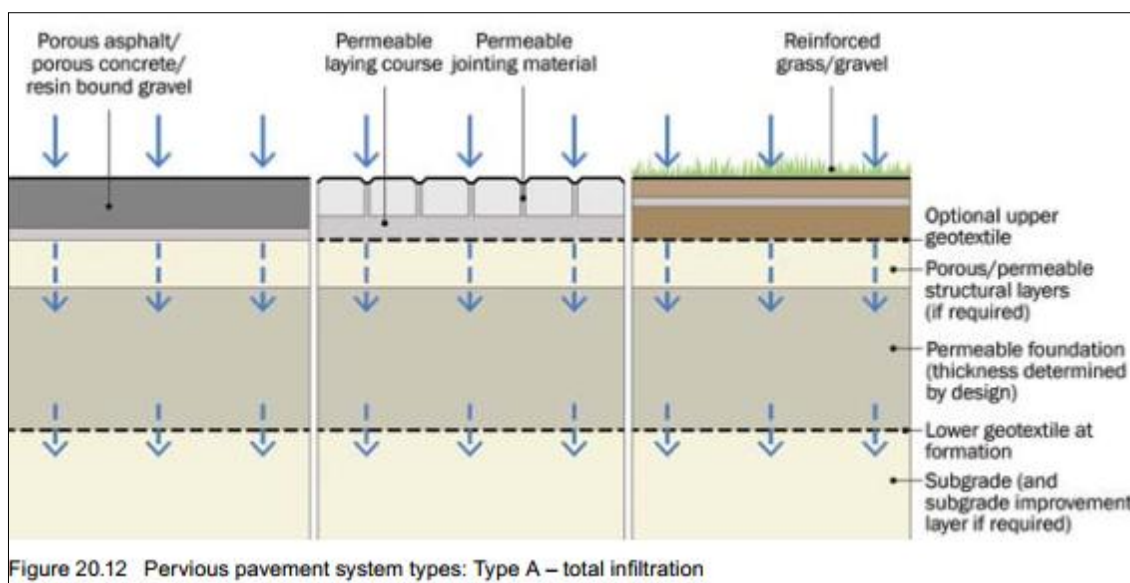
Figure 5-3: Typical Cross Section of infiltration permeable paving (Extract from CIRA SuDs Manual)

It is proposed to install permeable surfacing within the car parking areas of the site. The water, once permeated into the pavement, will be allowed to infiltrate into the ground. The inclusion of

the permeable paving will slow the surface water run off at source, treat the surface water runoff and provide storage. Refer to figure below.
